DA3B_LW16_003 Update (E288849, N6191590)

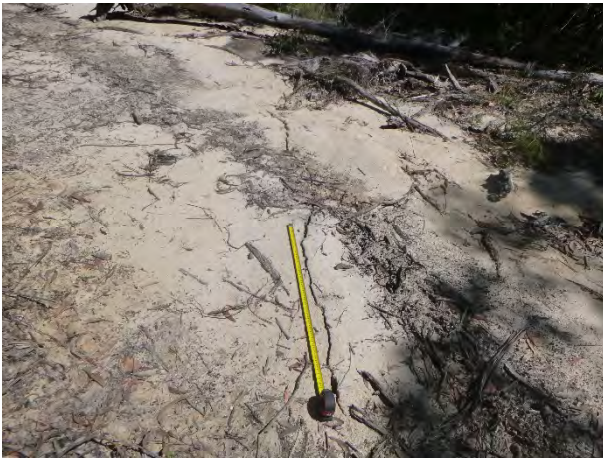
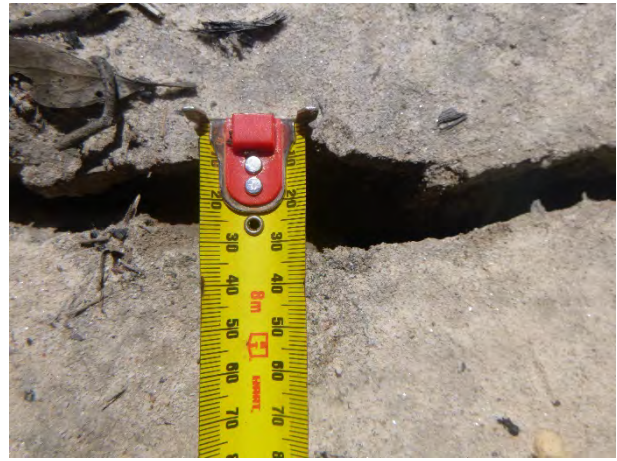
DA3B_LW16_034 is located on an access track running parallel to WC15 and was mined beneath by Longwall 16 on 8 September 2020 (Figure 1). The impact is comprised of three separate soil cracks spanning over a 25m length of the access track. The largest soil crack has a maximum continuous length of 9m, a maximum width of 0.03m and a maximum measurable depth of 0.45m.

DA3B_LW16_034 is a Level 1 trigger as per the DA3B Landscape TARP (Table 2), specifically:

- Crack or fracture up to 100mm width
- Crack or fracture up to 10m length

Photo 7: DA3B_LW16_034, looking at the length of soil cracking. Taken 28/09/2020.

Photo 8: DA3B_LW16_034 looking at the width of soil cracking. Taken on 28/09/2020.

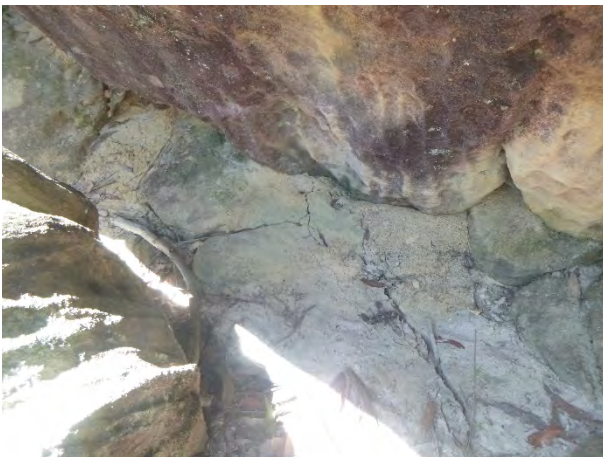
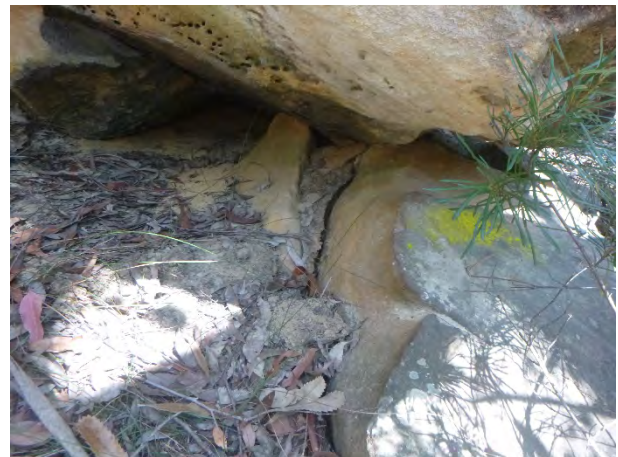
DA3B_LW16_035 is located approximately 15m from SLMMP site A3B-SS17 and was mined beneath by Longwall 16 on 11 September 2020 (Figure 1). The impact is comprised of soil cracking and displacement underneath a boulder. The soil cracking has an approximate length of 1m and an approximate width of 0.015m. The rock displacement has an approximate width of 0.015m. Measurements have been approximated due to safety concerns accessing beneath a step during active subsidence.

DA3B_LW16_035 is a Level 1 trigger as per the DA3B Landscape TARP (Table 2), specifically:

- Crack or fracture up to 100mm width
- Crack or fracture up to 10m length
- Surface movement or rock displacement with negligible soil surface exposed

Photo 9: DA3B_LW16_035, looking at a section of soil cracking. Taken 28/09/2020.

Photo 10: DA3B_LW16_035, looking at a section of displacement. Taken on 28/09/2020.

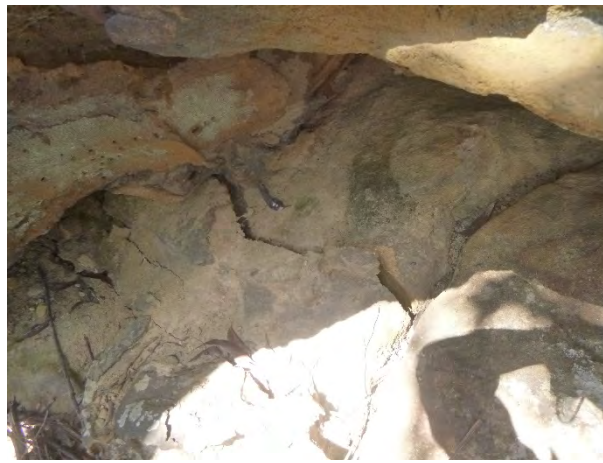
DA3B_LW16_036 is located at SLMMP site A3B-SS17 and was mined beneath by Longwall 16 on 11 September 2020 (Figure 1). The impact is comprised of a rock fracture to the base of a 2.5m step. The rock fracture has an approximate length of 1m and approximate width of 0.04m. Measurements have been approximated due to safety concerns accessing beneath a step during active subsidence.

DA3B_LW16_036 is a Level 1 trigger as per the DA3B Landscape TARP (Table 2), specifically:

- Crack or fracture up to 100mm width
- Crack or fracture up to 10m length

Photo 11: DA3B_LW16_036, looking at a section of rock fracturing. Taken 28/09/2020.

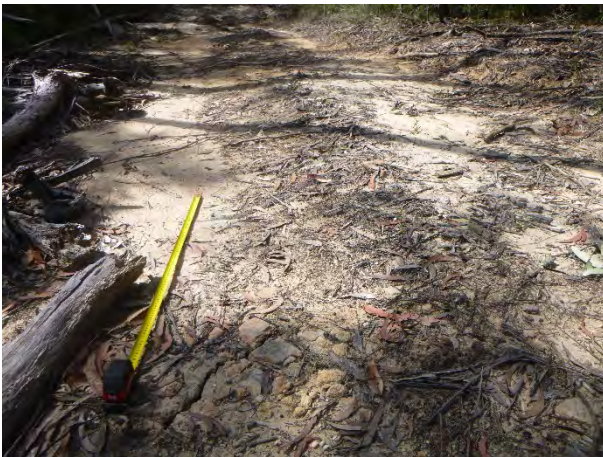
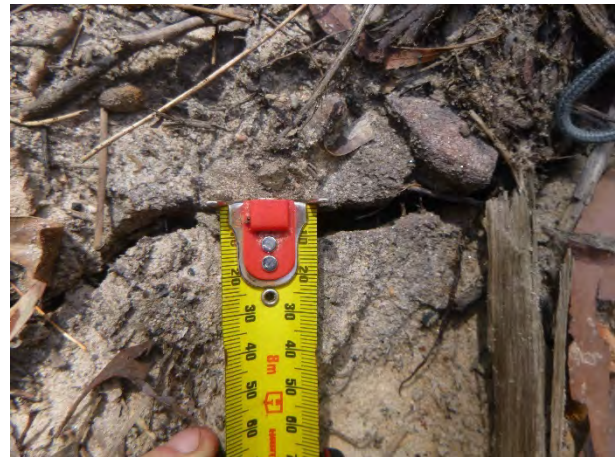
DA3B_LW16_037 is located at SLMMP site AT5-SLMMP and was mined beneath by Longwall 16 on 7 September 2020 (Figure 1). The impact is comprised of five separate soil cracks within a 35m length of an access track. The soil cracking has a maximum continuous length of 1.4m, a maximum width of 0.01m and a maximum measurable depth of 0.29m.

DA3B_LW16_037 is a Level 1 trigger as per the DA3B Landscape TARP (Table 2), specifically:

- Crack or fracture up to 100mm width
- Crack or fracture up to 10m length

Photo 12: DA3B_LW16_037, overview of soil cracking. Taken 28/09/2020.

Photo 13: DA3B_LW16_037, looking at the width of soil cracking. Taken on 28/09/2020.

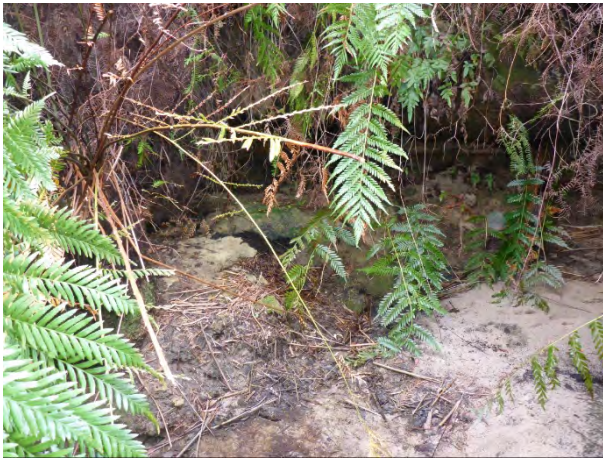
Photo 14: LA2_Pool 34, looking upstream. Taken on 24/03/2020, prior to identification of the iron staining.

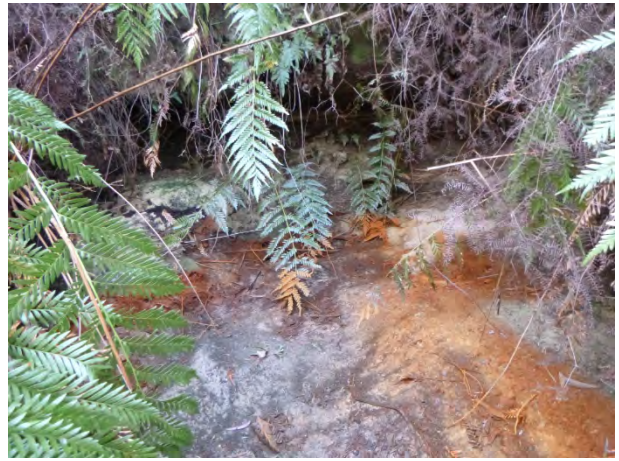
DA3B_LW16_038 consists of iron staining observed in tributary LA2 following the passing of Longwall 16 (Figure 1). The impacted site, Pool 34, was mined beneath by Longwall 16 on 5 May 2020. Throughout the monitoring period the pool has generally been ephemeral, responding to rainfall events. Following a recent rainfall event, iron staining was observed for the first time. The iron staining is localised to this pool and does not extend downstream.

DA3B_LW16_038 is a Level 1 trigger as per the DA3B Watercourse TARP (Table 2), specifically:

- Observable increase in iron staining within the mining area.

Photo 15: DA3B_LW16_038- iron staining at LA2_Pool 34, looking upstream. Taken on 14/09/2020.

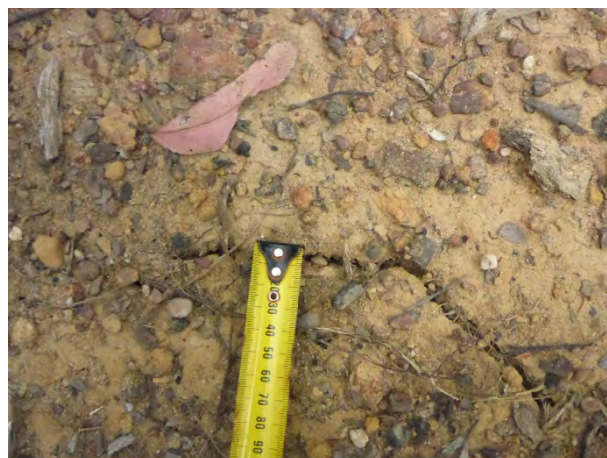
DA3B_LW16_039 consists of a series of soil cracks on an access track to the east of Swamp 14 (Figure 1). The cracks are up to 1.8m long, with a maximum width of 0.01m and measurable depth of 0.16m (Photo 1 and Photo 2).

Photo 2: DA3B_LW16_039 soil cracking to access track. Taken on 7/10/2020.

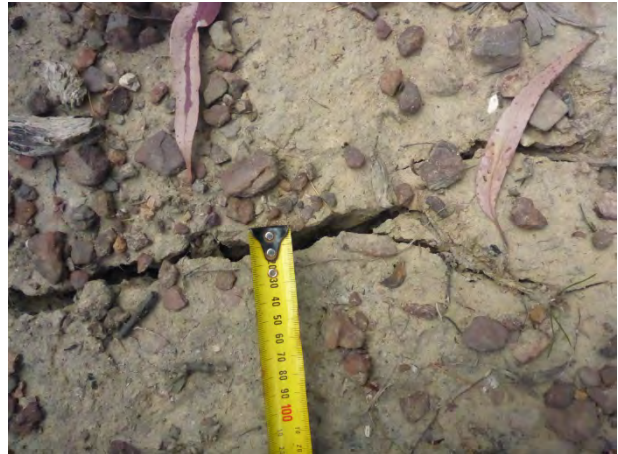
Photo 4: *DA3B_LW16_040*- soil cracking to access track. Taken on 7/10/2020.

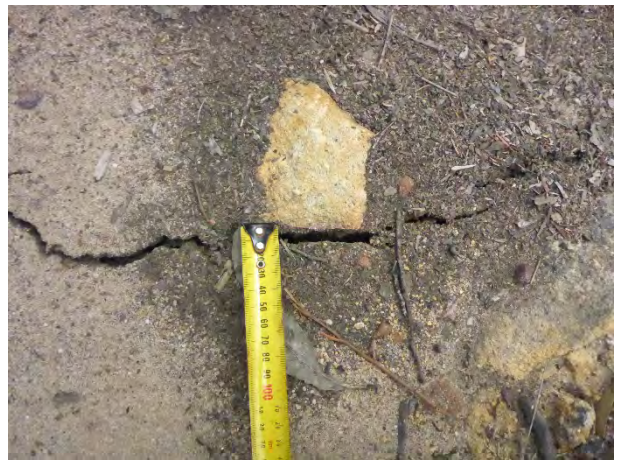
Photo 6: DA3B_LW16_041- soil cracking to access track. Taken on 7/10/2020.

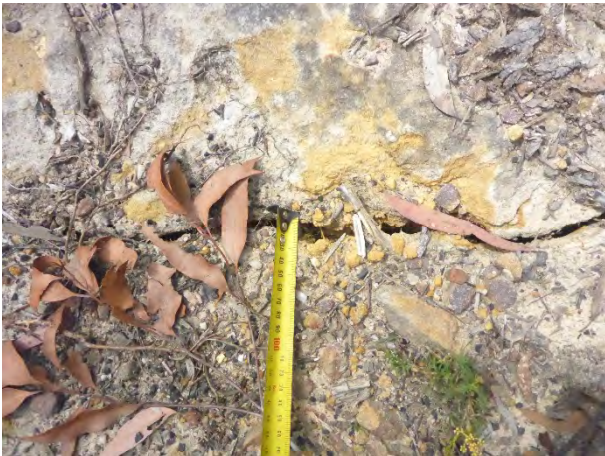
Photo 7: DA3B_LW16_041- soil cracking and displacement on access track. Taken on 7/10/2020.

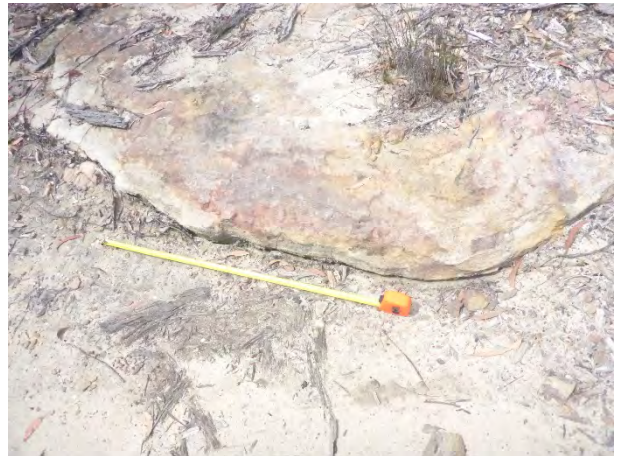
Photo 8: DA3B_LW16_041- displacement of soil from rock outcrop. Taken on 7/10/2020.

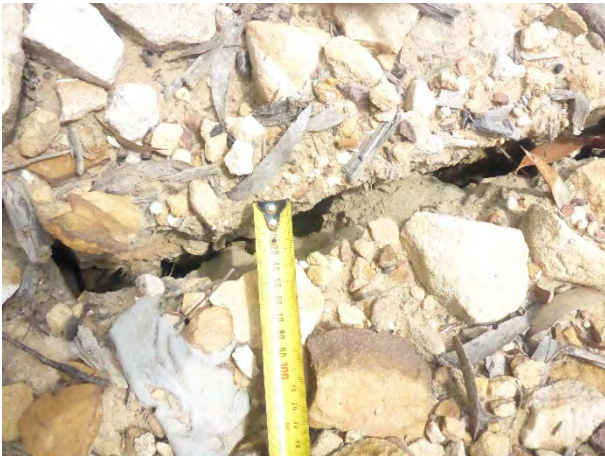
DA3B_LW16_042 consists of a group of discontinuous soil cracks to a steep section of access track to the east of Swamp 14 (Figure 1). The zone extends for approximately 30m, with the largest continuous crack up to 5.5m long and 0.04m wide, with a measurable depth of 0.75m (Photo 9 to Photo 12).

Photo 11: DA3B_LW16_042- soil cracking to access track. Taken on 7/10/2020.

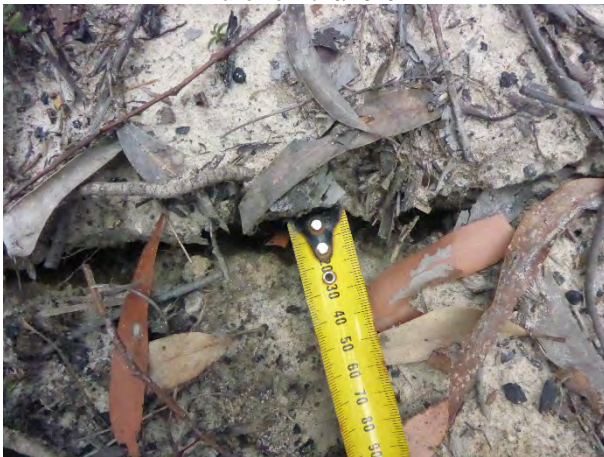
DA3B_LW16_043 consists of multiple discontinuous soil cracks to an access to the east of Swamp 14 (Figure 1). The largest continuous crack is up to 1.1m long and 0.02m wide, with a measurable depth of 0.35m (Photo 13 to Photo 15).

Photo 15: DA3B_LW16_043- soil cracking to access track.
Taken on 7/10/2020.

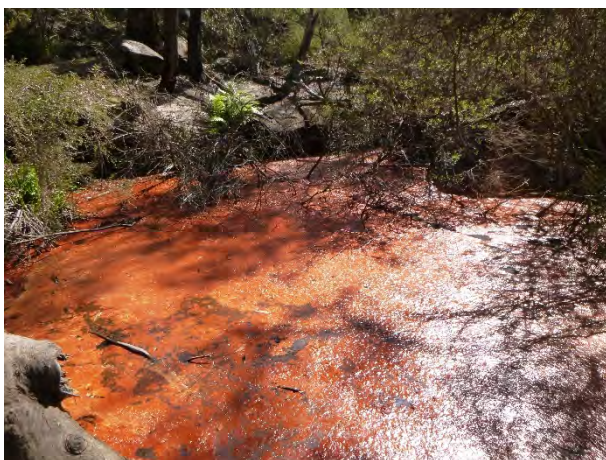
DA3_LW8_158 is now a Level 2 trigger as per the Dendrobium Area 3A Watercourse TARP (Appendix A: Table 2), specifically:

- Increase in iron staining, algal growth, or other observed changes, for >2 consecutive months in *Sandy Creek*, determined by comparing baseline photos with photos during the mining period.

Photo 1 *SC10C_Pool 3*, looking upstream at the furthest upstream location of the iron staining. Taken: 3/09/2020.

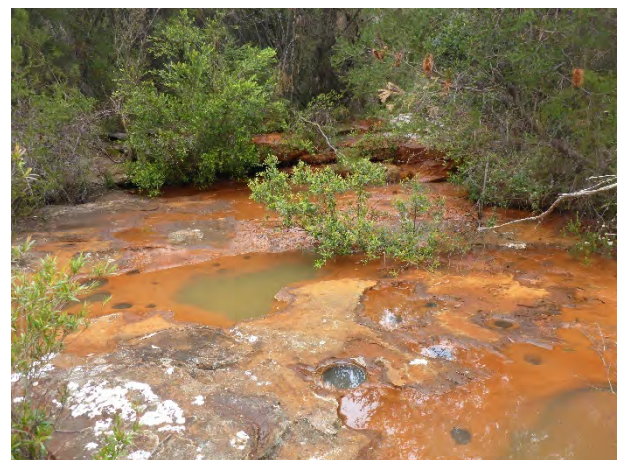
Photo 2: *SC10_Rockbar 3*, looking upstream during the latest inspection. Taken: 14/10/2020.

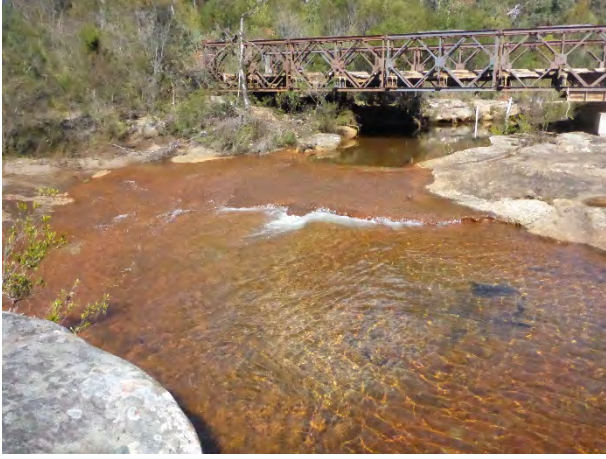
Photo 3: *SCK_Rockbar 5*, looking upstream prior to observed changes in stream appearance. Taken: 19/08/2020.

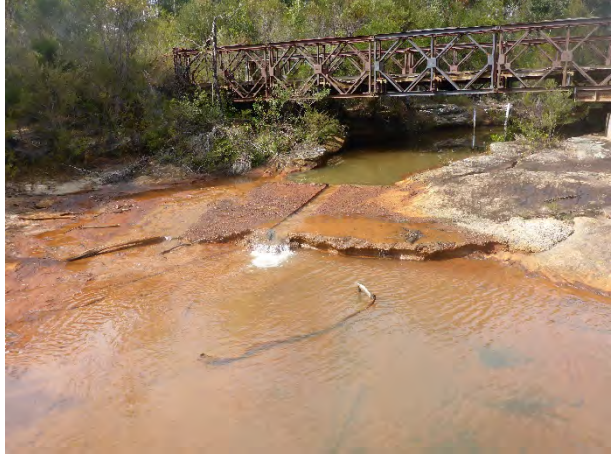
Photo 4: *SCK_Rockbar 5*, looking upstream at the increase in iron staining. Taken: 14/10/2020.

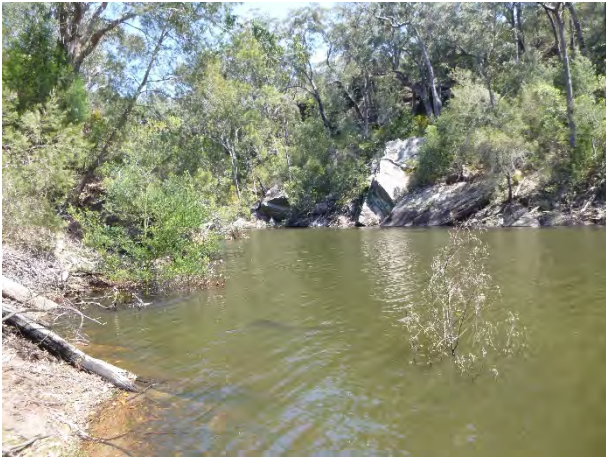
Photo 5: *Sandy Creek Arm*, looking upstream towards *Sandy Creek*. Taken: 15/10/2020.

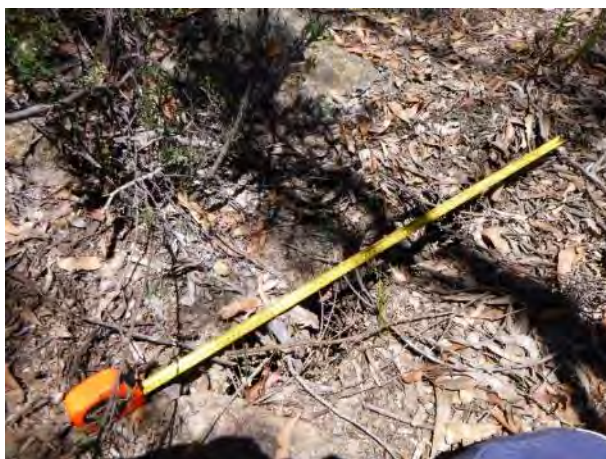
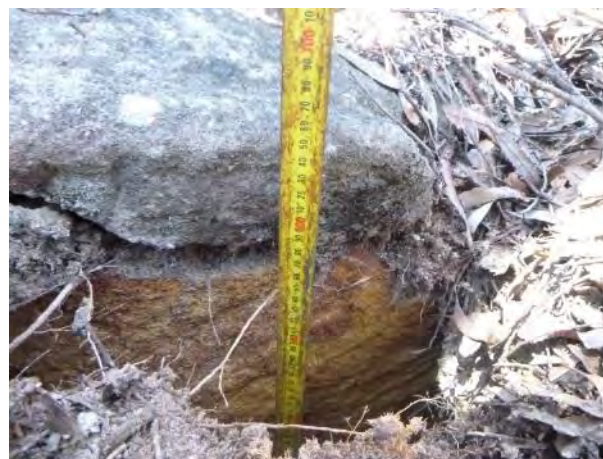
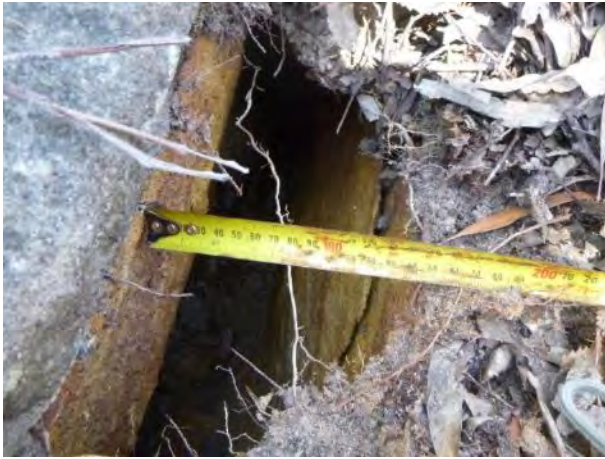
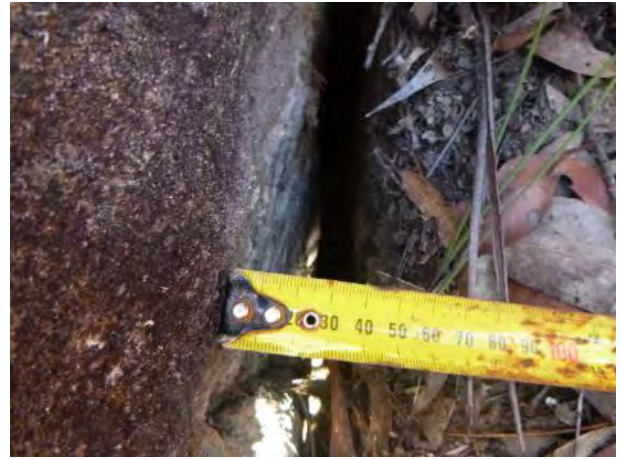
DA3B_LW16_044 is a Level 2 trigger as per the DA3B Landscape TARP (Table 1), specifically:

- Crack or fracture between 100mm and 300mm width.

Photo 1: DA3B_LW16_044, looking at length of soil cracking. Crack runs in orientation of tape measure. Taken on 10/11/2020.

Photo 2: DA3B_LW16_044, looking at depth of rock fracturing. Taken on 10/11/2020.

Photo 3: *DA3B_LW16_044*, looking at width of rock fracturing. Taken on 10/11/2020.

Photo 4: *DA3B_LW16_044*, looking at rock displacement from soil. Taken on 10/11/2020.

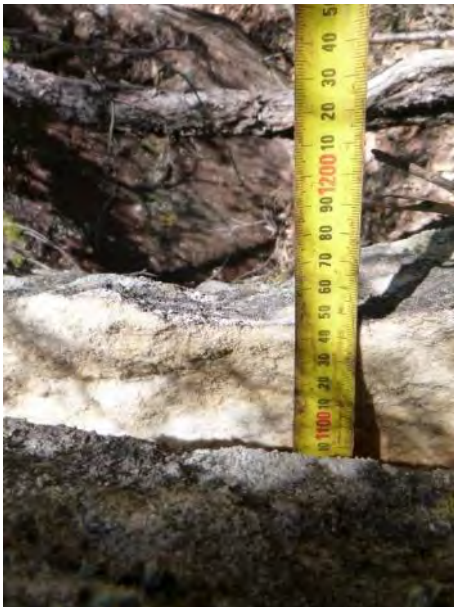
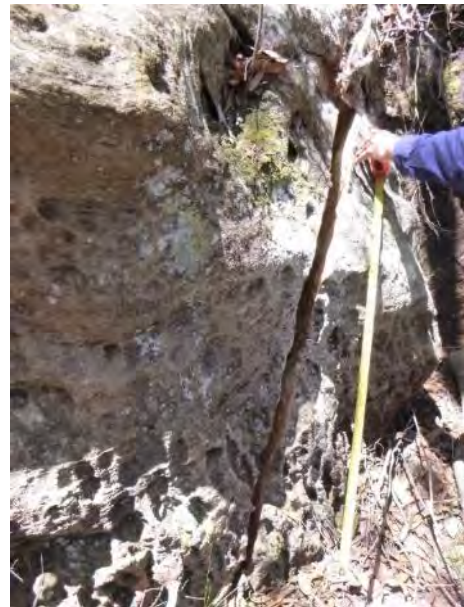
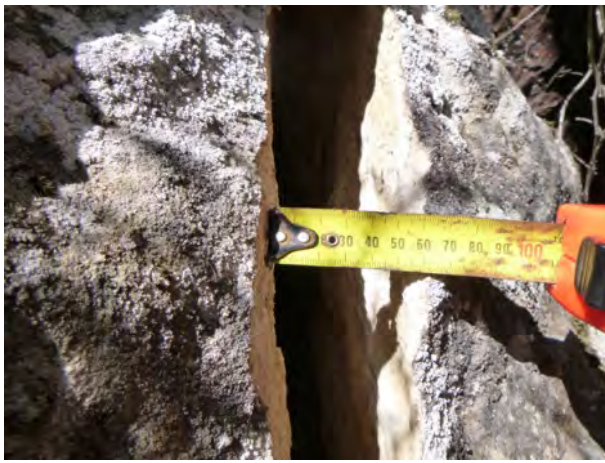
DA3B_LW16_045 is a Level 1 trigger as per the Dendrobium Area 3B Landscape TARP (Table 1), specifically:

- Crack or fracture up to 100mm width.
- Crack or fracture up to 10m length.

Photo 5: *DA3B_LW16_045*, looking at depth of rock fracturing. Taken on 10/11/2020.

Photo 6: *DA3B_LW16_045*, looking at length of rock fracturing. Taken on 10/11/2020.

Photo 7: DA3B_LW16_045, looking at width of rock fracturing. Taken on 10/11/2020.

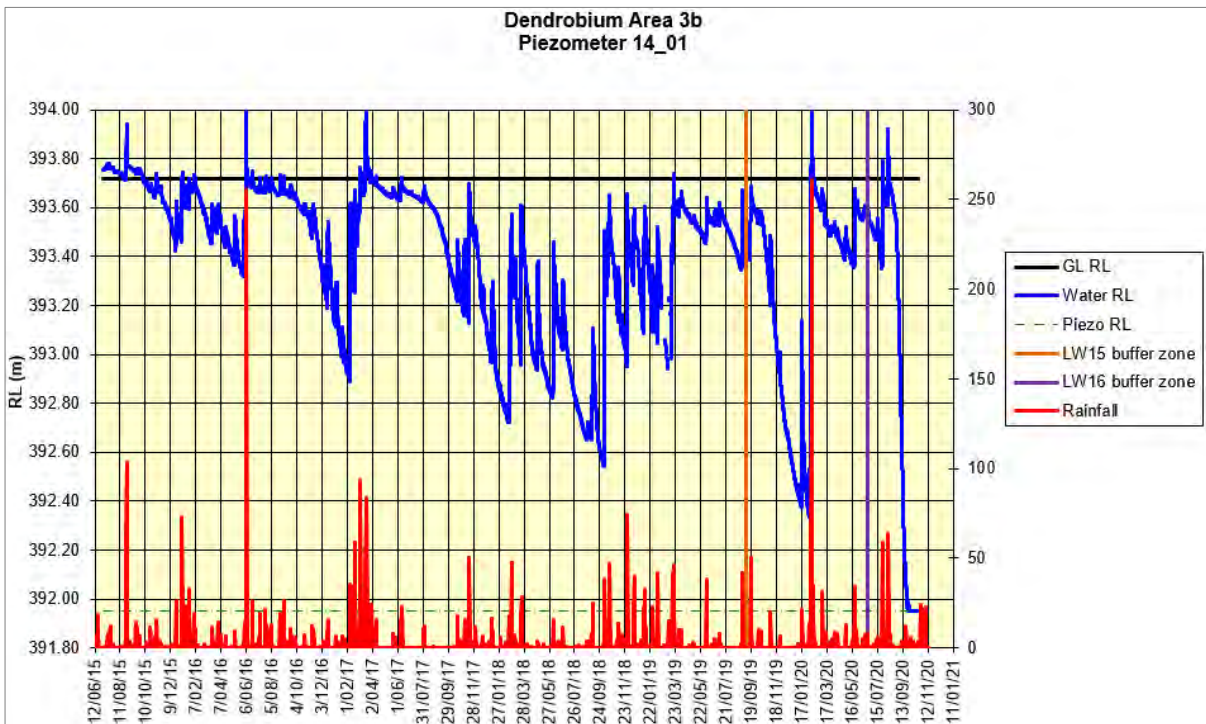
Longwall 15 triggers for water level and soil moisture at the site 14_01 were reported on 16 January 2020. On 8 August 2020, the site was mined beneath by Longwall 16. A trigger for rate of recession was subsequently reported on 11 September 2020 in accordance with the SIMMCP. Groundwater level at the site continued to recede and on 27 September 2020, the borehole was observed to be dry (Graph 1). This is the first time the borehole has been observed as dry since the monitoring started at the site.

Corrective Management Actions were initiated in accordance with the Dendrobium Area 3B Subsidence Management Plan. Site 14_01 remains a Level 3 trigger in accordance with the Dendrobium Swamp Impact Monitoring, Management and Congincy Plan (Table 2).

Graph 1: Near-surface groundwater levels at Swamp 14 site 14_01, logged hourly. Date range: 02/07/2015 to 20/10/2020.

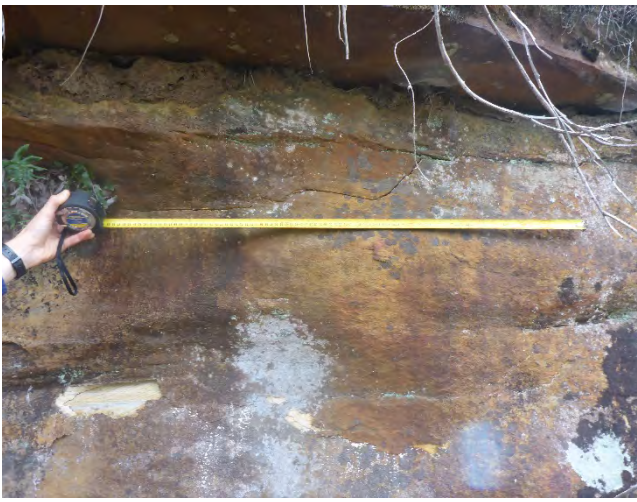
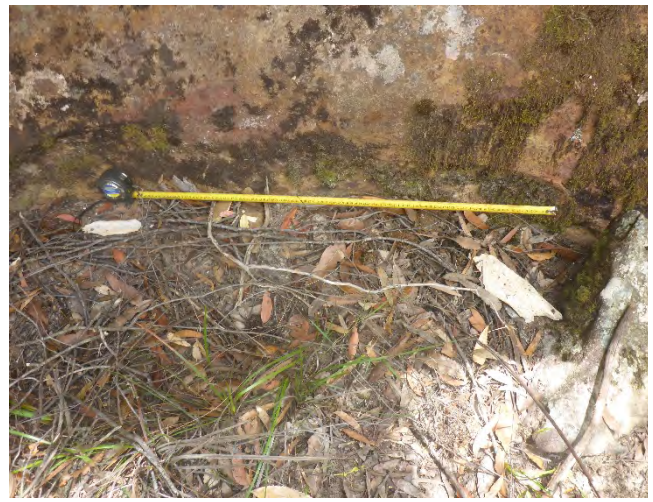
DA3B_LW16_049 consists of five rock fractures and associated fragmentation to a steep slope/step to the west of Swamp 14 (Figure 1). The site was mined beneath by Longwall 16 on 18 July 2020. The rock fracturing has a maximum continuous length of 12m and a maximum width of 0.004m. The rock fragmentation has maximum dimensions of 0.15m x 0.05m x 0.02m (Photo 5 and Photo 6).

DA3B_LW16_049 is a Level 2 trigger as per the Dendrobium Area 3B Landscape TARP (Table 1), specifically: a crack or fracture between 10 and 50m length.

Photo 5: *DA3B_LW16_049*, looking at a section of rock fracturing. Taken on 30/11/2020.

Photo 6: *DA3B_LW16_049*, looking at the rock fragmentation. Taken on 30/11/2020.

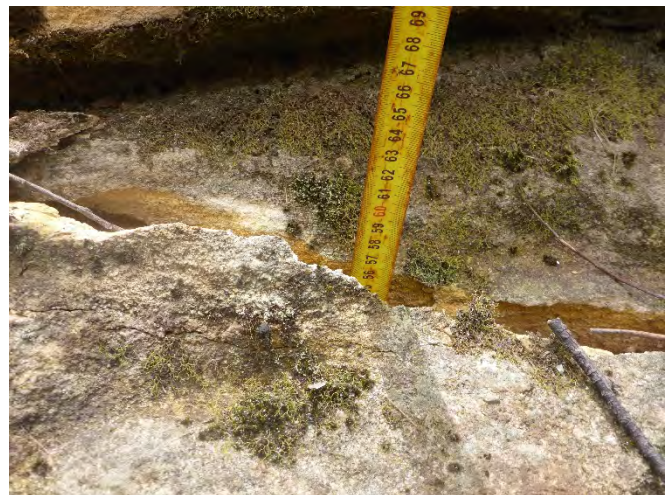
Photo 8: *DA3B_LW16_050*, looking at the depth of the rock fracture. Taken on 30/11/2020.

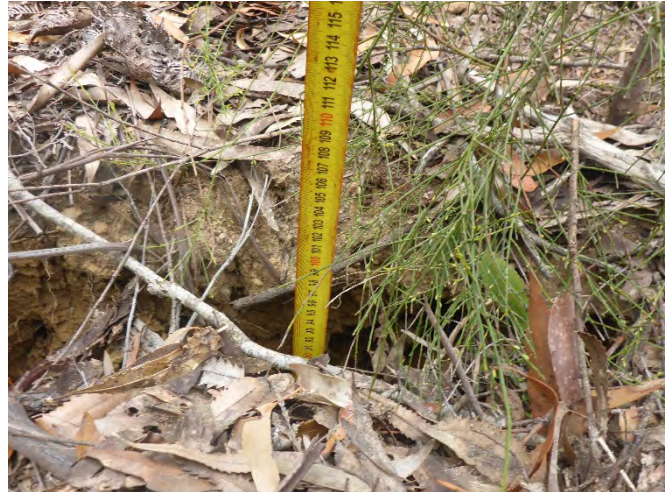
DA3B_LW16_051 consists of 32m of discontinuous soil cracking, rock fracturing and rock movement to a rock outcrop and bushland to the west of Swamp 14 (Figure 1). The site was mined beneath by Longwall 16 on 17 July 2020. The impact has a maximum continuous length of 20m, maximum width of 0.2m and a maximum measurable depth of 0.93m (Photo 9 to Photo 11). The cracking has been flagged with caution tape to highlight the cracking to anyone walking in the area.

Photo 10: DA3B_LW16_051, looking at the maximum depth. Taken on 30/11/2020.

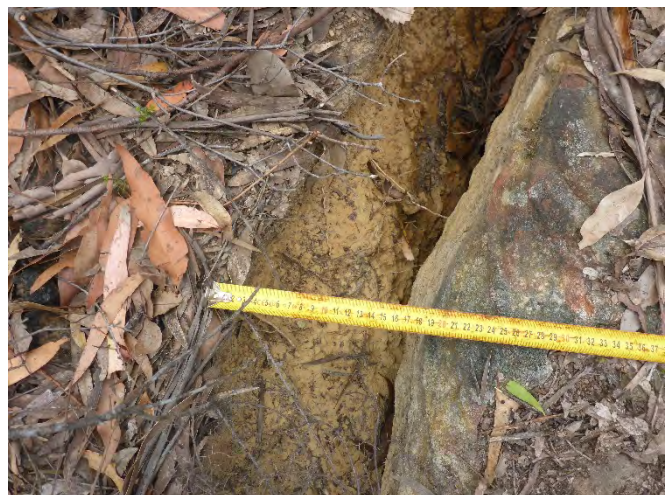
Photo 11: DA3B_LW16_051, looking at the maximum width. Taken on 30/11/2020.

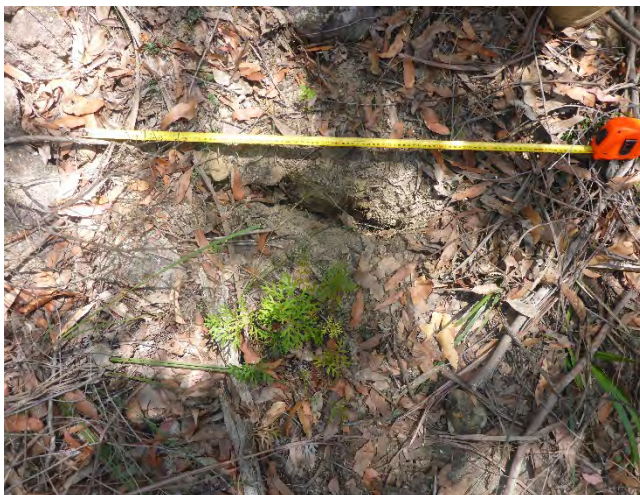
DA3B_LW16_052 consists of 4.7m of discontinuous soil cracking in bushland to the west of Swamp 14 (Figure 1). The site was mined beneath by Longwall 15 on 8 October 2019. The impact has a maximum continuous length of 1.3m, maximum width of 0.09m and a maximum measurable depth of 0.2m (Photo 12 and Photo 13).

DA3B_LW16_052 is a Level 1 trigger as per the Dendrobium Area 3B Landscape TARP (Table 1), specifically:

- Crack or fracture up to 100mm width.
- Crack or fracture up to 10m length.

Photo 12: DA3B_LW16_052, looking at a section of soil cracking. Taken on 1/12/2020.

- Continue monitoring program
- Report impacts to key stakeholders
- Summarise impacts and report in the End of Panel Report and AEMR
- Review monitoring frequency
- Notify relevant technical specialists and seek advice on any CMA required

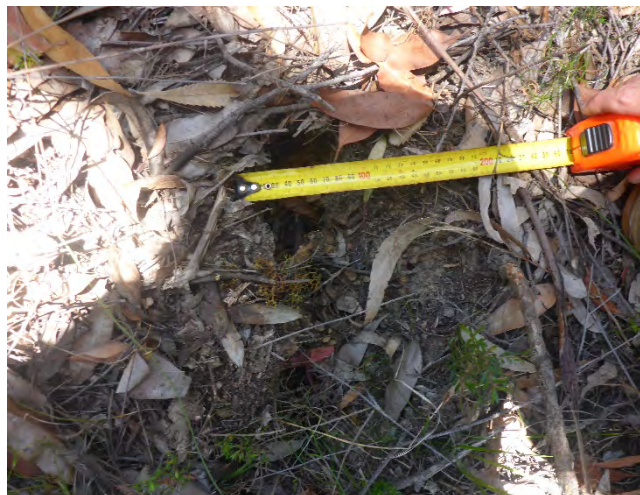
Photo 13: DA3B_LW16_052, looking at the maximum width. Taken on 1/12/2020.

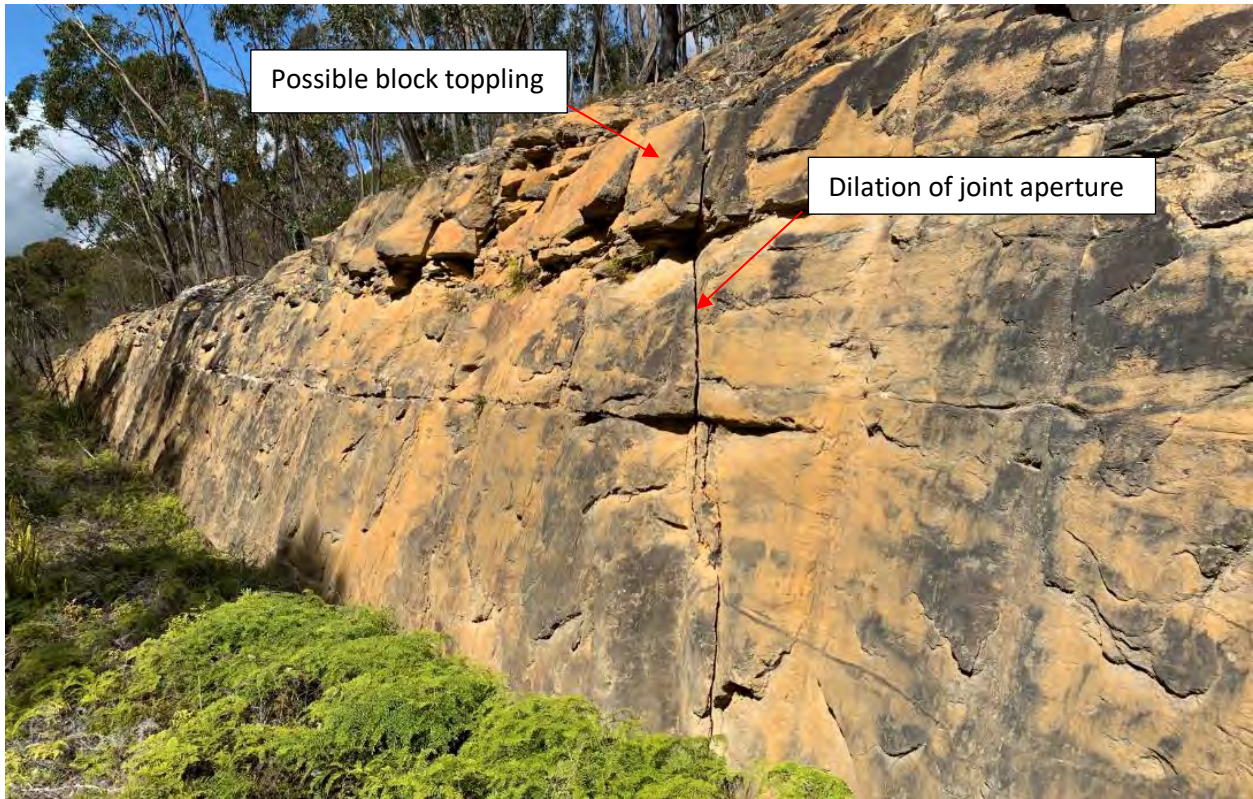
The apparent subsidence induced impacts observed included deformation (movement) of the rock mass along bedding planes of up to approximately 200 mm (consistent with horizontal movements noted in survey monitoring) which has created a narrow overhang within the cutting face (**Figure 3**), and appears to indicate the top unit moving broadly north west and/or south east relative to the bottom unit in a bending fashion.

Figure 5 Propagation of joint set behind slope crest (looking south west)

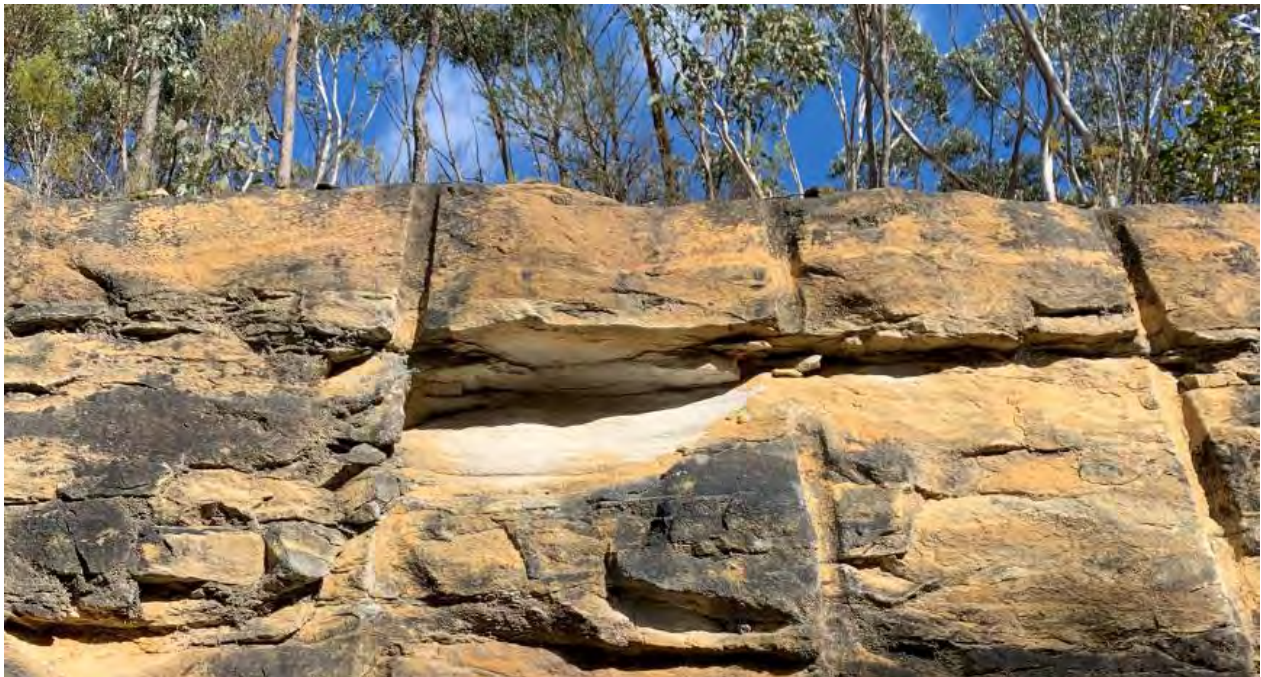
Figure 7 Recent wedge instability (intersection of bedding plane with high angle joint in southwest facing cut)
