**DENDROBIUM AREA 3B
LONGWALL 16 END OF PANEL
LANDSCAPE REPORT
DECEMBER 2020**

This report summarises the observed and measured subsidence effects on landscape features resulting from the extraction of Dendrobium Area 3B (DA3B) Longwall 16.

Longwall 16 is the eighth panel extracted from DA3B. Extraction began on 26 February 2020 and was completed on 4 November 2020.

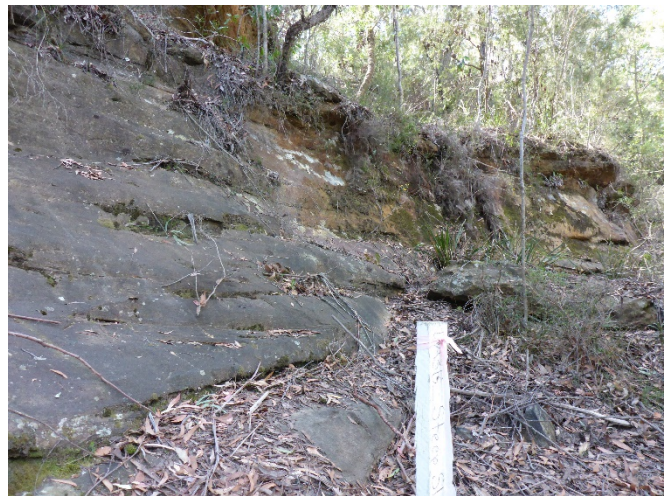
Photo 2: A3b-SS16, post-mining inspection. Taken on 28/09/20.

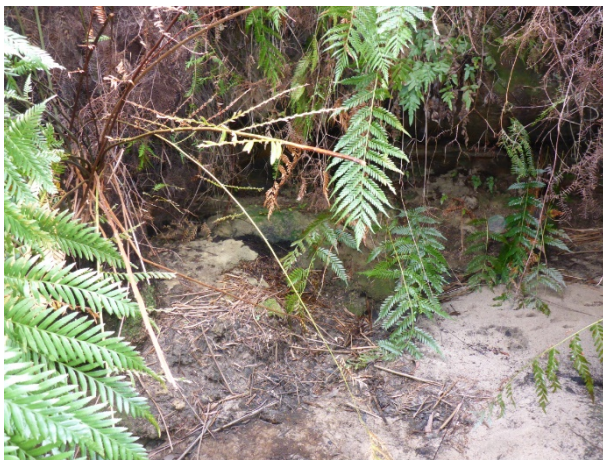
Photo 5: LA2_Pool 34, looking upstream. Taken on 24/03/2020, prior to identification of the iron staining.

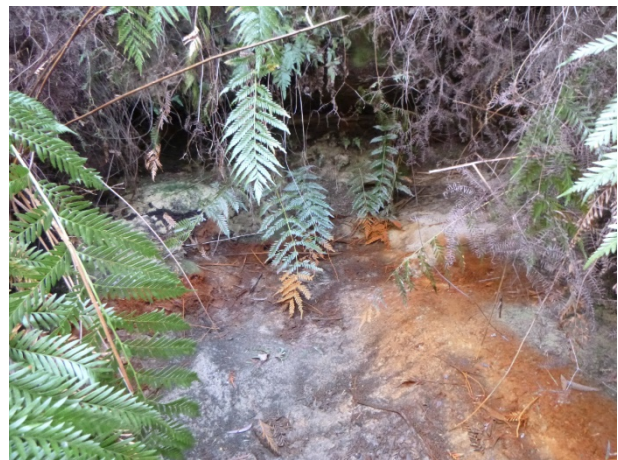
DA3B_LW16_038 consists of iron staining observed in tributary LA2 following the passing of Longwall 16 (Figure 2). The impacted site, Pool 34, was mined beneath by Longwall 16 on 5 May 2020. Throughout the monitoring period the pool has generally been ephemeral, responding to rainfall events. Following a rainfall event, iron staining was observed for the first time (Photo 5 and Photo 6). The iron staining is localised to this pool and does not extend downstream.

Level 1: Observable increase in iron staining within the mining area.

Photo 6: DA3B_LW16_038, iron staining at LA2_Pool 34, looking upstream. Taken on 14/09/2020.

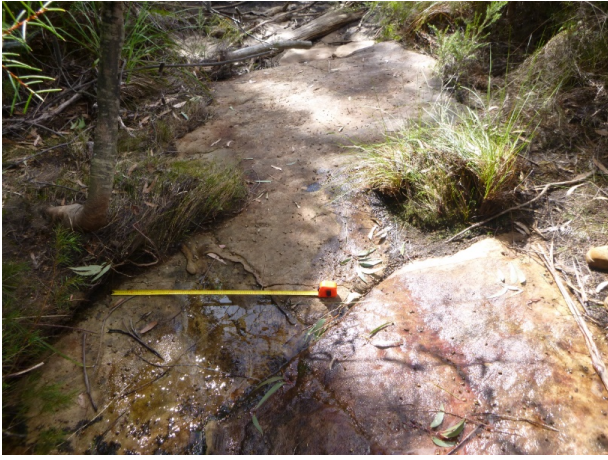
DA3B_LW16_028 consists of rock fracturing to a rockbar on tributary WC15, directly upstream from Pool 34 (Figure 3). The fracture is approximately 2.1m long and 0.01m wide (Photo 7 and Photo 8). There was a noticeable reduction in surface flow on the rockbar following identification of the fracture, with some surface seepage diverting in to the fracture. Pool 34, directly downstream, was also observed to be dry, with only surface seepage entering the pool from beneath the upstream step (Photo 9 and Photo 10). While Pool 34 has been observed to be dry during the baseline period, the rate of recession for this latest drying event is the fastest recorded and coincides with the passing of Longwall 16, approximately 10m at the closet horizontal distance (Figure 4). On 25 November 2020, the width of fracturing was observed to have increased to 0.02m with an uplift of 0.03m (Photo 11 and Photo 12).

Level 2: Crack or fracture that results in observable loss of surface water or erosion.

Photo 7: *DA3B_LW16_028*, rock fracture in foreground and edge of dry step and Pool 34 in background. Taken on 31/08/2020.

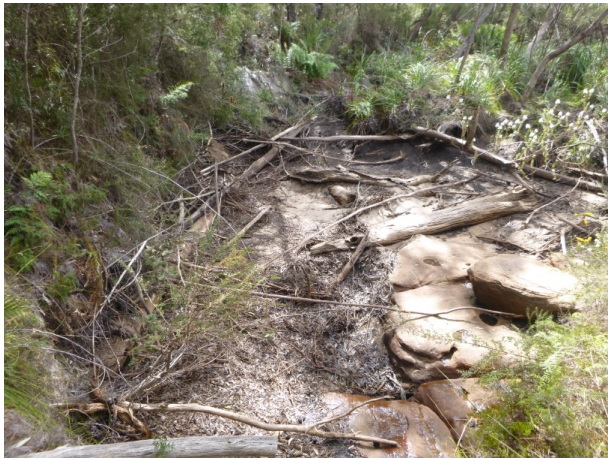
Photo 9: *WC15_Pool 34*, looking downstream over step. Taken on 31/08/2020.

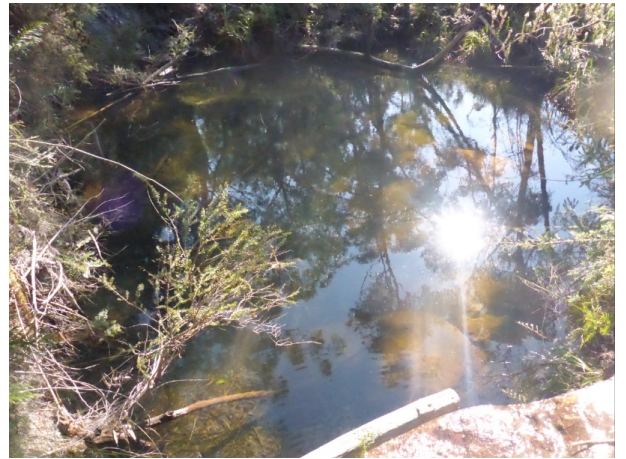
Photo 10: *WC15_Pool 34*, looking downstream over step. Taken on 24/08/2020.

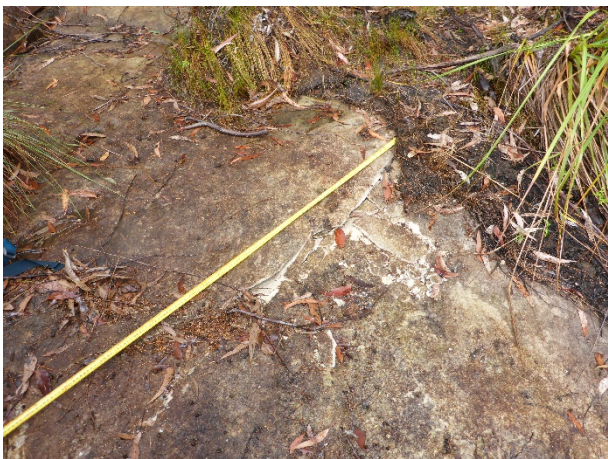
Photo 11: *DA3B_LW16_028*, looking at additional rock fracturing. Taken on 25/11/2020.

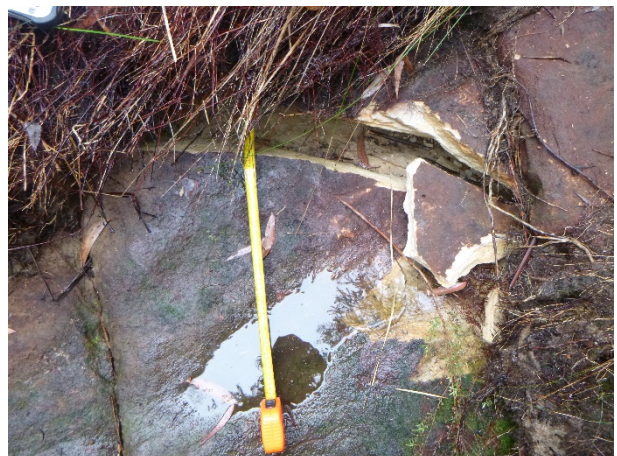
DA3B_LW14_017 is located on WC15, a tributary to Wongawilli Creek. The impacted feature is WC15_Channel 30 which is situated approximately 325m north of Longwall 16 at its closest point (Figure 3). The impact was originally comprised of two rock fractures (Photo 13). The original rock fracturing had a measurable length of 0.8m, a width of 0.025m and a maximum measurable depth of 0.17m. On 9 September 2020, an additional rock fracture and associated rock fragmentation was identified. The 1m rock fracture resulted in the displacement of a rock fragment, approximately 0.25m x 0.03m x 0.07m (Photo 14).

Level 2: Crack or fracture that results in observable loss of surface water or erosion.

Photo 14: DA3B_LW14_017, looking at the rock fracturing and displacement. Taken on 9/09/2020.

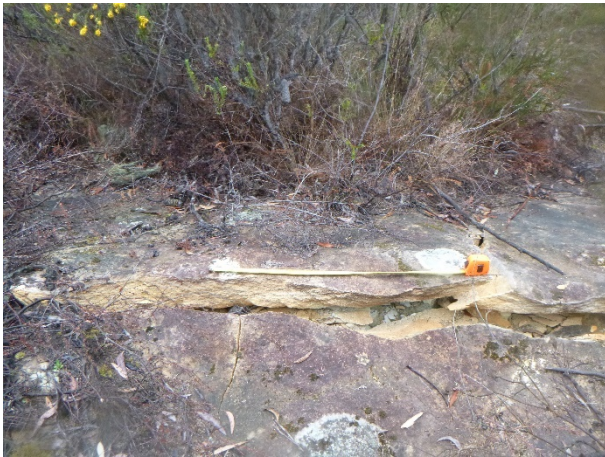
DA3B_LW14_019 is located near WC15, a tributary to Wongawilli Creek. The impacted feature is situated approximately 350m north of Longwall 16 at its closest point (Figure 3). The impact was originally comprised of rock fracturing and uplift. The original rock fracturing had a length of 4.5m, a width of 0.05m and a maximum measurable depth of 0.7m. On 9 September 2020, additional rock fracturing, uplift and rock displacement were identified within a 10m x 10m area (Photo 15 to Photo 18). The fracturing has a length of 6.8m, a width of 0.1m and a maximum measurable depth of 0.4m. The largest rock fragment displaced is 2m x 2m and uplift was measured up to 0.2m. DA3B_LW14_019 was inspected on 25 November 2020 and remains unchanged from original identification.

Level 2: Crack or fracture between 100 and 300mm width at its widest point, and/or, crack or fracture that results in observable loss of surface water or erosion.

Photo 15: DA3B_LW14_019, looking at a section of rock fracturing and uplift. Taken on 9/09/2020.

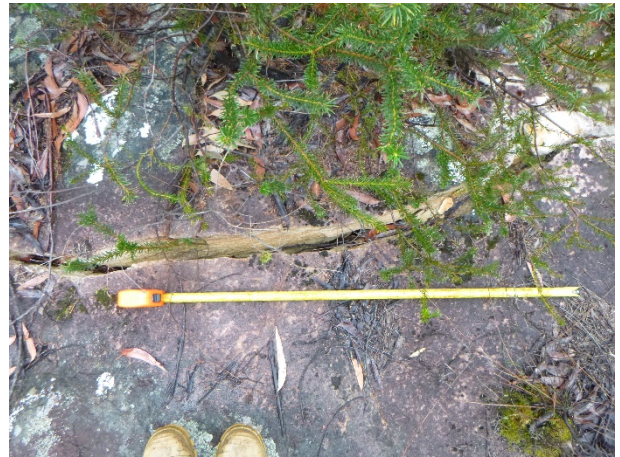
Photo 16: DA3B_LW14_019, looking at a section of rock fracturing. Taken on 9/09/2020.

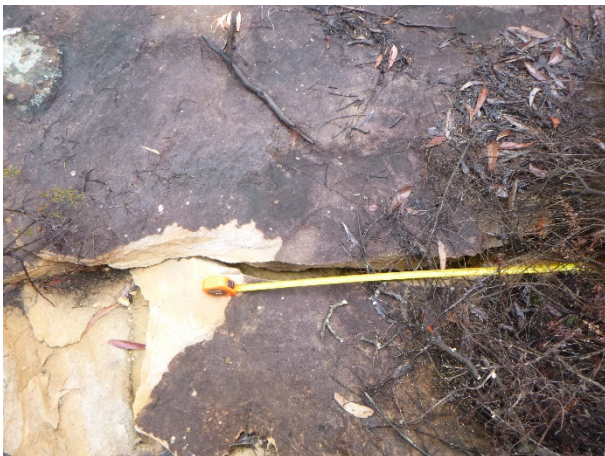
Photo 17: DA3B_LW14_019, looking at a section of rock fracturing and displacement. Taken on 9/09/2020.

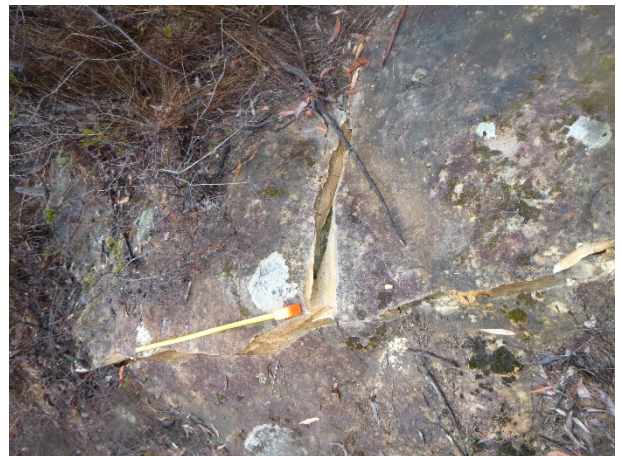
Photo 18: DA3B_LW14_019, looking at a section of rock fracturing and uplift. Taken on 9/09/2020.

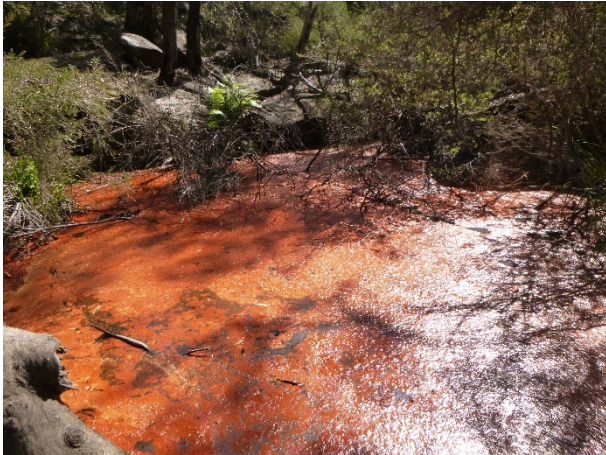
DA3_LW8_158 Update consists of iron staining in Sandy Creek. Iron staining was first reported in SC10C, a tributary in the Sandy Creek sub-catchment, on 11 March 2013 following the extraction of Longwall 8 (Figure 3). SC10C_Pool 3 is the furthest upstream location where iron staining has been identified (Photo 19). Iron staining was also observed in SC10, downstream from SC10C following the extraction of Longwall 8. Iron staining was observed at SC10_Rockbar 3 during a recent inspection (Photo 20). On 14 October 2020, the iron staining was observed to have extended downstream into Sandy Creek. The increase in iron staining is evident between the

Level 2: Increase in iron staining, algal growth, or other observed changes, for >2 consecutive months in Sandy Creek, determined by comparing baseline photos with photos during the mining period.

Photo 19: SC10C_Pool 3, looking upstream at the furthest upstream location of the iron staining. Taken on 3/09/2020.

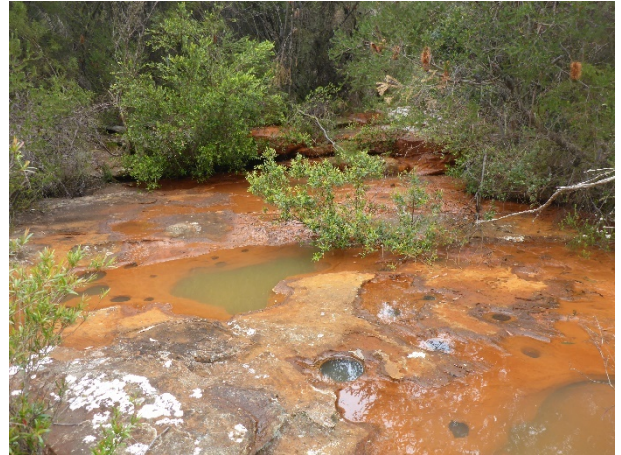
Photo 20: SC10_Rockbar 3, looking upstream during the latest inspection. Taken on 14/10/2020.

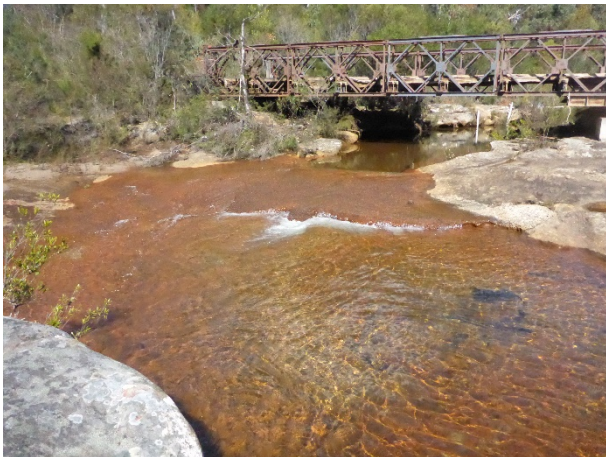
Photo 21: SCK_Rockbar 5, looking upstream prior to observed changes in stream appearance. Taken on 19/08/2020.

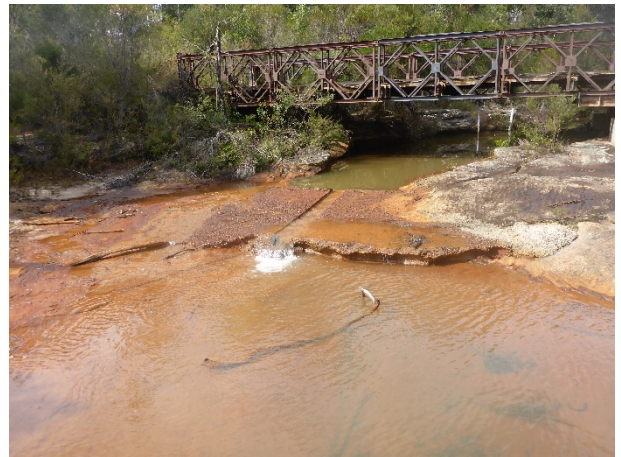
Sandy Creek-SC10 confluence and the Sandy Creek-Cordeaux Dam confluence (Photo 21 and Photo 22). On 15 October 2020, no iron staining was observed within Cordeaux Dam (Photo 23).

Photo 22: SCK_Rockbar 5, looking upstream at the increase in iron staining. Taken on 14/10/2020.

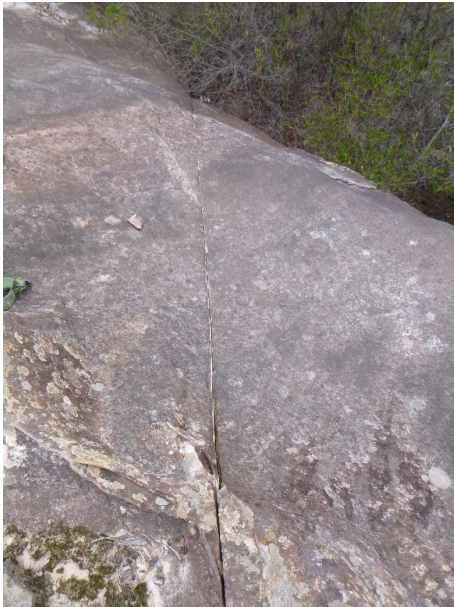
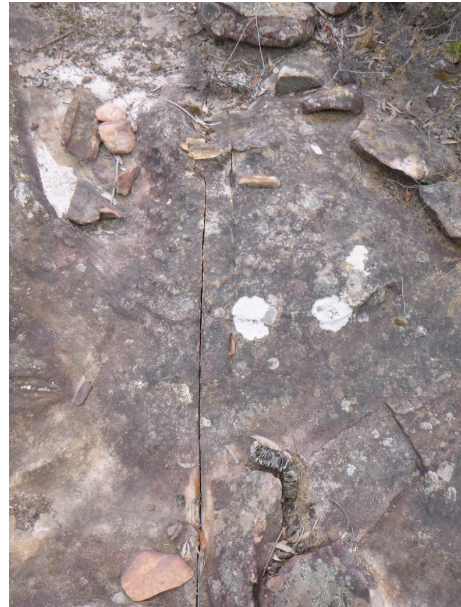
DA3B_LW16_010 is situated on a rock outcrop between *Lake Avon* and *Fire Road 6A* (Figure 2). The site was undermined by Longwall 16 on 14 April 2020. The impact is comprised of rock fracturing (Photo 24 and Photo 25). The rock fracturing has a maximum length of 16m, a maximum width of 0.02m and a maximum measurable depth of 2m. DA3B_LW16_010 was inspected on 19 November 2020 and remains unchanged from original identification.

Level 2: Crack or fracture between 10m and 50m length.

Photo 24: DA3B_LW16_010, an overview of the rock fracture. Taken on 27/04/2020.

Photo 25: DA3B_LW16_010, an overview of the rock fracture. Taken on 27/04/2020.

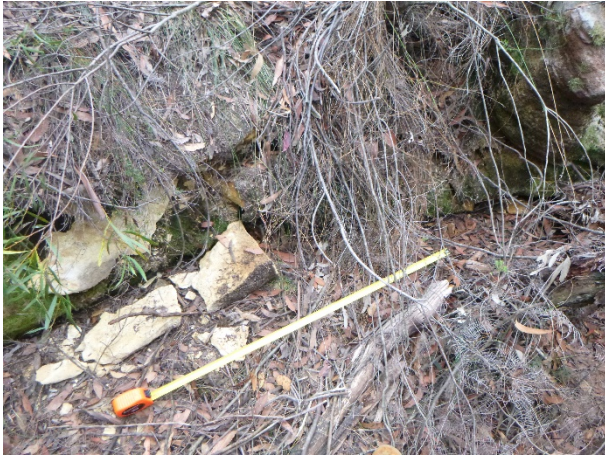
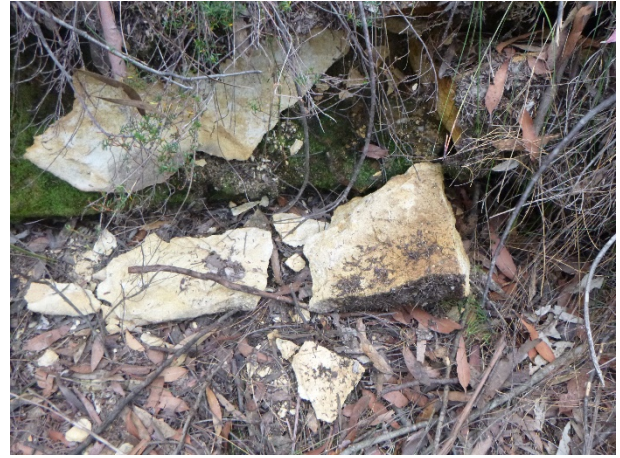
DA3B_LW16_011 is located at the base of a steep slope/step between *Lake Avon* and *Fire Road 6A* (Figure 2). The impact is situated approximately 70m south of Longwall 16 at its closest point. The impact is comprised of a small rock fall (Photo 26 and Photo 27). The largest rock fragment resulting from the rockfall is approximately 0.25m x 0.2m x 0.1m. DA3B_LW16_011 was inspected on 19 November 2020 and remains unchanged from original identification.

Level 1: Rockfall from a cliff (step) which is left mostly intact (<10% length) resulting in insignificant ground disturbance.

Photo 26: DA3B_LW16_011, overview of the rockfall. Taken on 27/04/2020.

Photo 27: DA3B_LW16_011, an overview of the rockfall. Taken on 27/04/2020.

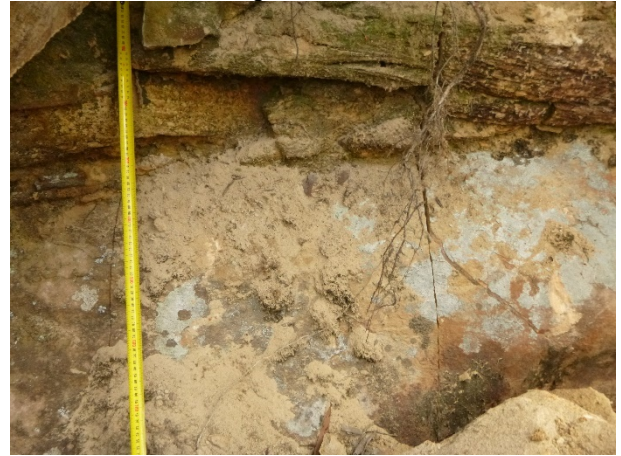
DA3B_LW16_016 is located at a steep slope/step between *Lake Avon* and *Fire Road 6A* (Figure 2). The site was undermined by Longwall 16 on 1 May 2020. The impact is comprised of a rock fall and rock fracturing (Photo 34 to Photo 36, next page). Four boulders were dislodged from the step with the largest boulder measuring 0.8m x 0.9m x 0.5m. The rock fracturing has a length of 2m and a width of 0.015m. *DA3B_LW16_016* was inspected on 19 November 2020 and remains unchanged from original identification.

Photo 36: DA3B_LW16_016, looking at a section of rock fracturing. Taken on 15/05/2020.

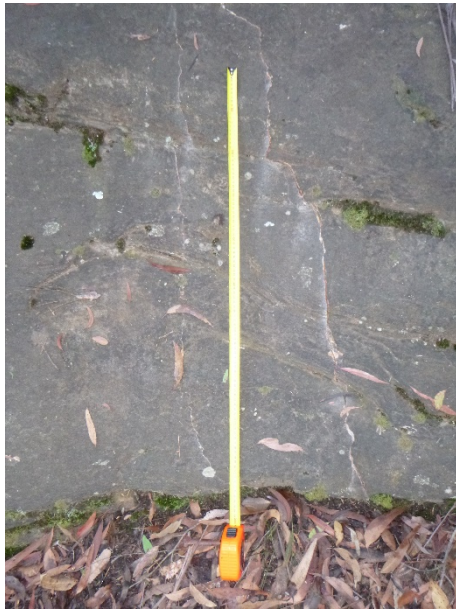
DA3B_LW16_018 is situated at SLMMP Site A3b-SS16, located between Swamp 23 and tributary LA2 (Figure 2). The site was mined beneath by Longwall 16 on 6 May 2020. The impact is comprised of two rock fractures and minor rock fragmentation (Photo 39 and Photo 40). The rock fracturing has a maximum continuous length of 4.5m, a maximum width of 0.004m and a maximum measurable depth of 0.21m. The rock fragmentation has a maximum length of 0.1m and a maximum width of 0.05m. DA3B_LW16_018 was inspected on 19 November 2020 and remains unchanged from original identification.

Level 1: Crack or fracture up to 100mm width, and/or, crack or fracture up to 10m length.

Photo 39: DA3B_LW16_018, looking at a section of rock fracturing. Taken on 16/06/2020.

Photo 40: DA3B_LW16_018, looking at a section of rock fragmentation. Taken on 16/06/2020.

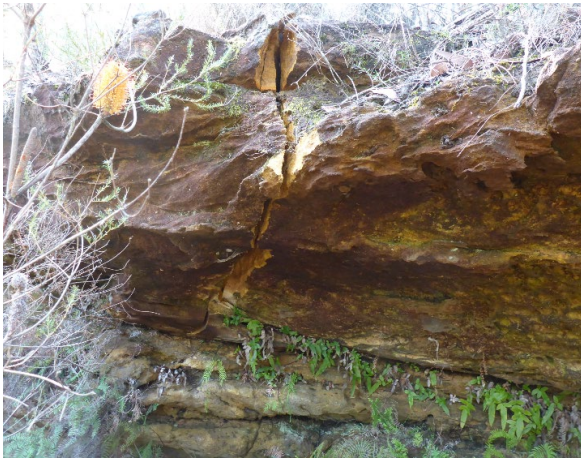
DA3B_LW16_021 consists of rock fracturing and a small rockfall to a 2m high step over Longwall 16 (Figure 2). The fracture is approximately 2m long, 0.12m wide and has a maximum measurable depth of 1m (Photo 41 and Photo 42). The largest rock fragment fallen from step is 0.35m long, with several smaller pieces also observed (Photo 43). On 1 December 2020, an additional rock fracture with a rock fall was observed with a maximum volume of 0.35m x 0.1m x 0.2m (Photo 44).

Level 2: Crack or fracture between 100mm and 300mm width.

Photo 41: DA3B_LW16_021, looking at fracture on step. Taken on 30/06/2020.

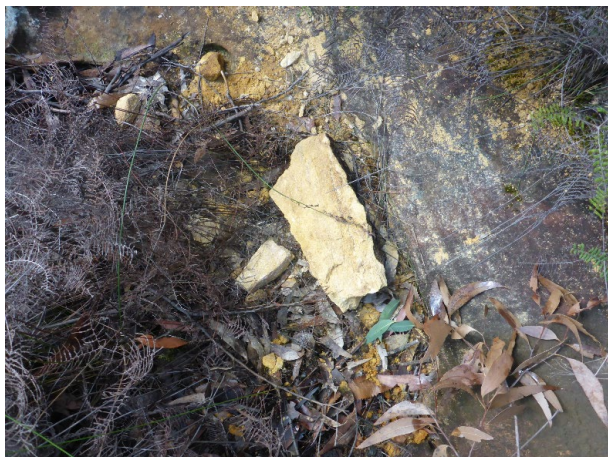
Photo 43: DA3B_LW16_021, looking at small rock fragments fallen from step. Taken on 30/06/2020.

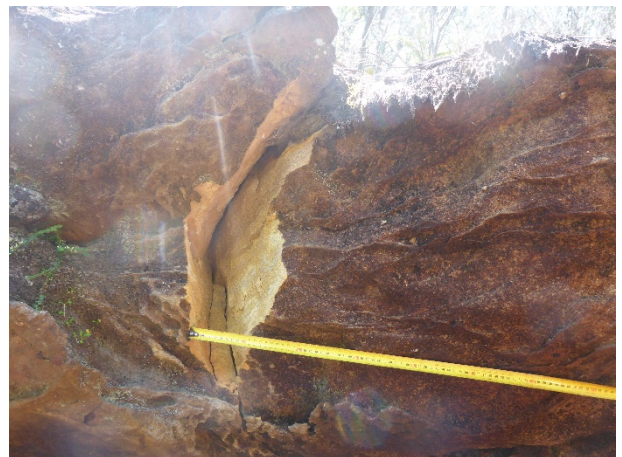
Photo 44: DA3B_LW16_021, looking at additional rock fracturing and rock fall. Taken on 1/12/2020.

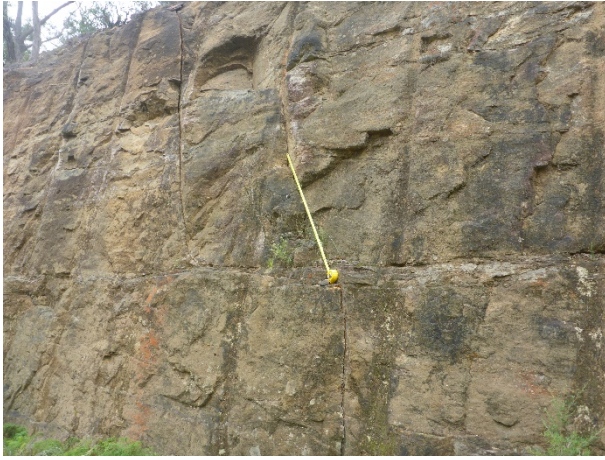
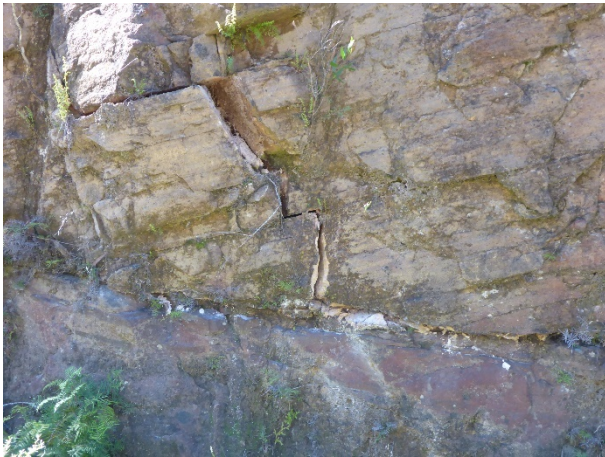
DA3B_LW16_022 consists of rock fracturing to the face of a cut through which forms part of the Maldon Dombarton railway corridor adjacent to Fire Road 6A (Figure 2). The impact was initially observed on 7 July 2020, with a maximum continuous length of 15m, a width up to 0.08m and a maximum measurable depth of 2.9m (Photo 45 and Photo 46). A follow-up inspection on 6 August 2020 identified multiple small rockfalls and changes to the fracturing (Photo 47 and Photo 48). The fracturing is now largely continuous on both the eastern and western side of the corridor for a distance of approximately 190m. Maximum values relating to the fracturing width and depth did not change from the original inspection. The largest fragment resulting from the rockfall was 0.3m x 0.3m x 0.05m.

Level 3: Crack or fracture over 50m length.

Photo 45: DA3B_LW16_022, fracturing down face of cut-through. Taken on 7/07/2020.

Photo 47: DA3B_LW16_022, fracturing down face of cut-through. Taken on 6/08/2020.

The site was inspected by a geotechnical engineer who determined that there was a low likelihood of additional movements at the site. No corrective management actions were recommended. As a precaution, the site was cordoned off until completion of Longwall 16. No additional impacts were observed at the site at completion of Longwall 16.

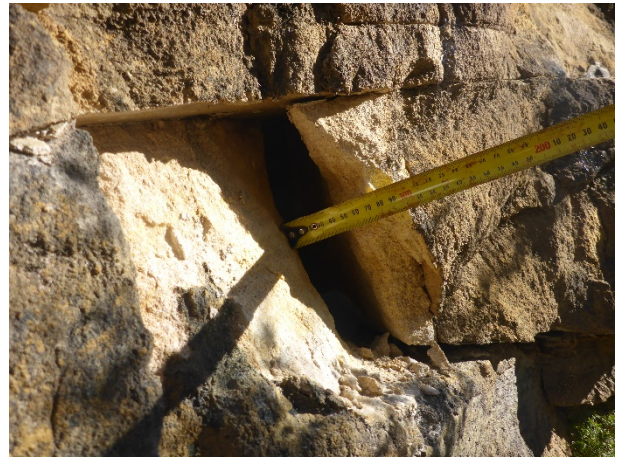
Photo 48: DA3B_LW16_022, looking at a section of rock fracturing. Taken on 6/08/2020.

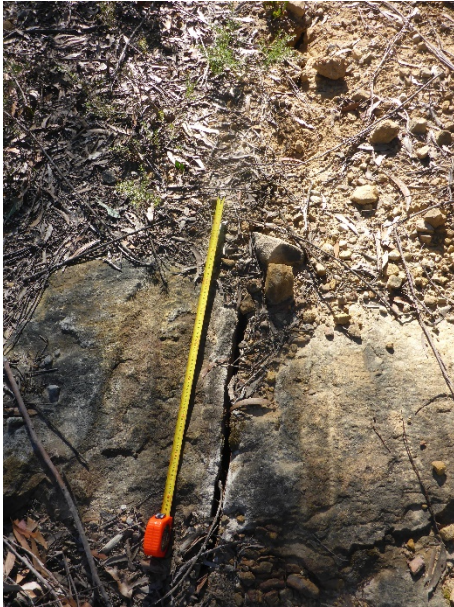
DA3B_LW16_024 is situated on a rehabilitated access track between *Swamp 14* and *Fire Road 6A* (Figure 2). The site was mined beneath by Longwall 16 on 1 July 2020. The impact is comprised of rock fracturing and soil cracking (Photo 49 and Photo 50). The impact has a maximum length of 3.2m, a maximum width of 0.03m and a maximum depth of 0.45m. DA3B_LW16_024 was inspected on 30 November 2020 and remains unchanged from original identification.

Level 1: Crack or fracture up to 100mm width, and/or, crack or fracture up to 10m length.

Photo 49: DA3B_LW16_024, looking at a section of rock fracturing. Taken on 06/08/2020.

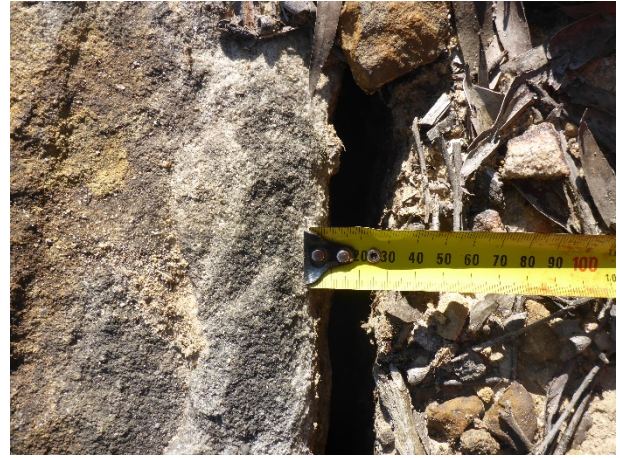
Photo 50: DA3B_LW16_024, looking at the width of rock fracturing. Taken on 06/08/2020.

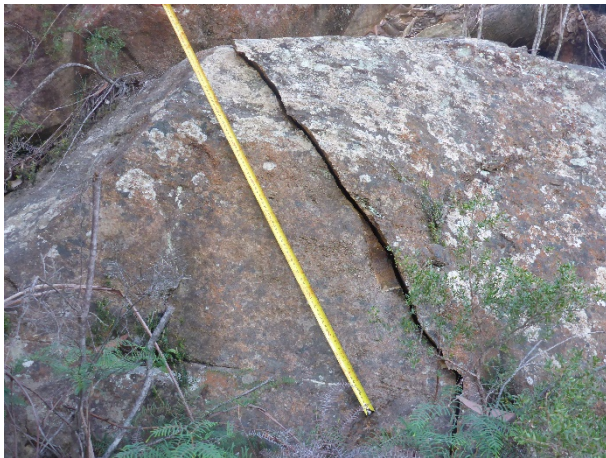
DA3B_LW16_025 is situated at a steep slope/step between *Swamp 14* and *Fire Road 6A* (Figure 2). The site was mined beneath by Longwall 16 on 15 July 2020. The impact is comprised of multiple rock fractures (Photo 51 and Photo 52). The rock fracturing has a maximum length of 2.5m, a maximum width of 0.035m and a maximum depth of 0.34m. On 30 November an additional rock fracture was identified at the base of the steep slope/step with a maximum length of 5m, maximum width of 0.004m and maximum measurable depth of less than 0.1m (Photo 53).

Level 1: Crack or fracture up to 100mm width, and/or, crack or fracture up to 10m length.

Photo 51: DA3B_LW16_025, looking at a section of rock fracturing. Taken on 06/08/2020.

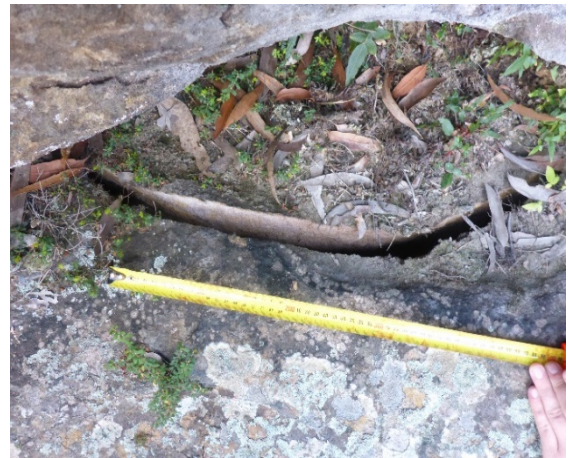
Photo 52: DA3B_LW16_025, looking at a section of rock fracturing. Taken on 06/08/2020.

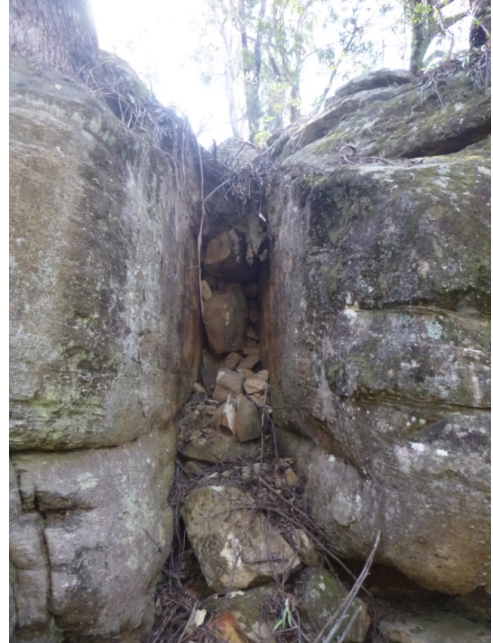
DA3B_LW16_029 consists of a rockfall from a step on the western slope of the WC15 valley (Figure 3). The rockfall is primarily made up of one large rock fragment, approximately 5m³ in volume (Photo 56), with some smaller broken rock fragments in the path of the fall (Photo 57). On 25 November 2020, additional soil cracking, rock fracturing and displacement was observed. The soil cracking has a maximum continuous length of 6m and a maximum width of 0.05m (Photo 58). The rock fracturing has a maximum length of 1.5m and a maximum width of 0.01m (Photo 59). The rock has been displaced 0.05m from the soil for a length of 3m.

Photo 57: DA3B_LW16_029, rockfall from step, looking at top of step where fragment originated. Taken on 31/08/2020.

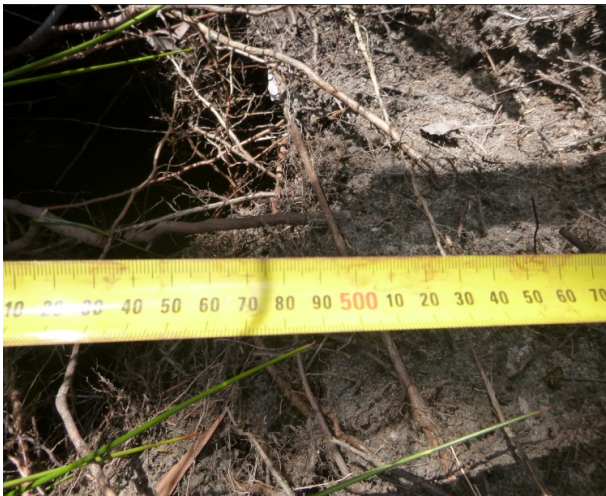
DA3B_LW16_030 consists of localised erosion on tributary WC15 (Figure 3). The erosion has formed a hole in the soil and root matter in a section of the tributary which has displayed surface and subsurface flow during the baseline period. The hole has length of 1.8m, a width of 0.5m and a measurable depth of 1.1m (Photo 60 to Photo 63). On 25 November 2020, width of erosion has increased to 0.62m. There is no evidence of subsidence cracking or fracturing associated with the erosion. The hole has been flagged to for safety reasons and will continue to be monitored to identify any potential changes.

Photo 62: DA3B_LW16_030, looking at width of localised erosion. Taken on 31/08/2020.

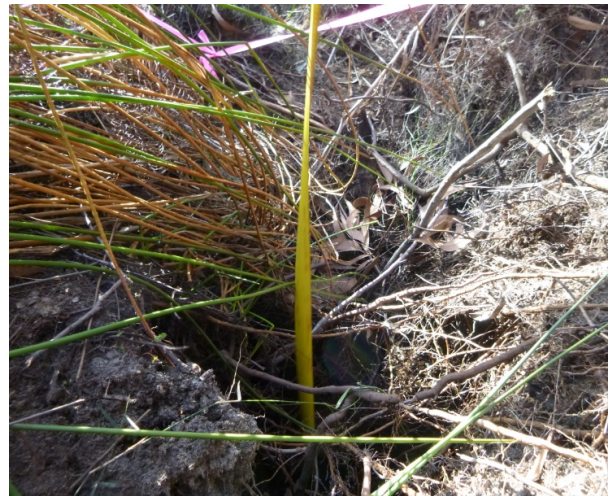
Photo 63: DA3B_LW16_030, looking at measurable depth of localised erosion. Taken on 31/08/2020.

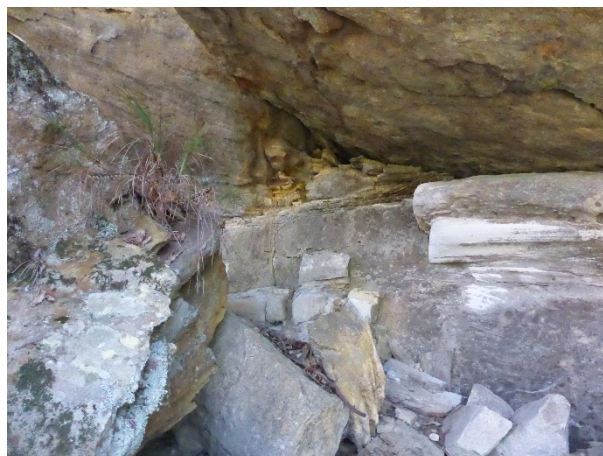
DA3B_LW16_031 is located on a step to the north-west of tributary WC15 (Figure 3). The impact is comprised of two vertical rock fractures and a rockfall (Photo 64 and Photo 65). The largest rock fracture has an approximate length of 1.5m and approximate maximum width of 0.005m. The rockfall consists of 10 pieces with an average volume of approximately 0.1m x 0.2m x 0.1m. The impact appears to be from a previous longwall, likely Longwall 15. DA3B_LW16_031 was inspected on 1 December 2020 and remains unchanged from original identification.

Level 1: Crack or fracture up to 100mm width, and/or, crack or fracture up to 10m length, and/or, rockfall from a cliff (step) which is left mostly intact (<10% length) resulting in insignificant ground disturbance.

Photo 65: DA3B_LW16_031, looking at the rockfall. Taken on 28/09/2020.

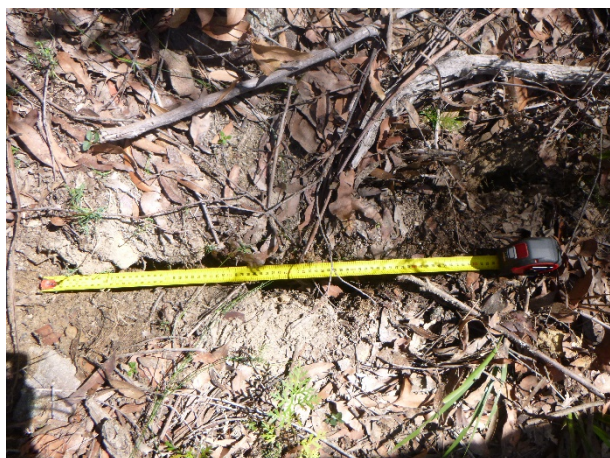
DA3B_LW16_032 is located approximately 220m north of Longwall 16 and to the north-west of WC15, a tributary to Wongawilli Creek (Figure 3). The impact is comprised of three separate soil cracks within a 10m length (Photo 66 and Photo 67). The largest soil crack has a maximum length of 0.55m, a maximum width of 0.095m and a maximum measurable depth of 0.48m. On 30 November 2020, signs of natural remediation to the soil cracking were observed.

Level 1: Crack or fracture up to 100mm width, and/or, crack or fracture up to 10m length.

Photo 66: DA3B_LW16_032, looking at the length of soil cracking. Taken on 28/09/2020.

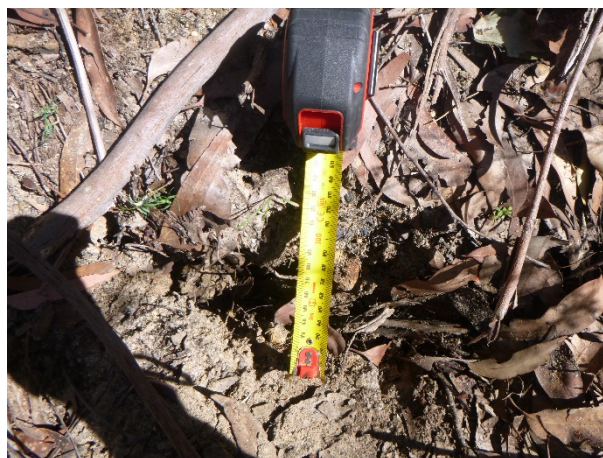
Photo 67: DA3B_LW16_032, looking at the width of soil cracking. Taken on 28/09/2020.

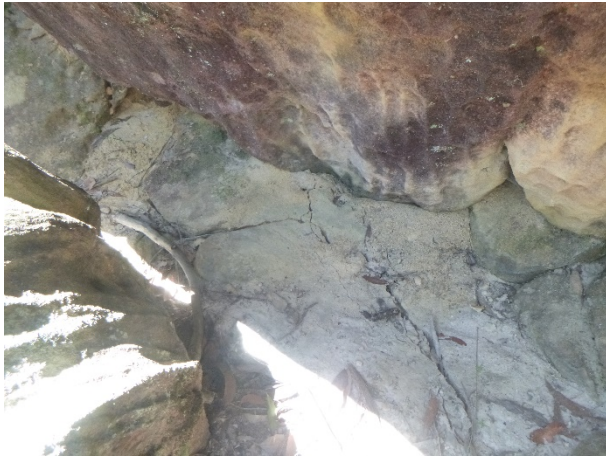
DA3B_LW16_035 is located approximately 15m from SLMMP site A3B-SS17 and was mined beneath by Longwall 16 on 11 September 2020 (Figure 3). The impact is comprised of soil cracking and displacement underneath a boulder (Photo 68 and Photo 69). The soil cracking has an approximate length of 1m and an approximate width of 0.015m. The rock displacement has an approximate width of 0.015m. Measurements have been approximated due to safety concerns accessing beneath a step during active subsidence. On 30 November 2020, signs of natural remediation to the soil cracking and displacement were observed. An additional rockfall was also present with a maximum volume of 0.04m x 0.15m x 0.4m.

Level 1: Crack or fracture up to 100mm width, and/or, crack or fracture up to 10m length, and/or, surface movement or rock displacement with negligible soil surface exposed.

Photo 68: DA3B_LW16_035, looking at a section of soil cracking. Taken on 28/09/2020.

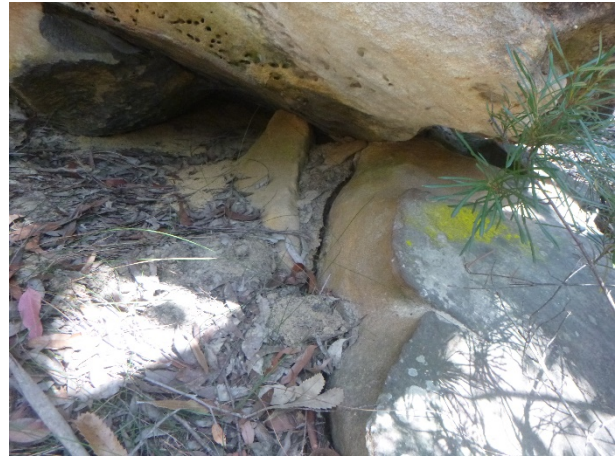
Photo 69: DA3B_LW16_035, looking at a section of displacement. Taken on 28/09/2020.

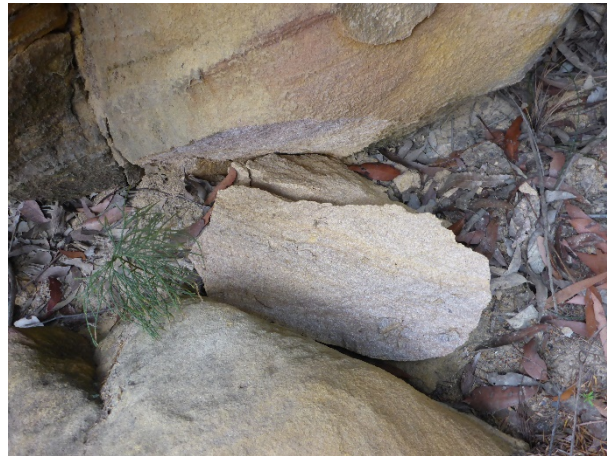
Photo 70: DA3B_LW16_035, looking at the rock fall. Taken on 30/11/2020.

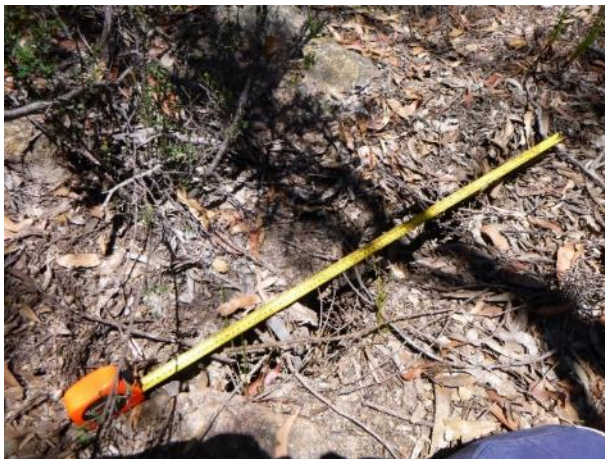
DA3B_LW16_044 consists of approximately 20m of discontinuous soil cracking, rock fracturing and rock-soil displacement along a steep slope, to the east of *Swamp 14* (Figure 3). The site was undermined by Longwall 16 on 21 September 2020. The longest single crack or fracture is 2m in length, with a maximum width of 0.15m and a maximum measurable depth of up to 0.6m (Photo 72 to Photo 74). The rock displacement is up to 0.05m wide (Photo 75). *DA3B_LW16_044* was inspected on 30 November 2020 and remains unchanged from original identification.

Level 2: Crack or fracture between 100mm and 300mm width.

Photo 72: *DA3B_LW16_044*, looking at length of soil cracking. Crack runs in orientation of tape measure. Taken on 10/11/2020.

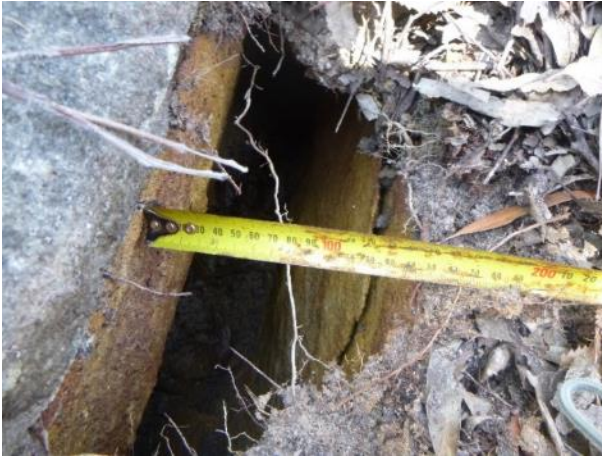
Photo 74: DA3B_LW16_044, looking at width of rock fracturing. Taken on 10/11/2020.

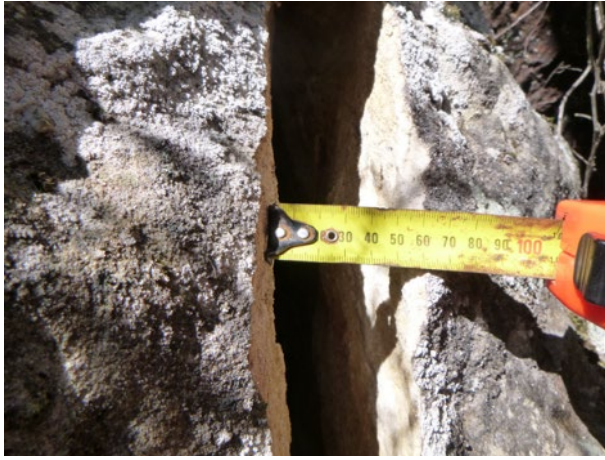
DA3B_LW16_045 consists of rock fracturing to a steep slope east of *Swamp 14* (Figure 3). The site was undermined by Longwall 16 on 17 September 2020. The rock fracturing has a maximum length of 2m, a maximum width of 0.06m and a maximum measurable depth of 1.1m (Photo 76 and Photo 78). DA3B_LW16_045 was inspected on 30 November 2020 and remains unchanged from original identification.

Level 1: Crack or fracture up to 100mm width, and/or, crack or fracture up to 10m length.

Photo 78: DA3B_LW16_045, looking at width of rock fracturing. Taken on 10/11/2020.

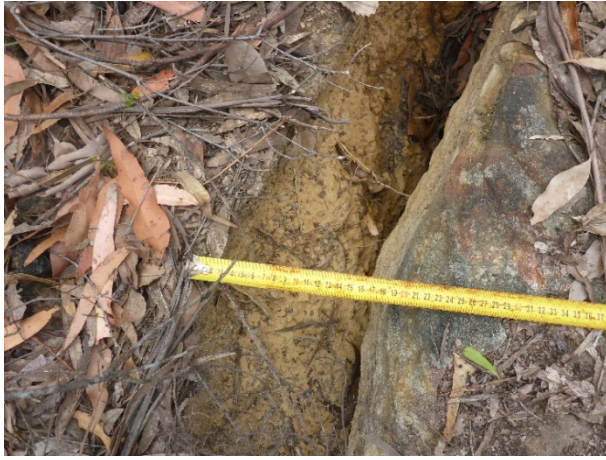
DA3B_LW16_051 consists of 32m of discontinuous soil cracking, rock fracturing and rock movement to a rock outcrop and bushland to the west of *Swamp 14* (Figure 3). The site was mined beneath by Longwall 16 on 17 July 2020. The impact has a maximum continuous length of 20m, maximum width of 0.2m and a maximum measurable depth of 0.93m (Photo 89 to Photo 91). The cracking has been flagged with caution tape to highlight the cracking to anyone walking in the area.

Level 2: Crack or fracture between 10m and 50m length, and/or, crack or fracture between 100 and 300mm width.

Photo 89: DA3B_LW16_051, looking at the maximum width. Taken on 30/11/2020.

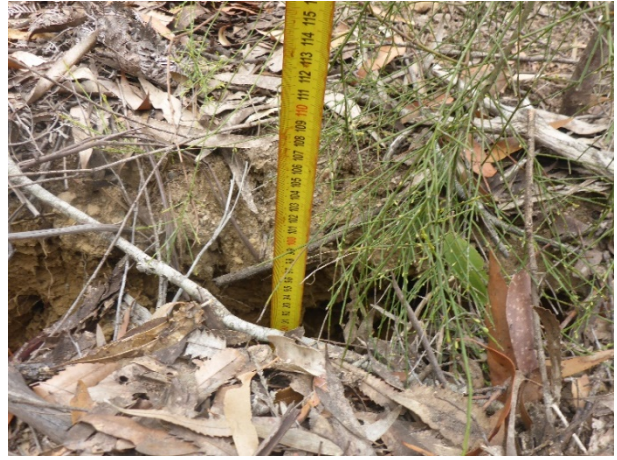
Photo 90: DA3B_LW16_051, looking at the maximum depth. Taken on 30/11/2020.

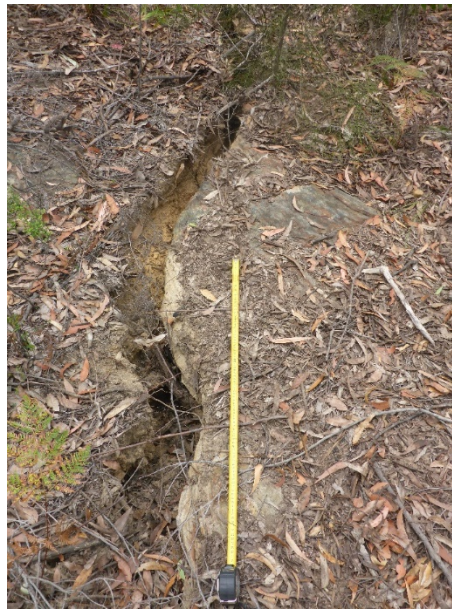
Photo 91: DA3B_LW16_051, looking at a section of soil cracking and rock fracturing. Taken on 30/11/2020.

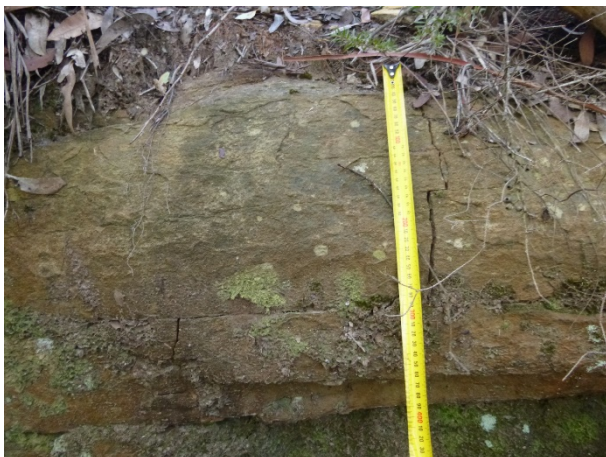
DA3B_LW15_002 is located on a 4m step adjacent to Swamp 23 (Figure 2). The site was undermined by Longwall 15 on 25 April 2019 and is located approximately 100m from the start of Longwall 16. The impact was previously reported as a rockfall. On 5 May 2020, additional rock fracturing was identified 5m from the rockfall (Photo 94 and Photo 95). The rock fracturing has a maximum length of 1.3m, a maximum width of 0.005m and maximum measurable depth of 0.15m. On 2 December 2020, the maximum width of fracturing was observed to have increased to 0.01m (Photo 96).

Level 1: Crack or fracture up to 100mm width, and/or, crack or fracture up to 10m length, and/or, rockfall from a cliff (step) which is left mostly intact (<10% length) resulting in insignificant ground disturbance.

Photo 94: DA3B_LW15_002, looking at a section of rock fracturing. Taken on 05/05/2020.

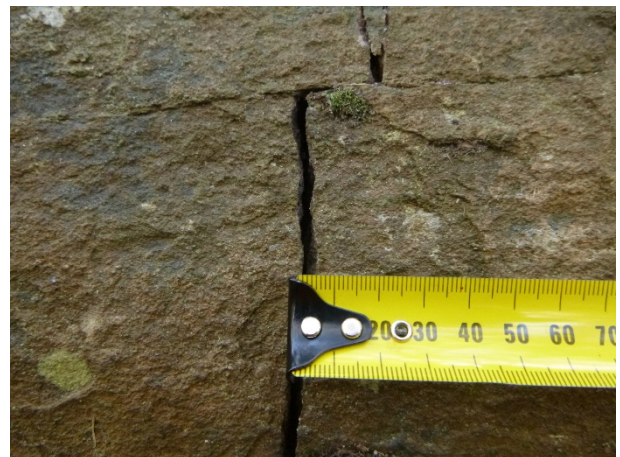
Photo 95: DA3B_LW15_002, looking at the width of rock fracturing. Taken on 05/05/2020.

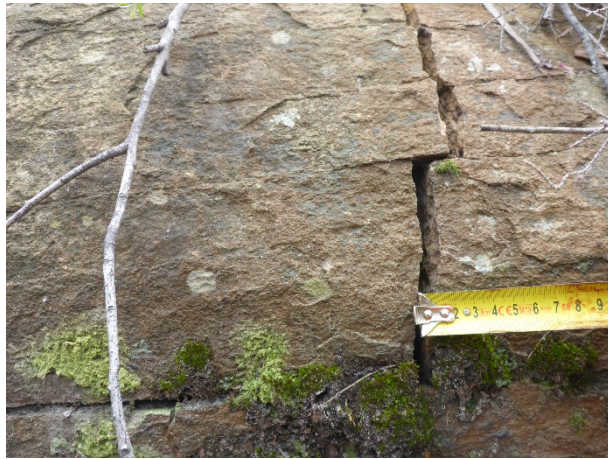
Photo 96: DA3B_LW15_002, looking at a section of rock fracturing. Taken on 2/12/2020.

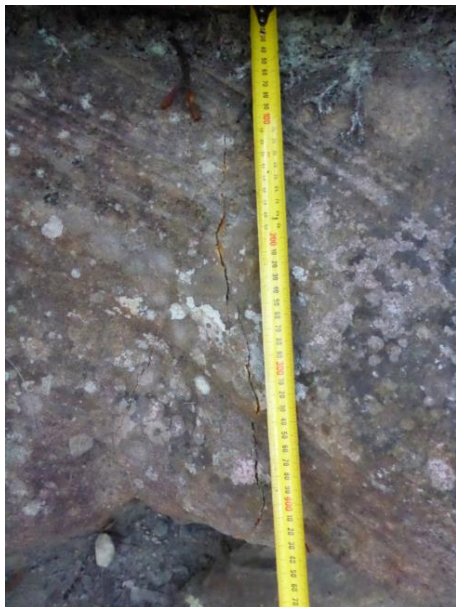
DA3B_LW15_026 is an impact site located at SLMMP monitoring location A3b-SS13, situated at a steep slope/step between *Swamp 14* and *Fire Road 6P* (Figure 3). Impacts were originally identified on 21 January 2020 after being mined beneath by Longwall 15. On 24 August 2020, an update to the rock fracturing was observed. An additional fracture was observed, up to 1.6m long and 0.005m wide, with the fracture extending under a slight overhang (Photo 97). A second fracture to a boulder/outcrop was also observed and is approximately 0.02m wide and 0.65m long, extending 0.25m in to the boulder (Photo 98).

Level 1: Crack or fracture up to 100mm width, and/or, crack or fracture up to 10m length.

Photo 97: DA3B_LW15_026, looking at a section of rock fracturing. Taken on 24/08/2020.

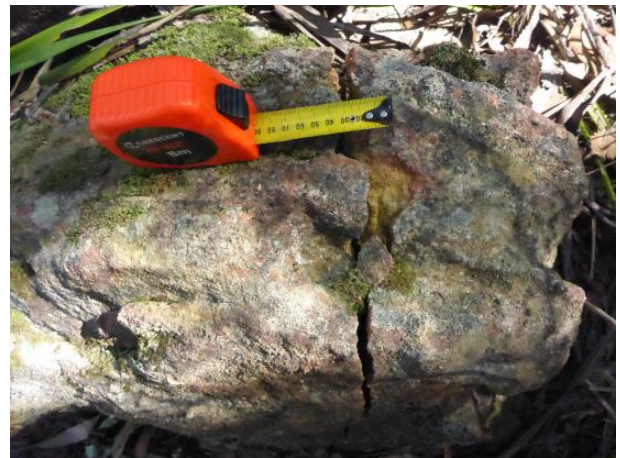
Photo 98: DA3B_LW15_026, looking at fracture to boulder. Taken on 24/08/2020.

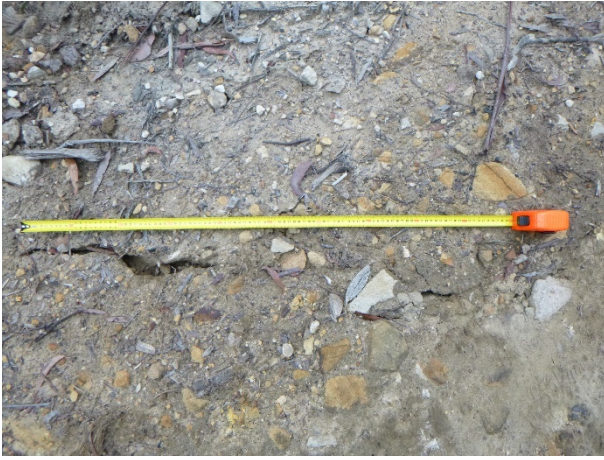
Photo 99: DA3B_LW16_001, soil cracking on access track between Lake Avon and FR6A. Taken on 16/04/2020.

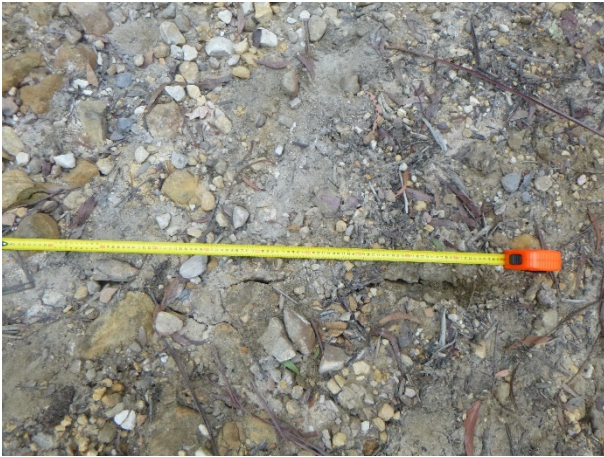
Photo 101: DA3B_LW16_002, soil cracking on access track between Lake Avon and FR6A. Taken on 16/04/2020.

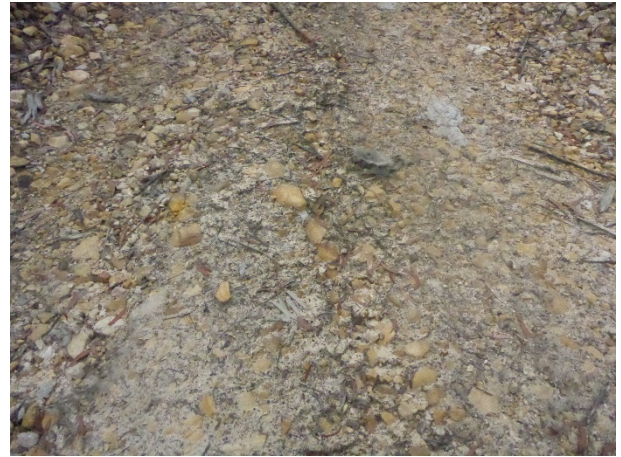
Photo 102: DA3B_LW16_002, soil cracking naturally remediated. Taken on 19/11/2020.

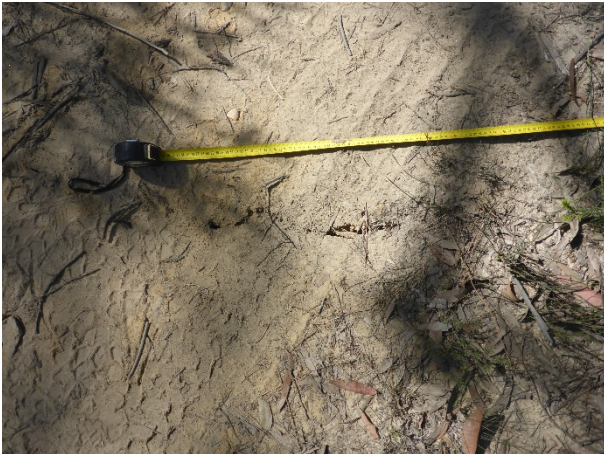
Photo 107: DA3B_LW16_006, soil cracking on access track between Lake Avon and FR6A. Taken on 22/04/2020.

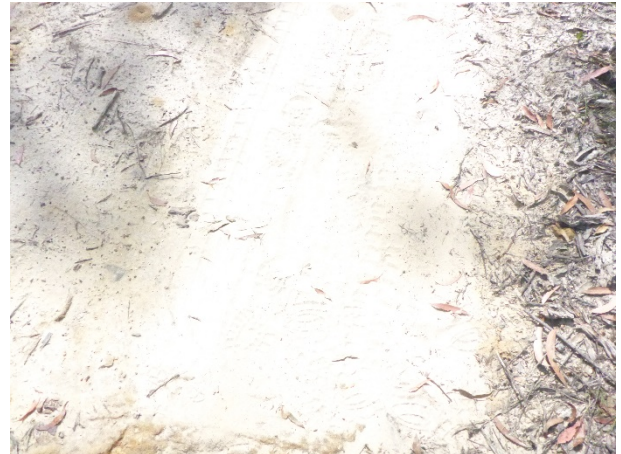
Photo 108: DA3B_LW16_006, soil cracking naturally remediated. Taken on 19/11/2020.

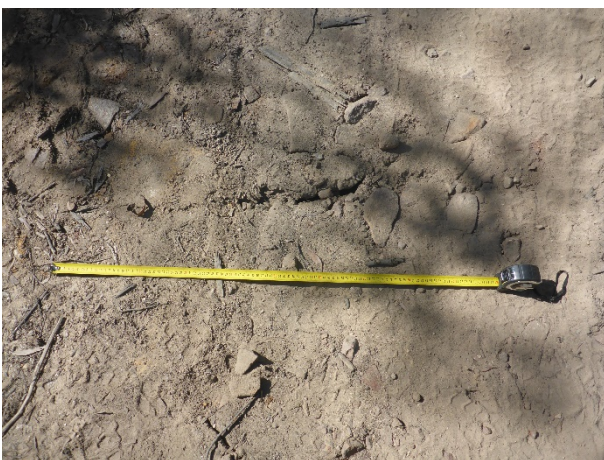
Photo 109: DA3B_LW16_007, soil cracking on access track between Lake Avon and FR6A. Taken on 22/04/2020.

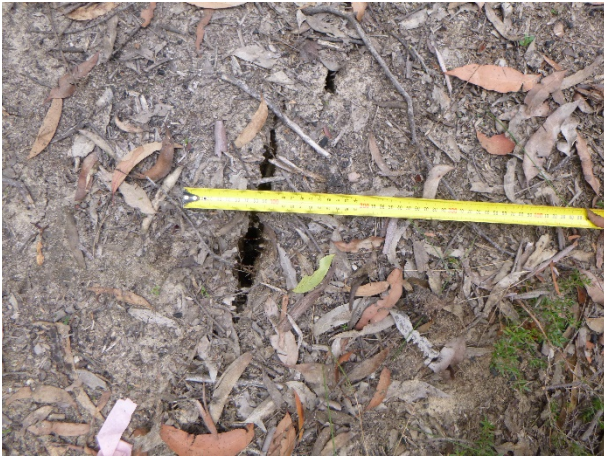
Photo 113: DA3B_LW16_009, soil cracking on rehabilitated access track between Lake Avon and FR6A. Taken on 27/04/2020.
