**DENDROBIUM AREA 3B
LONGWALL 16 END OF PANEL
LANDSCAPE REPORT
DECEMBER 2020**

This report summarises the observed and measured subsidence effects on landscape features resulting from the extraction of Dendrobium Area 3B (DA3B) Longwall 16.

Longwall 16 is the eighth panel extracted from DA3B. Extraction began on 26 February 2020 and was completed on 4 November 2020.

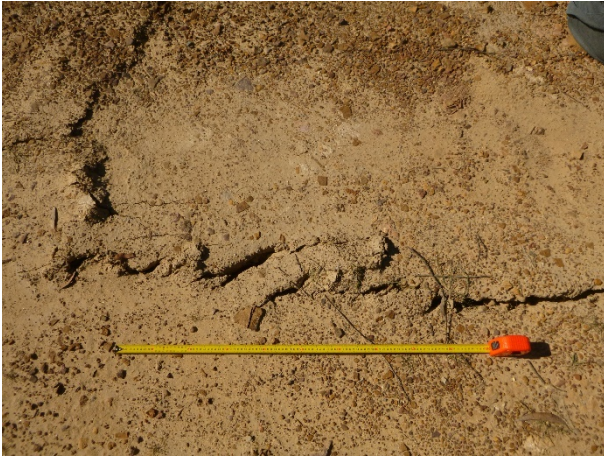
Photo 117: DA3B_LW15_008 (Update), soil cracking and uplift on FR6A. Taken on 12/05/2020.

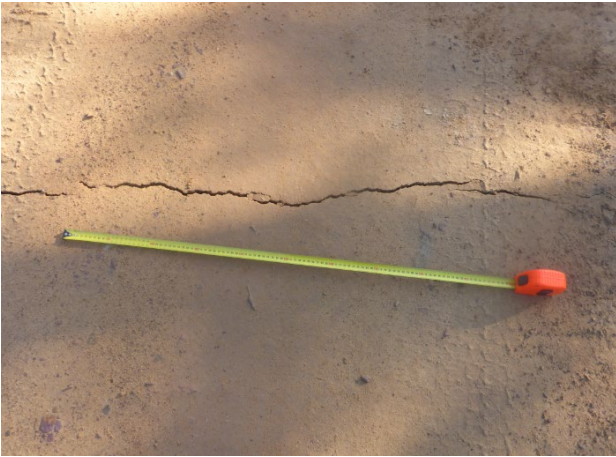
Photo 119: DA3B_LW16_020, soil cracking on FR6A. Taken on 30/06/2020.

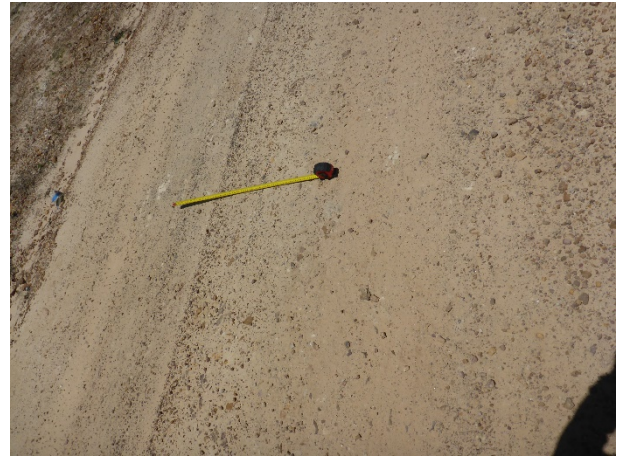
Photo 120: DA3B_LW16_020, soil cracking naturally remediated. Taken on 19/11/2020.

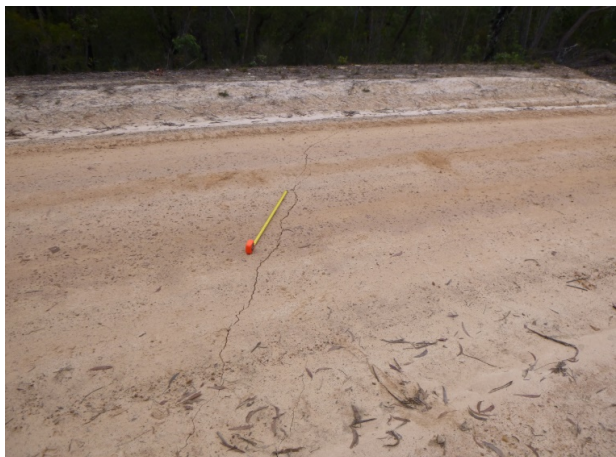
Photo 121: DA3B_LW16_023, cracking across Fire Road 6A. Taken on 7/07/2020.

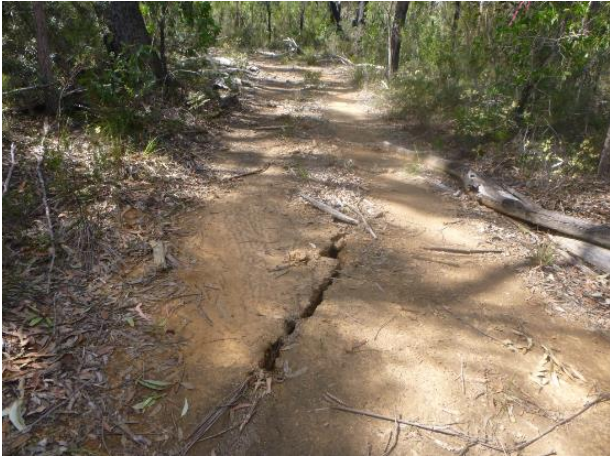
Photo 123: DA3B_LW16_027, soil cracking across Fire Road 6P. Taken on 21/08/2020.

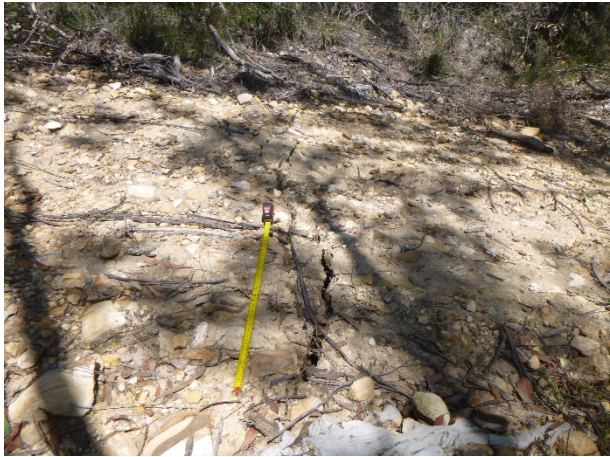
Photo 125: DA3B_LW16_033, section of soil cracking on access track parallel to WC15. Taken on 28/09/2020.

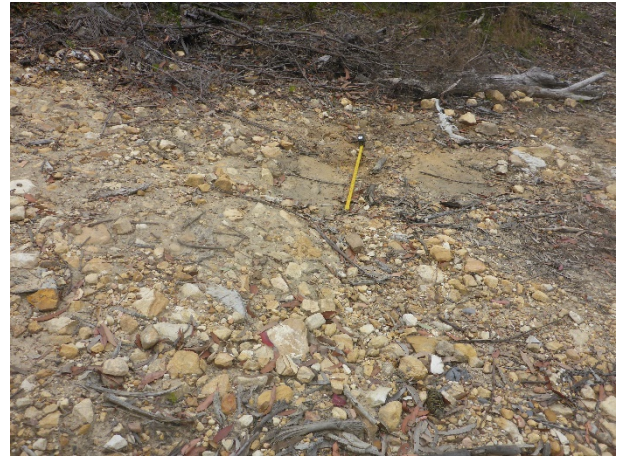
Photo 126: DA3B_LW16_033, soil cracking naturally remediated. Taken on 30/11/2020.

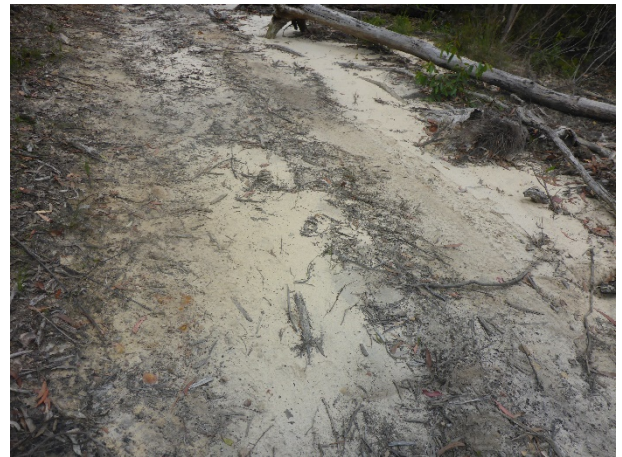
Photo 128: DA3B_LW16_034, soil cracking naturally remediated. Taken on 30/11/2020.

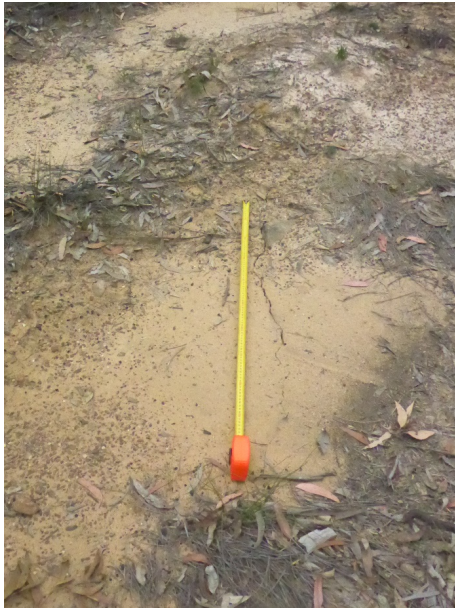
Photo 131: DA3B_LW16_039, soil cracking to access track east of Swamp 14. Taken on 7/10/2020.

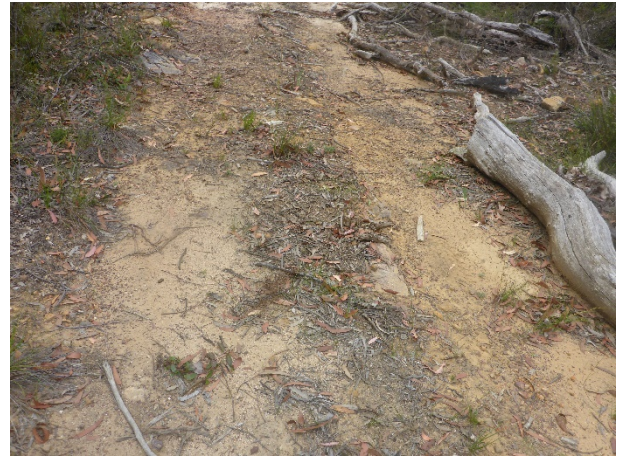
Photo 132: DA3B_LW16_039, soil cracking naturally remediated. Taken on 30/11/2020.

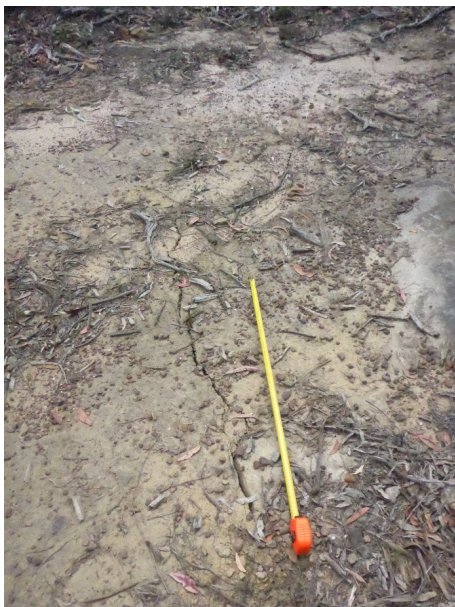
Photo 133: DA3B_LW16_040, soil cracking to access track east of Swamp 14. Taken on 7/10/2020.

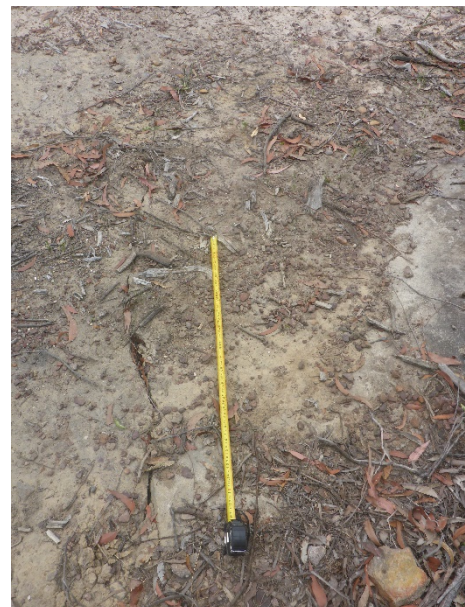
Photo 134: DA3B_LW16_040, no change to soil cracking. Taken on 30/11/2020.

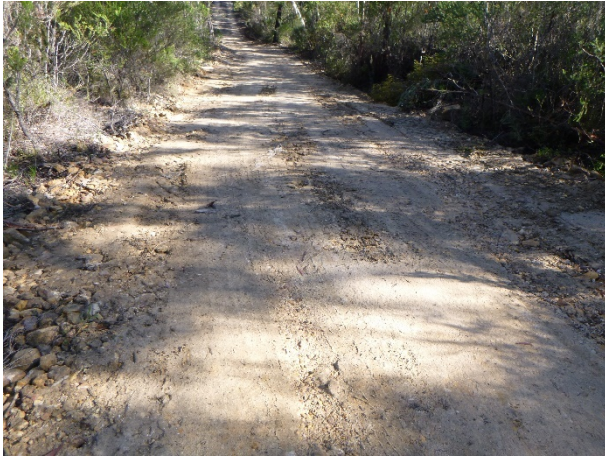
Photo 147: DA3B_LW16_013, looking at the remediated access track. Taken on 11/06/2020.

Following approval from WaterNSW, remediation was undertaken to surface cracking across *FR6A* and an access track between *Lake Avon* and *FR6A*. Some additional remediation was required following a large rainfall event. Minor soil cracks in other areas have, or are expected to continue to, infill through natural processes.

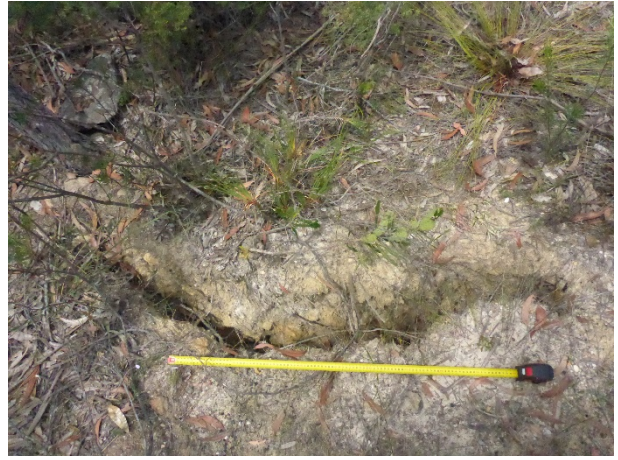
Photo 148: DA3B_LW16_013, looking at soil cracking adjacent to access track. Taken on 19/11/2020.
