**DENDROBIUM AREA 3B
LONGWALL 16 END OF
PANEL REPORT**

March 2021

Dendrobium Longwall 16 is located within Consolidated Coal Lease 768 and is the eighth panel to be extracted in DA3B. Extraction of Longwall 16 commenced on 26 February 2020 and was completed on 4 November 2020. The extracted longwall has a length of 1864 metres (m), a void width of 305m (including first workings) and a maximum cutting height up to 3.9m

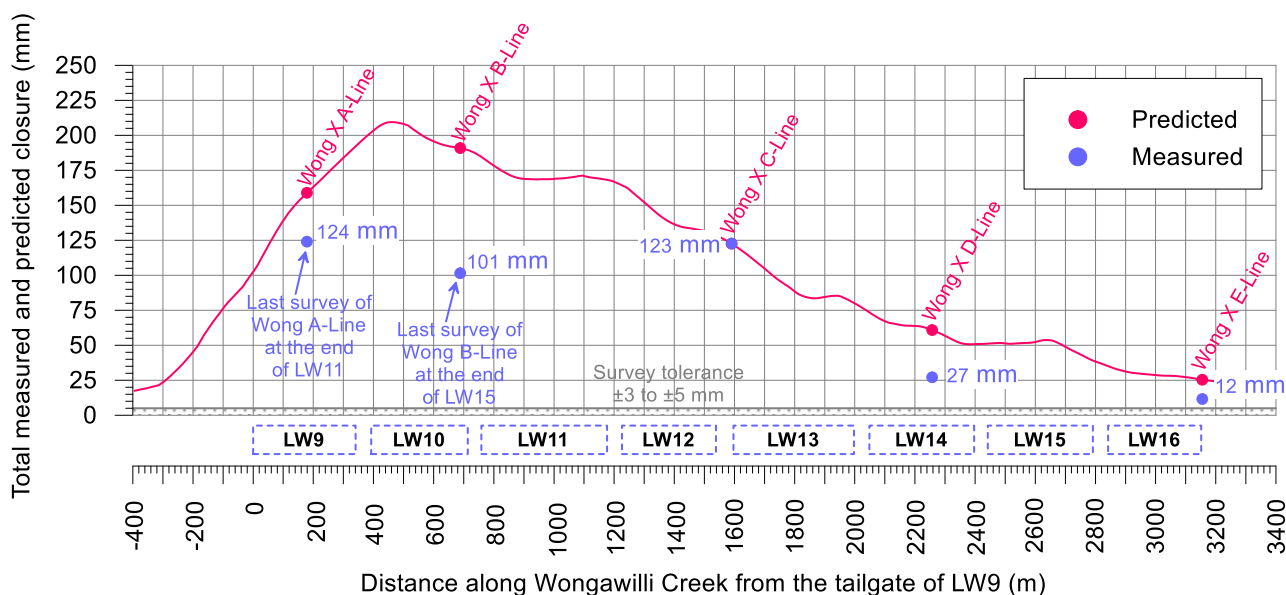
Figure 2: Measured and predicted total closure along Wongawilli Creek after the extraction of Longwall 16. (Source: Attachment B).

The maximum measured total closure at each of the Wongawilli Creek closure lines are similar to or less than the predictions after the completion of Longwall 16 (Figure 2).

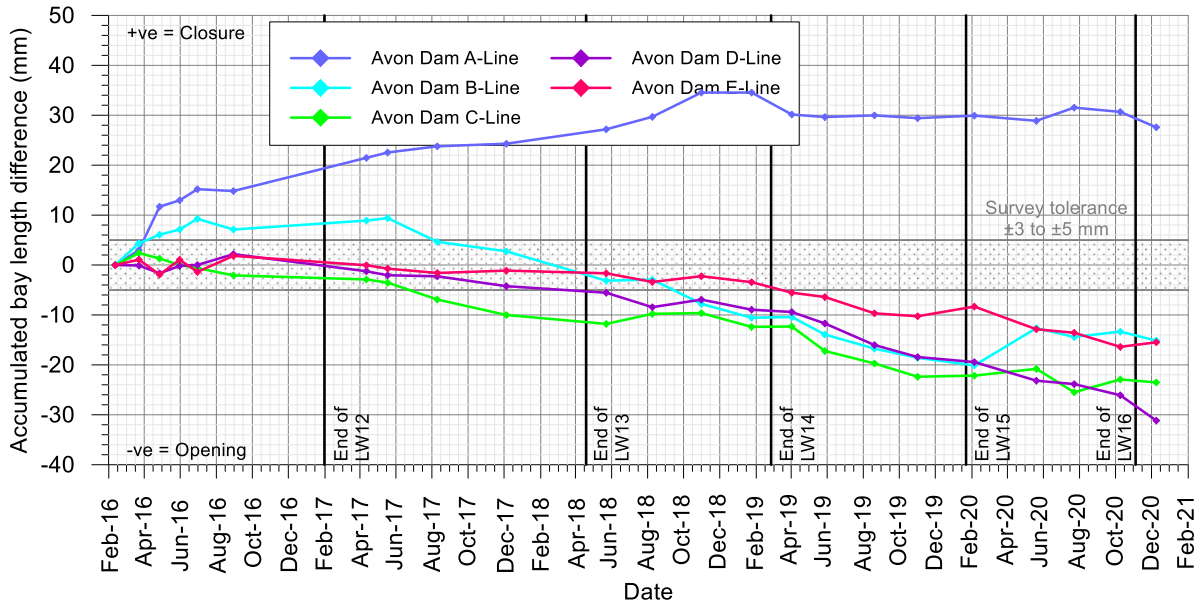
Figure 3: Measured accumulated closure for the Avon Dam closure lines. (Source: Attachment B).

The maximum measured total movements at the Avon Dam monitoring lines are similar to or less than the predictions at the completion of Longwall 16. The extraction of Longwall 16 has only resulted in a small decrease in the closure measured at the A-Line and small increases in the openings measured at each of the other monitoring lines (Figure 3).

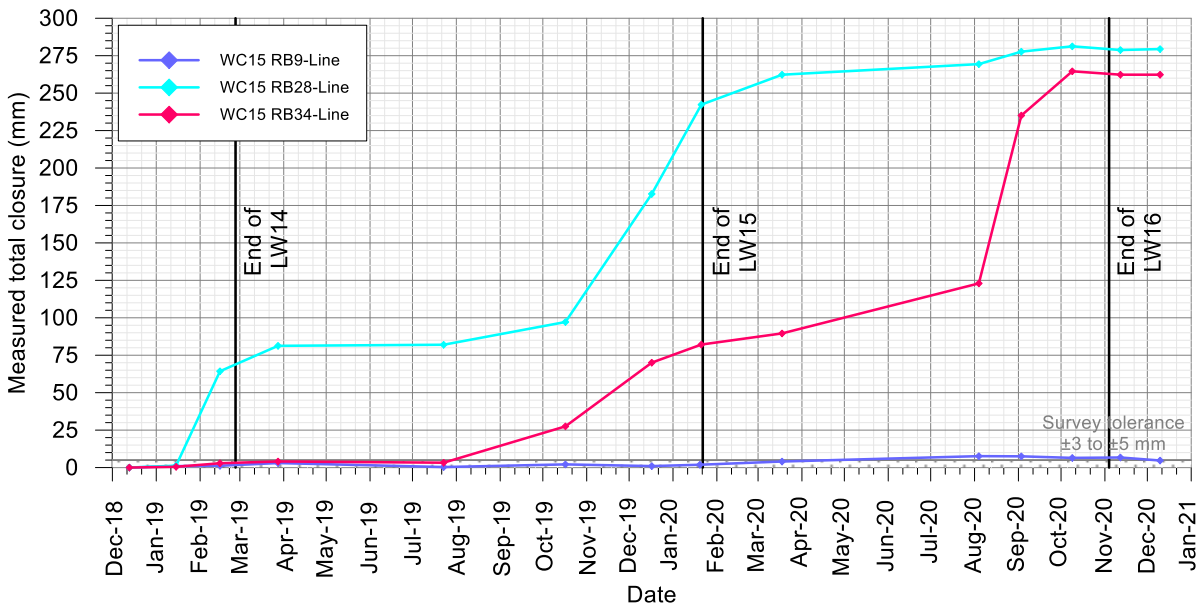
Figure 4: Measured accumulated closure for the WC15 cross lines. (Source: Attachment B).

The mine subsidence movements across WC15, a tributary to Wongawilli Creek, have been measured using 2D survey techniques. These monitoring lines were established in December 2018 during the mining of Longwall 14. The subsidence and closure (Figure 4) measured at WC15 RB9-Line, WC15 RB28-Line and WC15 RB34-Line are less than the predicted values.

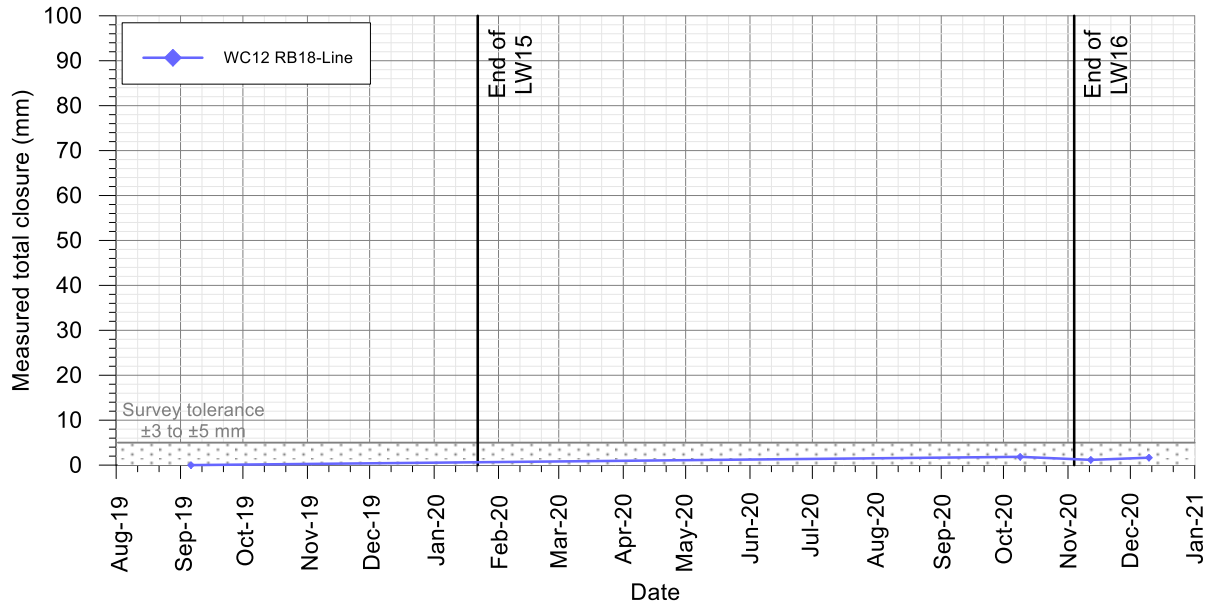
Figure 5: Measured accumulated closure for the WC12 cross line. (Source: Attachment B).

The mine subsidence movements across WC12, a tributary to Wongawilli Creek, have been measured using 2D survey techniques at the WC12 RB18-Line. The monitoring line was established during the mining of Longwall 15 and, therefore, it does not include the effects of Longwall 9 to Longwall 14 and part of Longwall 15. The subsidence and closure (Figure 5) measured at WC12 RB28-Line are less than the predicted values.

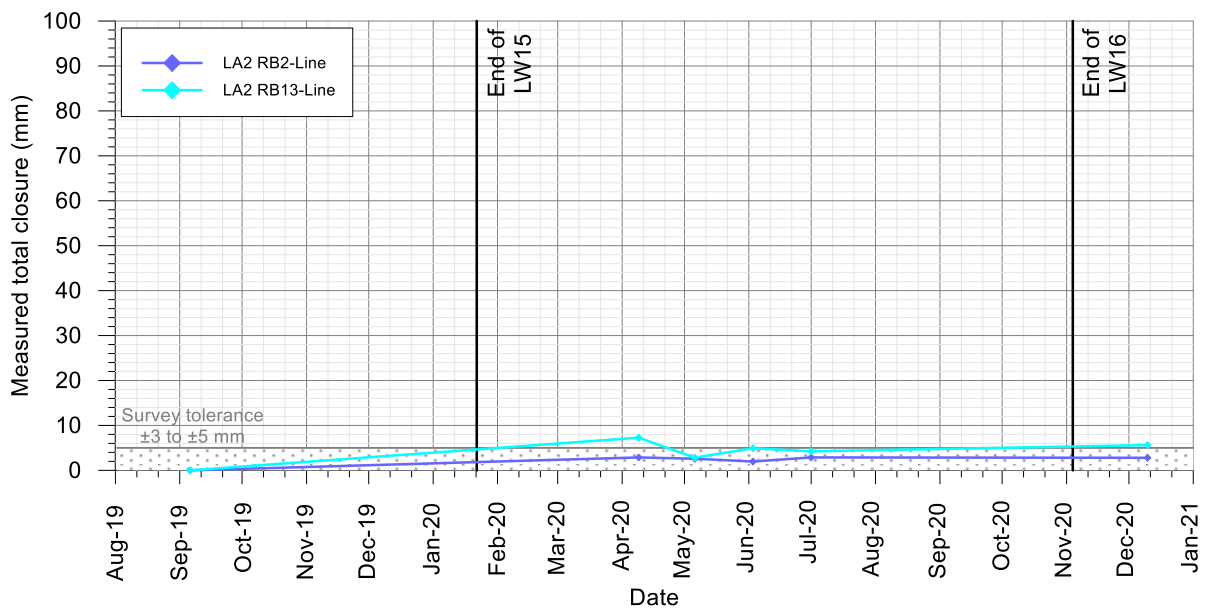
Figure 6: Measured total closure for the LA2 cross lines. (Source: Attachment B).

The mine subsidence movements across LA2, a tributary to Lake Avon, have been measured using 2D survey techniques at the LA2 RB2-Line and LA2 RB13-Line. These two monitoring lines were established during the mining of Longwall 15 and, therefore, they do not include the effects of Longwall 9 to Longwall 14 and part of Longwall 15. The subsidence and closure (Figure 6) measured at the LA2 RB2-Line and LA2 RB13-Line are less than the predicted values.

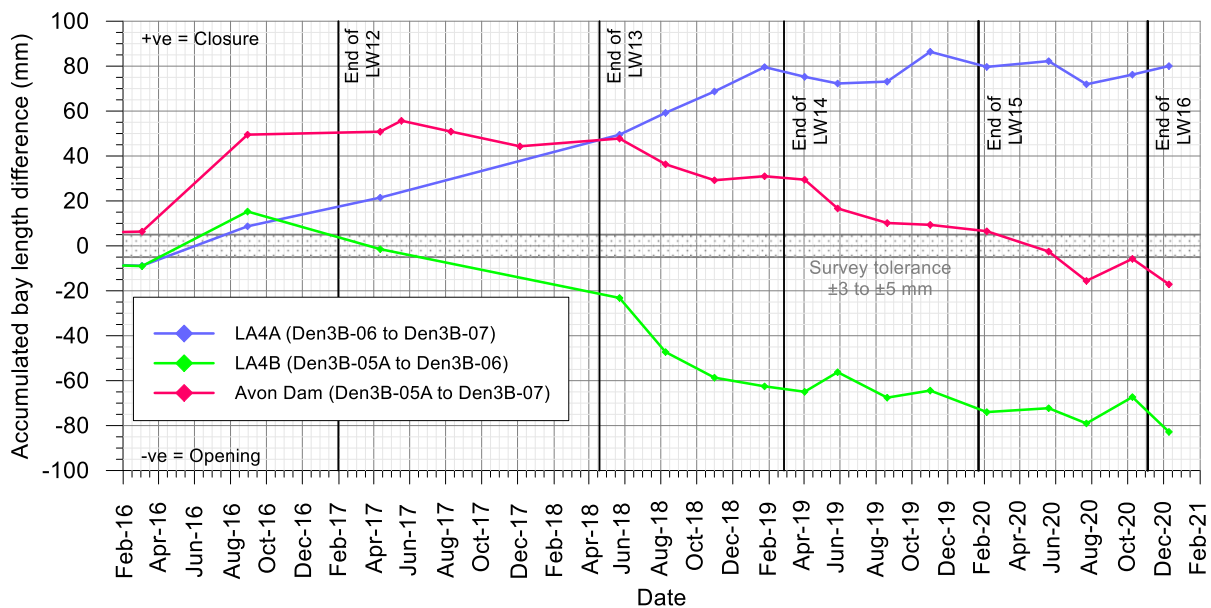
Figure 7: Measured accumulated closure for Tributaries LA4A, LA4B and the Avon Dam. (Source: Attachment B).

The closure across Avon Dam and two tributaries to Avon Dam (LA4A and LA4B), were measured using the Avon Dam GPS (Figure 7). The measured total closure at the LA4A monitoring line is less than the predicted value at the completion of Longwall 16. Net opening movements have been measured at the LA4B and Avon Dam monitoring lines due to the conventional subsidence effects being greater than the valley-related effects. The magnitudes of the measured opening movements are less than the magnitudes of the predicted closure movements.

The maximum measured total closure across Lake Avon is less than the maximum predicted value at the completion of Longwall 16. It is considered that the ground movements measured using these monitoring lines are consistent with the predictions.

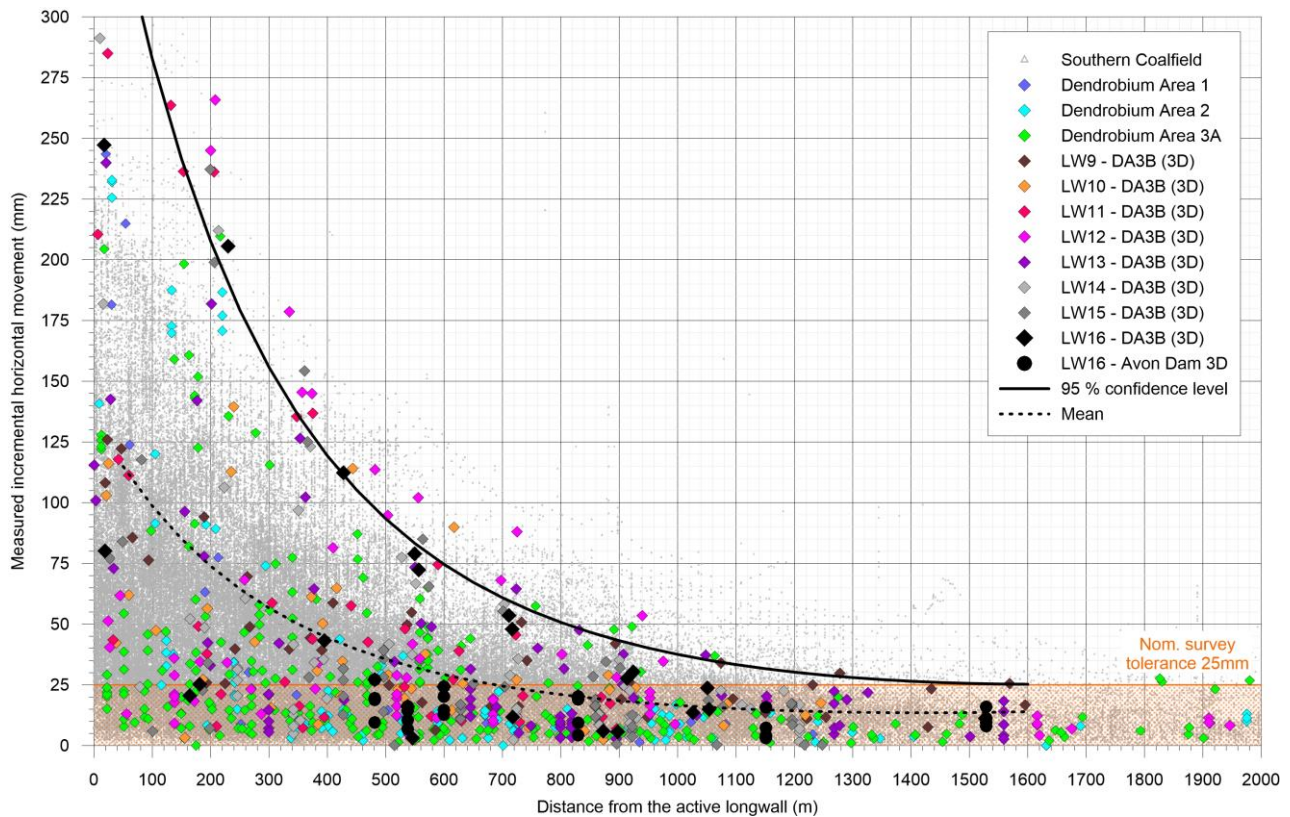
Figure 9: Measured incremental horizontal movements at Dendrobium Mine. (Source: Attachment B).

The measured incremental horizontal movements resulting from the extraction of Longwall 16 are typically within the range of those measured at similar distances from previously extracted longwalls at Dendrobium Mine and elsewhere in the Southern Coalfield (i.e. grey triangles).

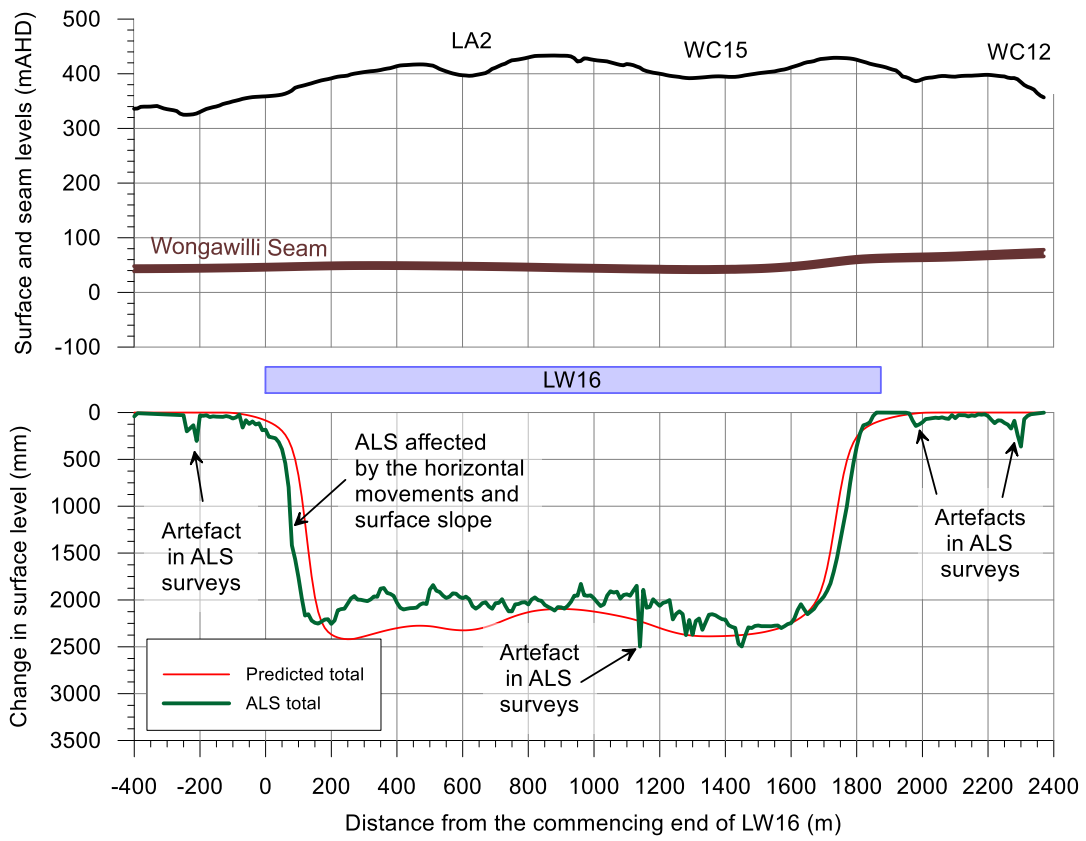
Figure 15: Measured changes in surface level and predicted vertical subsidence along Long section 1. (Source: Attachment B).

The measured change in surface level along Long-section 1 (Figure 15) is greater than the predicted vertical subsidence above the commencing end of Longwall 16 (i.e. left side of figure). However, this may be partly due to the surveying tolerance and the effects of the horizontal movements and sloping terrain on the ALS surveys. The ground directly above the commencing end of Longwall 16 has moved towards the longwall (i.e. following

the extraction face). The natural surface dips towards the west in this location (i.e. towards Avon Dam). The mining-induced horizontal movement, therefore, results in the measured changes in level at a fixed position to be greater than the true vertical subsidence above the commencing end of Longwall 16. There are localised areas outside of the longwalls where the measured changes in surface level exceed the predicted vertical subsidence. However, these are artefacts of the ALS surveys and are not real movements. Elsewhere, the low-level movements are in the order of accuracy of the measurement method. It is considered that the subsidence movements measured using the ALS surveys are consistent with the predicted subsidence movements.

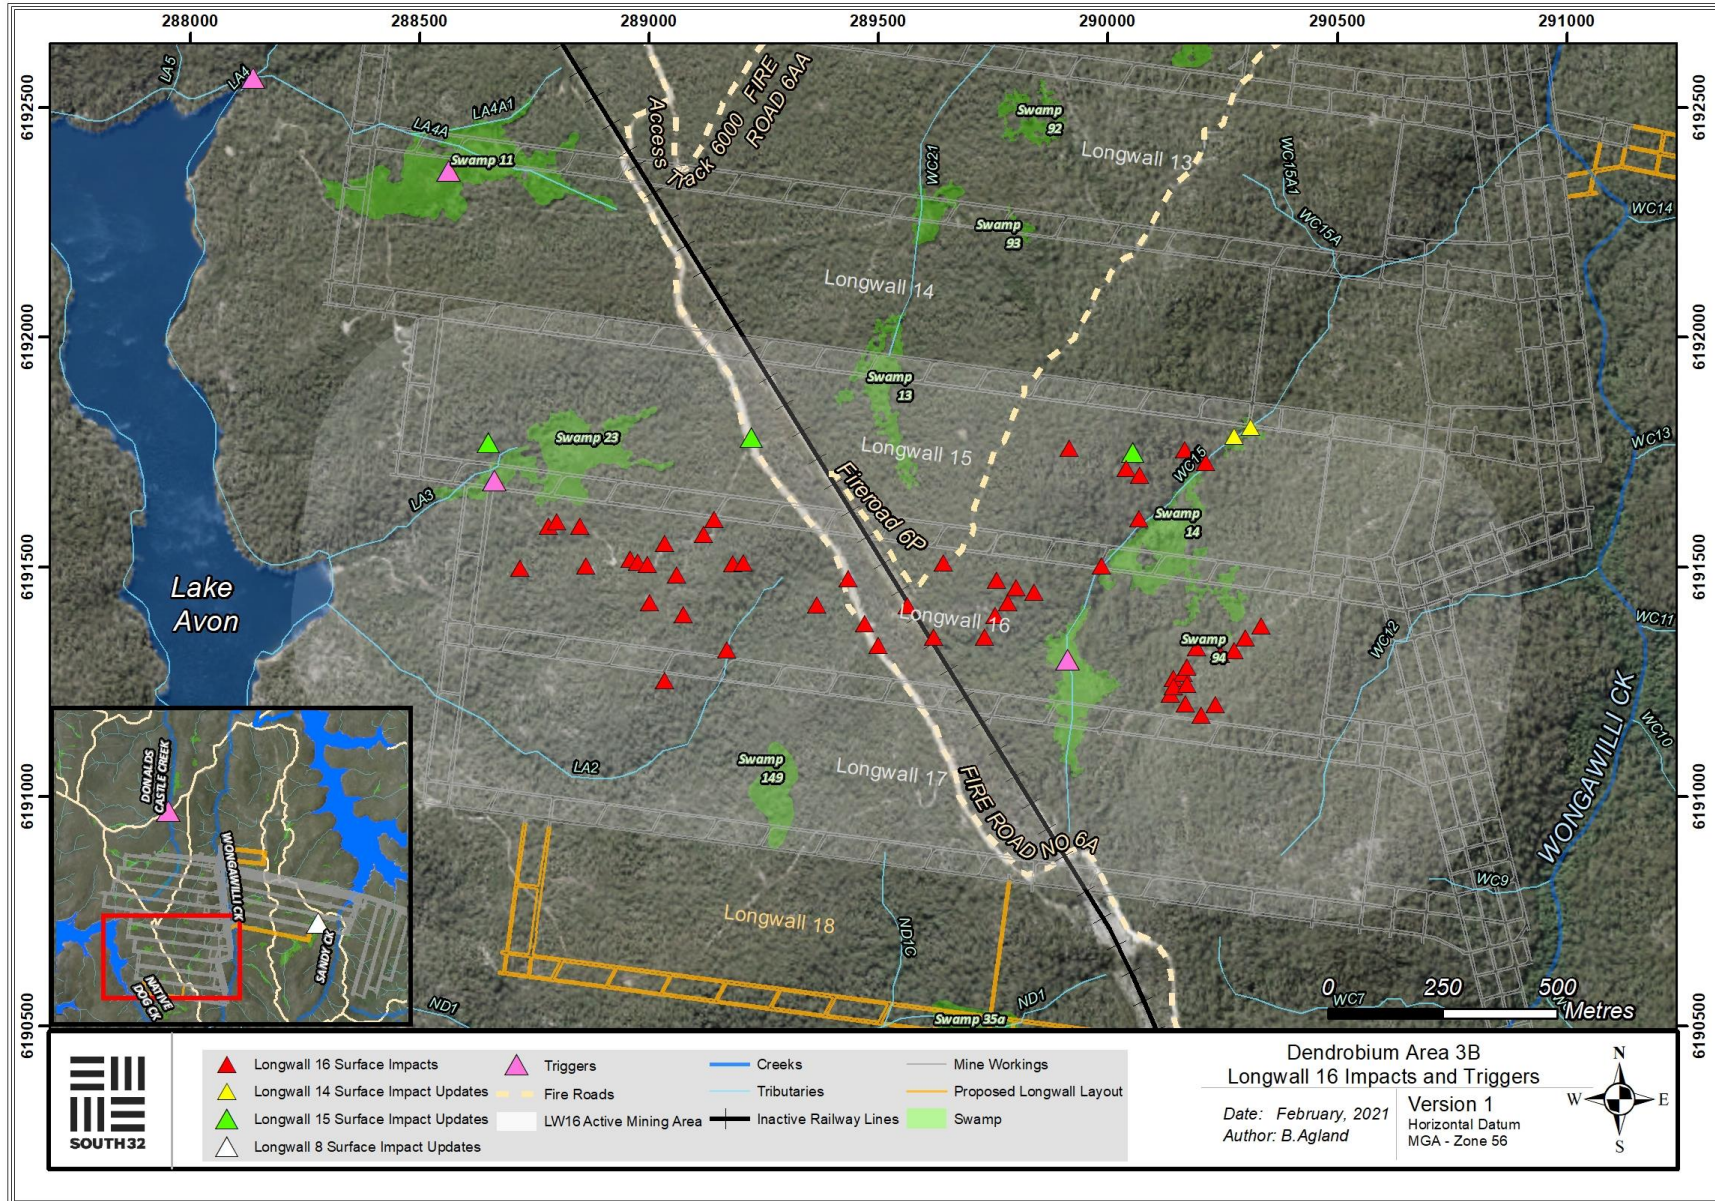
Figure 18: Overview of surface impacts observed during the extraction of Longwall 16.
