**DENDROBIUM AREA 3B  
LONGWALL 17 END OF  
PANEL  
LANDSCAPE REPORT  
NOVEMBER 2021**

## **EXECUTIVE SUMMARY**

This report summarises the observed and measured subsidence effects on landscape features resulting from the extraction of Dendrobium Area 3B (DA3B) Longwall 17. Longwall 17 is the ninth panel extracted from DA3B. Extraction began on 12 December 2020 and was completed on 13 October 2021. The Illawarra Metallurgical Coal Environmental Field Team (IMCEFT) conducts detailed monitoring and inspections of landscape features including swamps, watercourses, rock outcrops and landscape features within the mining area of DA3B. This monitoring was conducted in accordance with:

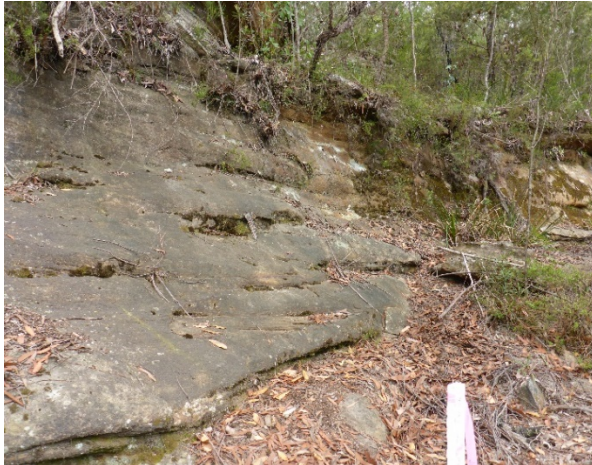
In accordance with the Dendrobium Area 3B SMP Approval, landscape monitoring sites (Subsidence Landscape Monitoring and Management Plan [SLMMP] photo points) within the active mining area were monitored at monthly intervals. Monitoring photos from SLMMP sites are compared to baseline photos at each site (Photo 1 and Photo 2). Landscape monitoring sites (SLMMP photo points) were monitored before, during and after the Longwall 17 extraction period (Table 1). Longwall 17 post-mining inspections were undertaken, and no impacts were observed.

Photo 1: A3b-SS16, baseline inspection. Taken on 27/12/17.

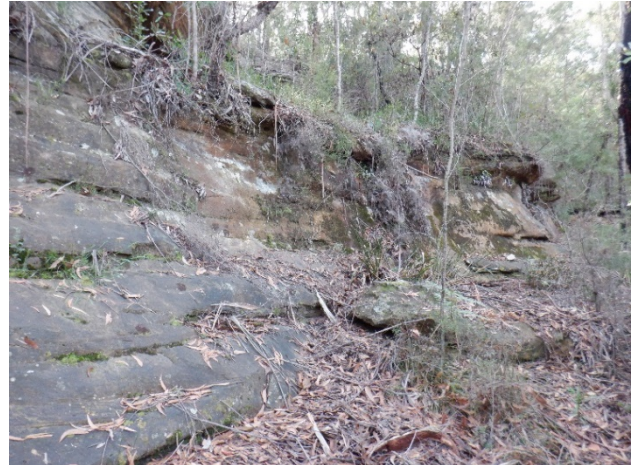
Photo 2: A3b-SS16, post-mining inspection. Taken on 7/6/21.

Site Name	Easting	Northing	Impact Description
<b>A3b-SS15</b>	288717	6191468	No impacts observed
<b>A3b-SS16</b>	289207	6191506	Rock Fracturing during LW16, no further changes observed
<b>A3b-SS17</b>	290163	6191269	Rock Fracturing during LW16, no further changes observed
<b>A3b-SS18</b>	288812	6190998	No impacts observed
<b>A3b-SS19</b>	289020	6191108	No impacts observed
<b>A3b-SS20</b>	289245	6190585	No impacts observed
<b>A3b-SS21</b>	289633	6190858	No impacts observed

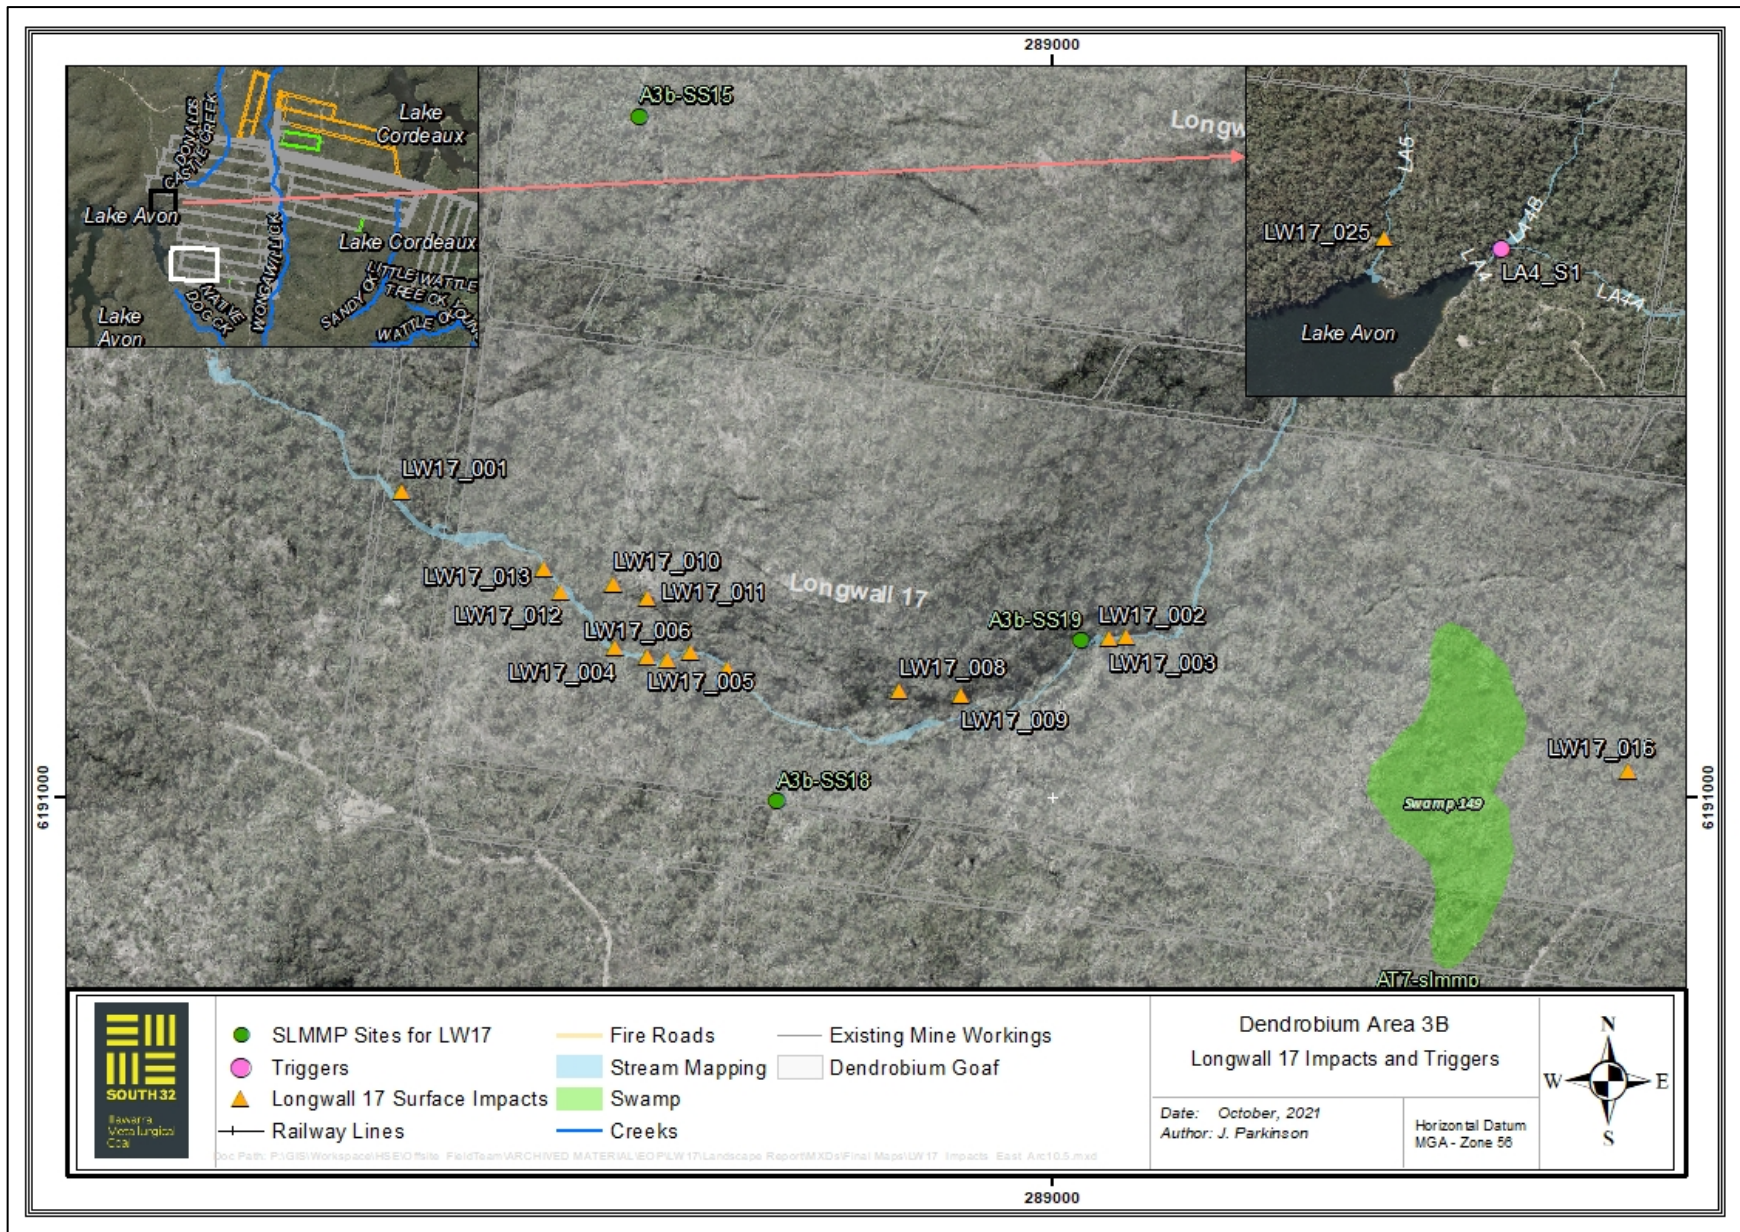
Figure 2: Map showing surface impacts and triggers recorded over western end of Longwall 17

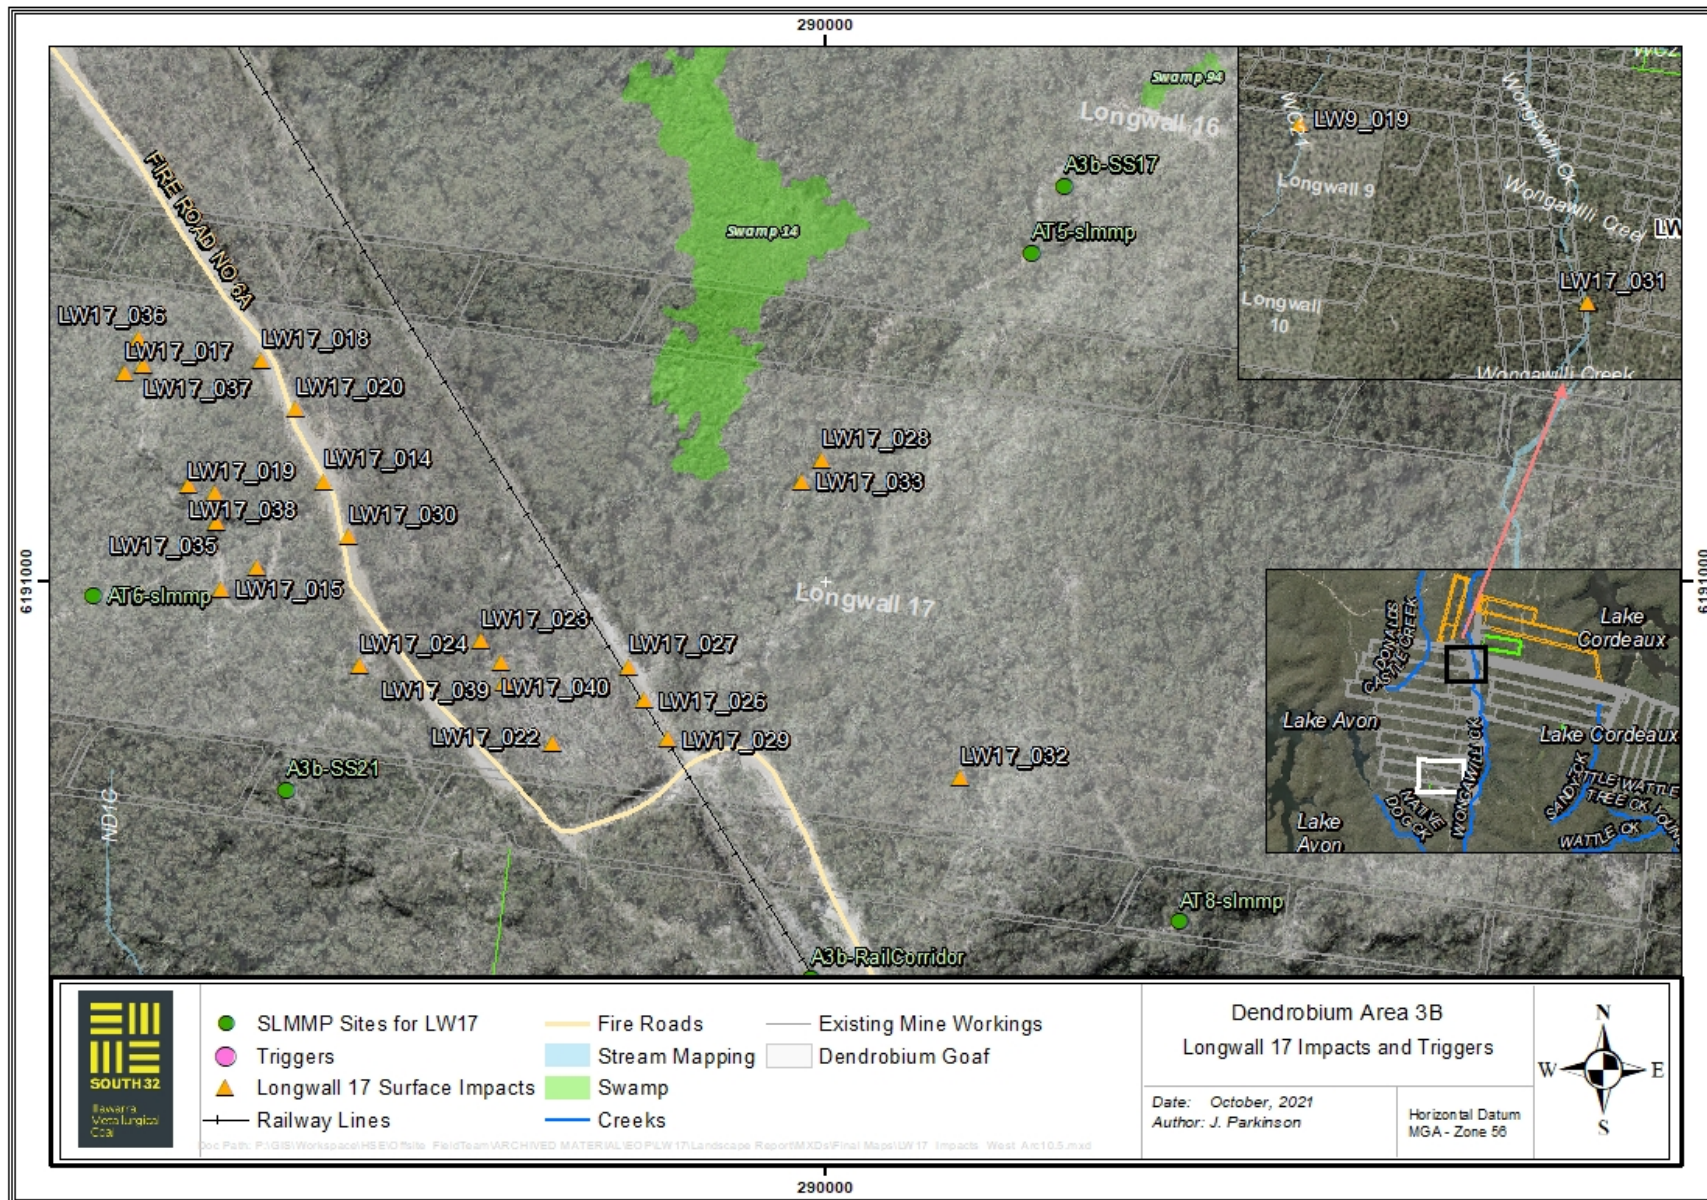
Figure 3: Map showing surface impacts and triggers recorded over eastern end of Longwall 17

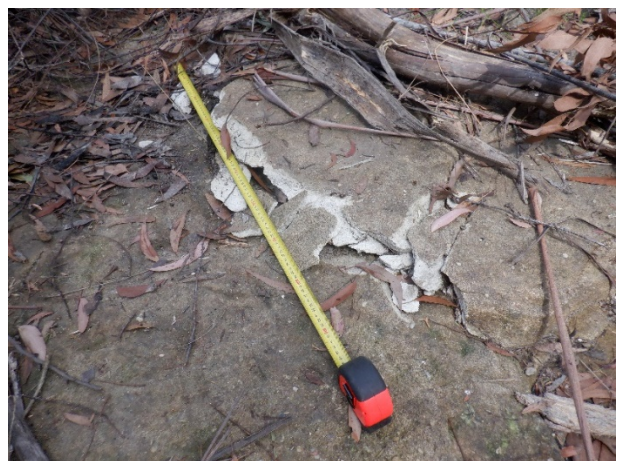
DA3B\_LW17\_001 is located on LA2, a tributary to Lake Avon. The impacted feature is LA2\_Channel 6B which is situated approximately 40m west of the commencing end of Longwall 17 (Figure 2). The impact is comprised of two rock fractures, uplift and associated rock fragmentation (Photo 5 to Photo 8). The rock fracturing has a maximum measurable length of 1.7m, a width of 0.01m and a maximum measurable depth of 0.47m. The uplift has a width of 0.045m. While not evident during the latest inspection, flow diversion would occur if surface flow was present. On the 10<sup>th</sup> of September, the impact had increased by 0.007m in length, width had increased from 0.01m to 0.04m with measurable depth staying the same.

Photo 8: DA3B\_LW17\_001, looking at a section of rock fragmentation. Taken on 10/09/2021.

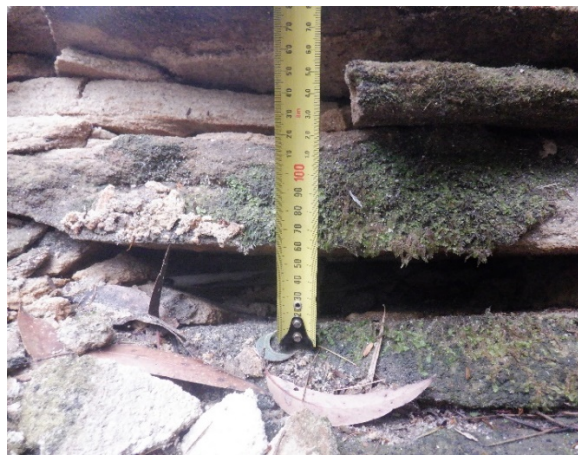
DA3B\_LW17\_006 is located on LA2, a tributary to Lake Avon (Figure 2). The impacted feature, LA2\_Pool 14, was mined beneath by Longwall 17 on 17 January 2021. The impact is comprised of rock fracturing, soil cracking and uplift within an area of 4m by 2m (Photo 13 to Photo 15). The rock fracturing has a maximum length of 1m, a maximum width of 0.045m and a maximum measurable horizontal depth of 0.43m. The soil cracking has a maximum length of 0.59m, a maximum width of 0.002m and a maximum measurable depth of 0.124m. No flow was present during the inspection however some flow diversion could be expected during surface flow; as the fracture runs across the main flow path of the tributary. The impact was inspected on 10<sup>th</sup> of September 2021, the width of the impact had increased to 0.06 with no soil cracking visible.

Photo 14: DA3B\_LW17\_006, looking at the width of the rock fracturing. Taken on 10/09/2021.

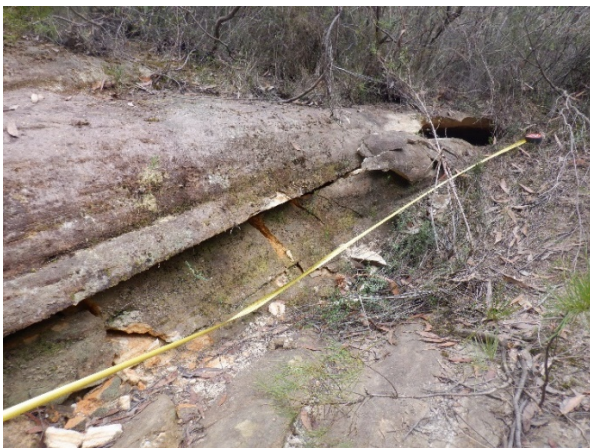
DA3B\_LW17\_002 is located on LA2, a tributary to Lake Avon and was originally reported on 16 February 2021. The site was mined beneath by Longwall 17 on 21 February 2021. During the latest inspection, further fracturing, uplift and changes to existing fracturing were observed (Photo 18 and Photo 19). The impact site was originally localised to LA2\_Rockbar 25 but now extends into the downstream feature LA2\_Pool 25. However it is now connected to impact DA3B\_LW17\_003 through fracturing. The rock fracturing now has a maximum length of 4.2m, width of 0.136m and a maximum measurable depth of 1.640m. The impact was inspected on 10<sup>th</sup> of September 2021, an increase in length from 4.2m to 4.8m was observed as well as width increasing to 0.170m.

DA3B\_LW17\_002 remains a Level 2 trigger as per the Dendrobium Area 3B Watercourse TARP (Table 9), specifically:

- Crack or fracture that (could) result in observable loss of surface water or erosion.
- Crack or fracture between 100 and 300m width at its widest point.

Photo 18: DA3B\_LW17\_002, looking at a section of rock fracturing. Taken on 10/09/2021.

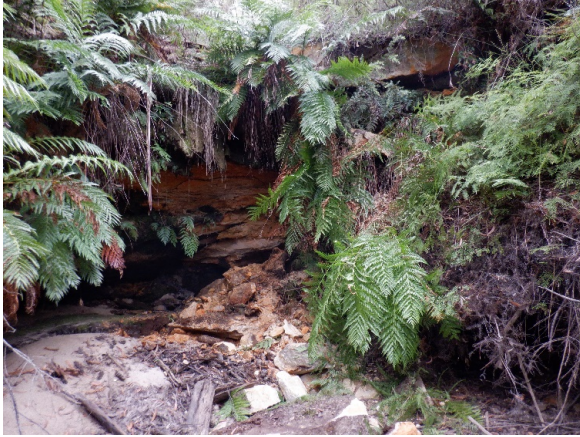
Rock fracturing and rockfall to the step below LA2\_Pool 24 was previously reported (Photo 20). The latest inspection of the site revealed additional rock fracturing and an increase in volume of rockfall. The estimated volume of rock and sediment fallen from the step is now approximately 6m<sup>3</sup> (Photo 21). The rockfall has also disturbed some vegetation growing on the step. The impact was inspected on 10<sup>th</sup> of September 2021, a change was observed but was unable to measure due to safety concerns. DA3B\_LW17\_003 remains a Level 2 trigger as per the DA3B Watercourse TARP (Table 9), specifically:

Photo 20: DA3B\_LW17\_003, rockfall to step as shown in previous update report. Taken on 10/03/2021.

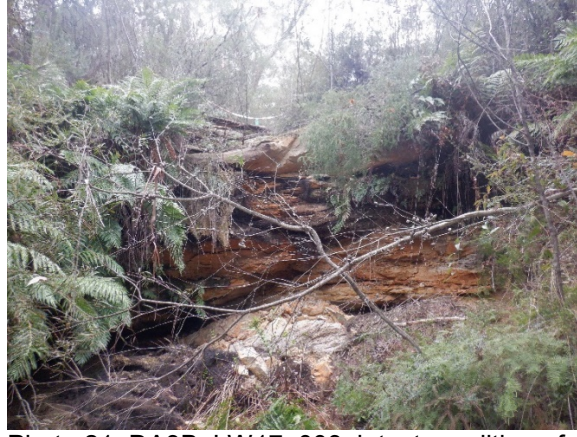
- Crack or fracture that (could) result in observable loss of surface water or erosion.
- Crack or fracture between 100 and 300m width at its widest point.
- Crack or fracture that (could) result in observable loss of surface water or erosion.
- Rockfall from cliff site (step), where characteristics of the cliff (step) have changed, and there has been significant ground disturbance.

Photo 21: DA3B\_LW17\_003, latest condition of step showing additional fallen material. Taken on 10/09/2021.

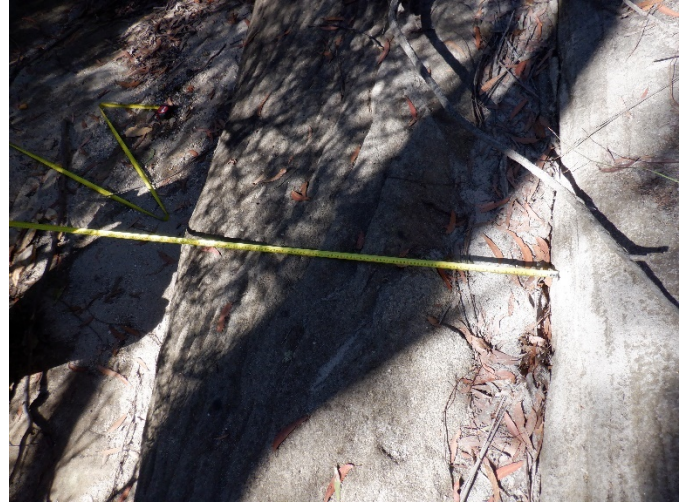
Impact *DA3B\_LW17\_012* includes fracturing which has resulted in a displaced section of rockbar on tributary LA2 (Figure 2). The displaced rock slab is 5.7m long, 1.2m wide and 0.35m thick and has dropped approximately 0.05m (Photo 22 to Photo 24). The longest observable fracture is approximately 7m long and 0.02m wide. Smaller additional fractures and uplift are also evident at the site (Photo 25). The fracturing extends across the flow path with flow diversion possible during surface flow at the site. The impact was inspected on 10<sup>th</sup> of September 2021 and remains unchanged from original identification.

Photo 23: DA3B\_LW17\_012, looking at width of displaced slab. Taken on 13/04/2021.

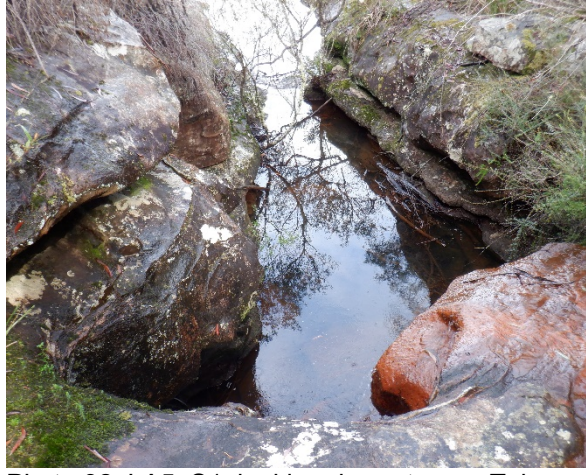
LA5 is a small tributary of Lake Avon, immediately to the west of LA4, that flows southward from DA3B mining operations (Figure 2) The upper reaches of the LA5 sub catchment was mined beneath by Longwall 12 in March 2016. No surface impacts have been observed in LA5 prior to this latest inspection. During the latest inspection on 1 July 2021, iron staining was observed at site LA5\_S1, extending in to Lake Avon (Photo 31 and Photo 32). This was not evident during a previous inspection in April (Photo 33 and Photo 34).

Photo 32: LA5\_S1, looking downstream. Taken on 1/07/2021.

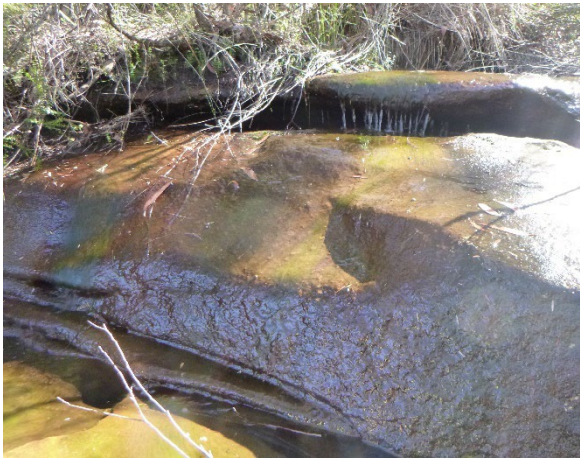
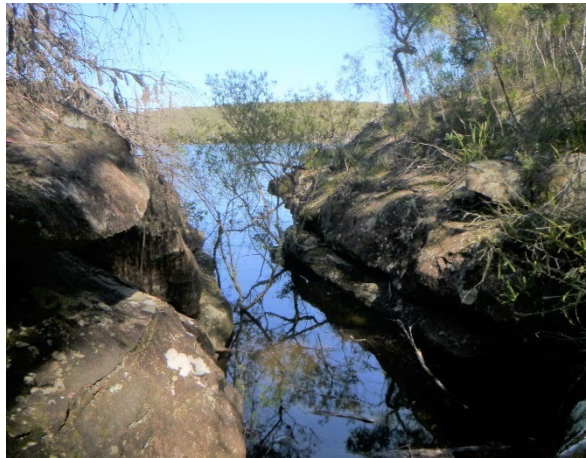
Photo 33: LA5\_S1, looking upstream. Taken on 13/04/2021.

Photo 34: LA5\_S1, looking downstream. Taken on 13/04/2021.

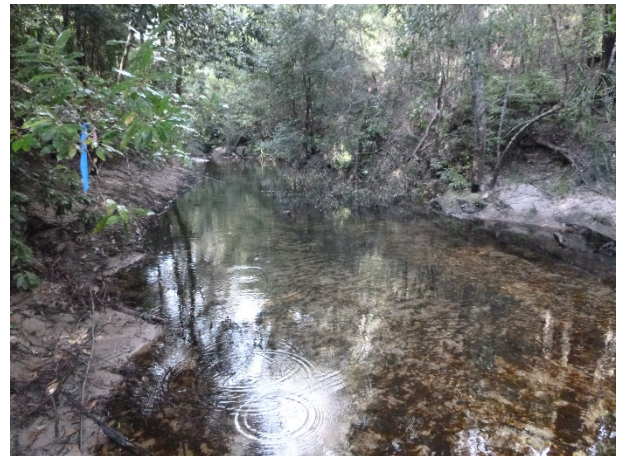
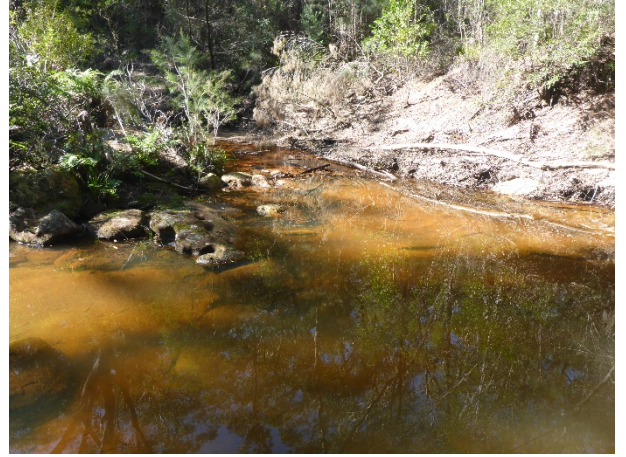
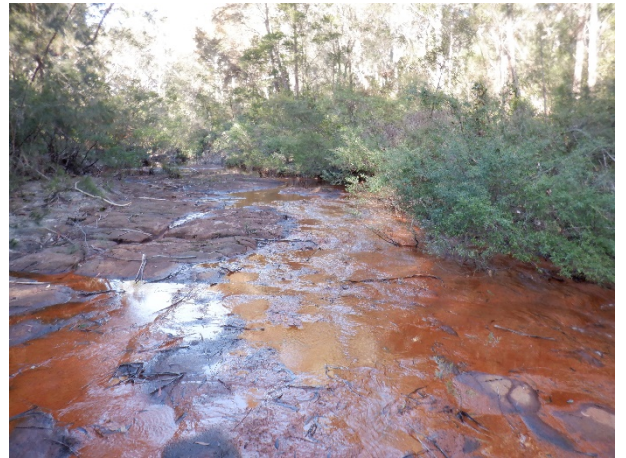
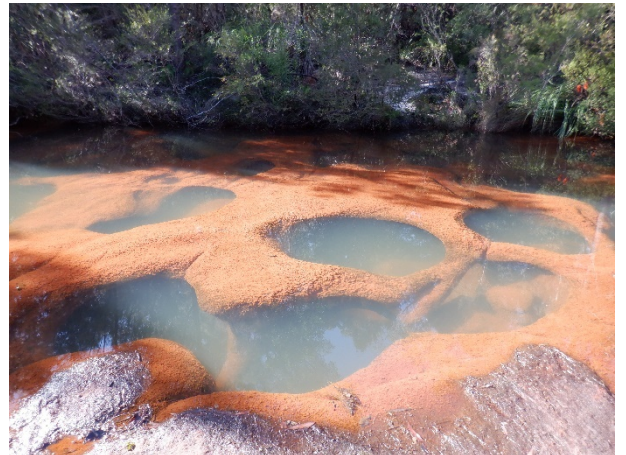
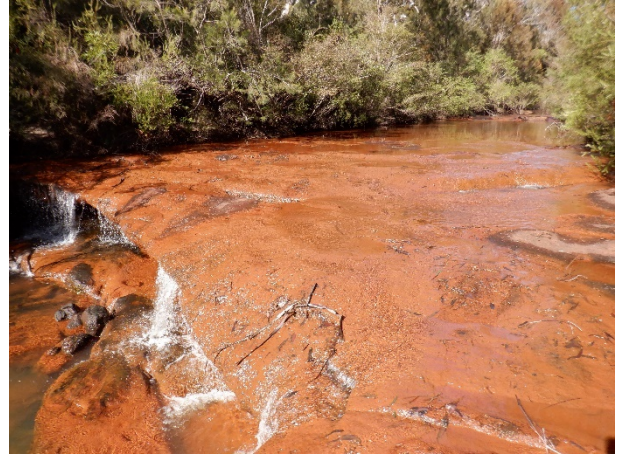
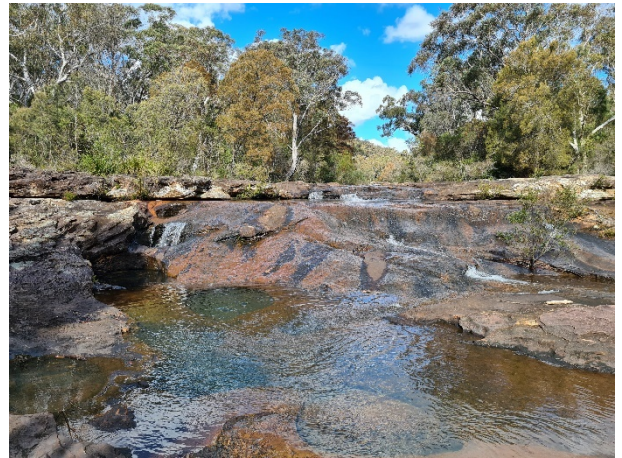
The recent influx of iron is evident in most stream features extending from *WC\_Pool 50* down to *WC\_Rockbar 12*. The distance between these features is approximately 2.9km. The source of the iron staining was identified as originating from a spring located on the valley slope of Wongawilli Creek, approximately 35m to the east, upslope from *WC\_Pool 50* (Photo 35 and Photo 36). The hillslope spring is not located within any named tributary and is releasing flow into Wongawilli Creek. The hillslope spring was first identified in March 2018, however during this inspection it was not observed to be outflowing into Wongawilli Creek. Upstream, between the spring's inflow to the Creek and WC17 confluence, is mostly unaffected with only a small amount of isolated iron staining, likely related to outflow from WC17. No changes are evident on Wongawilli Creek upstream of WC17.

Downstream of *WC\_Rockbar 12*, the iron staining is not observable at all features and is restricted to shallow sections of pools and rockbars with the deeper pools remaining unaffected. Photo 37 shows time comparison photos of locations along Wongawilli Creek.

Photo 38: *WC\_Pool 69*, looking upstream (site upstream of *WC17* Creek confluence). Taken: 23/07/2021.

Photo 40: WC\_Pool 50, looking downstream. Taken 22/07/2021.

Photo 42: WC\_Rockbar 27, looking upstream. Taken 2/08/2021.

Photo 44: WC\_Pool 32, looking cross stream. Taken 2/08/2021.

Photo 46: WC\_Rockbar 14, looking cross stream. Taken 2/08/2021.

Photo 48: WC\_Rockbar 7, looking upstream. Taken 2/08/2021.

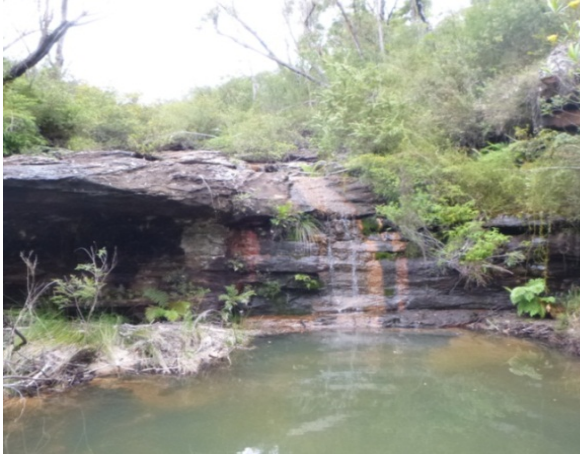
Iron staining and associated change in water appearance of *WC21\_Pool 10* was initially observed 24 December 2013 (Photo 49). Further updates on WC21 have been reported with the extent of the iron not reaching Wongawilli Creek. During a recent inspection of WC21, the extent of the iron was observed to have extended to Wongawilli Creek (Photo 50 to Photo 52).

Photo 49: WC\_21 Pool 10, looking upstream.  
Taken 24/12/2013.

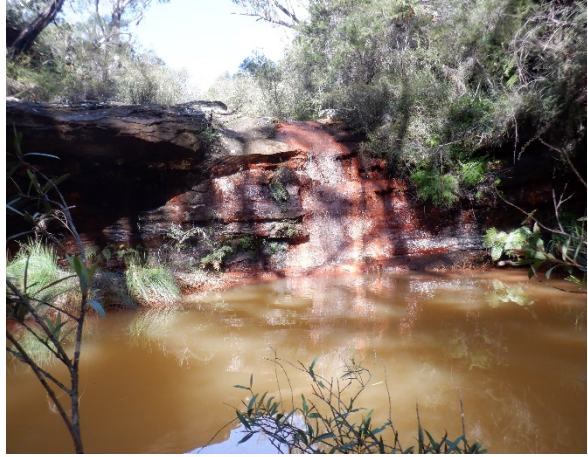
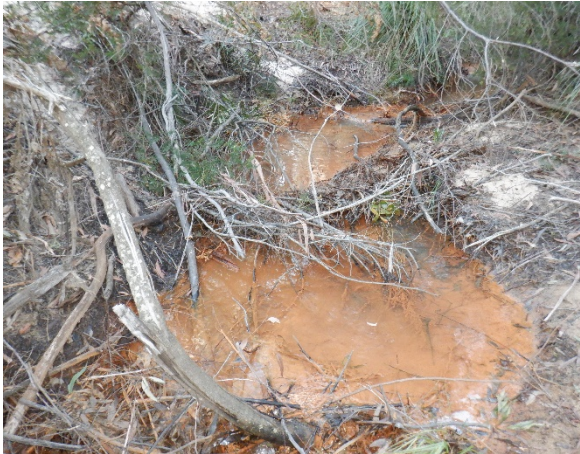
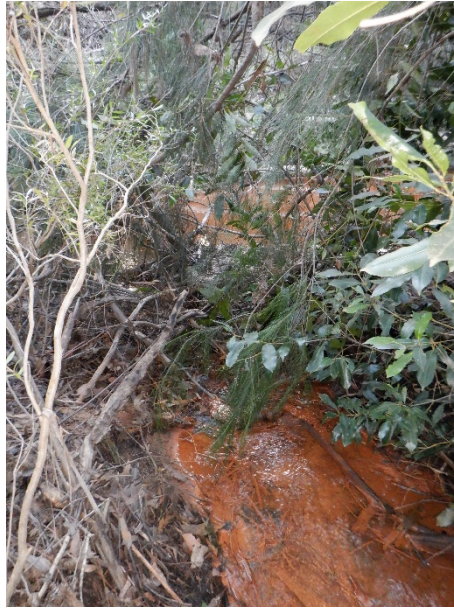
*DA3B\_LW9\_019* is a Level 3 trigger as per the Dendrobium Area 3B Watercourse TARP (Table 9), specifically:

- Observable increase in iron staining within the mining area continues more than 600m from the longwall.

Photo 50: WC21\_Pool 10, looking upstream.  
Taken 3/08/2021.

Photo 51: WC\_21 Confluence, looking  
upstream. Taken 2/08/2021.

Photo 52: WC\_21 Confluence, looking  
downstream towards Wongawilli Creek.  
Taken 2/08/2021.

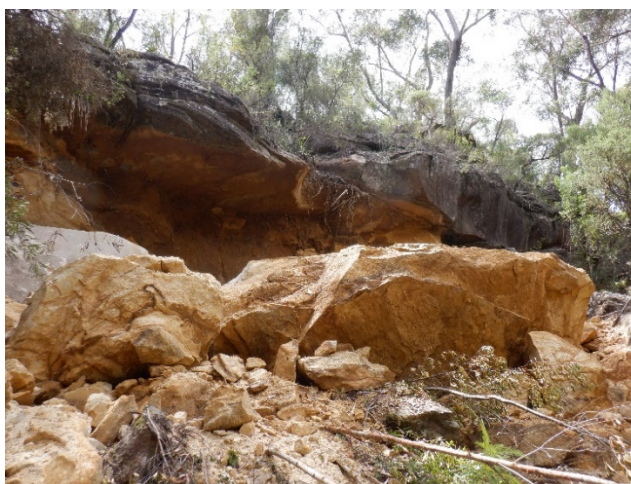
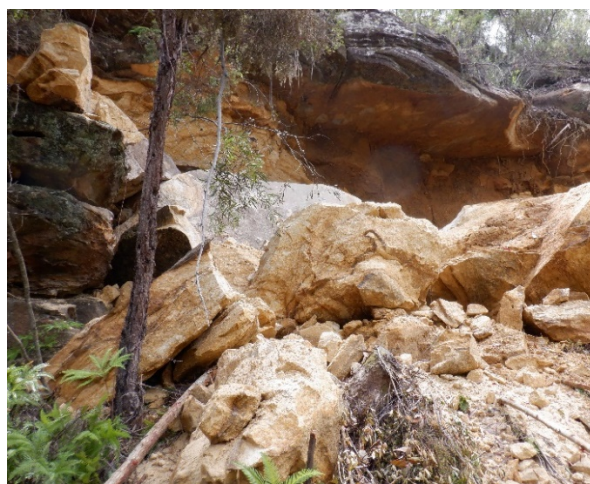
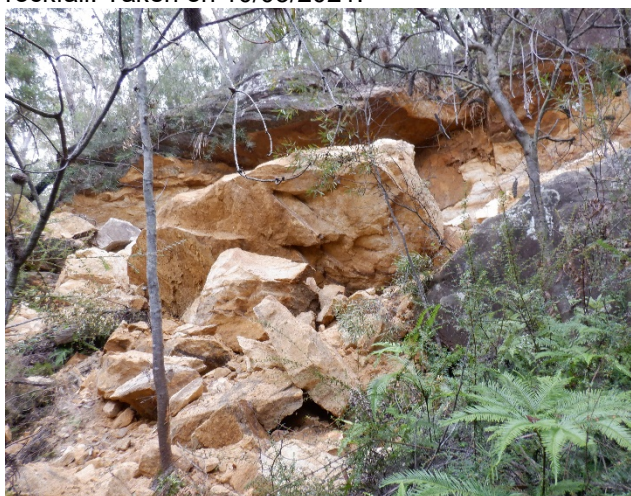
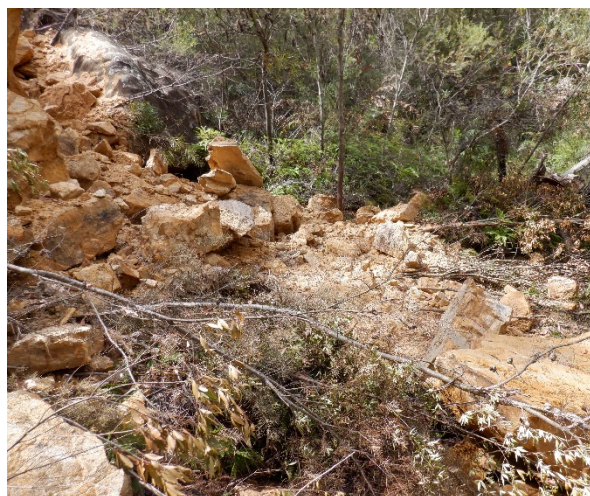
DA3B\_LW17\_008 is located at a steep slope/step approximately 30m north of tributary LA2 (Figure 2). The site was mined beneath by Longwall 17 on 5 February 2021. The impact is comprised of a large rockfall with associated displacement and fragmentation (Photo 53 to Photo 54). The impact was observed from a distance due to safety concerns, therefore the following values are estimates. The rockfall was estimated to be 20m in length by 3.5m in width and depth. The rockfall resulted in the dislodgment of variable sized rock fragments and boulders which is dispersed over an approximate area of 25m by 25m (625m<sup>2</sup>). The largest observable rock debris fragment is estimated to be 5m in length and 3m in width. The impact was inspected on 10<sup>th</sup> of September 2021 and remains unchanged from original identification.

DA3B\_LW17\_008 is a Level 2 trigger as per the Dendrobium Area 3B Landscape TARP ( Table 10), specifically:

- Rockfall or overhang collapse at a cliff site (step), where characteristics of the cliff have changed, and there has been significant ground disturbance.
-

Photo 53: DA3B\_LW17\_008, looking at a section of rockfall. Taken on 10/03/2021.

Photo 54: DA3B\_LW17\_008, looking at a section of rockfall. Taken on 10/03/2021.

Photo 55: DA3B\_LW17\_008, looking at a section of rockfall. Taken on 10/03/2021.

Photo 56: DA3B\_LW17\_008, looking at a section of rockfall. Taken on 10/03/2021.

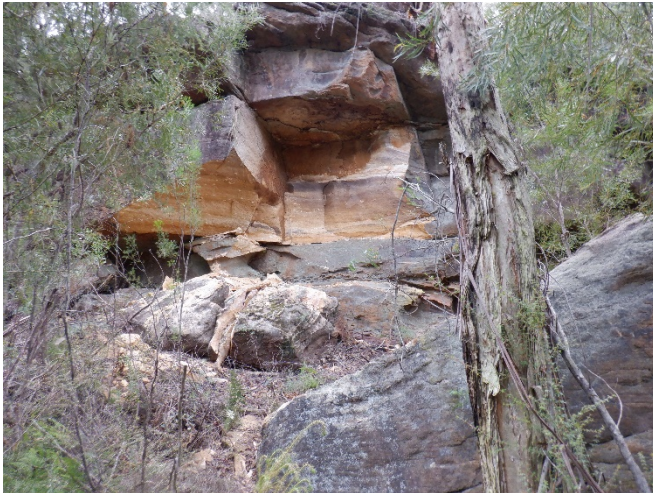
DA3B\_LW17\_009 is located at a steep slope/step approximately 15m north of tributary LA2 (Figure 2). The site was mined beneath by Longwall 17 on 10 February 2021. The impact is comprised of a rockfall with associated displacement and fragmentation (Photo 57 to Photo 60). The impact was observed from a distance due to safety concerns, therefore the following values are estimates. The rockfall has an estimated length of 10m, width of 4m and a depth of 2m. The rockfall resulted in the dislodgment of variable sized rock fragments and boulders, with the largest estimated to be 4m in length by 3m in width. The impact was inspected on 10<sup>th</sup> of September 2021 and remains unchanged from original identification.

DA3B\_LW17\_009 is a Level 2 trigger as per the DA3B Landscape TARP (Table 10), specifically:

- Rockfall or overhang collapse at a cliff site (step), where characteristics of the cliff have changed, and there has been significant ground disturbance.

Photo 57: DA3B\_LW17\_009, looking at a section of rockfall. Taken on 10/03/2021.

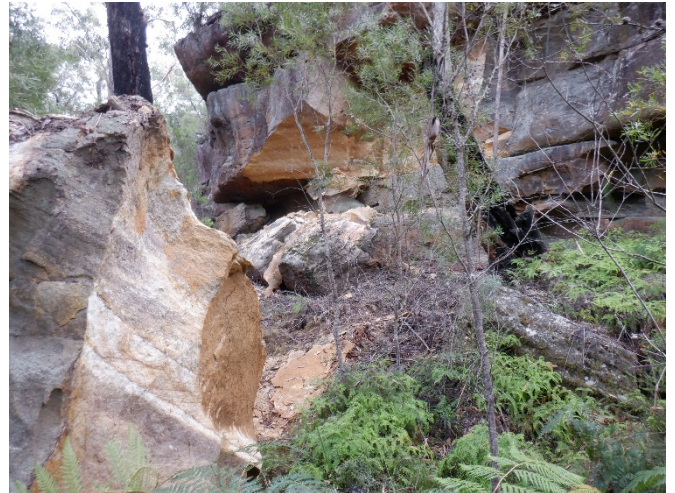
Photo 58: DA3B\_LW17\_009, looking at a section of rockfall. Taken on 10/03/2021.

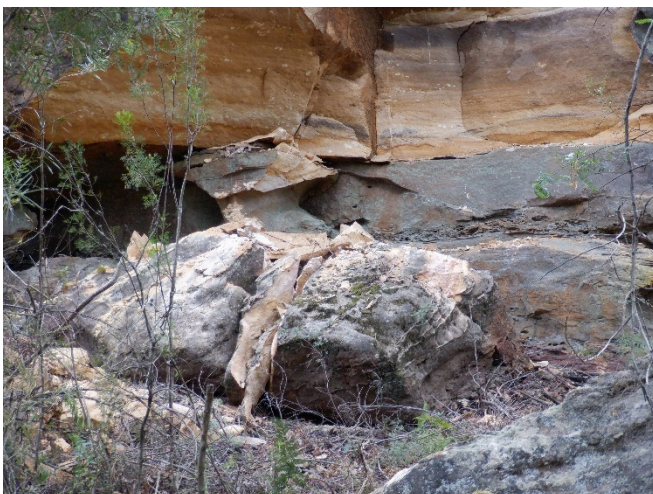
Photo 59: DA3B\_LW17\_009, looking at a section of rockfall. Taken on 10/03/2021.

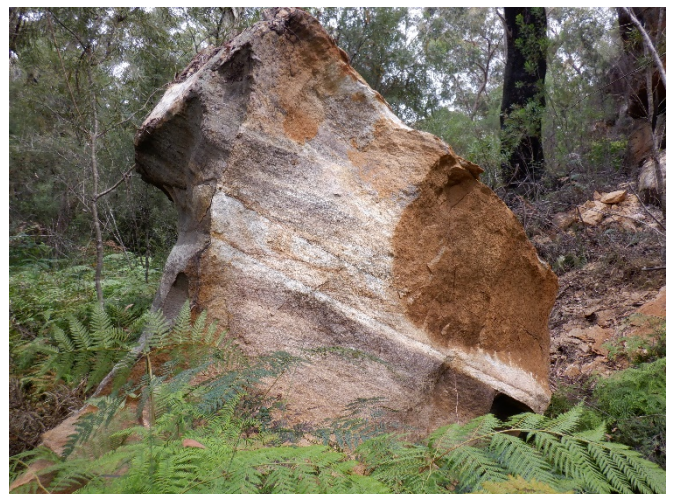
Photo 60: DA3B\_LW17\_009, looking at a section of rockfall. Taken on 10/03/2021.

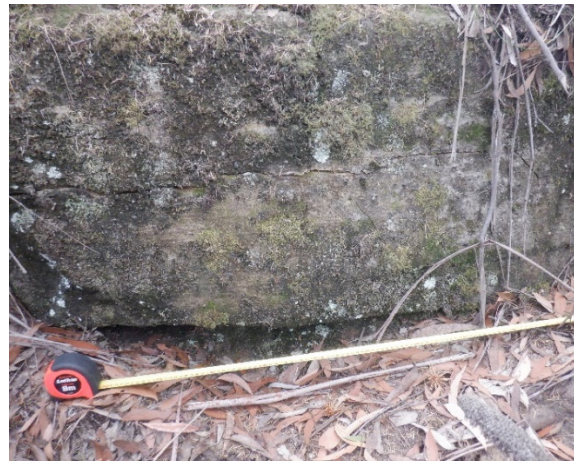
Impact *DA3B\_LW17\_010* consists of horizontal rock fracturing to a step on the northern slope of LA2 valley (Figure 2). The fracture is 2.5m long and 0.015m wide (Photo 61 and Photo 62). The fracturing appears stable. The impact was inspected on 10<sup>th</sup> of September 2021, the width of the impact had increased to 2.9m.

Photo 62: DA3B\_LW17\_010, fracturing along step. Taken on 10/09/2021.

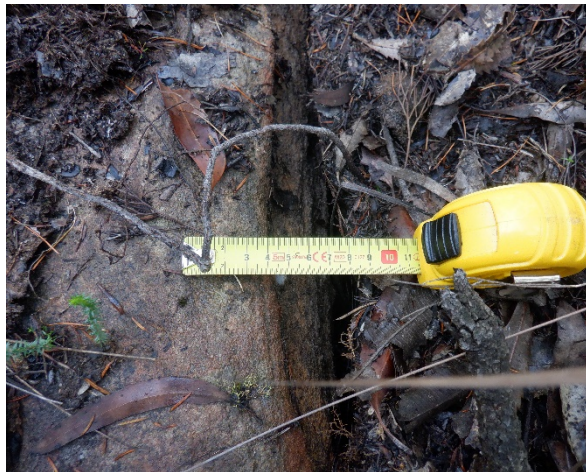
Impact *DA3B\_LW17\_017* consists of rock displacement from soil, west of Fire Road 6A (Figure 2). The rock displacement has a maximum length of 4.6m, a maximum width of 0.045m and a maximum measurable depth of 0.16m (Photo 69 and Photo 70). The displacement appears stable. The impact was inspected on 15<sup>th</sup> of September 2021 and remains unchanged from original identification.

Photo 70: DA3B\_LW17\_017 – width of rock displacement. Taken on 25/05/2021.

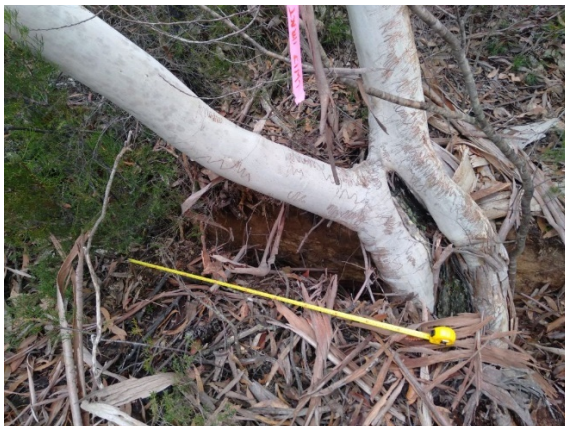
Impact *DA3B\_LW17\_019* consists of a 6m discontinuous soil crack and rock fracture in relatively flat bushland near a steep slope, west of Fire Road 6A (Figure 3). The soil cracking has a maximum continuous length of 2.4m, a maximum width of 0.6m and a maximum measurable depth of 0.7m

(Photo 71 to Photo 73). A tree has slumped into the soil cracking, however now appears stable. The impact was inspected on 15<sup>th</sup> of September 2021, length of the crack had increased to 3.3m and depth had increased to 0.9m, the width of the cracked remained the same.

Photo 73: DA3B\_LW17\_019, looking at a section of soil cracking. Taken on 8/06/2021.

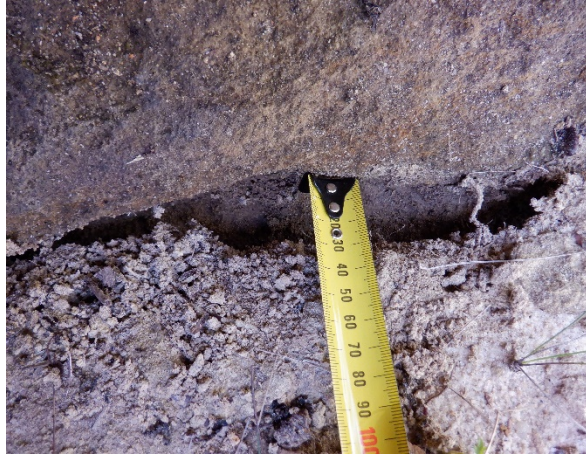
Impact *DA3B\_LW17\_032* consists of rock displacement from soil at the base of a small step/steep slope east of Fire Road 6A (Figure 3). The displacement has a maximum length of 0.95m, a maximum width of 0.035m and maximum measurable depth of 0.5m (Photo 84 and Photo 85). The displacement appears stable. The impact was inspected on 21<sup>th</sup> of October 2021 and remains unchanged from original identification.

Photo 85: DA3B\_LW17\_032, showing the width of the displacement. Taken on 17/08/2021.

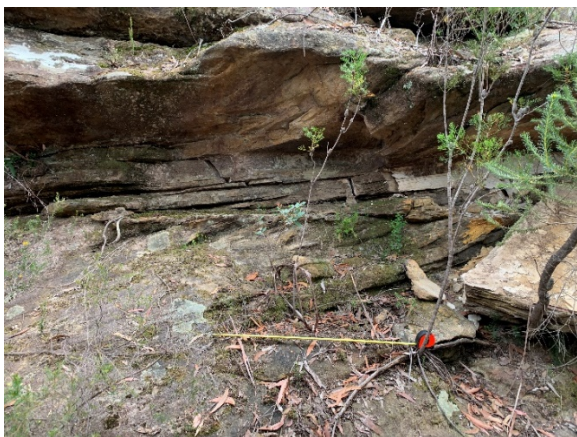
DA3B\_LW17\_035 is located at a steep slope/step approximately 85m to the west of Fire Road 6 (Figure 3). The site was mined beneath by Longwall 17 on 3 May 2021. The impact is comprised of rock fracturing and a rockfall, with associated displacement (Photo 86 to Photo 88). The impact was observed from a distance due to safety concerns, therefore the following values are estimates. The longest rock fracture was estimated to have a maximum length of 5m and a maximum width of 0.025m. The rockfall was estimated to have a volume of approximately 1.5m x 0.8m x 0.2m. The rockfall has resulted in the dislodgement of a singular boulder effecting a 2m<sup>2</sup> area. The size of the boulder was estimated to be approximately 1.5m by 0.8m by 0.2m (0.24m<sup>3</sup>). The rock fracturing and collapse appears to be stable.

DA3B\_LW17\_035 is a Level 1 trigger as per the Dendrobium Area 3B Landscape TARP (Table 10), specifically;

Photo 86: DA3B\_LW17\_035, showing the length of rock fracturing. Taken 15/9/2021.

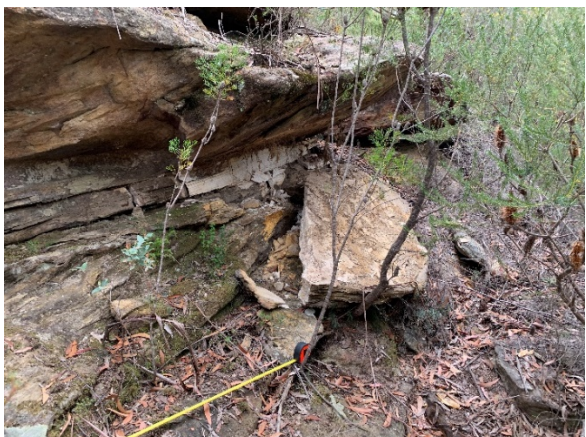
Photo 87: DA3B\_LW17\_035, showing the rockfall associated with rock fracturing. Taken 15/9/2021.

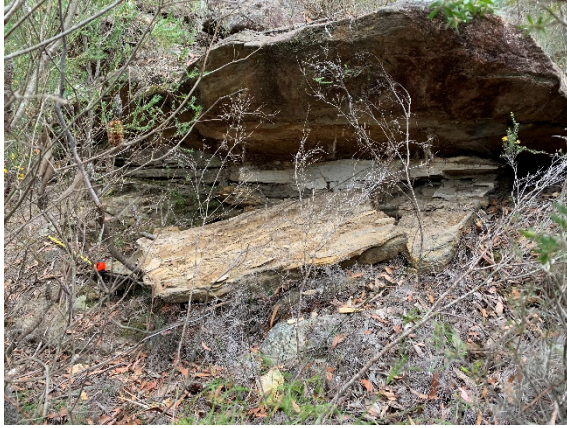
Photo 88: DA3B\_LW17\_035, showing the rockfall associated with rock fracturing. Taken 15/9/2021.

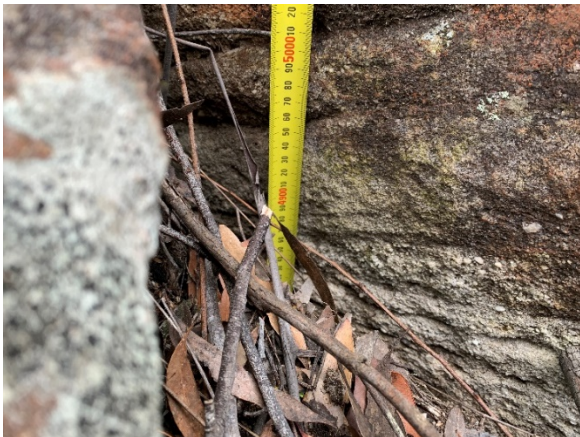
DA3B\_LW17\_038 is located at a steep slope/rock outcrop approximately 95m to the west of Fire Road 6 (Figure 3). The site was mined beneath by Longwall 17 on 29 April 2021. The impact consists of 11m in discontinuous soil cracking at the base of a rock outcrop/ steep slope. The rock displacement has a maximum length of 2.4m, a maximum width of 0.045m and a maximum measurable depth of 4.9m (Photo 96 to Photo 98). The rock displacement and soil cracking appear to be stable.

Photo 98: DA3B\_LW17\_038, looking at the depth of rock displacement. Taken 15/9/2021

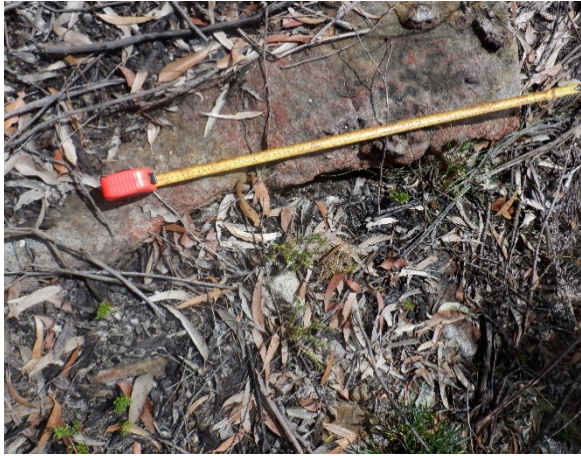
DA3B\_LW17\_039 is located on outcrop/step to the east of Fire Road 6A (Figure 3). Soil has moved away from the rock, creating a void. The void has a length of 1.350m, a width of up to 0.045m and a maximum measurable depth of 0.18m (Photo 99 to Photo 101).

DA3B\_LW17\_039 is a Level 1 trigger as per the Dendrobium Area 3B Landscape TARP (Table 10), specifically;

Photo 99: DA3B\_LW17\_039, showing the length of void. Taken 21/10/2021.

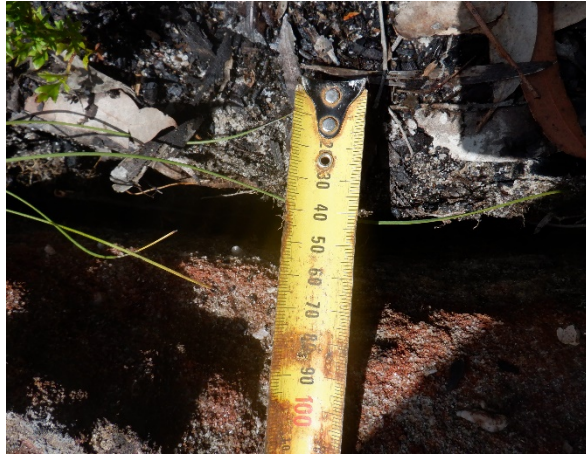
Photo 100: DA3B\_LW17\_039 showing the width of the void. Taken 21/10/2021.

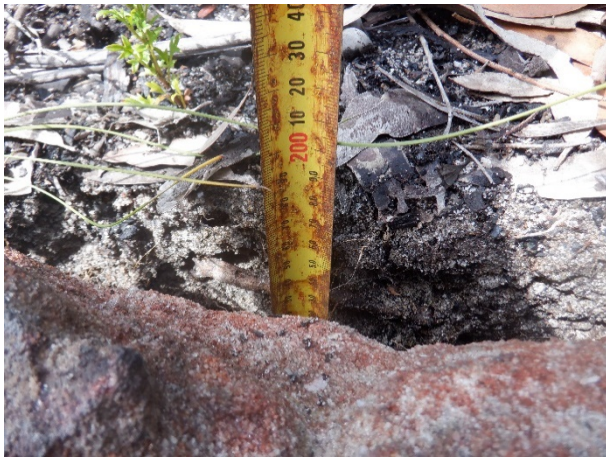
Photo 101: DA3B\_LW17\_039, showing the depth of rock movement. Taken 10/9/2021.

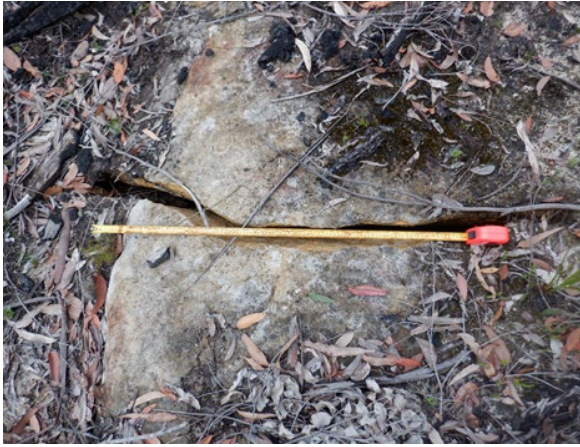
*DA3B\_LW17\_040* is located at a rock outcrop to the east of Fire Road 6A (Figure 3). The impact is comprised of rock fracturing. The fracture has length of 2.4m, a width of 0.05m and a maximum measurable depth of 1.75m (Photo 102 to Photo 104).

*DA3B\_LW17\_040* is a Level 1 trigger as per the Dendrobium Area 3B Landscape TARP (Table 10), specifically;

Photo 102: DA3B\_LW17\_040, showing the length of rock fracturing. Taken 21/10/2021.

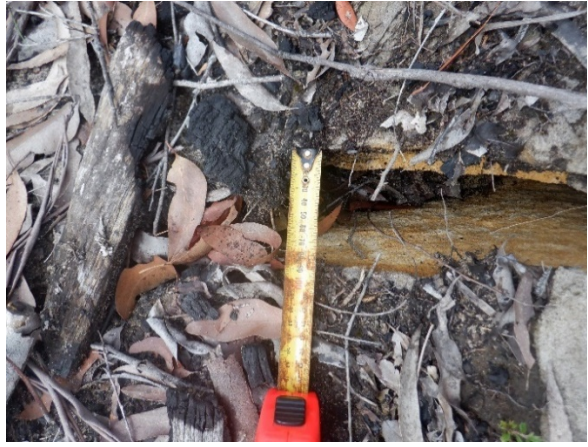
Photo 103: DA3B\_LW17\_040, showing width of the rock fracturing. Taken 21/10/2021

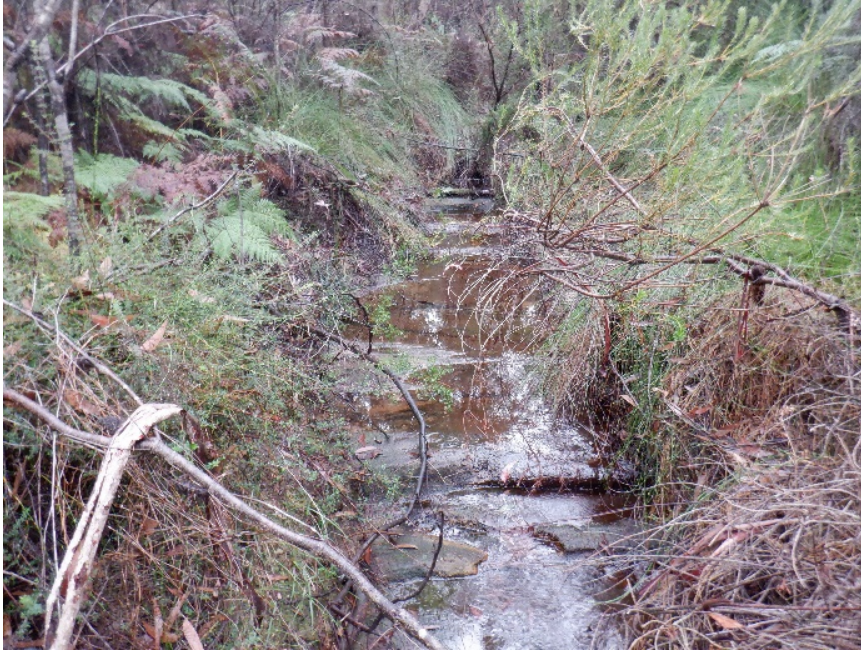
These observations contribute to a Level 3 trigger for EC and pH, as per the DA3B Watercourse Impact Monitoring, Management and Contingency Plan (Table 9), specifically:

Photo 105: LA4\_S1, looking upstream. Taken on 1/07/2021.

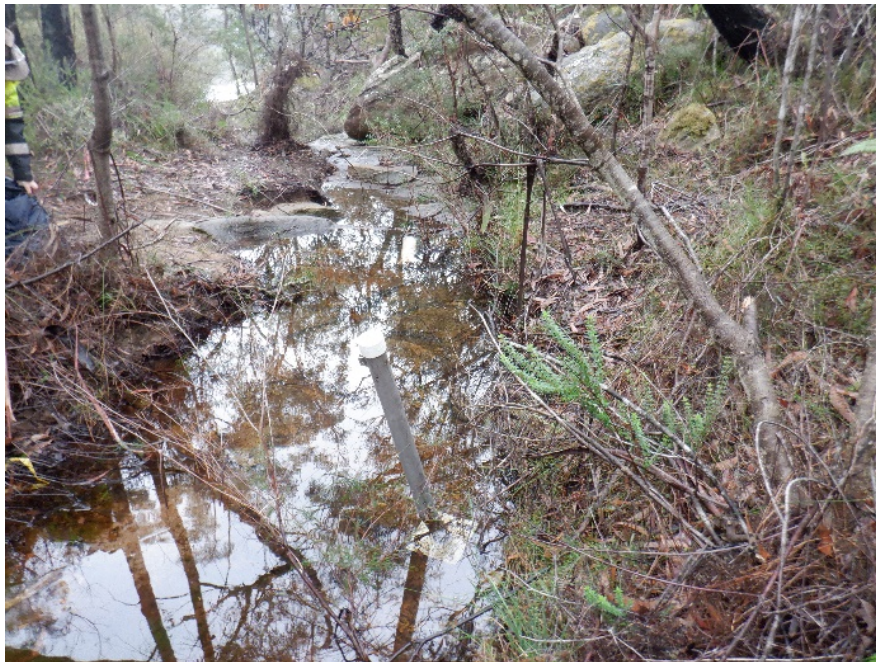
Photo 106: LA4\_S1, looking downstream. Taken on 1/07/2021

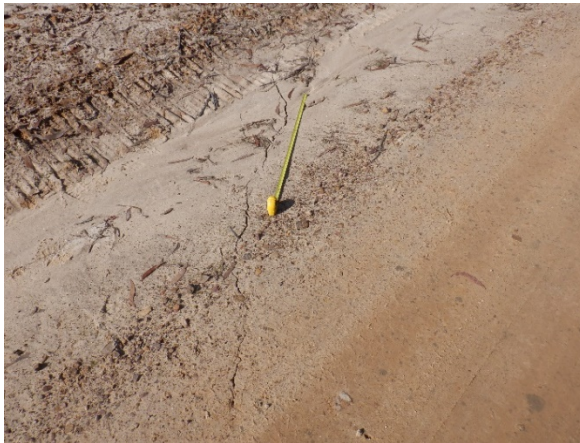
Photo 109: DA3B\_LW17\_018 – section of soil cracking. Taken on 25/05/2021.

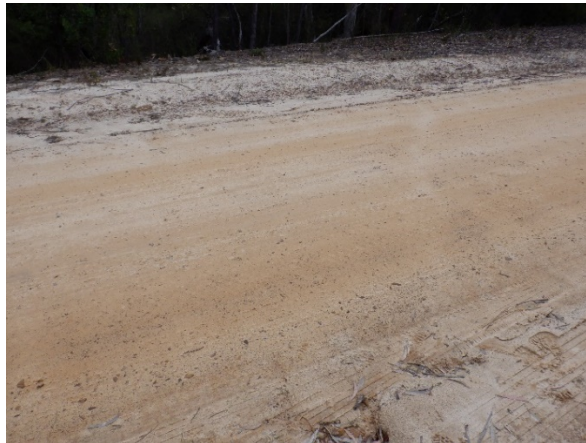
Photo 110: DA3B\_LW17\_018 – soil crack naturally remediated. Taken 16/09/2021
