**DENDROBIUM AREA 3B  
LONGWALL 17 END OF  
PANEL  
LANDSCAPE REPORT  
NOVEMBER 2021**

## **EXECUTIVE SUMMARY**

This report summarises the observed and measured subsidence effects on landscape features resulting from the extraction of Dendrobium Area 3B (DA3B) Longwall 17. Longwall 17 is the ninth panel extracted from DA3B. Extraction began on 12 December 2020 and was completed on 13 October 2021. The Illawarra Metallurgical Coal Environmental Field Team (IMCEFT) conducts detailed monitoring and inspections of landscape features including swamps, watercourses, rock outcrops and landscape features within the mining area of DA3B. This monitoring was conducted in accordance with:

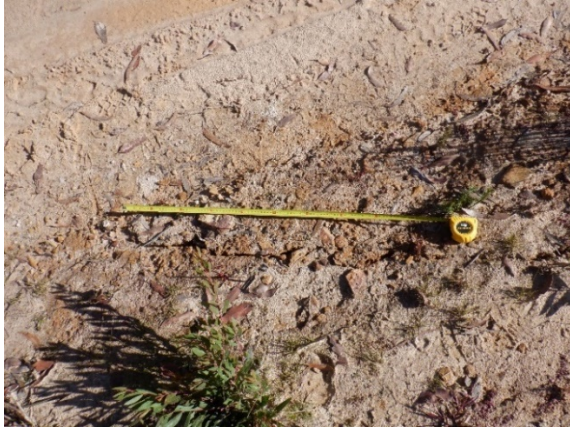
Photo 111: DA3B\_LW17\_020- soil crack on Fire Road 6A. Taken on 8/06/2021

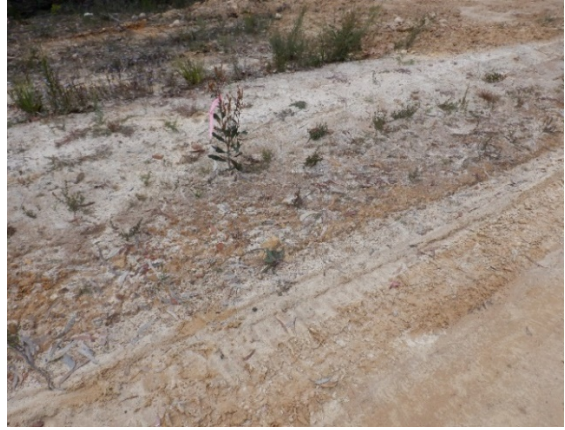
Photo 112: DA3B\_LW17\_020- Soil crack on Fire Road 6A naturally remediated. Taken on 16/09/2021.

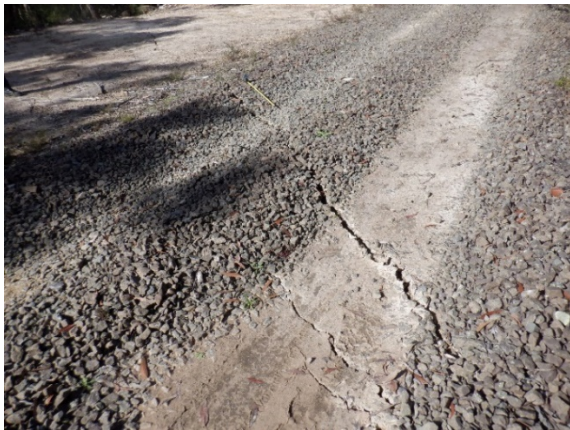
Photo 113: DA3B\_LW17\_26, cracking extending across railway corridor. Taken on 7/07/2021.

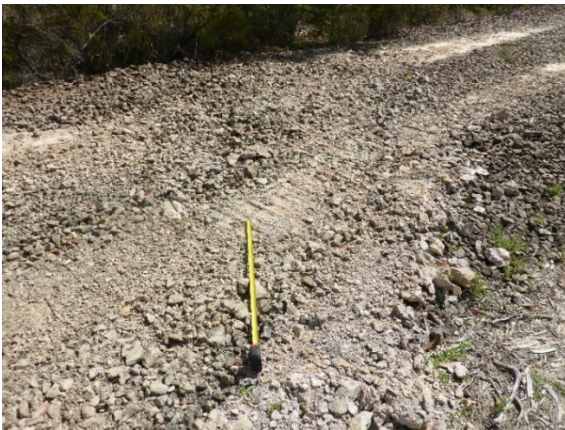
Photo 114: DA3B\_LW17\_26, Remediated crack on railway corridor. Taken on 22/09/2021.

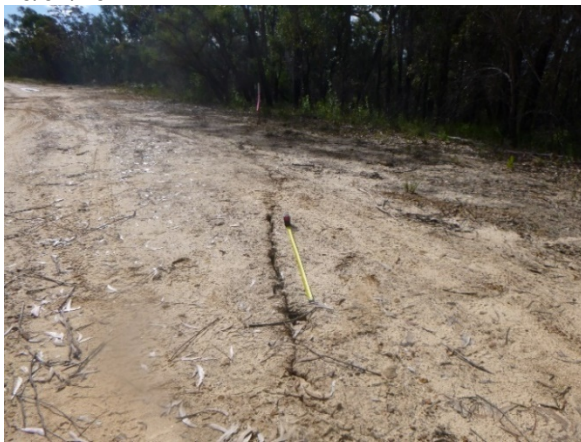
Photo 119: DA3B\_LW17\_030- soil cracking on Fire Road 6A. Taken on 26/07/2021.

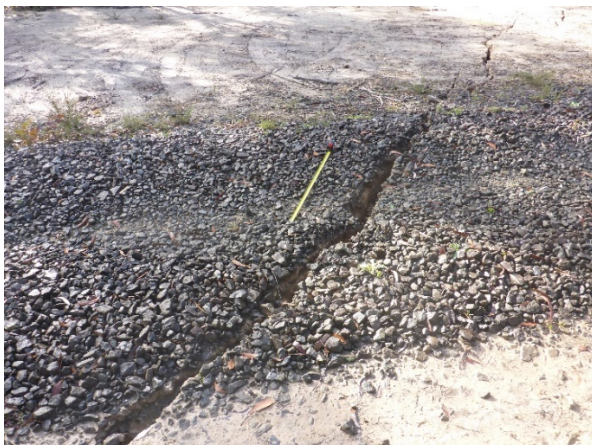
Photo 125: DA3B\_LW17\_27- showing the width of cracking. Taken on 15/07/2021.
