**DENDROBIUM AREA 3B
LONGWALL 18 END OF PANEL
LANDSCAPE REPORT
OCTOBER 2022**

This report summarises the observed and measured subsidence effects on landscape features resulting from the extraction of Dendrobium Area 3B (DA3B) Longwall 18. Longwall 18 is the tenth panel extracted from DA3B. Extraction began on 2 December 2021 and was completed on 17 May 2022.

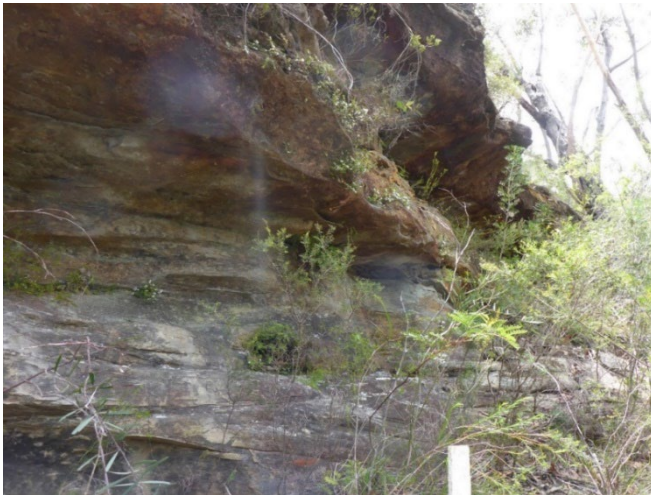
Photo 1: A3b-SS20, baseline inspection. Taken on 5/12/2017.

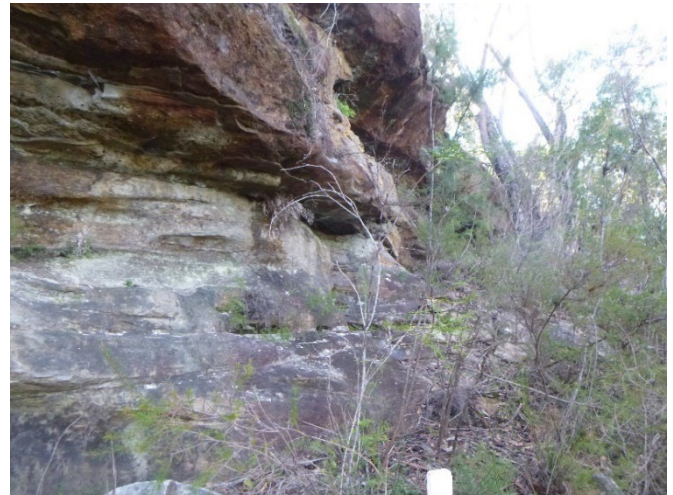
In accordance with the Dendrobium Area 3B SMP Approval, landscape monitoring sites (Subsidence Landscape Monitoring and Management Plan [SLMMP] photo points) within the active mining area were monitored at monthly intervals. Monitoring photos from SLMMP sites are compared to baseline photos at each site (Photo 1 and Photo 2). Landscape monitoring sites (SLMMP photo points) were monitored before, during and after the Longwall 18 extraction period (Table 1). Longwall 18 post-mining inspections were undertaken, and no impacts were observed.

Photo 2: A3b-SS20, post-mining inspection. Taken on 6/08/2022.

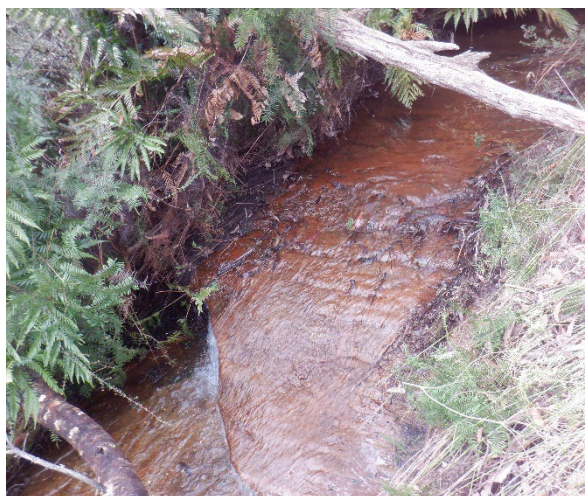
LA3 is a tributary of Lake Avon, that flows southward from DA3B mining operations (Figure 2). The upper reaches of the LA3 sub catchment were mined beneath by Longwall 15 and Longwall 16. During an inspection on 16 August 2022, iron staining was observed to originate at *LA3_Boulderfield 4a* and extend downstream to *LA3_Step 2* (Photo 5 to Photo 8). Iron staining was not observed upstream or downstream of these features (Photo 9 and Photo 10). No surface impacts have been observed on LA3 prior to this.

Photo 8: *LA3_Step 2*, looking upstream. Taken 16/08/2022.

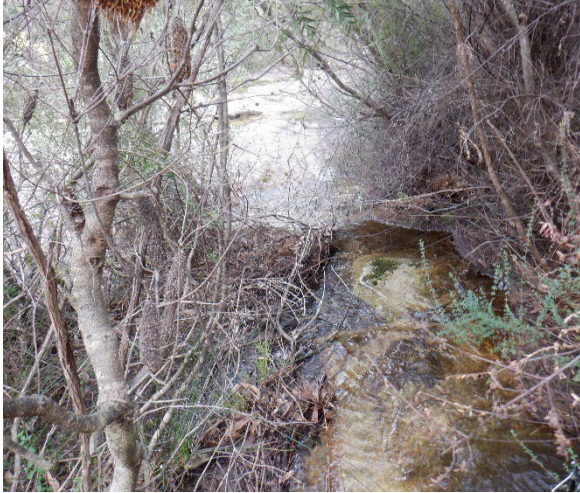
Photo 9: *LA3_Rockbar 4b*, looking downstream.
Taken 15/08/2022.

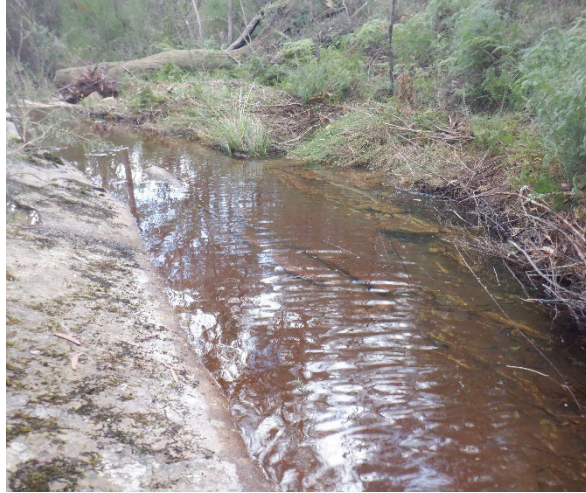
Photo 10: *LA3_Rockbar 2b*, looking downstream. Taken 16/08/2022.

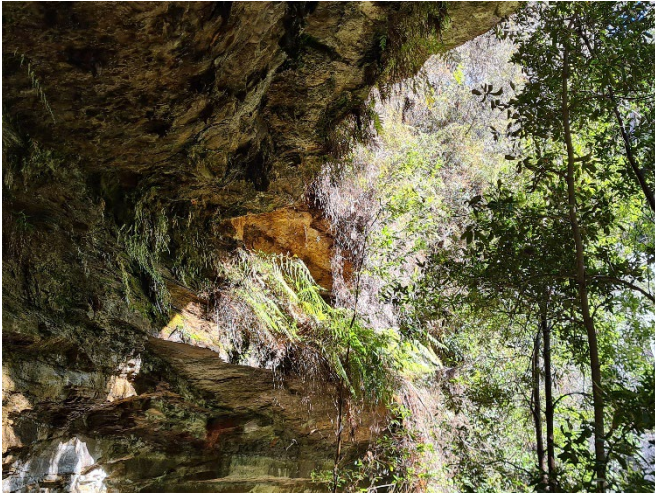
DA3B_LW17_041 is located at *Waterfall 54*, a feature of Wongawilli Creek (Figure 1). The impact was identified on 2 August 2022 and consists of a rock fall. The rockfall site has an approximate length of 3m, depth of 1.5m and height of 1m (Photo 11). Rock debris is evident at the base of the waterfall (Photo 12). Analysis of photo records to determine the time when the fall occurred, indicates that the rockfall occurred between the 6 October 2021 and 28 October 2021. This period coincides with the extraction and finishing of Longwall 17 (Photo 13 and Photo 14). Visual inspections beneath Waterfall 54 during this period and during active subsidence were restricted due to safety concerns. During active subsidence inspections were conducted from a distance set back from the waterfall. The rockfall occurred behind densely vegetated area and was therefore not observed due to the vegetation and setback observation point.

DA3B_LW17_041 is exceeding predictions as per the Wongawilli Creek Waterfall 54 Trigger Action Response Plan (TARP) (Table 1), specifically;

- Mining results in rock fall at WC-WF54 or its overhang

Photo 11: *DA3B_LW17_041*, showing site of rock fall. Taken 2/08/2022.

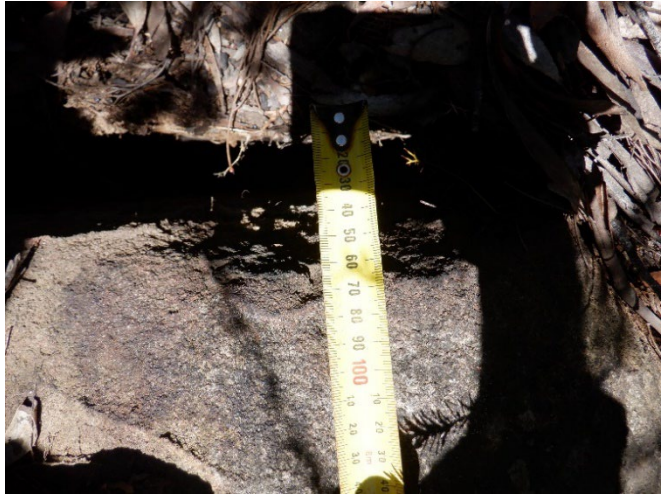
DA3B_LW18_005 is located on a steep slope/ridgeline west of Fire Road 6A (Figure 2). The impact consists of displacement between soil and adjacent rock strata. The displacement has a discontinuous length of 5.5m, a continuous length of 1.9m, a width of up to 0.06m and a maximum measurable depth of 1.1m (Photo 28 and Photo 29). The impact was re-inspected on 30 June 2022 and additional soil cracking was observed. The soil cracking has a maximum continuous length of 16m, discontinuous length of 42.4m, maximum width of 0.09m and maximum measurable depth of 3.09m (Photo 30 and Photo 31).

Photo 29: DA3B_LW18_005, showing the width of the displacement. Taken 9/02/2022.

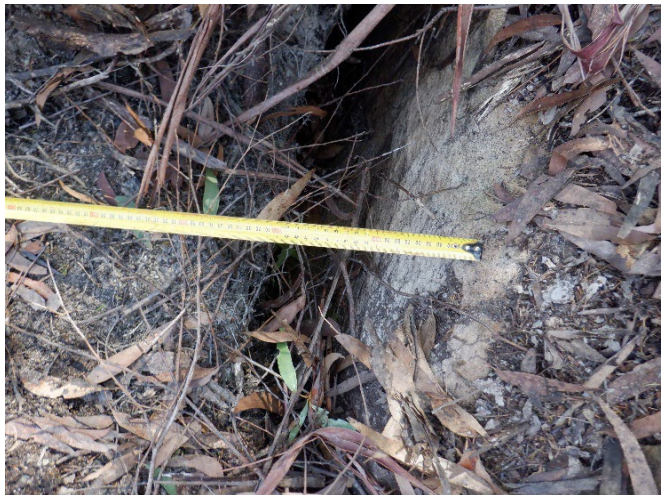
DA3B_LW18_009 is located in bushland near ND1C (Figure 2). The impact is comprised of rock displacement, fracturing and fragmentation. The rock displacement has a maximum continuous length of 0.9m, a maximum width of 0.2m and a maximum measurable depth of 1.0m (Photo 39 and Photo 40). The rock fracture has a maximum continuous length of 4.2m, a maximum width of 0.02m and a maximum measurable depth of 0.22m (Photo 41 and Photo 42).

Photo 40: DA3B_LW18_009, showing the width of rock displacement. Taken 9/06/2022.

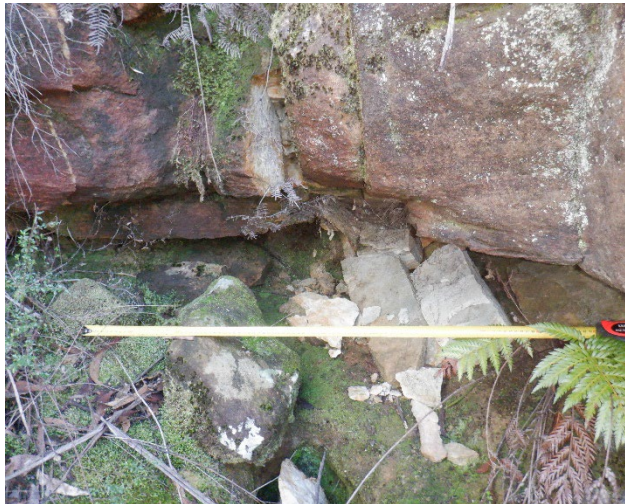
DA3B_LW18_017 is located on a steep slope/step on the northern slope of LA2 valley (Figure 2). The impact was mined beneath by Longwall 17. The impact is comprised of a rockfall, rock displacement and rock fracturing (Photo 59 and Photo 60). The dislodged rock has a volume of approximately 0.13m³ (1.1m x 0.16m x 0.75m). Minor rock fracturing is present.

Photo 60: DA3B_LW18_017, showing rockfall. Taken 16/08/2022.

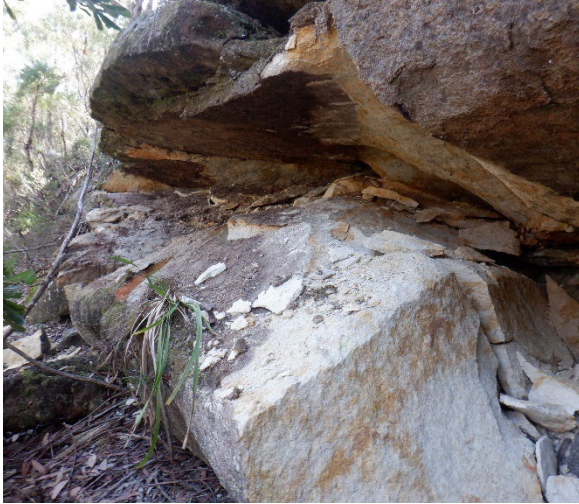
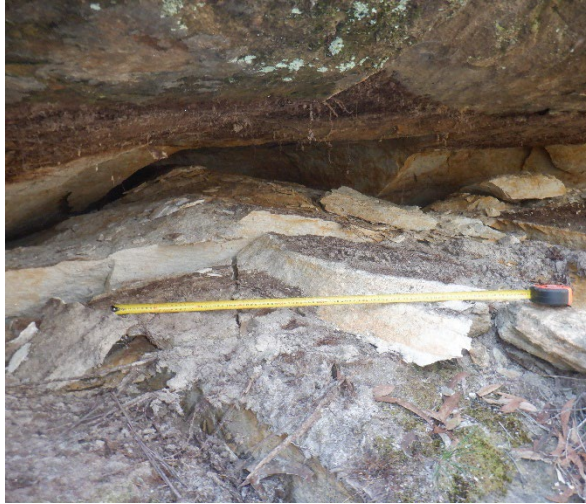
DA3B_LW18_020 is located on a step on the northern slope of LA2 valley (Figure 2). The impact site was mined beneath by Longwall 17. The impact is comprised of a rockfall from a small overhang on a step (Photo 67 and Photo 68). The rockfall is 7.3m in length, 3.9m in width and 0.9m in depth, having an approximate volume of 25.6m³. The debris area is 7.3m by 3.9m.

DA3B_LW18_020 is a Level 1 trigger as per the DA3B Landscape (Table 9), specifically:

- Rockfall from a cliff which is left mostly intact (<10% length), resulting in insignificant ground disturbance

Photo 67: *DA3B_LW18_020*, showing overview of impact. Taken 16/08/2022.

Photo 68: *DA3B_LW18_020*, showing rockfall closer up. Taken 16/08/2022.

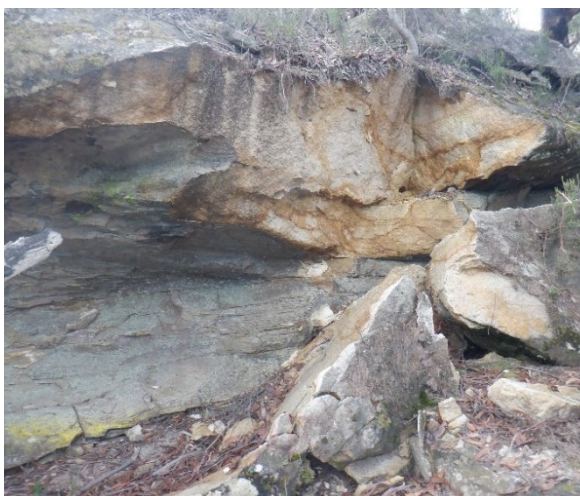
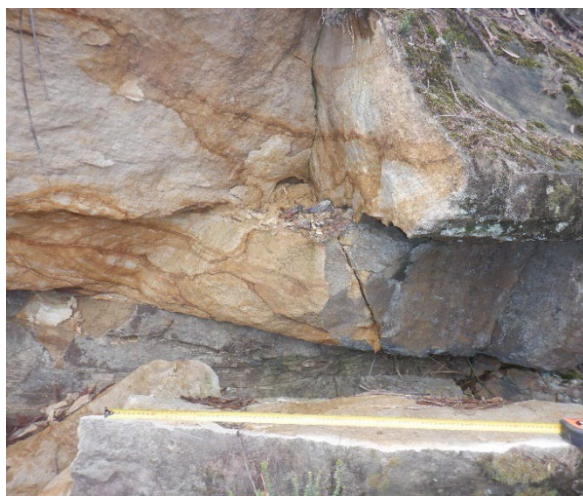
DA3B_LW18_022 is located on a steep slope/step on the northern slope of LA2 valley (Figure 2). The impact site was mined beneath by Longwall 17. The impact is comprised of a rockfall from a steep slope/step (Photo 73 and Photo 74). The rockfall was 2.6m in length, 1.3m in width and 1.2m in depth, having a volume of approximately 4m³.

DA3B_LW18_022 is a Level 1 trigger as per the DA3B Landscape (Table 9), specifically:

- Rockfall from a cliff which is left mostly intact (<10% length), resulting in insignificant ground disturbance

Photo 73: *DA3B_LW18_022*, showing overview of impact. Taken 16/08/2022.

Photo 74: *DA3B_LW18_022*, showing section of rockfall/debris. Taken 16/08/2022.

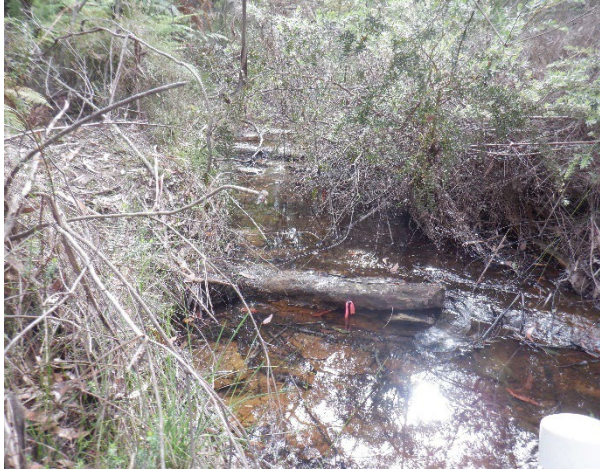
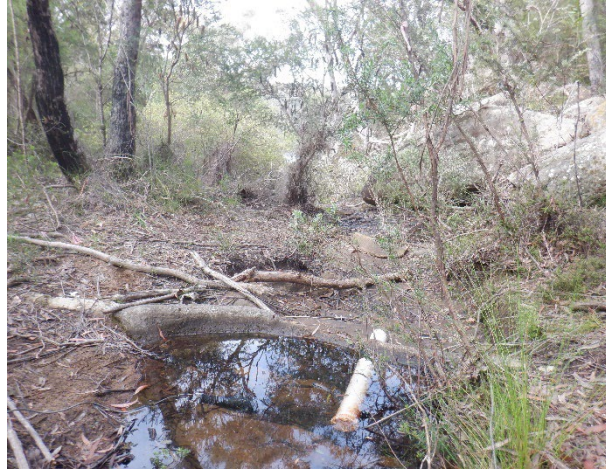
These observations constitute a Level 1 trigger and Exceeding Predictions triggers as per the DA3B Watercourse Impact, Monitoring Management and Contingency Plan (Table 8) specifically:

- One exceedance of the ± 3 standard deviation level (negative for pH and DO, positive for EC) from the baseline mean within six months:
 - DO 69.5 %
- Mining results in two consecutive exceedances or three exceedances of the ± 3 standard deviation level (positive for EC, negative for pH and DO) from the baseline mean within six months:
 - pH 4.90
 - EC 129.8 µS/cm

Photo 78: LA4_S1, looking upstream. Taken on 17/12/2021.

Photo 79: LA4_S1, looking downstream. Taken on 17/12/2021.
