#### **DA3B\_LW18\_001 (E 288784, N 6191476)**

Table 2: Summary of Longwall 18 impacts and triggers. Highlighted rows indicate the latest impacts featured in this report.

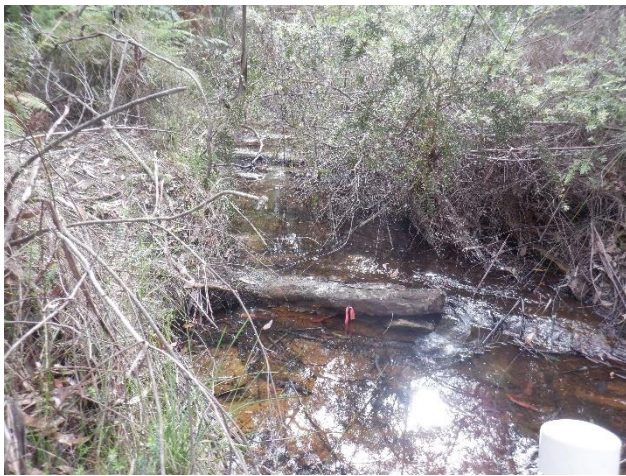
**Photo 1:** LA4\_S1, looking upstream. Taken on 17/12/2021.

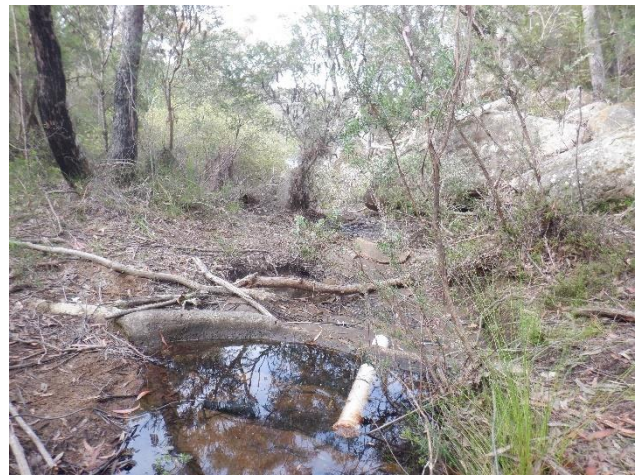
**Photo 2:** LA4\_S1, looking downstream. Taken on 17/12/2021.

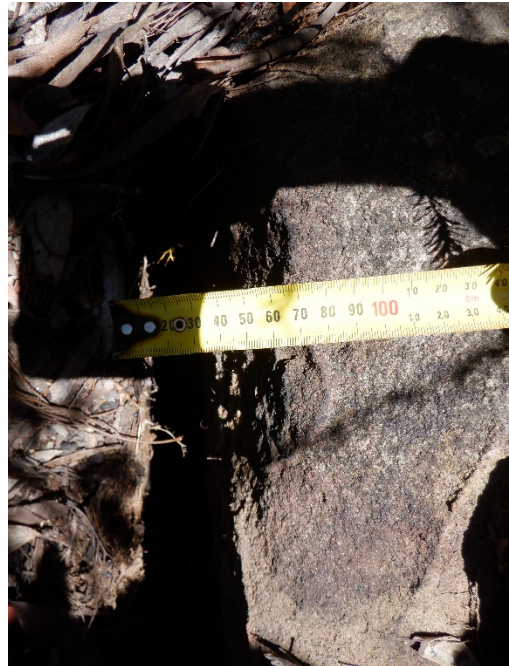
- Crack or fracture up to 10m in length;
- Crack or fracture up to 100mm width.

Photo 4: DA3B\_LW18\_005, showing the width of the displacement. Taken 9/02/2022.

In accordance with the DA3B SMP, the following actions have been initiated:

- Continue monitoring program as required in the DA3B SMP.
- Report impacts to key stakeholders.
- Summarise impacts and report in the End of Panel Report and Annual Review.

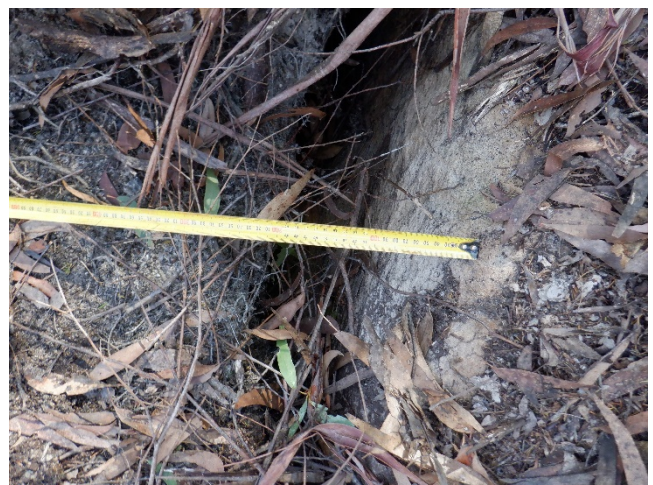
*DA3B\_LW18\_009* is located in bushland near NDC1 (Figure 1). The impact is comprised of rock displacement, fracturing and fragmentation. The rock displacement has a maximum continuous length of 0.9m, a maximum width of 0.2m and a maximum measurable depth of 1.0m (Photo 5 and Photo 6). The rock fracture has a maximum continuous length of 4.2m, a maximum width of 0.02m and a maximum measurable depth of 0.22m (Photo 7 and Photo 8).

Photo 6: *DA3B\_LW18\_009*, showing the width of rock displacement. Taken 9/06/2022.

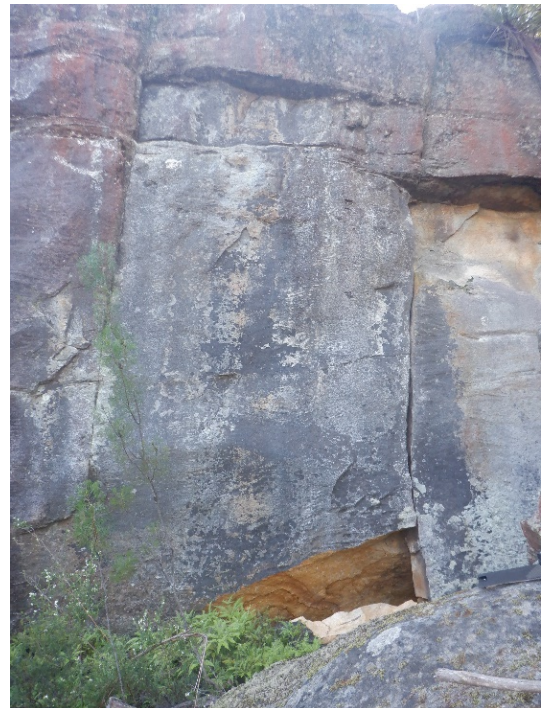
*DA3B\_LW18\_010* is located at the base of a 7m high steep slope, west of Fire Road 6A (Figure 1). The impact is comprised of rock fall and fragmentation. The rockfall site has an approximate length of 1.6m, width of 1.0m and depth of 0.6m (values have been estimated due to safety concerns getting closer) (Photo 9 and Photo 10).

Photo 10: *DA3B\_LW18\_010*, showing rock fall and fragmentation site. Taken 10/06/2022.

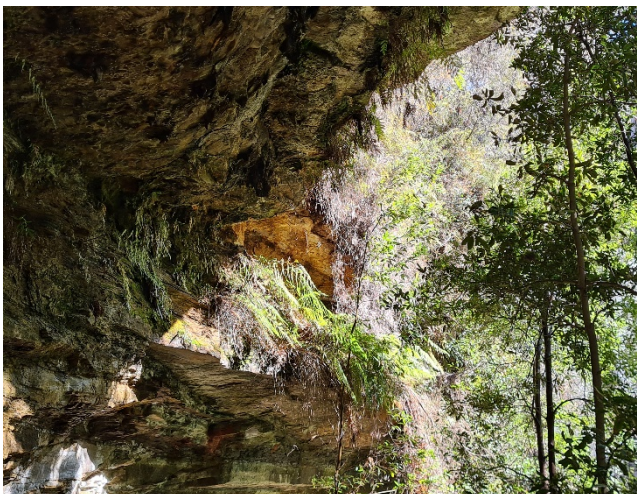
*DA3B\_LW17\_041* is exceeding predictions as per the Wongawilli Creek Waterfall 54 Trigger Action Response Plan (TARP) (Table 1), specifically;

- Mining results in rock fall at WC-WF54 or its overhang

Photo 1: *DA3B\_LW17\_041*, showing site of rock fall. Taken 2/08/2022.

- Continue monitoring program as required in the Wongawilli Creek And Waterfall 54 Management Strategy.
- Report impacts to key stakeholders (Biodiversity and Conservation Division; WaterNSW; Resources Regulator)
- Summarise impacts and report in the End of Panel Report and Annual Review.
- Independent expert to advise on monitoring frequency.
- Review monitoring frequency.
- Notify relevant technical specialists and seek advice on any CMA required.
- Implement agreed CMAs as approved.
- Investigate reasons for the exceedance.
- Offer site visit with Biodiversity and Conservation Division; WaterNSW; NSW Resources Regulator.
- Review relevant TARP and Management Plan in consultation with key agencies.

- Update future predictions based on the outcomes of the investigation.
- Provide residual environmental offset for any mining impact where CMAs are unsuccessful as required by Condition 14 Schedule 3 of the Development Consent.

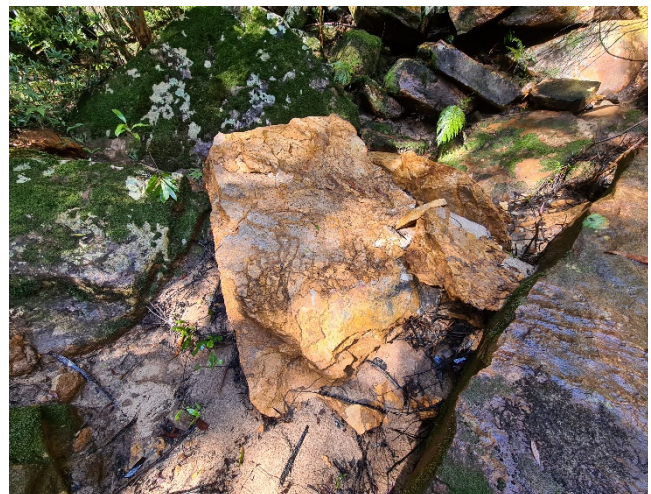
Photo 2: *DA3B\_LW17\_041*, showing a section of potential rock fall. Taken 2/08/2022.

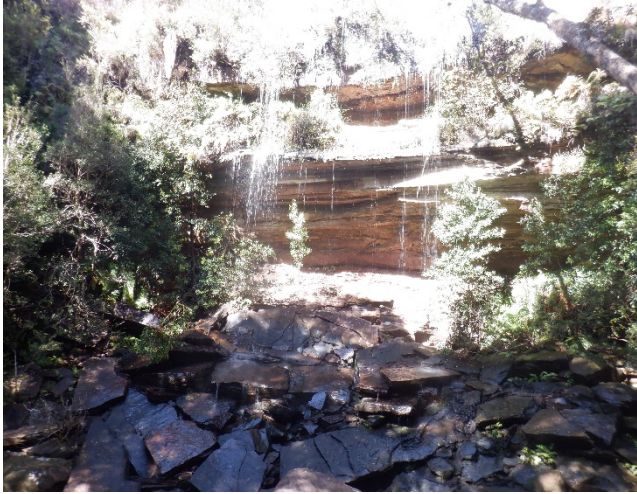
Photo 3: Waterfall 54 inspection. Taken 6/10/2021.

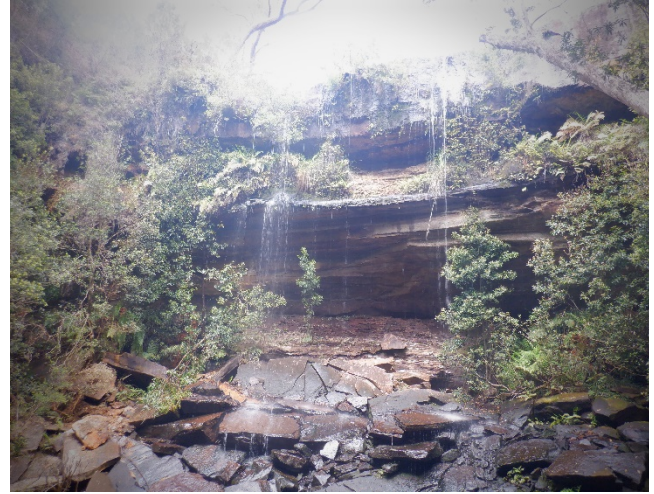
Photo 4: Waterfall 54 inspection displaying visual change in rock debris (bottom left corner of image). Taken 28/10/2021.

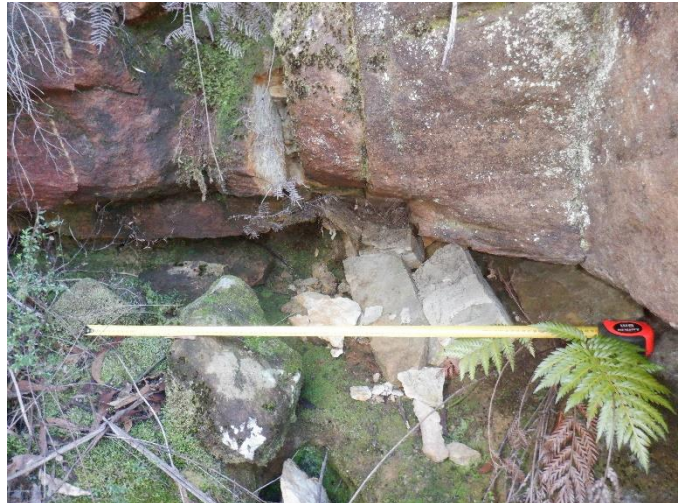
DA3B\_LW18\_017 is located on a steep slope/step on the northern slope of LA2 valley (Figure 1 Figure 1). The impact was mined beneath by Longwall 17. The impact is comprised of a rockfall, rock displacement and rock fracturing (Photo 11 and Photo 12). The dislodged rock has a volume of approximately  $0.13\text{m}^3$  ( $1.1\text{m} \times 0.16\text{m} \times 0.75\text{m}$ ). Minor rock fracturing present.

Photo 12: DA3B\_LW18\_017, showing rockfall. Taken 16/08/2022.

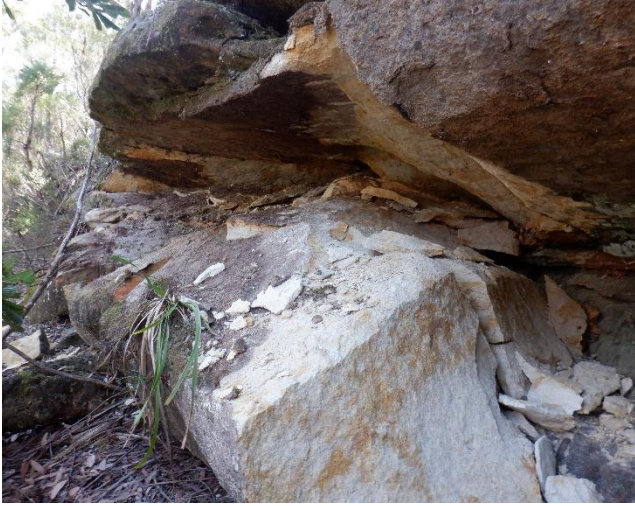
*DA3B\_LW18\_020* is located on a step on the northern slope of LA2 valley (Figure 1). The impact site was mined beneath by Longwall 17. The impact is comprised of a rockfall from a small overhang on a step (Photo 19 and Photo 20). The rockfall is 7.3m in length, 3.9m in width and 0.9m in depth, having an approximate volume of 25.6m<sup>3</sup>. The debris area is 7.3m by 3.9m.

*DA3B\_LW18\_020* is a Level 1 trigger as per the DA3B Landscape (Table 1), specifically:

- Rockfall from a cliff which is left mostly intact (<10% length), resulting in insignificant ground disturbance

Photo 19: *DA3B\_LW18\_020*, showing overview of impact. Taken 16/08/2022.

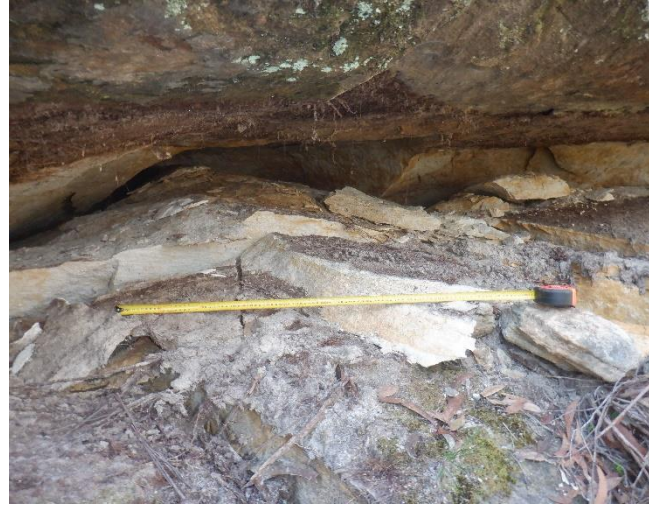
Photo 20: *DA3B\_LW18\_020*, showing rockfall closer up. Taken 16/08/2022.

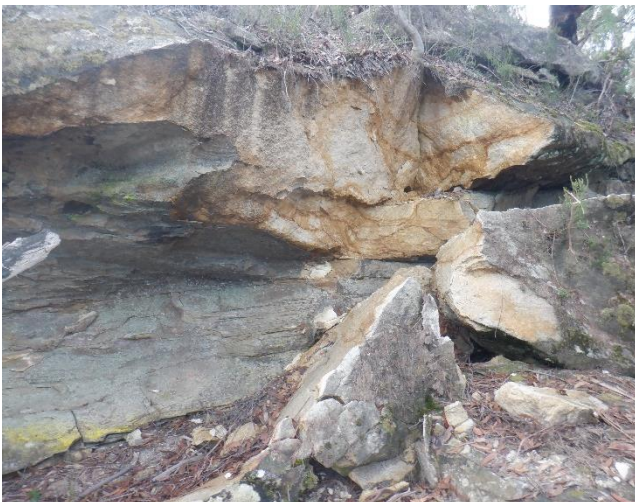
*DA3B\_LW18\_022* is a Level 1 trigger as per the DA3B Landscape (Table 1), specifically:

- Rockfall from a cliff which is left mostly intact (<10% length), resulting in insignificant ground disturbance

Photo 25: *DA3B\_LW18\_022*, showing overview of impact. Taken 16/08/2022.

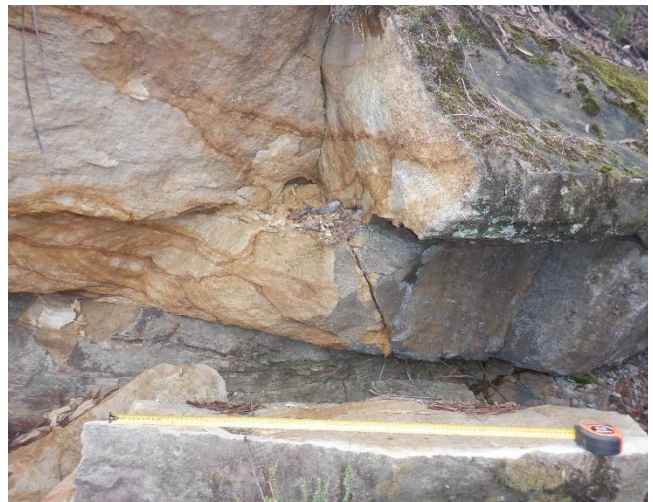
Photo 26: *DA3B\_LW18\_022*, showing section of rockfall/debris. Taken 16/08/2022.

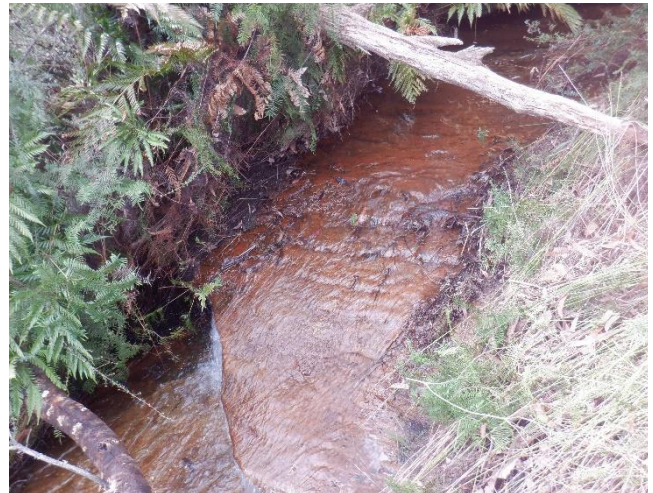
Photo 33: *LA3\_Step 2*, looking upstream. Taken 16/08/2022.

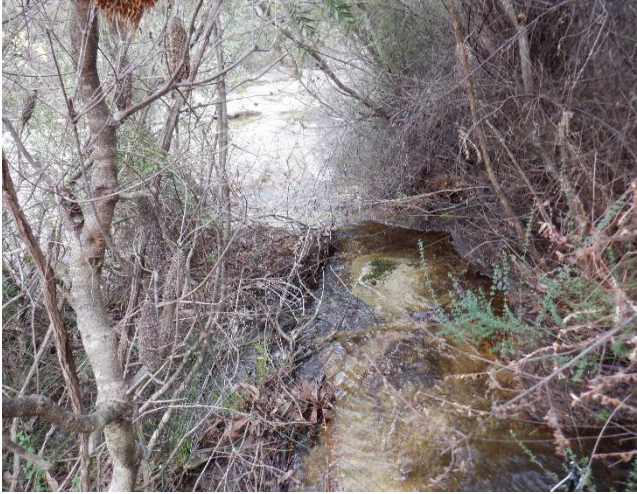
Photo 34: *LA3\_Rockbar 4b*, looking downstream.  
Taken 15/08/2022.

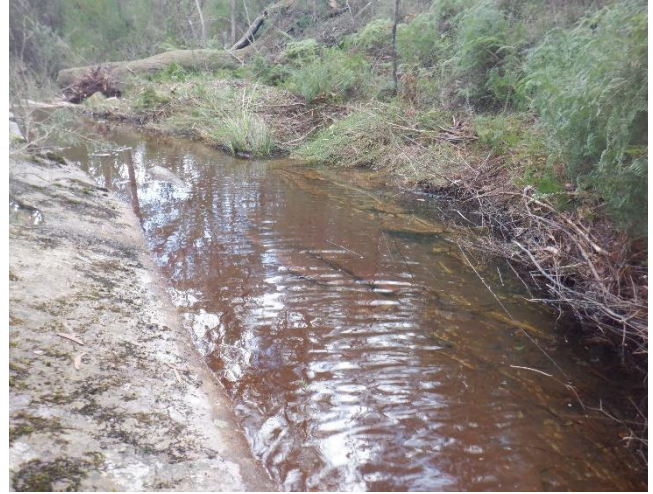
Photo 35: *LA3\_Rockbar 2b*, looking downstream.  
Taken 16/08/2022.

- Continue monitoring program as required in the DA3B SMP.
- Report impacts to key stakeholders (Biodiversity and Conservation Division; WaterNSW; NSW Resources Regulator; Regional NSW – Mining, Exploration and Geoscience)
- Summarise impacts and report in the End of Panel Report and Annual Review.
- Provide flagging as appropriate
- Review monitoring frequency.
- Notify relevant technical specialists and seek advice on any CMA required.
- Implement agreed CMAs as approved.
