END OF PANEL
LANDSCAPE REPORT
DENDROBIUM AREA 3A

DENDROBIUM AREA 3A
LONGWALL 19 END OF PANEL
LANDSCAPE REPORT
JUNE 2023

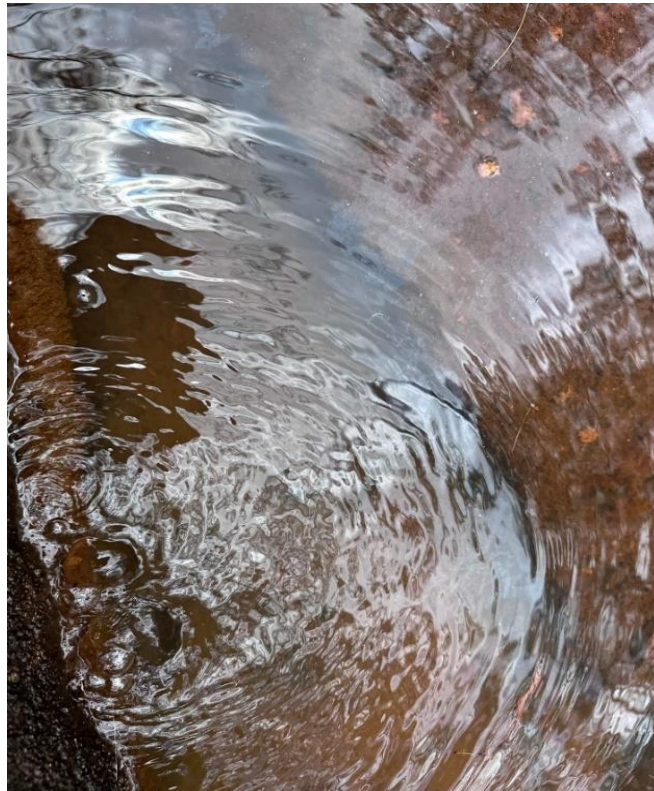
DA3A_LW19_029 is a Level 1 trigger as per the Dendrobium Area 3A Watercourse TARP (Table 7), specifically:

- Observable release of strata (*unconfirmed*) gas at the surface.

Photo 3: DA3A_LW19_029 - gas release from base of sandstone ledge on the western side of WC_Pool 50, Wongawilli Creek. Taken on 18/01/2023.

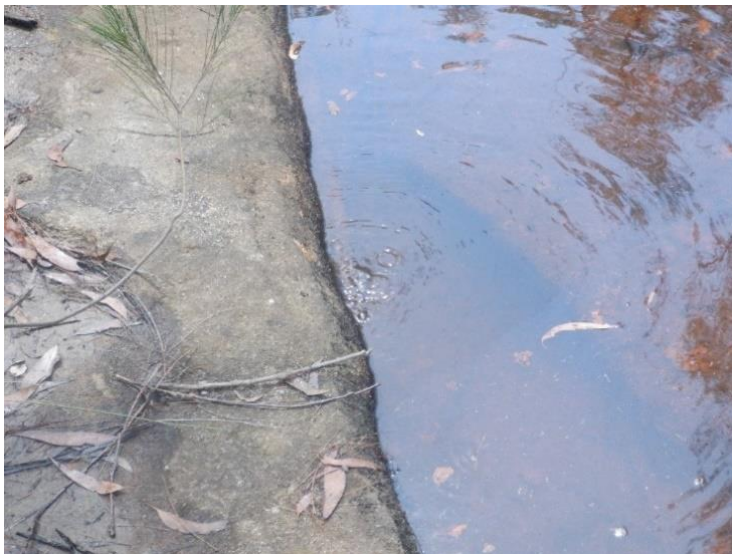
Photo 4: DA3A_LW19_029 gas release from base of sandstone ledge on the western side of WC_Pool 50, Wongawilli Creek. Taken on 1/02/2023.

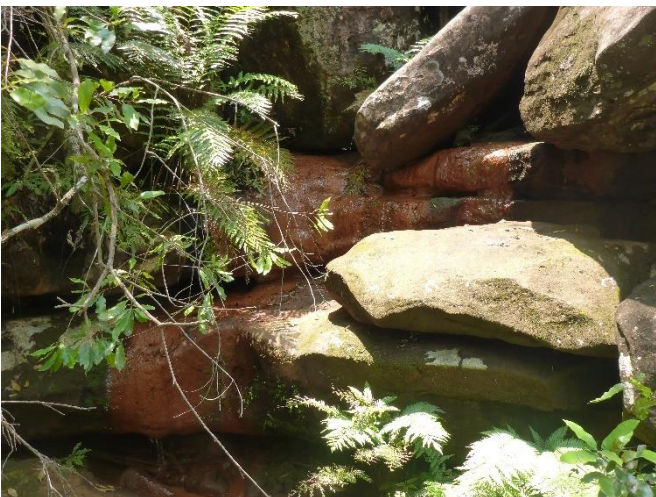
Photo 12: WC14_Boulderfield 1, looking at a section of iron staining. Taken on 17/12/2019.

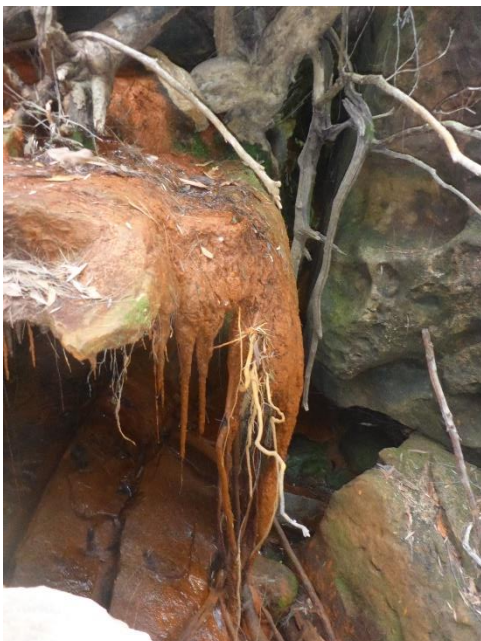
Photo 18: WC14_Step 3, looking at the iron staining. Taken on 28/01/2020.

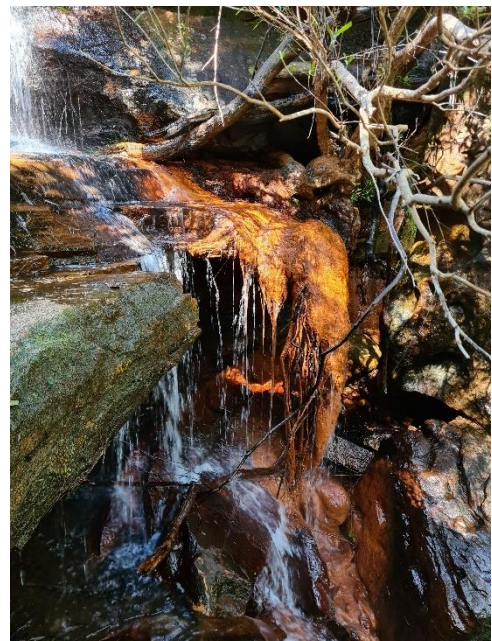
WC14 is a tributary of Wongawilli Creek, that flows westward from DA3A mining operations (Figure 4). Rock fracturing and iron staining on WC14 was previously identified and reported in January 2020, however likely occurred during the extraction of Longwall 8. During recent inspections of WC14, an increase in the extent of the iron staining was observed between WC14_Pool 10 and the confluence of WC14 and Wongawilli Creek (Photo 6 to Photo 21). Iron staining was not evident in Wongawilli Creek (Photo 9). Isolated sections of iron staining were evident upstream between WC14_Pool 10 and WC14_Step 3. Similar observations were recorded during baseline mapping in 2020 (Photo 18 and Photo 19). No iron was observed upstream of WC14_Step 3 (Photo 20 and Photo 21). The impact was re-inspected on 11 May 2023 and no changes were observed.

This observation is a Level 2 trigger as per the DA3A Watercourse Impact, Monitoring Management and Contingency Plan (Table 7Error! Reference source not found.), specifically:

- Observable increase in iron staining within the mining area continues to outside the mining area. i.e. 400 m from the Longwall.

Photo 19: WC14_Step 3, looking at the iron staining. Taken on 16/08/2022.

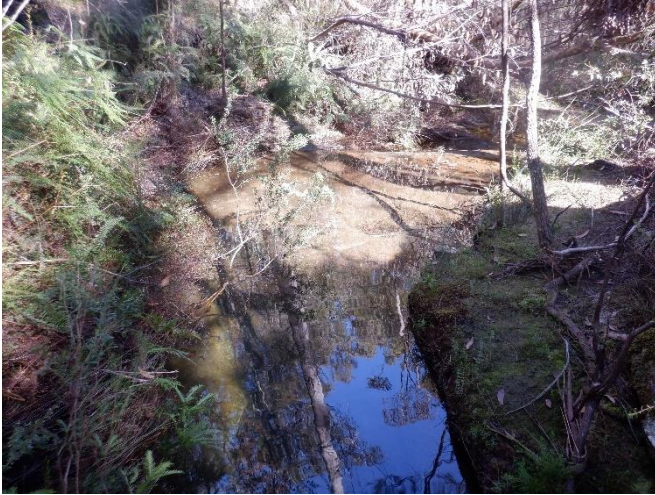
Photo 20: WC14_Pool 16, looking downstream. Taken on 16/08/2022.

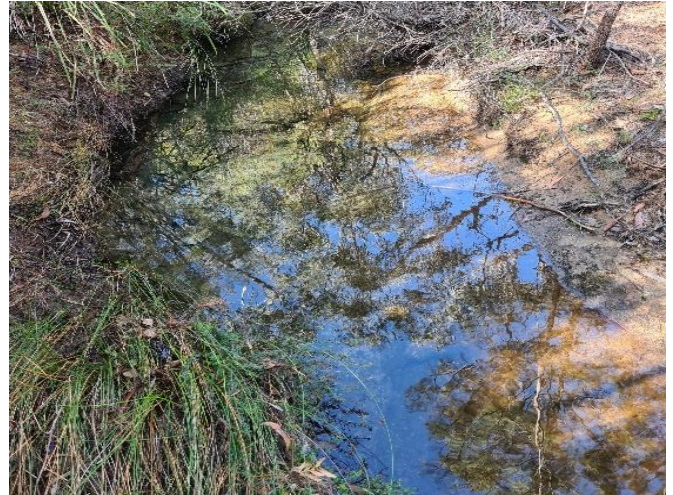
Photo 21: WC14_Pool 18, looking upstream. Taken on 16/08/2022.

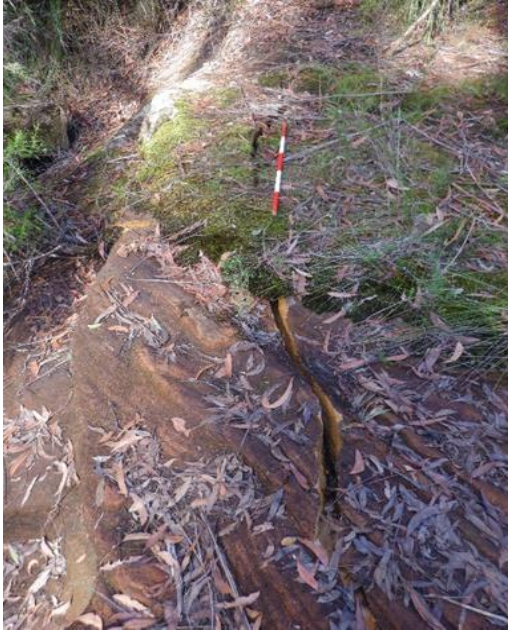
DA3A_LW19_043 consists of multiple rock fractures and some associated uplift on *WC14*, a tributary to *Wongawilli Creek* (Figure 4). The largest fracture has a maximum continuous length of 7.7m, a maximum width of 0.08m and a maximum measurable depth of 0.81m (Photo 22 to Photo 25). Some rock fracturing has uplifted on the rockbar with a measured uplift of 0.13m occurring at the downstream end of the impacted rockbar. No flow was present during the inspection however some flow diversion could be expected during surface flow as the fracture runs across the main flow path of the tributary.

DA3A_LW19_043 is a Level 2 trigger as per the DA3A Watercourse Impact, Monitoring Management and Contingency Plan (Table 7), specifically:

- Crack or fracture that (could) result in observable loss of surface water or erosion.

Photo 22: DA3A_LW19_043, looking at rock Fracturing on rockbar. Taken 17/04/2023.

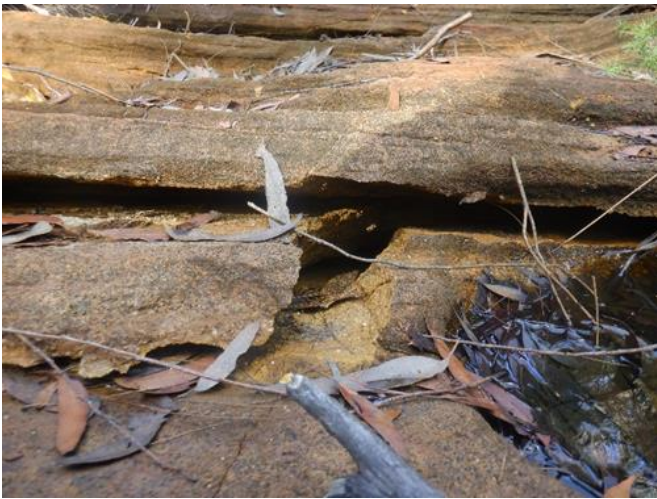
Photo 24: DA3A_LW19_043, looking at rock fracturing across rockbar. Taken 17/04/2023.

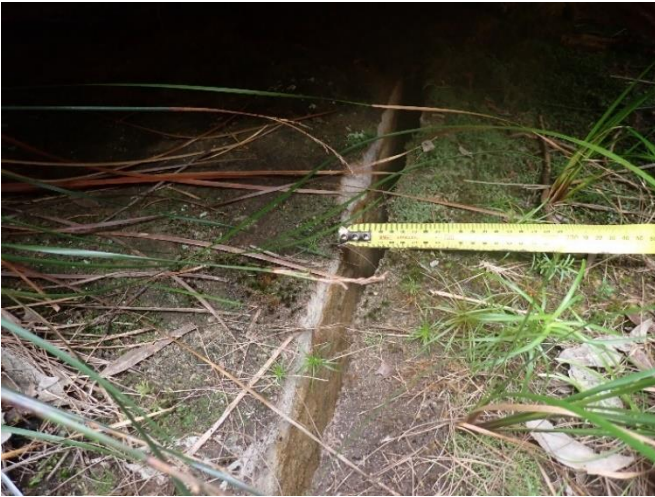
DA3A_LW8_003 was originally recorded on 28 January 2020, with changes to the impact recently observed. DA3A_LW8_003 is located on WC14, a tributary to Wongawilli Creek (Figure 4). During the initial inspection the impact consisted of rock fracturing and uplift at the top of a step, located approximately 3m south of Longwall 19. The impact site now displays a continuation in rock fracturing which extends beneath a step with small associated rockfalls/fragments. Originally the rock fracturing was recorded with a maximum continuous length of 1.8m and a maximum width of 0.005m. The latest fracturing has a maximum continuous length of 2.73m, a maximum width of 0.04m and maximum measurable depth of 0.49m (Photo 26 to Photo 28). The associated rockfall/fragments dimensions were estimated due to safety concerns, with an approximate rockfall volume of 0.2m³ (Photo 29). No follow up inspection was undertaken as the impact was identified following the completion of Longwall 19.

DA3A_LW8_003 is a Level 1 trigger as per the DA3A Watercourse Impact, Monitoring, Management and Contingency Plan (Table 7), specifically:

- Crack or fracture up to 100mm width;
- Crack or fracture up to 10m length;
- Rockfall from a cliff (step) which is left mostly intact (<10% length), resulting in insignificant ground disturbance.

Photo 26: DA3A_LW8_003, looking at the width of rock fracturing. Taken 12/04/2023.

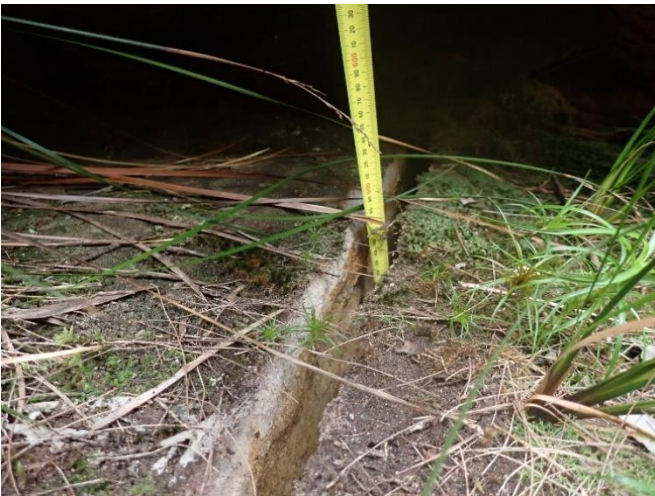
Photo 28: DA3A_LW8_003, looking at the depth of rock fracturing. Taken 12/04/2023.

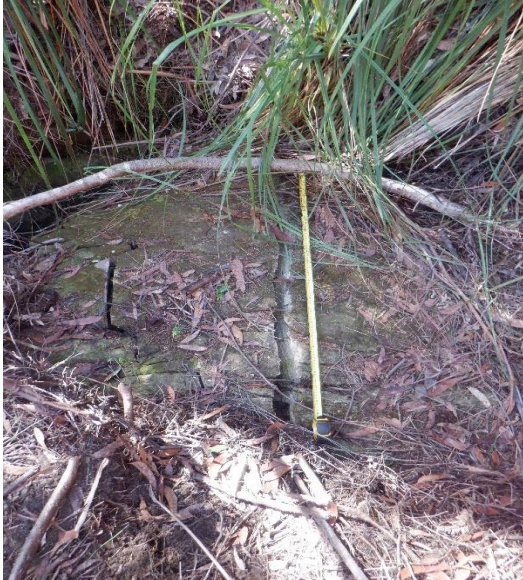
DA3A_LW19_051 is located on WC14, a tributary to Wongawilli Creek (Figure 4). The impact consists of multiple rock fractures to a rock outcrop within Swamp 148 with the largest fracture having a maximum continuous length of 1.15m, a maximum width of 0.06m and a maximum measurable depth of 1.27m (Photo 30 and Photo 31). During both the baseline inspection and the recent Longwall 19 impact inspection there was no flow present at the site, therefore the fracture is not associated with loss of surface water. No follow up inspection was undertaken as the impact was identified following the completion of Longwall 19.

DA3A_LW19_051 is a Level 1 trigger as per the DA3A Watercourse Impact, Monitoring, Management and Contingency Plan (Table 7), specifically:

- Crack or fracture up to 100mm width at its widest point with no observable loss of surface water or erosion
- Crack or fracture up to 10m length with no observable loss of surface water or erosion

Photo 30: DA3A_LW19_051, showing rock fracturing to an outcrop on WC14. Taken on 4/5/2023.

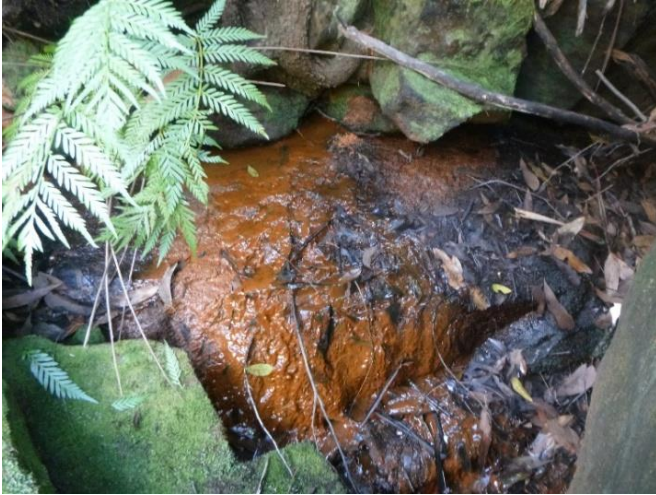
WC15 is a tributary of *Wongawilli Creek* that flows eastward towards DA3A mining operations (Figure 4). DA3A_LW19_045 consists of iron staining which appears at the base of a step above WC15_Pool 2 and extends downstream approximately 1.4m, to the pool before disappearing beneath a boulder on the tributary's edge (Photo 32 and Photo 33). Impact DA3B_LW13_046 was previously recorded at the site on 1 April 2019 during Longwall 13, consisting of rock fracturing and displacement at WC15_Pool 2. The iron staining has only appeared during Longwall 19.

DA3A_LW19_045 is a Level 1 trigger as per the DA3A Watercourse Impact, Monitoring, Management and Contingency Plan (Table 7), specifically:

- Observable increase in iron staining within the mining area

Photo 32: DA3A_LW19_045, showing iron staining appearing at base of a step. Taken on 26/04/2023.

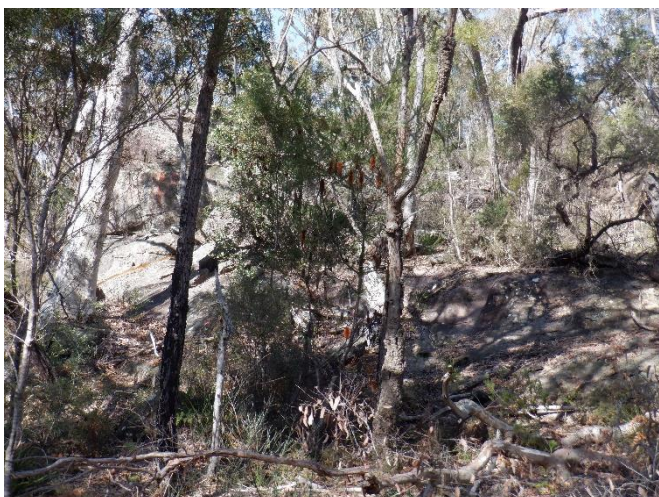
DA3A_LW19_002 is located on a steep slope/step east of Fire Road 6F (Figure 3). The impact was identified on 3 August 2022, consisting of two rock fractures approximately 10m apart. During the initial inspection measurements were estimated due to safety concerns. The rock fracturing had an approximate maximum length of 4m and a maximum width of less than 0.1m (Photo 36 to Photo 38). The impact was re-inspected on 19 April 2023, with a measured maximum continuous length of approximately 8m and a maximum width of 0.1m (Photo 39).

Photo 36: *DA3A_LW19_002*, showing overview of site. Taken 3/08/2022.

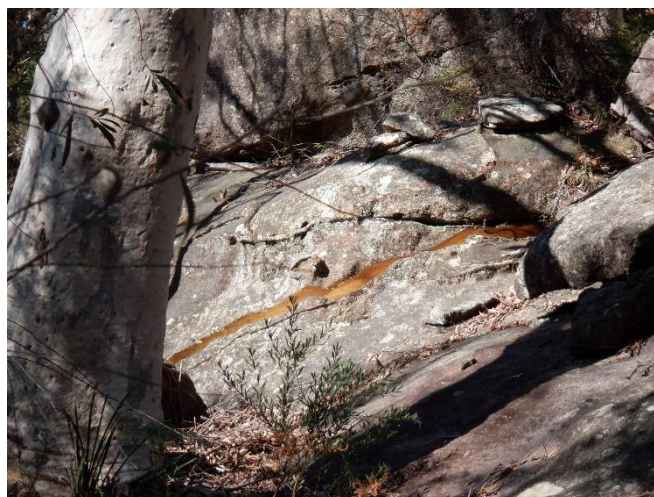
Photo 37: *DA3A_LW19_002*, showing a section of rock fracturing. Taken 3/08/2022.

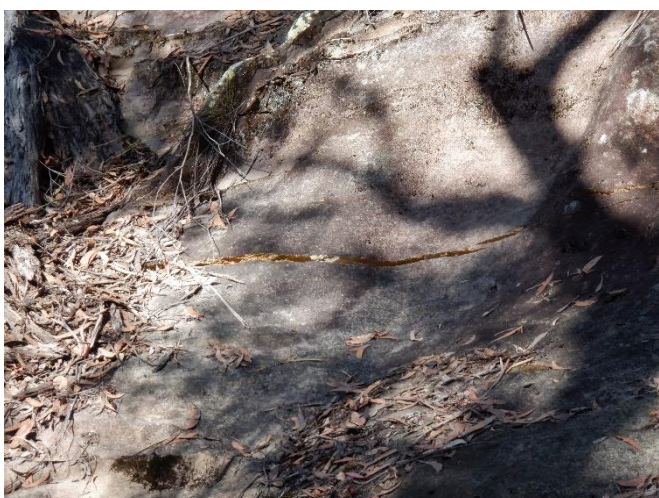
Photo 38: *DA3A_LW19_002*, showing a section of rock fracturing. Taken 3/08/2022.

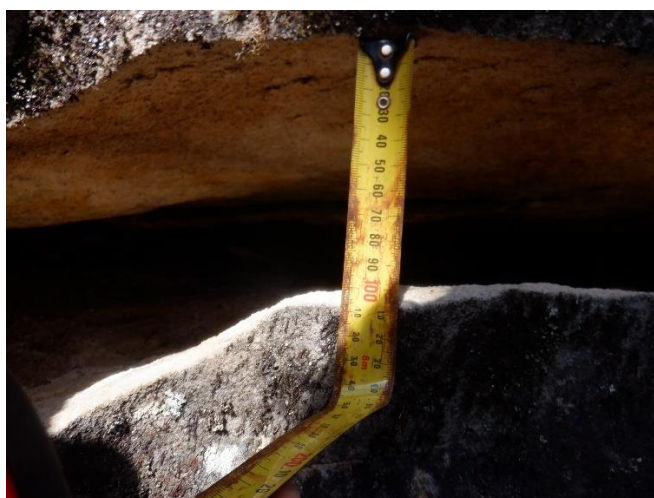
DA3A_LW19_002 is a now Level 2 trigger as per the Dendrobium Area 3A Landscape TARP (Table 8), specifically;

- Crack or fracture between 100mm and 300mm width

Photo 39: *DA3A_LW19_002*, showing width of rock fracturing. Taken 19/04/2023.

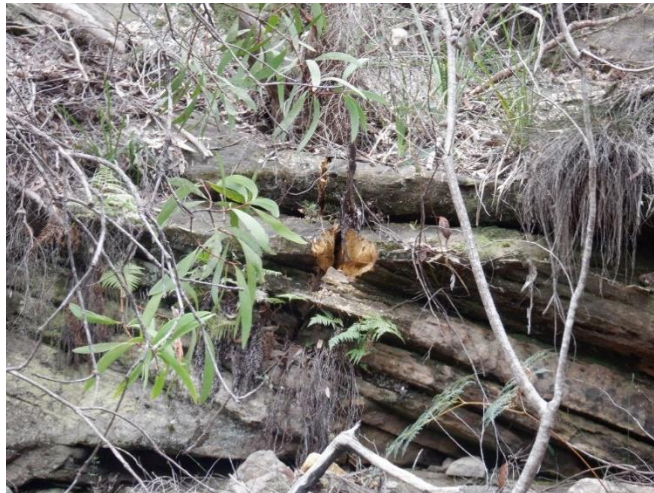
DA3A_LW19_004 is located on a steep slope/ step west of Swamp 15b (Figure 3). The impact was identified on 19 August 2022, consisting of rock fracturing and fragmentation. Measurements were estimated due to safety concerns. The rock fracturing had an approximate maximum length of 1.5m and a maximum width of 0.05m (Photo 40). The rock fragmentation has an approximate volume of less than 0.1m³. The impact was re-inspected on 19 April 2023. The continuous length remained the same however, the width had decreased after it was measured to 0.035m (initial recordings were estimated due to safety concerns).

DA3A_LW19_004 is a Level 1 trigger as per the Dendrobium Area 3A Landscape TARP (Table 8), specifically:

- Crack or fracture up to 10m length
- Crack or fracture up to 100mm width

Photo 40: *DA3A_LW19_004*, looking at rock fracturing and fragmentation. Taken on 19/08/2022.

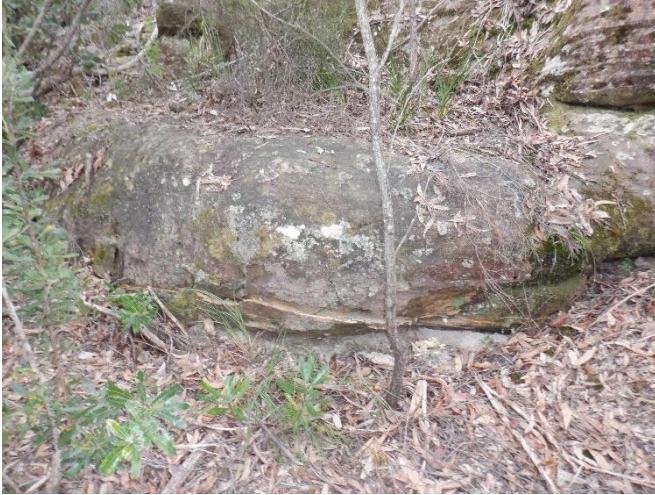
DA3A_LW19_005 is located on a steep slope/step west of Swamp 15b (Figure 3). The impact was identified on 19 August 2022, consisting of two rock fractures. The rock fracturing had a maximum continuous length of 2.59m, a width of 0.035m and a maximum measurable depth of 0.37m (Photo 41 to Photo 43). Minor rock displacement from the soil was observed. The impact was re-inspected on 19 April 2023. The dimensions remained the same however, a section had fallen from the fracture (Photo 44).

DA3A_LW19_005 is a Level 1 trigger as per the Dendrobium Area 3A Landscape TARP (Table 8), specifically:

- Crack or fracture up to 10m length
- Crack or fracture up to 100mm width

Photo 41: DA3A_LW19_005, looking at section of rock fracturing. Taken on 19/08/2022.

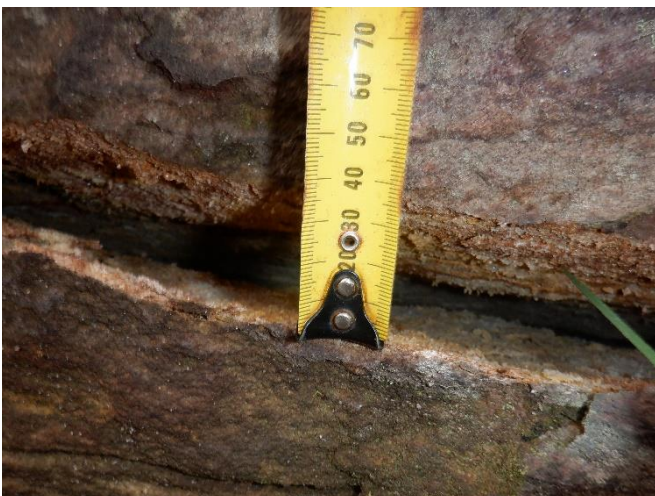
Photo 43: DA3A_LW19_005, looking at width of rock fracture. Taken on 19/08/2022.

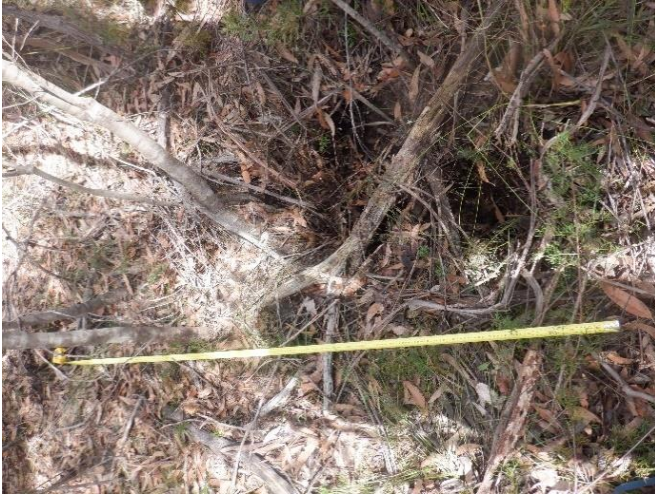
DA3A_LW19_006 is a Level 2 trigger as per the Dendrobium Area 3A Landscape TARP (Table 8), specifically:

- Crack or fracture between 100mm and 300mm width

Photo 45: Maximum continuous length of soil cracking (measuring tape set at 2.5m). Taken 31/08/2022.

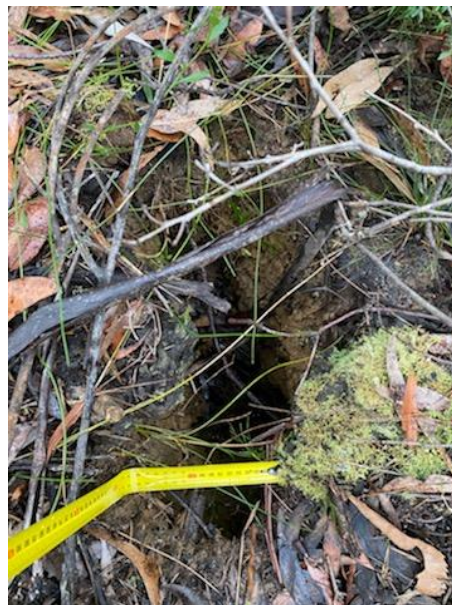
Photo 47: Width of soil crack. Taken 1/09/2022.

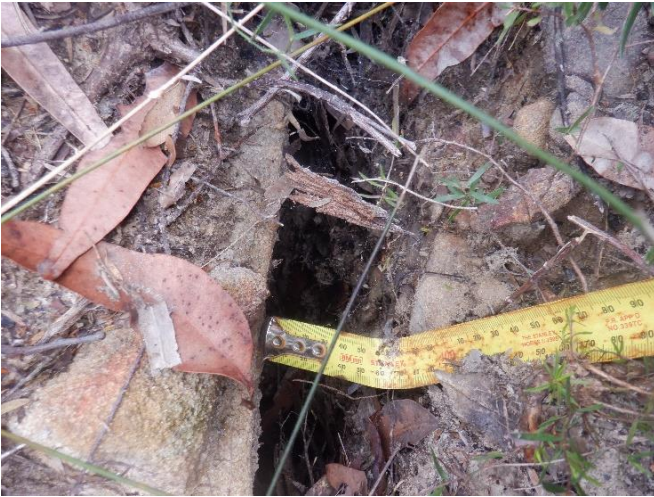
DA3A_LW19_007 was identified on 18 October 2022 and consists of soil cracking, located 100m to the north of Longwall 19 (Figure 3). The soil cracking is situated in bushland and runs parallel to a closed access track. The cracking had a maximum continuous length of 2.4m, a maximum width of 0.08m and maximum measurable depth of 0.4m (Photo 48 to Photo 51). It had a total discontinuous length of approximately 50m. In some sections, the soil is displaced from adjacent rock outcropping (Photo 48). This impact likely occurred during Longwall 8 but was only identified during the latest inspection of the area. Some sections of the soil cracking indicate more recent movements, likely due to Longwall 19. The impact was re-inspected on 19 April 2023. The soil crack's length remained the same however, the width was re-recorded and was measured 0.095m wide (Photo 49).

DA3A_LW19_007 is a Level 1 trigger as per the Dendrobium Area 3A Landscape TARP (Table 8), specifically:

Photo 48: *DA3A_LW19_007*, width of soil cracking. Taken on 18/10/2022.

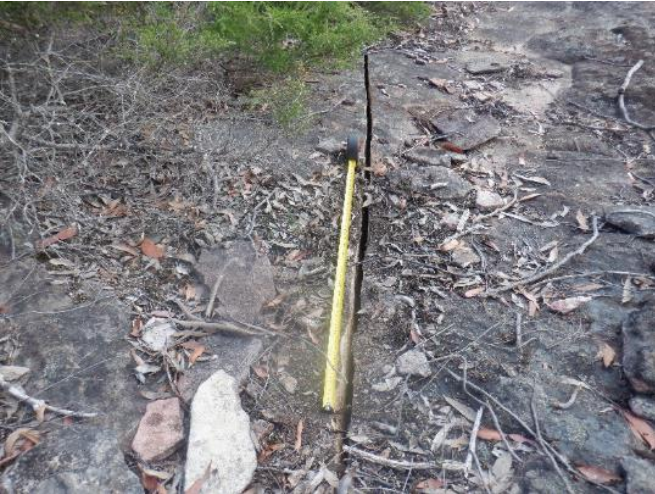
DA3A_LW19_008 is located 80m east of Fire Road 6F and consists of rock fracturing to a rock outcrop (Figure 3). The fracturing had a maximum continuous length of 5.4m, a maximum width of 0.028m and maximum measurable depth of 1.54m (Photo 52 to Photo 53). The fracture had a total discontinuous length of approximately 22m. Flagging tape is in place at the site as a safety precaution. The impact was re-inspected on 9 May 2023 and the rock fracturing then had a maximum continuous length of 6.8m and a maximum width of 0.042m (Photo 54 and Photo 55).

Photo 52: DA3A_LW19_008, section of rock fracturing. Taken on 7/11/2022.

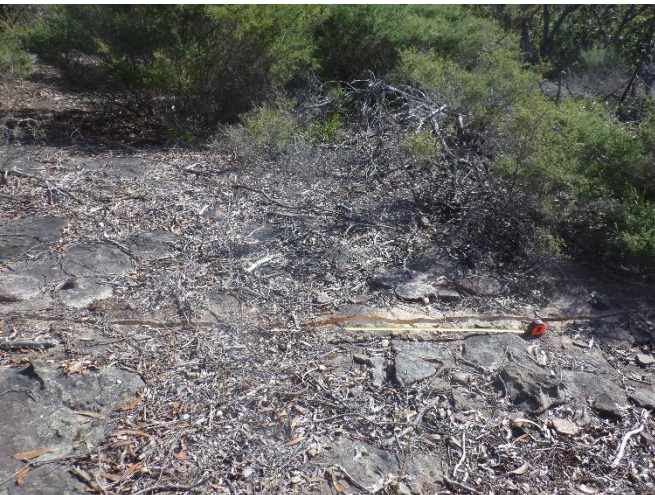
Photo 54: DA3A_LW19_008, section of rock fracturing taken on 09/05/2023.

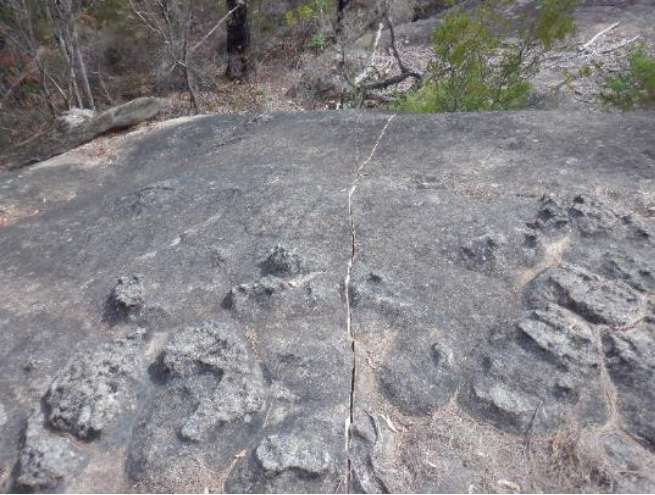
DA3A_LW19_009 is located 95m east of Fire Road 6F and consists of rock fracturing to a rock outcrop (Figure 3). The fracturing had a maximum continuous length of 7.44m, a maximum width of 0.016m and maximum measurable depth of 0.043m (Photo 56 and Photo 57). The fracture had a total discontinuous length of approximately 48m. Flagging tape is in place at the site as a safety precaution. The impact was re-inspected on 9 May 2023 and the length of rock fracturing remained the same however, the width increased to 0.045m (Photo 58).

DA3A_LW19_009 is a Level 1 trigger as per the Dendrobium Area 3A Landscape TARP (Table 8), specifically:

Photo 56: DA3A_LW19_009, section of rock fracturing. Taken on 7/11/2022.

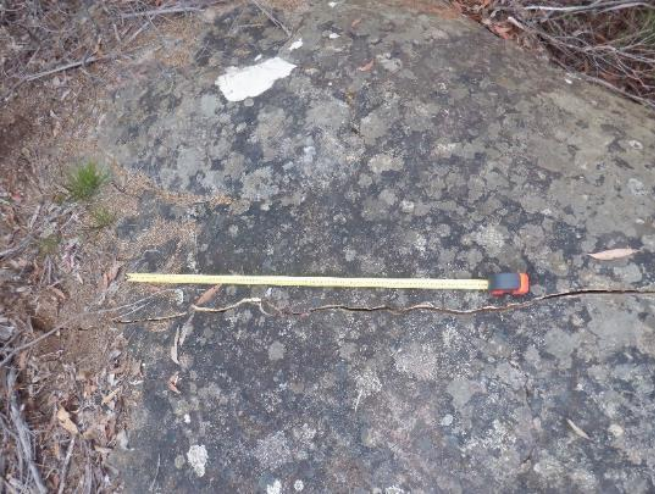
DA3A_LW19_010 is located 115m east of Fire Road 6F and consists of rock fracturing to a rock outcrop (Figure 3). The fracturing has a maximum continuous length of 2.8m, a maximum width of 0.012m and maximum measurable depth of 0.29m (Photo 59 and Photo 60). The impact was re-inspected on 9 May 2023 and no changes were observed.

DA3A_LW19_010 is a Level 1 trigger as per the Dendrobium Area 3A Landscape TARP (Table 8), specifically:

Photo 59: DA3A_LW19_010, section of rock fracturing. Taken on 7/11/2022.

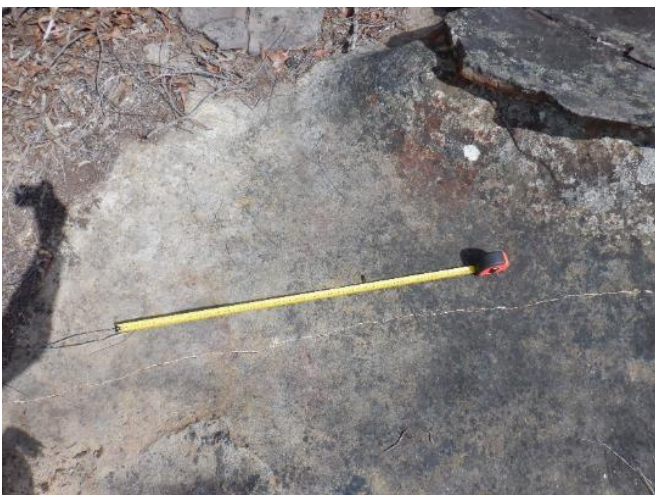
DA3A_LW19_011 is located 115m east of Fire Road 6F and consists of two rock fractures to a rock outcrop (Figure 3). The fracturing has a maximum continuous length of 4m and a maximum width of 0.003m (Photo 61 and Photo 62). Flagging tape is in place at the site as a safety precaution. The impact was re-inspected on 9 May 2023 and no changes were observed.

DA3A_LW19_011 is a Level 1 trigger as per the Dendrobium Area 3A Landscape TARP (Table 8), specifically:

Photo 61: DA3A_LW19_011, section of rock fracturing. Taken on 7/11/2022.

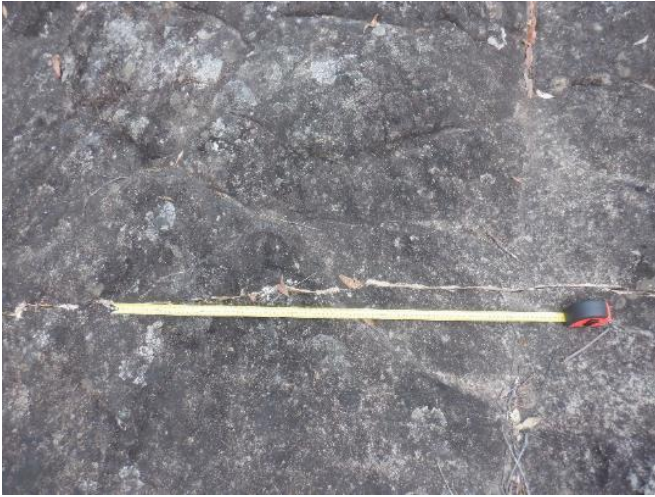
DA3A_LW19_012 is located 165m east of Fire Road 6F and consists of rock fracturing to a rock outcrop (Figure 3). The fracturing has a maximum continuous length of 5.7m, a maximum width of 0.008m and maximum

measurable depth of 0.17m (Photo 63 and Photo 64). The fracture has a total discontinuous length of approximately 9.5m. The impact was re-inspected on 9 May 2023 and no changes were observed.

DA3A_LW19_012 is a Level 1 trigger as per the Dendrobium Area 3A Landscape TARP (Table 8), specifically:

Photo 63: *DA3A_LW19_012*, section of rock fracturing. Taken on 7/11/2022.

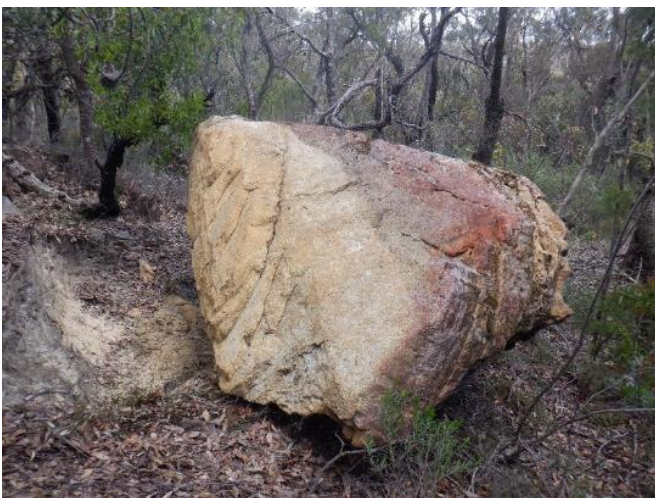
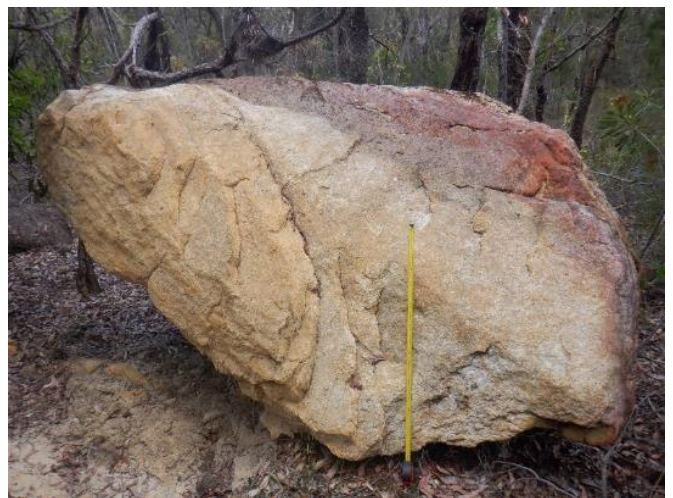
DA3A_LW19_014 is located 350m east of Fire Road 6F and consists of the movement of a boulder (Figure 3). The boulder has been dislodged from its natural position and rolled forward approximately 1m. The boulder has a length of 3.4m, a width of 2.5m, height of 1.1m and an approximate volume less than 9m³ (Photo 67 and Photo 68). Flagging tape is in place at the site as a safety precaution however the boulder now appears stable. The impact was re-inspected on 9 May 2023 and no changes were observed.

DA3A_LW19_014 is a Level 1 trigger as per the Dendrobium Area 3A Landscape TARP (Table 8), specifically:

Photo 67: DA3A_LW19_014, looking at the displacement of the boulder. Taken on 7/11/2022.

Photo 68: DA3A_LW19_014, looking at the displacement of the boulder. Taken on 7/11/2022.

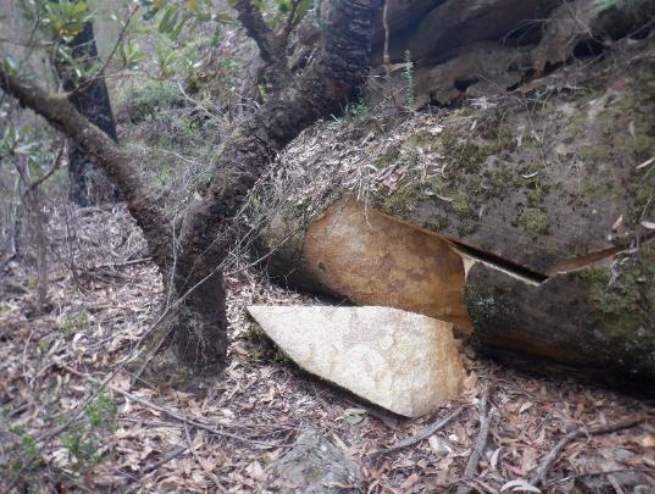
DA3A_LW19_016 is located 320m east of Fire Road 6F and consists of two rock fractures and associated displacement at a steep slope/step (Figure 3). The following measurements have been estimated from a distance due to safety concerns. The largest fracture had a length of 2m and a maximum width of 0.1m (Photo 71 and Photo 72). The rock displacement/fragmentation had approximate dimensions of 1.3m x 0.8m x 0.5m. The impact was re-inspected on 19 April 2023. The rock fracturing now has extended to 3.9m and the width reduced to 0.06m (Photo 73) (initial recordings estimated from distance for safety reasons).

DA3A_LW19_016 is a Level 2 trigger as per the Dendrobium Area 3A Landscape TARP (Table 8), specifically:

Photo 71: DA3A_LW19_016, section of rock fracturing. Taken on 7/11/2022.

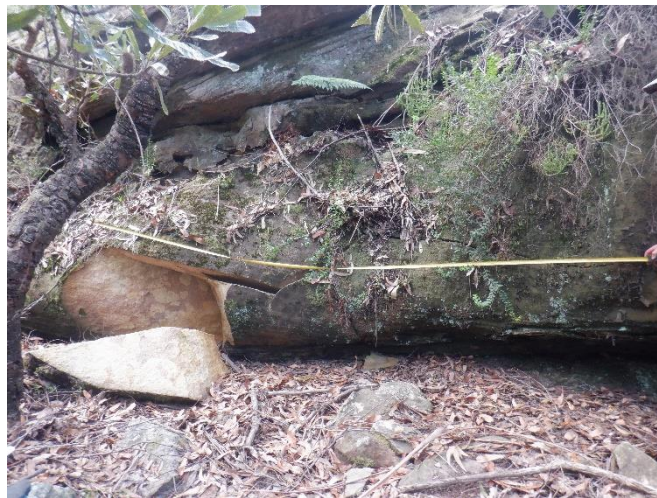
Photo 73: DA3A_LW19_016, showing extent of rock fracturing. Taken on 19/04/2023.

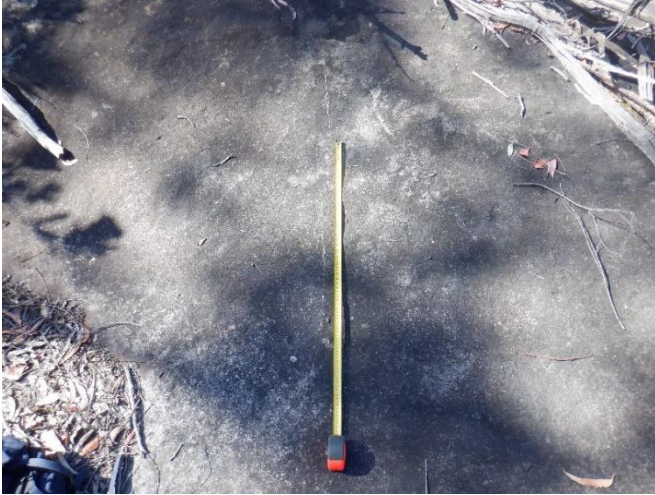
DA3A_LW19_017 is located 130m east of Fire Road 6F and consists of rock fracturing to a rock outcrop (Figure 3). The fracturing has a maximum continuous length of 2.8m and a maximum width of 0.001m (Photo 74 and Photo 75). The impact was re-inspected on 9 May 2023 and no changes were observed.

DA3A_LW19_017 is a Level 1 trigger as per the Dendrobium Area 3A Landscape TARP (Table 8), specifically:

Photo 74: DA3A_LW19_017, section of rock fracturing. Taken on 13/12/2022.

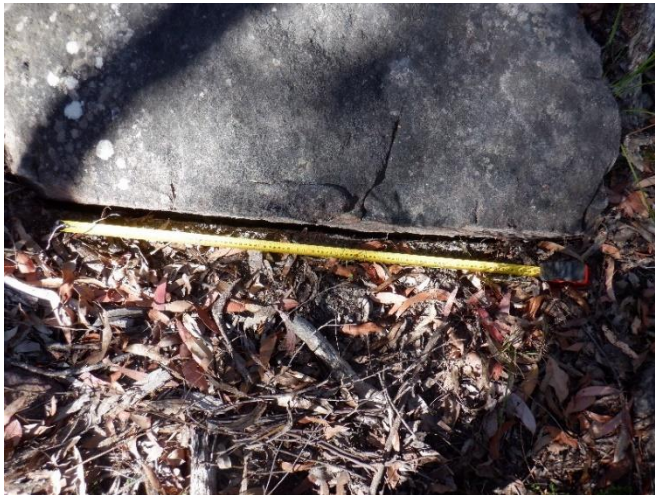
DA3A_LW19_018 is located approximately 280m east of Fire Road 6F and consists of rock displacement away from soil (Figure 3). The displacement has a maximum continuous length of 1.1m, a maximum width of 0.015m and maximum measurable depth of 0.22m (Photo 76 and Photo 77). The impact was re-inspected on 9 May 2023 and no changes were observed.

DA3A_LW19_018 is a Level 1 trigger as per the Dendrobium Area 3A Landscape TARP (Table 8), specifically:

Photo 76: DA3A_LW19_018, section of rock displacement. Taken on 13/12/2022.

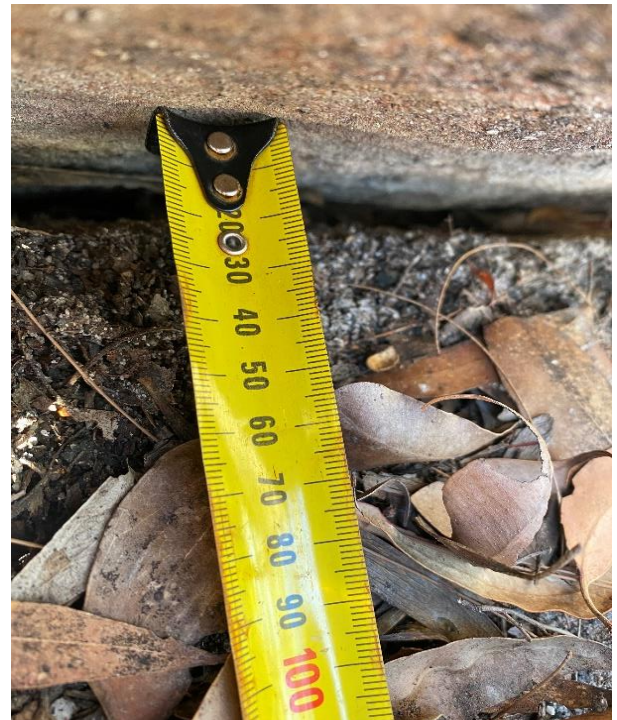
Photo 77: DA3A_LW19_018, width of rock displacement. Taken on 13/12/2022.

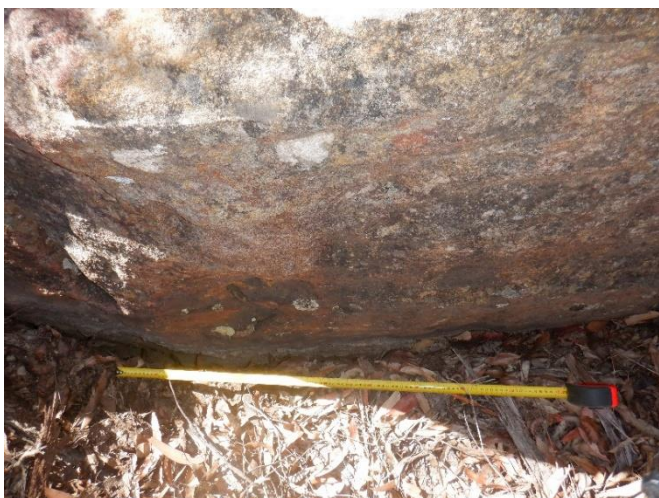
DA3A_LW19_019 is a Level 1 trigger as per the Dendrobium Area 3A Landscape TARP (Table 8), specifically:

Photo 78: DA3A_LW19_019, section of rock displacement. Taken on 13/12/2022.

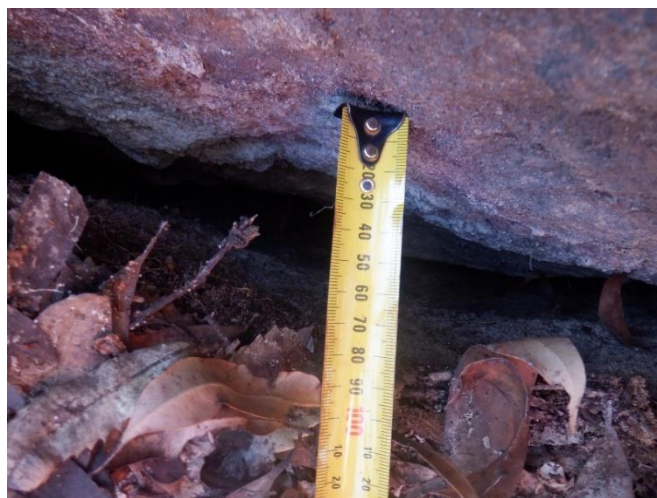
Photo 79: DA3A_LW19_019, width of rock displacement. Taken on 13/12/2022.

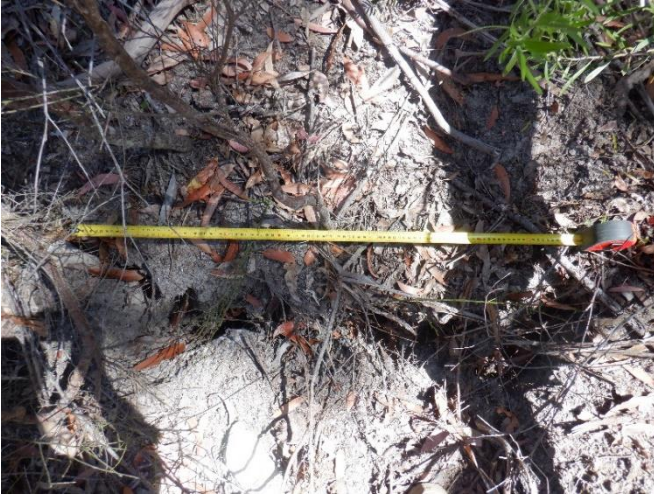
DA3A_LW19_020 is a Level 2 trigger as per the Dendrobium Area 3A Landscape TARP (Table 8), specifically:

Photo 80: DA3A_LW19_020, section of soil cracking. Taken on 13/12/2022.

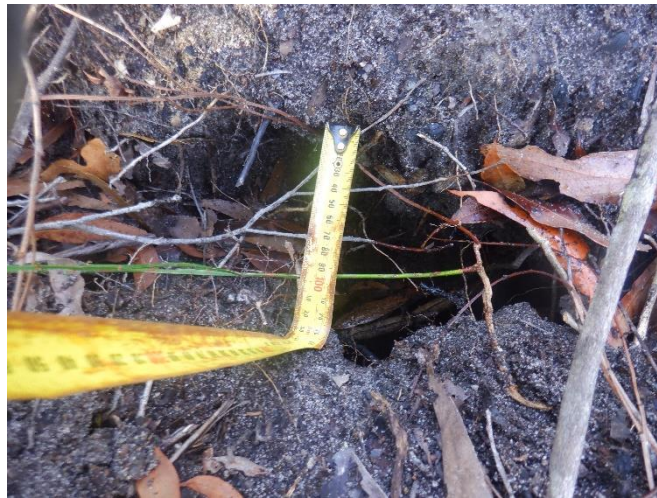
Photo 82: DA3A_LW19_020, showing erosion of soil crack. Taken on 09/05/2023.

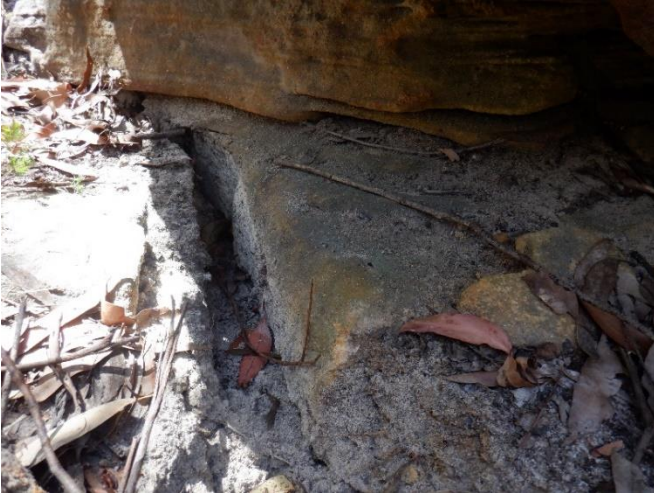
DA3A_LW19_021 is a Level 2 trigger as per the Dendrobium Area 3A Landscape TARP (Table 8), specifically:

Photo 83: DA3A_LW19_021, section of soil cracking. Taken on 13/12/2022.

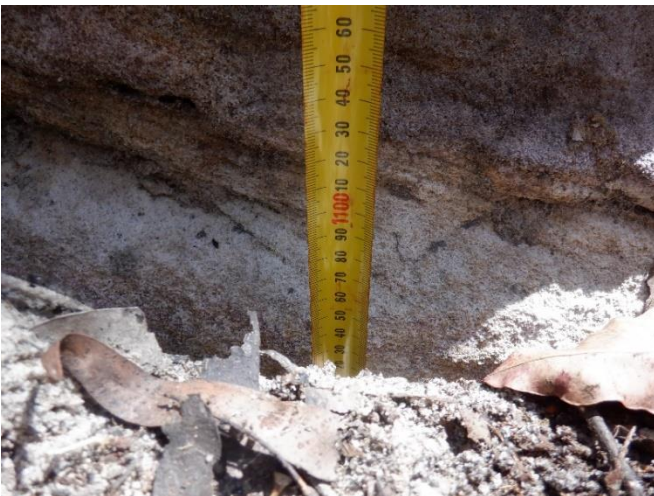
Photo 85: DA3A_LW19_021, depth of soil cracking. Taken on 13/12/2022.

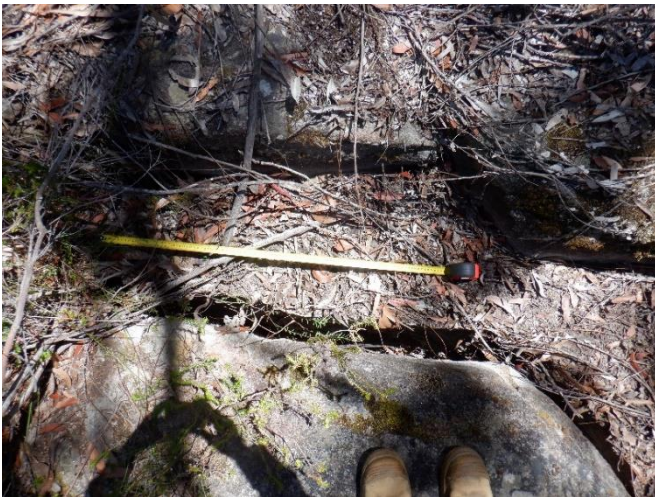
Photo 89: *DA3A_LW19_022*, section of rock displacement. Taken on 13/12/2022.

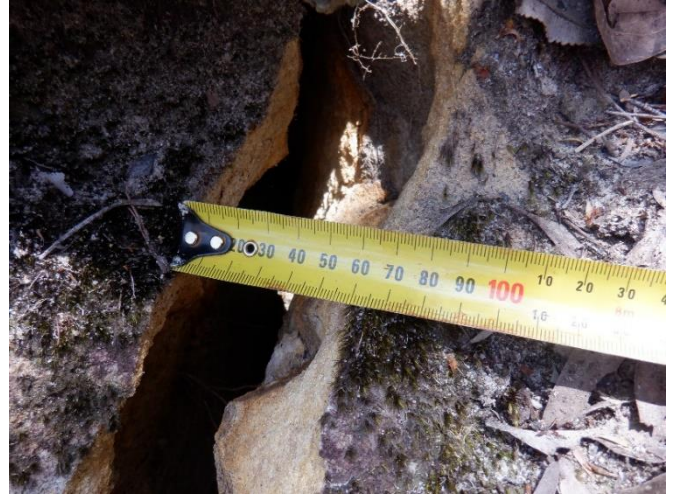
Photo 92: *DA3A_LW19_023*, width of rock displacement. Taken on 13/12/2022.

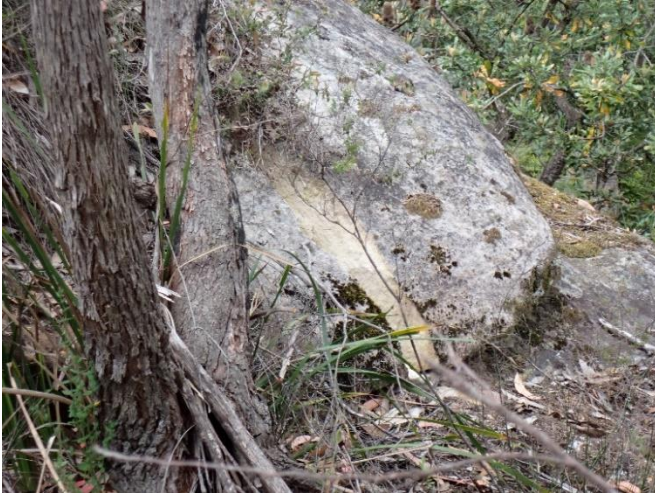
DA3A_LW19_024 is located 490m east of Fire Road 6F and consists of rock fracturing to steep slope/step and soil cracking (Figure 3). The rock fracturing and soil cracking are connected, with a maximum continuous length of 5m, a maximum width of 0.16m and a maximum measurable depth of 1.5m (Photo 93 to Photo 95). Other smaller rock fractures are also present within a 25m² area. The impact was reinspected on 19 April 2023 and there were no recordable changes to the dimensions however, there were some signs of erosion to the soil crack (Photo 96).

DA3A_LW19_024 is a Level 2 trigger as per the Dendrobium Area 3A Landscape TARP (Table 8), specifically:

Photo 93: DA3A_LW19_024, section of rock fracturing. Taken on 20/12/2022.

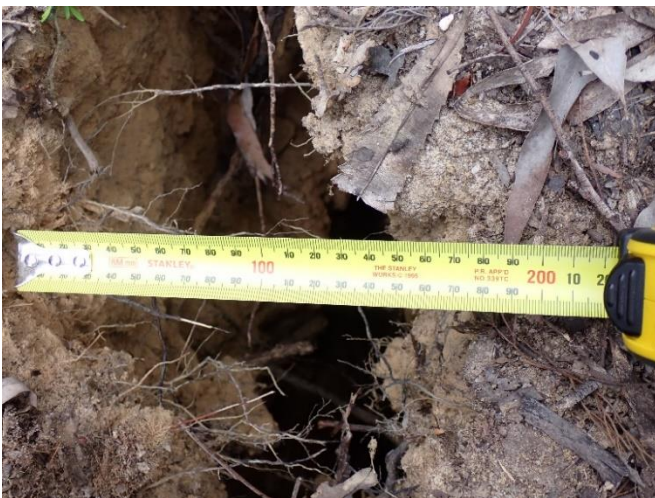
Photo 95: DA3A_LW19_024, width of soil cracking. Taken on 20/12/2022.

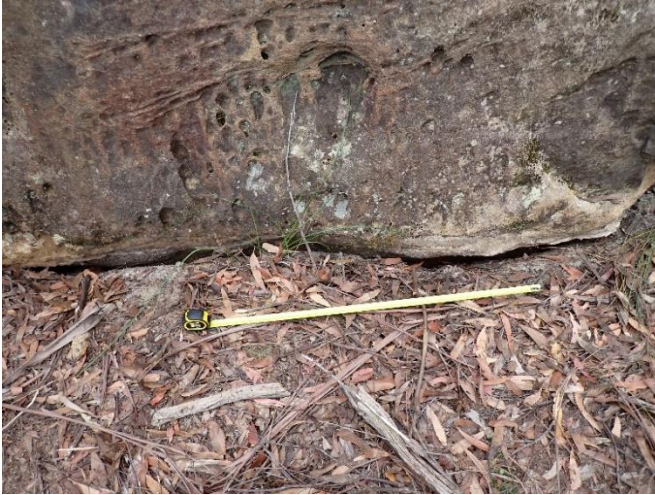
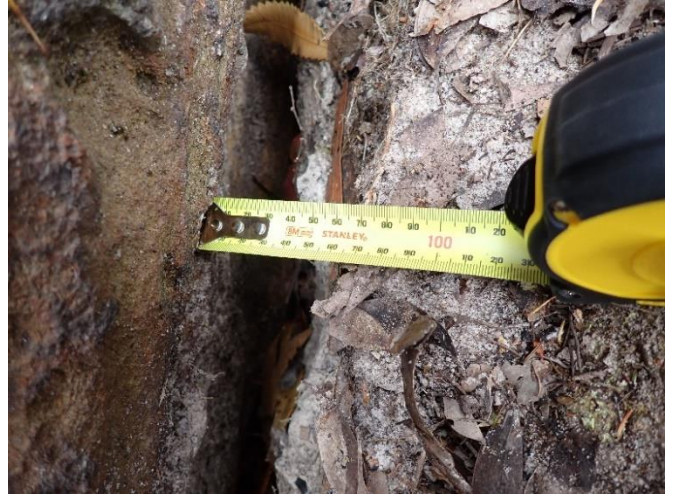
DA3A_LW19_025 is located approximately 590m east of Fire Road 6F and consists of rock displacement away from soil (Figure 3). The displacement has a maximum continuous length of 6.2m, a maximum width of 0.07m and maximum measurable depth of 0.32m (Photo 97 and Photo 98). The impact was re-inspected on 19 April 2023 and there were no changes observed.

DA3A_LW19_025 is a Level 1 trigger as per the Dendrobium Area 3A Landscape TARP (Table 8), specifically:

Photo 97: DA3A_LW19_025, section of rock displacement.
Taken on 20/12/2022.

Photo 98: DA3A_LW19_025, width of rock displacement.
Taken on 20/12/2022.

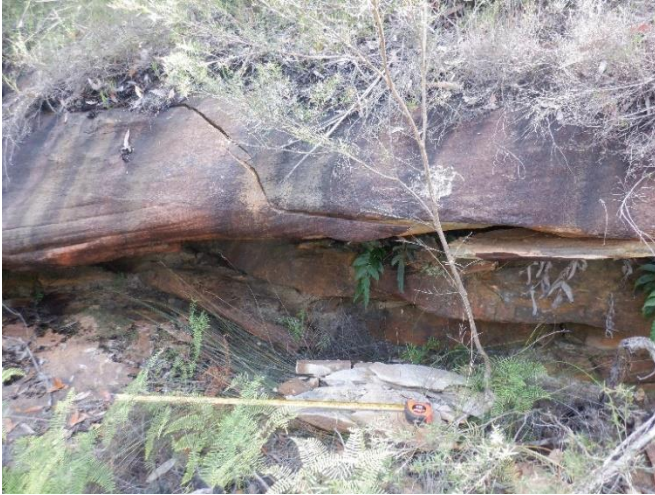
DA3A_LW19_027 consists of rock fracturing and associated small rockfalls at a step approximately 55m west of Fire Road 6F (Figure 4). The rock fracturing has a discontinuous length of 9m, a maximum continuous length of 2.09m, a maximum width of 0.018m and a maximum measurable depth of 0.76m (Photo 99 and Photo 102). Two small rockfalls are evident at the site, with approximate rockfall volumes of 1m³ and 0.5m³ (Photo 99 to Photo 101) flagging tape is in place at the site as a safety precaution. The impact was re-inspected on 11 May 2023 and no changes were observed.

DA3A_LW19_027 is a Level 1 trigger as per the Dendrobium Area 3A Landscape TARP (Table 8), specifically:

Photo 99: DA3A_LW19_027, section of rock fracturing and rockfall. Taken on 10/01/2023.

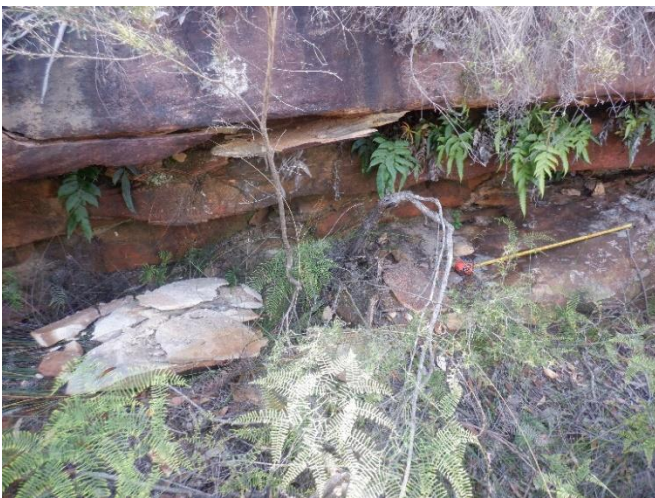
Photo 101: DA3A_LW19_027, section of rock fracturing and rockfall. Taken on 10/01/2023.

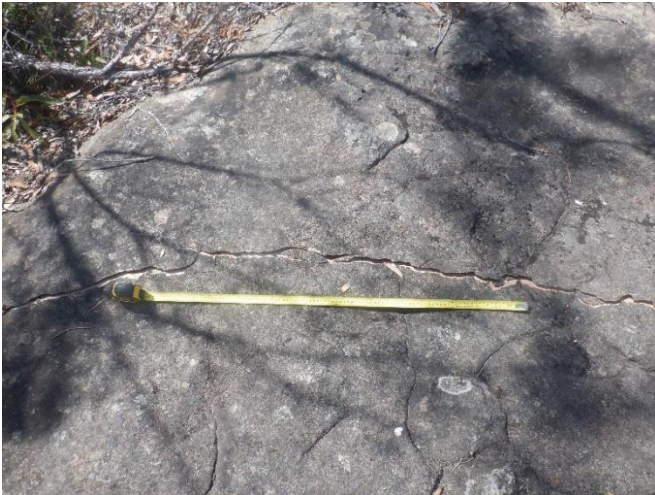
DA3A_LW19_028 consists of rock fracturing to a rock outcrop east of Fire Road 6F (Figure 3). The impact consists of three rock fractures within an area of 25m x 1m. The rock fracturing has a maximum continuous length of 5.86m, a maximum width of 0.016m and a maximum measurable depth of 0.4m (Photo 103 and Photo 104). The site was re-inspected on 11 May 2023 and no changes were observed.

DA3A_LW19_028 is a Level 1 trigger as per the Dendrobium Area 3A Landscape TARP (Table 8), specifically:

Photo 103: DA3A_LW19_028, section of rock fracturing. Taken on 6/02/2023.
