END OF PANEL
LANDSCAPE REPORT
DENDROBIUM AREA 3A

DENDROBIUM AREA 3A
LONGWALL 19 END OF PANEL
LANDSCAPE REPORT
JUNE 2023

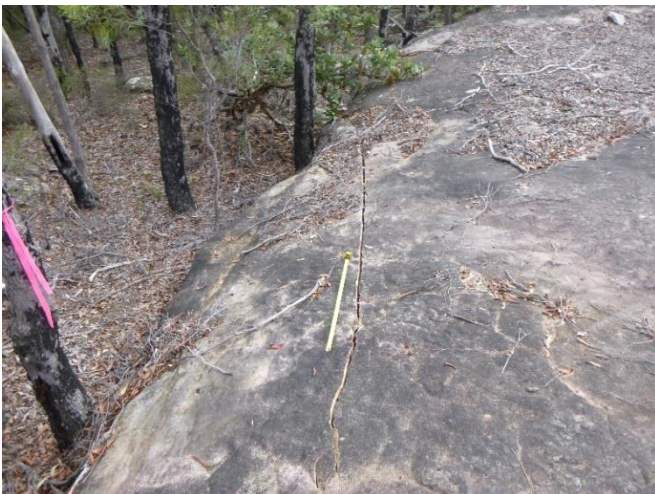
DA3A_LW19_030 consists of rock fracturing to a rock outcrop east of Fire Road 6F (Figure 3). The impact consists of a single rock fracture. The fracture had a maximum continuous length of 9.8m, a maximum width of 0.032m and a maximum measurable depth of 1.1m (Photo 105 and Photo 106). The impact was re-inspected on 9 May 2023 and while the width remained the same the length of fracture increased to 10.5m continuous.

DA3A_LW19_030 is a Level 2 trigger as per the Dendrobium Area 3A Landscape TARP (Table 8), specifically:

Photo 105: DA3A_LW19_030, rock fracturing to an outcrop. Taken on 15/2/2023.

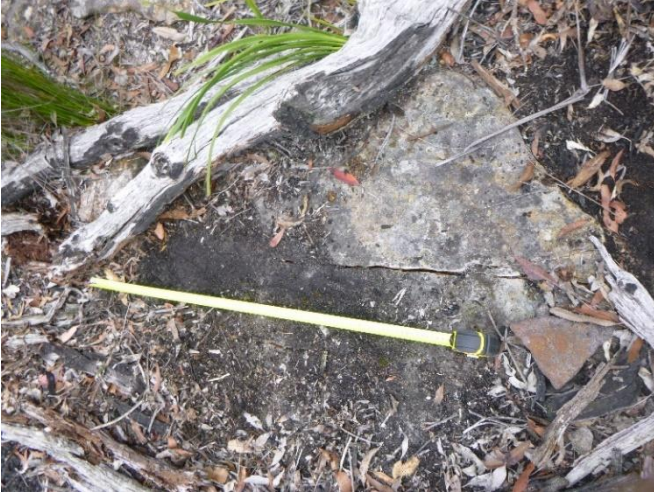
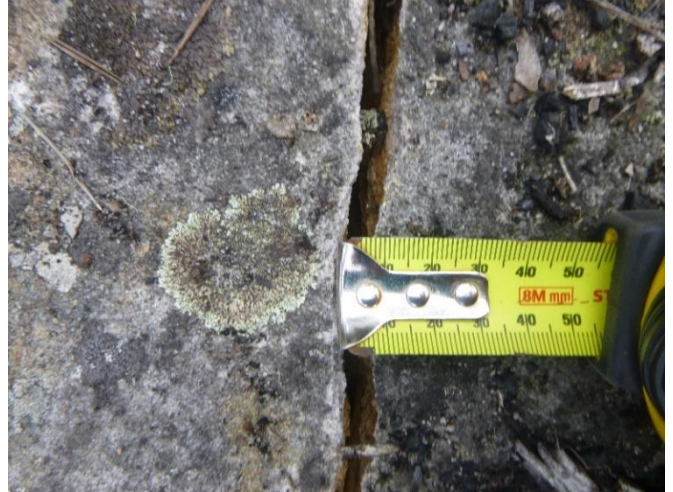
measurable depth of 0.23m (Photo 107 and Photo 108). The impact was re-inspected on 9 May 2023 and while the width remained the same the length of fracture increased to 1.04m continuous (Photo 109).

DA3A_LW19_031 is a Level 1 trigger as per the Dendrobium Area 3A Landscape TARP (Table 8), specifically:

Photo 107: *DA3A_LW19_031*, rock fracturing to an outcrop. Taken on 15/2/2023

Photo 108: *DA3A_LW19_031*, width of rock fracture on outcrop. Taken on 15/2/2023

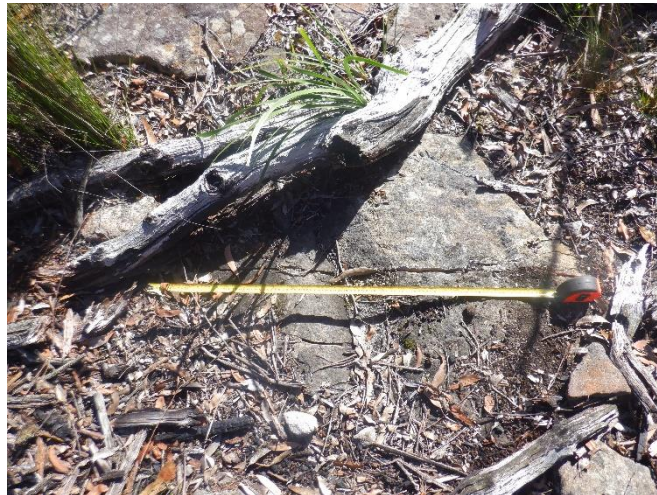
Photo 109: *DA3A_LW19_031*, length of fracturing increased. Photo taken on 09/05/2023.

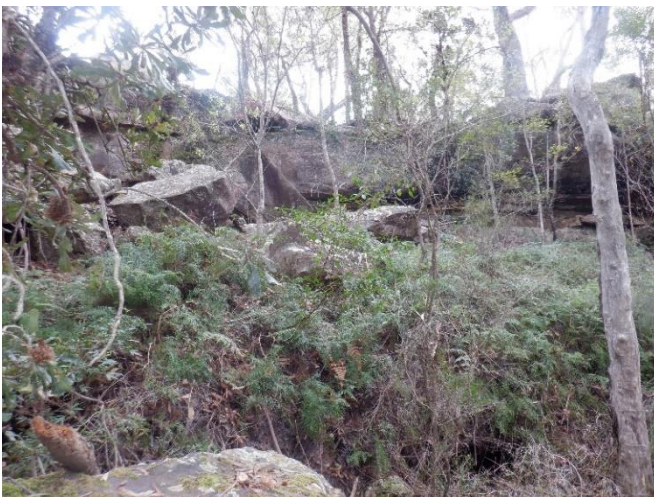
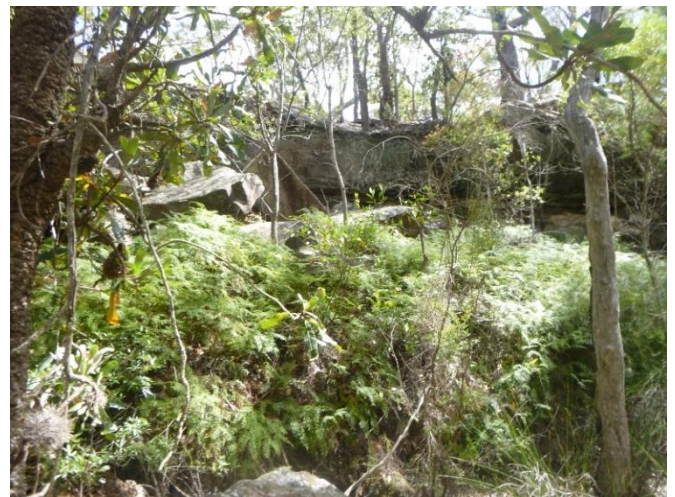
DA3A_LW19_032 consists of a rock fracture that runs vertically up a rock step, to the east of Fire Road 6F and within close proximity to landscape monitoring site *LW19_SS11* (Figure 1 and Figure 3). The rock fracture is not visible at the landscape monitoring site photo point (Photo 111). A baseline photo is provided for pre-mining comparison (Photo 112). The rock fracture has a maximum continuous length of 1.2m, a maximum width of 0.01m and a maximum measurable depth of 0.31m (Photo 110). The impact was re-inspected on 11 May 2023 and no changes were observed.

Photo 111: Landscape monitoring site LW19_SS11. Taken 16/06/2022.

Photo 112: Landscape monitoring site LW19_SS11. Taken 15/02/2023.

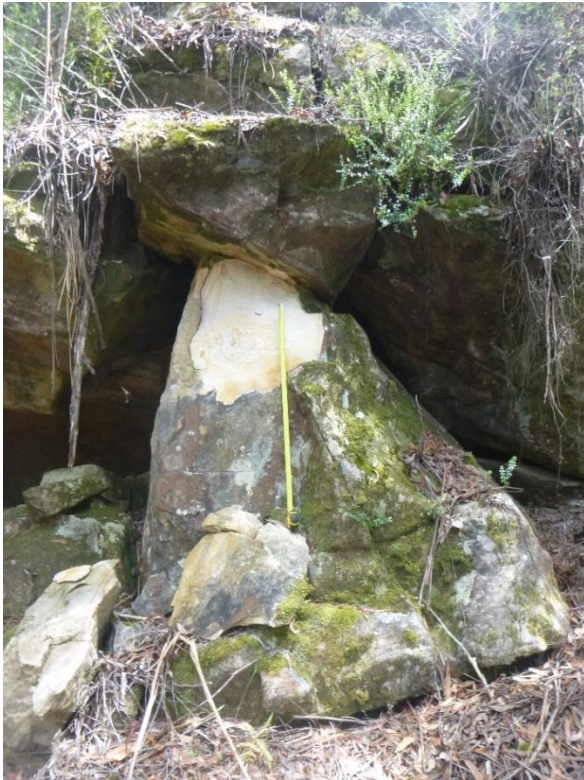
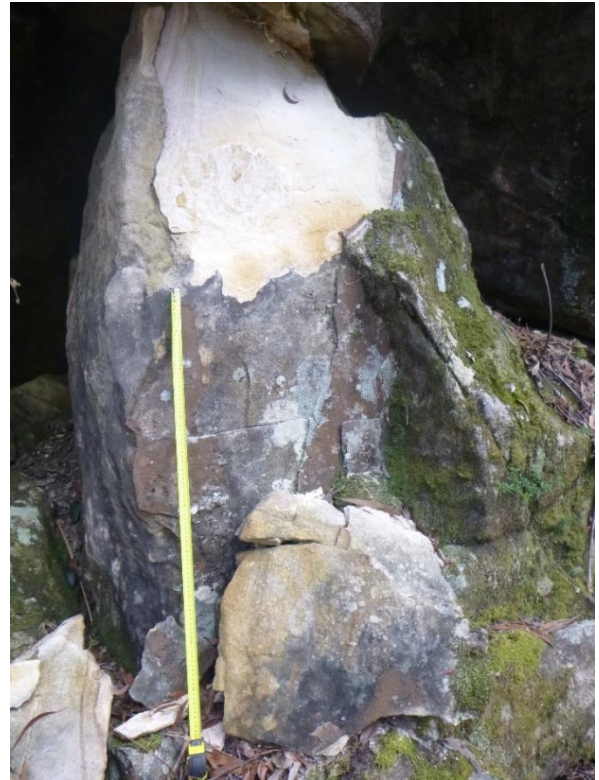
DA3A_LW19_033 is a Level 1 trigger as per the Dendrobium Area 3A Landscape TARP (Table 8), specifically:

- Rockfall from a cliff (step) which is left mostly intact (<10% length), resulting in insignificant ground disturbance.

Photo 113: DA3A_LW19_033, rock fall from edge of steep slope. Taken on 15/2/2023.

Photo 114: DA3A_LW19_033, rock fall from edge of steep slope. Taken on 15/2/2023.

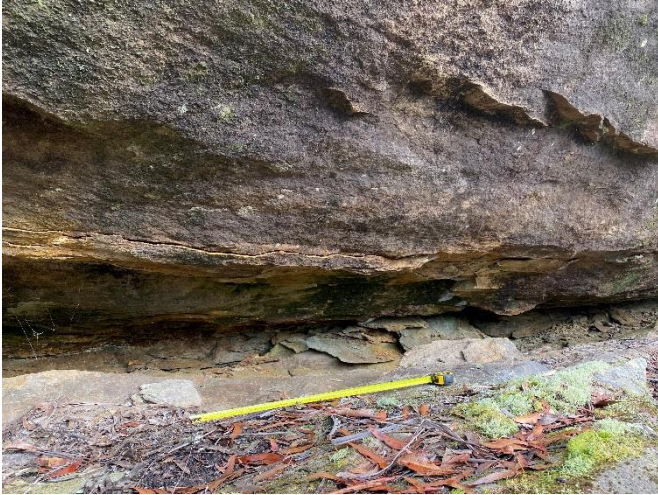
DA3A_LW19_037 is a Level 2 trigger as per the Aboriginal Cultural Heritage Management Plan Longwall 19, Dendrobium Area 3A TARP, specifically:

- Change in shelter conditions not attributable to natural weathering or preservation- change in drip line or seepage, cracking or exfoliation of overhang or shelter, movement or opening of existing planes and joints in panel, block fall within shelter or overhang, shelter, or overhang collapse.

Photo 116: DA3A_LW19_037, rock fracturing. Taken on 28/03/2023.

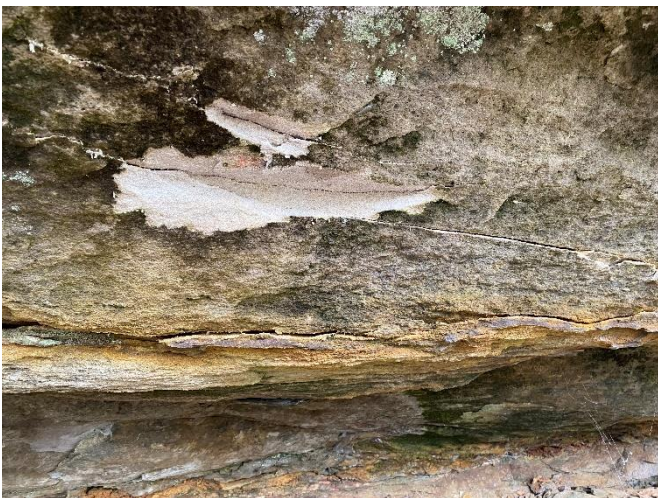
DA3A_LW19_037 is located 57m east of Fire Road 6F and consists of rock fracturing beneath an overhang with some small associated rockfalls (Figure 3). At the time of inspection, the rock fracture had a length of 5.2m, width of 0.022m, and measurable depth of 0.34m (Photo 116 to Photo 119). The site is registered Aboriginal Heritage site *Sandy Creek 21 (52-5-0273)*. The fracturing is approximately 6m away from the site's recorded artwork.

Photo 118: DA3A_LW19_037, rock fall. Taken on 28/03/2023.

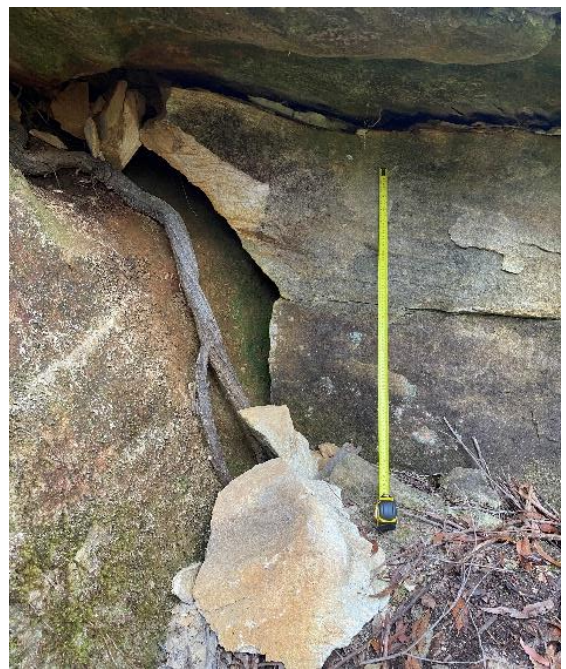
Photo 119: DA3A_LW19_037, rock fall. Taken on 28/03/2023.

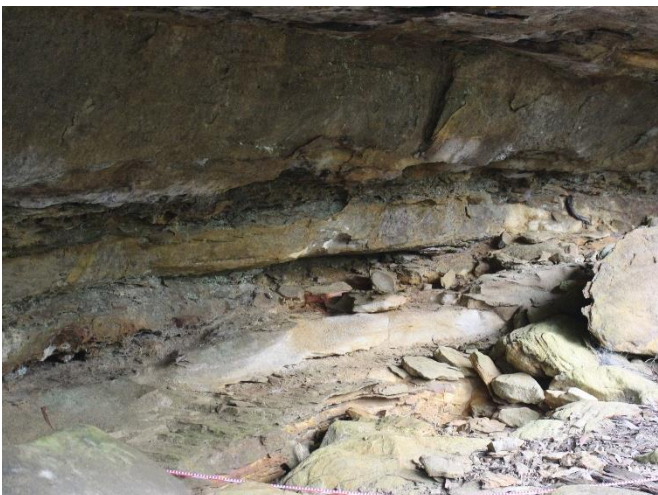
Photo 120: Baseline photo of Sandy Creek 21. Taken circa October 2020.

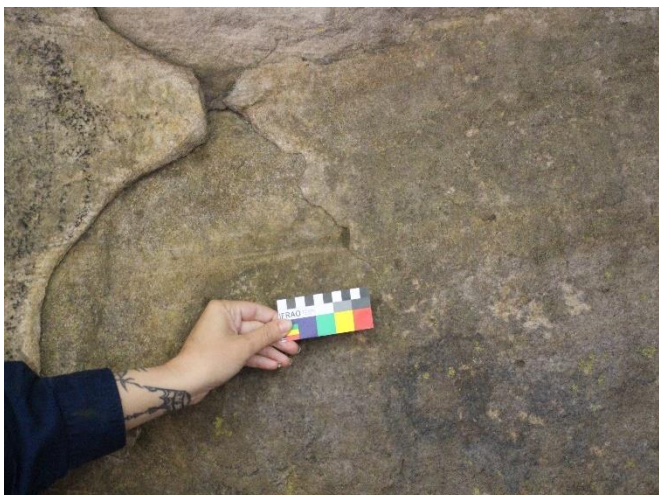
Photo 122: Baseline photo of art at *Sandy Creek 21*. Taken circa October 2020.

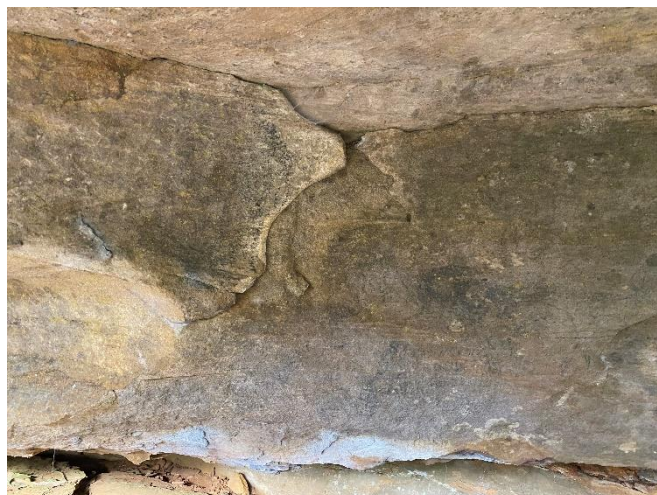
Photo 123: *Sandy Creek 21* showing no impacts to artwork following Longwall 19. Taken on 28/03/2023.

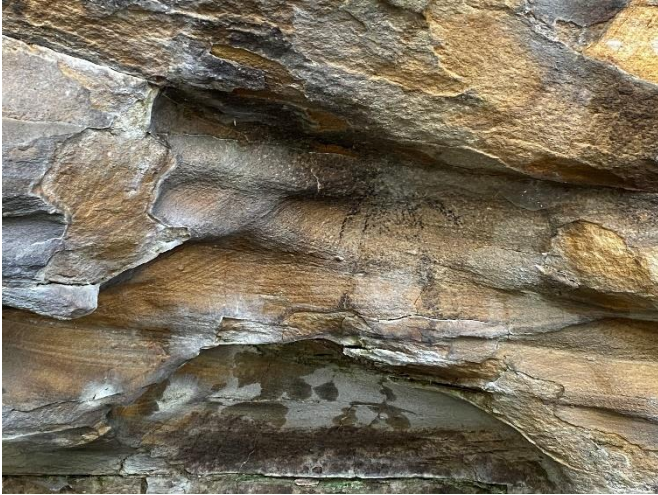
DA3A_LW19_038 is located 125m north of tributary WC14 and consists of rock fracturing with some smaller associated rockfalls (Figure 4). Fracture measurements were estimated due to limited site access. At the time of inspection, the fracture had an estimated length of 2m and a maximum width of 0.001m. The fracture extends vertically up from an existing horizontal fracture present in the baseline record. The rockfall at the site has an approximate volume of less than 0.1m³ (Photo 124 to Photo 127).

The site is registered Aboriginal Heritage site *DM15 (52–2–3639)*. The new hairline fracture runs through a part of the artwork and up to the ceiling of the overhang with a small rockfall. Baseline observations prior to mining included one pre-existing fracture through the art (Photo 128 and Photo 129). The impact was re-inspected on 11 May 2023 and no changes were observed. This will be addressed further in the Longwall 19 EoP Cultural Heritage Assessment.

DA3A_LW19_038 is a Level 2 trigger as per the Aboriginal Cultural Heritage Management Plan Longwall 19, Dendrobium Area 3A TARP, specifically:

Photo 124: DA3A_LW19_038, rock fracturing at artwork. Taken on 28/03/2023.

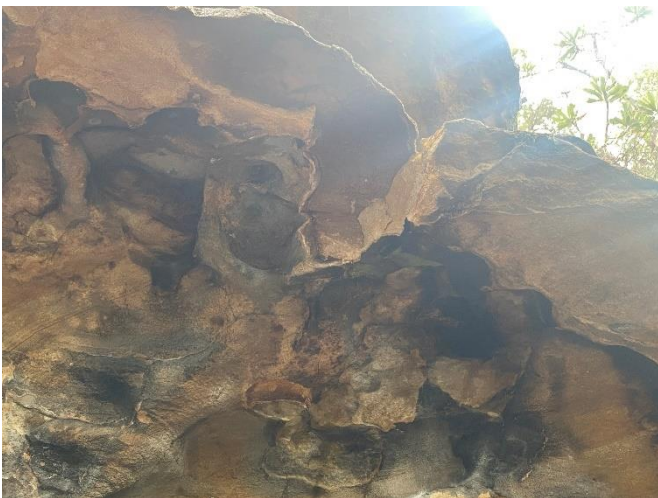
Photo 126: DA3A_LW19_038, section where rock fall occurred. Taken on 28/03/2023.

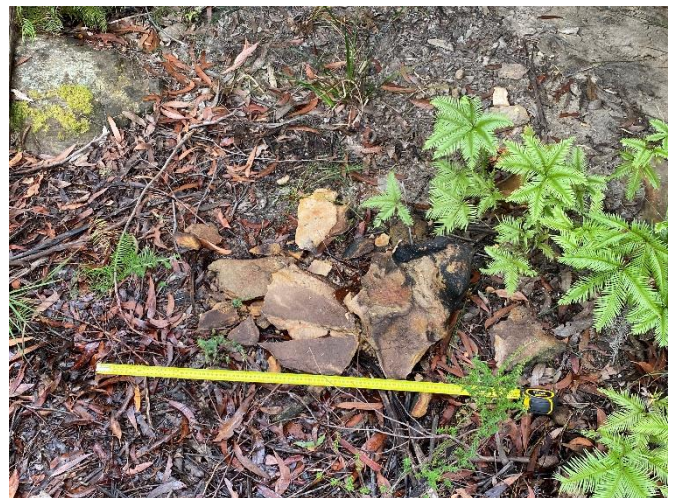
Photo 127: DA3A_LW19_038, rock fall on ground. Taken on 28/03/2023.

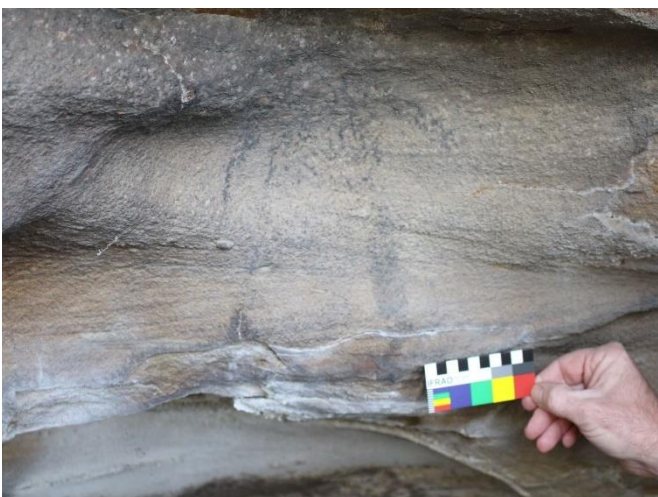
Photo 128: Art at DM15- baseline image displaying horizontal rock fracture identified prior to mining. Taken circa October 2020.

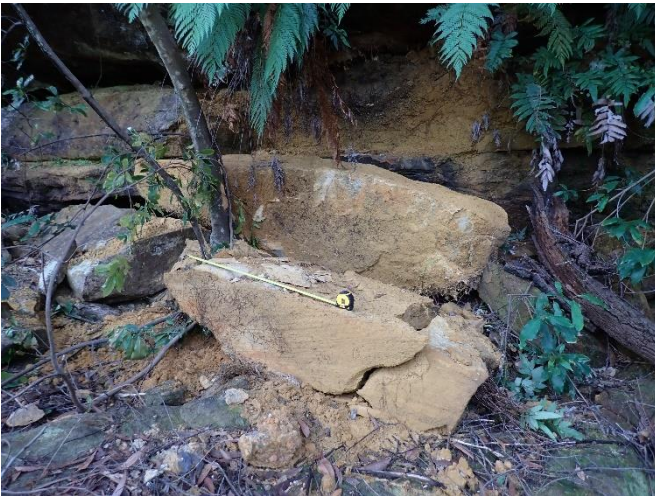
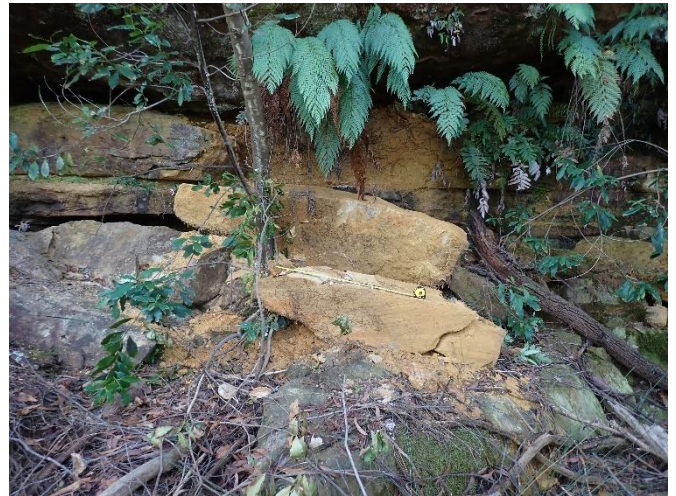
DA3A_LW19_039 is a Level 1 trigger as per the Dendrobium Area 3A Landscape TARP (Table 8), specifically:

- Rockfall from a cliff (step) which is left mostly intact (<10% length), resulting in insignificant ground disturbance.

Photo 130: *DA3A_LW19_039*, looking at the rockfall.
Taken 12/04/2023

Photo 131: *DA3A_LW19_039*, looking at the rockfall.
Taken 12/04/2023

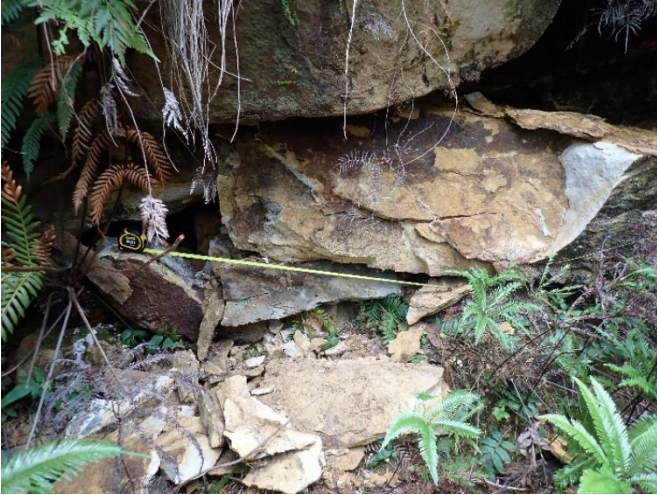
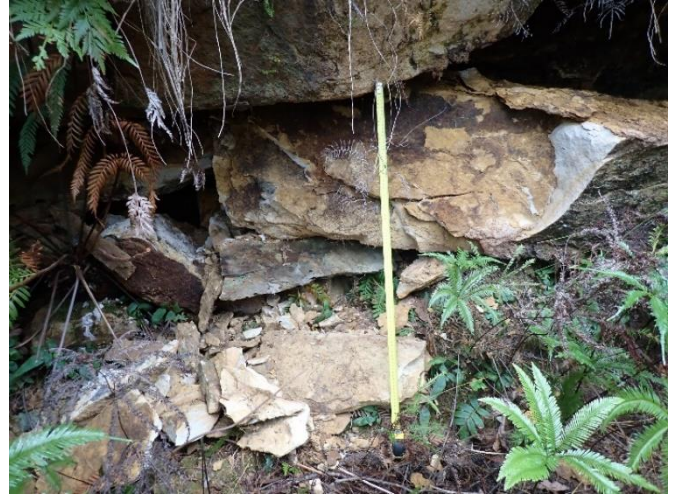
DA3A_LW19_040 consists of rockfalls and fragmentation at the base of a step, approximately 80m to the north of tributary *WC14* (Figure 4). The rockfall has an approximate rockfall volume of 0.3m³ with some rock fragments spread out in an area of approximately 1m² (Photo 132 and Photo 133). No follow up inspection was undertaken as the impact was identified following the completion of Longwall 19.

DA3A_LW19_040 is a Level 1 trigger as per the Dendrobium Area 3A Landscape TARP (Table 8), specifically:

- Rockfall from a cliff (step) which is left mostly intact (<10% length), resulting in insignificant ground disturbance.

Photo 132: DA3A_LW19_040, looking at rockfall and fragments. Taken 12/04/2023.

Photo 133: DA3A_LW19_040, looking at rockfall and fragments. Taken 12/04/2023.

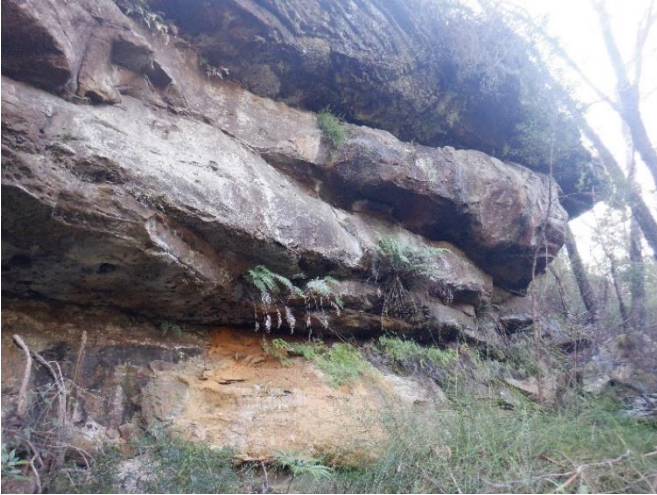
Photo 134: Baseline photo taken of *LW10_SS5* pre-mining. Taken 17/06/2022.

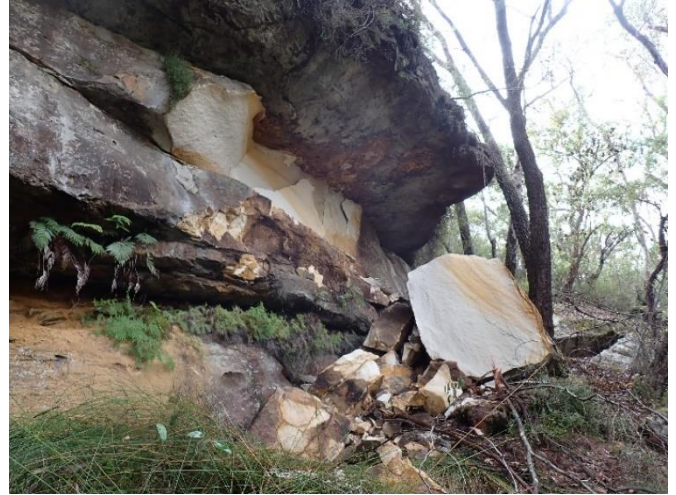
DA3A_LW19_041 consists of a rockfall that runs horizontally along landscape monitoring site LW19_SS5 (Figure 1 and Figure 4). Two large boulders have become dislodged with one boulder rolling downhill approximately 25m from the steep slope with associated ground disturbance over this distance and extending up to 8m wide (Photo 136 and Photo 137). A baseline photo is provided for pre-mining comparison (Photo 134). The largest boulder was measured with an approximate volume of less than 9m³ (Photo 137). The other slightly smaller boulder was unable to be measured due to safety concerns around the steep slope. The surface area where the boulders detached from the steep slope has an estimated area of 21m² (Photo 135). No follow up inspection was required as the impact was identified following the completion of Longwall 19.

DA3A_LW19_041 is a Level 2 trigger as per the Dendrobium Area 3A Landscape TARP (Table 8), specifically:

- Rock fall or overhang collapse at cliff (steep slope) site, where characteristics of the cliff (steep slope) have changed, and there has been significant ground disturbance.

Photo 135: *DA3A_LW19_041* looking at the rockfall at landscape site *LW19_SS5*. Taken 12/04/2023.

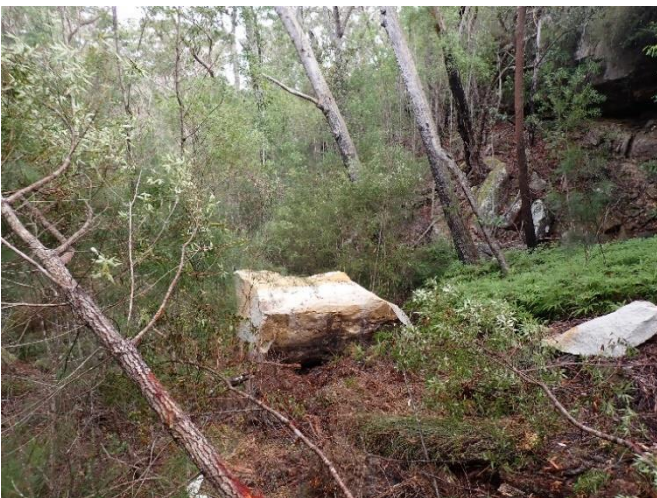
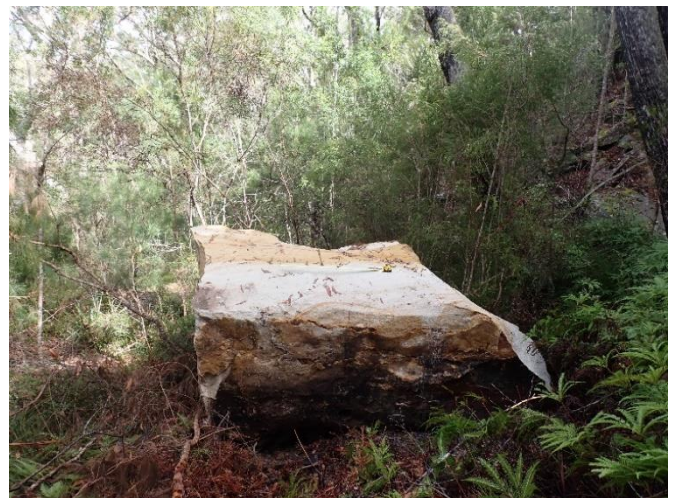
Photo 136: *DA3A_LW19_041* looking at boulder that has dislodged and rolled downhill from steep slope.

Photo 137: *DA3A_LW19_041* looking at boulder that has dislodged and rolled downhill from steep slope.

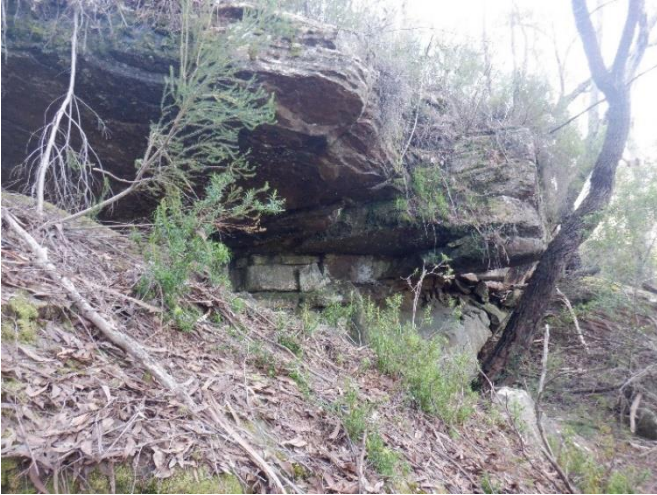
Photo 138: LW19_SS4 during its baseline inspection. Taken 17/06/2022.

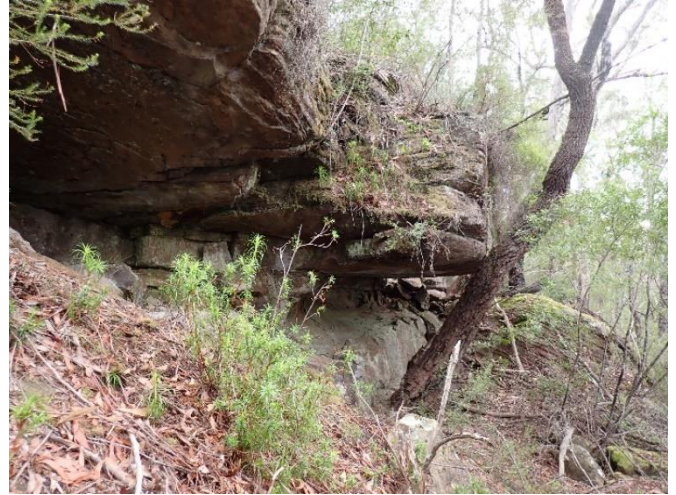
Photo 139: LW19_SS4 during its most recent inspection. Taken 12/04/2023.

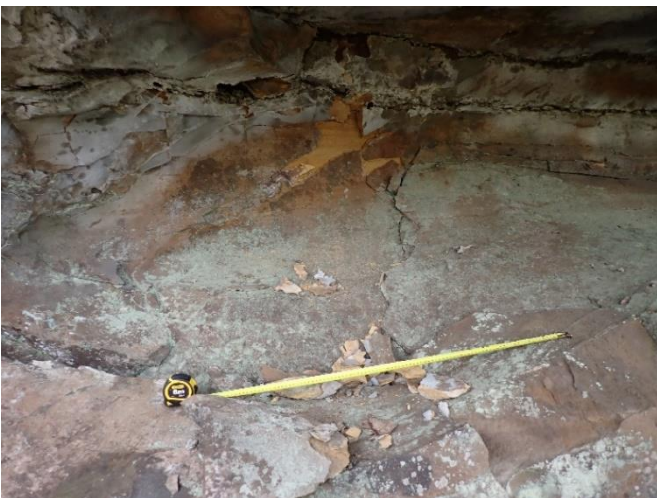
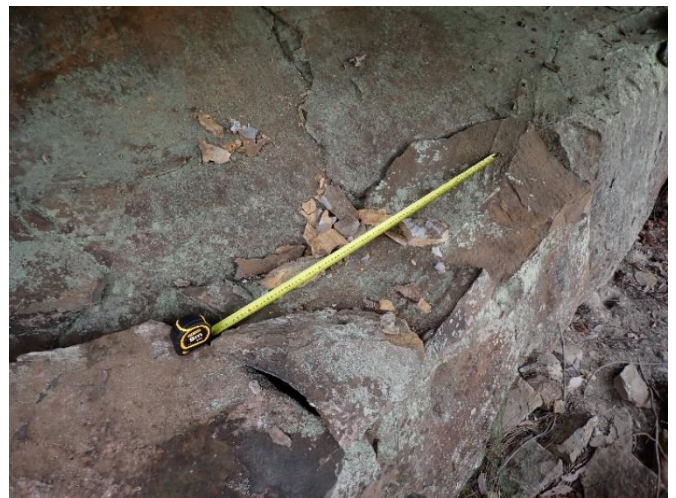
DA3A_LW19_042 consists of a very small rockfall/fragmentation from the ceiling and side of an overhang at landscape monitoring site *LW19_SS4* (Figure 1 and Figure 4). A baseline photo is included for a pre-mining comparison (Photo 138). The rockfall and fragments were estimated due to safety concerns. The rockfall has an estimated volume of less than 0.1m³, with fragments scattered below (Photo 139 to Photo 141). No follow up inspection was undertaken as the impact was identified following the completion of Longwall 19.

DA3A_LW19_042 is a Level 1 trigger as per the Dendrobium Area 3A Landscape TARP (Table 8), specifically:

- Rockfall from a cliff (step) which is left mostly intact (<10% length), resulting in insignificant ground disturbance.

Photo 140: DA3A_LW19_042 looking at rockfall and associated fragments. Taken 12/04/2023.

Photo 141: DA3A_LW19_042 looking at rockfall and associated fragments. Taken 12/04/2023.

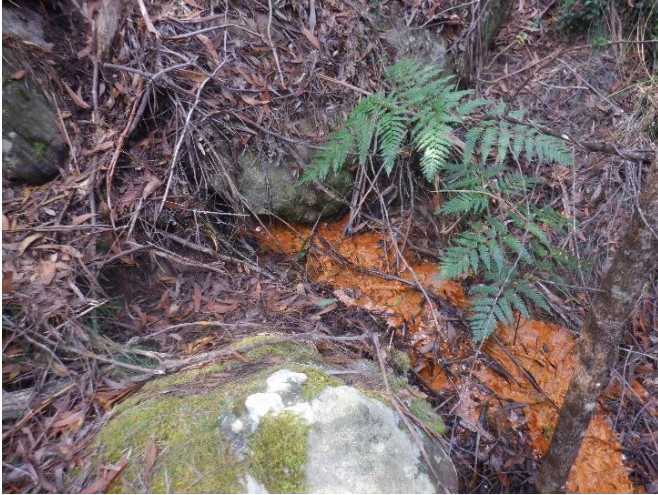
DA3A_LW19_044 is located approximately 15m east of *Wongawilli Creek* (Figure 4). The impact consists of iron staining which appears beneath a rock (Photo 142) and flows westward from DA3A mining area. The iron staining's extent is approximately 20m in length and does not flow into *Wongawilli Creek* (Photo 143). No follow up inspection was undertaken as the impact was identified following the completion of Longwall 19.

DA3A_LW19_044 is a Level 1 trigger as per the DA3A Watercourse Impact, Monitoring Management and Contingency Plan (Table 7), specifically:

- Observable increase in iron staining within the mining area

Photo 142: *DA3A_LW19_044*, looking at origin of iron staining beneath a rock. Taken 19/04/2023.

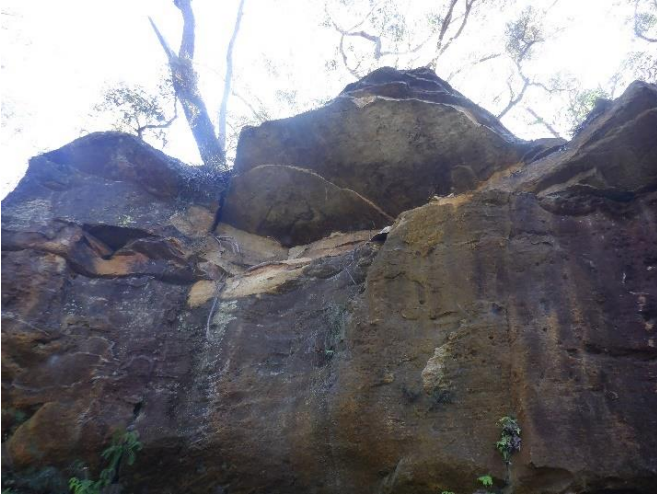
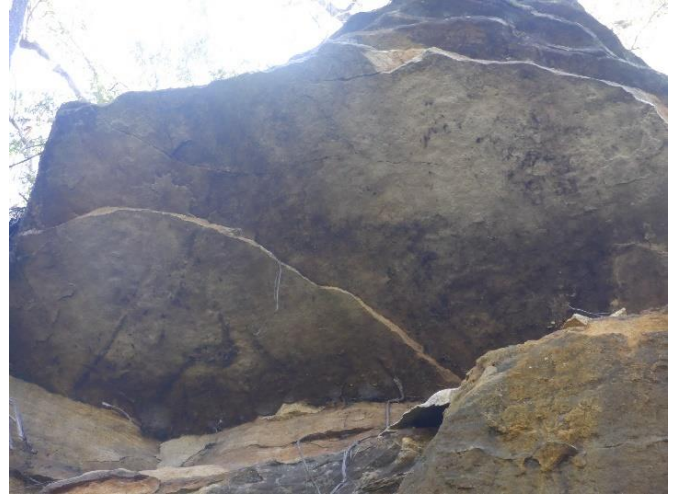
DA3A_LW19_046 is located approximately 390m west of *Fire Road 6F* (Figure 4). The impact consists of a rockfall on a steep slope/step. Several boulders have become dislodged from the steep slope/step face with an approximate debris area of 7m² (Photo 144 to Photo 146). The boulders that detached have a total combined rockfall volume of approximately 10m³. The impact site has minimal impact to vegetation or ground disturbance. No follow up inspection was required as the impact was identified following the completion of Longwall 19.

DA3A_LW19_046 is a Level 1 trigger as per the Dendrobium Area 3A Landscape TARP (Table 8), specifically:

Photo 144: DA3A_LW19_046, showing steep slope/ step face where rocks detached. Taken on 27/04/2023.

Photo 145: DA3A_LW19_046, showing steep slope/ step face where rocks detached. Taken on 27/04/2023.

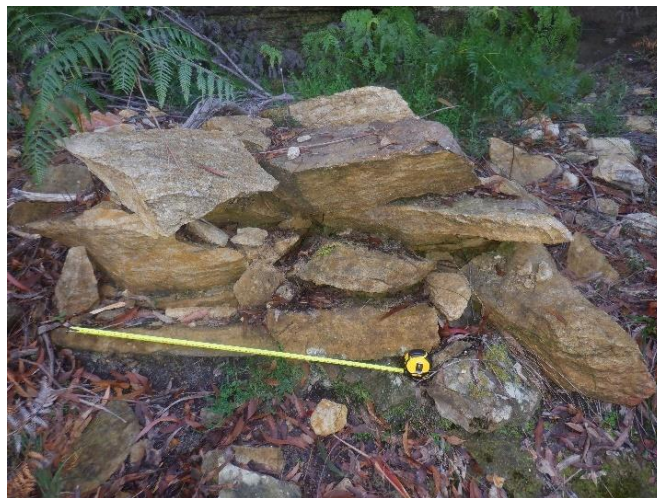
Photo 146: DA3A_LW19_046, showing debris area. Taken on 27/04/2023.

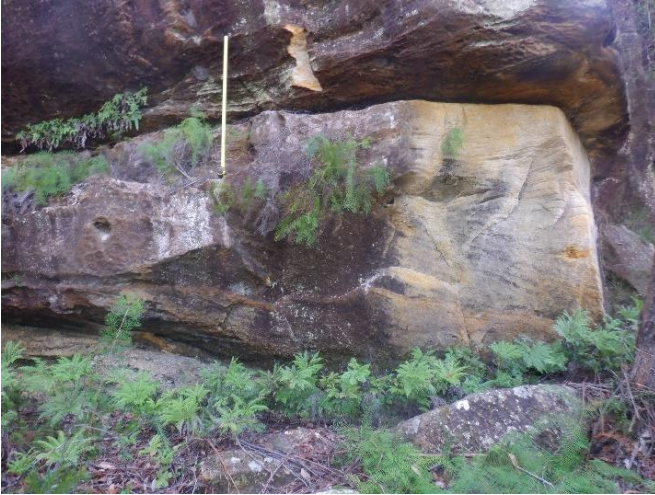
DA3A_LW19_047 is located approximately 460m to the north of WC14, a tributary to *Wongawilli Creek* (Figure 4). The impact consists of a rockfall on a steep slope/step. The largest rock segment that has detached from the slope face has an approximate rockfall volume of less than 0.1m³ (Photo 147) and a debris area of 0.7m² (Photo 148). The impact site has very minimal impact to vegetation or ground disturbance. No follow up inspection was required as the impact was identified following the completion of Longwall 19.

DA3A_LW19_047 is a Level 1 trigger as per the Dendrobium Area 3A Landscape TARP (Table 8), specifically:

Photo 147: DA3A_LW19_047, showing steep slope/ step where rock has detached from rock face. Taken on 27/04/2023.

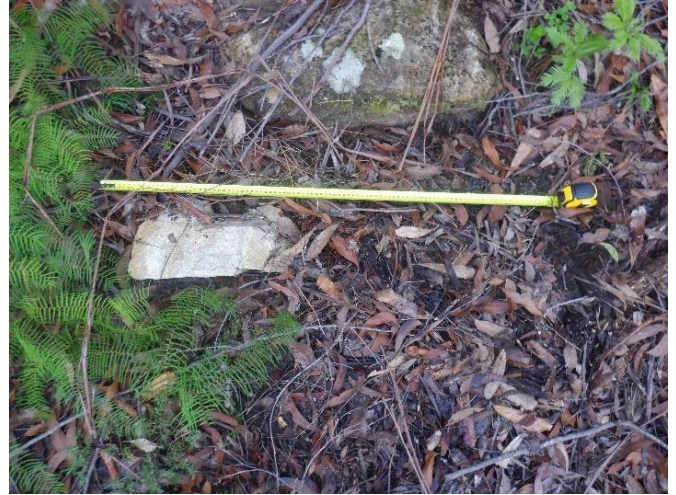
Photo 148: DA3A_LW19_047, showing debris area. Taken on 27/04/2023.

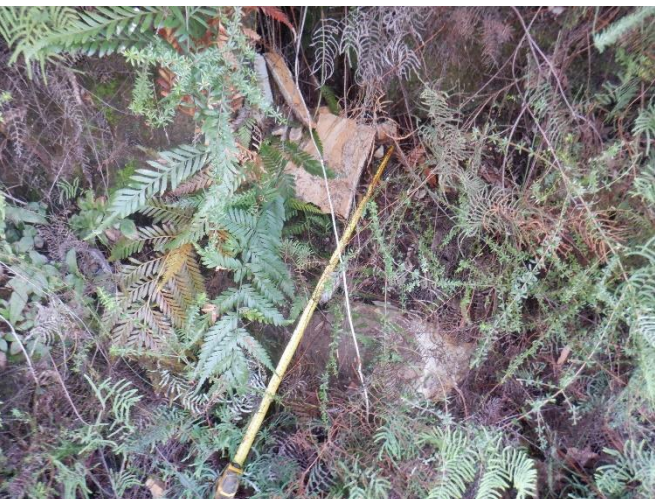
DA3A_LW19_052 is located approximately 40m to the north of WC14, a tributary to Wongawilli Creek (Figure 4). The impact consists of rock fracturing along a steep slope with a small associated rockfall. The fracturing has a maximum continuous length of 3m, and a maximum width of 0.01m (Photo 150). The associated rockfall has a volume of less than 0.1m³ (Photo 149).

DA3A_LW19_052 is a Level 1 trigger as per the Dendrobium Area 3A Landscape TARP (Table 8), specifically:

Photo 149: DA3A_LW19_052, showing area of rockfall. Taken on 4/5/2023.

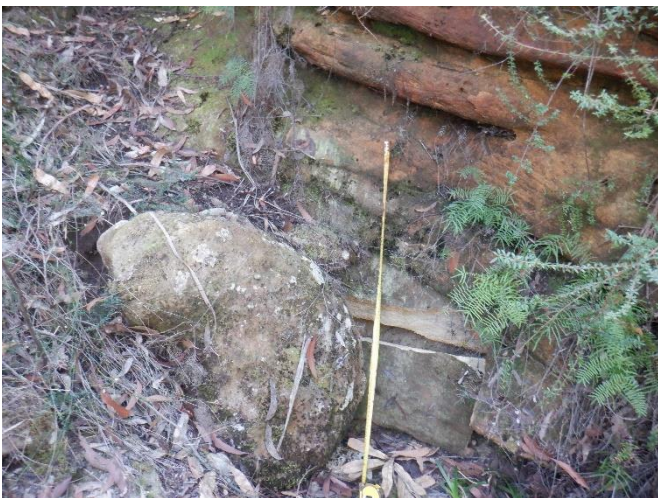
DA3A_LW19_053 is located approximately 155m to the north of tributary WC14 (Figure 4). The impact consists of rock fracturing and associated rockfall along the base of a step. The rock fracturing has a maximum continuous length of 0.35m and a maximum width of 0.001m wide (Photo 152). The rockfall has an approximate volume of 0.3m³ (Photo 151). No follow up inspection was undertaken as the impact was identified following the completion of Longwall 19.

DA3A_LW19_053 is a Level 1 trigger as per the Dendrobium Area 3A Landscape TARP (Table 8), specifically:

Photo 151: DA3A_LW19_053, showing area of rockfall. Taken on 4/5/2023.

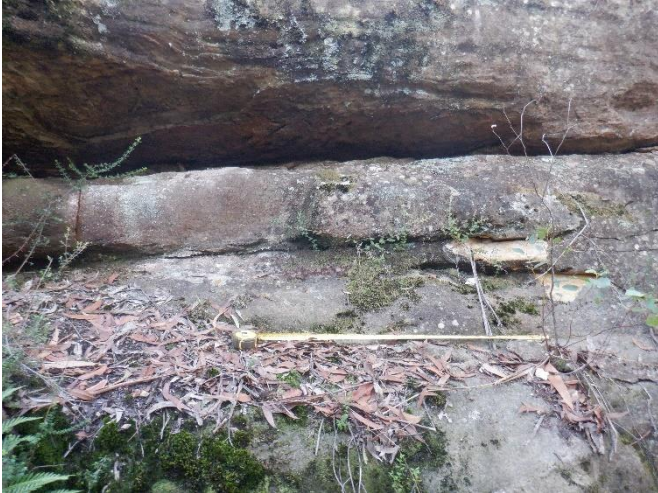
DA3A_LW19_054 is located 365m to the west of Fire Road 6F (Figure 4). The impact consists of rock fracturing and associated fragmentation. The rock fracturing has a maximum continuous length of 3.4m and a maximum width of 0.01m (Photo 153 and Photo 154). The largest rock fragment has a volume of less than 0.1m³ (Photo 154). No follow up inspection was required as the impact was identified following the completion of Longwall 19.

DA3A_LW19_054 is a Level 1 trigger as per the Dendrobium Area 3A Landscape TARP (Table 8), specifically:

Photo 153: DA3A_LW19_054, showing rock fracturing and fragmentation. Taken on 4/5/2023.

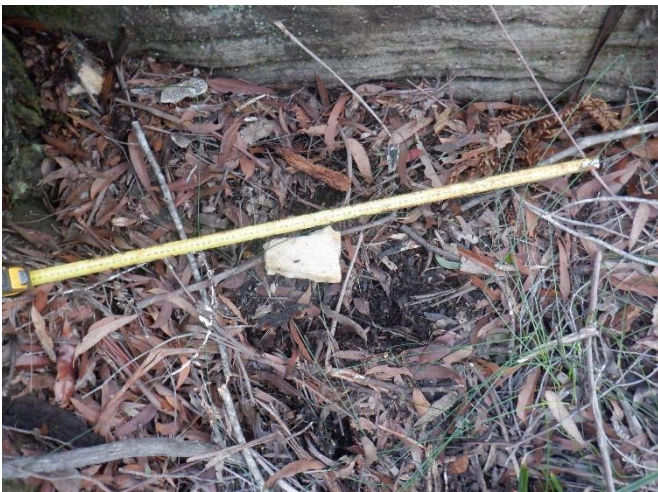
DA3A_LW19_055 is located approximately 150m to the north of tributary WC14 (Figure 4). The impact consists of rock fracturing and a small rockfall beneath an overhang of a steep slope. Rock fracturing beneath the overhang has a maximum continuous length of 1.2m, a maximum width of 0.003m and a maximum measurable depth of 0.58m (Photo 156). The rockfall has an approximate volume of less than 0.01m³ (Photo 155). No follow up inspection was undertaken as the impact was identified following the completion of Longwall 19.

DA3A_LW19_055 is a Level 1 trigger as per the Dendrobium Area 3A Landscape TARP (Table 8), specifically:

Photo 155: DA3A_LW19_055, showing area of rockfall. Taken on 4/5/2023.

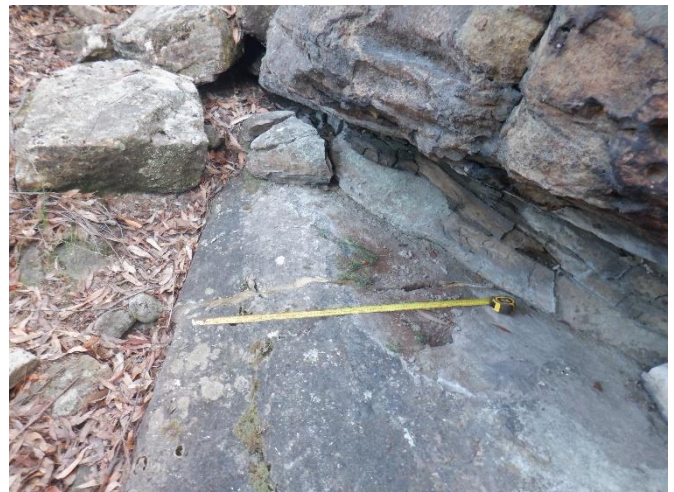
Photo 156: DA3A_LW19_055, showing rock fracturing. Taken on 4/5/2023.

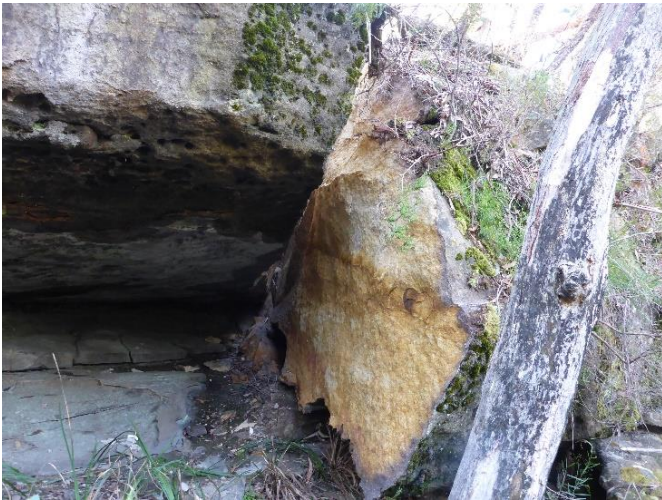
DA3A_LW19_056 is located 160m to the north of tributary WC14 (Figure 4). The impact consists of rock fracturing and rockfall/ block movement on a step/ overhang. The rock fracture has a maximum continuous length of 17.5m. The large section of rock that has detached from the adjacent ground has an estimated volume of 110m³ (Photo 157). There are multiple fractures under the overhang estimated to be up to 1.5m in length with widths up to 0.05m. There are also three rock fractures on the outcrop above the overhang, up to 0.15m in length and a width up to 0.04m (Photo 158). The impact site has minimal downslope vegetation disturbance. The immediate area around the impact was flagged with marking tape as a safety precaution. No follow up inspection was undertaken as the impact was identified following the completion of Longwall 19.

DA3A_LW19_056 is a Level 2 trigger as per the Dendrobium Area 3A Landscape TARP (Table 7), specifically:

- Rock fall or overhang collapse at a cliff (step) site, where characteristics of the cliff (step) have changed.
- Crack or fracture between 10 and 50m length.

Photo 157: DA3A_LW19_056, showing step/overhang that detached. Taken on 5/05/2023.

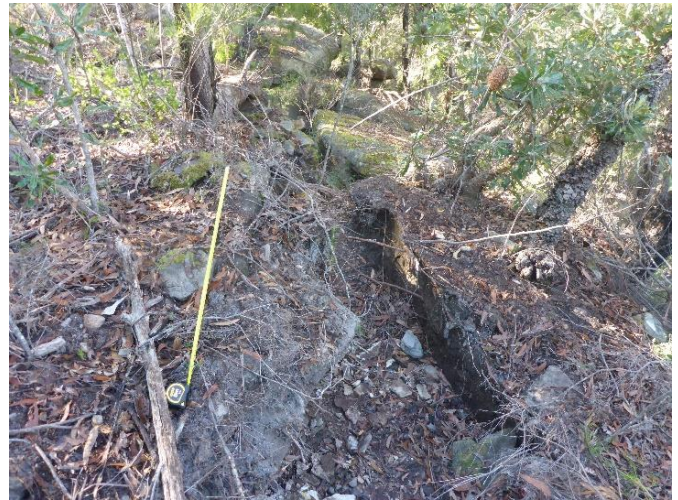
Photo 158: DA3A_LW19_056, showing top view of block that have moved away from the adjacent ground. Taken on 5/05/2023.

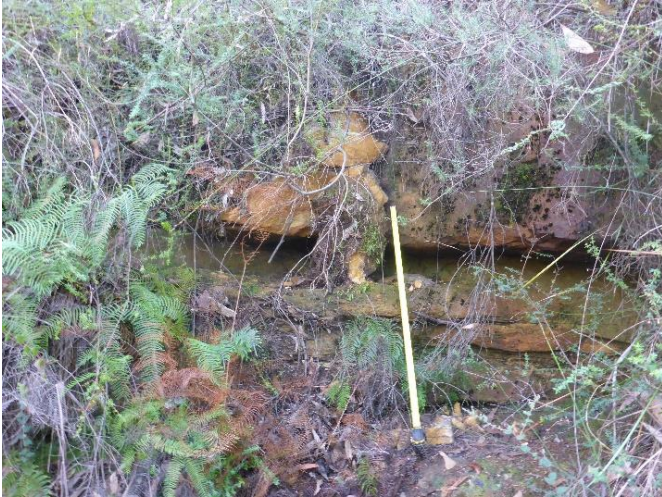
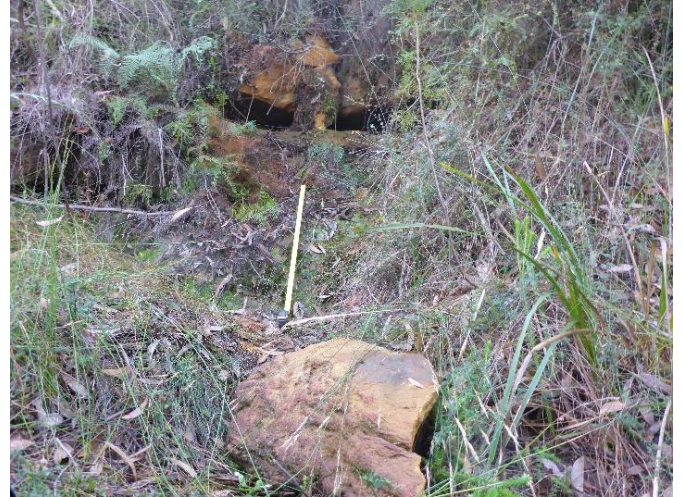
DA3A_LW19_057 is a Level 1 trigger as per the Dendrobium Area 3A Landscape TARP (Table 8), specifically:

Photo 159: DA3A_LW19_057, showing step where rocks detached. Taken on 5/05/2023.

Photo 160: DA3A_LW19_057, showing step where rocks detached and debris area. Taken on 5/05/2023.

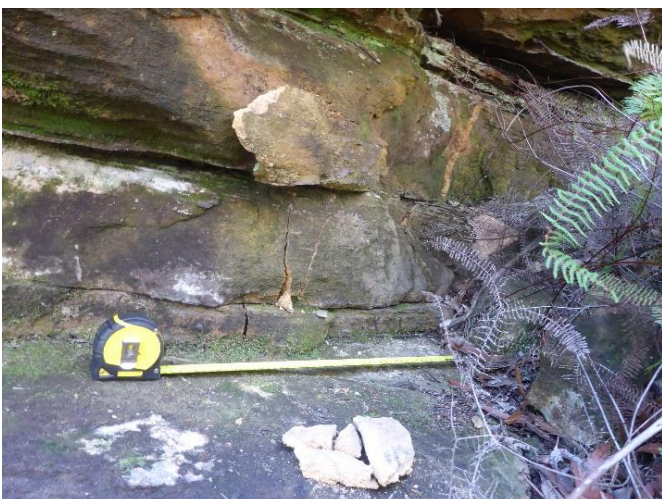
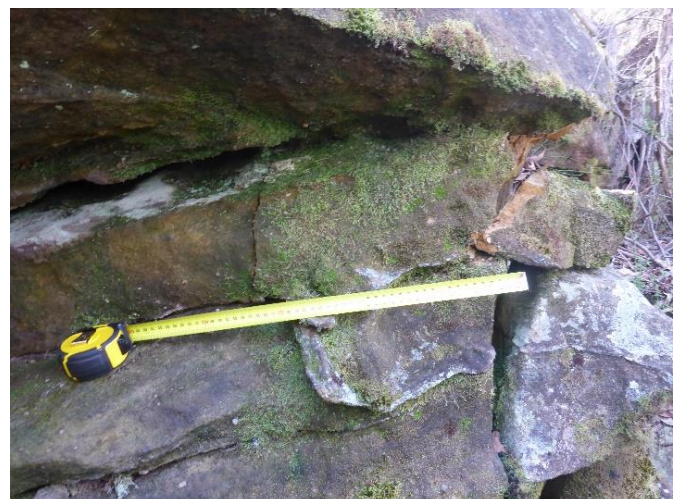
DA3A_LW19_058 is located 190m to the north of tributary WC14 (Figure 4). The impact consists of a series of small fractures to a rock outcrop (Photo 161). The maximum continuous length of the fractures is 0.26m while the maximum width is 0.015m (Photo 162). The impact also contained a small rockfall which with total volume less than 0.01m³ (Photo 162). No follow up inspection was required as the impact was identified following the completion of Longwall 19.

DA3A_LW19_058 is a Level 1 trigger as per the Dendrobium Area 3A Landscape TARP (Table 8), specifically:

Photo 161: DA3A_LW19_058, showing step where rock has detached from rock face. Taken on 5/05/2023. Note: Tape measure is set to 0.5m in length.

Photo 162: DA3A_LW19_058, showing step where rock has detached from rock face. Taken on 5/05/2023. Note: Tape measure is set to 0.5m in length.

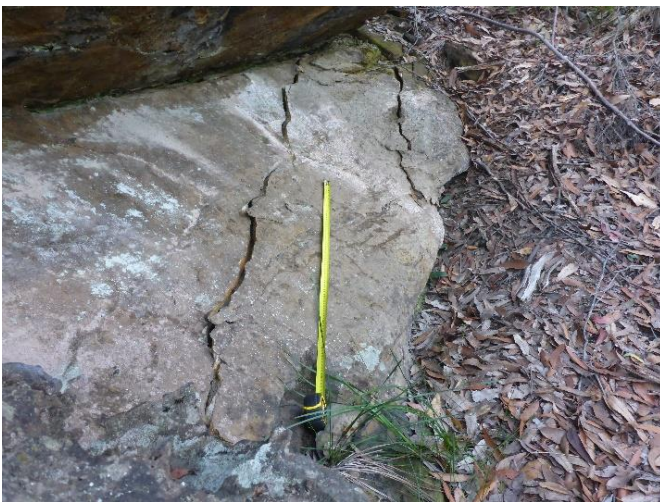
DA3A_LW19_059 is located 225m to the north of tributary *WC14* (Figure 4). The impact consists of two rock fractures beneath a small overhang. The largest fracture has a maximum continuous length of 2.34m, a maximum width of 0.03m and a maximum measurable depth of 0.15m (Photo 163). The fractures resulted in a small rockfall less than 0.01m³ in volume (Photo 164). No follow up inspection was undertaken as the impact was identified following the completion of Longwall 19.

DA3A_LW19_059 is a Level 1 trigger as per the Dendrobium Area 3A Landscape TARP (Table 8), specifically:

Photo 163: *DA3A_LW19_059*, showing rock fracturing. Taken on 5/05/2023.

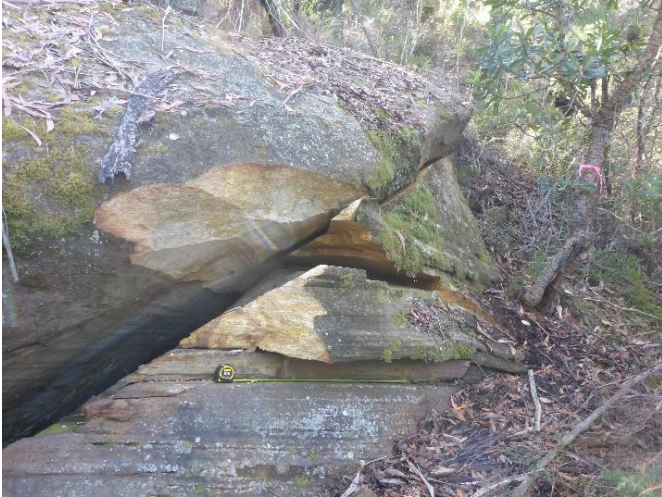
DA3A_LW19_060 is located 235m to the north of tributary *WC14* (Figure 4). The impact consists of a rock fracture, displacement and rockfall on a step/outcrop (Photo 165 to Photo 167). The rock fracture has a maximum continuous length of 3.26m and a maximum width of 0.04m. The displacement along the outcrop measured 3.43m in length (Photo 166). The total volume of the rockfall is approximately 0.7m³ (Photo 167). No follow up inspection was undertaken as the impact was identified following the completion of Longwall 19.

DA3A_LW19_060 is a Level 1 trigger as per the Dendrobium Area 3A Landscape TARP (Table 8), specifically:

Photo 165: DA3A_LW19_060, showing extent of rock fracture and rockfall. Taken on 5/05/2023.

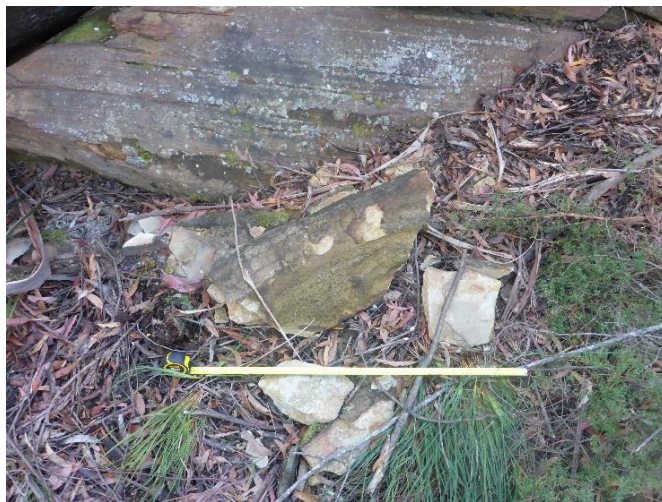
Photo 167: DA3A_LW19_060, showing rockfall. Taken on 5/05/2023

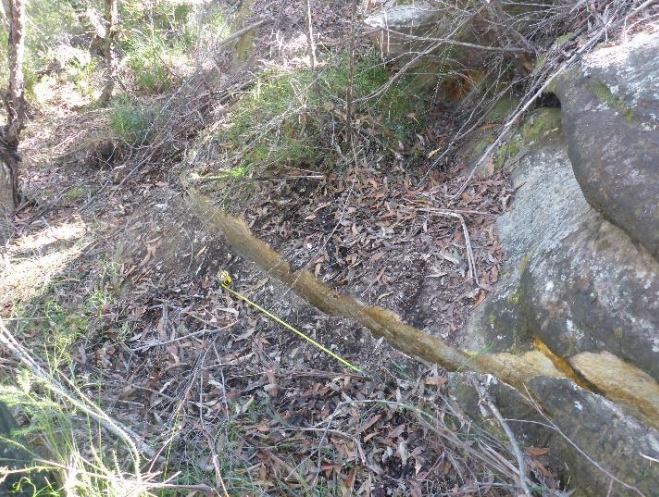
DA3A_LW19_061 is located 265m to the north of tributary WC14 (Figure 4). The impact consists of a rock fracture on a step/outcrop and associated soil cracking. The rock fracture has a total continuous length of 5.6m, a maximum width of 0.14m and a maximum measurable depth of 1.16m (Photo 168). The soil cracking has a total continuous length of 9.5m, a maximum width of 0.13m and a maximum measurable depth of 0.5m (Photo 169). No follow up inspection was undertaken as the impact was identified following the completion of Longwall 19.

DA3A_LW19_061 is a Level 2 trigger as per the Dendrobium Area 3A Landscape TARP (Table 8), specifically:

- Crack or fracture between 100mm and 300mm width.

Photo 168: DA3A_LW19_061, showing extent of rock fracture. Taken on 05/05/2023.

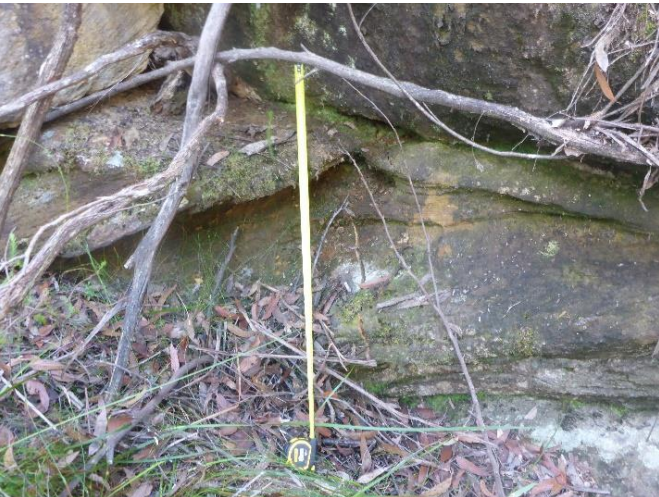
DA3A_LW19_062 is located 200m to the north of WC14, a tributary to Wongawilli Creek (Figure 4). The impact consists of multiple rock fractures on the face of a rock outcrop. The largest continuous length of the fractures is 0.60m while the largest width is 0.01m (Photo 170 and Photo 171). No follow up inspection was undertaken as the impact was identified following the completion of Longwall 19.

DA3A_LW19_062 is a Level 1 trigger as per the Dendrobium Area 3A Landscape TARP (Table 8), specifically:

- Crack or fracture up to 100mm width;
- Crack or fracture up to 10m length;

Photo 170: DA3A_LW19_062, showing extent of rock fracture. Taken on 05/05/2023.
