END OF PANEL
LANDSCAPE REPORT
DENDROBIUM AREA 3A

DENDROBIUM AREA 3A
LONGWALL 19 END OF PANEL
LANDSCAPE REPORT
JUNE 2023

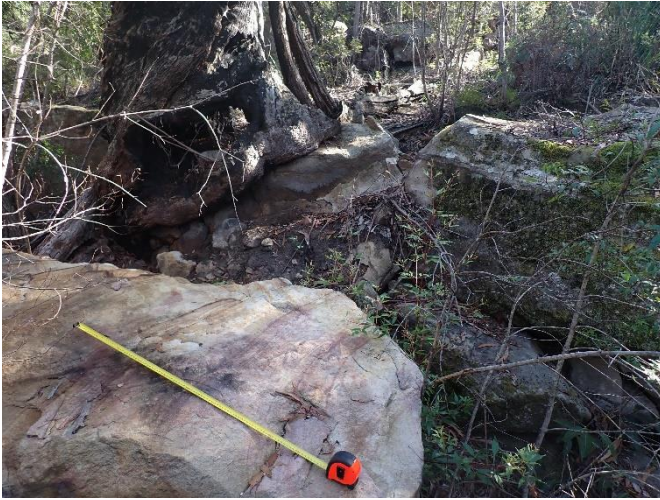
DA3A_LW19_063 is located 150m to the east of Fire Road 6F (Figure 3). The impact consists of rock movement from a steep slope where a boulder has shifted downslope, with associated fragmentation (Photo 172 and Photo

DA3A_LW19_063 is a Level 1 trigger as per the Dendrobium Area 3A Landscape TARP (Table 8), specifically:

- Surface movement or rock displacement with negligible soil surface exposed

Photo 172: DA3A_LW19_063, showing rock movement site. Taken on 10/05/2023.

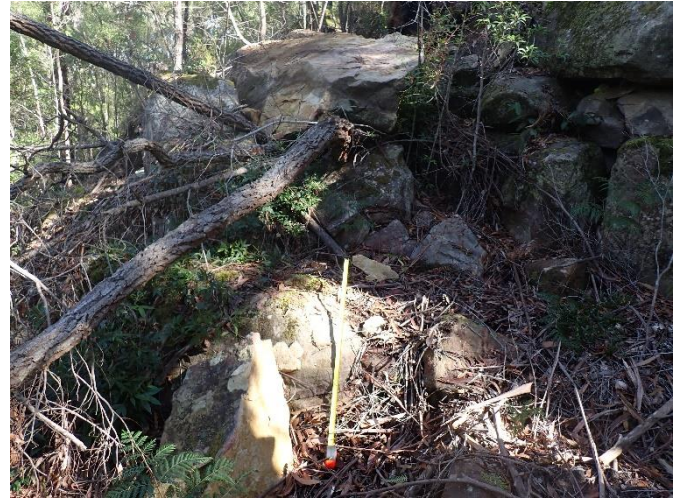
Photo 173: DA3A_LW19_063, showing associated rock fragmentation. Taken on 10/05/2023.

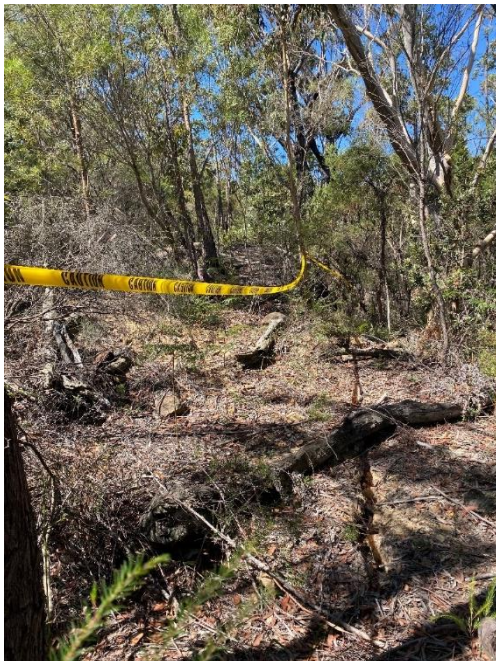
DA3A_LW19_035 consists of soil cracking and rock displacement to a closed vehicle access track and surrounding bushland west of Fire Road 6F (Figure 4). The site is situated near Landscape monitoring site LW19_AT1 (Figure 1). The soil cracking extends across a closed vehicle access track where it continues into the bushland causing rock displacement. The impact has a discontinuous length of 18m, a maximum continuous length of 15 m, a maximum width of 0.10m and a maximum measurable depth of 2.29m (Photo 176 to Photo 179). Caution tape barricading is in place at the site

Photo 178: DA3A_LW19_035, overview of the impact. Taken on 16/03/2023.

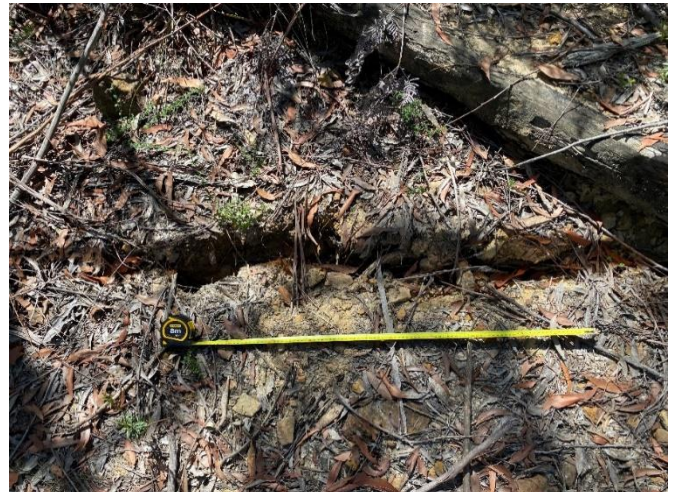
Photo 179: DA3A_LW19_035, section of soil cracking. Taken on 16/03/2023.

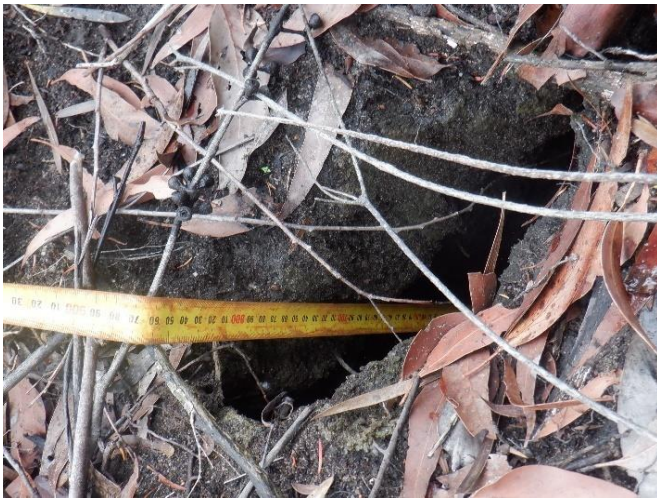
DA3A_LW19_036 is located 480m north of Longwall 19 and consists of soil cracking on closed access track adjacent to watercourse WC17 (Figure 4). Due to the nature and location of the soil crack it is likely historic and occurred during extraction of Longwall 7. The soil crack has a maximum length of 0.65m, a maximum width of 0.07m, and a maximum measurable depth of 0.79m (Photo 180 and Photo 181). A follow up inspection was undertaken on 11 May 2023 and no changes were observed.

DA3A_LW19_036 is a Level 1 trigger as per the Dendrobium Area 3A Landscape TARP (Table 8), specifically:

- Crack or fracture up to 100mm width;
- Crack or fracture up to 10m length.

Photo 180: DA3A_LW19_036, soil cracking. Taken on 21/03/2023.

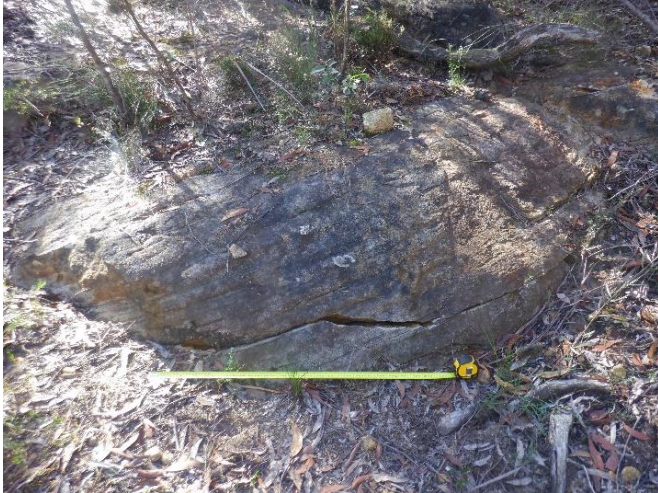
DA3A_LW19_048 is located approximately 280m west of Fire Road 6F (Figure 4). The impact consists of rock fracturing and rock movement along a closed access track. The rock fracture has a maximum continuous length of 3.1m, a maximum width of 0.045m and a maximum measurable depth of 0.265m (Photo 182 to Photo 183). The rock movement presents a gap between soil and rock that's approximately 0.035m wide (Photo 184). The rock fracture has no impact to the access track. No follow up inspection was required as the impact was identified following the completion of Longwall 19.

DA3A_LW19_048 is a Level 1 trigger as per the Dendrobium Area 3A Landscape TARP (Table 8), specifically:

- Crack or fracture up to 100mm width;
- Crack or fracture up to 10m length;

Photo 182: DA3A_LW19_048, showing rock fracturing. Taken on 27/04/2023.

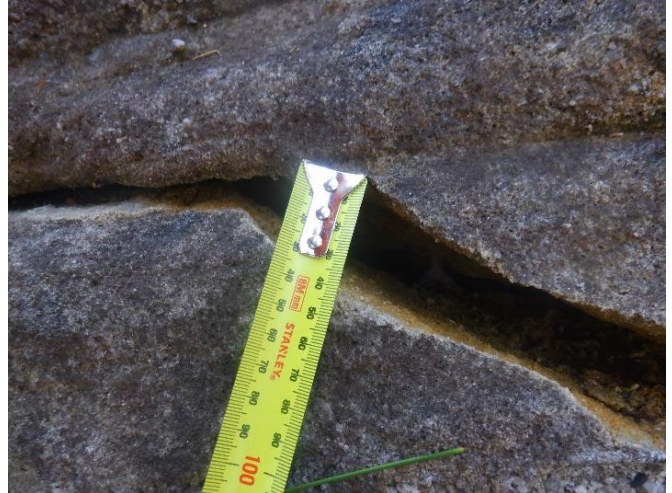
Photo 183: DA3A_LW19_048, showing width of rock fracture. Taken on 27/04/2023.

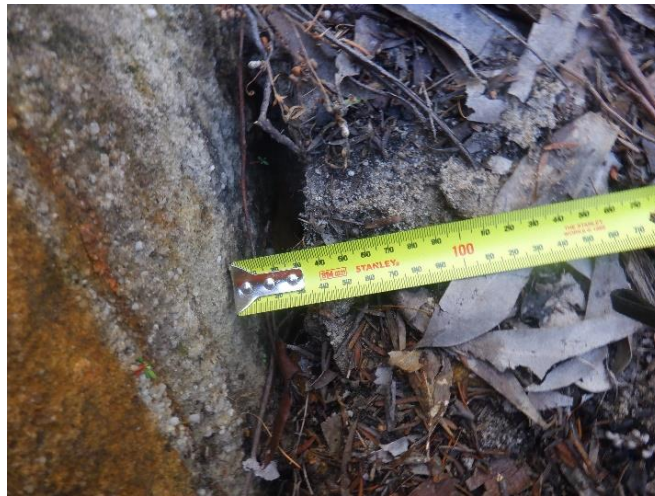
Photo 184: DA3A_LW19_048, showing rock movement. Taken on 27/04/2023.

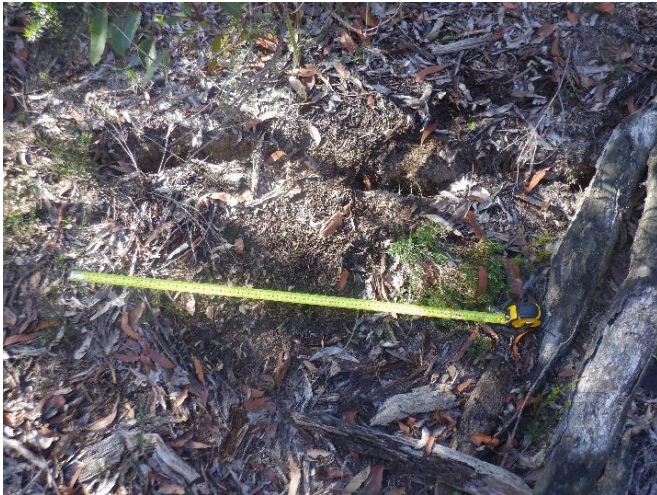
DA3A_LW19_049 is located approximately 260m west of *Fire Road 6F* (Figure 4). The impact consists of soil cracking along a closed access track. The soil crack has a total discontinuous length of 9.9m, a maximum continuous length of 3.1m, a maximum width of 0.08m and a maximum measurable depth of 0.9m (Photo 185 and Photo 186). Flagging tape was put along the access track as a safety precaution. No follow up inspection was undertaken as the impact was identified following the completion of Longwall 19.

DA3A_LW19_049 is a Level 1 trigger as per the Dendrobium Area 3A Landscape TARP (Table 8), specifically:

- Crack or fracture up to 100mm width;
- Crack or fracture up to 10m length;

Photo 185: DA3A_LW19_049, showing extent of soil crack.
Taken on 27/04/2023.

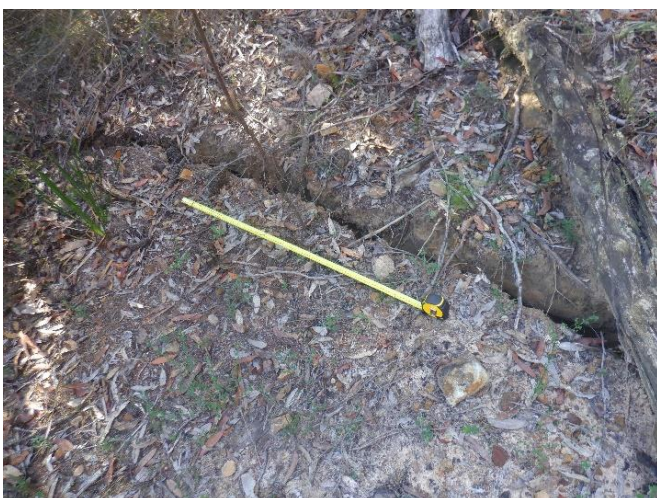
DA3A_LW19_050 is located approximately 230m west of *Fire Road 6F* (Figure 4). The impact consists of soil cracking along a closed access track. The soil crack has a total discontinuous length of 6.3m, a maximum continuous length of 2.9m, a maximum width of 0.15m and a maximum measurable depth of 0.63m (Photo 187 and Photo 188). Flagging tape was put along the access track as a safety precaution. No follow up inspection was required as the impact was identified following the completion of Longwall 19.

DA3A_LW19_050 is a Level 2 trigger as per the Dendrobium Area 3A Landscape TARP (Table 8), specifically:

- Crack or fracture between 100mm and 300mm width;
- Crack or fracture between 10m and 50m length;

Photo 187: DA3A_LW19_050, showing extent of soil crack.
Taken on 27/04/2023.
