Monitoring of watercourses, swamps and landscape features is undertaken to identify subsidence impacts. These features are monitored by the Illawarra Metallurgical Coal Environmental Field Team (IMCEFT) on a monthly basis prior to mining and weekly during mining. Monitoring is conducted in accordance with the approved Subsidence Management Plan (SMP) for Dendrobium Area 3A (DA3A). Extraction of Longwall 19 commenced 20 June 2022 and as of 2 August 2022 had progressed approximately 284m. During a recent inspection, two new subsidence impacts were identified.

**DA3A\_LW19\_001 (E 292826, N6192225)**

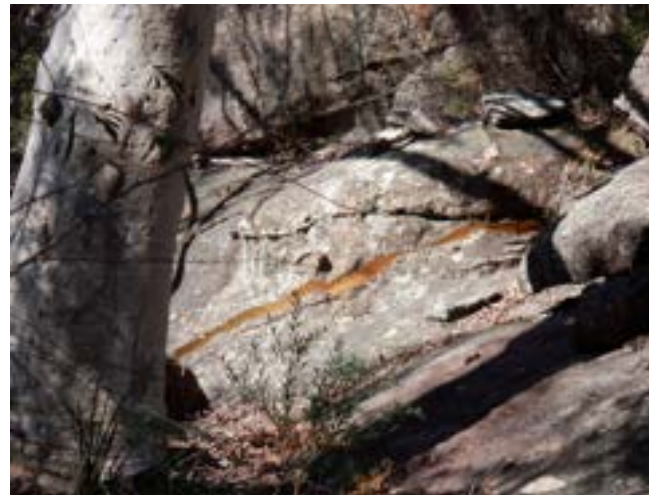
DA3A\_LW19\_002 is located on a steep slope/ step east of Fire Road 6F (Figure 1). The impact was identified on 3 August 2022, consisting of two rock fractures approximately 10m apart. The rock fracturing has an approximate maximum length of 4m and a maximum width of less than 0.1m (Photo 2 to Photo 4). Measurements have been estimated due to safety concerns.

Photo 3: DA3A\_LW19\_002, showing a section of rock fracturing. Taken 3/08/2022.

- Continue monitoring program as required in the DA3B SMP.
- Report impacts to key stakeholders (Biodiversity and Conservation Division; WaterNSW; NSW Resources Regulator; Regional NSW – Mining, Exploration and Geoscience)
- Summarise impacts and report in the End of Panel Report and Annual Review.

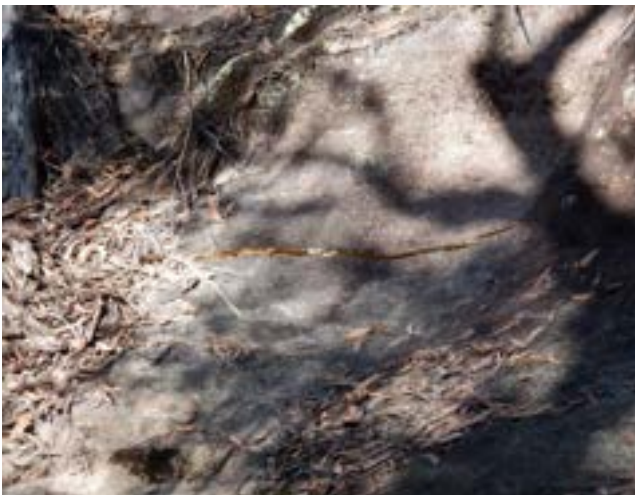
Photo 4: DA3A\_LW19\_002, showing a section of rock fracturing. Taken 3/08/2022.

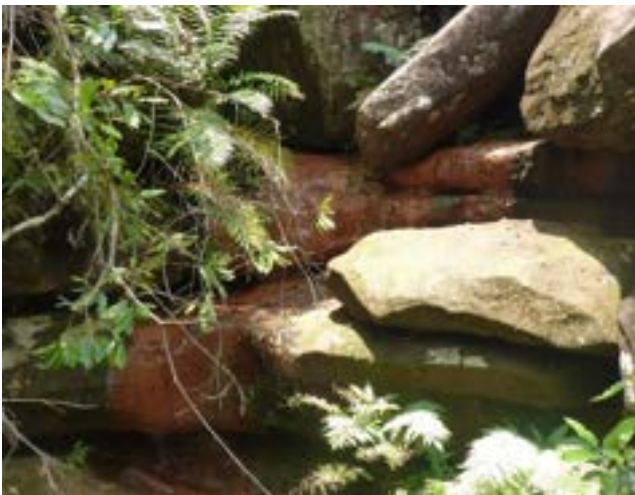
Photo 7: WC14\_Boulderfield 1, looking at a section of iron staining. Taken on 17/12/2019.

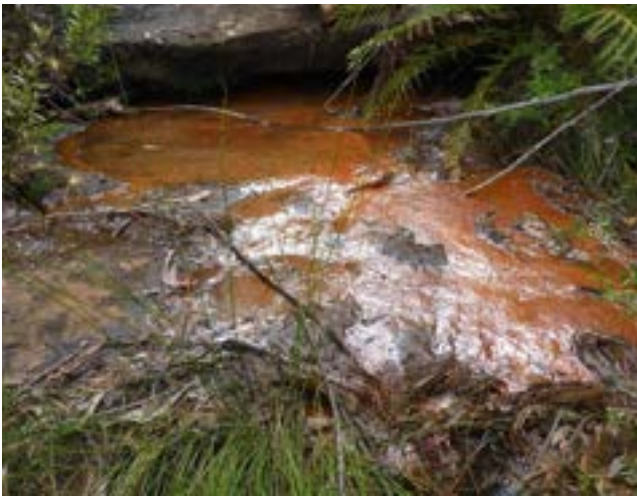
Photo 11: WC14\_Rockbar 3, looking upstream. Taken on 28/01/2020.

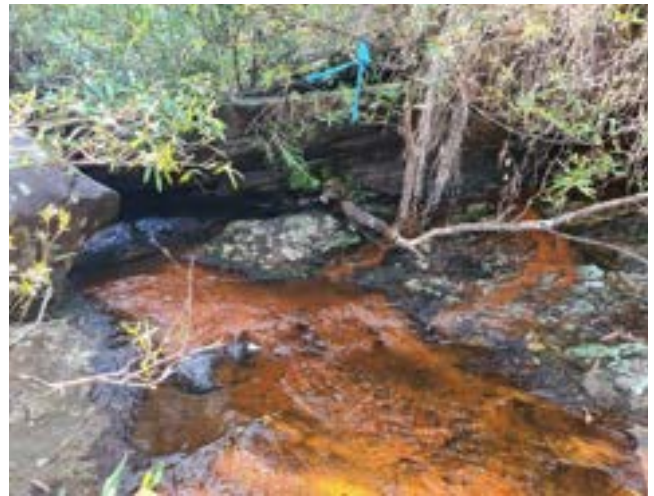
WC14 is a tributary of Wongawilli Creek, that flows westward from DA3A mining operations (Figure 1). Rock fracturing and iron staining on WC14 was previously identified and reported in January 2020, however likely occurred during the extraction of Longwall 8. During recent inspections of WC14, an increase in the extent of the iron staining was observed between WC14\_Pool 10 and the confluence of WC14 and Wongawilli Creek (Photo 1 to Photo 12). Iron staining was not evident in Wongawilli Creek (Photo 4). Isolated sections of iron staining were evident upstream between WC14\_Pool 10 and WC14\_Step 3. Similar observations were recorded during baseline mapping in 2020 (Photo 13 and Photo 14). No iron was observed upstream of WC14\_Step 3 (Photo 15 and Photo 16).

Photo 12: WC14\_Rockbar 3, looking upstream. Taken on 16/08/2022.

- Continue monitoring program as required in the DA3A SMP;
- Report impacts to key stakeholders;
- Summarise impacts and report in the End of Panel Report;
- Review monitoring frequency;
- Submit letter report to DPE, Resources Regulator and Water NSW and seek advice on any CMA required;
- Implement agreed CMAs as approved (subject to agency feedback).

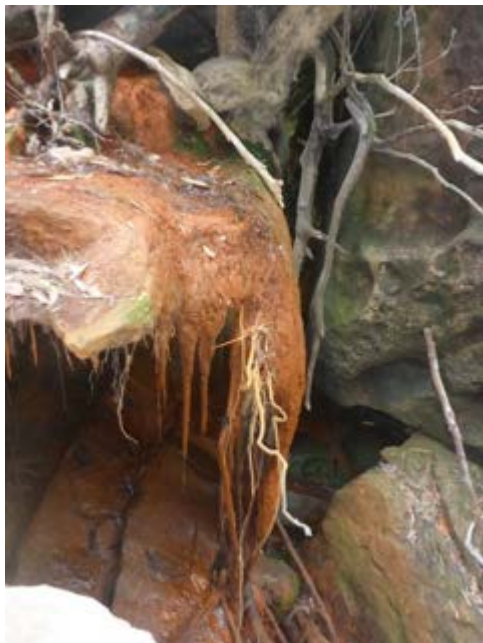
Photo 13: WC14\_Step 3, looking at the iron staining. Taken on 28/01/2020.

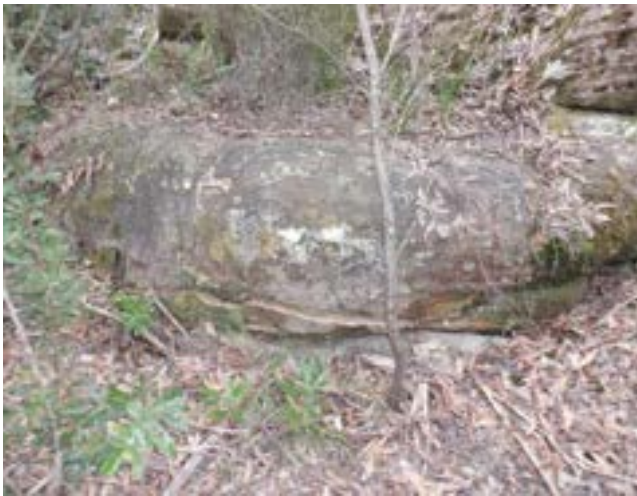
DA3A\_LW19\_005 is located on a steep slope/ step west of Swamp 15b (Figure 1). The impact was identified on 19 August 2022, consisting of two rock fractures. The rock fracturing has maximum continuous length of 2.59m, a width of 0.035m and a maximum measurable depth of 0.37m (Photo 2 to Photo 4). Minor rock displacement from the soil is present.

DA3A\_LW19\_005 is a Level 1 trigger as per the Dendrobium Area 3A Landscape TARP (Table 1), specifically:

Photo 2: DA3A\_LW19\_005, looking at section of rock fracturing. Taken on 19/08/2022.

- Continue monitoring program as required in the DA3A SMP
- Report impacts to key stakeholders (Biodiversity and Conservation Division; WaterNSW; NSW Resources Regulator)
- Summarise impacts and report in the End of Panel Report and Annual Review

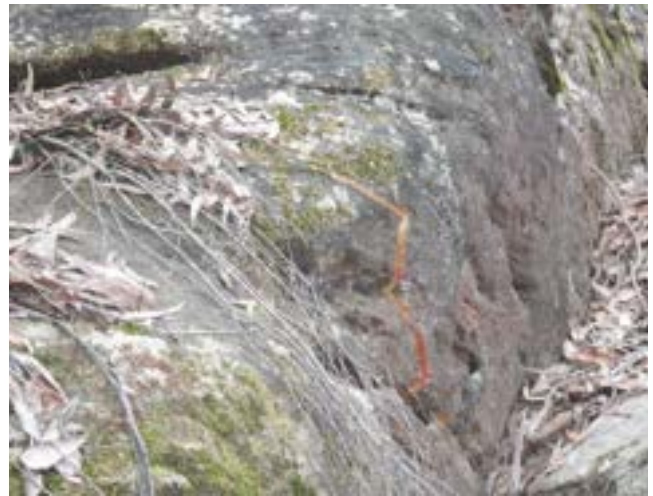
Photo 3: DA3A\_LW19\_005, looking at section of rock fracturing. Taken on 19/08/2022.

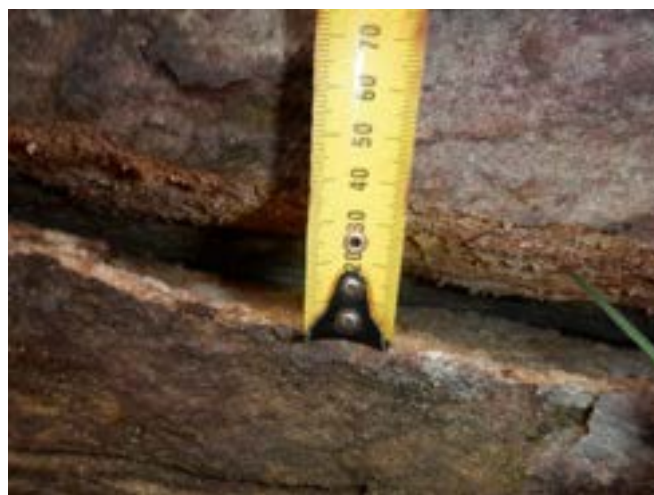
Photo 4: DA3A\_LW19\_005, looking at width of rock fracture. Taken on 19/08/2022.

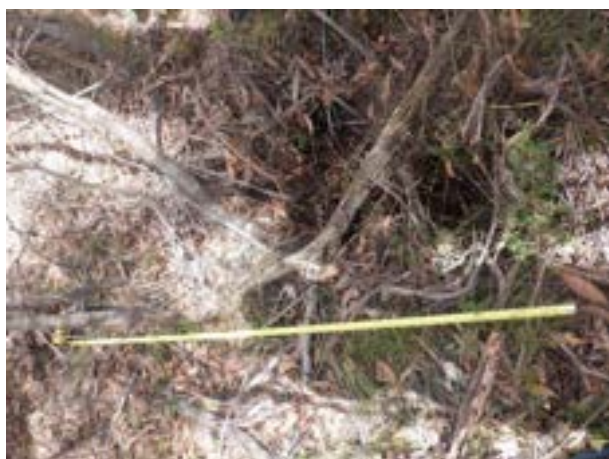
DA3A\_LW19\_006 is located approximately 150m south of tributary SC10C (Figure 1). The impact was identified on 31 August 2022 and consists of soil cracking. The soil cracking has a maximum continuous length of 2.5m (Photo 1), a maximum discontinuous length of 10m and maximum measurable depth of 1.1m. The soil crack has a maximum width of 0.14m (Photo 3). Surface erosion at the site has a maximum width of 0.7m (Photo 2). Flagging tape is in place as a safety precaution. This impact likely occurred due to the mining of Longwall 8 but was not identified during previous inspections.

DA3A\_LW19\_006 is a Level 2 trigger as per the Dendrobium Area 3A Landscape TARP (Table 1), specifically:

*Photo 1: Maximum continuous length of soil cracking (measuring tape set at 2.5m). Taken 31/08/2022.*

- Continue monitoring program as required in the DA3A SMP
- Report impacts to key stakeholders (Biodiversity and Conservation Division; WaterNSW; NSW Resources Regulator)
- Summarise impacts and report in the End of Panel Report and Annual Review
- Review monitoring frequency
- Notify relevant technical specialists and seek advice on any CMA required
- Provide safety signage and barricades as appropriate
- Implement agreed CMAs as approved

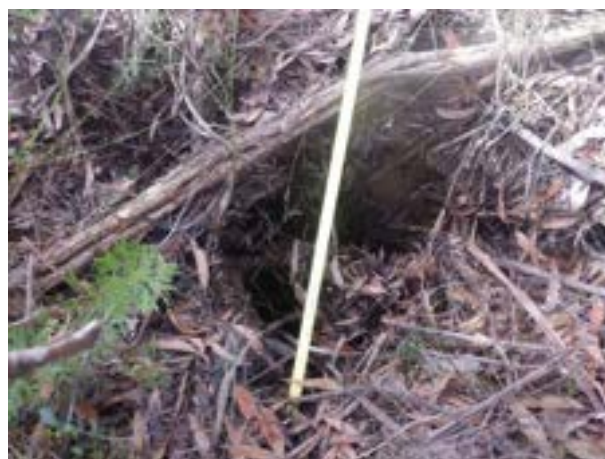
*Photo 2: Width of surface erosion. Taken 31/08/2022.*

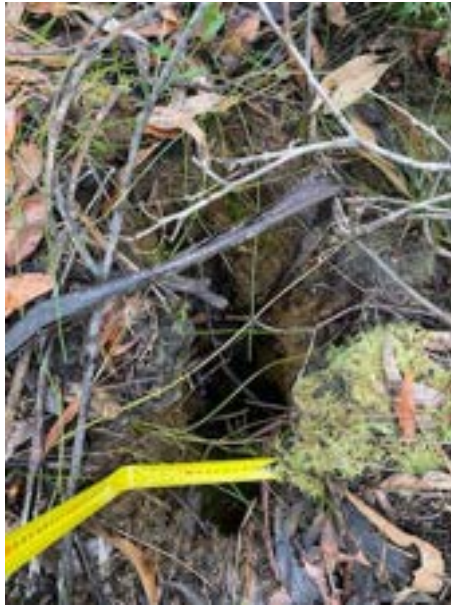
*Photo 3: Width of soil crack. Taken 1/09/2022.*

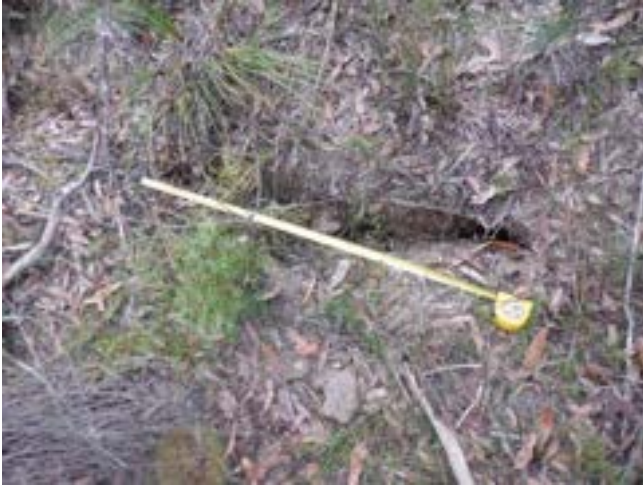
*DA3A\_LW19\_007* was identified on 18 October 2022 and consists of soil cracking, located 100m to the north of Longwall 19 (Figure 1). The soil cracking is situated in bushland and runs parallel to a closed access track. The cracking has a maximum continuous length of 2.4m, a maximum width of 0.08m and maximum measurable depth of 0.4m (Photo 1 to Photo 4). It has a total discontinuous length of approximately 50m. In some sections, the soil is displaced from adjacent rock outcropping (Photo 2). This impact likely occurred during Longwall 8 but was only identified during the latest inspection of the area. Some sections of the soil cracking indicate more recent movements, likely due to Longwall 19.

*DA3A\_LW19\_007* is a Level 1 trigger as per the Dendrobium Area 3A Landscape TARP (Table 1), specifically:

Photo 1: DA3A\_LW19\_007, section of soil cracking. Taken on 18/10/2022.

- Continue monitoring program as required in the DA3A SMP
- Report impacts to key stakeholders (Biodiversity Conservation and Science Division; WaterNSW; NSW Resources Regulator)
- Summarise impacts and report in the End of Panel Report and Annual Review

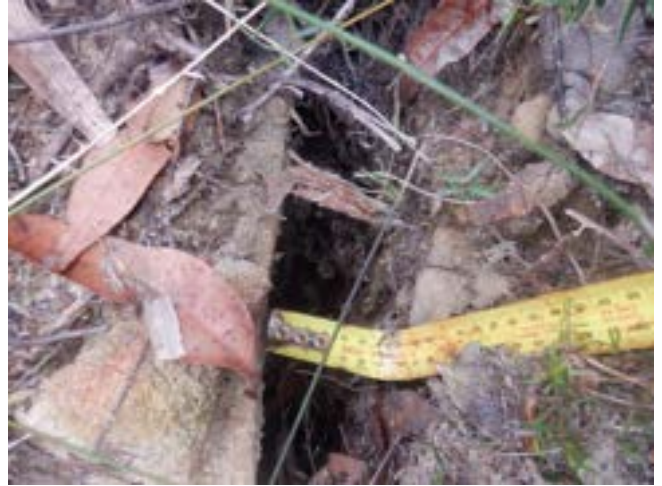
Photo 2: DA3A\_LW19\_007, width of soil cracking. Taken on 18/10/2022.

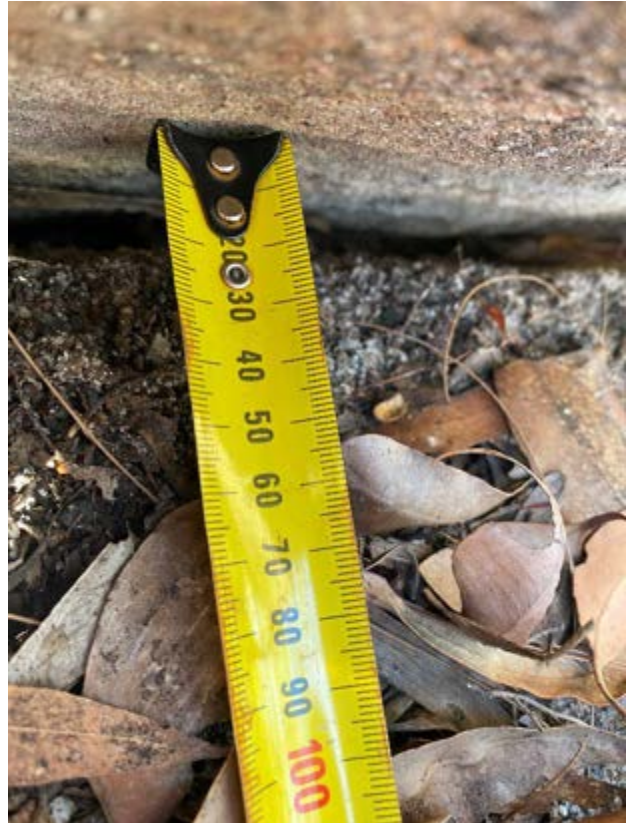
Photo 4: *DA3A\_LW19\_018*, width of rock displacement. Taken on 13/12/2022.

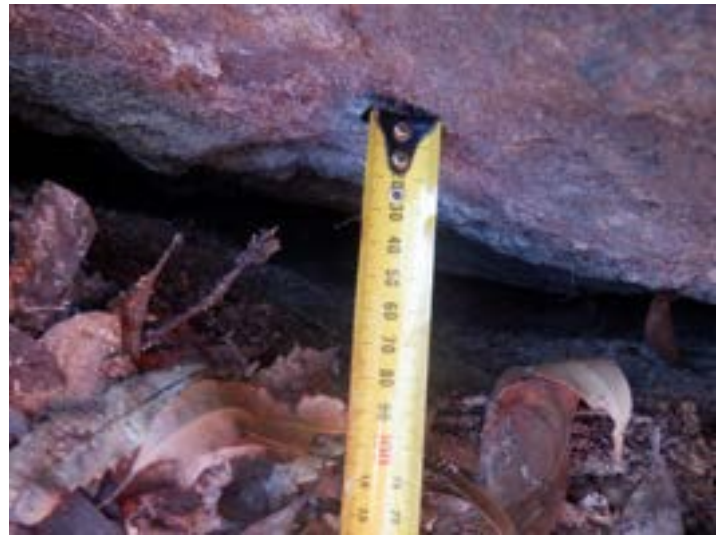
Photo 6: DA3A\_LW19\_019, width of rock displacement. Taken on 13/12/2022.

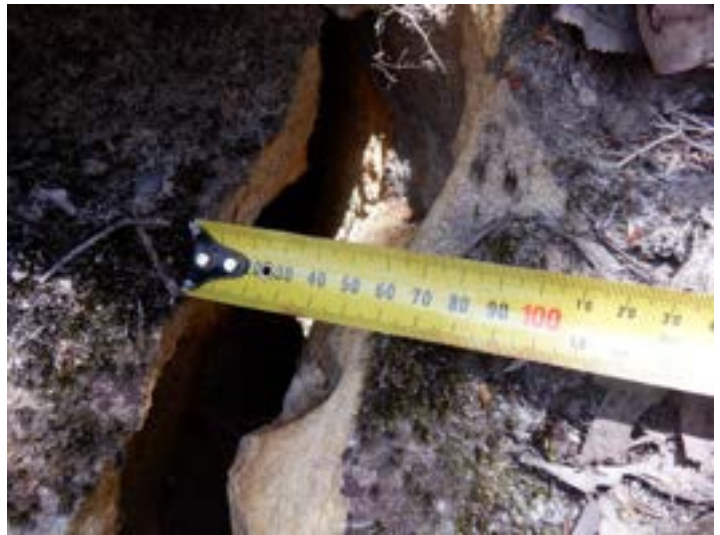
DA3A\_LW19\_023 is located approximately 395m east of Fire Road 6F and consists of rock fracturing (Figure 1). The rock fracturing has a maximum continuous length of 2m (partially cover by sediment), a maximum width of 0.065m and maximum measurable depth of 0.9m (Photo 17 and Photo 18).

Photo 18: *DA3A\_LW19\_023*, width of rock displacement. Taken on 13/12/2022.

- Continue monitoring program as required in the DA3A SMP
- Report impacts to key stakeholders (Biodiversity and Conservation Division; WaterNSW; NSW Resources Regulator)
- Summarise impacts and report in the End of Panel Report and Annual Review
- Review monitoring frequency
- Notify relevant technical specialists and seek advice on any CMA required
- Provide safety signage and barricades as appropriate
- Implement agreed CMAs as approved

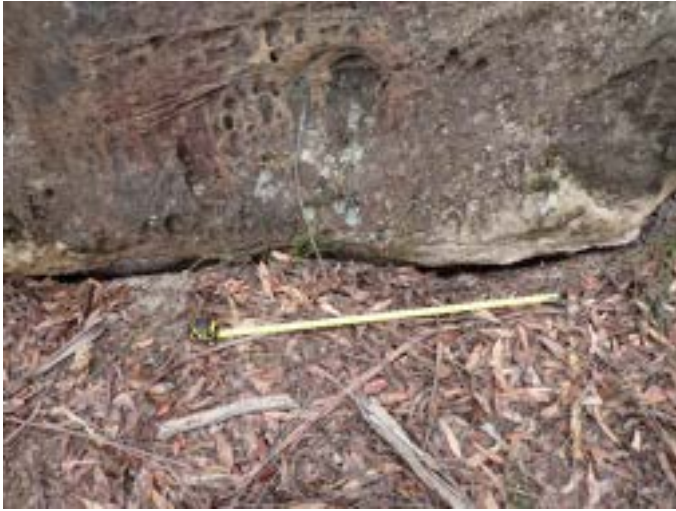
DA3A\_LW19\_025 is a Level 1 trigger as per the Dendrobium Area 3A Landscape TARP (Table 1), specifically:

Photo 5: *DA3A\_LW19\_025*, section of rock displacement. Taken on 20/12/2022.

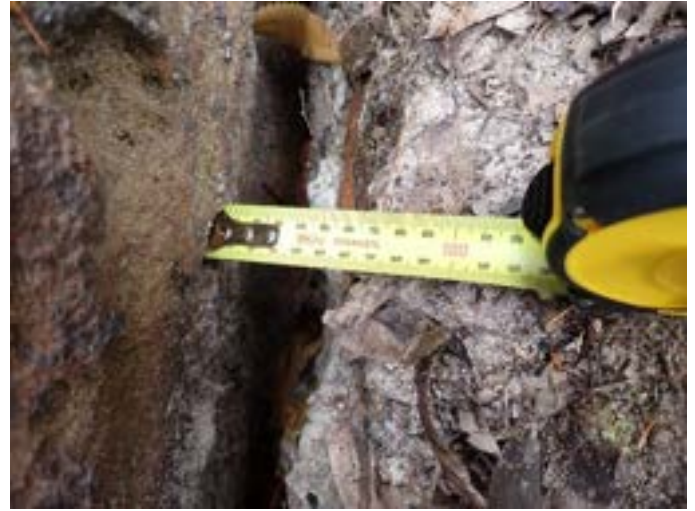
Photo 6: *DA3A\_LW19\_025*, width of rock displacement. Taken on 20/12/2022.

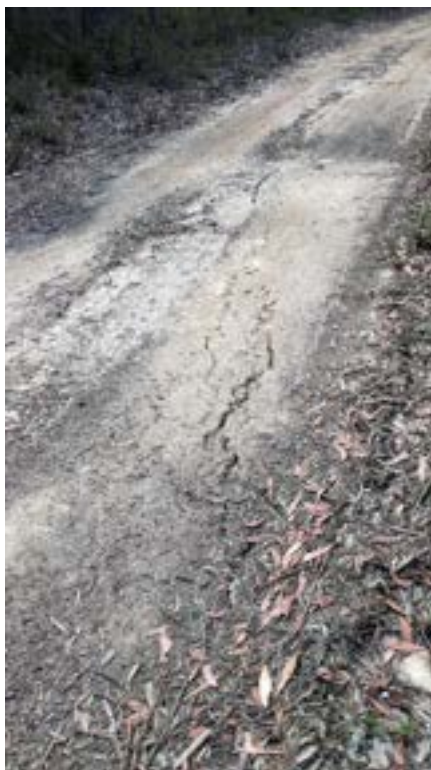
*DA3A\_LW19\_026* is located on Fire Road 6F and consists of soil cracking (Figure 1). The soil cracking has an approximate discontinuous length of 12m, a maximum continuous length of 6m, a maximum width of 0.05m and maximum measurable depth of approximately 0.2m (Photo 7 and Photo 8).

*DA3A\_LW19\_026* is a Level 1 trigger as per the Dendrobium Area 3A Landscape TARP (Table 1), specifically:

Photo 7: *DA3A\_LW19\_026*, section of soil cracking. Taken on 21/12/2022.

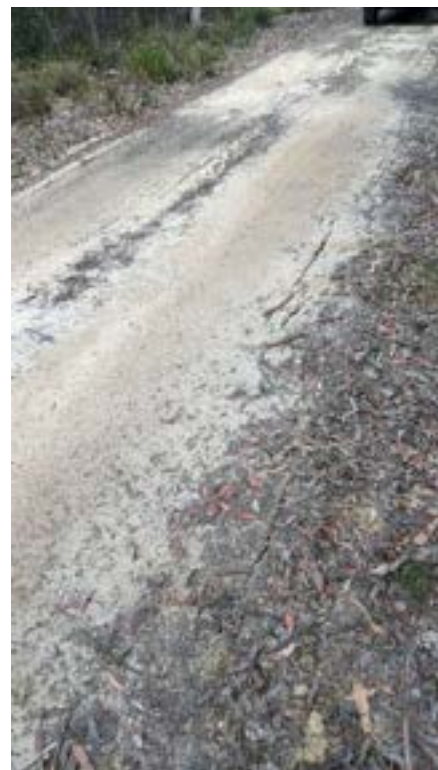
Photo 8: *DA3A\_LW19\_026*, section of soil cracking. Taken on 21/12/2022.

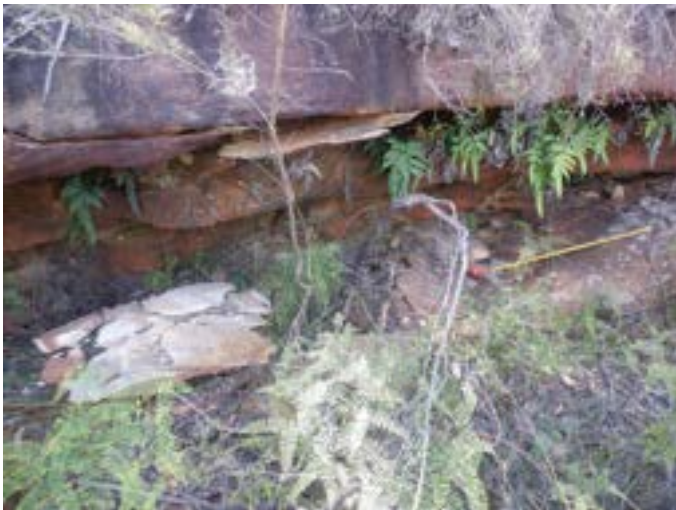
*DA3A\_LW19\_027* consists of rock fracturing and associated small rockfalls at a step approximately 55m west of Fire Road 6F (Figure 1). The rock fracturing has a discontinuous length of 9m, a maximum continuous length of 2.09m, a maximum width of 0.018m and a maximum measurable depth of 0.76m. Two small rockfalls are evident at the site, with approximate rockfall volumes of 1m<sup>3</sup> and 0.5m<sup>3</sup> (Photo 1 to Photo 4). Flagging tape is in place at the site as a safety precaution.

Photo 3: DA3A\_LW19\_027, section of rock fracturing and rockfall. Taken on 10/01/2023.

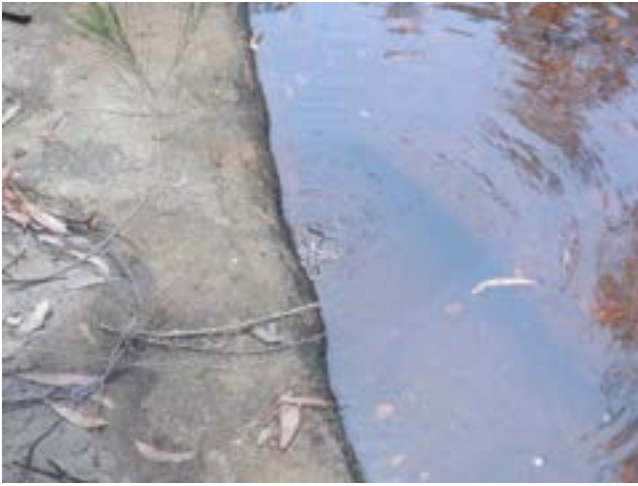
A follow-up inspection of the site was undertaken on 1 February 2023 to collect a gas sample for laboratory analysis and to determine whether the release was strata gas, as opposed to, for example, biological decomposition. During this inspection a similar release was observed from the same location on the western side of the pool (Photo 4). A light, intermittent release was observed towards the centre of the pool (Photo 5). A gas sample was taken from the release on the western margin of the pool. The release was intermittent during sampling as a constant release was not observed. Results of the gas sample are presented in Appendix A. Results of the analysis show mostly carbon dioxide and very low levels of methane. Methane content was lower than that expected from strata or in-seam gas. A light sheen was also observed on the surface of the pool during this inspection however this was similar to that observed at other sites around the catchment and is likely the result of natural oils derived from plant material or iron floc, originating upstream from a previously reported iron spring.

Photo 4: *DA3A\_LW19\_029*- gas release from base of sandstone ledge on the western side of WC\_Pool 50, Wongawilli Creek. Taken on 1/02/2023.

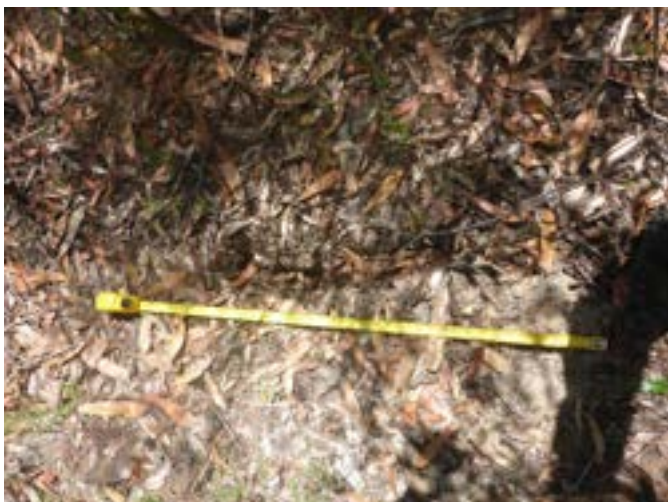
DA3A\_LW19\_025 was originally recorded on 20 December 2022 with changes to the impact recently observed. The impact consisted of rock displacement away from soil and soil cracking, located approximately 590m east of Fire Road 6F (Figure 1). The impact site now displays soil cracking and rock fracturing in addition to the previously reported displacement and cracking, that had an original length of 6.2m. The latest fracturing has a maximum continuous length of 1.96m, a maximum width of 0.096m and a maximum measurable depth of 1.13m. Other smaller fractures and soil cracks were observed over a total discontinuous length of approximately 23m, which includes the length of the originally reported displacement and soil cracking.

Photo 8: DA3A\_LW19\_025, showing soil cracking. Taken  
on 17/01/2023

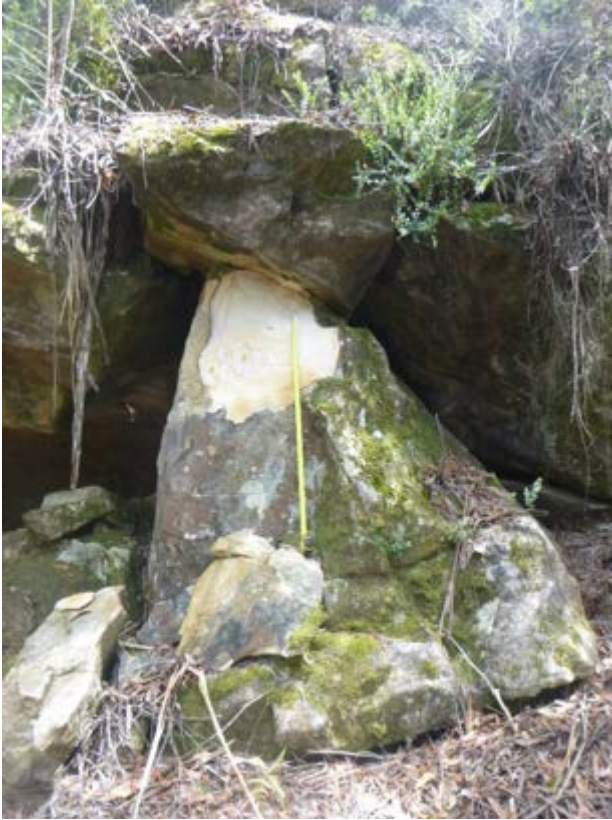
*DA3A\_LW19\_033* is a Level 1 trigger as per the Dendrobium Area 3A Landscape TARP (Table 1), specifically:

Photo 8: DA3A\_LW19\_033, rock fall from edge of steep slope. Taken on 15/2/2023.

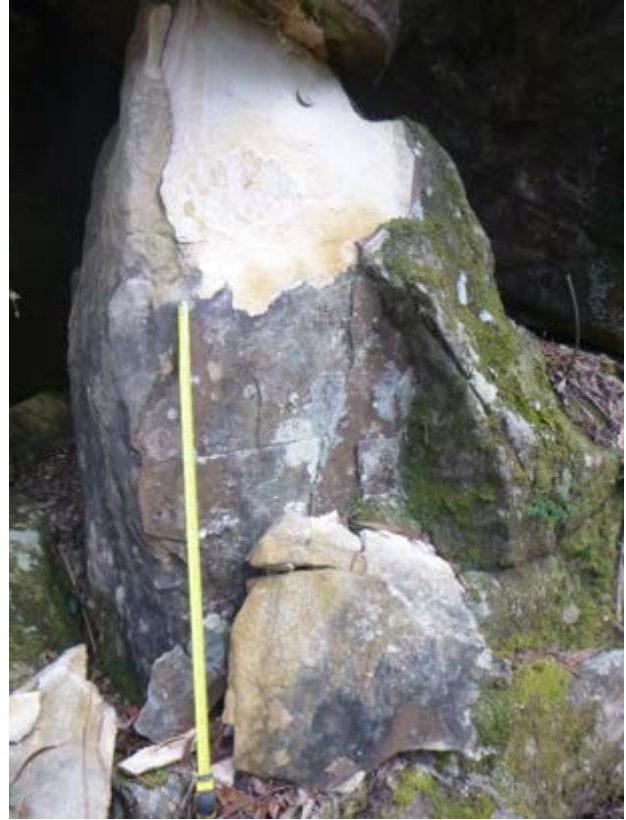
Photo 9: DA3A\_LW19\_033, rock fall from edge of steep slope. Taken on 15/2/2023.

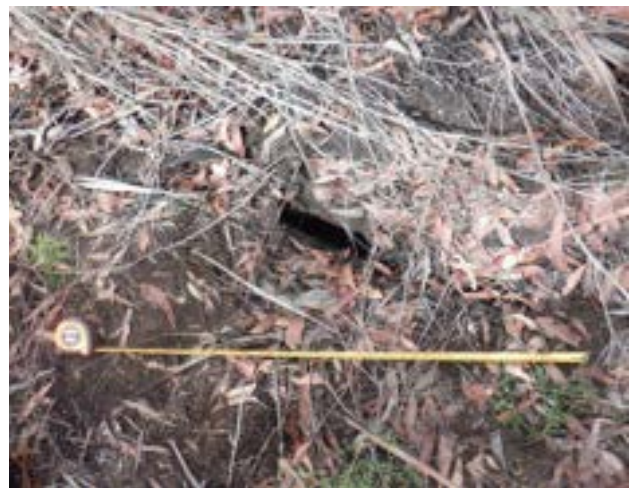
Photo 2: DA3A\_LW19\_036, soil cracking. Taken on 21/03/2023.

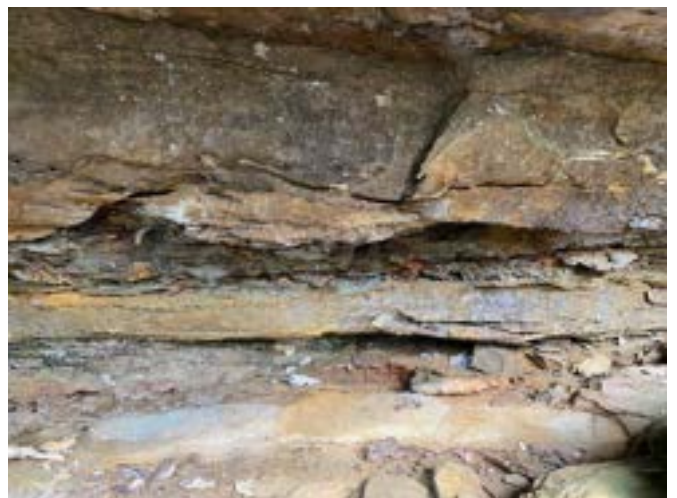
Photo 6: DA3A\_LW19\_037, rock fracturing through overhang at Sandy Creek 21. Taken on 28/03/2023.

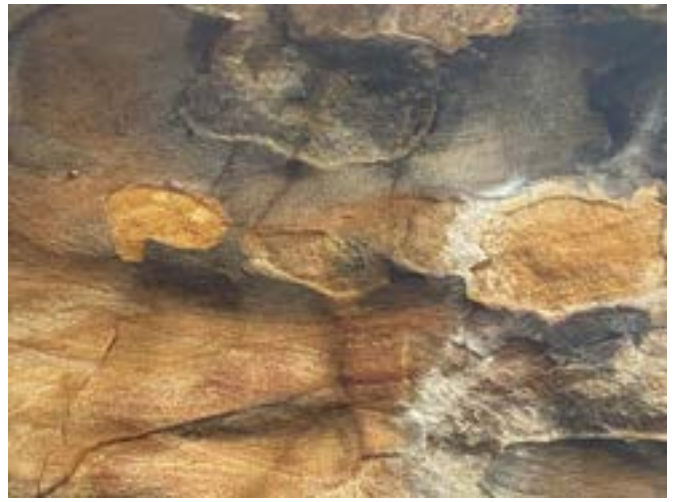
Photo 10: DA3A\_LW19\_038, rock fracturing extending to the upper part of overhang. Taken on 28/03/2023.

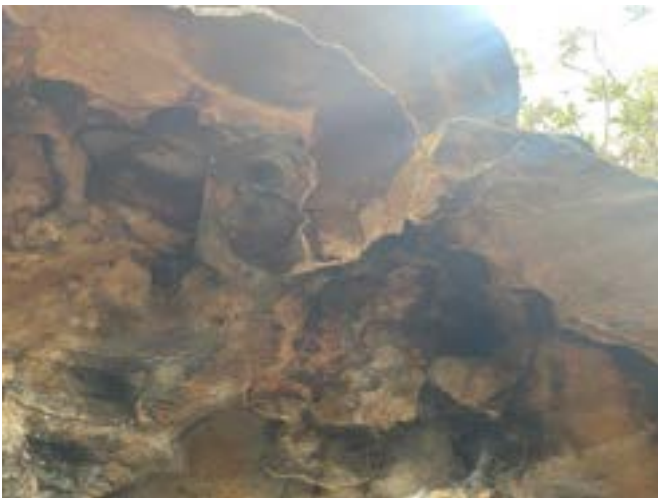
Photo 11: DA3A\_LW19\_038, section where rock fall occurred. Taken on 28/03/2023.

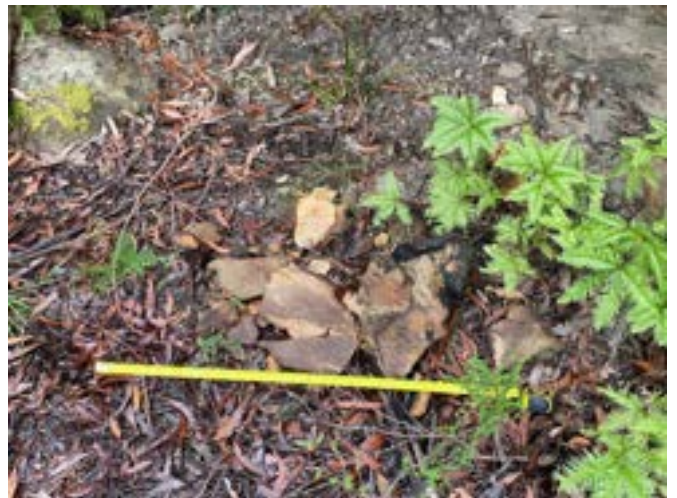
Photo 12: DA3A\_LW19\_038, rock fall on ground. Taken on 28/03/2023.

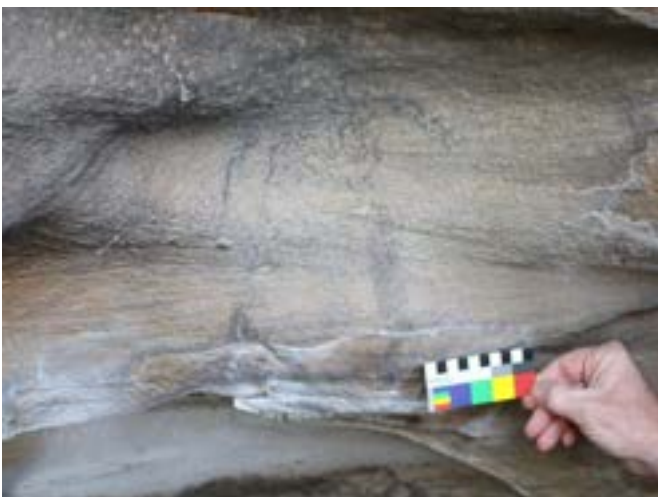
Photo 13: Art at DM15- baseline image displaying horizontal rock fracture identified prior to mining. Taken circa October 2020.

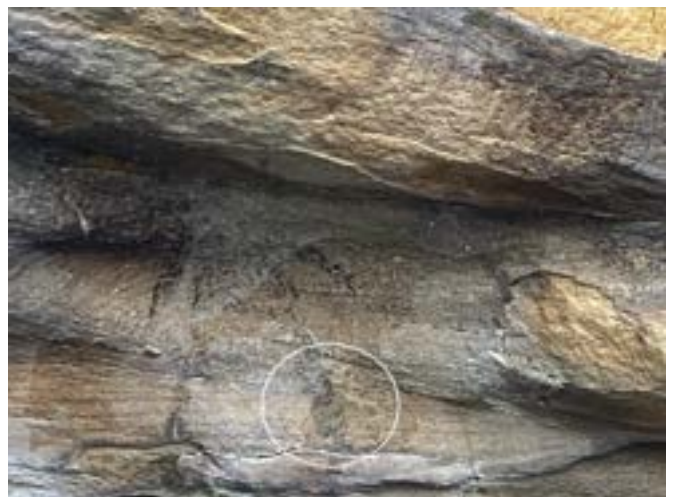
Photo 14: Art at DM15- image taken in latest inspection showing current fracturing. Recent fracture is circled. Taken on 28/03/2023.

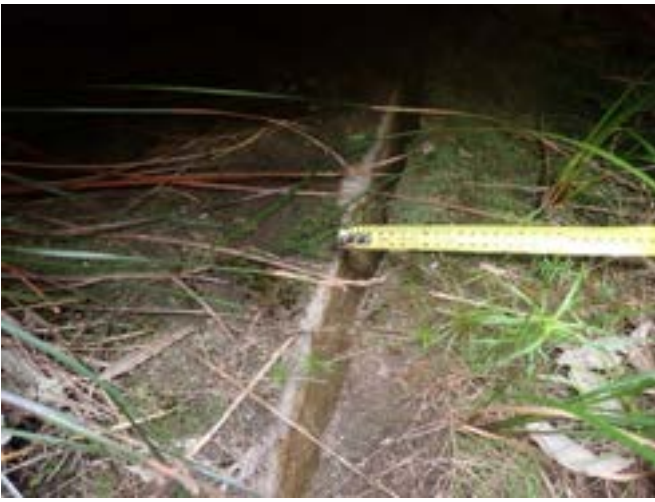
*DA3A\_LW8\_003* is a Level 1 trigger as per the Dendrobium Area 3A Landscape TARP (Table 1), specifically:

- Crack or fracture up to 100mm width;
- Crack or fracture up to 10m length;
- Rockfall from a cliff (step) which is left mostly intact (<10% length), resulting in insignificant ground disturbance.

Photo 1: DA3A\_LW8\_003, looking at the width of rock fracturing. Taken 12/04/2023.

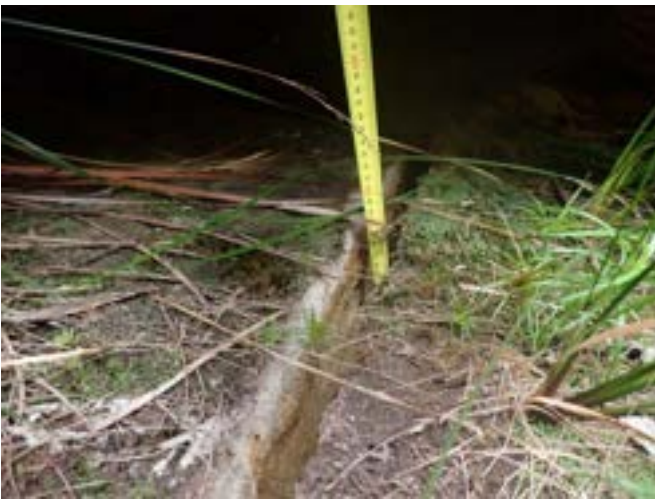
Photo 3: DA3A\_LW8\_003, looking at the depth of rock fracturing. Taken 12/04/2023.

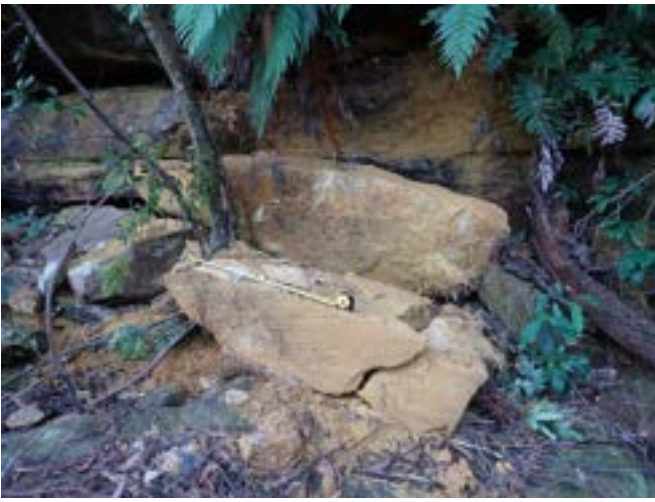
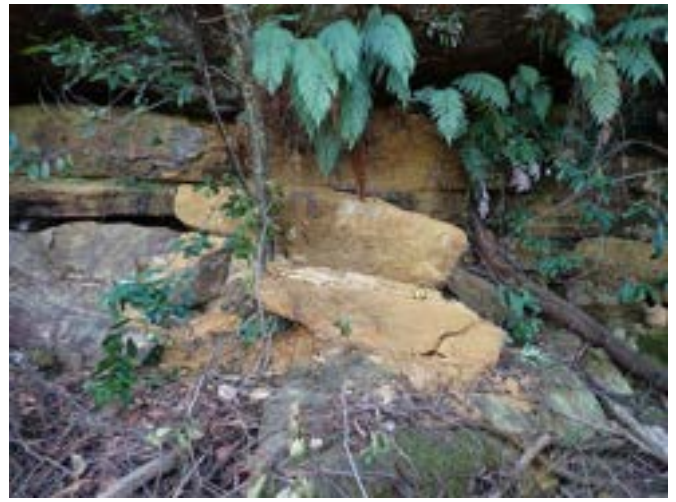
DA3A\_LW19\_039 is a Level 1 trigger as per the Dendrobium Area 3A Landscape TARP (Table 1), specifically:

- Rockfall from a cliff (step) which is left mostly intact (<10% length), resulting in insignificant ground disturbance.

Photo 5: *DA3A\_LW19\_039*, looking at the rockfall.  
Taken 12/04/2023

Photo 6: *DA3A\_LW19\_039*, looking at the rockfall.  
Taken 12/04/2023

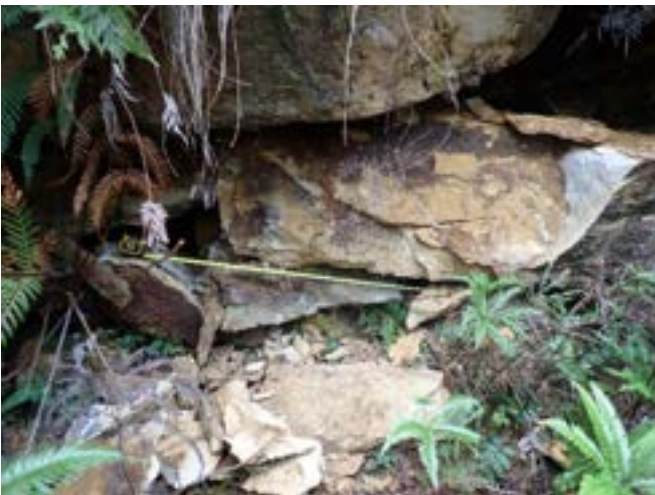
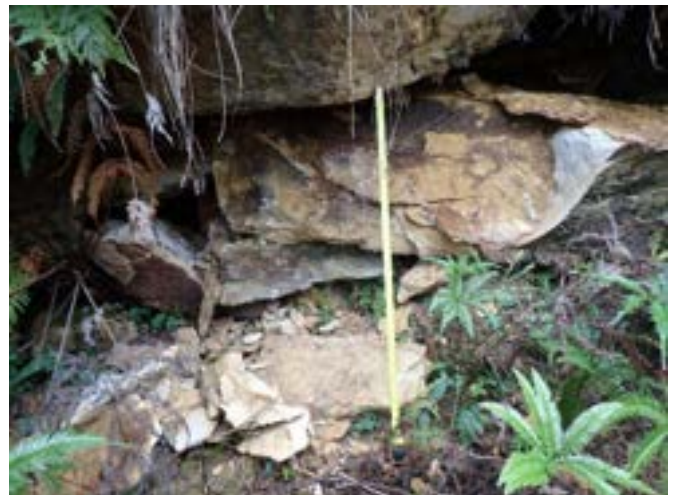
*DA3A\_LW19\_040* is a Level 1 trigger as per the Dendrobium Area 3A Landscape TARP (Table 1), specifically:

- Rockfall from a cliff (step) which is left mostly intact (<10% length), resulting in insignificant ground disturbance.

Photo 7: *DA3A\_LW19\_040*, looking at rockfall and fragments. Taken 12/04/2023.

Photo 8: *DA3A\_LW19\_040*, looking at rockfall and fragments. Taken 12/04/2023.

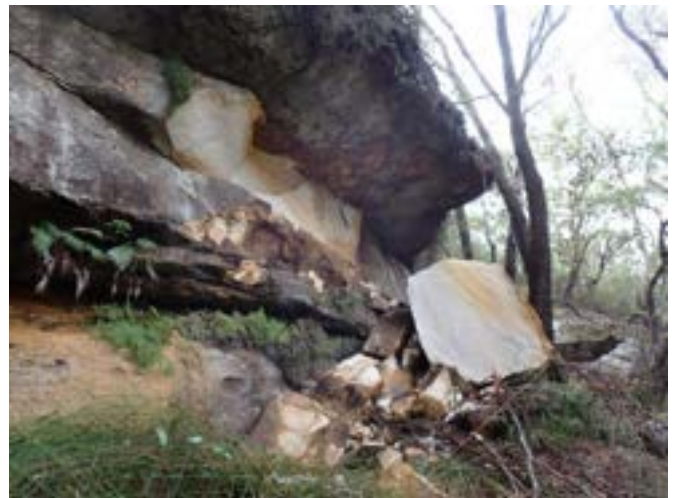
DA3A\_LW19\_041 is a Level 2 trigger as per the Dendrobium Area 3A Landscape TARP (Table 1), specifically:

- Rock fall or overhang collapse at cliff (steep slope) site, where characteristics of the cliff (steep slope) have changed, and there has been significant ground disturbance.

Photo 10: DA3A\_LW19\_041 looking at the rockfall at landscape site LW19\_SS5. Taken 12/04/2023.

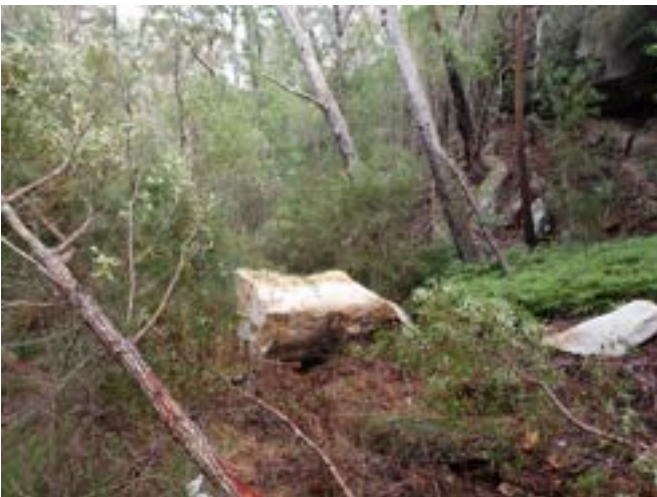
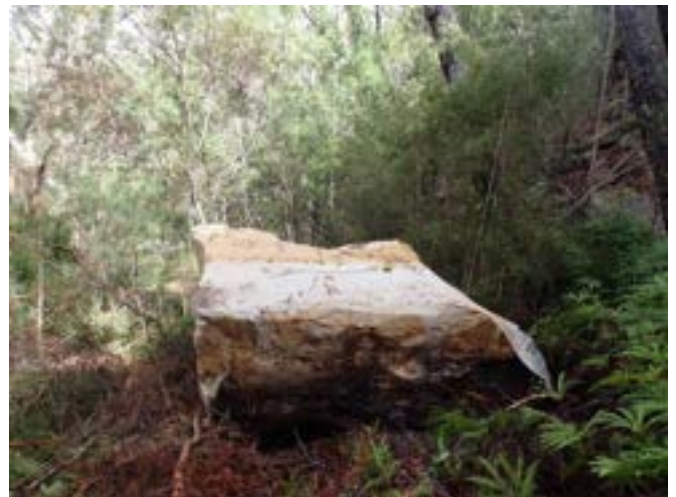
Photo 11: DA3A\_LW19\_041 looking at boulder that has dislodged and rolled downhill from steep slope.

Photo 12: DA3A\_LW19\_041 looking at boulder that has dislodged and rolled downhill from steep slope.

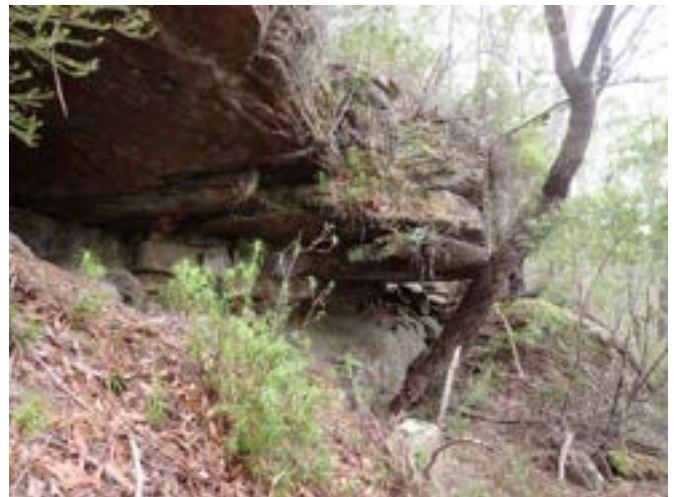
DA3A\_LW19\_042 consists of a very small rockfall/fragmentation from the ceiling and side of an overhang at landscape monitoring site LW19\_SS4 (Figure 1). A baseline photo is included for a pre-mining comparison (Photo 13). The rockfall and fragments were estimated due to safety concerns. The rockfall has an estimated volume of 0.005m<sup>3</sup>, with fragments scattered below (Photo 14 to Photo 16).

Photo 14: LW19\_SS4 during its most recent inspection.  
Taken 12/04/2023.

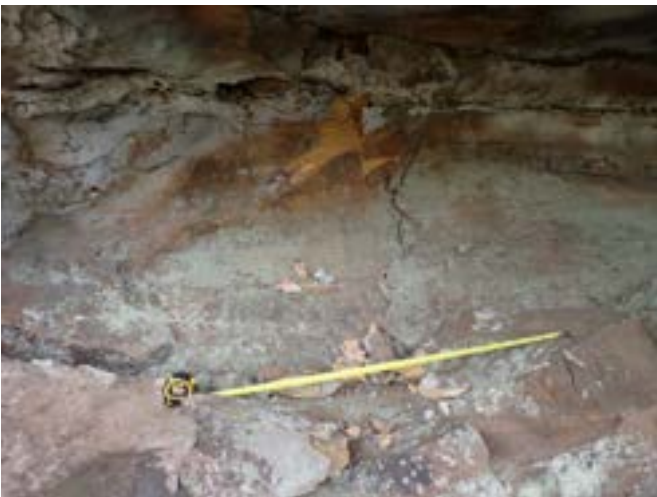
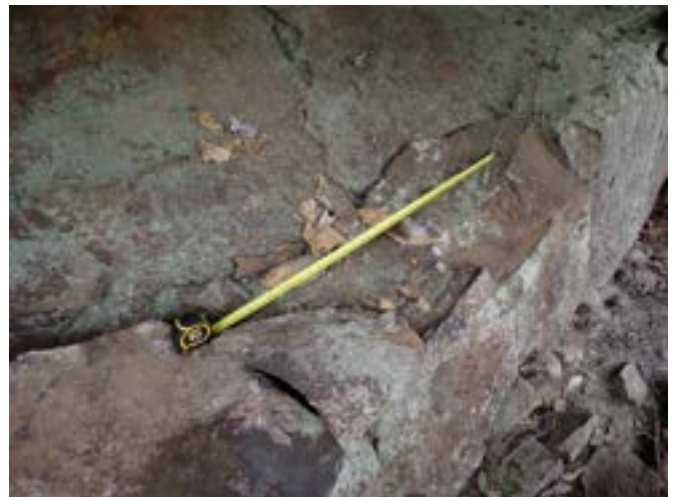
DA3A\_LW19\_042 is a Level 1 trigger as per the Dendrobium Area 3A Landscape TARP (Table 1), specifically:

- Rockfall from a cliff (step) which is left mostly intact (<10% length), resulting in insignificant ground disturbance.

Photo 15: DA3A\_LW19\_042 looking at rockfall and associated fragments. Taken 12/04/2023.

Photo 16: DA3A\_LW19\_042 looking at rockfall and associated fragments. Taken 12/04/2023.

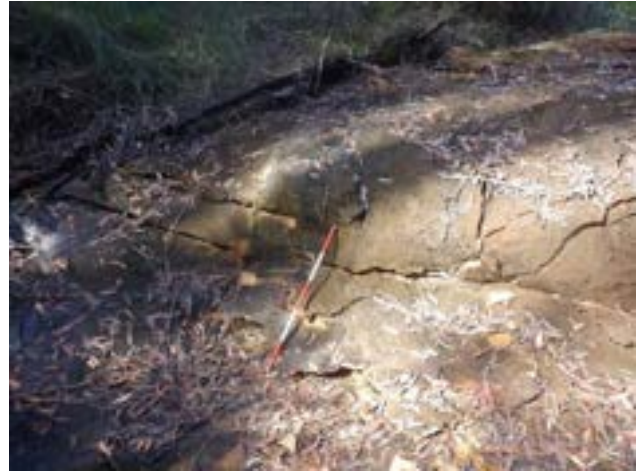
Photo 2: DA3A\_LW19\_043, looking upstream at rock fracturing on rockbar. Taken 17/04/2023.

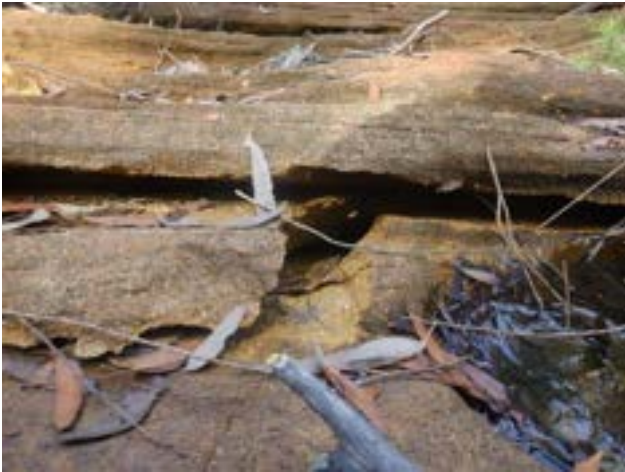
Photo 3: DA3A\_LW19\_043, looking at rock fracturing across rockbar. Taken 17/04/2023.

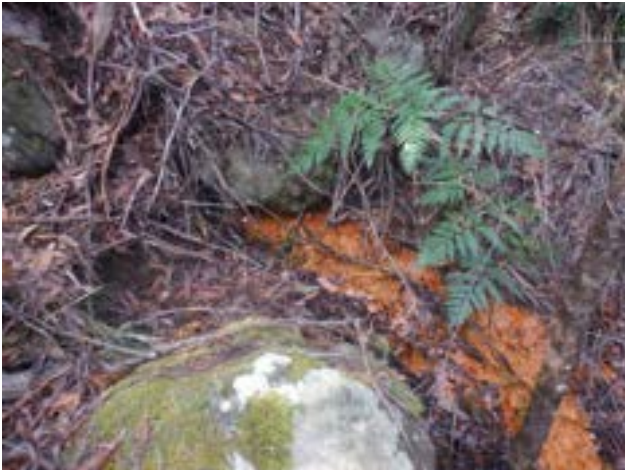
DA3A\_LW19\_044 is located approximately 15m east of *Wongawilli Creek* (Figure 1). The impact consists of iron staining which appears beneath a rock (Photo 5) and flows westward from DA3A mining operations. The iron staining's extent is approximately 20m in length and does not flow into *Wongawilli Creek* (Photo 6).

DA3A\_LW19\_044 is a Level 1 trigger as per the DA3A Watercourse Impact, Monitoring Management and Contingency Plan (Table 1), specifically:

- Observable increase in iron staining within the mining area

Photo 5: DA3A\_LW19\_044, looking at origin of iron staining beneath a rock. Taken 19/04/2023.

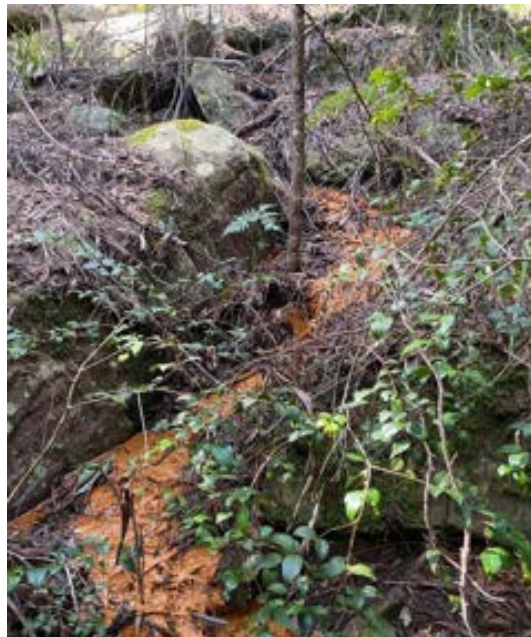
Photo 6: DA3A\_LW19\_044, looking at extent of iron staining. Taken 19/04/2023.

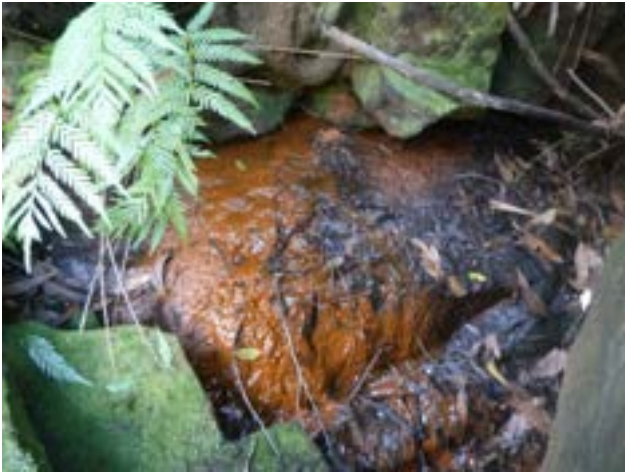
*DA3A\_LW19\_045* is a Level 1 trigger as per the DA3A Watercourse Impact, Monitoring, Management and Contingency Plan (Table 1), specifically:

- Observable increase in iron staining within the mining area

Photo 1: DA3A\_LW19\_045, showing iron staining appearing at base of a step. Taken on 26/04/2023.

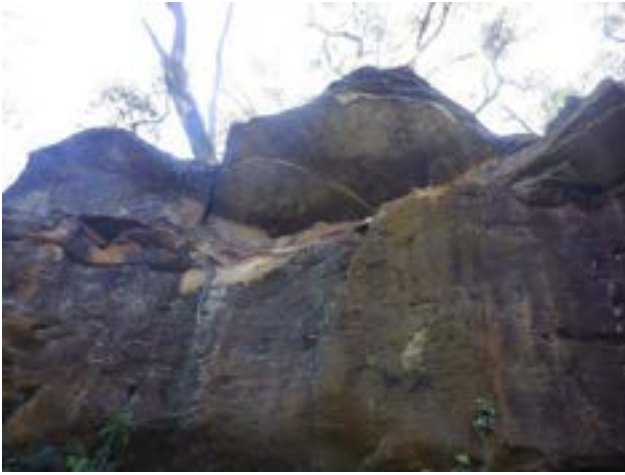
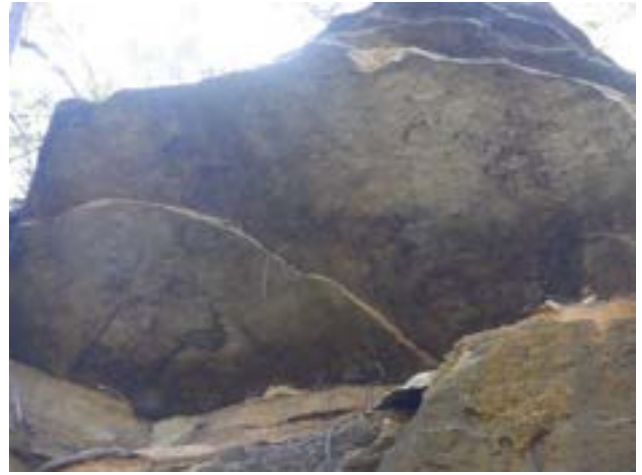
DA3A\_LW19\_046 is a Level 1 trigger as per the Dendrobium Area 3A Landscape TARP (Table 2), specifically:

- Rockfall from a cliff (step) which is left mostly intact (<10% length), resulting in insignificant ground disturbance.

Photo 3: DA3A\_LW19\_046, showing steep slope/step face where rocks detached. Taken on 27/04/2023.

Photo 4: DA3A\_LW19\_046, showing steep slope/step face where rocks detached. Taken on 27/04/2023.

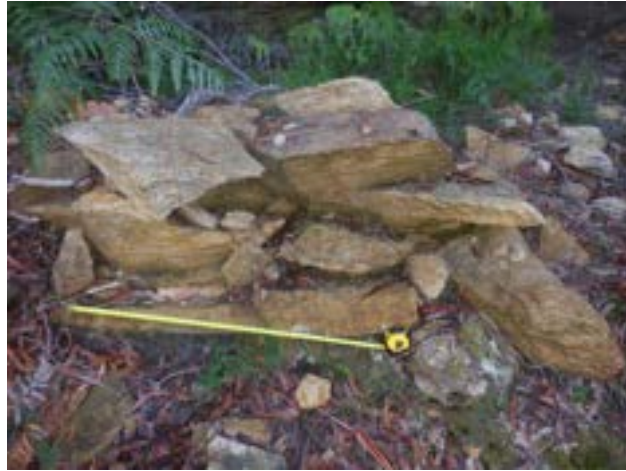
Photo 5: DA3A\_LW19\_046, showing debris area. Taken on 27/04/2023.

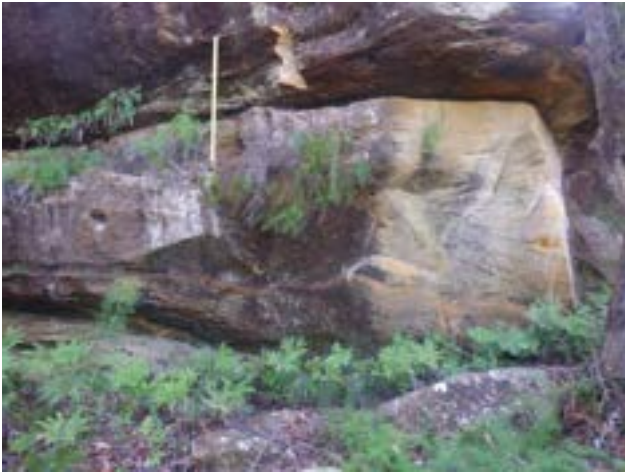
DA3A\_LW19\_047 is a Level 1 trigger as per the Dendrobium Area 3A Landscape TARP (Table 2), specifically:

- Crack or fracture up to 100mm width;
- Crack or fracture up to 10m length;
- Rockfall from a cliff (step) which is left mostly intact (<10% length), resulting in insignificant ground disturbance.

Photo 6: DA3A\_LW19\_047, showing steep slope/step where rock has detached from rock face. Taken on 27/04/2023
