Monitoring of watercourses, swamps and landscape features is undertaken to identify subsidence impacts. These features are monitored by the Illawarra Metallurgical Coal Environmental Field Team (IMCEFT) on a monthly basis prior to mining and weekly during mining. Monitoring is conducted in accordance with the approved Subsidence Management Plan (SMP) for Dendrobium Area 3A (DA3A). Extraction of Longwall 19 commenced 20 June 2022 and as of 2 August 2022 had progressed approximately 284m. During a recent inspection, two new subsidence impacts were identified.

**DA3A\_LW19\_001 (E 292826, N6192225)**

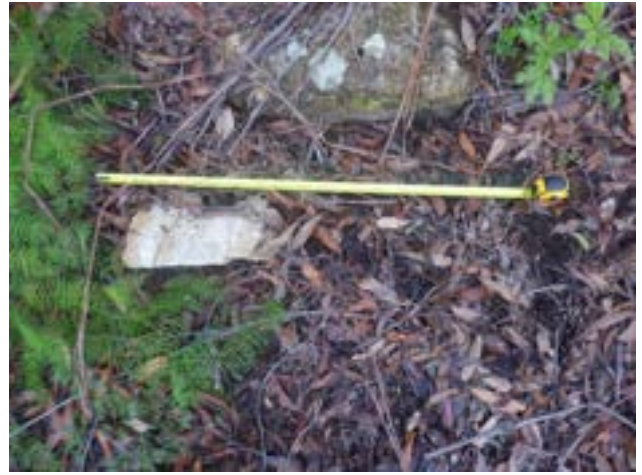
Photo 7: DA3A\_LW19\_047, showing debris area. Taken on 27/04/2023.

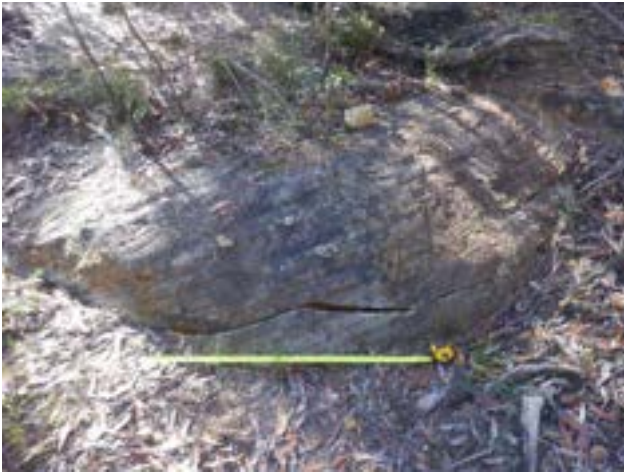
DA3A\_LW19\_048 is a Level 1 trigger as per the Dendrobium Area 3A Landscape TARP (Table 2), specifically:

- Crack or fracture up to 100mm width;
- Crack or fracture up to 10m length;

Photo 8: DA3A\_LW19\_048, showing rock fracturing. Taken on 27/04/2023.

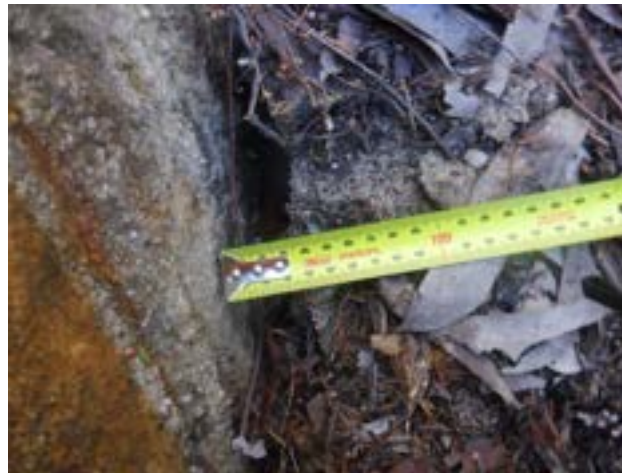
Photo 10: DA3A\_LW19\_048, showing rock movement. Taken on 27/04/2023.

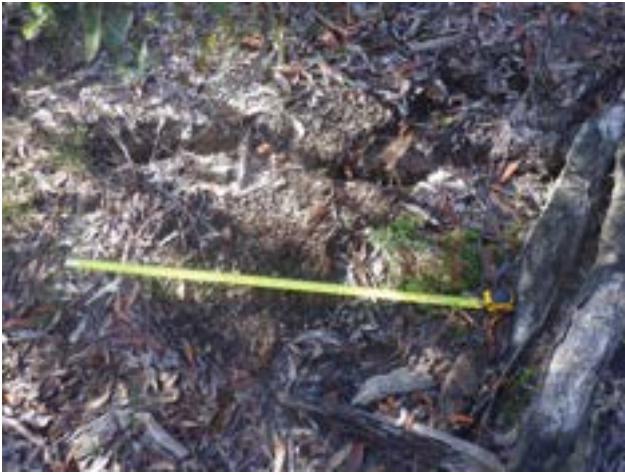
DA3A\_LW19\_049 is a Level 1 trigger as per the Dendrobium Area 3A Landscape TARP (Table 2), specifically:

- Crack or fracture up to 100mm width;
- Crack or fracture up to 10m length;

Photo 11: DA3A\_LW19\_049, showing extent of soil crack. Taken on 27/04/2023.

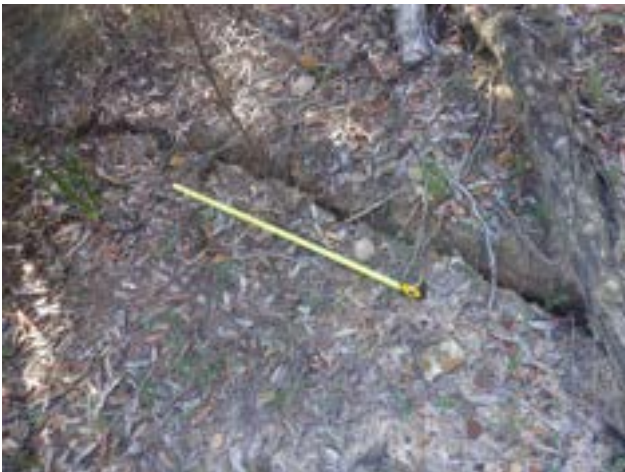
DA3A\_LW19\_050 is a Level 2 trigger as per the Dendrobium Area 3A Landscape TARP (Table 2), specifically:

- Crack or fracture between 100mm and 300mm width;
- Crack or fracture between 10m and 50m length;

Photo 13: DA3A\_LW19\_050, showing extent of soil crack. Taken on 27/04/2023.

- Continue monitoring program as required in the Longwall 19 SMP
- Report impacts to key stakeholders (Biodiversity and Conservation Division; WaterNSW; NSW Resources Regulator and Department of Planning and Environment)
- Summarise impacts and report in the End of Panel Report and Annual Review
- Review monitoring frequency
- Notify relevant technical specialists and seek advice on any CMA required
- Provide safety signage and barricades as appropriate
- Implement approved repairs to ensure safety and serviceability on fire trails
- Implement agreed CMAs as approved (subject to agency feedback)

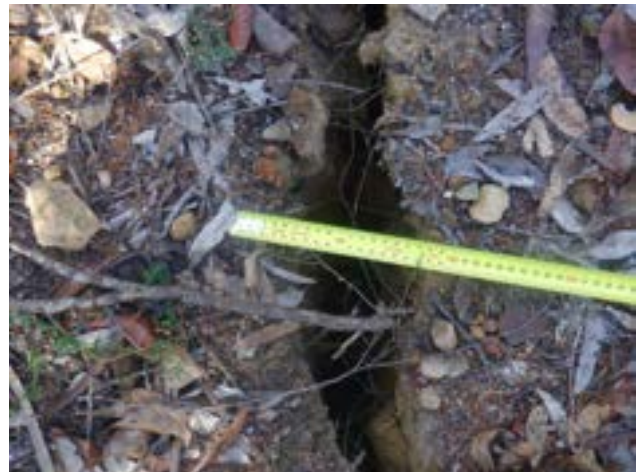
Photo 14: DA3A\_LW19\_050, showing width of soil crack. Taken on 27/04/2023.

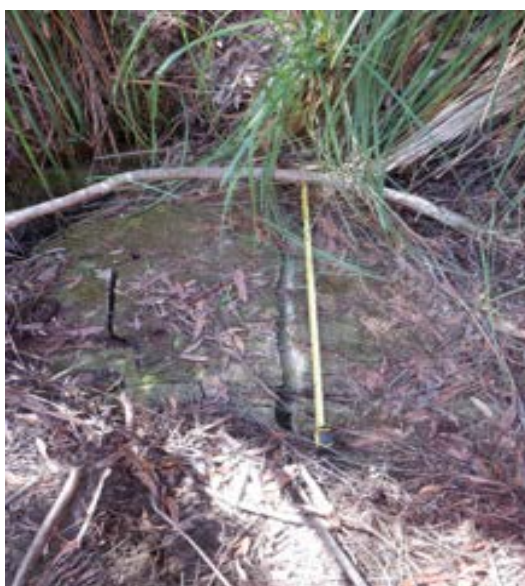
*DA3A\_LW19\_051* is a Level 1 trigger as per the DA3A Watercourse Impact, Monitoring, Management and Contingency Plan (Table 1), specifically:

- Crack or fracture up to 100mm width at its widest point with no observable loss of surface water or erosion
- Crack or fracture up to 10m length with no observable loss of surface water or erosion

Photo 1: *DA3A\_LW19\_051*, showing rock fracturing to an outcrop on *WC14*. Taken on 4/5/2023.

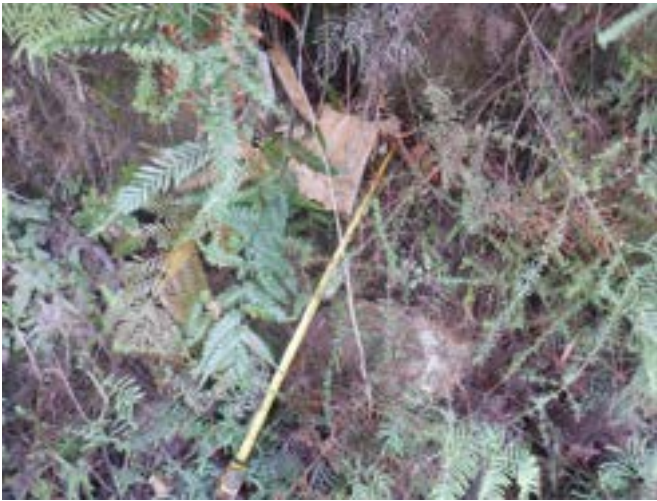
DA3A\_LW19\_052 is a Level 1 trigger as per the Dendrobium Area 3A Landscape TARP (Table 2), specifically:

- Crack or fracture up to 100mm width;
- Crack or fracture up to 10m length;
- Rockfall from a cliff (step) which is left mostly intact (<10% length), resulting in insignificant ground disturbance.

Photo 3: DA3A\_LW19\_052, showing area of rockfall.  
Taken on 4/5/2023.

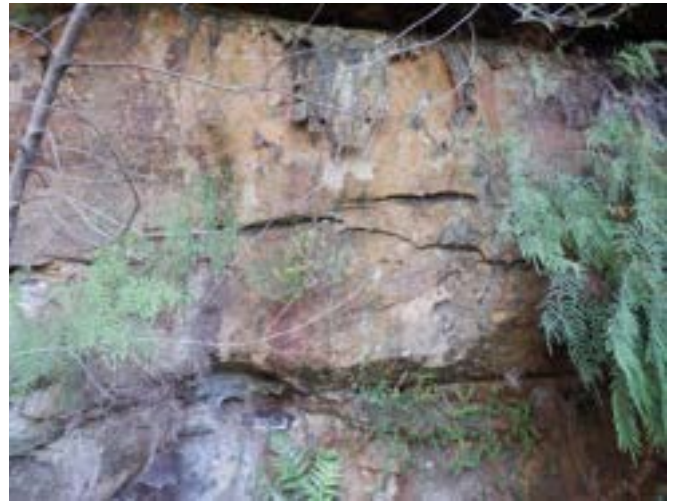
Photo 4: DA3A\_LW19\_052, showing area of rock fracturing.  
Taken on 4/5/2023.

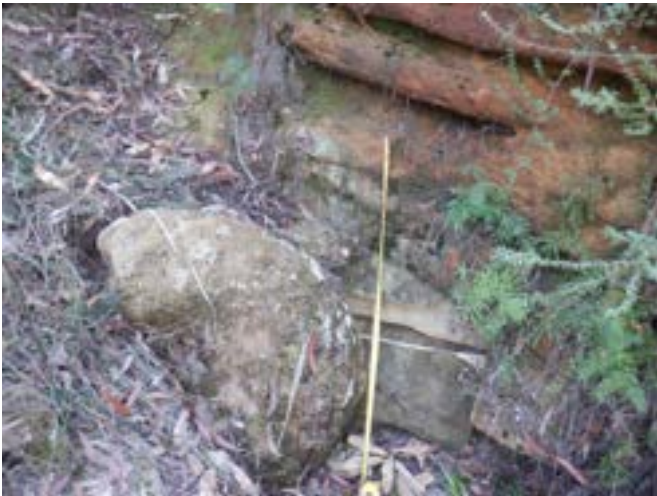
*DA3A\_LW19\_053* is located approximately 155m to the north of tributary *WC14* (Figure 1). The impact consists of rock fracturing and associated rockfall along the base of a step. The rock fracturing has a maximum continuous length of 0.35m and a maximum width of 0.001m wide (Photo 6). The rockfall has an approximate volume of 0.27m<sup>3</sup> (Photo 5).

*DA3A\_LW19\_053* is a Level 1 trigger as per the Dendrobium Area 3A Landscape TARP (Table 2), specifically:

- Crack or fracture up to 100mm width;
- Crack or fracture up to 10m length;
- Rockfall from a cliff (step) which is left mostly intact (<10% length), resulting in insignificant ground disturbance.

Photo 5: *DA3A\_LW19\_053*, showing area of rockfall.  
Taken on 4/5/2023.

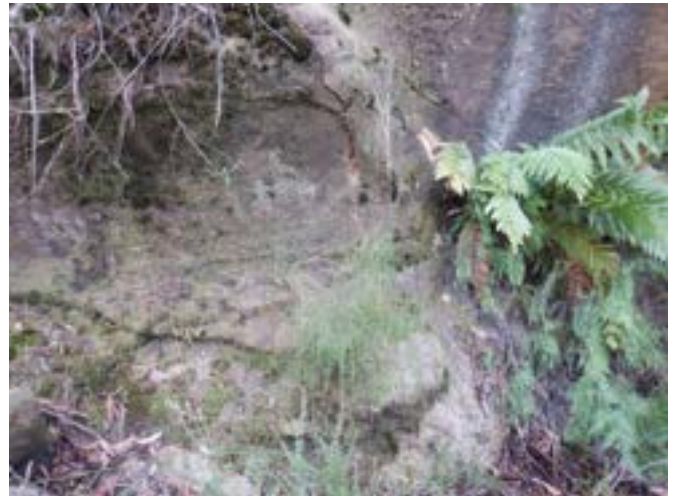
Photo 6: *DA3A\_LW19\_053*, showing rock fracturing.  
Taken on 4/5/2023

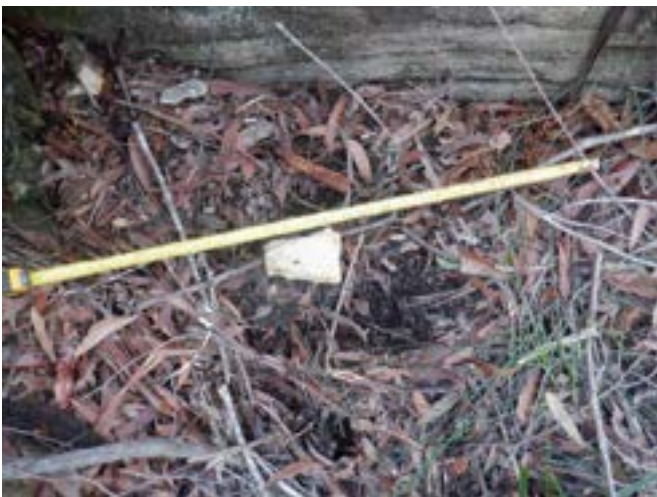
*DA3A\_LW19\_055* is located approximately 150m to the north of tributary *WC14* (Figure 1). The impact consists of rock fracturing and a small rockfall beneath an overhang of a steep slope. Rock fracturing beneath the overhang has a maximum continuous length of 1.2m, a maximum width of 0.003m and a maximum measurable depth of 0.58m (Photo 10). The rockfall has an approximate volume of less than 0.01m<sup>3</sup> (Photo 9).

*DA3A\_LW19\_055* is a Level 1 trigger as per the Dendrobium Area 3A Landscape TARP (Table 2), specifically:

- Crack or fracture up to 100mm width;
- Crack or fracture up to 10m length;
- Rockfall from a cliff (step) which is left mostly intact (<10% length), resulting in insignificant ground disturbance.

Photo 9: *DA3A\_LW19\_055*, showing area of rockfall. Taken on 4/5/2023.

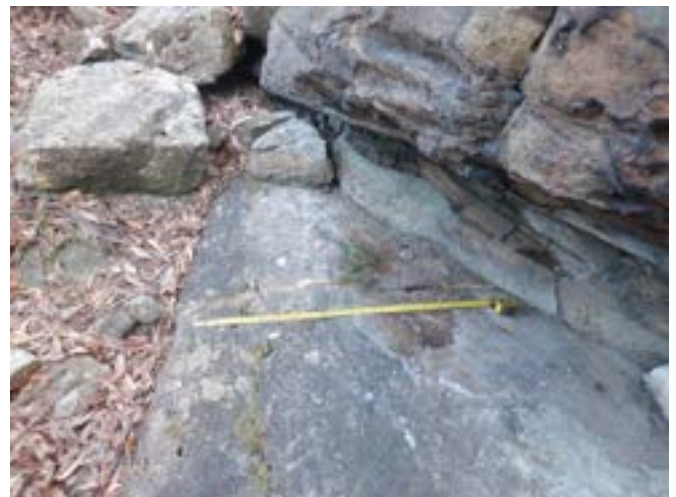
Photo 10: *DA3A\_LW19\_055*, showing rock fracturing. Taken on 4/5/2023.

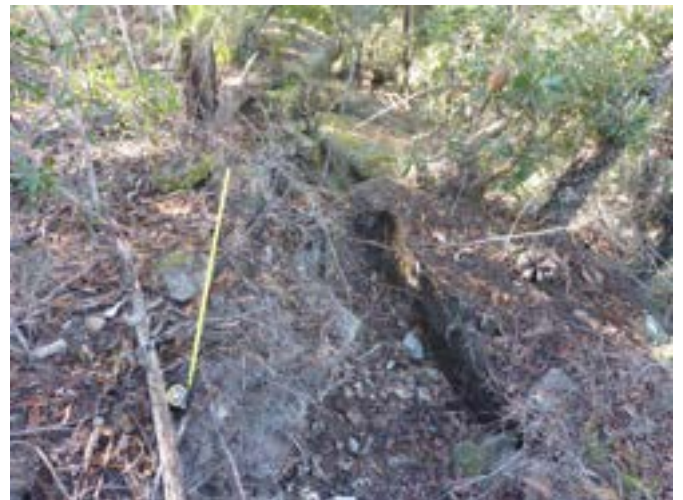
DA3A\_LW19\_056 is located 160m to the north of tributary WC14 (Figure 1). The impact consists of rock fracturing and rockfall/block movement on a step/overhang. The rock fracture has a maximum continuous length of 17.5m. The large section of rock that has detached from the adjacent ground has an estimated volume of 110m<sup>3</sup> (Photo 11). There are multiple fractures under the overhang estimated to be up to 1.5m in length with widths up to 0.05m. There are also three rock fractures on the outcrop above the overhang, up to 0.15m in length and a width up to 0.04m (Photo 12). The impact site has minimal downslope vegetation disturbance. The immediate area around the impact was flagged with marking tape as a safety precaution.

Photo 12: DA3A\_LW19\_056, showing top view of block that have moved away from the adjacent ground. Taken on 5/05/2023.

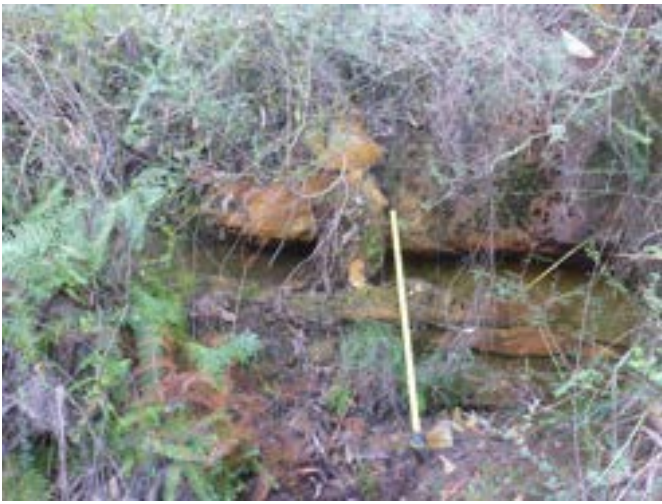
DA3A\_LW19\_057 is located 180m to the north of WC14, a tributary to Wongawilli Creek (Figure 1). The impact consists of a rockfall from a step. Two small debris falls of approximately 0.16m<sup>3</sup> and 0.03m<sup>3</sup> were observed (Photo 13 and Photo 14). The rockfall has a combined total volume of approximately 0.5m<sup>3</sup> (Photo 14). The impact site has minimal ground disturbance or impact to vegetation.

DA3A\_LW19\_057 is a Level 1 trigger as per the Dendrobium Area 3A Landscape TARP (Table 2), specifically:

- Rockfall from a cliff (step) which is left mostly intact (<10% length), resulting in insignificant ground disturbance.

Photo 13: *DA3A\_LW19\_057*, showing step where rocks detached. Taken on 5/05/2023.

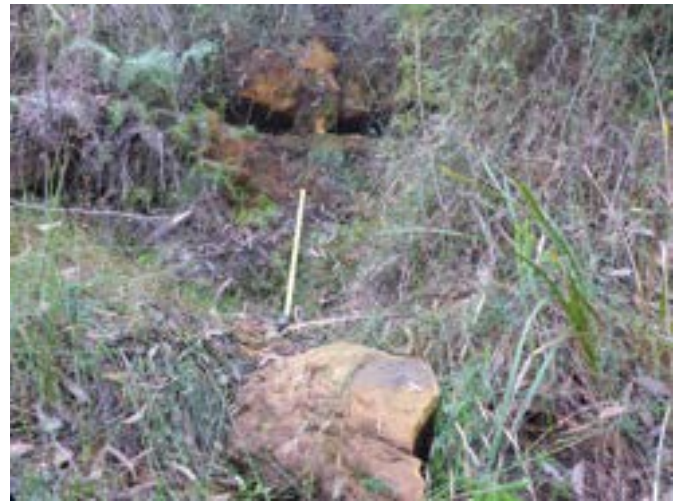
Photo 14: *DA3A\_LW19\_057*, showing step where rocks detached and debris area. Taken on 5/05/2023.

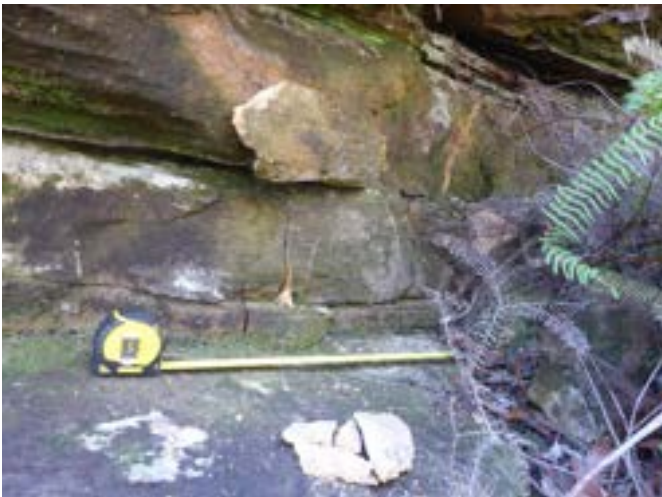
*DA3A\_LW19\_058* is located 190m to the north of tributary *WC14* (Figure 1). The impact consists of a series of small fractures to a rock outcrop (Photo 15). The maximum continuous length of the fractures is 0.26m while the largest width is 0.015m (Photo 16). The impact also contained a small rockfall which with total volume less than 0.01m<sup>3</sup> (Photo 16).

*DA3A\_LW19\_058* is a Level 1 trigger as per the Dendrobium Area 3A Landscape TARP (Table 2), specifically:

- Crack or fracture up to 100mm width;
- Crack or fracture up to 10m length;
- Rockfall from a cliff (step) which is left mostly intact (<10% length), resulting in insignificant ground disturbance.

Photo 15: *DA3A\_LW19\_058*, showing step where rock has detached from rock face. Taken on 5/05/2023.  
Note: Tape measure is set to 0.5m in length.

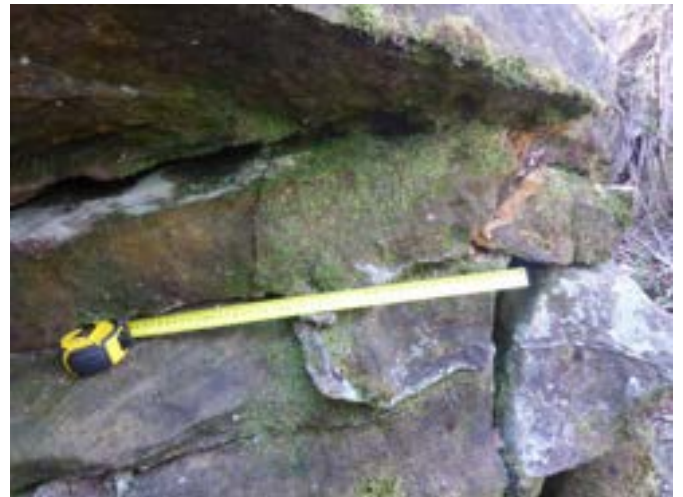
Photo 16: *DA3A\_LW19\_058*, showing step where rock has detached from rock face. Taken on 5/05/2023.  
Note: Tape measure is set to 0.5m in length.

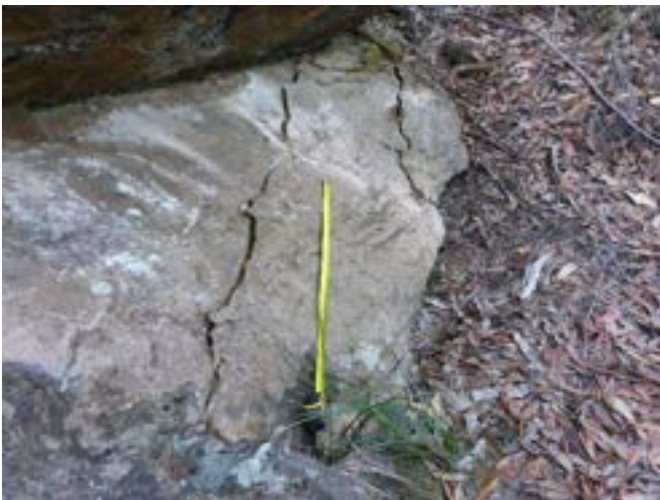
*DA3A\_LW19\_059* is located 225m to the north of tributary *WC14* (Figure 1). The impact consists of two rock fractures beneath a small overhang. The largest fracture has a maximum continuous length of 2.34m, a maximum width of 0.03m and a maximum measurable depth of 0.15m (Photo 17). The fractures resulted in a small rockfall less than 0.01m<sup>3</sup> in volume (Photo 18).

*DA3A\_LW19\_059* is a Level 1 trigger as per the Dendrobium Area 3A Landscape TARP (Table 2), specifically:

- Crack or fracture up to 100mm width;
- Crack or fracture up to 10m length;
- Rockfall from a cliff (step) which is left mostly intact (<10% length), resulting in insignificant ground disturbance.

Photo 17: *DA3A\_LW19\_059*, showing rock fracturing. Taken on 5/05/2023.

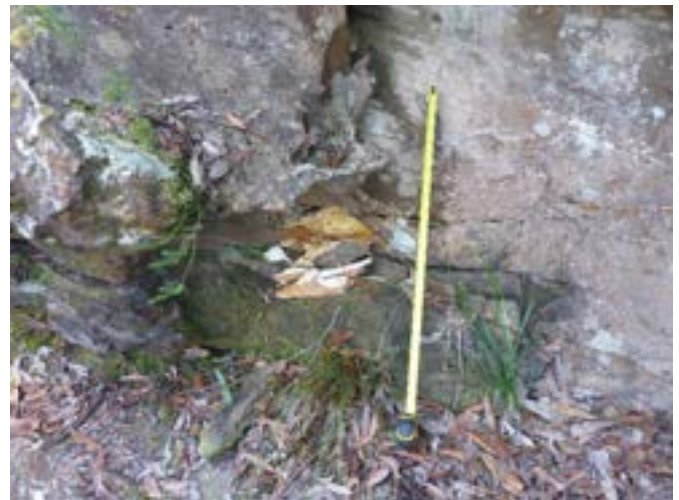
Photo 18: *DA3A\_LW19\_059*, showing fallen debris. Taken on 5/05/2023.

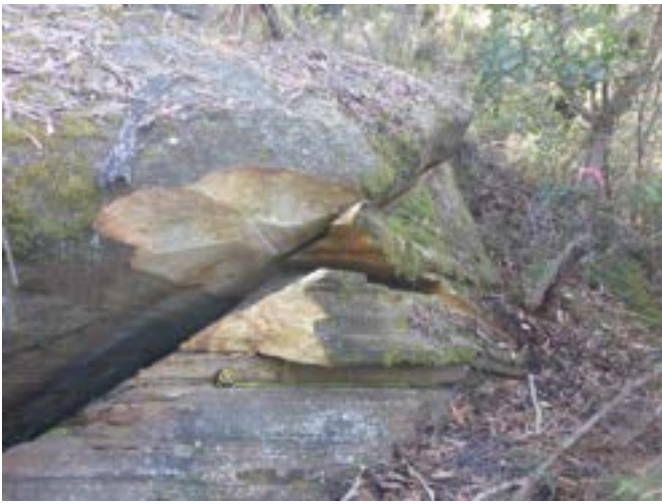
*DA3A\_LW19\_060* is located 235m to the north of tributary *WC14* (Figure 1). The impact consists of a rock fracture, displacement and rockfall on a step/outcrop (Photo 19 to Photo 21). The rock fracture has a maximum continuous length of 3.26m and a maximum width of 0.04m. The displacement along the outcrop measured 3.43m in length (Photo 20). The total volume of the rockfall is approximately 0.7m<sup>3</sup> (Photo 21).

*DA3A\_LW19\_060* is a Level 1 trigger as per the Dendrobium Area 3A Landscape TARP (Table 2), specifically:

- Crack or fracture up to 100mm width;
- Crack or fracture up to 10m length;
- Rockfall from a cliff (step) which is left mostly intact (<10% length), resulting in insignificant ground disturbance.

Photo 19: *DA3A\_LW19\_060*, showing extent of rock fracture and rockfall. Taken on 5/05/2023.

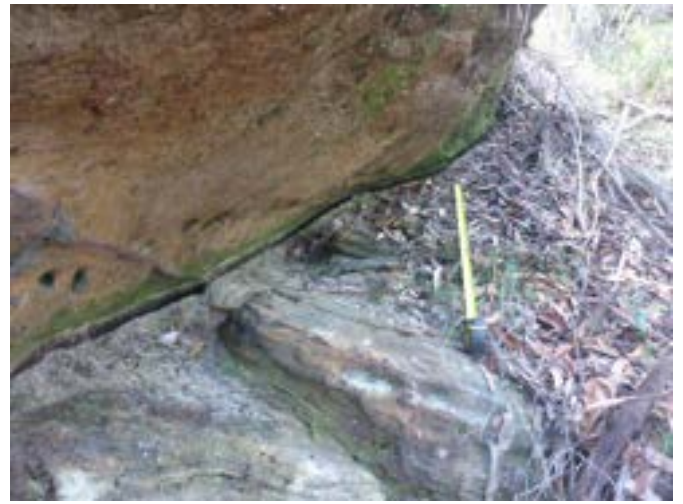
Photo 20: *DA3A\_LW19\_060*, showing extent of displacement. Taken on 5/05/2023.

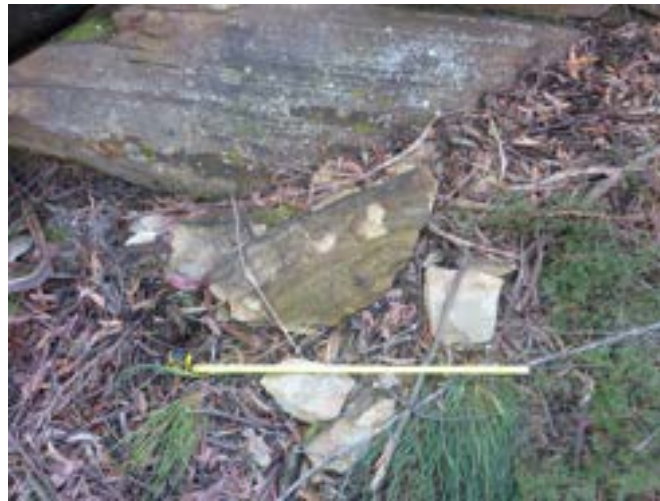
Photo 21: *DA3A\_LW19\_060*, showing rockfall. Taken on 5/05/2023

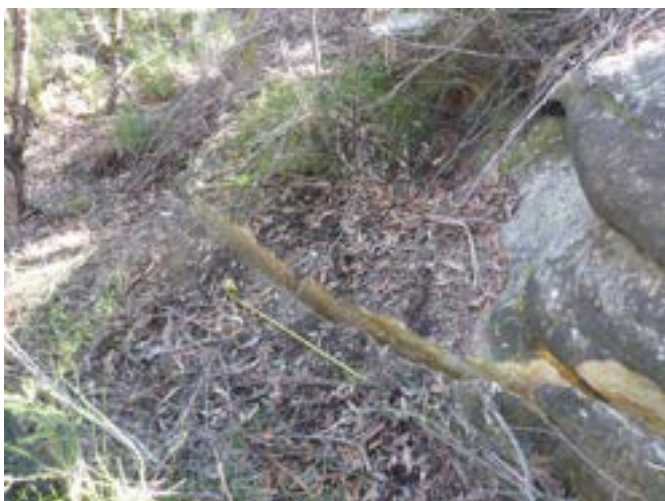
*DA3A\_LW19\_061* is located 265m to the north of tributary *WC14* (Figure 1). The impact consists of a rock fracture on a step/outcrop and associated soil cracking. The rock fracture has a total continuous length of 5.6m, a maximum width of 0.14m and a maximum measurable depth of 1.16m (Photo 22). The soil cracking has a total continuous length of 9.5m, a maximum width of 0.13m and a maximum measurable depth of 0.5m (Photo 23).

*DA3A\_LW19\_061* is a Level 2 trigger as per the Dendrobium Area 3A Landscape TARP (Table 2), specifically:

- Crack or fracture between 100mm and 300mm width.

Photo 22: *DA3A\_LW19\_061*, showing extent of rock fracture. Taken on 05/05/2023.

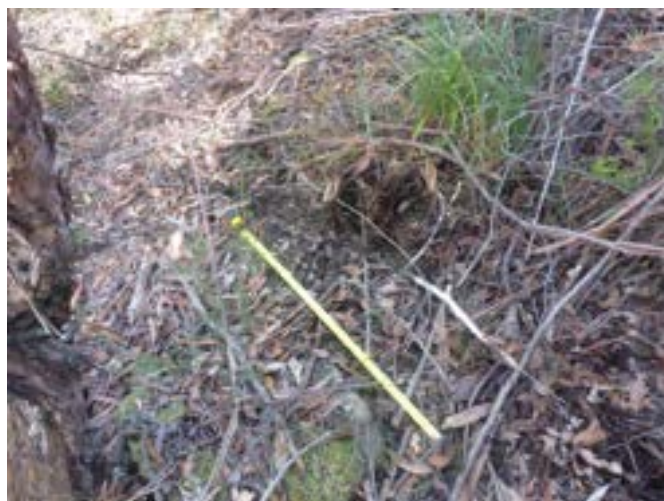
Photo 23: *DA3A\_LW19\_061*, showing extent of soil crack. Taken on 05/05/2023.

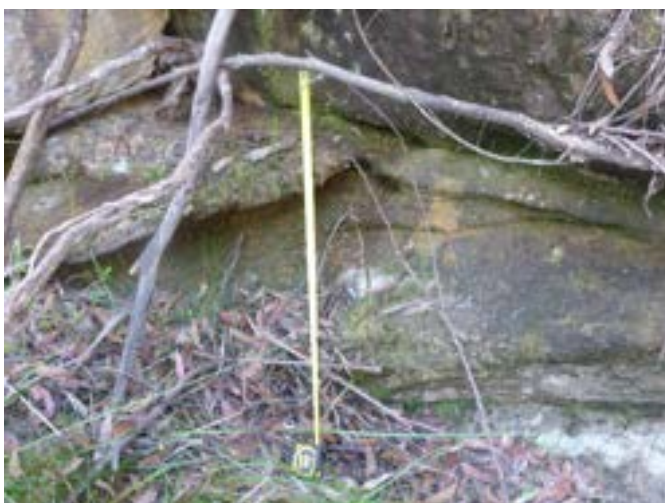
*DA3A\_LW19\_062* is located 200m to the north of *WC14*, a tributary to *Wongawilli Creek* (Figure 1). The impact consists of multiple rock fractures on the face of a rock outcrop. The largest continuous length of the fractures is 0.60m while the largest width is 0.01m (Photo 24 and Photo 25).

*DA3A\_LW19\_062* is a Level 1 trigger as per the Dendrobium Area 3A Landscape TARP (Table 2), specifically:

- Crack or fracture up to 100mm width;
- Crack or fracture up to 10m length;

Photo 24: *DA3A\_LW19\_061*, showing extent of rock fracture. Taken on 05/05/2023.

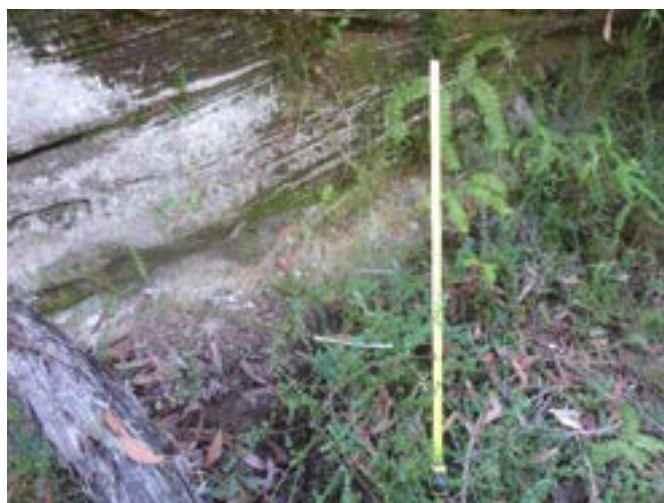
Photo 25: *DA3A\_LW19\_061*, showing extent of rock fracture. Taken on 05/05/2023.

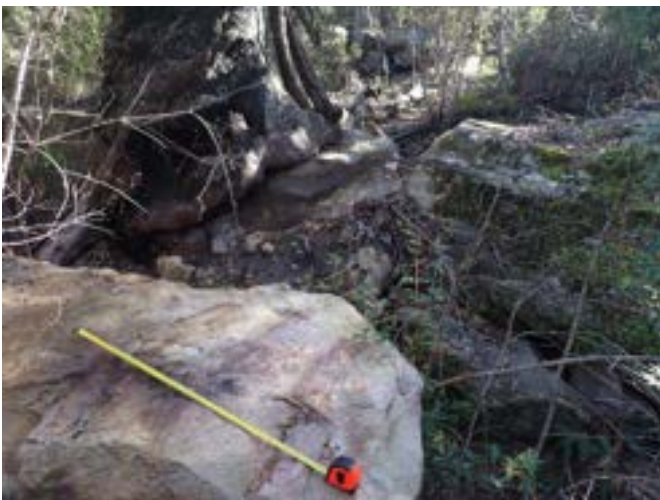
DA3A\_LW19\_063 is a Level 1 trigger as per the Dendrobium Area 3A Landscape TARP (Table 1), specifically:

- Surface movement or rock displacement with negligible soil surface exposed

Photo 1: DA3A\_LW19\_063, showing rock movement site.  
Taken on 10/05/2023.

- Continue monitoring program as required in the Longwall 19 SMP
- Report impacts to key stakeholders (Biodiversity and Conservation Division; WaterNSW; NSW Resources Regulator and Department of Planning and Environment)
- Summarise impacts and report in the End of Panel Report and Annual Review
