**DENDROBIUM AREA 3A
LONGWALL 19
END OF PANEL REPORT
July 2023**

This End of Panel (EoP) report has been prepared in accordance with Schedule 3 Condition 9 of the Dendrobium Development Consent (DA 60-03-2001). The EoP report outlines the measured and observed impacts during the extraction of Dendrobium Area 3A (DA3A) Longwall 19 and presents monitoring results and analyses compared to relevant impact assessment criteria and predictions in the DA3A Subsidence Management Plan (SMP).

Dendrobium Longwall 19 is located within Consolidated Coal Lease 768 and is the fourth panel to be extracted in DA3A. Extraction of Longwall 19 commenced on 20 June 2022 and was completed on 29 March 2023. The extracted longwall has a length of 1651 metres (m), a void width of 305 m (including first workings) and a maximum cutting height up to 3.9m.

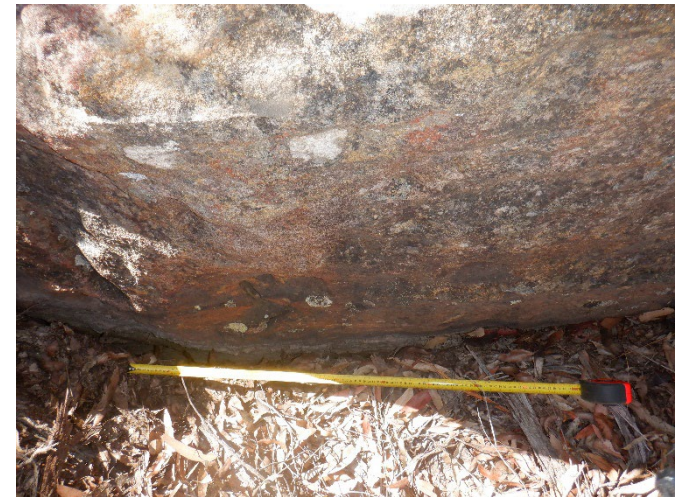
Photo 24: DA3A_LW19_019, showing rock displacement.
Taken on 13/12/2022.

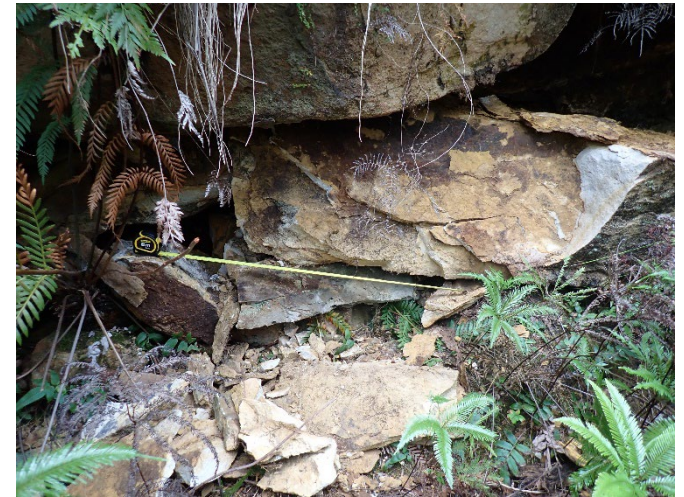
Photo 39: DA3A_LW19_040, showing rock fall and fragmentation. Taken on 12/04/2023.

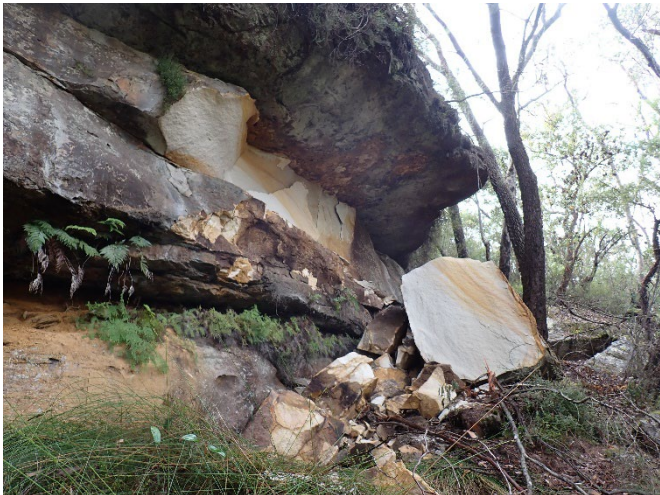
Photo 40: DA3A_LW19_041, showing rockfall at landscape monitoring site LW19_SS5. Taken on 12/04/2023.

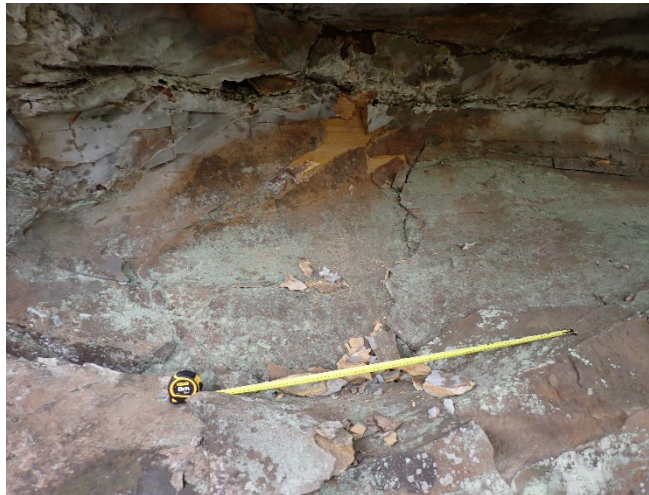
Photo 41: DA3A_LW19_042, showing rockfall and fragmentation at landscape monitoring site LW19_SS4. Taken on 12/04/2023.

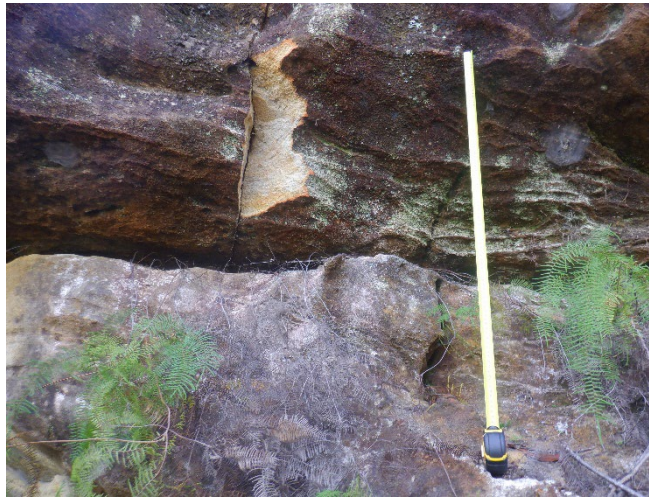
Photo 44: DA3A_LW19_047, showing rockfall. Taken on 27/04/2023.

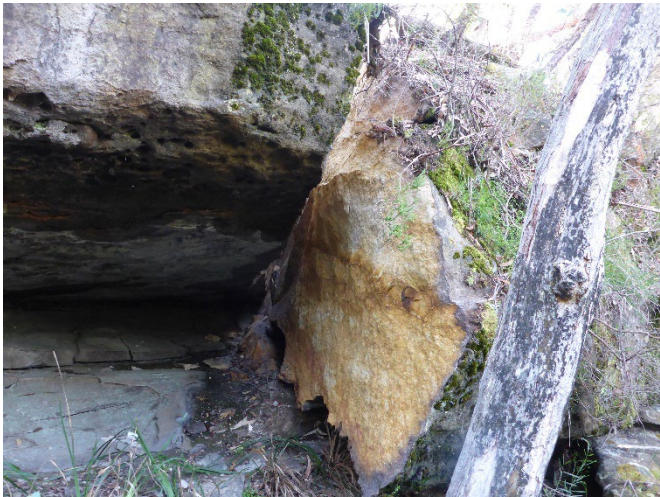
Photo 49: DA3A_LW19_056, showing rockfall. Taken on 05/05/2023.

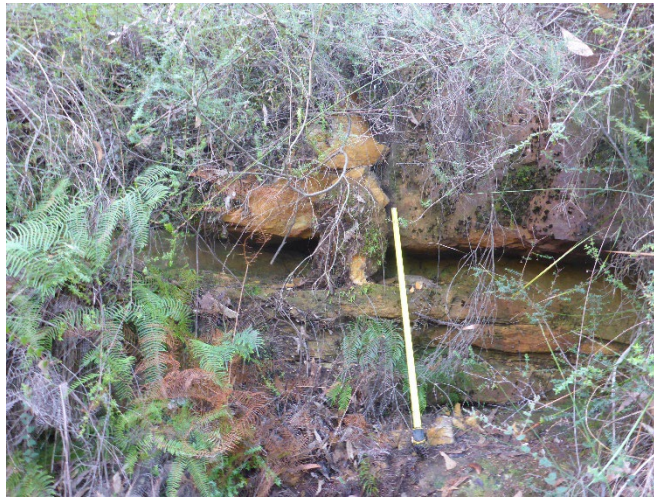
Photo 50: DA3A_LW19_057, showing rockfall. Taken on 05/05/2023.

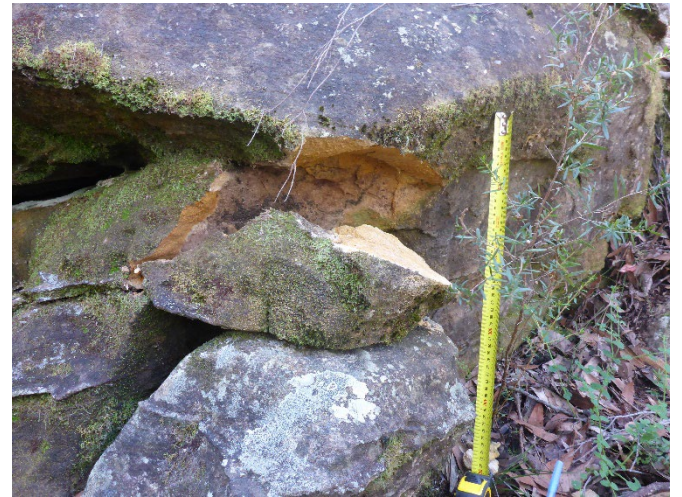
Photo 51: DA3A_LW19_058, showing rockfall. Tape measure set at 0.5m. Taken on 05/05/2023.

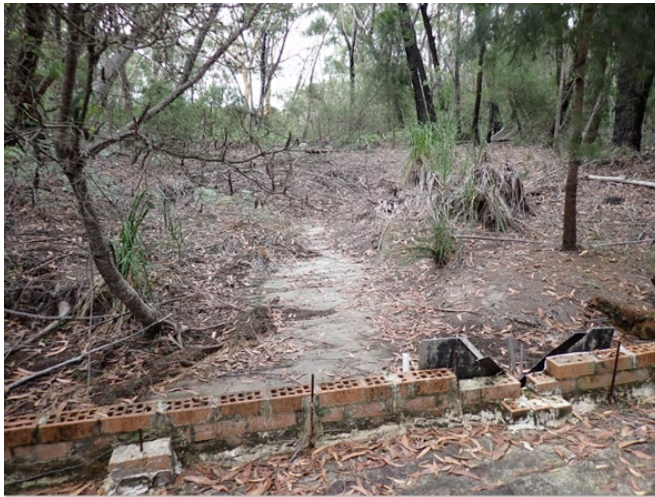
An area of erosion was identified on tributary DC13. The erosion was identified immediately upstream from BCD-installed flow monitoring weir (Photo 58). The baseline condition of the site can be seen in Photo 57. Following recent observations erosion of the soil was identified extending upstream from the sandstone rockbar. A sandstone-base channel was present during the baseline mapping of the watercourse, however during recent inspections there is evidence of erosion to the soil banks and loss of vegetation (Photo 59). The erosion does not extend upstream into Swamp 1b. This site will continue to be monitored on a periodic basis to determine whether there is continued erosion.

Photo 59: Erosion upstream of weir on DC13. Taken on 28/02/2023.
