**DENDROBIUM AREA 3C
LONGWALL 21 END OF PANEL
LANDSCAPE REPORT
NOVEMBER 2023**

EXECUTIVE SUMMARY

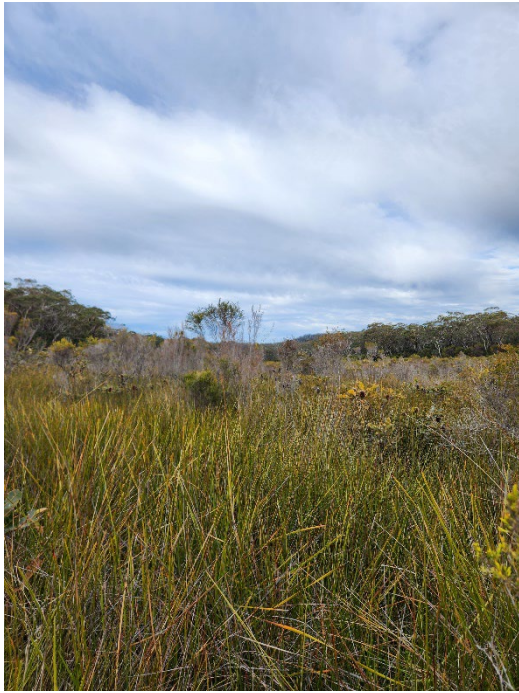
Photo 1: Reference site S22_S02. Taken on 22/06/2023.

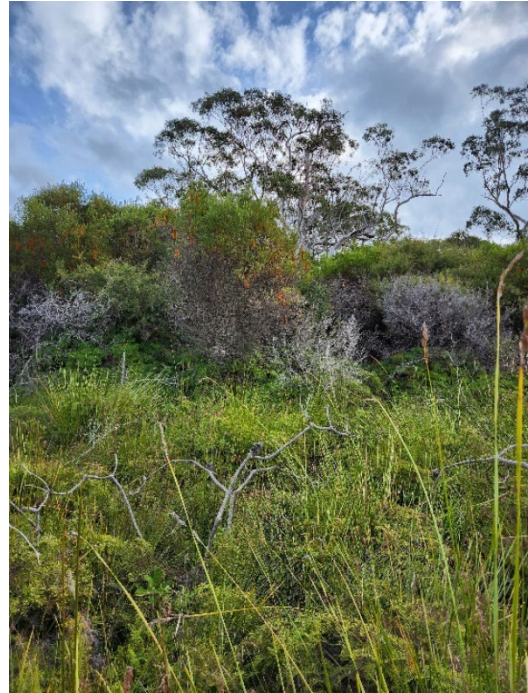
Photo 2: Reference site S24_S01. Taken on 22/06/2023.

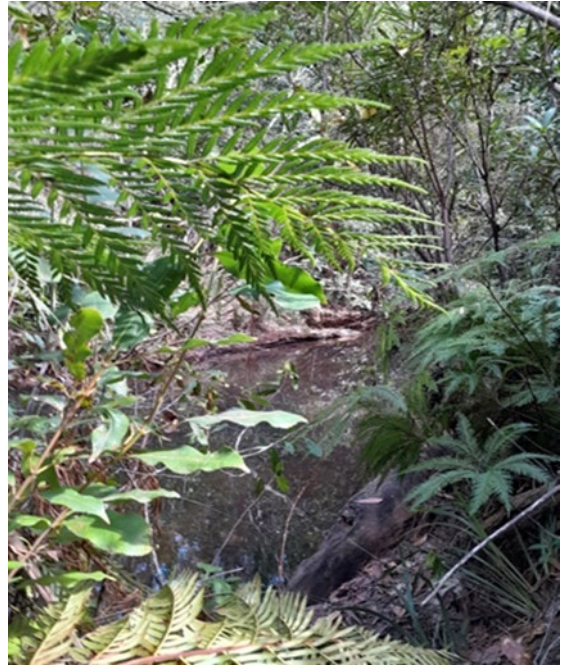
During inspections undertaken in September 2023, no iron was evident on Wongawilli Creek upstream of spring at *WC_Pool 53* (Photo 3 and Photo 4). Downstream of *WC_Pool 20* (Photo 9 and Photo 10), isolated sections of iron staining were restricted to shallow sections of pools and rockbars with the deeper pools remaining unaffected. No observable iron was evident at *Wongawilli Creek (FR6)* (Photo 11 and Photo 12) and *WC_Pool 2* (Photo 13 and Photo 14) (Figure 5).

Photo 4: *WC_Pool 53* looking downstream.
Taken 11/09/2023.

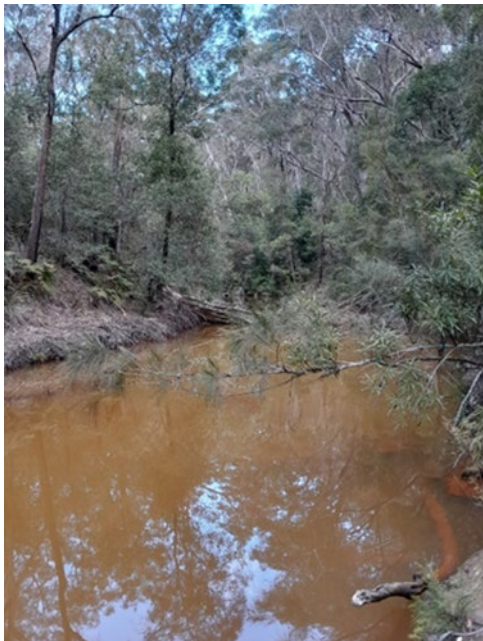
Photo 5: *WC_Pool 50* looking upstream.
Taken 11/09/2023.

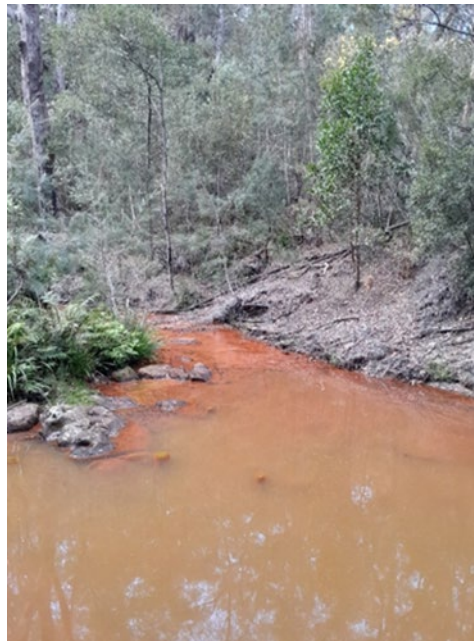
Photo 6: *WC_Pool 50* looking downstream. Taken 11/09/2023.

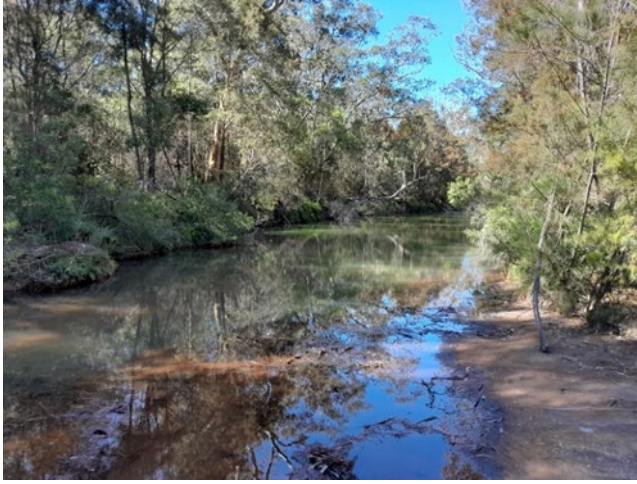
Photo 7: *WC_Pool 30* looking upstream.
Taken 11/09/2023.

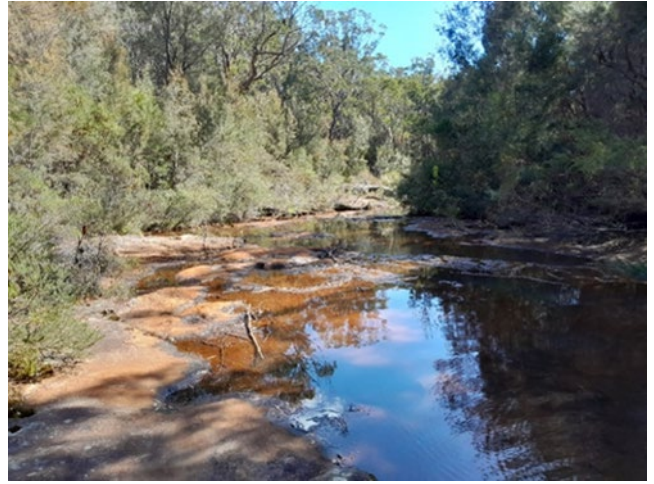
Photo 8: *WC_Pool 30* looking downstream.
Taken 11/09/2023.

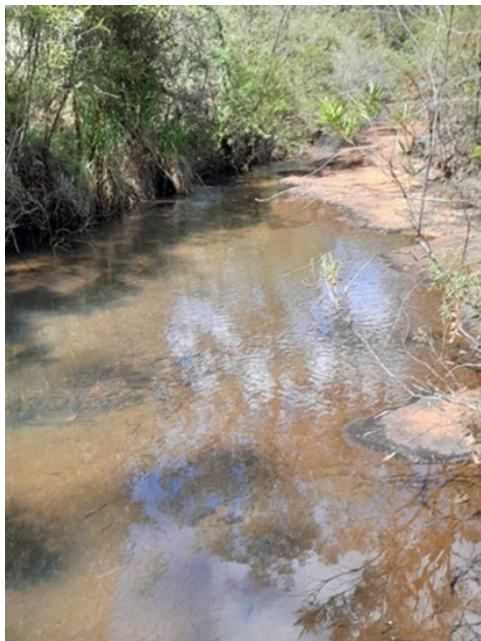
Photo 9: *WC_Pool 20* looking upstream.
Taken 11/09/2023.

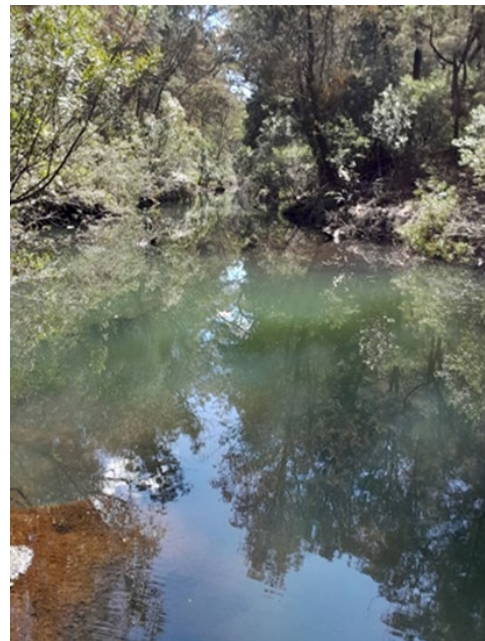
Photo 10: *WC_Pool 20* looking
downstream.
Taken 11/09/2023.

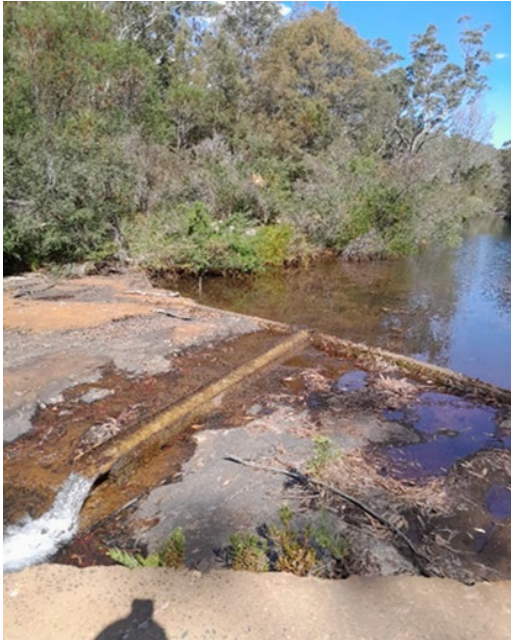
Photo 11: *Wongawilli Creek (FR6)* looking upstream. Taken 19/09/2023.

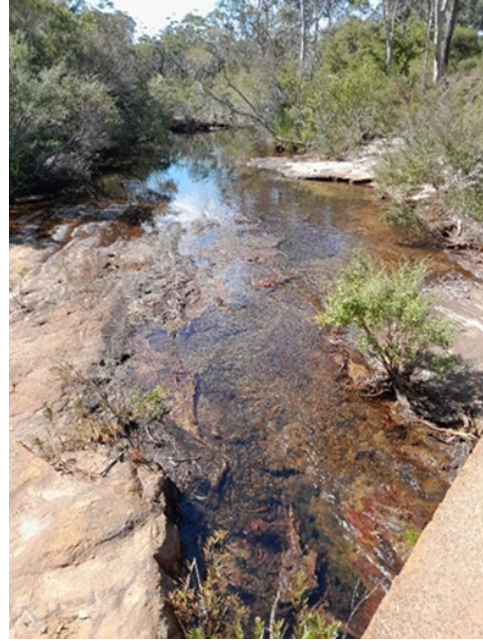
Photo 12: *Wongawilli Creek (FR6)* looking downstream. Taken 19/09/2023.

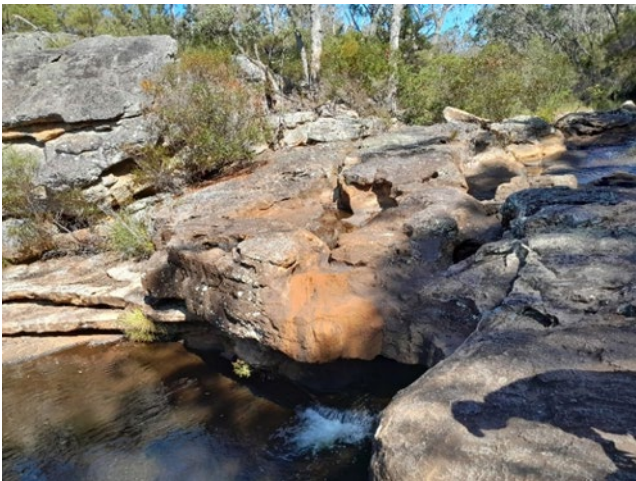
Photo 13: *WC_Pool 2* looking upstream. Taken 19/09/2023.

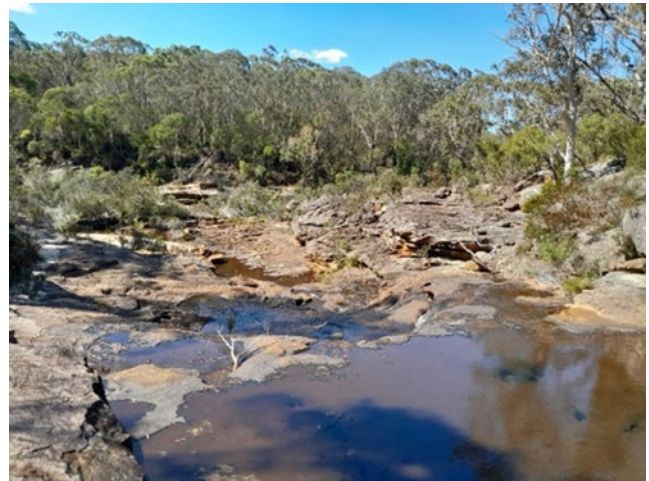
Photo 14: *WC_Pool 2* looking upstream. Taken 19/09/2023.

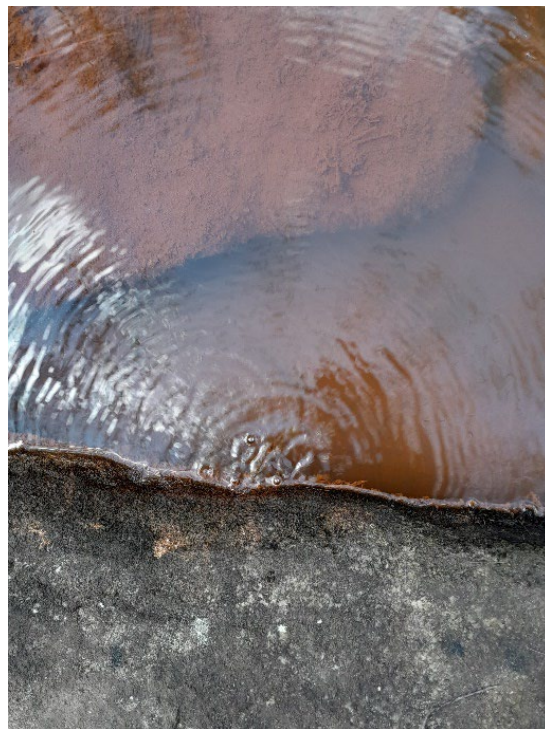
The latest inspection was undertaken on 11 September 2023. During this inspection, one light gas release was reported from the base of the sandstone step on the western side of the pool (Photo 16). This release was

Photo 16: *DA3A_LW19_029*, gas release from base of sandstone ledge on the western side of *WC_Pool 50*, Wongawilli Creek. Taken on 11/09/2023.

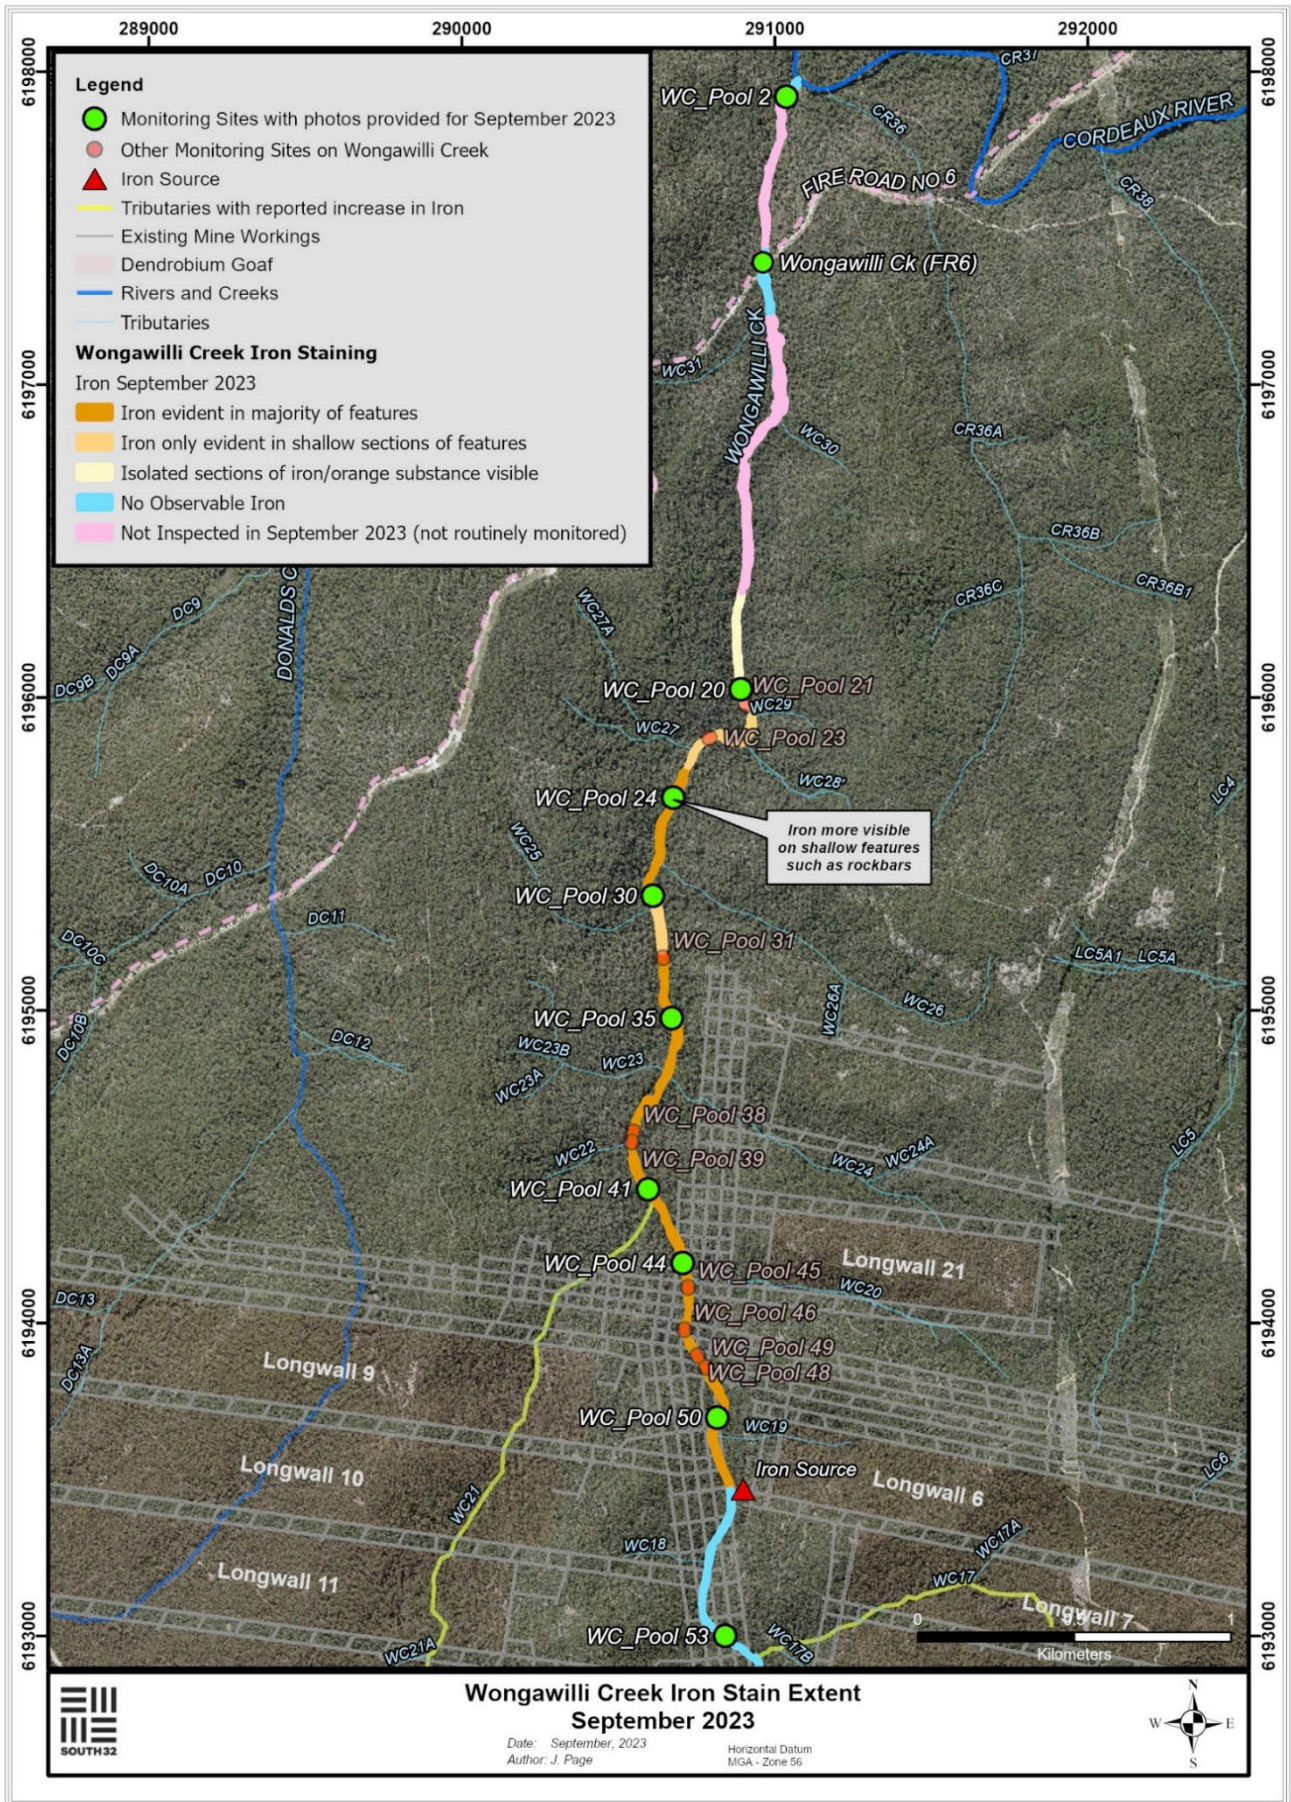
Figure 5: Wongawilli Creek iron stain extent, September 2023.

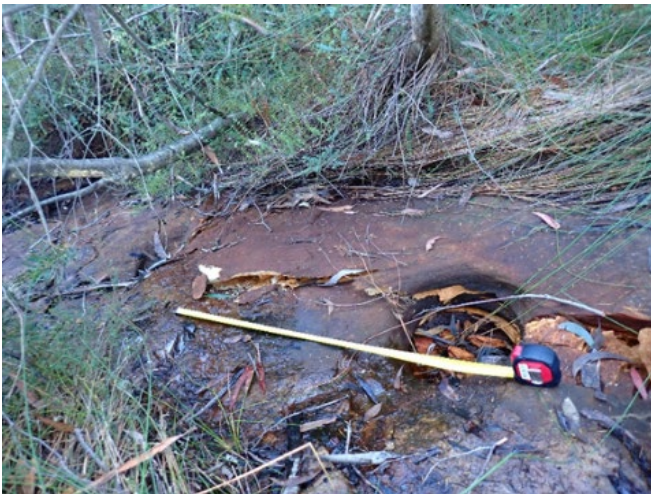
Impact *DA3C_LW21_014* consists of rock fracturing on tributary WC20 (Figure 3). The fracturing was observed on mapped feature '*WC20_Rockbar 22*' (Photo 20 and Photo 21), with damage to the concrete footing of flow monitoring site *WC20S2* observed directly upstream (Photo 19). The fracturing on the rockbar has a maximum continuous length of 3.45m, a maximum width of 0.06m and a maximum measured depth of 0.57m. There was no surface flow at the site during this inspection and flow diversion is likely.

DA3C_LW21_014 is a Level 2 trigger as per the Dendrobium Watercourse TARP (Table 7), specifically:

- ...fracture that results in observable loss of surface water or erosion.

Photo 21: *DA3C_LW21_014*, section of the rock fracturing. Taken on 11/07/2023.

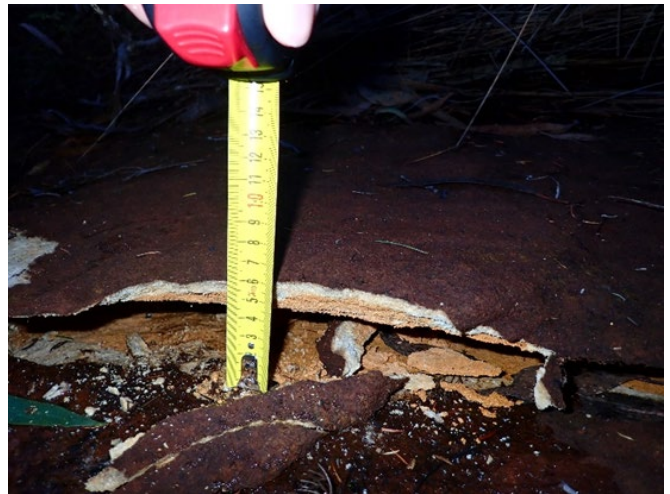
Photo 22: *DA3C_LW21_014*, width of the rock fracture. Taken on 11/07/2023.

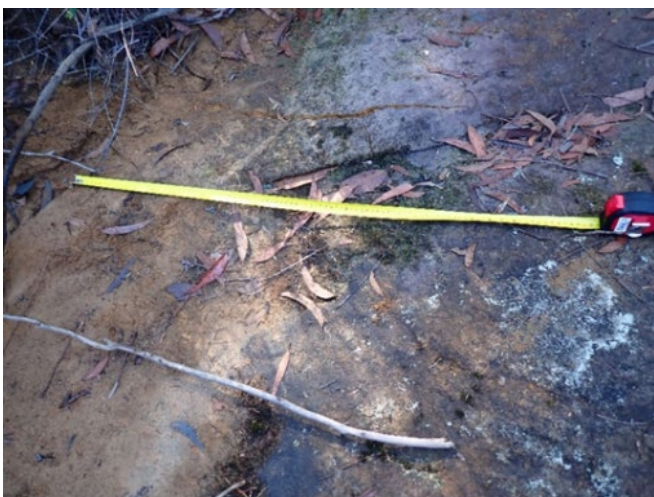
Impact *DA3C_LW21_015* consists of rock fracturing on tributary WC20 (Figure 3). The fracturing was observed on mapped feature '*WC20_Channel 8*' and has a maximum length of 2.26m, a maximum width of 0.02 and maximum measurable depth of 0.37m (Photo 24 to Photo 26). No surface flow or pooling was observed at the site during this inspection and flow diversion is likely.

DA3C_LW21_015 is a Level 2 trigger as per the Dendrobium Watercourse TARP (Table 7), specifically:

- ...fracture that results in observable loss of surface water or erosion.

Photo 24: *DA3C_LW21_015*, section of rock fracturing. Taken on 11/07/2023.

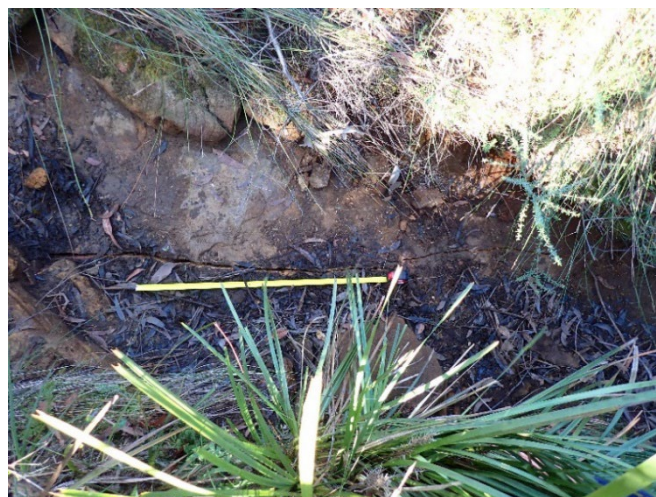
Photo 25: *DA3C_LW21_015*, other section of rock fracturing. Taken on 11/07/2023.

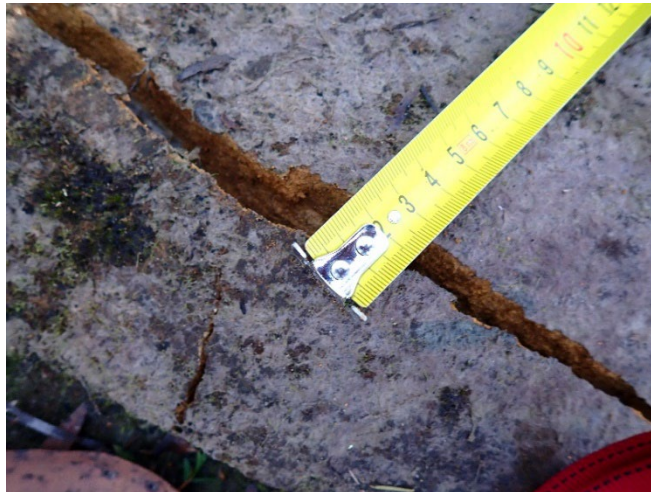
Photo 26: *DA3C_LW21_015*, width of rock fracture. Taken on 11/07/2023.

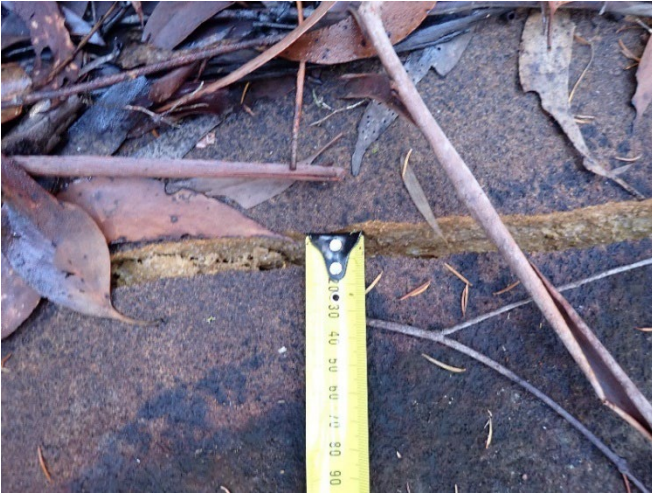
Impact *DA3C_LW21_017* consists of rock fracturing and uplift to '*WC20_Rockbar 15*' on tributary WC20 (Figure 3). The fracturing has a maximum length of 2.6m, a maximum width of 0.012m and uplift of 0.02m (Photo 27 to Photo 30). No surface flow was present during the inspection however the impact is not situated in the direct flow path, therefore flow diversion is unlikely to occur.

DA3C_LW21_017 is a Level 1 trigger as per the Dendrobium Watercourse TARP (Table 7), specifically:

- Crack or fracture up to 100mm width at its widest point with no observable loss of surface water or erosion;
- Crack or fracture up to 10m in length with no observable loss of surface water or erosion.

Photo 27: DA3C_LW21_017, width of the rock fracture. Taken on 26/07/2023.

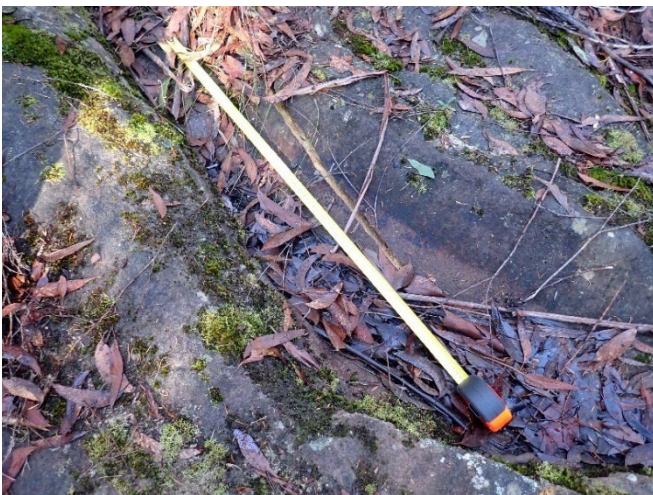
Photo 29: DA3C_LW21_017, section of rock fracturing. Taken on 26/07/2023.

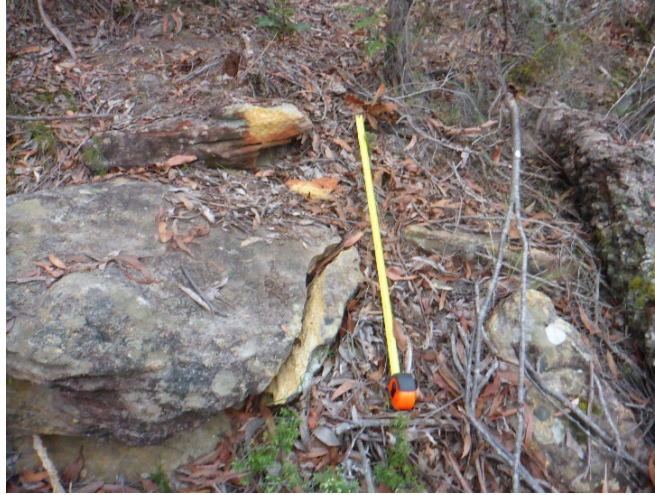
DA3C_LW21_001 is a Level 1 trigger as per the Dendrobium Landscape TARP (Table 8), specifically:

- Crack or fracture up to 100mm width;
- Crack or fracture up to 10m length.

Photo 36: *DA3C_LW21_001*, showing rock fracture.
Taken on 06/06/2023.

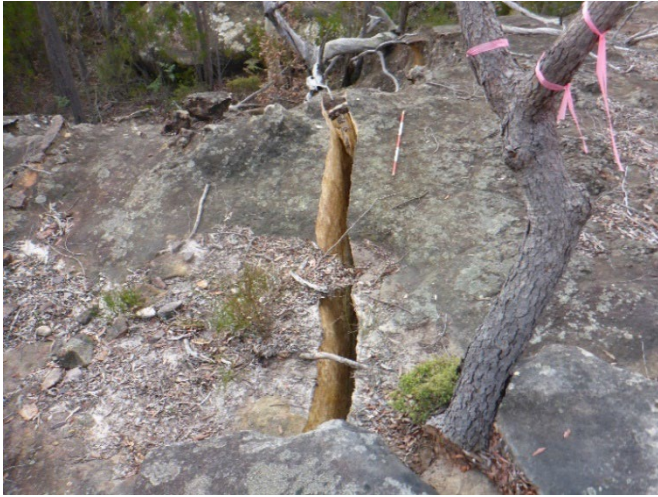
DA3C_LW21_002 is located approximately 140m west of *Fire Road 6F* (Figure 3). The impact consists of multiple large fractures on a rock outcrop at Landscape Monitoring site *LW21_RO1* (Figure 1). The largest fracture has a maximum continuous length of 16m, a maximum width of 0.265m and a maximum measurable depth of 9m (Photo 35 and Photo 36). Rock movement from boulders directly above the fracturing were displaced by 0.26m with exposed soil (Photo 37). Minimal impact to vegetation however moderate ground disturbance to rock outcrop from additional smaller rock fractures (Photo 38 and Photo 39).

DA3A_LW21_002 is a Level 2 trigger as per the *Dendrobium Landscape TARP* (Table 8), specifically:

- Crack or fracture between 100mm and 300mm width;
- Crack or fracture between 10m and 50m length.

Photo 37: DA3C_LW21_002, showing largest rock fracture in series. Taken on 06/06/2023.

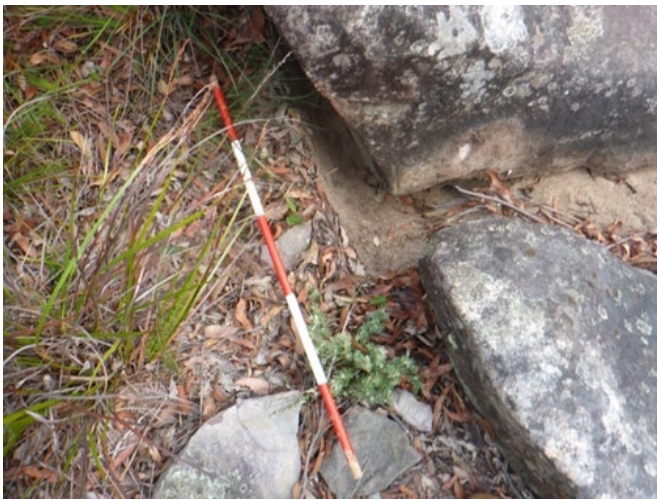
Photo 39: DA3C_LW21_002, showing rock movement on largest fracture. Taken on 6/06/2023.

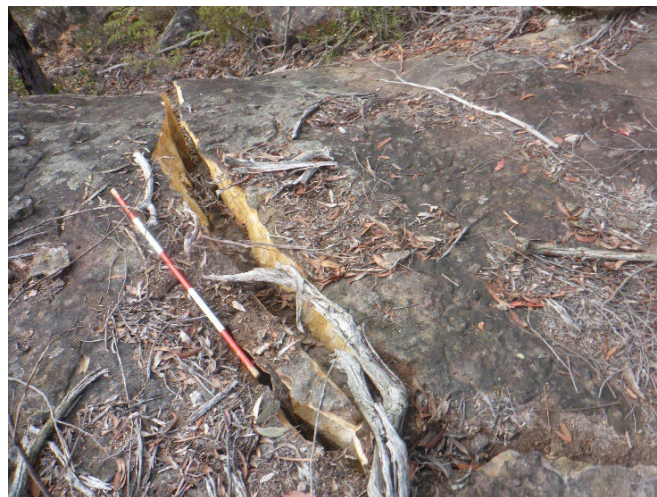
Photo 41: DA3C_LW21_002, showing section of rock fracturing. Taken on 06/06/2023.

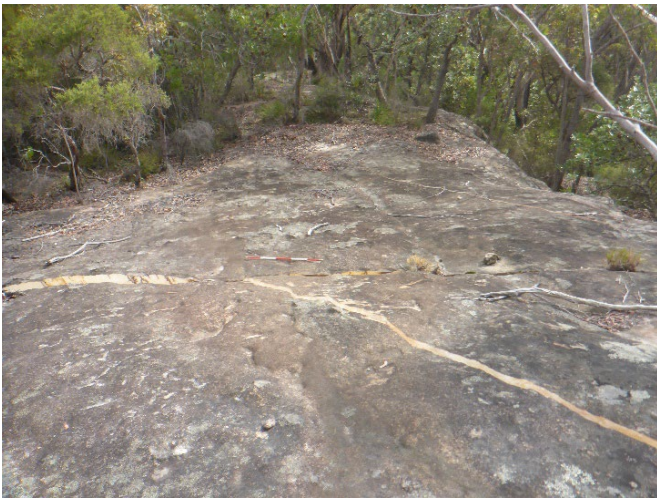
DA3C_LW21_003 is located approximately 225m west of *Fire Road 6F* (Figure 3). The impact consists of multiple large rock fractures on a rock outcrop and a rockfall from the edge of a step on the same outcrop. The largest rock fracture has a maximum continuous length of 22m, a maximum width of 0.26m and a maximum measurable depth of 3m (Photo 40 and Photo 41). One boulder from the step has dislodged with a rockfall volume of less than 0.1m³ and an approximate debris area of 0.5m² (Photo 42 and Photo 43). The impact has minimal impact to vegetation.

DA3C_LW21_003 is a Level 2 trigger as per the Dendrobium Landscape TARP (Table 8), specifically:

- Crack or fracture between 100mm and 300mm width;
- Crack or fracture between 10 and 50m length.

Photo 42: DA3C_LW21_003, rock fracture on an outcrop. Taken on 06/06/2023.

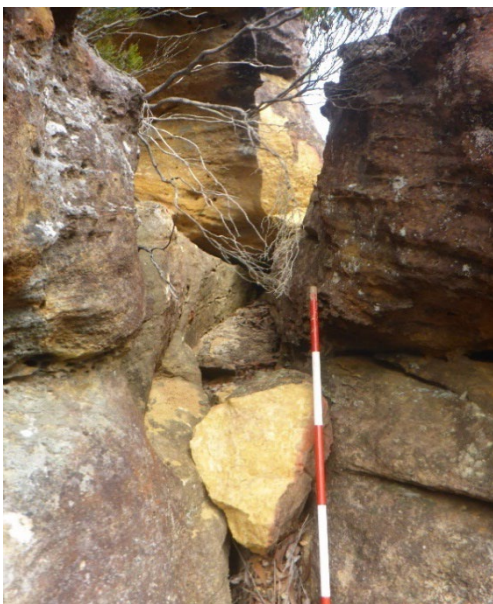
Photo 44: DA3C_LW21_003, showing rockfall and fragmentation. Taken on 06/06/2023.

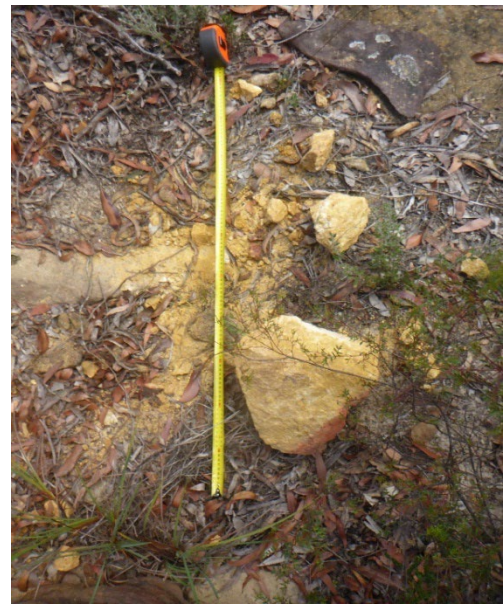
Photo 45: DA3C_LW21_003, showing rockfall debris. Taken on 06/06/2023.

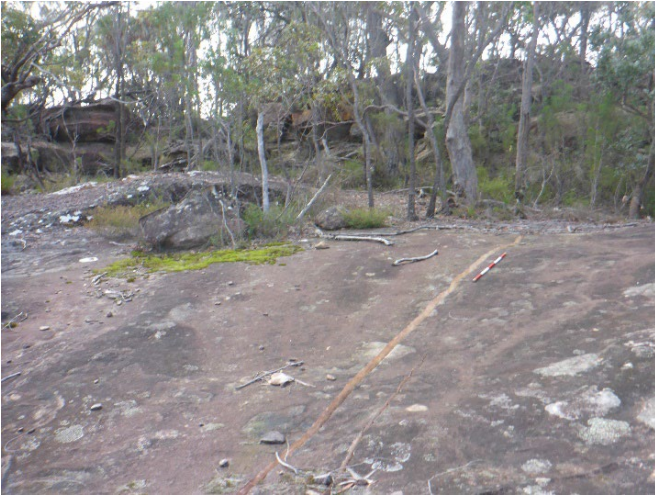
DA3C_LW21_004 is located approximately 210m west of *Fire Road 6F* (Figure 3). The impact consists of rock fracturing on an outcrop. The rock fracture has a continuous length of approximately 12m, a maximum width of 0.09m and a maximum measurable depth of 2.4m (Photo 44 and Photo 45).

DA3C_LW21_004 is a Level 2 trigger as per the Dendrobium Landscape TARP (Table 8), specifically:

- Crack or fracture between 100mm and 300mm width;
- Crack or fracture between 10 and 50m length;

Photo 46: DA3C_LW21_004, rock fracture on an outcrop. Taken on 06/06/2023.

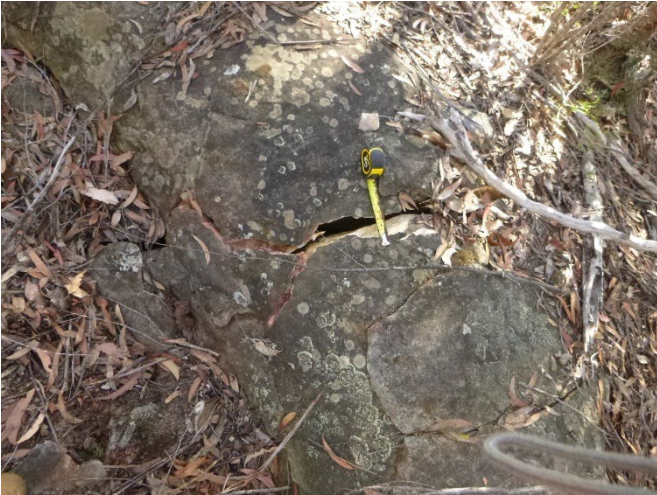
DA3C_LW21_005 is located approximately 150m northeast of *WC20*, a tributary of *Wongawilli Creek* (Figure 3). The impact consists of a fracture to a rock outcrop (Photo 46 and Photo 47). The rock fracture has a continuous length of 2.1m, a maximum width of 0.05m and a maximum measurable depth of 1.84m. The fracture also resulted in a displacement of small rock fragments.

DA3C_LW21_005 is a Level 1 Trigger as per the Dendrobium Landscape TARP (Table 8), specifically:

- Crack or fracture up to 100mm width;
- Crack or fracture up to 10m length.

Photo 48: *DA3C_LW21_005*, fracture to rock outcrop. Taken on 15/06/2023.

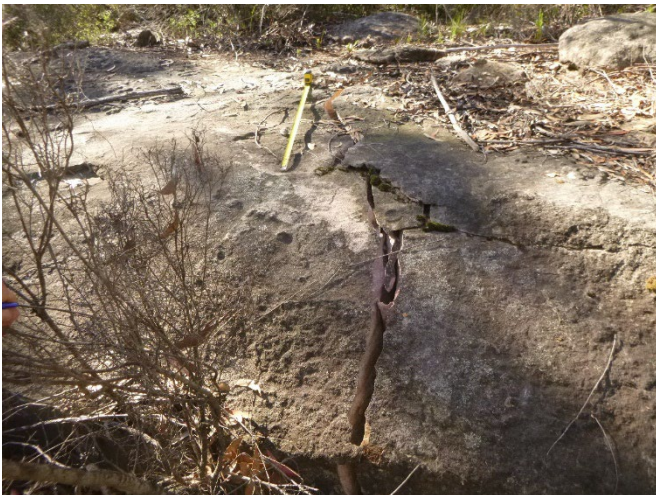
DA3C_LW21_006 is a Level 1 trigger as per the *Dendrobium Landscape TARP* (Table 8), specifically:

- Crack or fracture up to 100mm width;
- Crack or fracture up to 10m length.

Photo 50: *DA3C_LW21_006*, fracturing to rock outcrop. Taken on 15/06/2023.

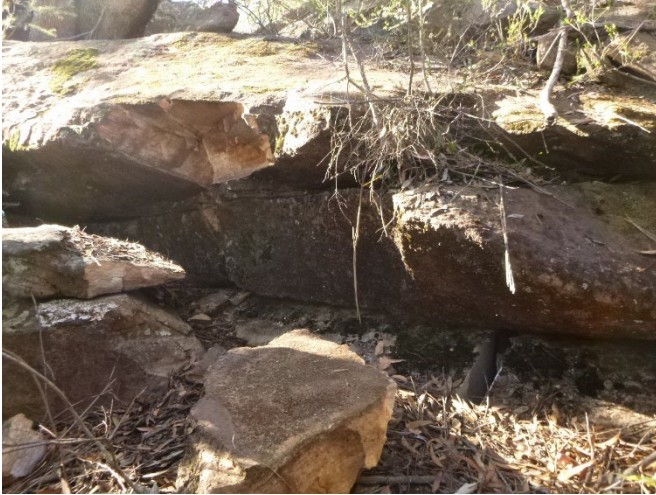
DA3C_LW21_007 is a Level 2 trigger as per the Dendrobium Landscape TARP (Table 8), specifically:

- Crack or fracture between 100mm and 300mm width.

Photo 52: DA3C_LW21_007, fracturing and rock fall to outcrop. Taken on 15/06/2023.

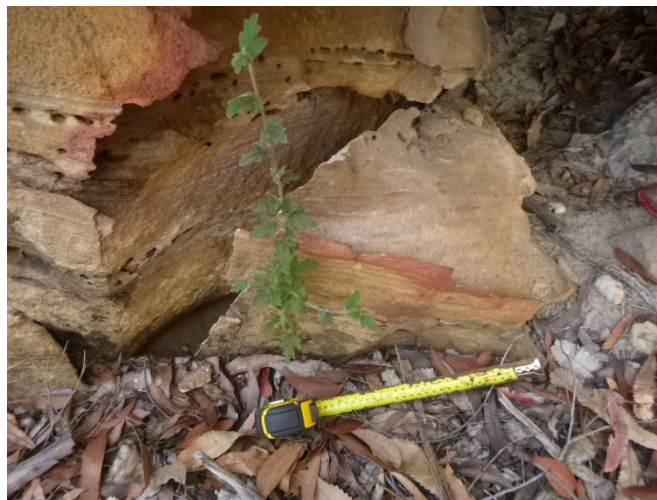
Photo 54: DA3C_LW21_007, rock fall. Taken on 15/06/2023.

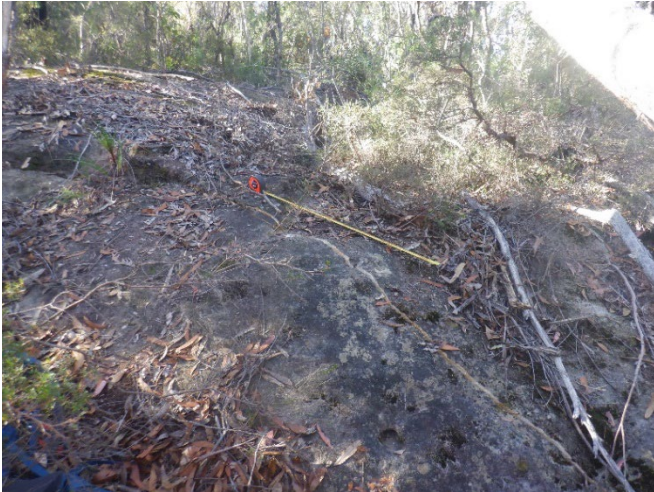
DA3C_LW21_008 is a Level 1 trigger as per the Dendrobium Landscape TARP (Table 8), specifically:

Photo 55: DA3C_LW21_008, overview of the rock fracture. Taken on 19/06/2023.

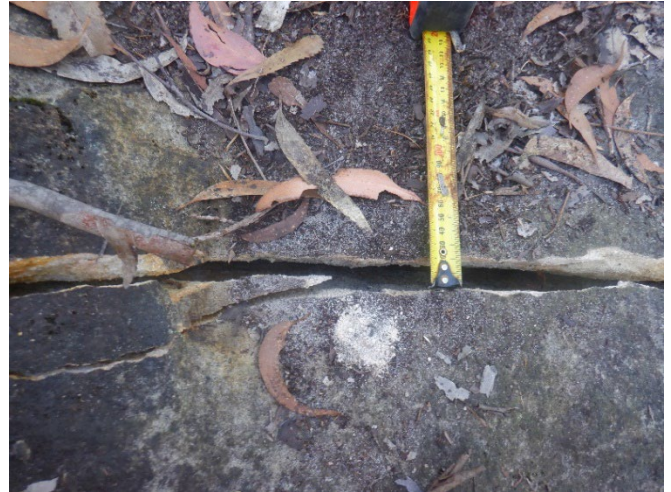
Photo 56: DA3C_LW21_008, maximum width of the rock fracture. Taken on 19/06/2023.

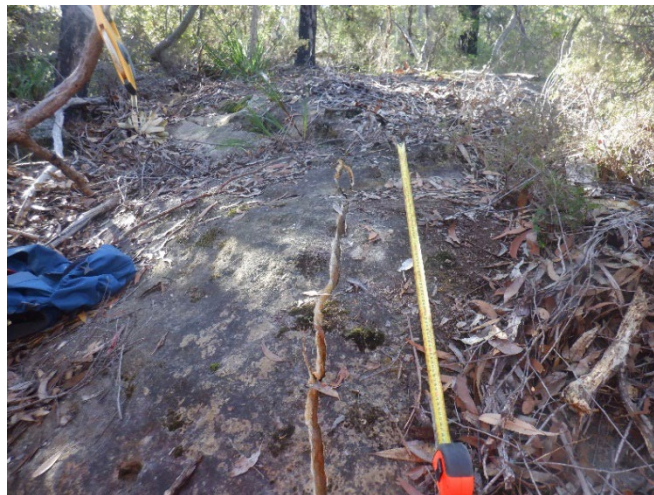
Photo 57: DA3C_LW21_008, section of the rock fracture. Taken on 19/06/2023.

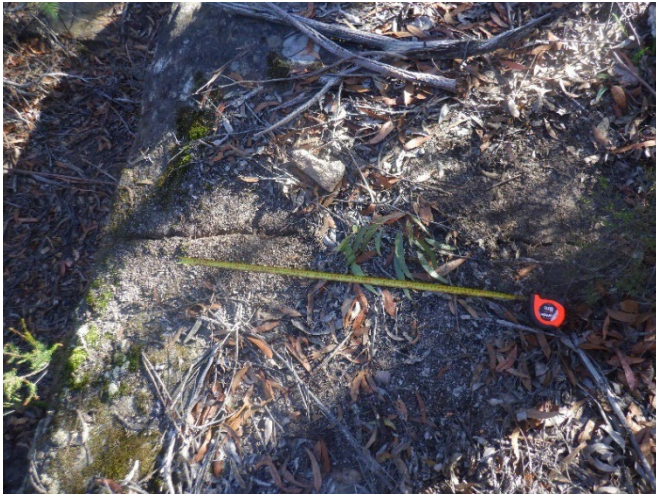
DA3C_LW21_009 is located approximately 245m west of Fire Road 6F (Figure 3). The impact consists of a rock fracture at a small rock step which disappears upslope into bushland (Photo 56 to Photo 58). The impact has a maximum continuous length of 1.65m, a maximum width of 0.012m and a maximum measurable depth of 0.73m.

DA3C_LW21_009 is a Level 1 trigger as per the Dendrobium Landscape TARP (Table 8), specifically:

Photo 58: DA3C_LW21_009, section of the rock fracture. Taken on 19/06/2023.

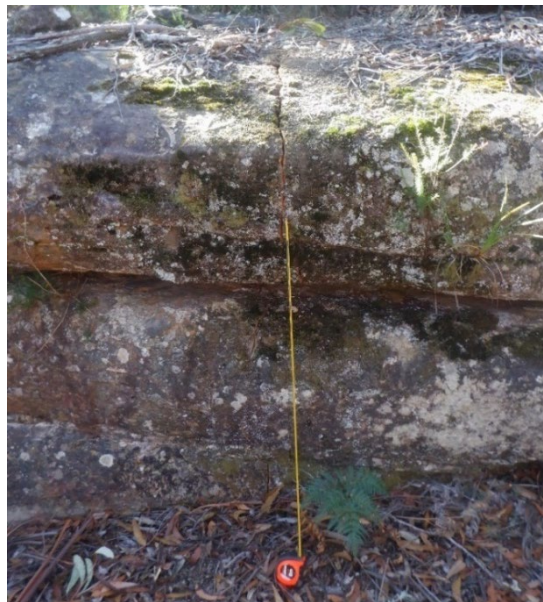
Photo 60: DA3C_LW21_009, overview of the rock fracture. Taken on 19/06/2023.

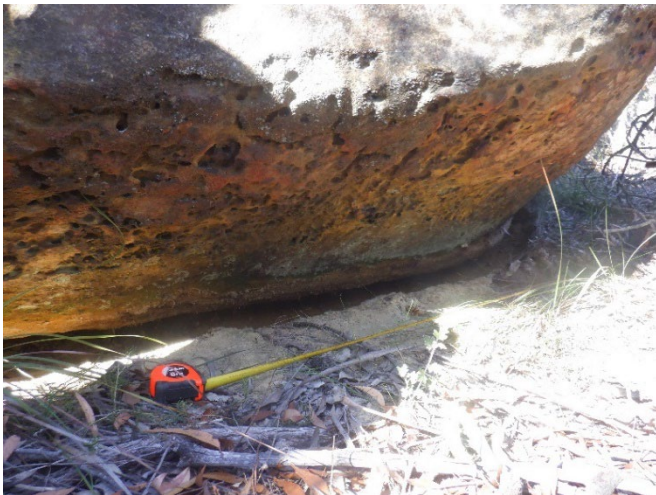
DA3C_LW21_010 is located approximately 125m west of Fire Road 6F (Figure 3). The impact consists of rock fracturing at a rock outcrop covered in shallow soil and leaf litter (Photo 60 and Photo 61). Rock movement/displacement is also evident between a large boulder and adjacent soil at the southern extent of the impact (Photo 59). The total impact area is approximately 60m². The rock fracture has a maximum continuous length of 7.6m, a maximum width of 0.20m and a maximum measurable depth of 1.4m. Flagging tape barricading is in place at the site as a safety precaution.

DA3C_LW21_010 is a Level 2 trigger as per the Dendrobium Landscape TARP (Table 8), specifically:

Photo 61: DA3C_LW21_010, Overview of the rock movement/displacement. Taken on 19/06/2023.

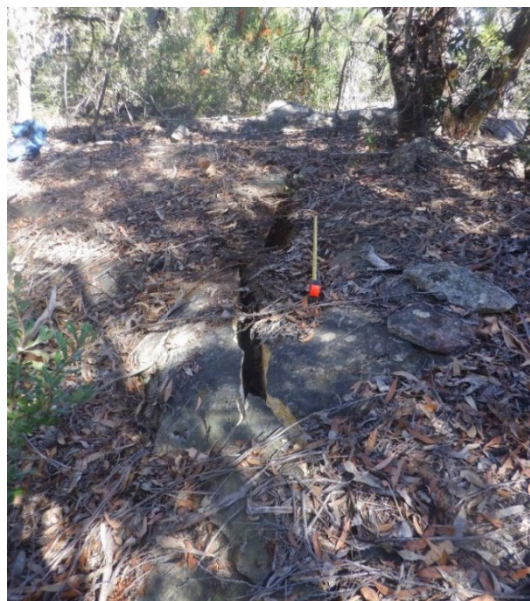
Photo 63: DA3C_LW21_010, overview of the rock fracture. Taken on 19/06/2023.

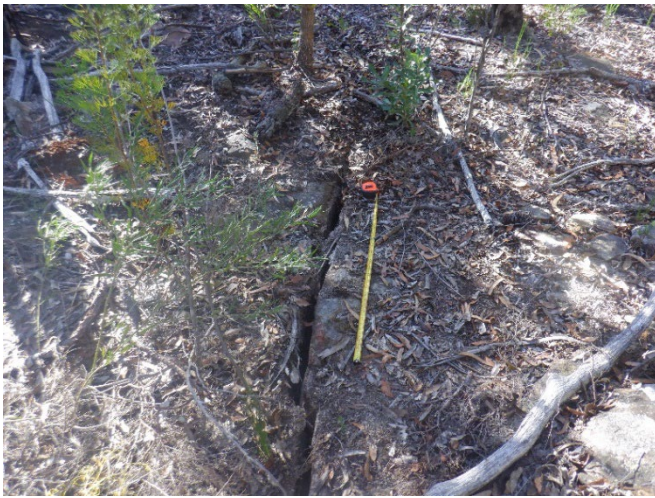
DA3C_LW21_011 is located approximately 95m west of Fire Road 6F (Figure 3). The impact consists of 25m of discontinuous rock fracturing and soil cracking to a rock outcrop and adjacent bushland (Photo 62 and Photo 63). The fracturing has a maximum continuous length of 8m, a maximum width of 0.06m and a maximum measurable depth of 0.44m. The rock fracturing has resulted in the displacement of rock from the edge of the rock outcrop (Photo 64 and Photo 65).

DA3C_LW21_011 is a Level 1 trigger as per the Dendrobium Landscape TARP (Table 8), specifically:

Photo 64: DA3C_LW21_011, section of rock fracturing. Taken on 19/06/2023.

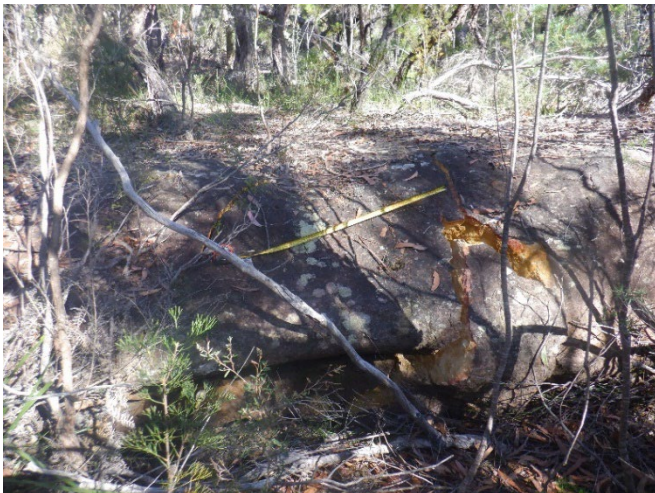
Photo 66: DA3C_LW21_011, section of rock fracturing and rock displacement. Taken on 19/06/2023.

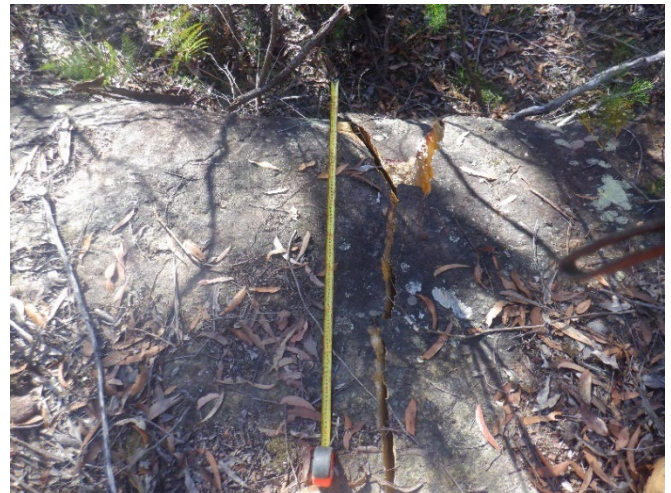
Photo 67: DA3C_LW21_011, section of rock fracturing and rock displacement. Taken on 19/06/2023.

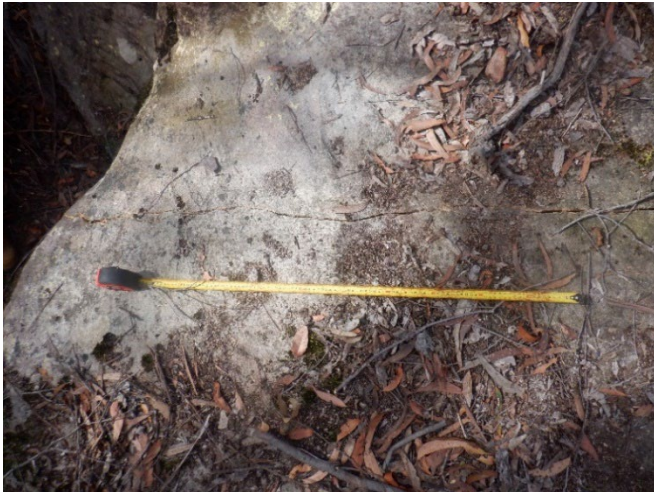
DA3C_LW21_012 is located approximately 240m west of Fire Road 6F (Figure 3). The impact consists of a rock fracture at a small rock step which disappears upslope into bushland (Photo 66 to Photo 68). The impact has a maximum continuous length of 2.65m, a maximum width of 0.01m and a maximum measurable depth of 0.30m.

DA3C_LW21_012 is a Level 1 trigger as per the Dendrobium Landscape TARP (Table 8), specifically:

Photo 68: DA3C_LW21_012, section of the rock fracture. Taken on 27/06/2023.

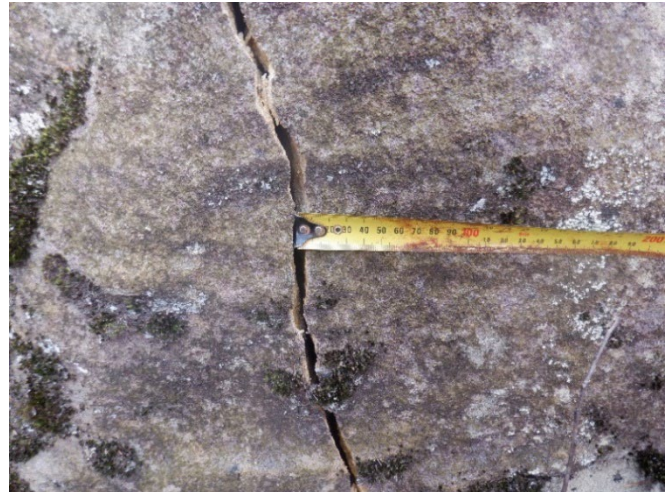
Photo 69: DA3C_LW21_012, maximum width of the rock fracture. Taken on 27/06/2023.

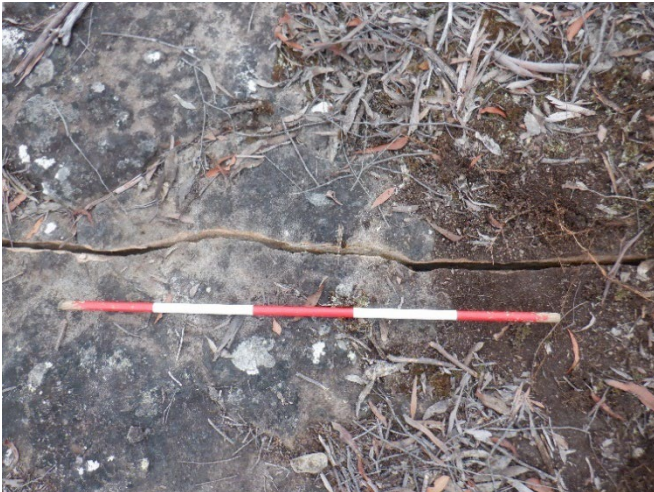
DA3C_LW21_013 is located approximately 600m west of fire Road 6F (Figure 3). The impact consists of rock fracturing to a rock outcrop with some minor associated soil cracking/rock displacement. The impact has a maximum continuous length of 3.7m, a maximum width of 0.02m and a maximum measured depth of 0.7m (Photo 69 to Photo 71).

DA3C_LW21_013 is a Level 1 trigger as per the Dendrobium Landscape TARP (Table 8), specifically:

Photo 71: DA3C_LW21_013, section of the rock fracture. Taken on 03/07/2023.

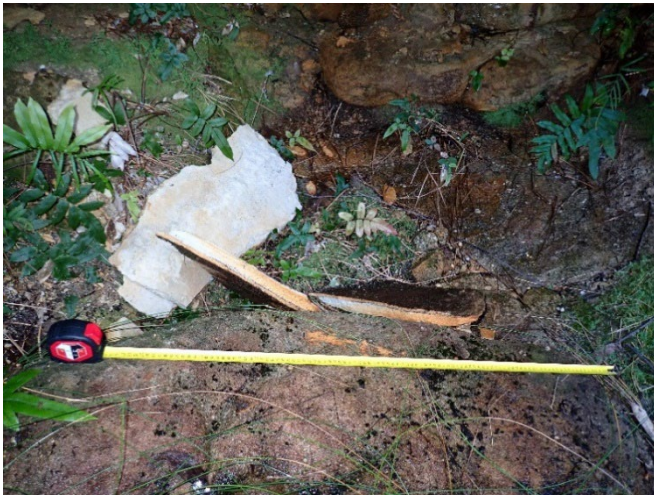
Impact *DA3C_LW21_016* consists of a small rockfall to a mapped step on tributary *WC20* (Figure 3). The fracturing was observed beneath the overhang of the step and has an approximate volume of 0.14m³ (Photo 72 and Photo 73).

DA3C_LW21_016 is a Level 1 trigger as per the Dendrobium Landscape TARP (Table 8), specifically:

Photo 74: *DA3C_LW21_016*, fragments of rockfall from step. Taken on 11/07/2023.

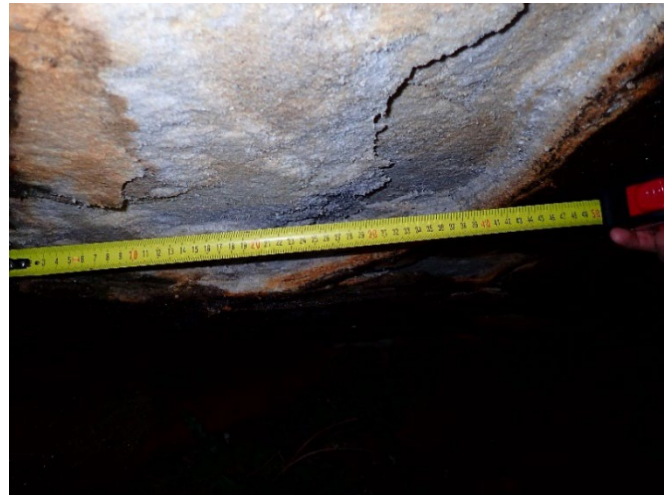
Photo 75: *DA3C_LW21_016*, underside of step from which rock fragments fell. Taken on 11/07/2023.

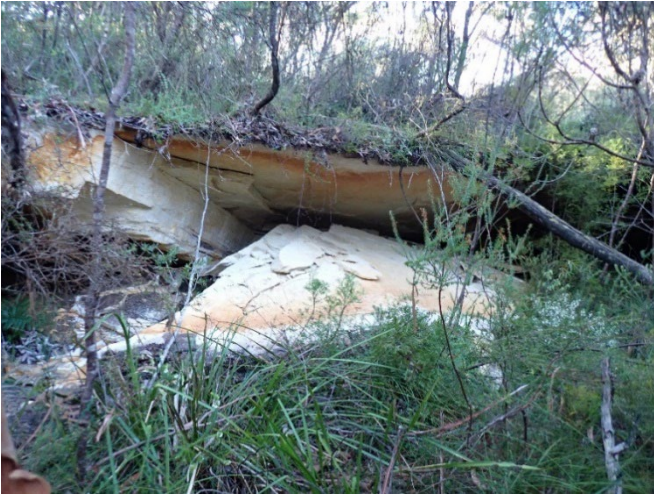
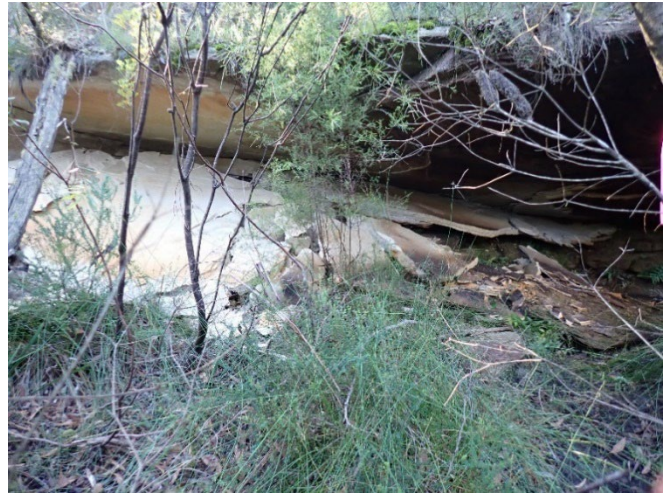
Impact *DA3C_LW21_016* was first observed on 11 July 2023 and consisted of a small rock fall ($\approx 0.14\text{m}^3$) at a step 10m north of tributary *WC20* (Figure 3). On a follow up inspection on 26 July 2023, an increase in the rockfall area was identified. The following measurements were estimated at a distance due to safety concerns. The rockfall now has a length of $\approx 7\text{m}$, a width of $\approx 1\text{m}$, a height of $\approx 2.5\text{m}$, a total volume of $\approx 17.5\text{m}^3$ and a ground disturbance area of $\approx 20\text{m}^2$ (Photo 74 and Photo 75). Flagging tape is in place at the site as a safety precaution. Note- coordinates have been updated from initial report to better reflect the impact location.

DA3C_LW21_016 is now a Level 2 trigger as per the Dendrobium Landscape TARP (Table 8), specifically:

Photo 76: *DA3C_LW21_016*, looking at the rockfall.
Taken on 26/07/2023.

Photo 77: *DA3C_LW21_016*, looking at the rockfall.
Taken on 26/07/2023.

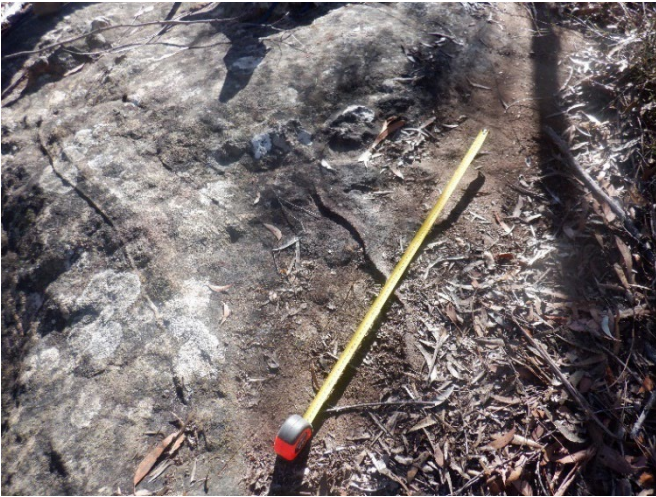
DA3C_LW21_018 is located approximately 105m north of tributary *WC20* (Figure 3). The impact consists of two rock fractures to a rock outcrop/ledge. The fracturing has a maximum continuous length of 2.87m and a maximum width of 0.003m (Photo 76 to Photo 78). Flagging tape is in place at the site as a safety precaution.

DA3C_LW21_018 is a Level 1 trigger as per the *Dendrobium Landscape TARP* (Table 8), specifically:

Photo 78: DA3C_LW21_018, section of rock fracturing. Taken on 26/07/2023.
