**DENDROBIUM AREA 3C
LONGWALL 21 END OF PANEL
LANDSCAPE REPORT
NOVEMBER 2023**

EXECUTIVE SUMMARY

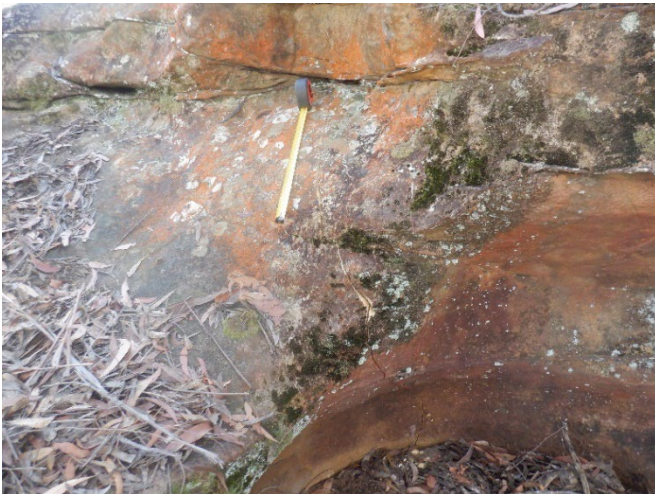
Photo 80: DA3C_LW21_018, overview of rock fracturing. Taken on 26/07/2023.

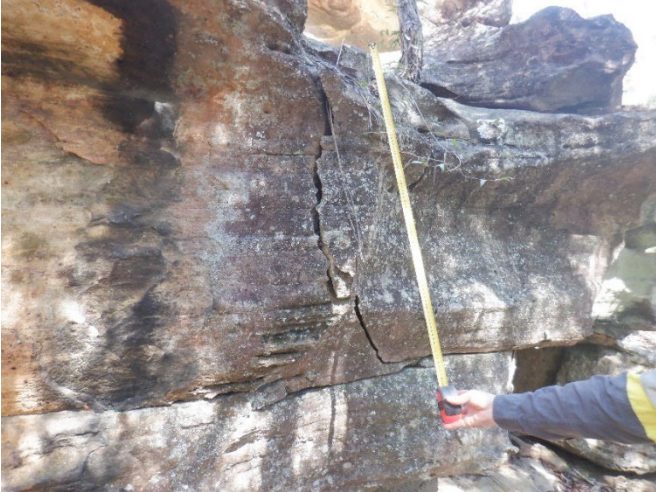
DA3C_LW21_019 is located approximately 210m west of Fire Road 6F (Figure 3). The impact consists of a single rock fracture to a rock step. The fracture has a continuous length of 2m, a maximum width of 0.03m and a maximum measurable horizontal depth of 0.3m (Photo 79 to Photo 81). Flagging tape is in place at the site as a safety precaution.

Photo 81: DA3C_LW21_019, looking at the rock fracture.
Taken on 1/08/2023.

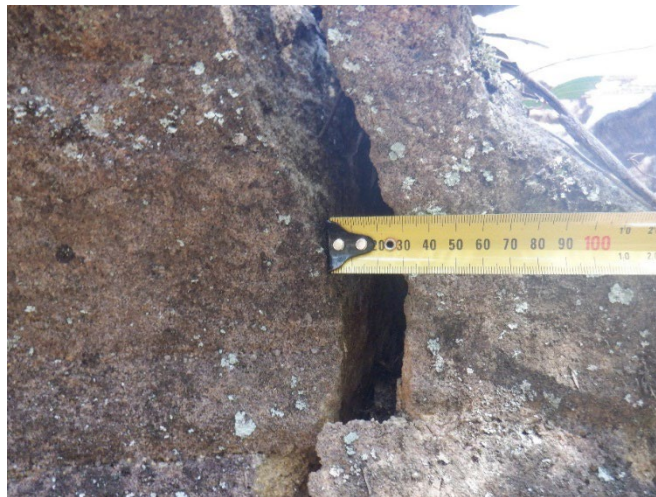
Photo 83: DA3C_LW21_019, looking at the width of
the rock fracture.
Taken on 1/08/2023.

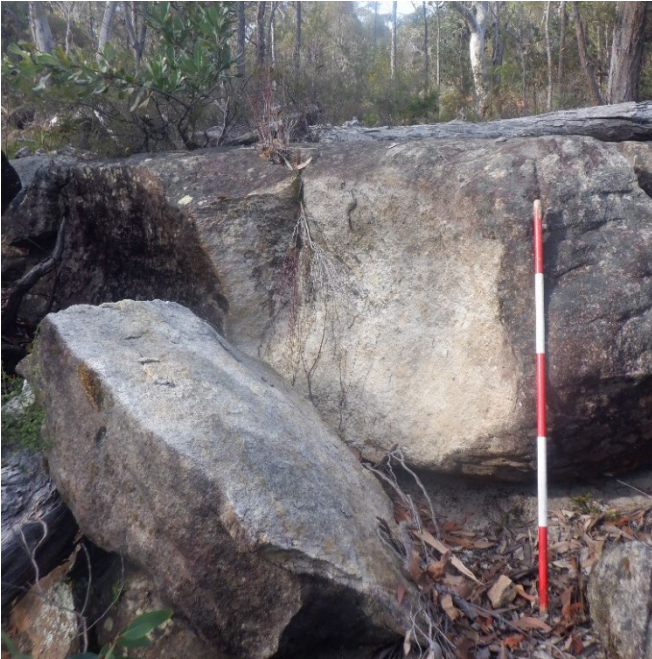
Impact DA3C_LW21_022 consists of a rockfall from a rock outcrop/step approximately 420m west of Fire Road 6F (Figure 3). Weathered sections of rock face are observed along with fresh rock face. The impact is likely from a natural fracture which has opened further and fallen away due to mining. Approximate volume of the rock is less than 0.5m³ (Photo 82 to Photo 84).

DA3C_LW21_022 is a Level 1 trigger as per the Dendrobium Landscape TARP (Table 8), specifically:

Photo 84: *DA3C_LW21_022*, overview of boulder fallen away from step. Taken 7/08/2023.

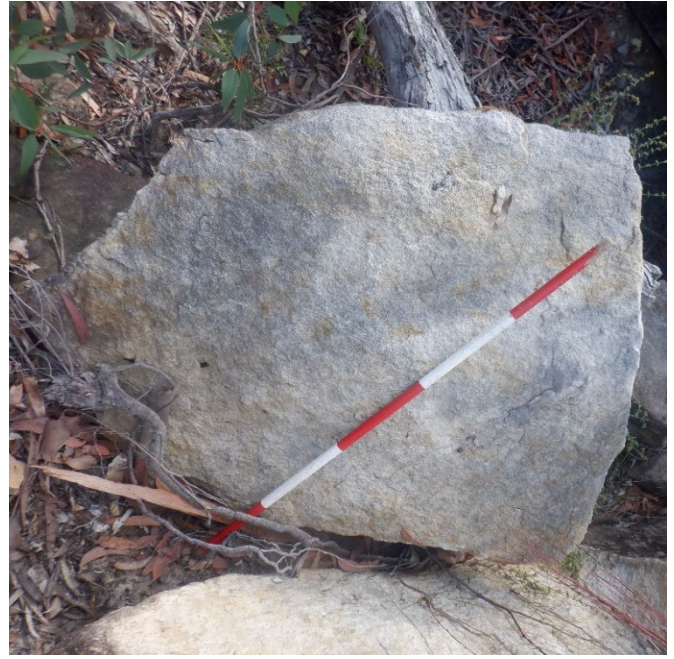
Photo 85: *DA3C_LW21_022*, Rockfall showing unweathered rock, looking down from step above. Taken 7/08/2023.

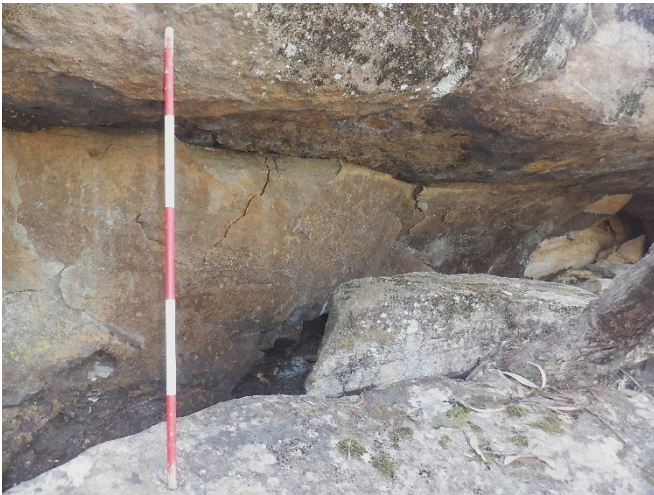
DA3C_LW21_026 is located approximately 50m north of tributary WC20 (Figure 3). The impact consists of a rockfall and rock fracturing to a rock overhang (Photo 93 to Photo 96). Some measurements were estimated due to safety concerns. The rockfall volume was estimated to be $\approx 1\text{m}^3$ in total, the rock fracturing has a maximum length of 1.7m and maximum width of 0.032m.

DA3C_LW21_026 is a Level 1 trigger as per the Dendrobium Landscape TARP (Table 8), specifically:

Photo 95: DA3C_LW21_026, section of rock fracture and rockfall. Taken 06/09/2023.

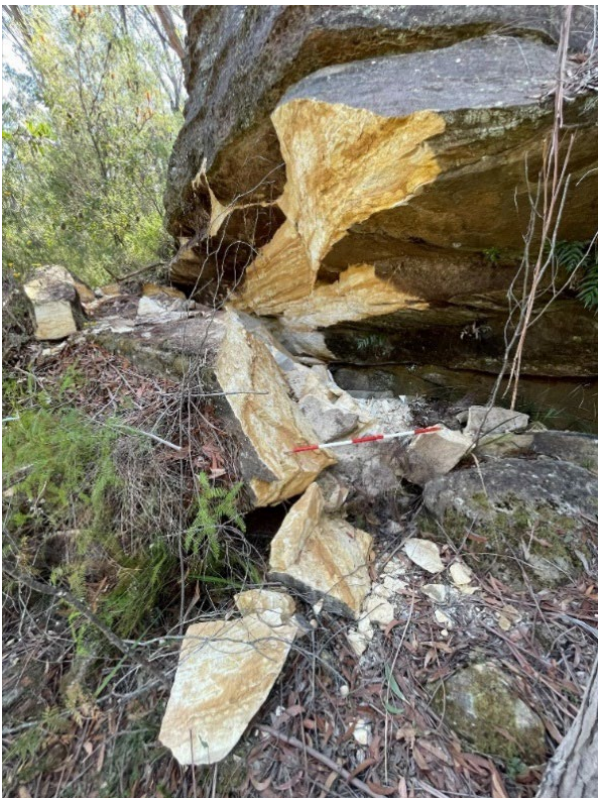
DA3C_LW21_027 is a Level 2 trigger as per the Dendrobium Landscape TARP (Table 8), specifically:

Photo 99: DA3C_LW21_027, overview of rockfall.
Taken 06/09/2023.

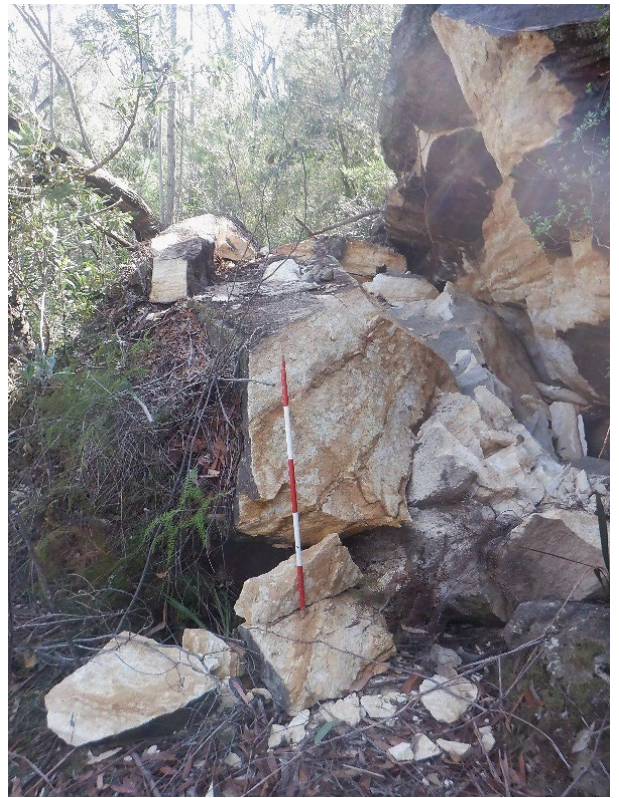
Photo 100: DA3C_LW21_027, overview of rockfall.
Taken 06/09/2023.

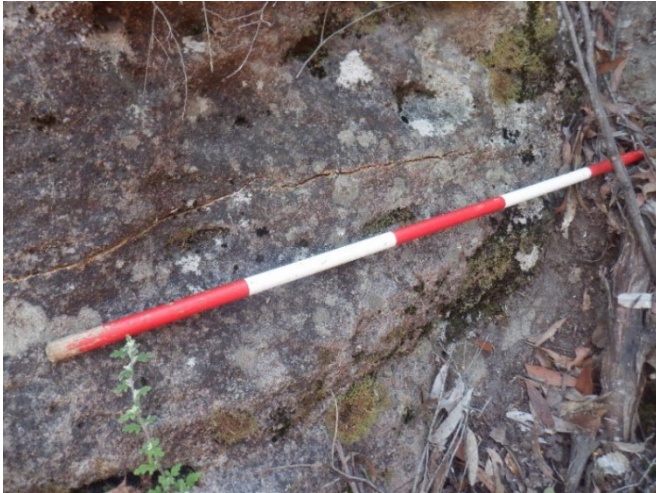
DA3C_LW21_028 is located approximately 55m north of tributary WC20 (Figure 3). The impact consists of a horizontal fracture to a rock outcrop (Photo 99 and Photo 100). The fracture has a maximum length of 1m, a maximum width of 0.003m and a maximum measurable depth of 0.06m.

DA3C_LW21_028 is a Level 1 trigger as per the Dendrobium Landscape TARP (Table 8), specifically:

Photo 101: *DA3C_LW21_028*, rock fracture. Taken 06/09/2023.

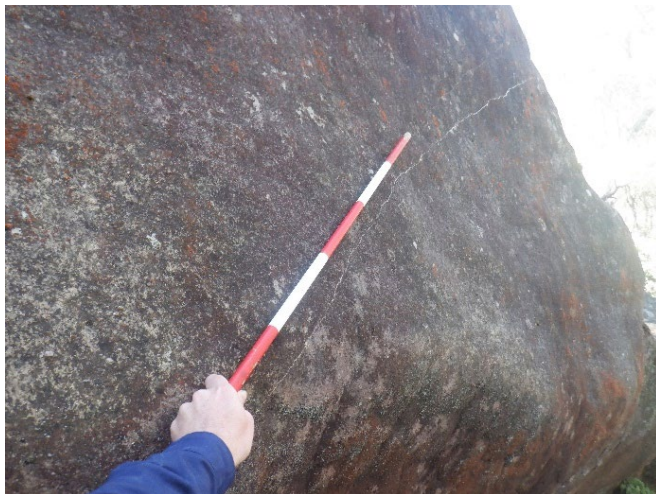
DA3C_LW21_029 is located approximately 80m north of tributary WC20 (Figure 3). The impact consists of fracturing to a rock outcrop and step at Landscape Monitoring site *LW21_SS3* (Figure 1) (Photo 101 and Photo 102). Some measurements were estimated due to safety. The fracturing has a maximum length of $\approx 6\text{m}$ and a maximum width of $\approx 0.01\text{m}$.

DA3C_LW21_029 is a Level 1 trigger as per the Dendrobium Landscape TARP (Table 8), specifically:

Photo 103: *DA3C_LW21_029*, section of rock fracture. Taken 6/09/2023.

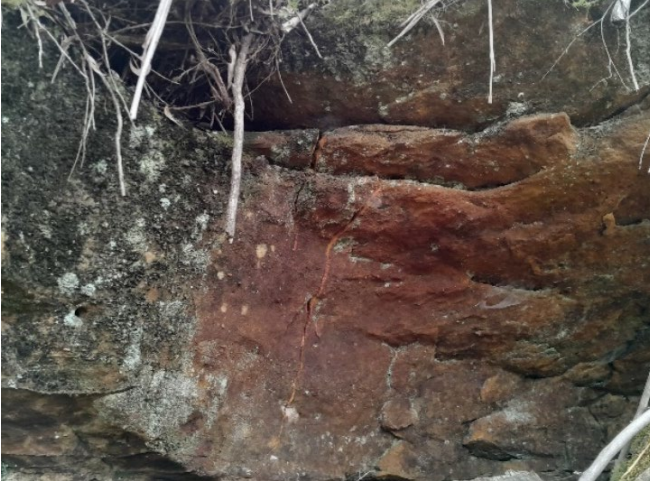
DA3C_LW21_032 is located approximately 30m north of tributary WC20 (Figure 3). The impact consists of multiple fractures to a rock step/overhang, with varying lengths and orientations (Photo 107 and Photo 108). Measurements were estimated from distance for safety reasons. The rock fracturing has an approximate maximum continuous length of $\approx 1\text{m}$ and a maximum width of $\approx 0.035\text{m}$. Caution tape barricading is in place at the site as a safety precaution due to the overhanging nature of the step.

DA3C_LW21_032 is a Level 1 trigger as per the Dendrobium Landscape TARP (Table 8), specifically:

Photo 109: *DA3C_LW21_032*, overview of fracturing to rock step/overhang.
Taken 12/09/2023.

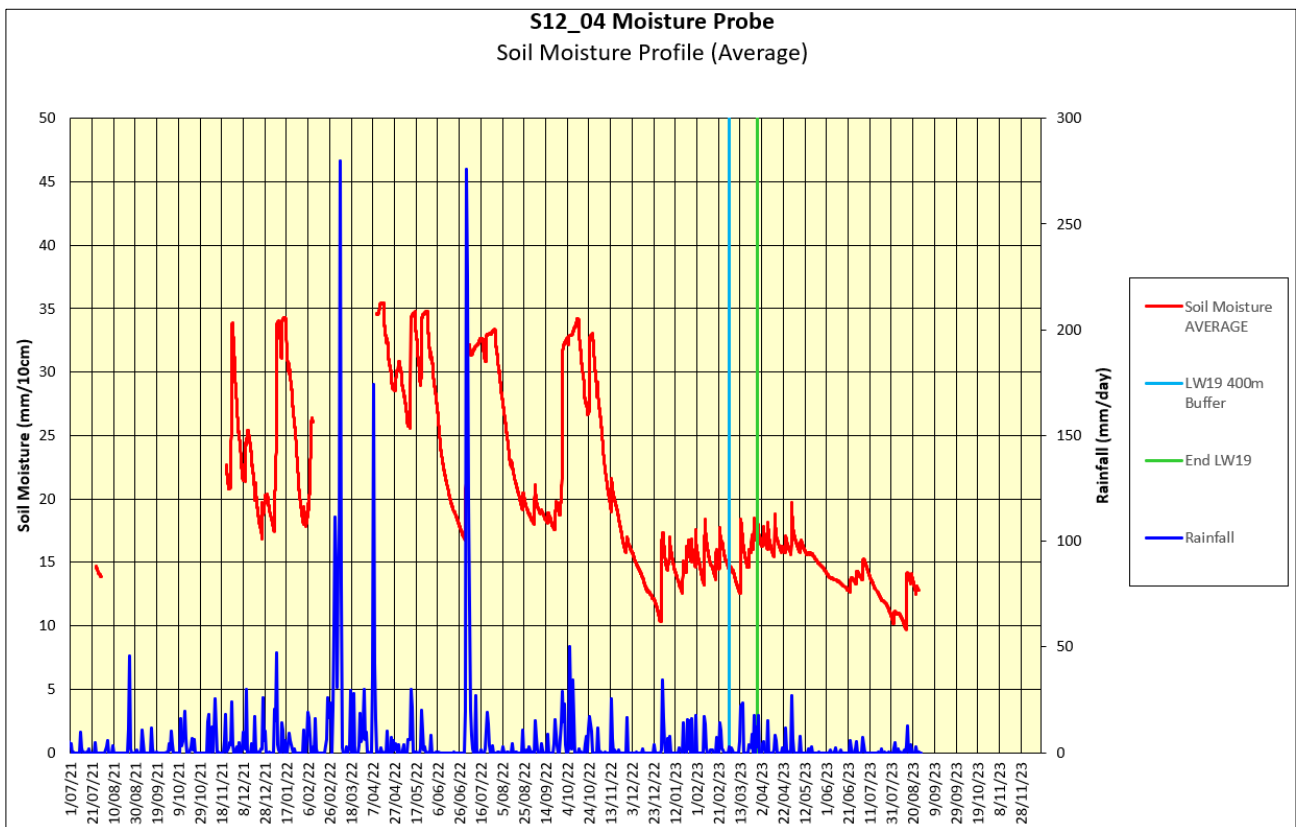
A soil moisture trigger was identified at monitoring site S12_04 in Swamp 12 during analysis of moisture data. S12_04 is located 395 m north from the western end of Longwall 19 (Figure 4). The site entered the Longwall 19 400m active mining area on 3 March 2023 and remained within the active mining area until the end of extraction. On 1 August 2023 the average soil moisture value receded below the lowest level recorded during the baseline monitoring period (Graph 12).

As S12_04 is the only soil moisture site in Swamp 12 within 400 m of Longwall 19 mining, these results contribute to a Level 3 trigger according to the Dendrobium Swamps TARP (Table 6), specifically:

It is important to note that S12_04 has previously been within 400m of the active mining area during the extraction of Longwall 6, Longwall 7 and Longwall 8 (between 2010 and 2012). The baseline monitoring period for this site occurred during a period of unusually high rainfall in 2021 and 2022. In contrast, 2023 has been the driest year during the S12_04 monitored period and the third driest year-to-date in the 22 years of rainfall records from Cordeaux Colliery. There were no impacts recorded when the site was within the Longwall 19 active mining area.

Graph 12: Average soil moisture levels at site S12_04, logged hourly, date range: 27/07/2021 to 25/08/2023.

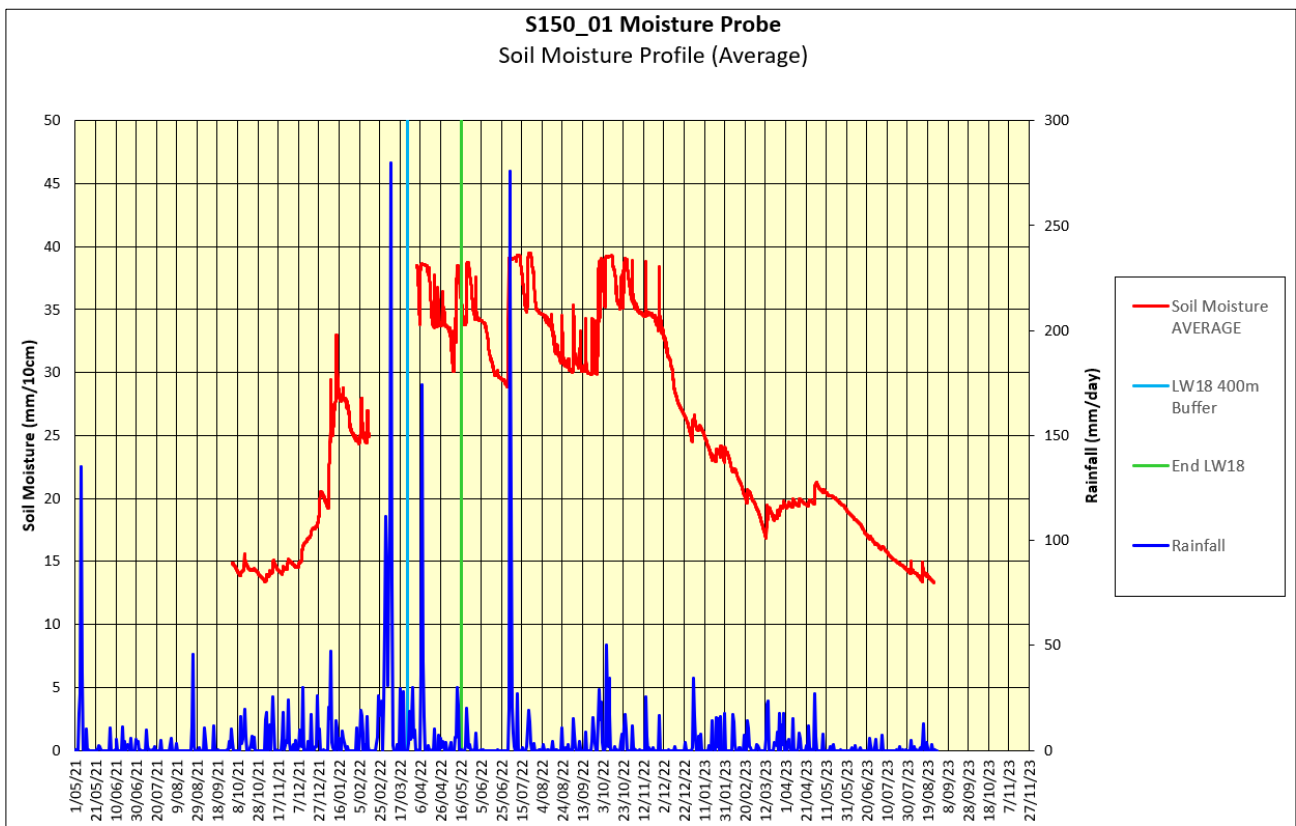
A soil moisture trigger was identified at monitoring site S150_01 in Swamp 150 during recent analysis of soil moisture data. S150_01 is located 280 m south of the eastern end of Longwall 18 (Figure 4). The site entered the Longwall 18 400m active mining area on 24 March 2022 and remained in the active mining area until the end of extraction. On 24 August 2023, one year and three months after completion of Longwall 18, the average soil moisture value receded below the lowest level recorded during the baseline monitoring period (Graph 13).

As the soil moisture probe S150_01 is the only one installed in Swamp 150, these results contribute to a Level 3 trigger according to the Dendrobium Swamps TARP (Table 6), specifically:

Monitoring for this site has predominately occurred during a period of unusually high rainfall in 2021 and 2022. In contrast, 2023 has been the driest year during the S150_01 monitored period and the third driest year-to-date in the 22 years of rainfall records from Cordeaux Colliery. There were triggers recorded when the soil moisture probe was within the Longwall 18 active mining area.

Graph 13: Average soil moisture levels at site S150_01, logged hourly, date range: 02/10/2021 to 25/08/2023.

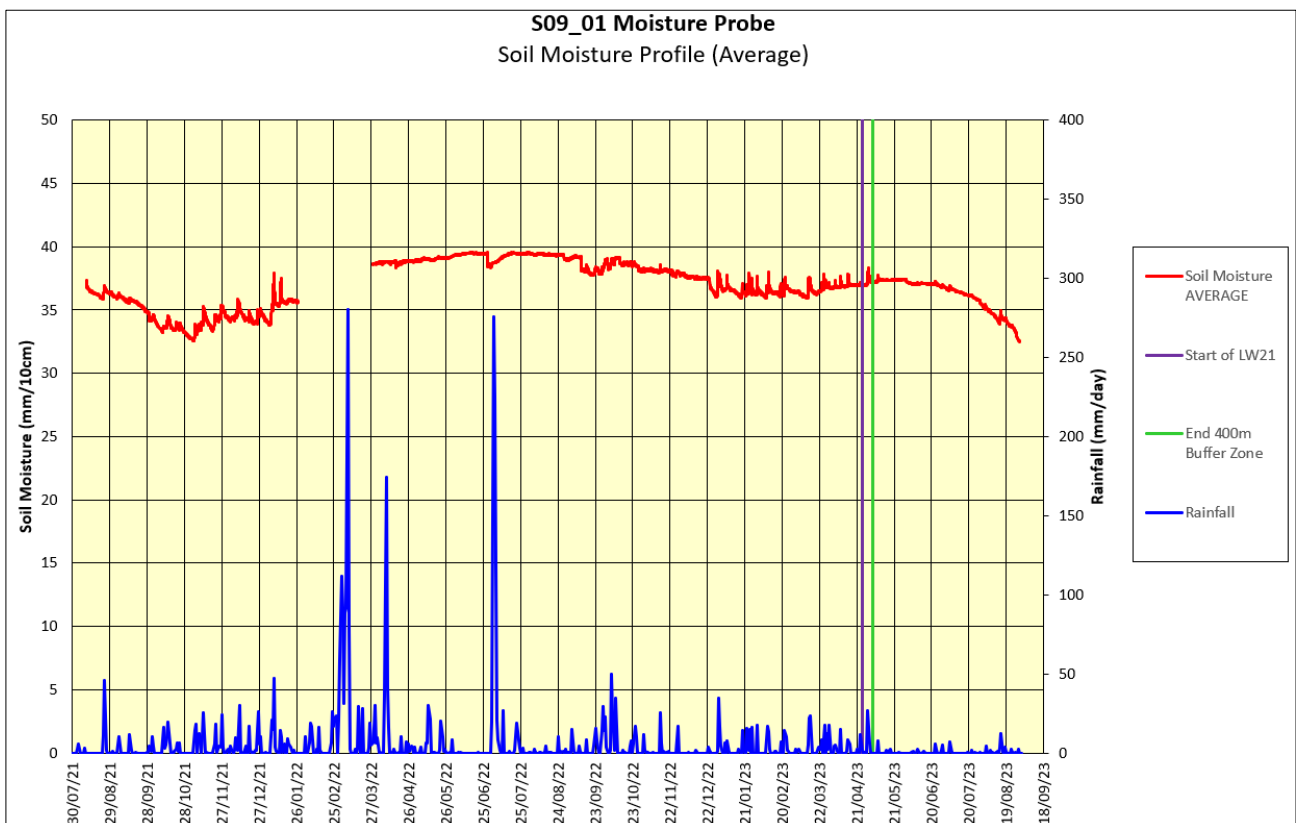
Site S09_01 is located 368 m east of Longwall 21 (Figure 3). The site was within the 400m active mining area between 25 April 2023 and 2 May 2023. On 28 August 2023 the average soil moisture value at S09_01 receded below the lowest level recorded before mining (Graph 14).

These results contribute to a Level 3 soil moisture triggers according to the Dendrobium Swamps TARP (Table 6), specifically:

It is important to note the baseline monitoring period occurred during a period of unusually high rainfall, with low rainfall since.

Graph 14: Average soil moisture levels at site S09_01, logged hourly, date range: 10/08/2021 to 29/08/2023.

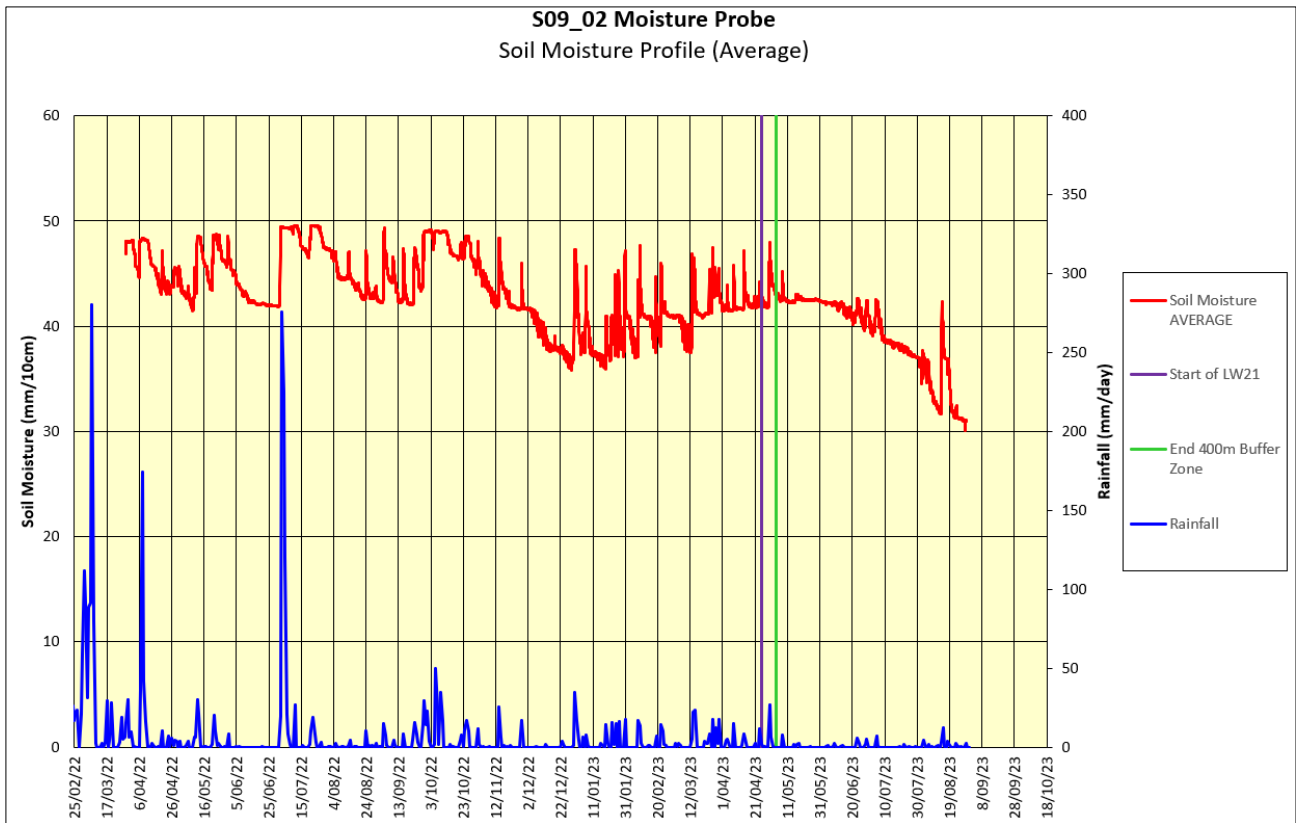
Site S09_02 is located 350 m east of Longwall 21 (Figure 3). The site was within the 400m active mining area between 25 April 2023 and 4 May 2023. On 1 August 2023 the average soil moisture value in the probe S09_02 receded below the lowest level recorded before mining (Graph 15). The groundwater trigger at site 09_02 was reported on 9 August 2023.

Graph 15: Average soil moisture levels at site S09_02, logged hourly, date range: 28/03/2022 to 29/08/2023.

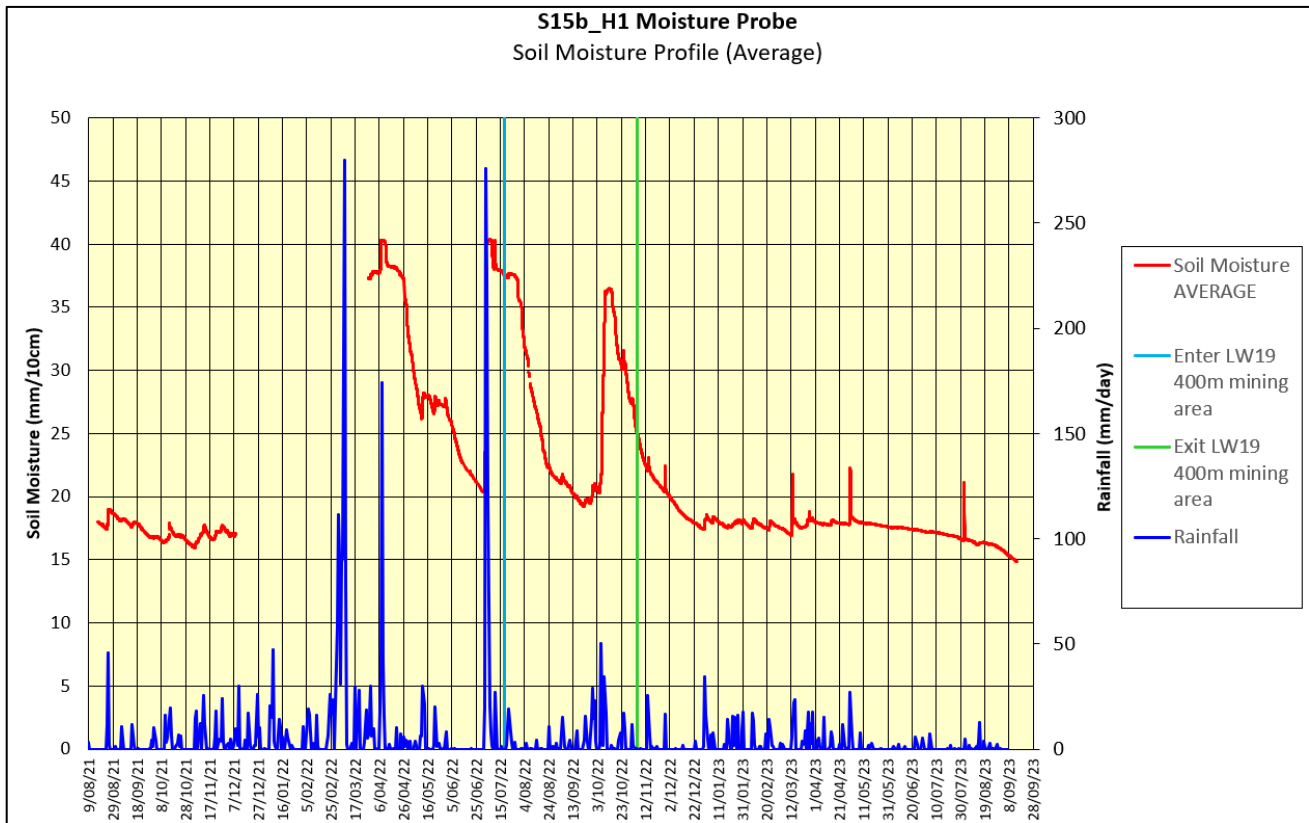
Four soil moisture probes and dataloggers were installed in *Swamp 15b* at sites *S15b_H1*, *S15b_H2*, *S15b_H3* and *S15b_39* in August 2021. Recent analysis of records at *S15b_H1* shows the average soil moisture data after completion of extraction being lower than the lowest data recorded during the baseline period (Graph 16). Soil moisture triggers at *S15b_H2*, *S15b_H3* and *S15b_39* were identified and reported in May 2023.

It should be noted that Longwalls 7 and 8 were extracted between 4 May 2011 and 29 December 2012 and would likely have had an influence on soil moisture in the swamp however soil moisture probes were not part of swamp monitoring at this time. The proximity of Longwalls 7 and 8 to Swamp 15B is displayed in Figure 4. As such, the baseline period for recent soil moisture data should be treated as Longwall 19 pre-mining data only.

Graph 16: Average soil moisture records at S15b_H1, logged hourly. Date range: 16/08/2021 to 14/09/2023

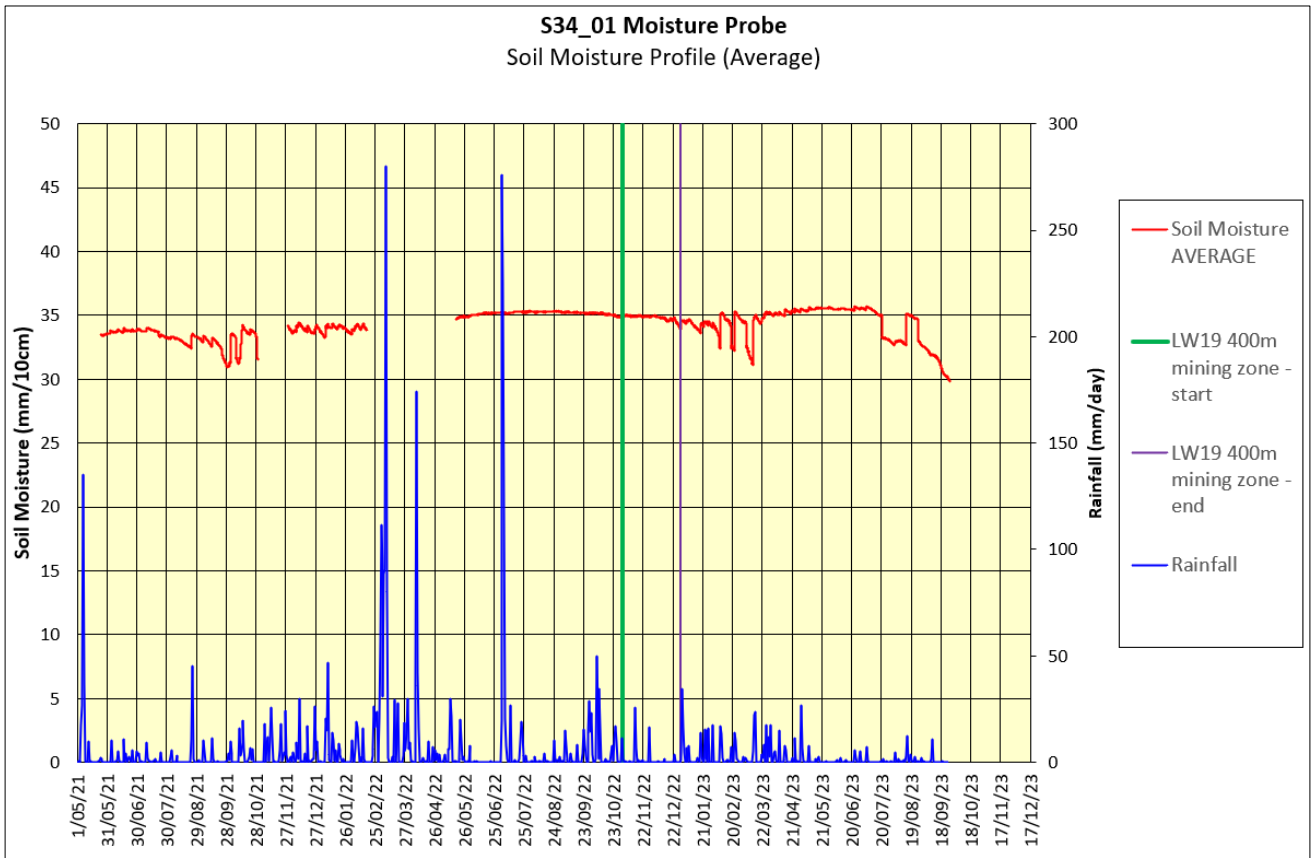
A soil moisture trigger was identified at monitoring site S34_01 in Swamp 34 during recent analysis of moisture data by the IMCEFT. S34_01 is located approximately 360 m south of Longwall 19. It entered the Longwall 19, 400m active mining area on 1 November 2022 and remained in the mining area until 29 December 2022. Recent analysis of records shows that the average soil moisture data after the completion of extraction is now lower than the lowest data recorded during the baseline period. As S34_01 is the only soil moisture site in Swamp 34, these results contribute to a Level 3 trigger according to the Dendrobium Swamps TARP (Table 6), specifically:

Graph 17: Average soil moisture records at S34_01, logged hourly. Date range: 25/05/2021 to 26/09/2023.
