Monitoring of watercourses, swamps and landscape features is undertaken to identify subsidence impacts. These features are monitored by the Illawarra Metallurgical Coal Environmental Field Team (IMCEFT) monthly prior to mining and weekly during mining. Monitoring is conducted in accordance with the approved Subsidence Management Plan (SMP) for Dendrobium Area 3C (DA3C). Extraction of Longwall 21 commenced on 25 April 2023 and as of 6 June 2023 there were four new subsidence impacts identified.

This Version 2 of the report includes a summary of consultation with stakeholders undertaken since the initial report.

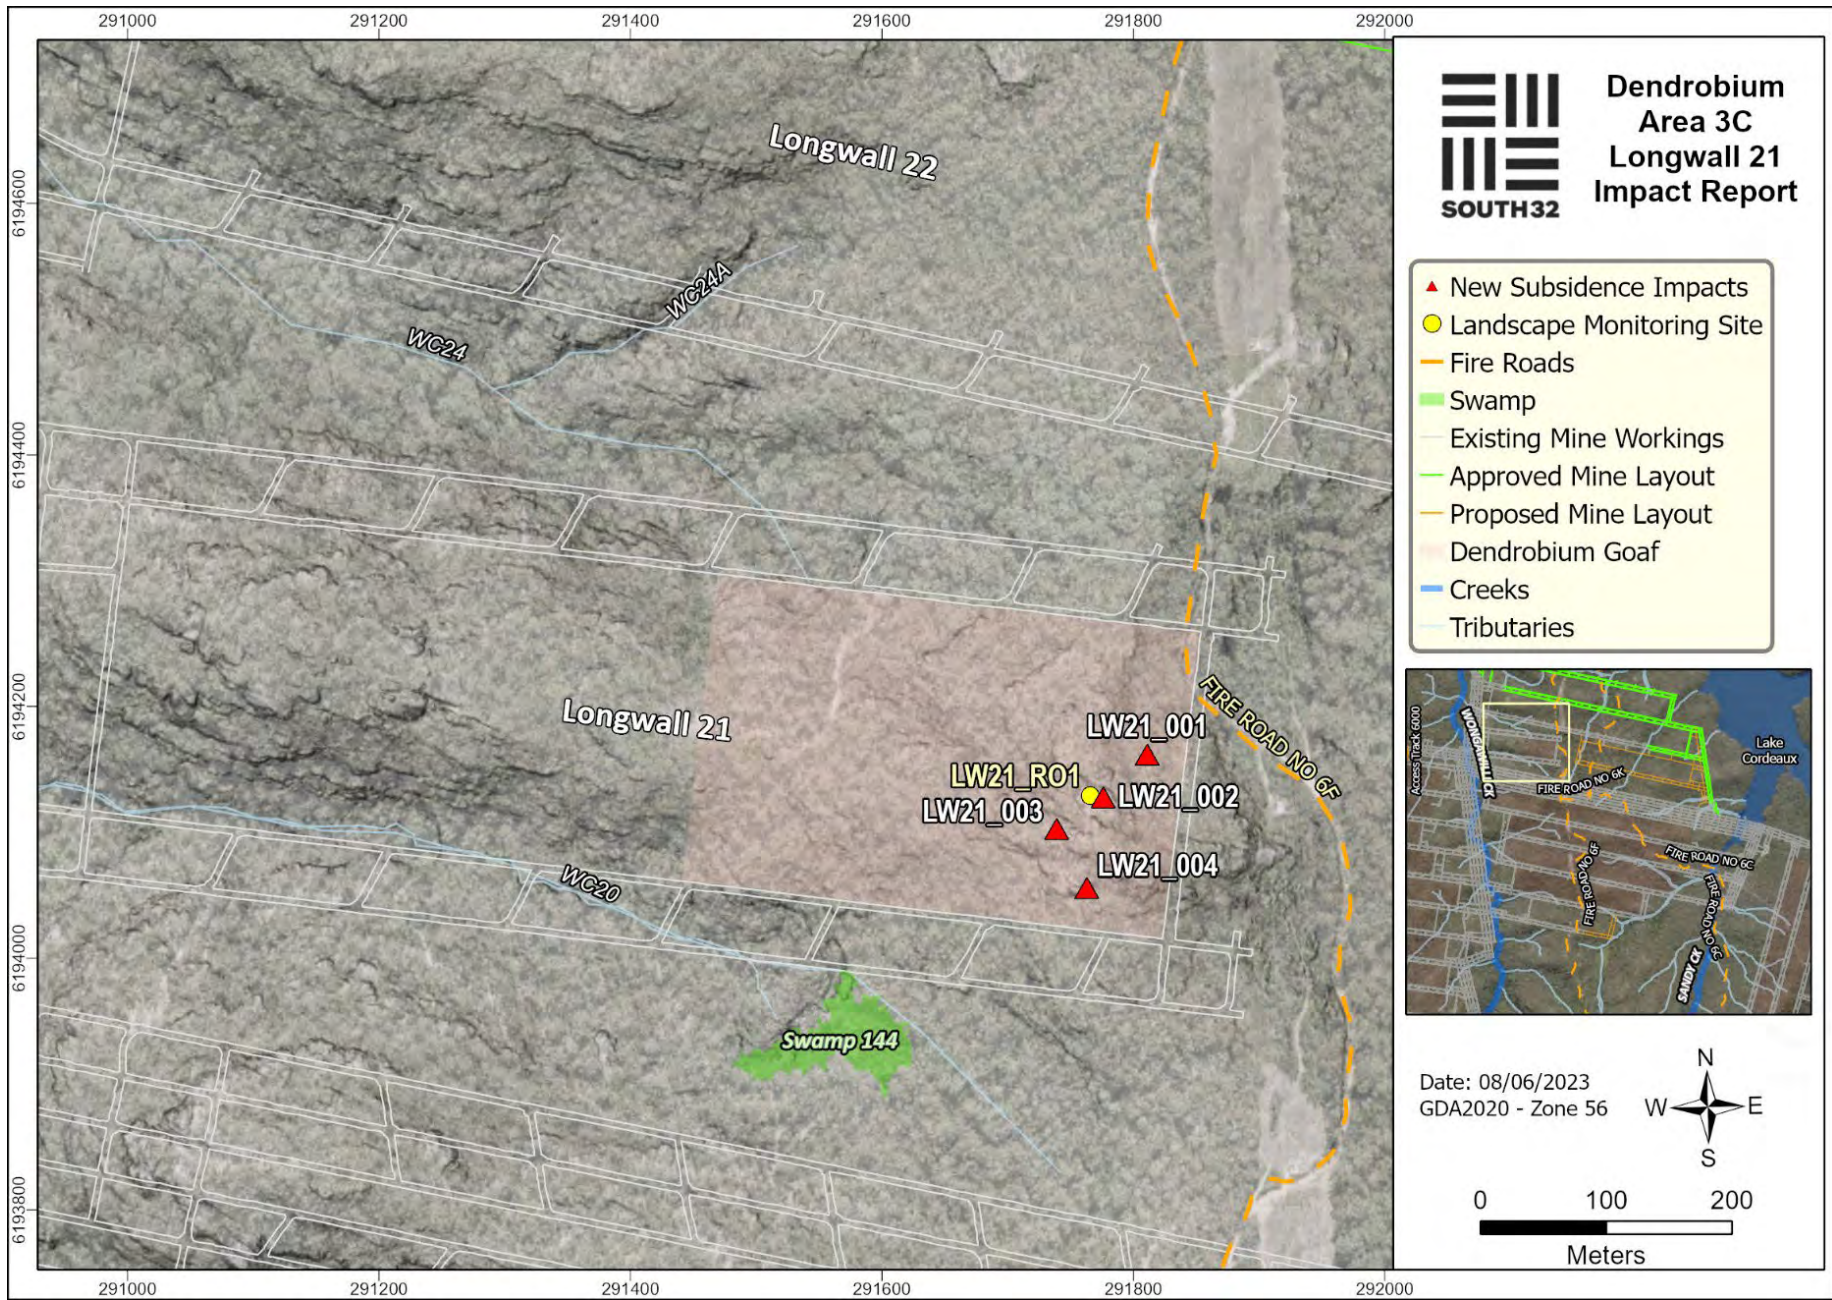
Figure 1: Map showing the latest subsidence impacts. Inset shows main frame of map in relation to Dendrobium mining operations.

DA3C_LW21_001 is located approximately 80m west of *Fire Road 6F* (Figure 1). The impact consists of rock fracturing to an outcrop. The rock fracturing had a total continuous length of 0.56m, with the piece of rock dislodged from the outcrop. The fracturing has minimal impact to vegetation or ground disturbance. (Photo 1 and Photo 2).

- Continue Monitoring Program
- Submit an Impact Report to key stakeholders
- Summarise impacts and report in the EoP and the AR
- Review monitoring frequency
- Notify relevant technical specialists and seek advice on any CMA required
- Provide safety signage and barricades as appropriate
- Implement approved repairs to ensure safety and serviceability on fire trails
- Implement agreed CMAs as approved

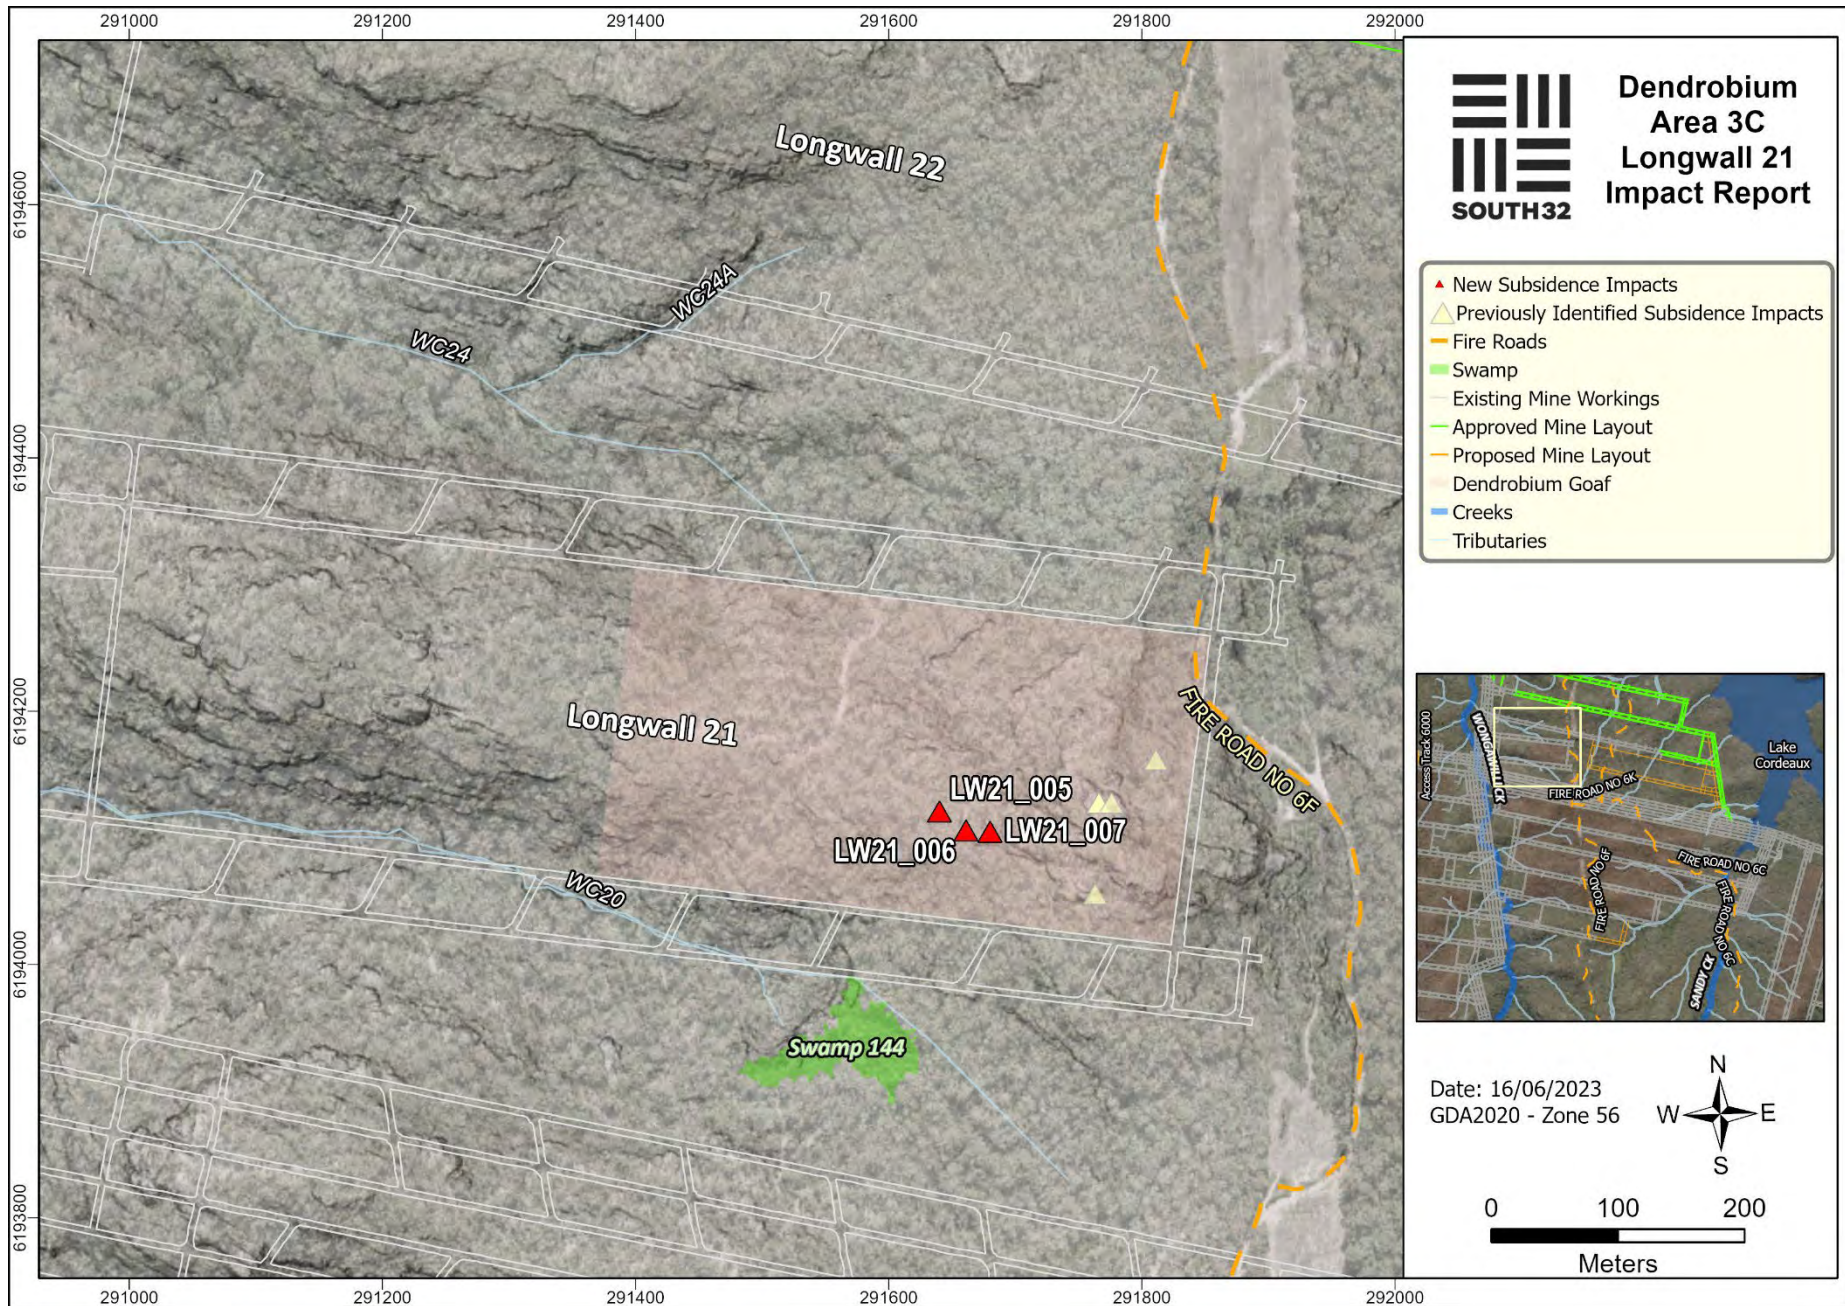
Figure 1: Map showing the latest subsidence impacts. Inset shows main frame of map in relation to Dendrobium mining operations.

DA3C_LW21_005 is located approximately 150m northeast of *WC20*, a tributary of *Wongawilli Creek* (Figure 1). The impact consists of a fracture to a rock outcrop (Photo 1 and Photo 2). The rock fracture has a continuous length of 2.1m, a maximum width of 0.05m and a maximum measurable depth of 1.84m. The fracture also resulted in a displacement of small rock fragments.

DA3C_LW21_006 is located approximately 150m northeast of *WC20*, a tributary of *Wongawilli Creek* (Figure 1). The impact consists of fracturing to a rock outcrop. (Photo 3 and Photo 4). Two intersecting fractures were observed, the longest continuous length measured was 9.0m. The maximum measured width was 0.04m and the maximum measured depth was 1.12m.

DA3C_LW21_007 is located approximately 160m northeast of *WC20*, a tributary of *Wongawilli Creek* (Figure 1). The impact consists of two rock fractures and associated rock fall to a rock outcrop (Photo 5). The maximum continuous length of the fractures was 2.74m, with a maximum width of 0.14m (Photo 6). The largest measurable depth was 1.83m. The total volume of the rockfall was less than 0.60m³ with a total debris area of approximately 3m² (Photo 5 and Photo 7).

- Continue Monitoring Program
- Submit an Impact Report to key stakeholders
- Summarise impacts and report in the End of Panel and the Annual Review
- Review monitoring frequency
- Notify relevant technical specialists and seek advice on any Corrective Management Actions (CMAs) required
- Provide safety signage and barricades as appropriate
- Implement approved repairs to ensure safety and serviceability on fire trails
- Implement agreed CMAs as approved

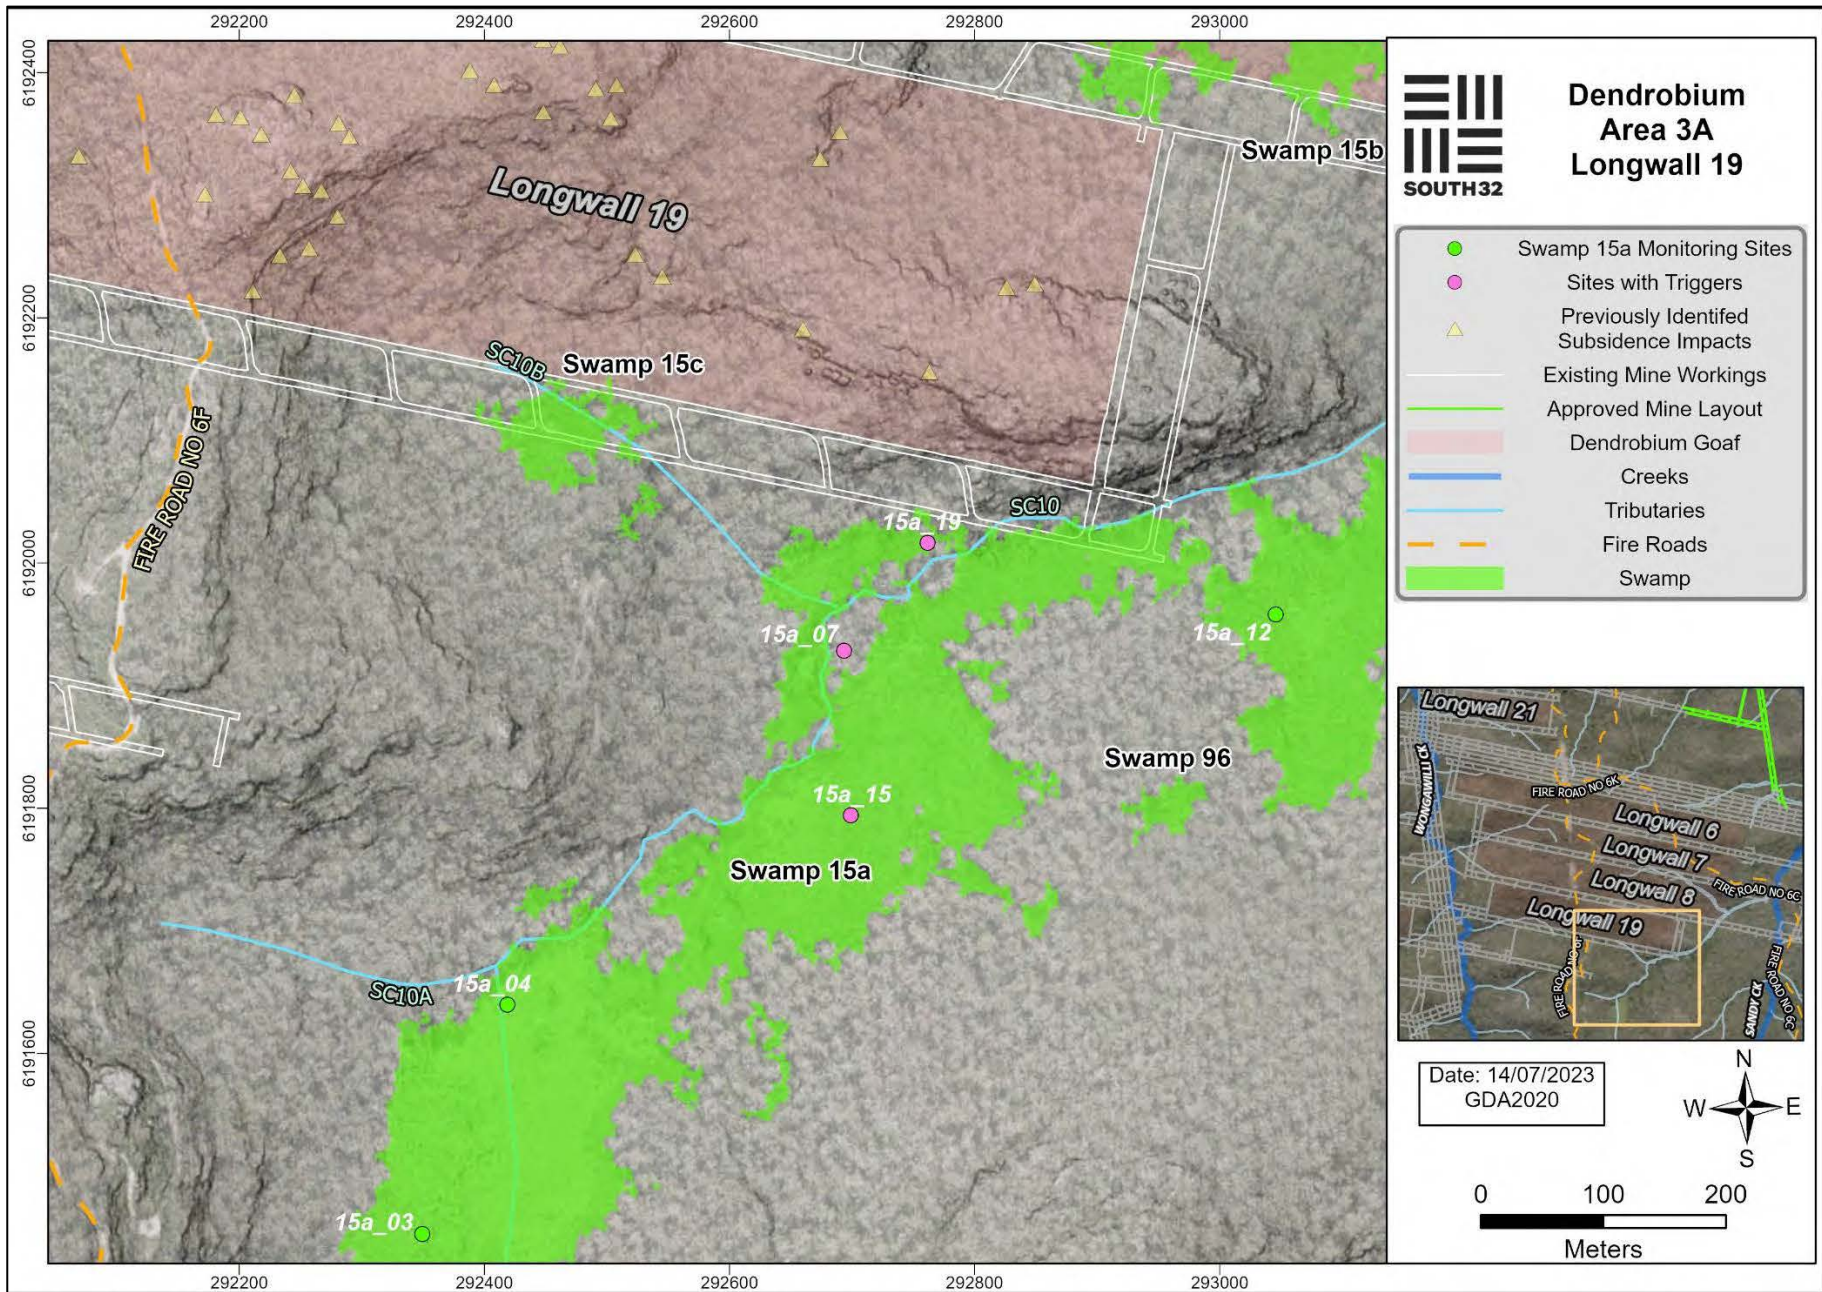
Figure 2: Swamp 15a monitoring sites and triggers in relation to Longwall 19, DA3A. Inset shows frame in relation to Dendrobium mining operations.

Near-surface groundwater and soil moisture triggers were recorded in Swamp 15a during recent analysis of groundwater data for the swamp. These include soil moisture triggers at sites S15a_07, S15a_15 and S15a_19, and groundwater trigger at 15a_19 (Figure 2). Sites with a an 'S' prefix denote soil moisture triggers at those sites.

Site 15a_07 is located approximately 245m south-west from the start of Longwall 19 (Figure 2) i.e., within the longwall's 400 m mining area since the start of mining. The site was passed by Longwall 19 on 17 July 2022 at a distance of approximately 173 m and exited the mining area 14 September 2022. On 24 December 2022 the average soil moisture value receded below the lowest level recorded during the monitoring period before mining (Graph 3). Below average rainfall has also been observed through this period.

- Continue monitoring program
- Submit an Impact Report to key stakeholders – BCD, DPE, Resources Regulator and WaterNSW
- Report in the End of Panel Report
- Summarise actions and monitoring in AEMR
- Review monitoring frequency
- Notify technical specialists and seek advice on any CMA required
- Submit letter report to DPE, BCD, Resource Regulator and WaterNSW and seek advice on any CMA required
- Implement agreed CMAs as approved (subject to agency feedback)
