From: [Zanotto, Linda](#)
To: [Camilla Edmunds](#); [Maria Dubikova](#); [Girja Sharma](#); [Glen Capararo](#); [Ravi Sundaram](#)
Cc: [Brassington, Gary](#); gabrielle.allan@dpie.nsw.gov.au
Subject: Dendrobium Mine - Review of distance to swamp impacts
Date: Friday, 8 September 2023 12:17:00 PM
Attachments: [Ltr WaterNSW - DA3 Distance to Swamp Impacts_08092023.pdf](#)
[Att 1 - Dendrobium Area 3A Update Report 230314_V2.pdf](#)
[Att 2 - WaterNSW letter - Dendrobium Impact Report 231314.pdf](#)
[Att 3 - 20230706c_ImpactReport-Hydrology-Swamp35b01_and 15a_19.pdf](#)
[Att 4 - R053c_Dendrobium-Distance to Swamp Impacts to June2023.pdf](#)

Re: Dendrobium Area 3C – Impact report – 31st July 2023

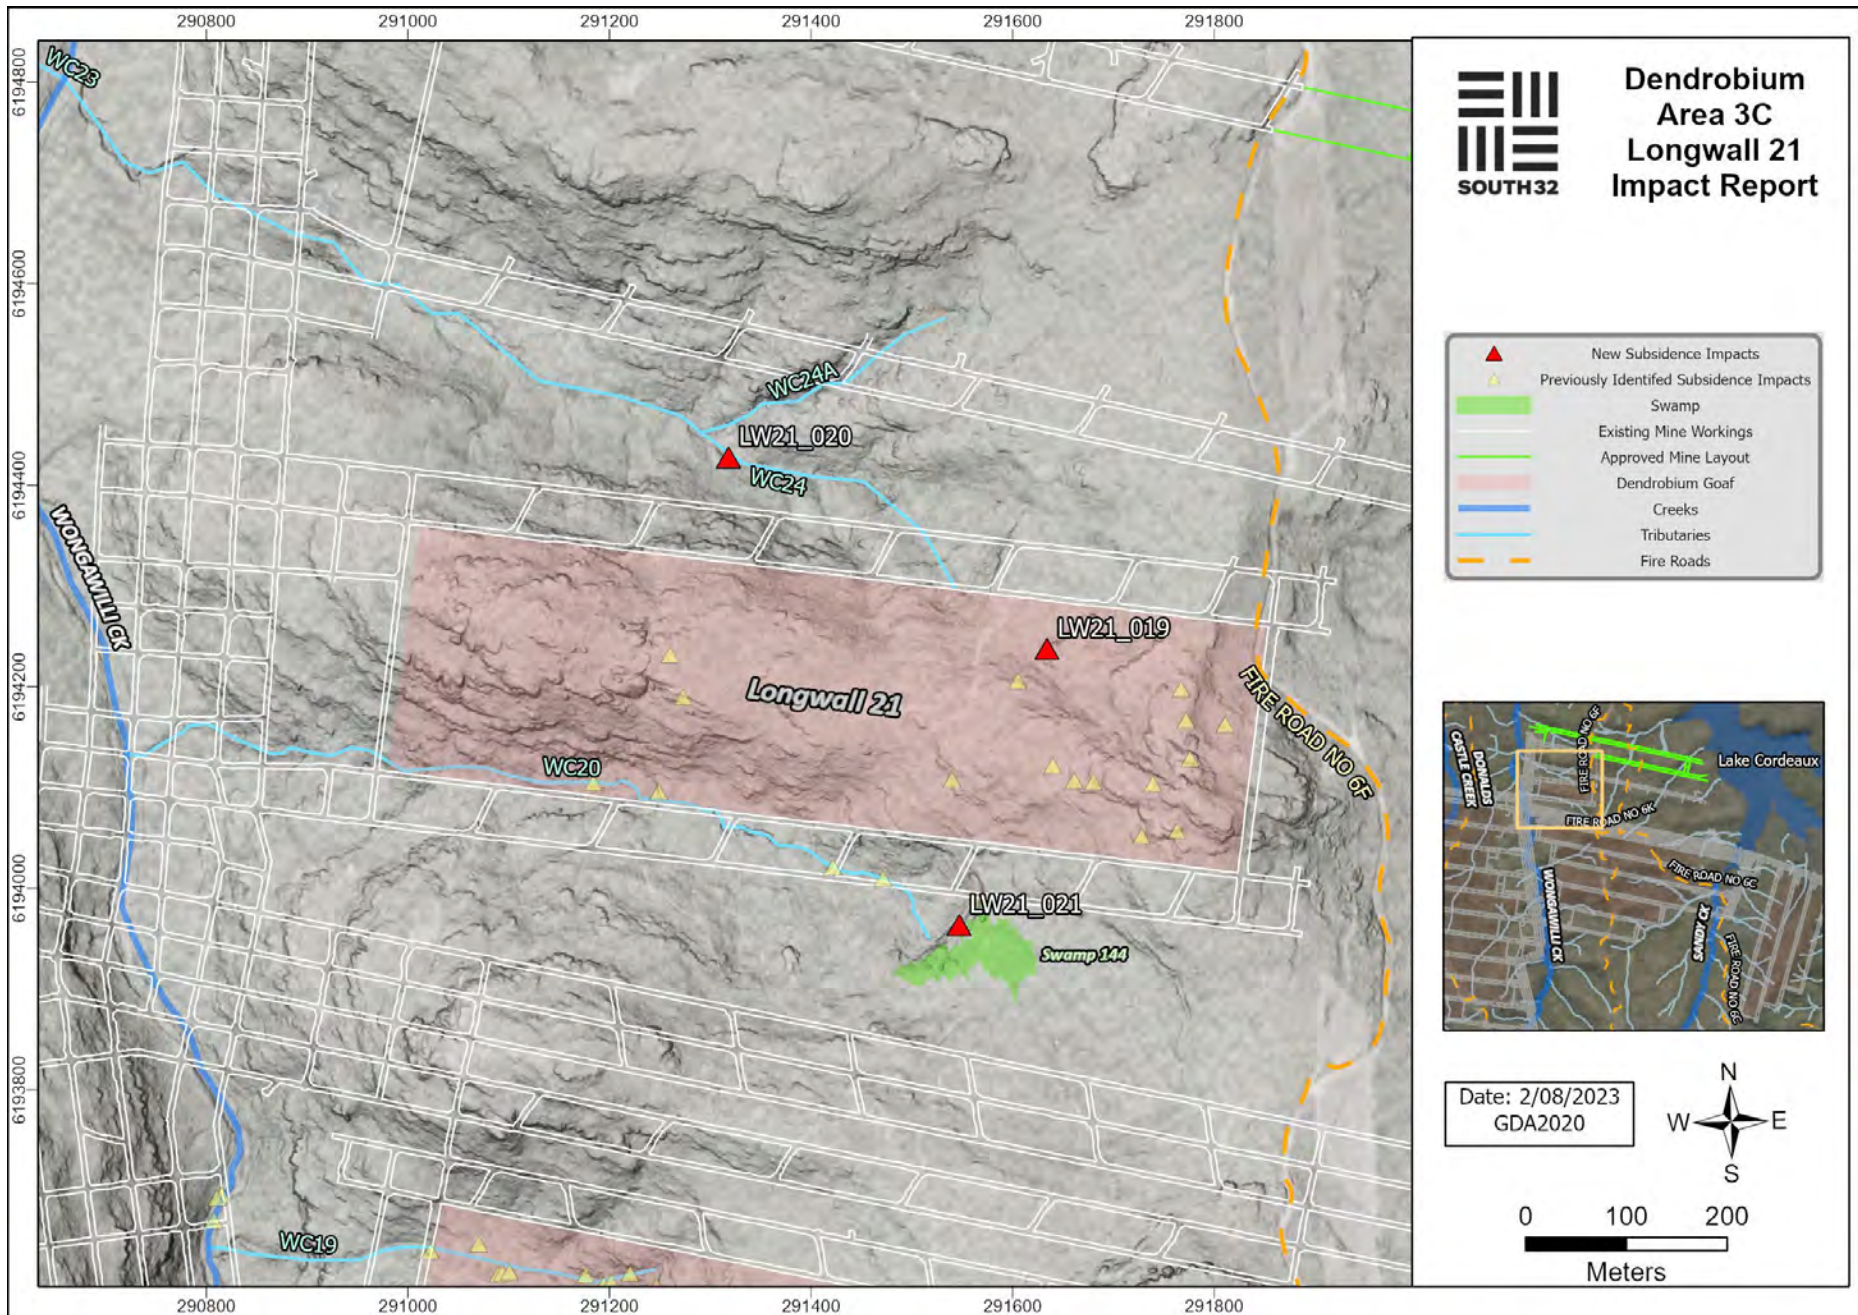
DA3C_LW21_019 is located approximately 210m west of Fire Road 6F (Figure 1). The impact consists of a single rock fracture to a rock step. The fracture has a continuous length of 2m, a maximum width of 0.03m and a maximum measurable horizontal depth of 0.3m (Photo 1 to Photo 3). Flagging tape is in place at the site as a safety precaution.

WC24 is a tributary of Wongawilli Creek that flows westward from DA3C mining operations (Figure 1). The upper reaches of the WC24 sub catchment were mined beneath by Longwall 21. Localised iron staining was observed along a 45m stretch of dry streambed on WC24 during the latest inspection (Photo 4 to Photo 7). The iron staining originates at *WC24_Pool 35* and extends downstream to *WC24_Rockbar 15*. During the baseline mapping of WC24, no surface water was observed in this part of the tributary, like latest observations. However, the recently recorded iron staining was not present in the baseline mapping. No other surface impacts have been observed in WC24.

DA3C_LW21_021 consists of localised iron staining on the downstream basal step of Swamp 144 and the headwaters of tributary *WC20* (Figure 1). The iron staining originates from beneath a large boulder mid-way down the basal step (Photo 8). The iron staining is approximately 2m in length, 1m in width and disappears downslope into bushland. No other surface impacts were observed on or above the basal step.

Figure 1: Latest subsidence impacts over Longwall 21 mining area in DA3C. Inset shows frame in relation to Dendrobium mining operations.

The following management actions have been initiated:

- Continue monitoring program
- Submit an Impact Report to key stakeholders
- Report in the End of Panel Report
- Summarise actions and monitoring in AEMR

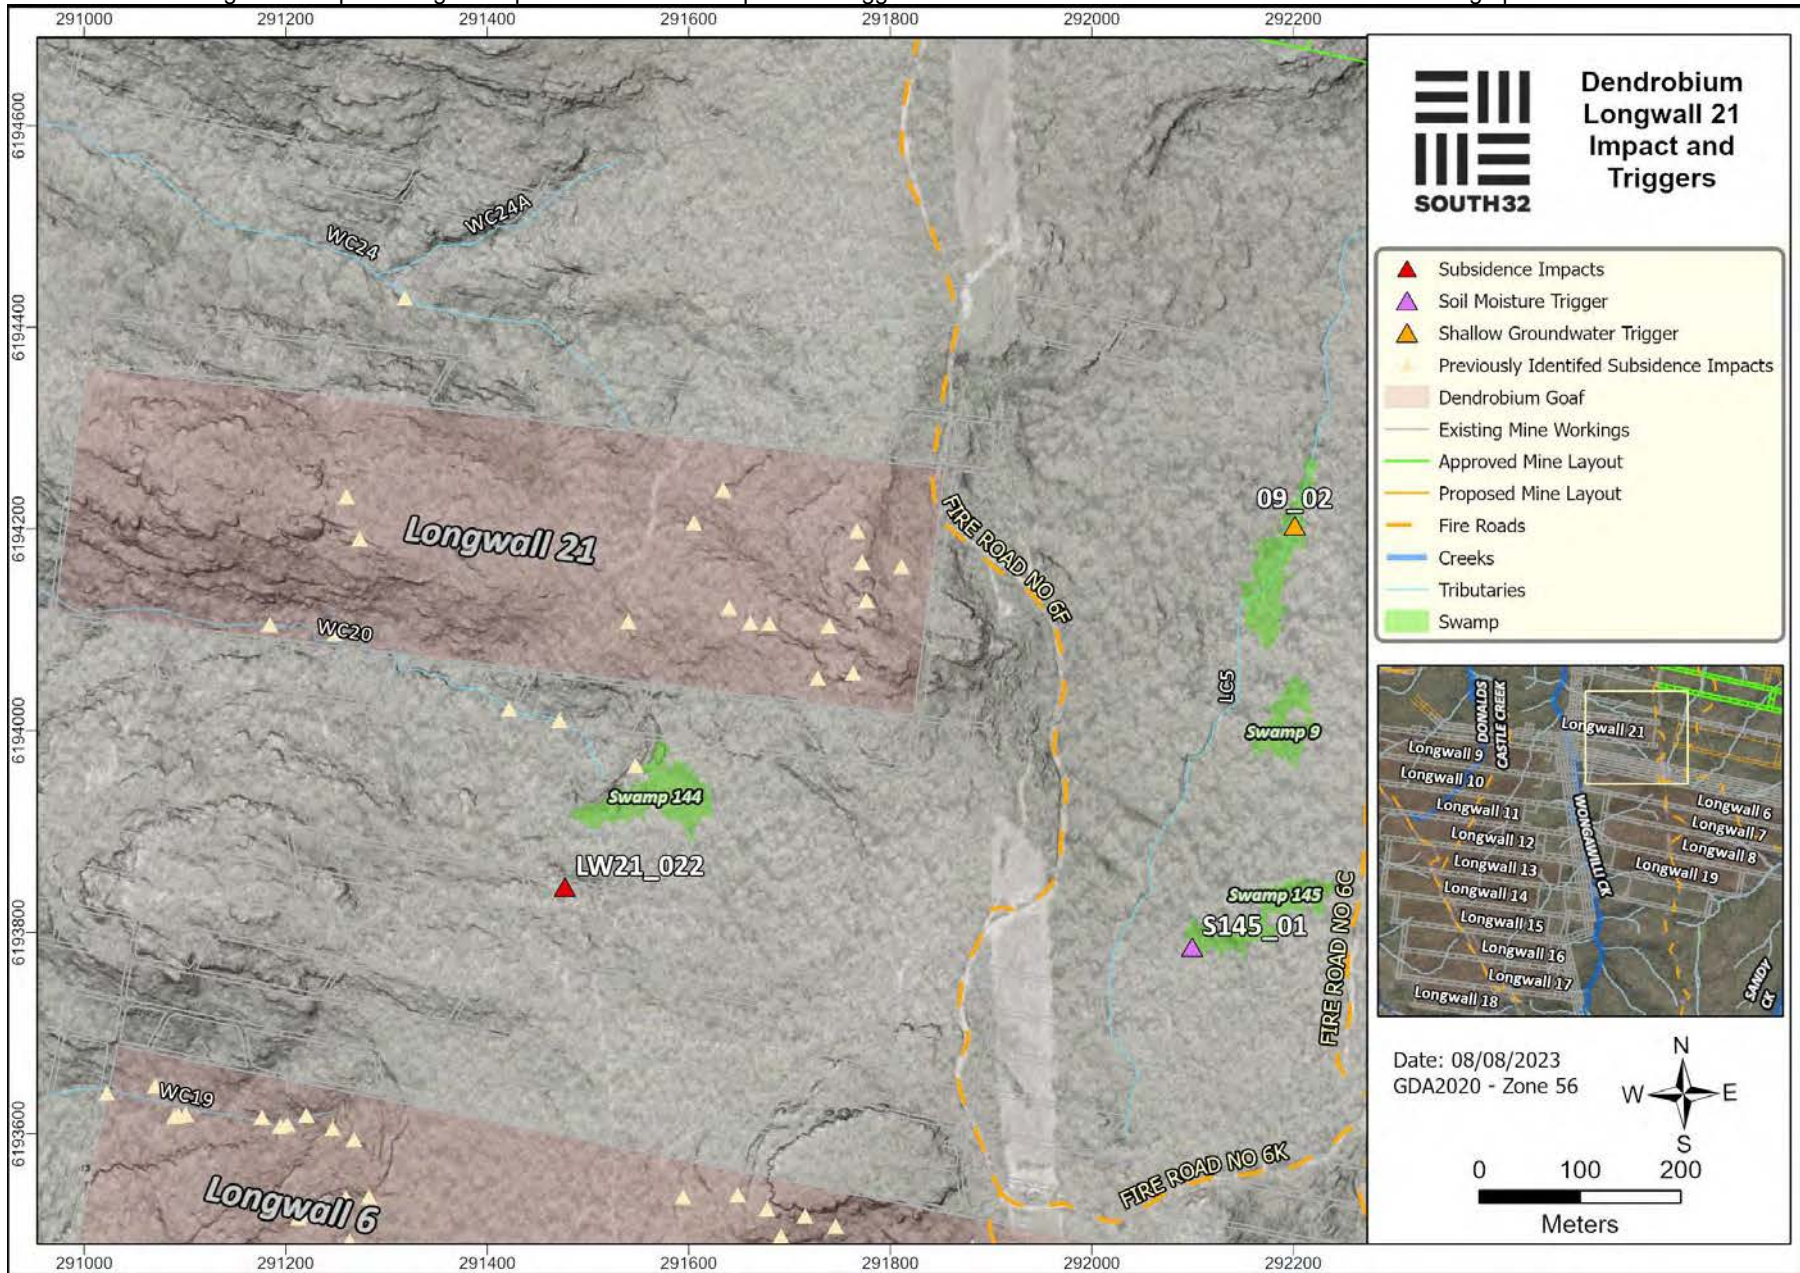
Impact DA3C_LW21_022 consists of a rockfall from a rock outcrop/step approximately 420m west of Fire Road 6F (Figure 1). Weathered sections of rock face are observed along with fresh rock face. The impact is likely from a natural fracture which has opened further and fallen away due to mining. Approximate volume of the rock is less than 0.5m³ (Photo 1 to Photo 3).

A near-surface groundwater trigger was recorded in Swamp 9 (Piezometer *09_02*) during recent analysis of groundwater data from the swamp. Site *09_02* is located 350 m east of the starting (eastern) end of Longwall 21 (Figure 1), i.e. within the longwall's 400 m buffer zone since the start of mining. The site exited the buffer on 4 May 2023. On 27 July 2023 the water level in the borehole receded below the lowest level recorded before mining (graph 1). There are two piezometers installed in Swamp 9 (one triggered and one not triggered).

A soil moisture trigger was recorded in Swamp 145 (moisture probe *S145_01*). Site *S145_01* is located 359 m to the south-east of the starting (eastern) end of Longwall 21 (Figure 1), i.e. within the longwall's 400 m buffer zone since the start of mining. The site exited the buffer on 4 May 2023. On 3 June 2023 the average soil moisture value receded below the lowest level recorded before mining (Graph 2).

Figure 1: Map showing the reported subsidence impact and triggers. Inset shows frame in relation to Dendrobium mining operations.

- Continue monitoring program
- Submit an Impact Report to key stakeholders
- Seek advice on any other CMAs
- Report in the End of Panel Report
- Summarise actions and monitoring in AEMR
