**ATTACHMENT C1 –  
LONGWALL 37 END OF  
PANEL REPORT**

**LANDSCAPE MONITORING  
IMPACT REPORTS**

**ILLAWARRA COAL ENVIRONMENTAL  
FIELD TEAM, JUNE 2014 TO  
JANUARY 2015**

## West Cliff Area 5 Longwall 36 Impact Report

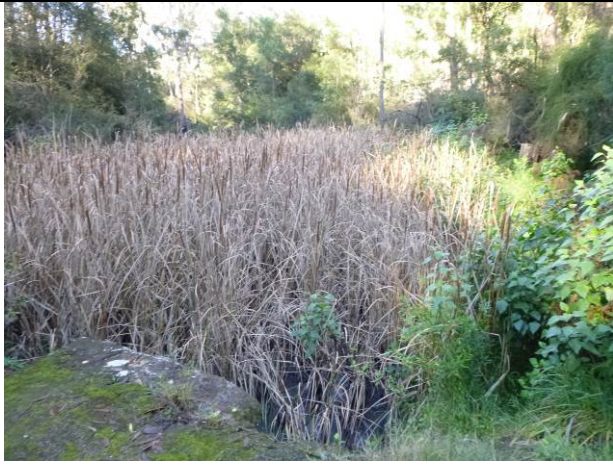
On the latest inspection GR\_Pool 60 in the Georges River was observed to be at a level below that experienced in the baseline period (**Photos 5 and 6**). As shown in Graph 1, this lower-than-baseline water level has been observed previously and was reported as Impact WCA5\_LW35\_023.

Photo 5: GR\_Pool 60 looking upstream.  
Taken on 18/06/2014.

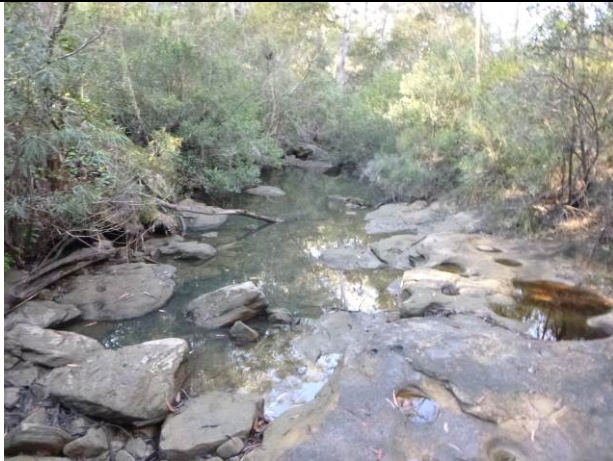
On the latest inspection of GR\_Pool 58 in the Georges River the water level was 'Dry Below Nail' (**Graph 2**). This water level has previously been reported (**Photos 7 and 8**). The latest observation is a trigger according to the GRMP and is discussed in the TARP section of this report.

Photo 7: GR\_Pool 58 looking upstream. Taken on  
18/06/2014.

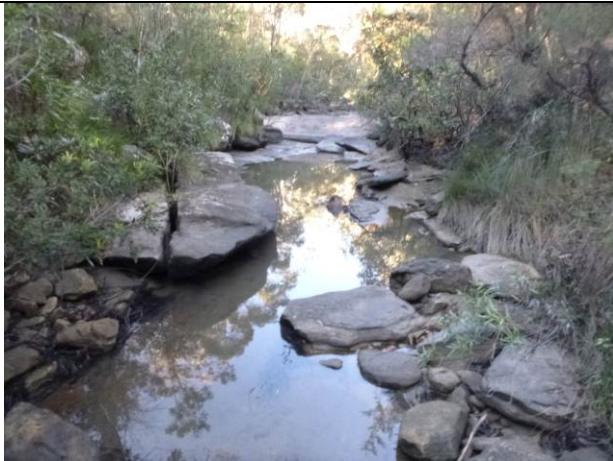
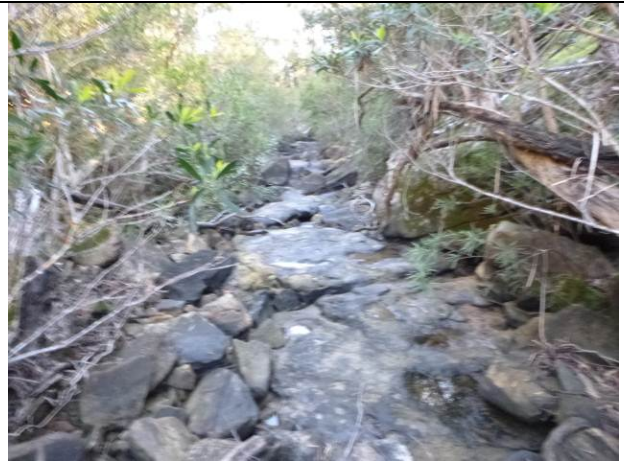
On the latest inspection of GR\_Pool 57 in the Georges River it was observed to be at a level below that experienced in the baseline period (**Graph 3**). The latest observation (**Photos 9 and 10**) is a trigger according to the GRMP and is discussed in the TARP section of this report.

Photo 9: GR\_Pool 57 looking upstream. Taken on  
18/06/2014.

Photo 10: GR\_Pool 57 looking downstream. Taken  
on 18/06/2014.

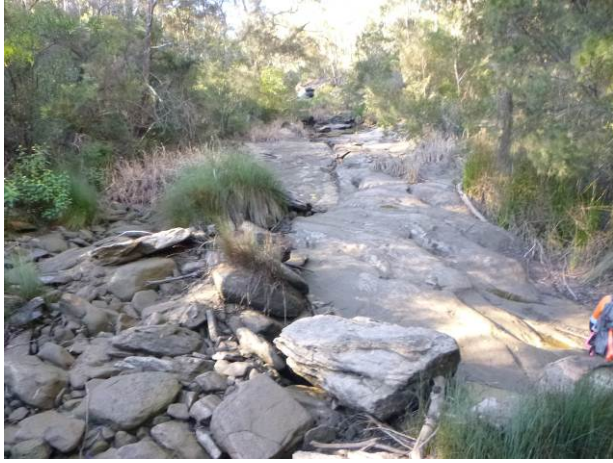
On the latest inspection of GR\_Pool 54 in the Georges River it was observed to be dry. The latest observation (**Photos 11 and 12**) is a trigger according to the GRMP and is discussed in the TARP section of this report.

Photo 11: GR\_Pool 54 looking upstream. Taken on 18/06/2014.

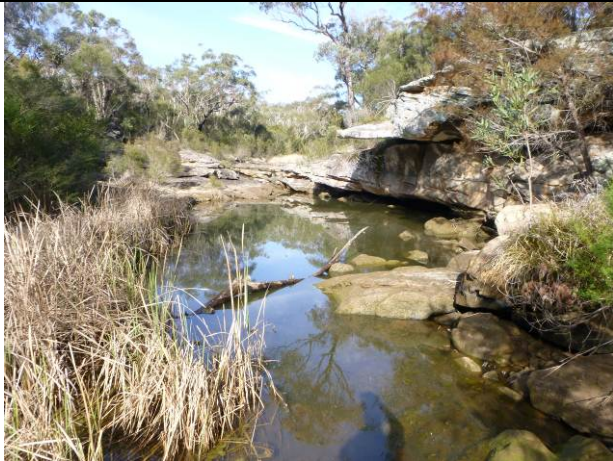
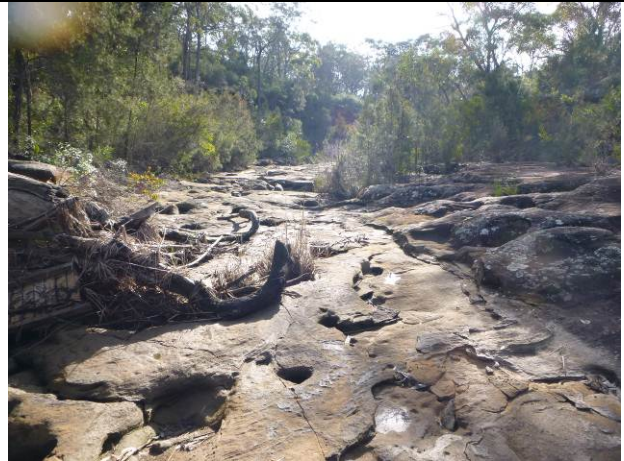
On the latest inspection of GR\_Pool 44 in the Georges River it was 'Dry Below Nail' (**Graph 6**). The latest observation (**Photos 13 and 14**) is a trigger according to the GRMP and is discussed in the TARP section of this report.

Photo 13: GR\_Pool 44 looking upstream Taken on 18/06/2014.

Photo 14: GR\_Pool 44 looking downstream. Taken on 18/06/2014.

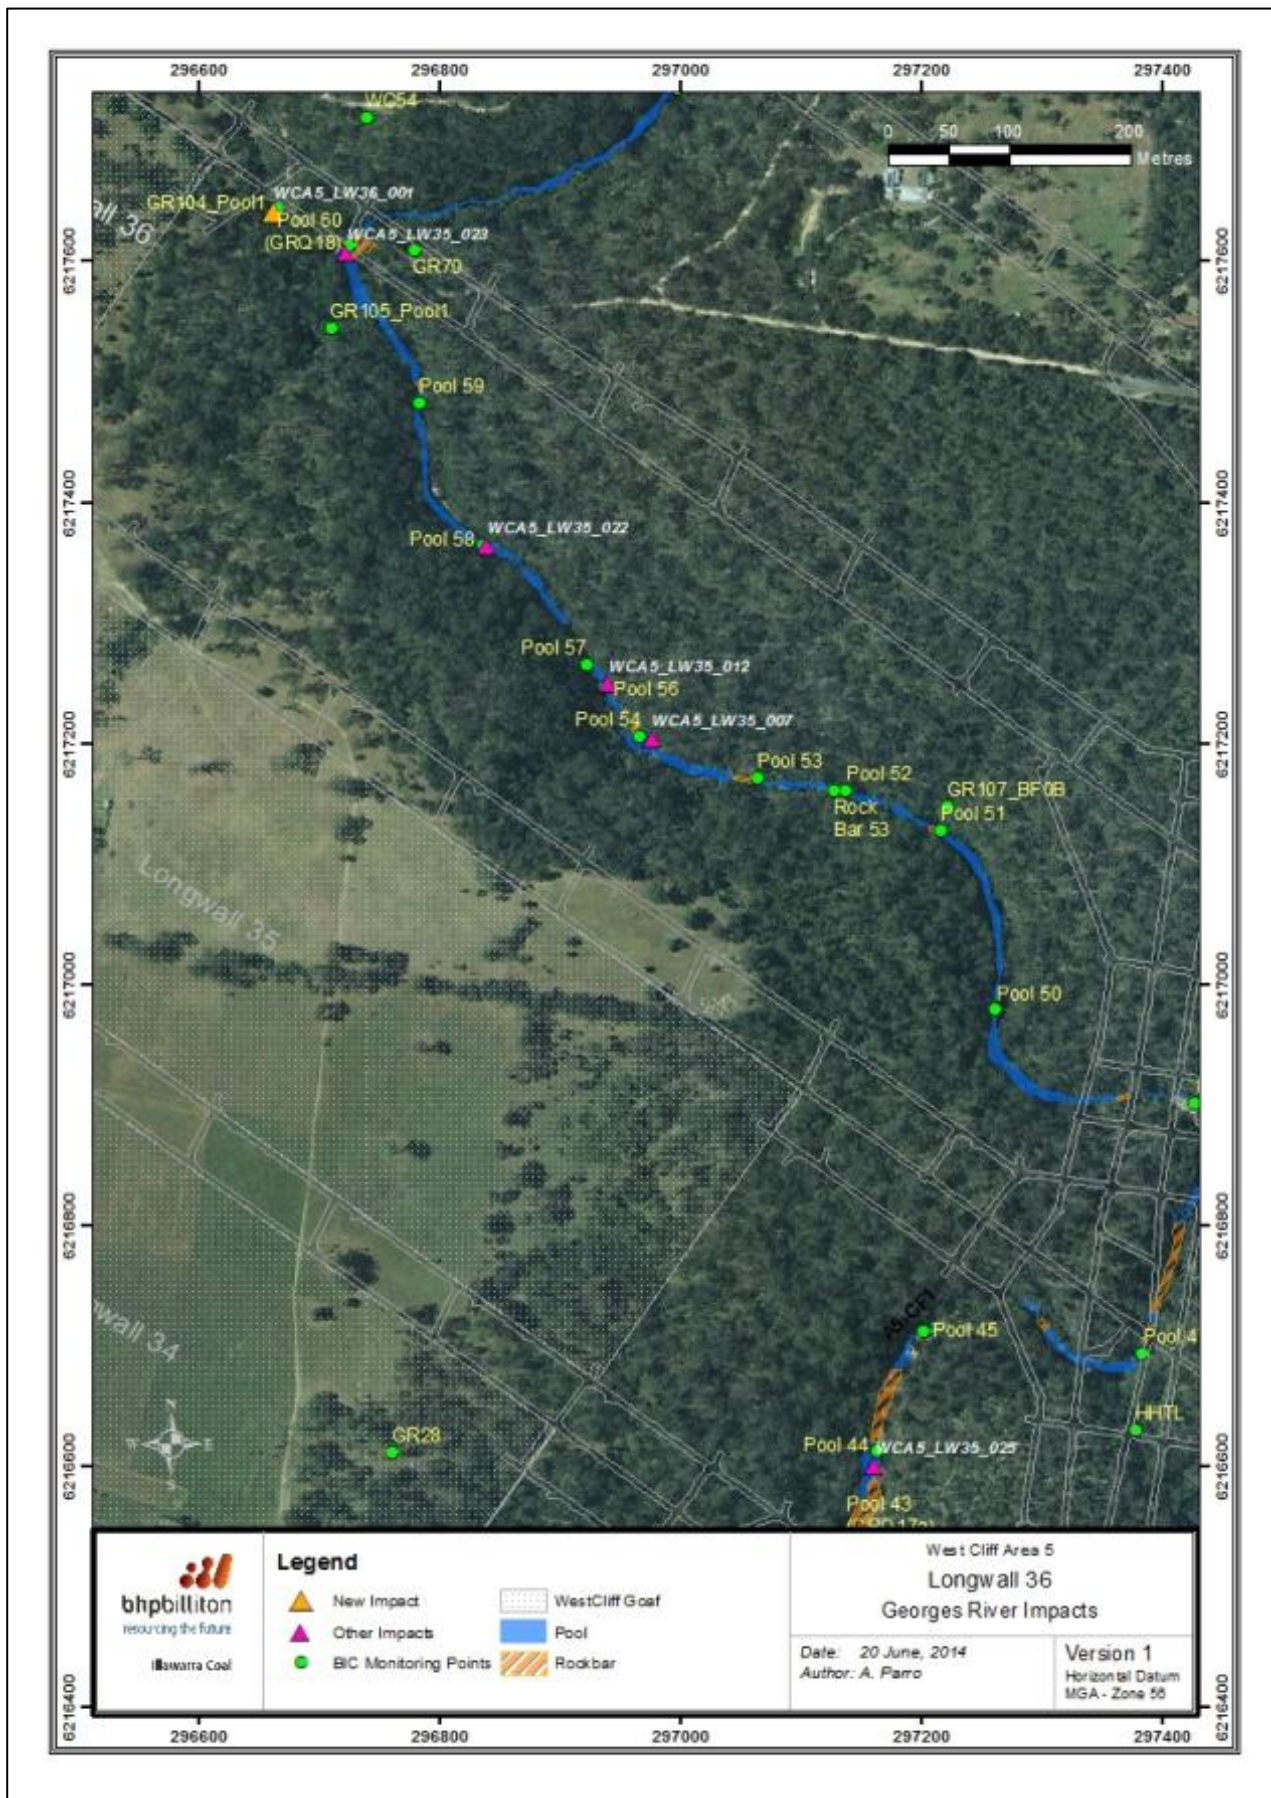
Rock fracturing and uplift was observed on a Georges River tributary at site GR104\_Pool 1 (**Figure 1**), approximately 65m from the end of Longwall 36. The impact (**Photos 1 to 4**) is comprised of two fractures approximately 1.5m and 0.5m long with a maximum uplift of 0.03m.

**Figure 1:** Map showing location of latest impact WCA5\_LW36\_001 and recent impacts in relation to other features.

Monitoring is being conducted as outlined in the West Cliff Area 5 Longwall 34 to 36 SMP. The rock fracture (WCA5\_LW36\_001) is consistent with a minor trigger as defined in the SMP. Standard monitoring will continue and no corrective actions are recommended.

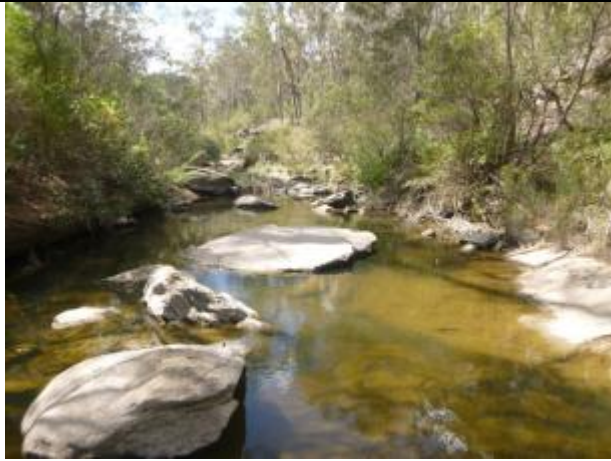
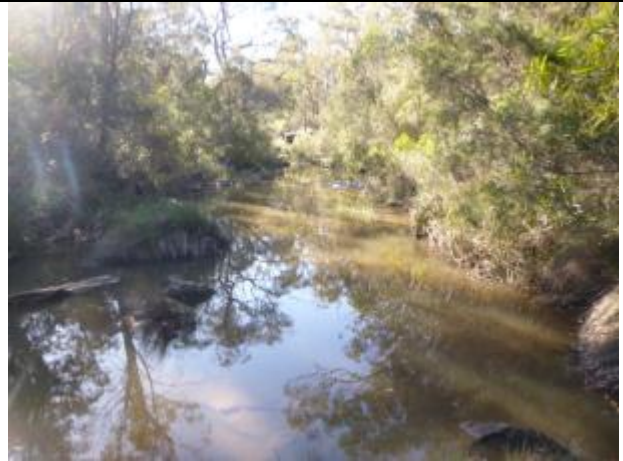
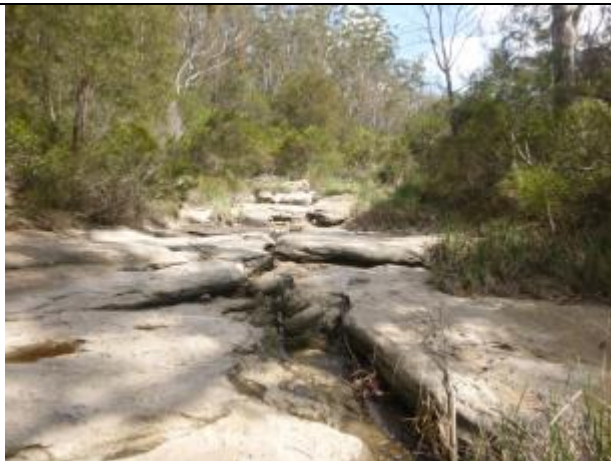
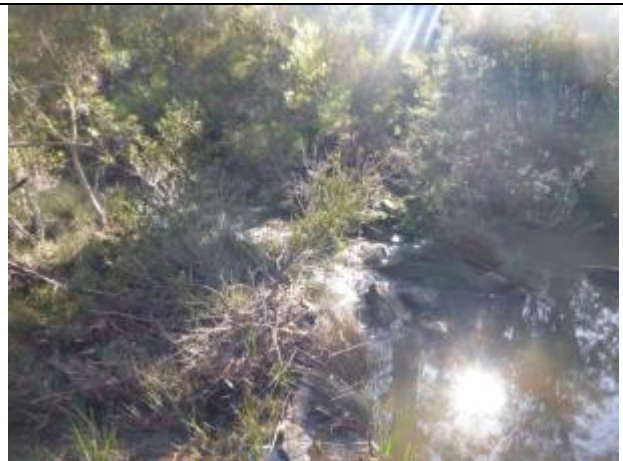
On the 9<sup>th</sup> October 2014 an inspection of GR\_Pool 54 in the Georges River was conducted and the water level was found to be 'Dry Below Nail'. This water level has previously been reported. This observation is a trigger according to the GRMP and is discussed in the TARP section of this report. An inspection was conducted on 16<sup>th</sup> October 2014 and water level was found to have returned to above pre-mining level (**Graph 3**). A comparison of pool water levels for the two inspections is presented in photos 7 to 10.

Photo 7: GR\_Pool 54 looking upstream. Taken on 09/10/2014.

Photo 8: GR\_Pool 54 looking upstream. Taken on 16/10/2014.

Photo 9: GR\_Pool 54 looking downstream. Taken on 09/10/2014.

Photo 10: GR\_Pool 54 looking downstream. Taken on 16/10/2014.

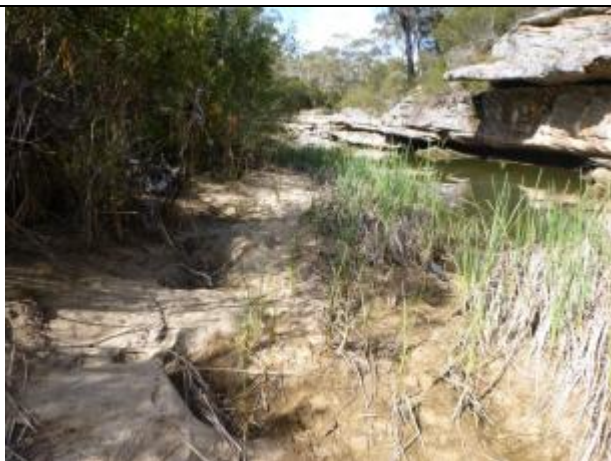
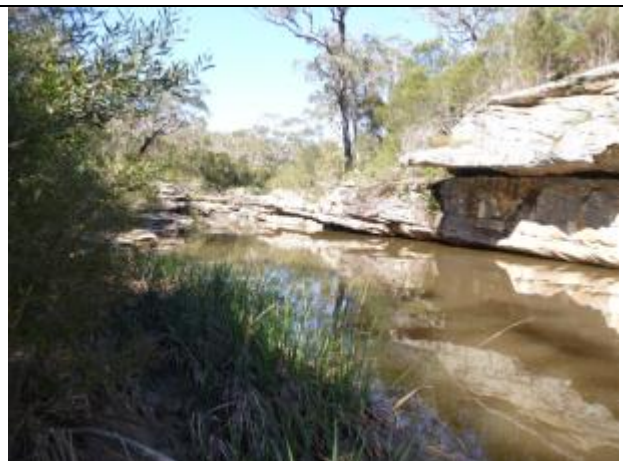
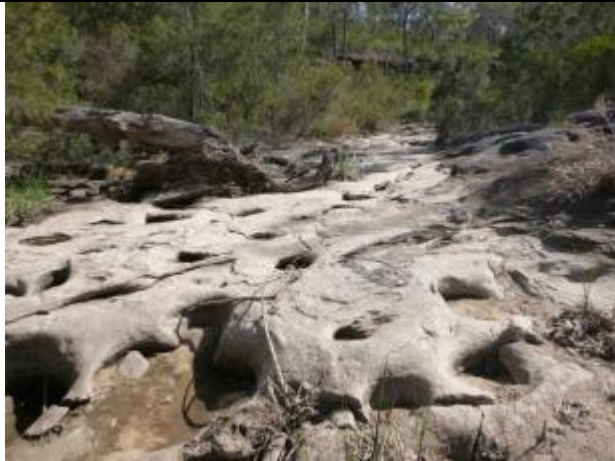
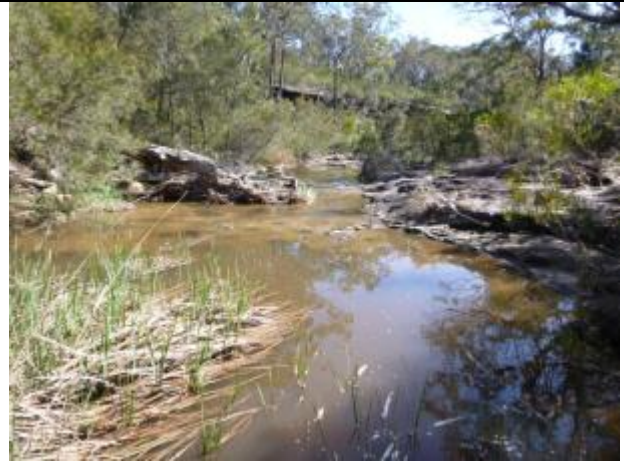
On the 9<sup>th</sup> October 2014 an inspection of GR\_Pool 44 in the Georges River was conducted and the water level was found to be 'Dry Below Nail'. This water level has previously been reported. This observation is a trigger according to the GRMP and is discussed in the TARP section of this report. An inspection was conducted on 16<sup>th</sup> October 2014 and water level was found to have returned to above pre-mining level (**Graph 4**). A comparison of pool water levels for the two inspections is presented in photos 11 to 14.

Photo 11: GR\_Pool 44 looking upstream. Taken on 09/10/2014.

Photo 12: GR\_Pool 44 looking upstream. Taken on 16/10/2014.

Photo 13: GR\_Pool 44 looking downstream. Taken on 09/10/2014.

Photo 14: GR\_Pool 44 looking downstream. Taken on 16/10/2014.

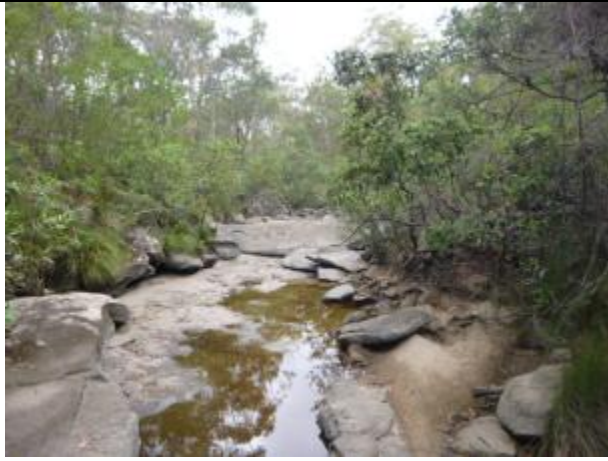
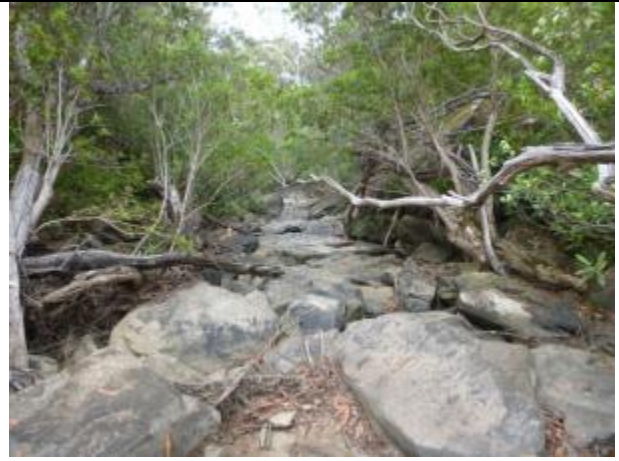
On the latest inspection of GR\_Pool 57 the pool was 'Dry Below Nail' (Graph 4). This water level has been reported previously, is below the lowest level experienced in the baseline period and is a trigger according to the GRMP. Photos 7 and 8 show the latest pool conditions.

**Photo 7:** GR\_Pool 57, looking upstream. Taken on 27/11/2014.

**Photo 8:** GR\_Pool 57, looking downstream. Taken on 27/11/2014.

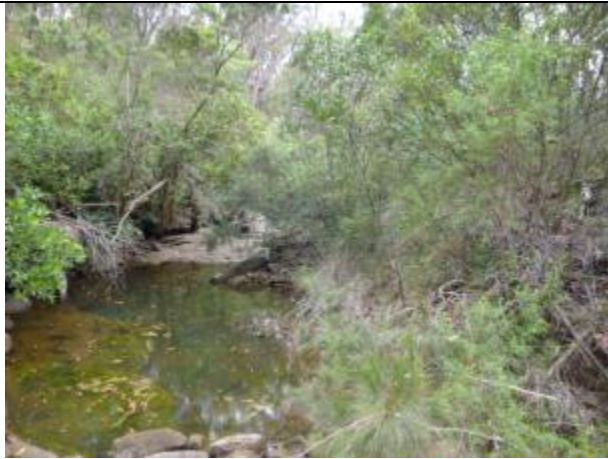
**Photo 9:** GR\_Pool 58, looking upstream. Taken on 27/11/2014.

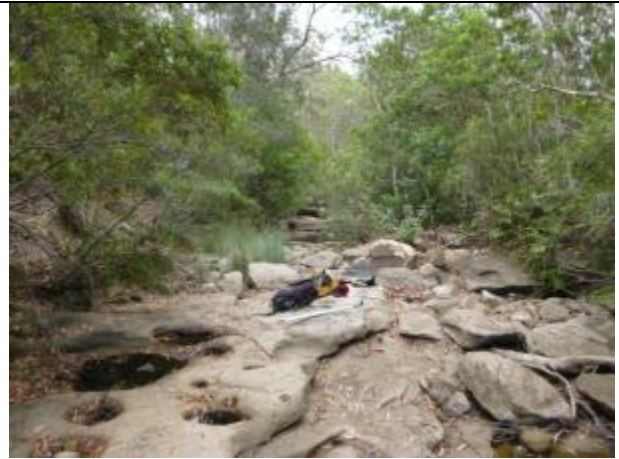
**Photo 10:** GR\_Pool 58, looking downstream. Taken on 27/11/2014.

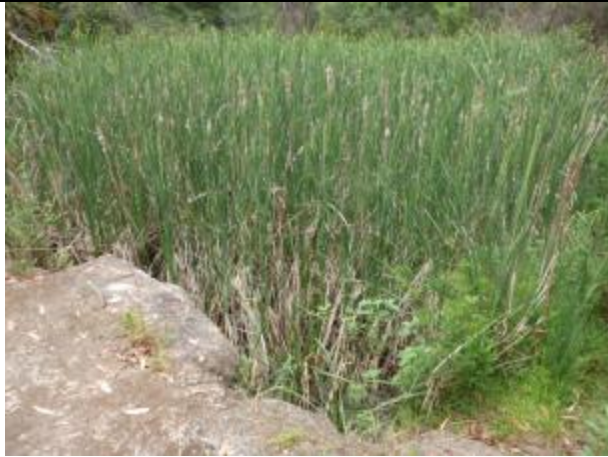
**Photo 11:** GR\_Pool 60, looking upstream. Taken on 27/11/2014.

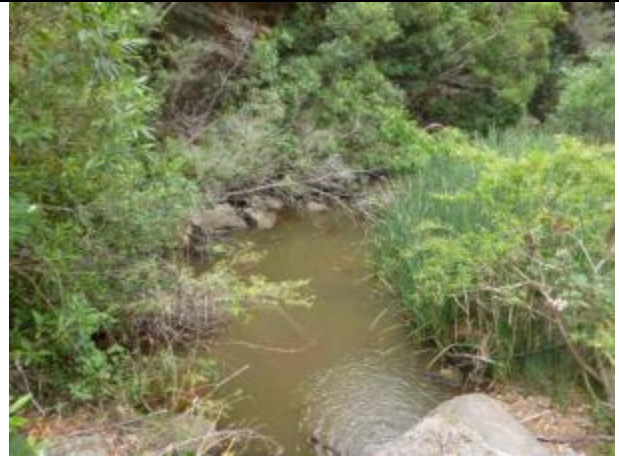
**Photo 12:** GR\_Pool 60, looking downstream. Taken on 27/11/2014.

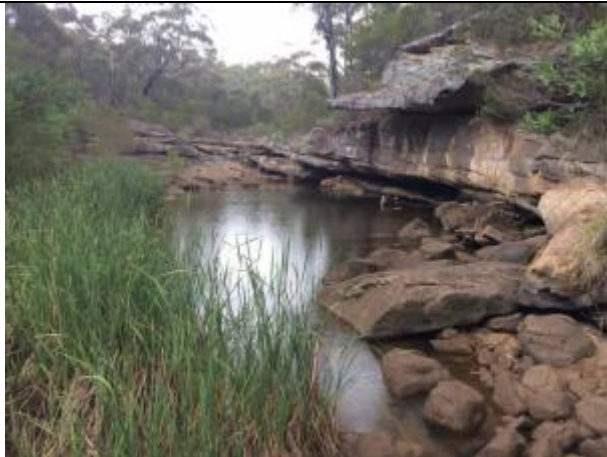
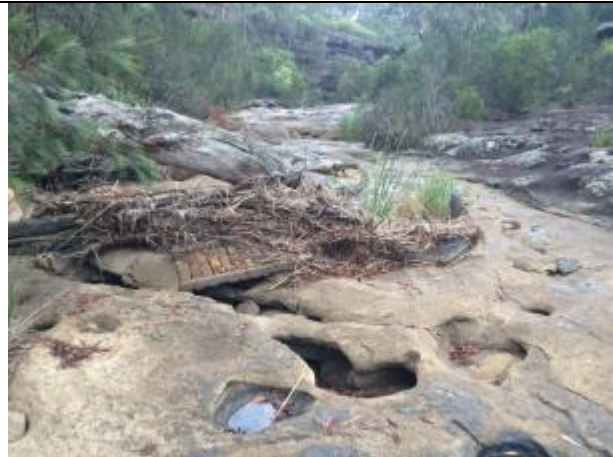
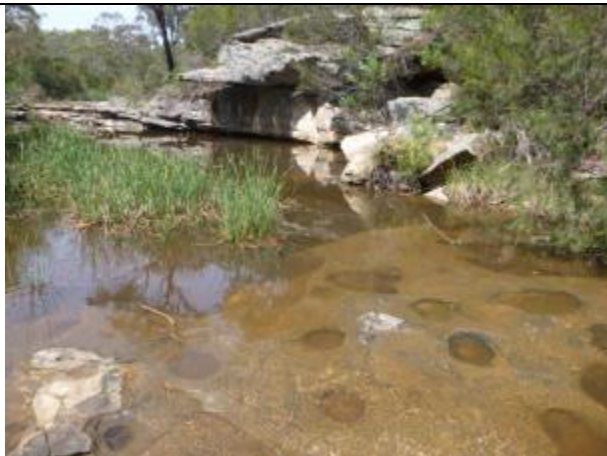
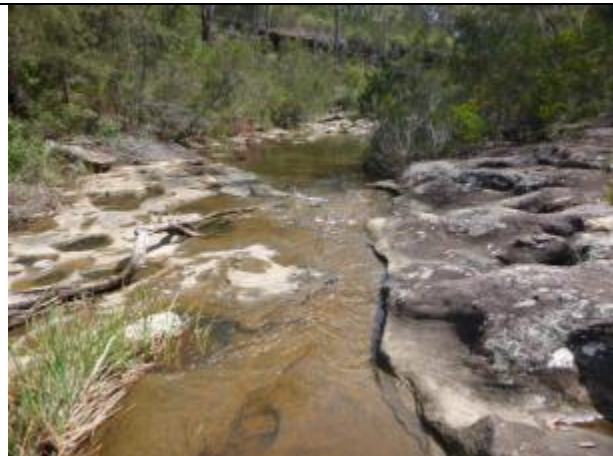
GR\_Pool 44 levels are now above baseline (Graph 1). Photos 1 to 4 show a comparison of pool conditions from the inspections.

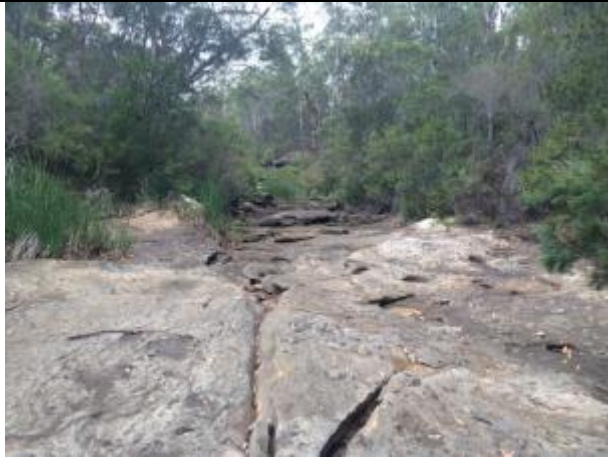
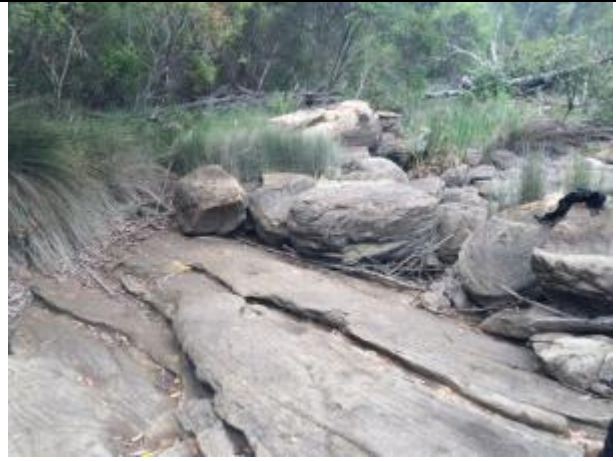
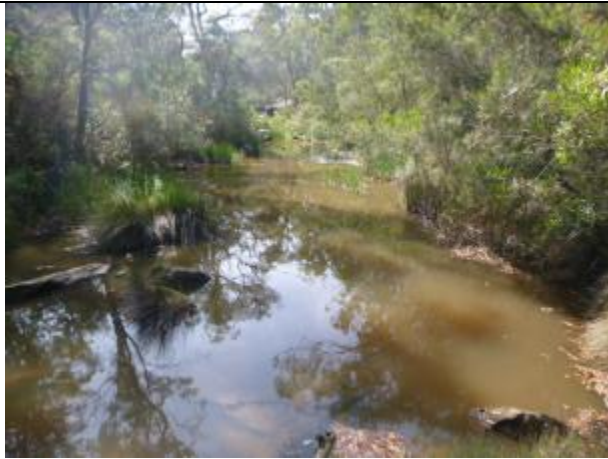
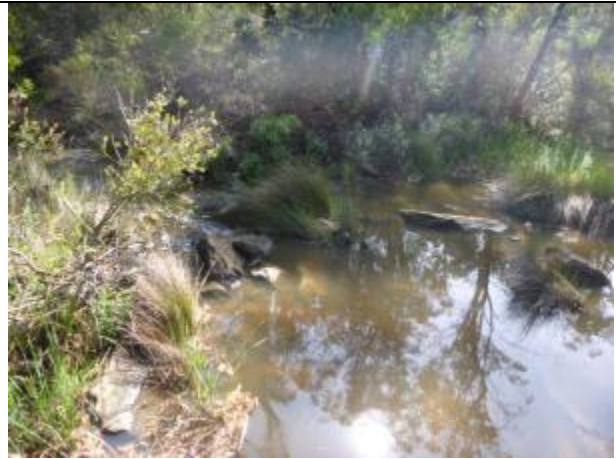
GR\_Pool 54 levels are now above baseline (Graph 2). Photos 5 to 8 show a comparison of pool conditions from the inspections.

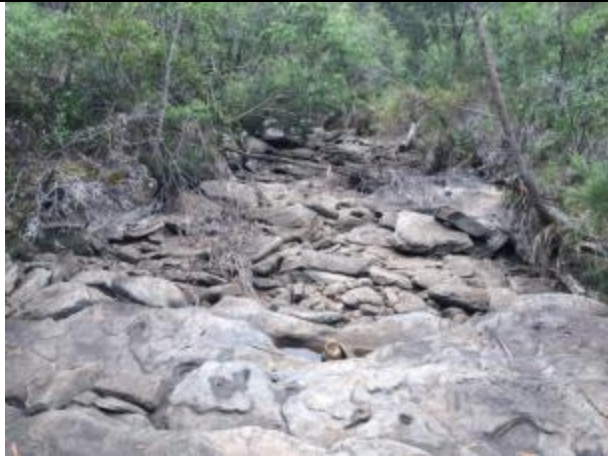
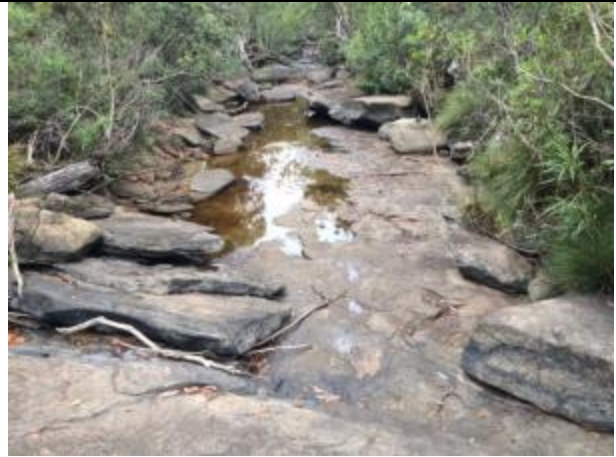
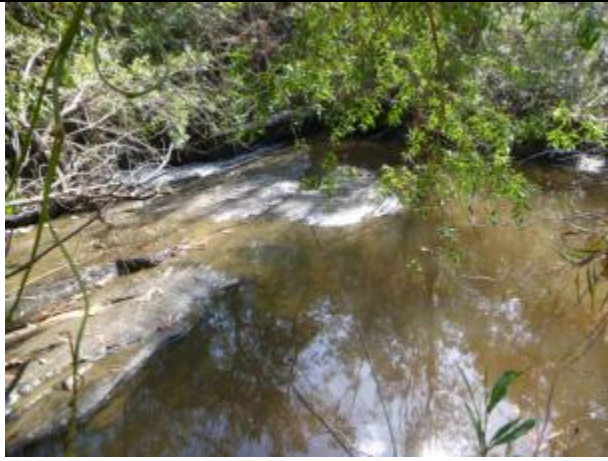
GR\_Pool 56 levels are above baseline (Graph 3). Photos 9 to 11 show a comparison of pool conditions from the inspections.

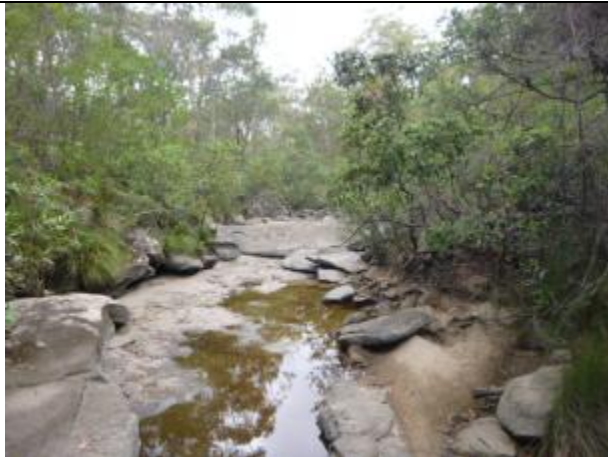
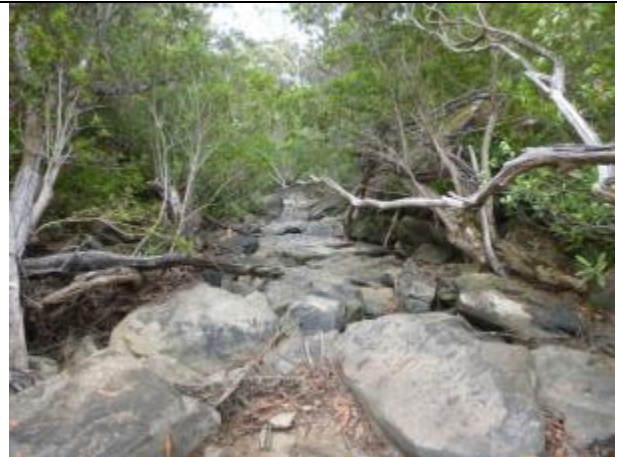
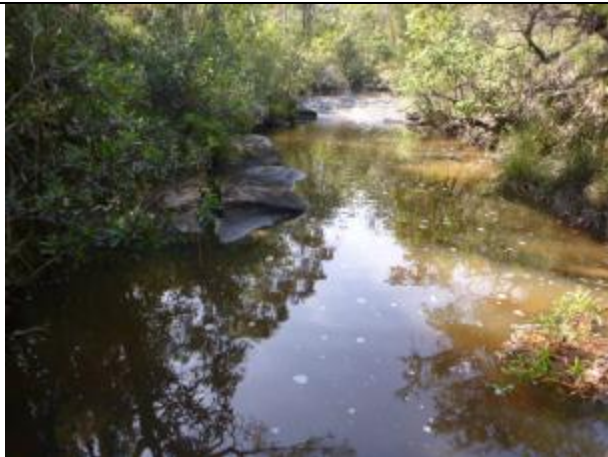
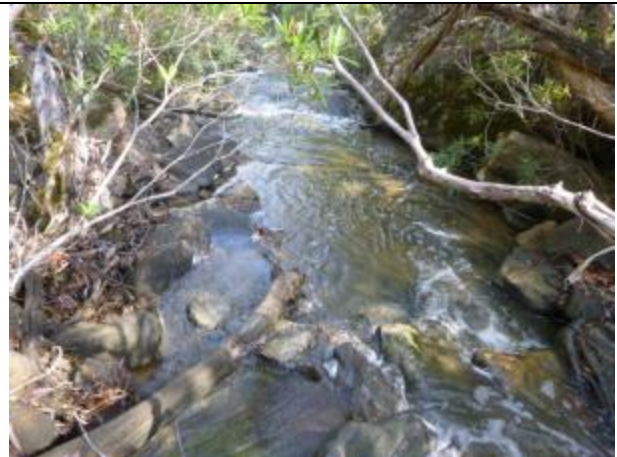
GR\_Pool 57 levels are above baseline (Graph 4). Photos 12 to 15 show a comparison of pool conditions from the inspections.

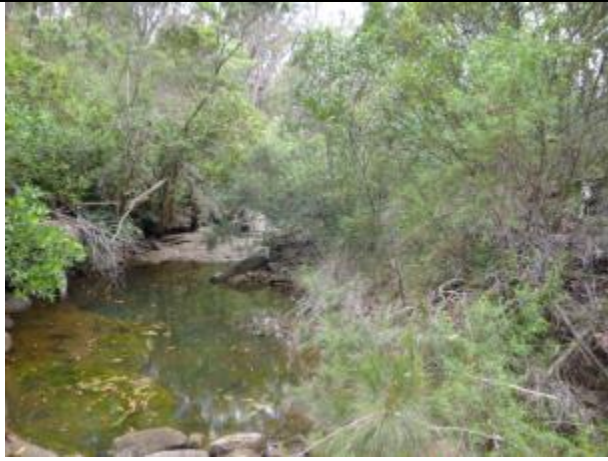
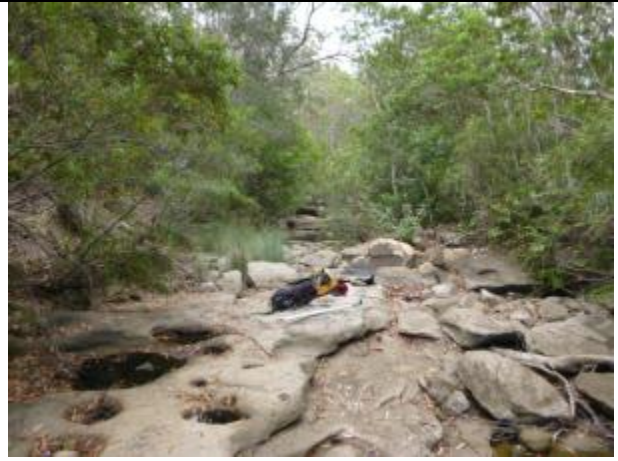
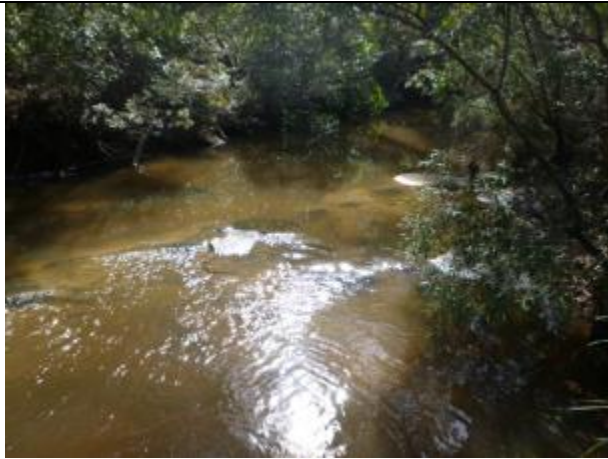
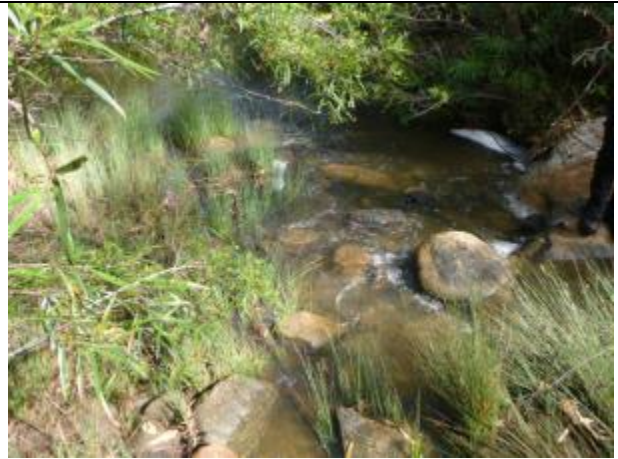
GR\_Pool 58 levels are above baseline (Graph 5). Photos 16 to 19 show a comparison of pool conditions from the inspections.

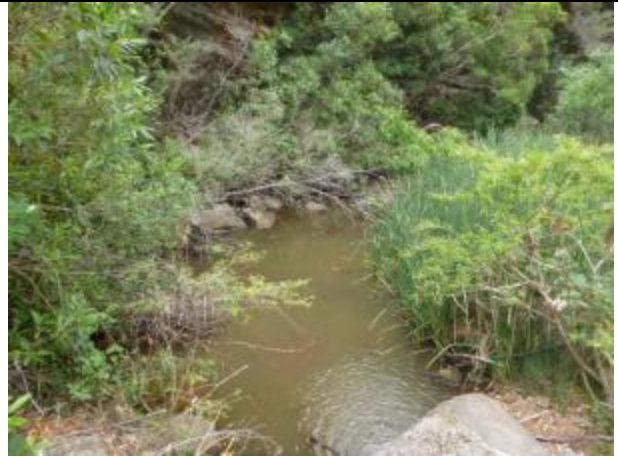
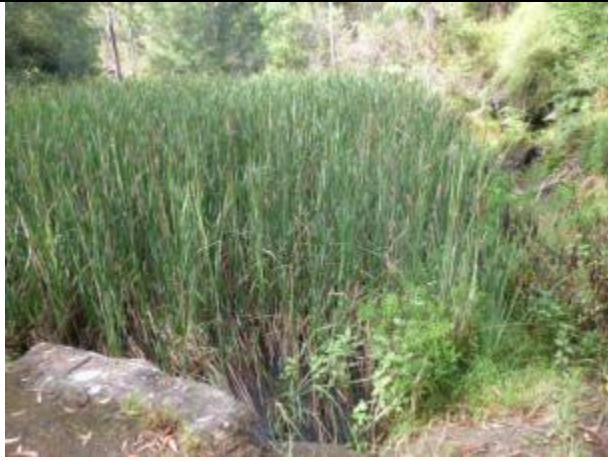
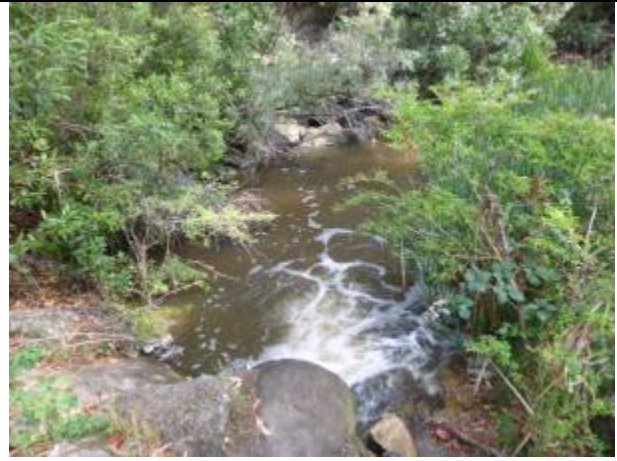
GR\_Pool 60 levels are above baseline (Graph 6). Photos 20 to 23 show a comparison of pool conditions from the inspections.

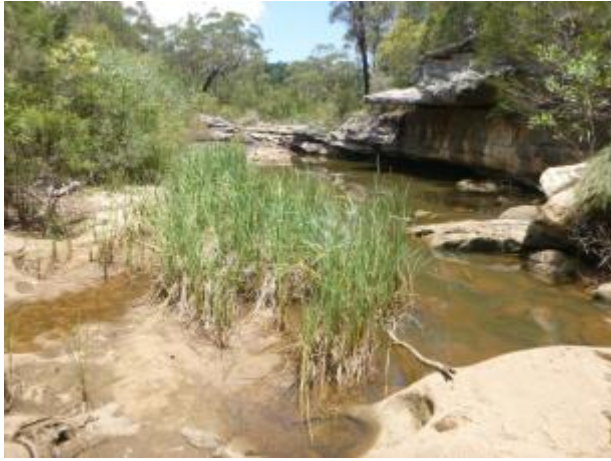
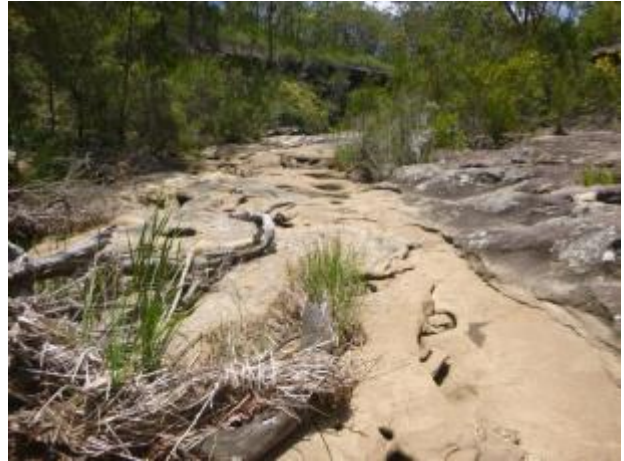
Photo 1: GR\_Pool 44, looking upstream. Taken on 15/12/2014.

Photo 2: GR\_Pool 44, looking downstream. Taken on 15/12/2014.

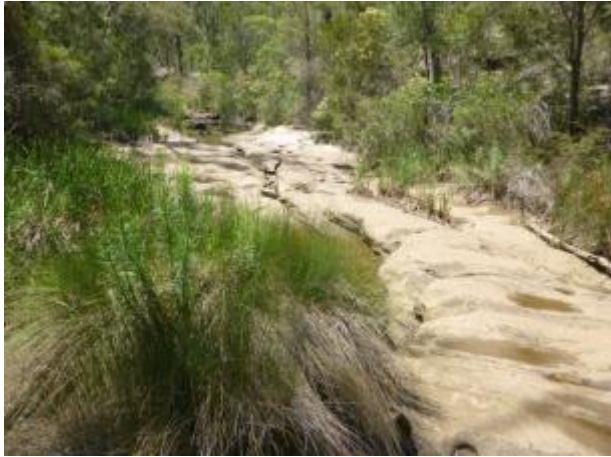
Photo 3: GR\_Pool 54, looking upstream. Taken on 15/12/2014.

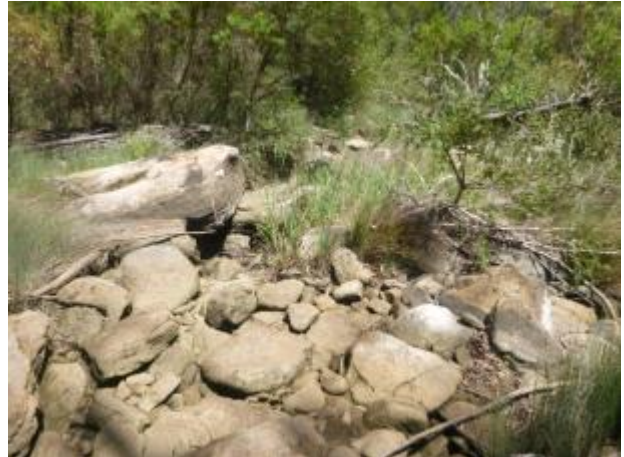
Photo 4: GR\_Pool 54, looking downstream. Taken on 15/12/2014.

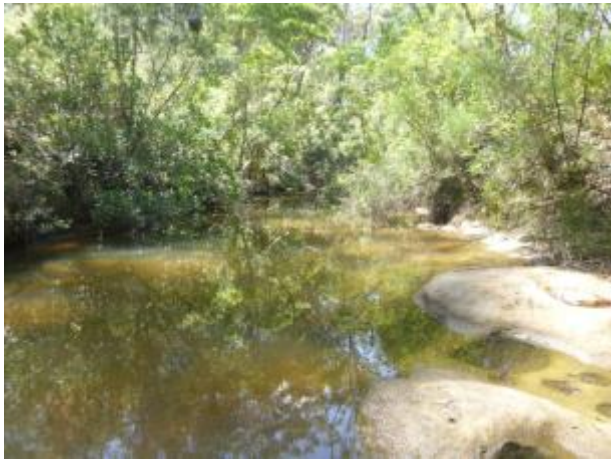
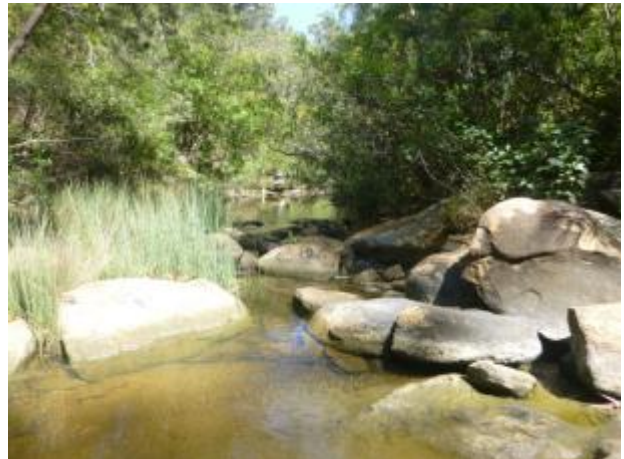
Photo 5: GR\_Pool 58, looking upstream. Taken on 15/12/2014.

Photo 6: GR\_Pool 58, looking downstream. Taken on 15/12/2014.

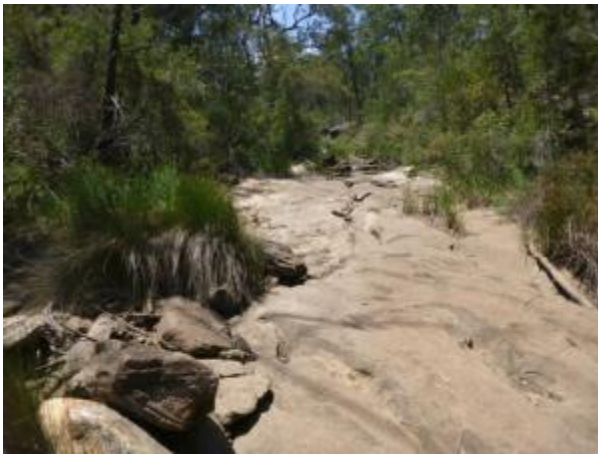
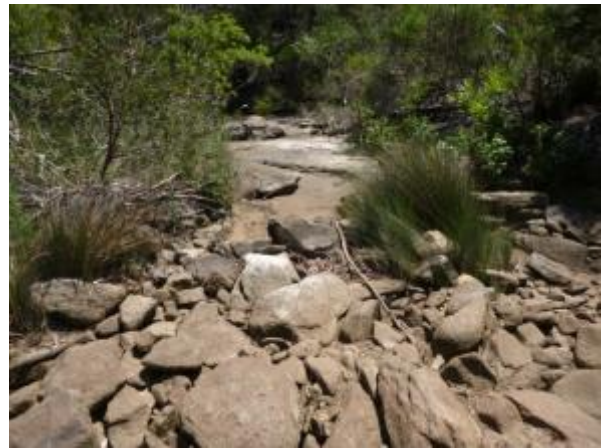
On the latest inspection of GR\_Pool 54 the pool was dry (Graph 2). This has been reported previously, is below the lowest level experienced in the baseline period and is a trigger according to the GRMP. Photos 3 and 4 show the latest pool conditions.

Photo 3: GR\_Pool 54 looking upstream. Taken on 23/12/2014

Photo 4: GR\_Pool 54 looking downstream. Taken on 23/12/2014

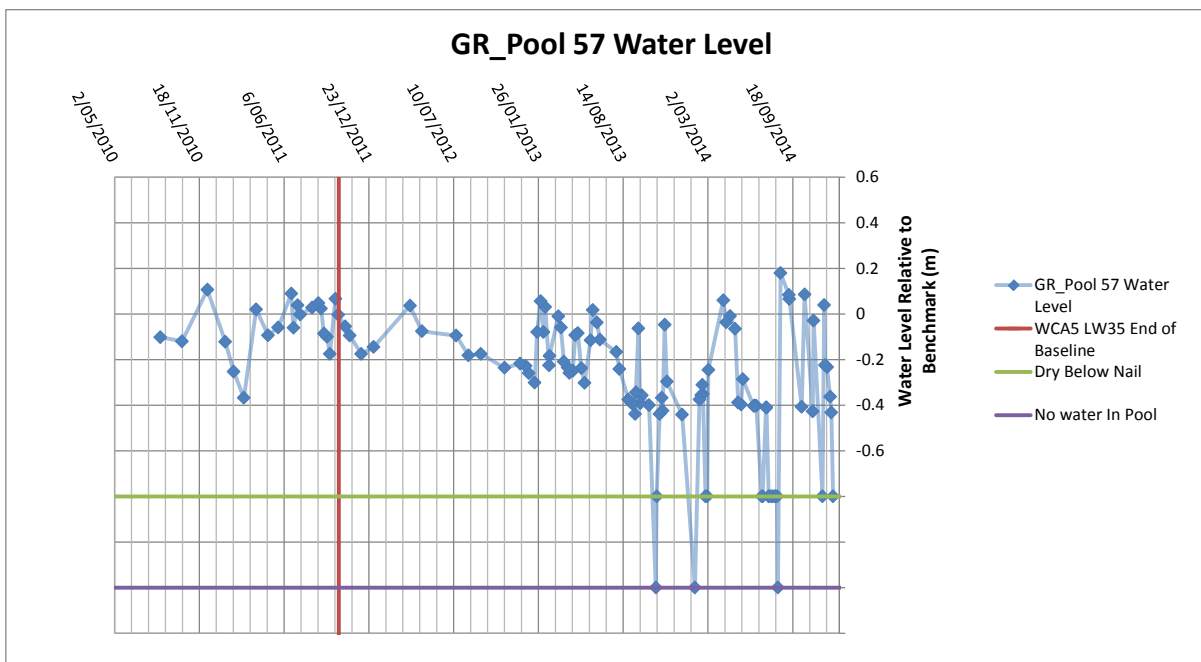
Graph 3: Water levels recorded in GR\_Pool 57

On the latest inspection of GR\_Pool 57 the pool water level was 'Dry Below Nail' (Graph 3). This has been reported previously, is below the lowest level experienced in the baseline period and is a trigger according to the GRMP. Photos 5 and 6 show the latest pool conditions.

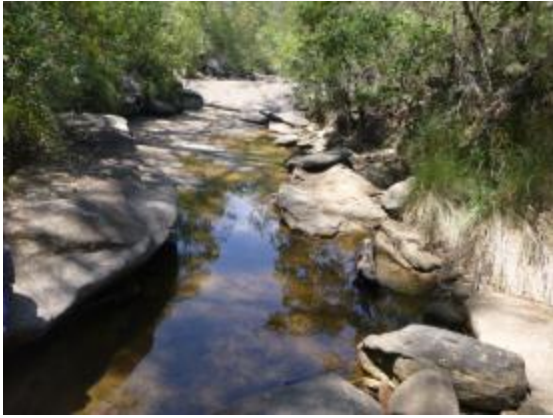
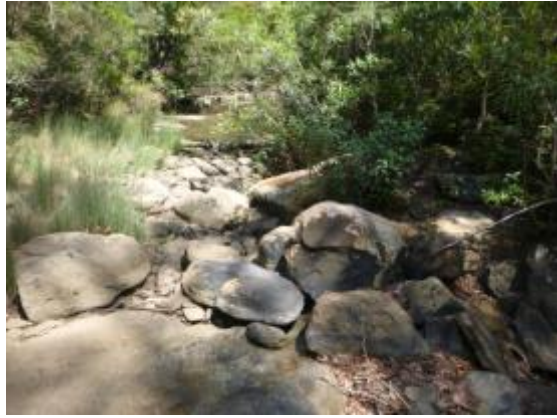
Photo 5: GR\_Pool 57 looking upstream. Taken on 23/12/2014

Photo 6: GR\_Pool 57 looking downstream. Taken on 23/12/2014

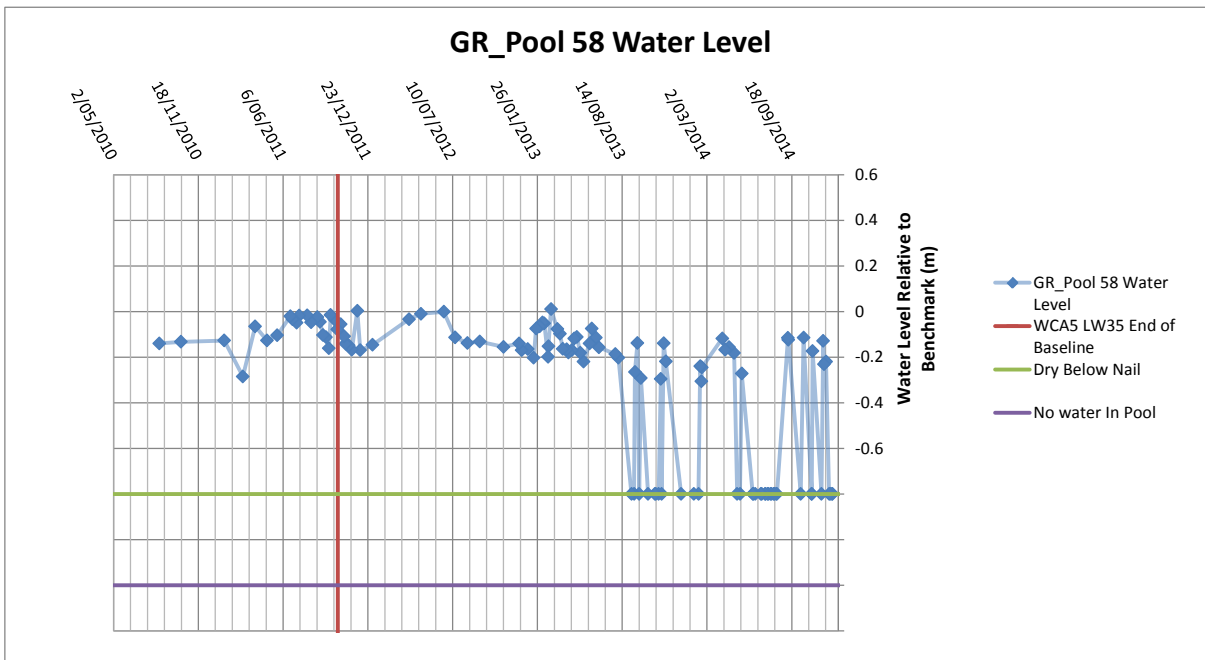
Graph 4: Water levels recorded in GR\_Pool 58

On the latest inspection of GR\_Pool 58 the pool water level was ‘Dry Below Nail’ (Graph 4). This has been reported previously, is below the lowest level experienced in the baseline period and is a trigger according to the GRMP. Photos 7 and 8 show the latest pool conditions.

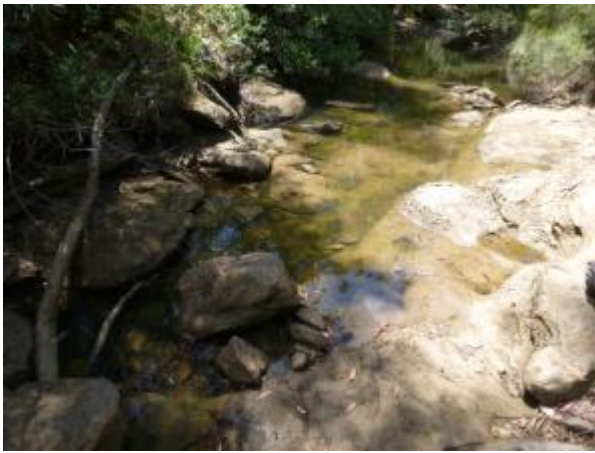
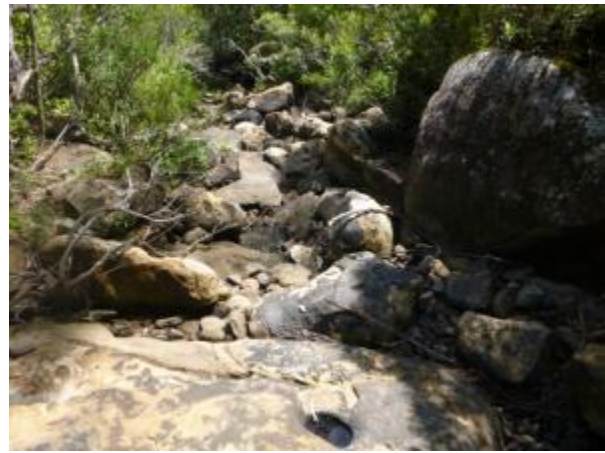
Photo 7: GR\_Pool 58 looking upstream. Taken on 23/12/2014

Photo 8: GR\_Pool 58 looking downstream. Taken on 23/12/2014

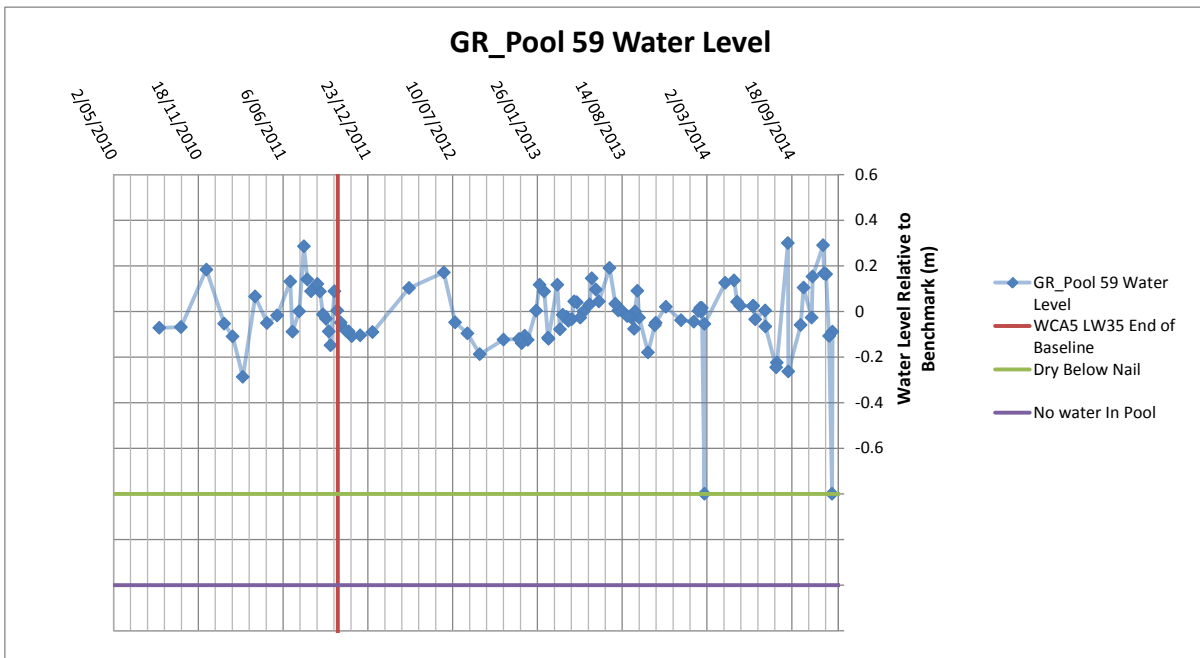
Graph 5: Water levels recorded in GR\_Pool 59

On the 22<sup>nd</sup> of December 2014 an inspection of GR\_Pool 59 was conducted and the water level was observed to be ‘Dry Below Nail’. This was below the lowest level experienced during the baseline period and is a trigger according to the GRMP. An additional inspection was carried out on the 23<sup>rd</sup> of December 2014, where it was observed that pool water level had returned to above baseline levels (Graph 5). Photos 9 to 12 show a comparison of pool conditions between the two days.
