**ATTACHMENT C1 –  
LONGWALL 37 END OF  
PANEL REPORT**

**LANDSCAPE MONITORING  
IMPACT REPORTS**

**ILLAWARRA COAL ENVIRONMENTAL  
FIELD TEAM, JUNE 2014 TO  
JANUARY 2015**

## West Cliff Area 5 Longwall 36 Impact Report

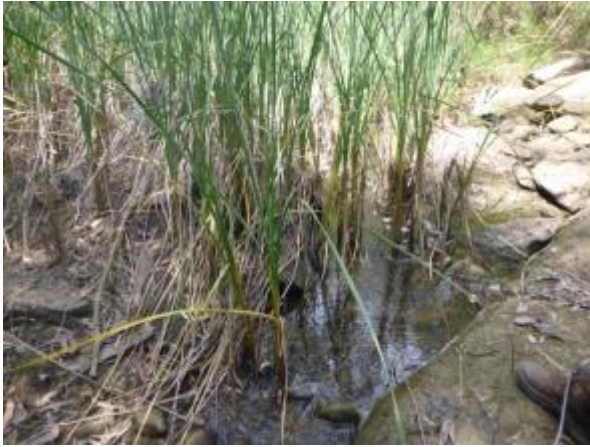
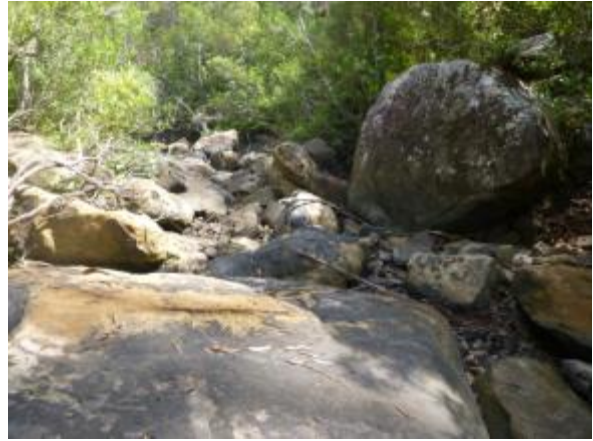
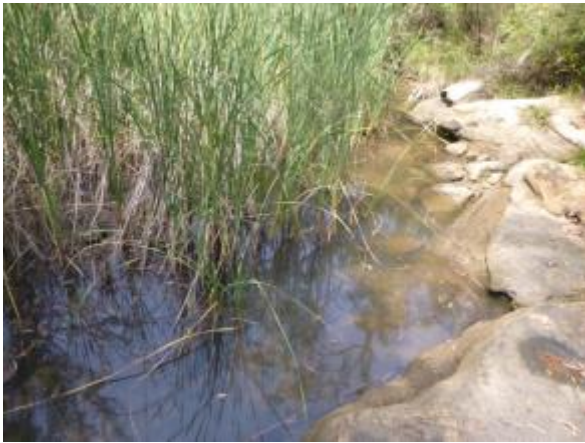
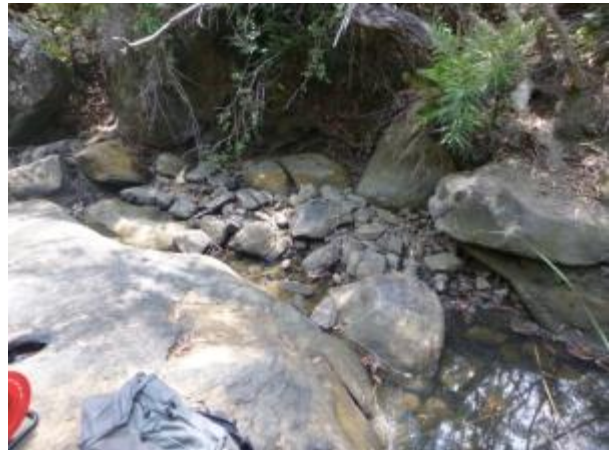
On the 22<sup>nd</sup> of December 2014 an inspection of GR\_Pool 59 was conducted and the water level was observed to be ‘Dry Below Nail’. This was below the lowest level experienced during the baseline period and is a trigger according to the GRMP. An additional inspection was carried out on the 23<sup>rd</sup> of December 2014, where it was observed that pool water level had returned to above baseline levels (Graph 5). Photos 9 to 12 show a comparison of pool conditions between the two days.

Photo 9: GR\_Pool 59 looking upstream. Taken on 22/12/2014

Photo 10: GR\_Pool 59 looking downstream. Taken on 22/12/2014.

Photo 11: GR\_Pool 59 looking upstream. Taken on 23/12/2014

Photo 12: GR\_Pool 59 looking downstream. Taken on 23/12/2014

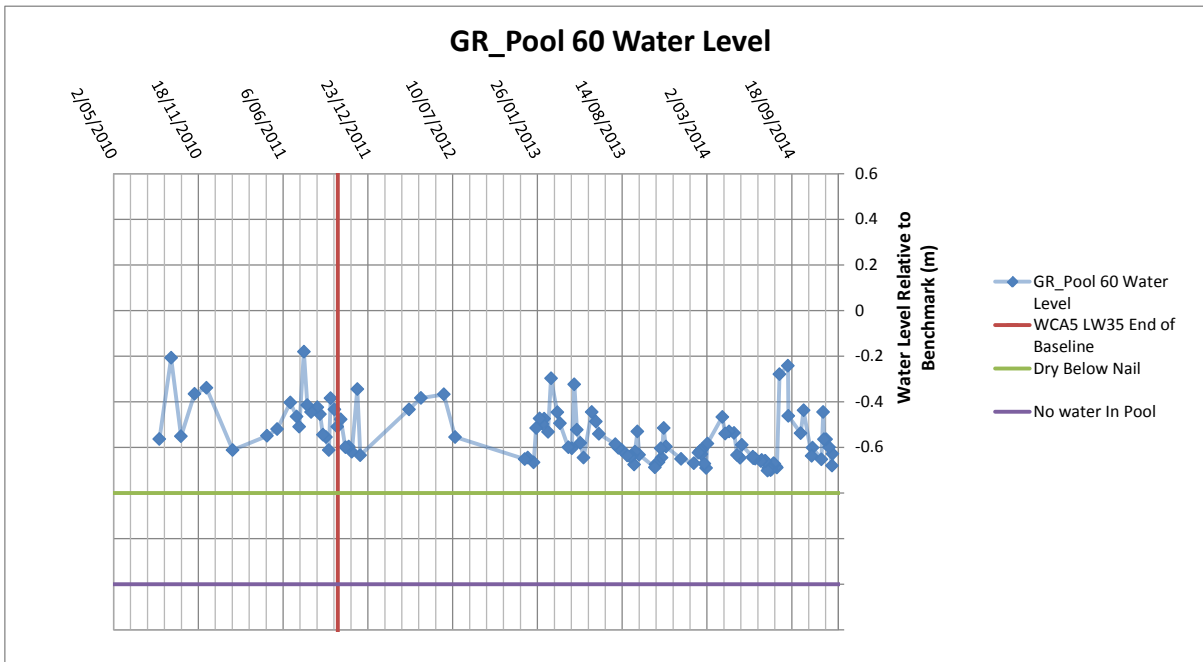
Graph 6: Water levels recorded in GR\_Pool 60

On the latest inspection of GR\_Pool 60 the pool water level was observed to be below baseline levels (Graph 6). This has been reported previously and is a trigger according to the GRMP. Photos 13 and 14 show the latest pool conditions.

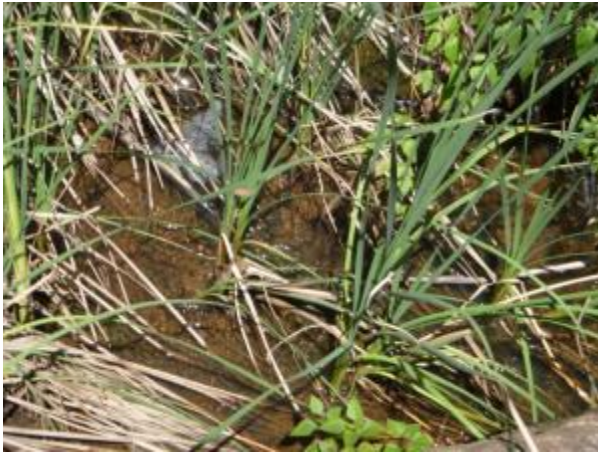
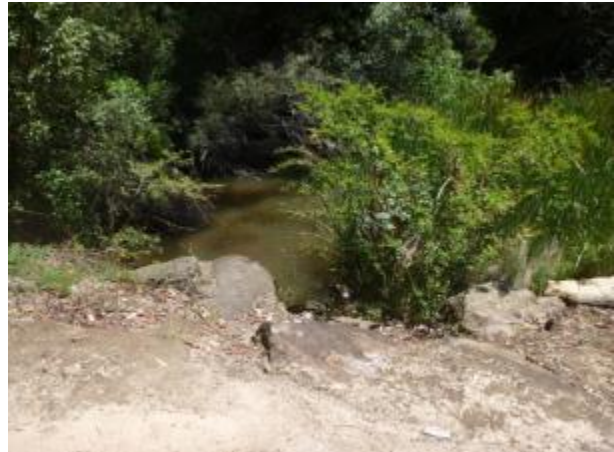
Photo 13: GR\_Pool 60 looking upstream .Taken on 23/12/2014

Photo 14: GR\_Pool 60 looking upstream. Taken on 23/12/2014

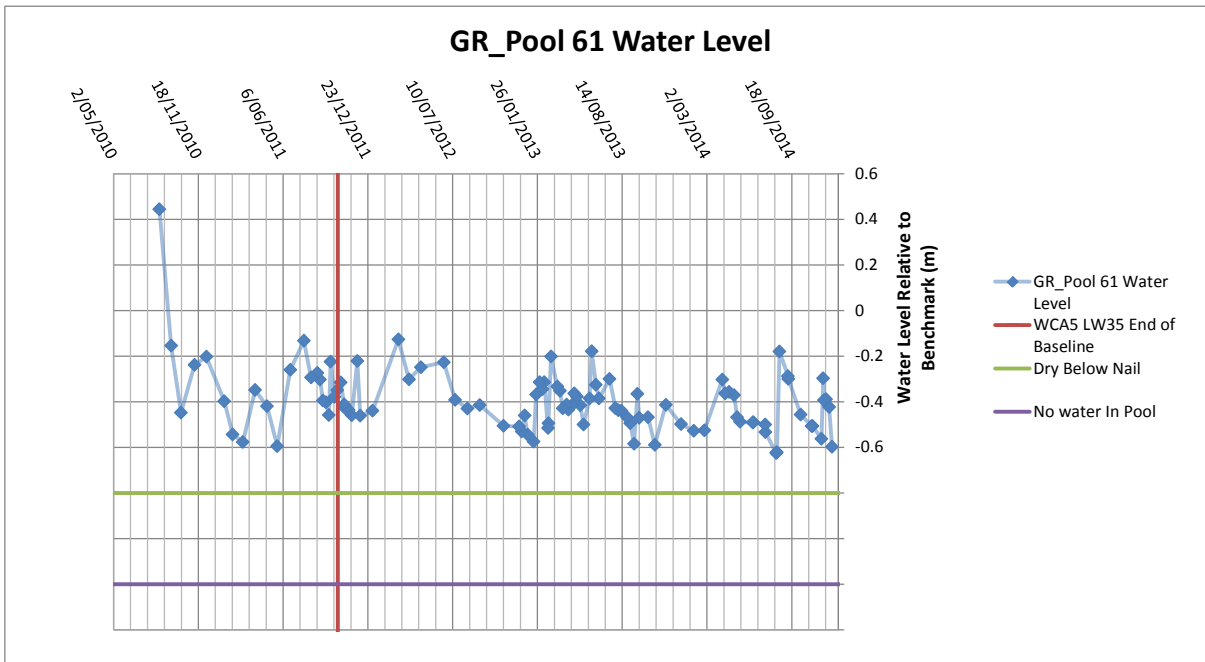
Graph 7: Water levels recorded in GR\_Pool 61

On the latest inspection of GR\_Pool 61 the pool water level was observed to be below baseline levels (Graph 7). This has been reported previously and is a trigger according to the GRMP. Photos 15 and 16 show the latest pool conditions.

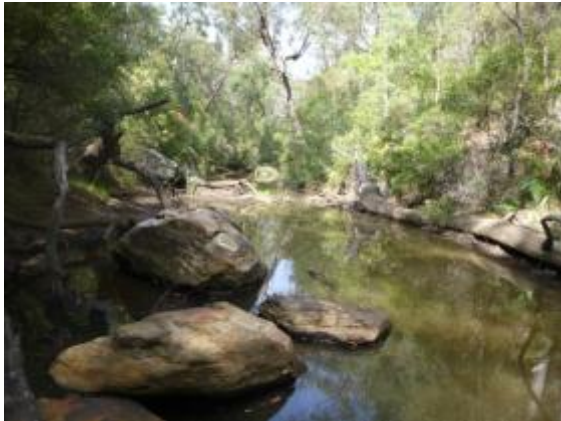
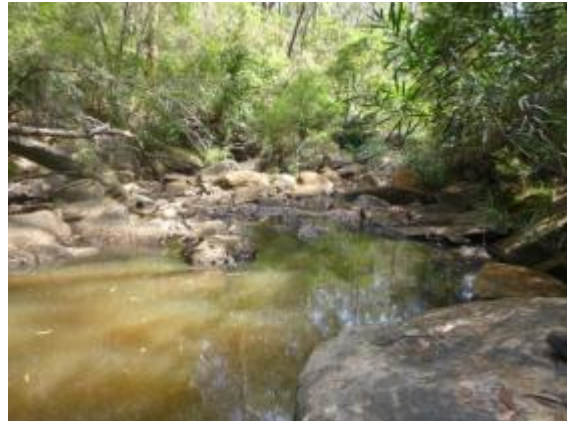
Photo 15: GR\_Pool 61 looking upstream. Taken on 22/12/2014

Photo 16: GR\_Pool 61 looking downstream. Taken on 22/12/2014

- Continue monitoring as required by the SMP (return to twice weekly inspections);
- Release additional water from BCD (when permitted)

An assessment of pool water level reduction and remedial works to restore pool water level is being drafted.

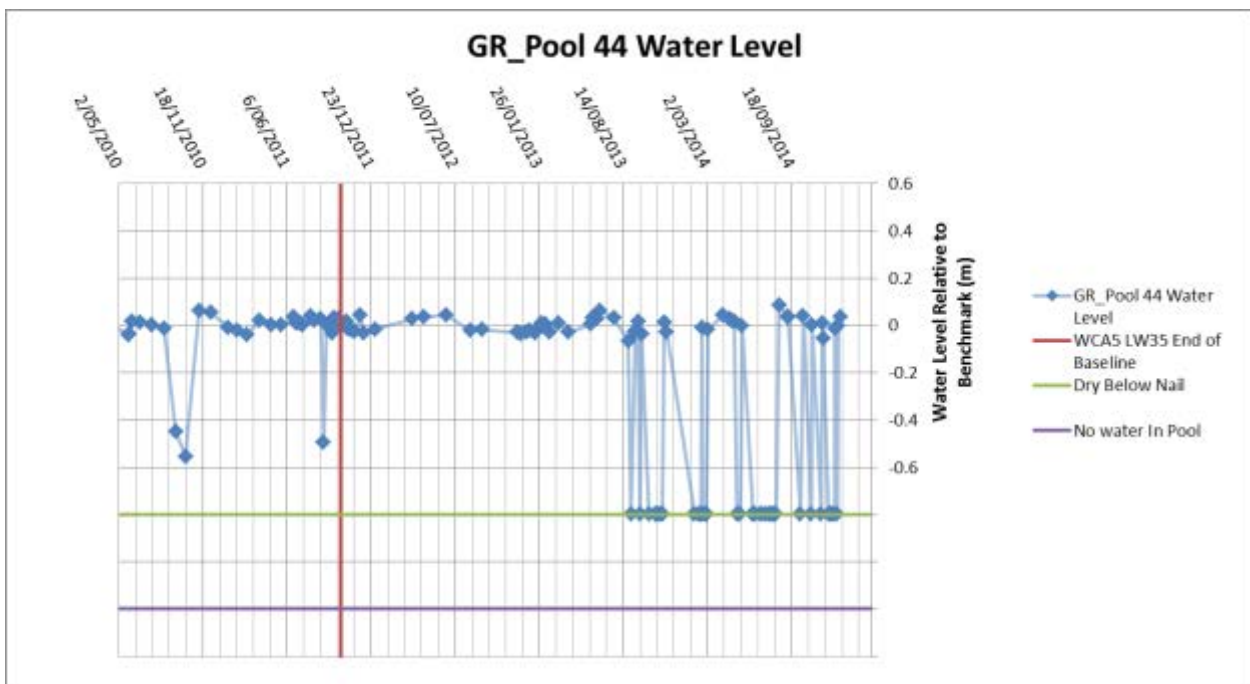
Graph 1: Water levels recorded in GR\_Pool 44.

Water levels in GR\_Pool 44 were previously reported as below baseline. On the latest inspection of GR\_Pool 44 the pool water level was above pre-mining baseline levels (Graph 1). Photos 1 and 2 show the latest pool conditions.

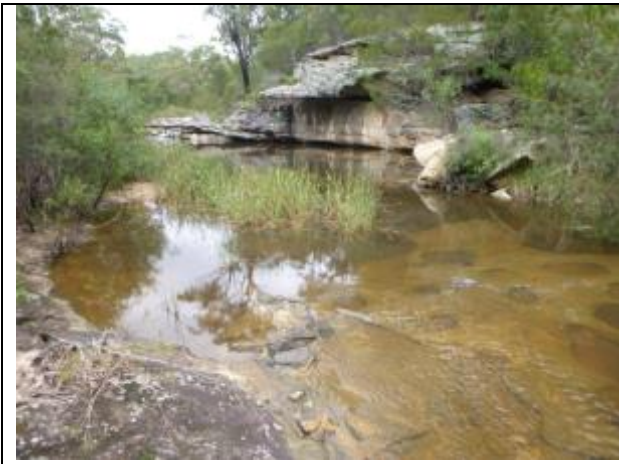
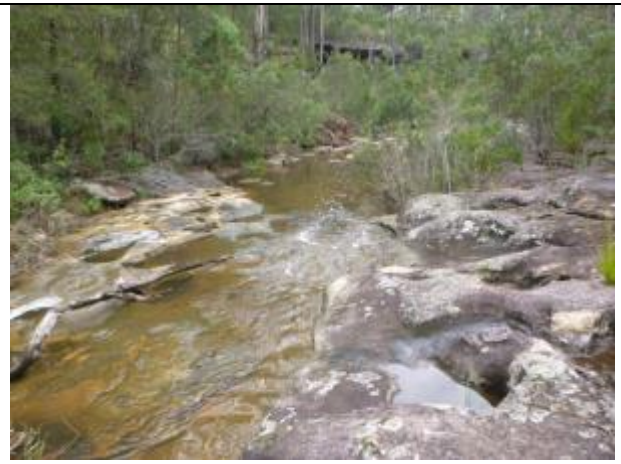
Photo 1: GR\_Pool 44 looking upstream. Taken on 12/01/2015.

Photo 2: GR\_Pool 44 looking downstream. Taken on 12/01/2015.

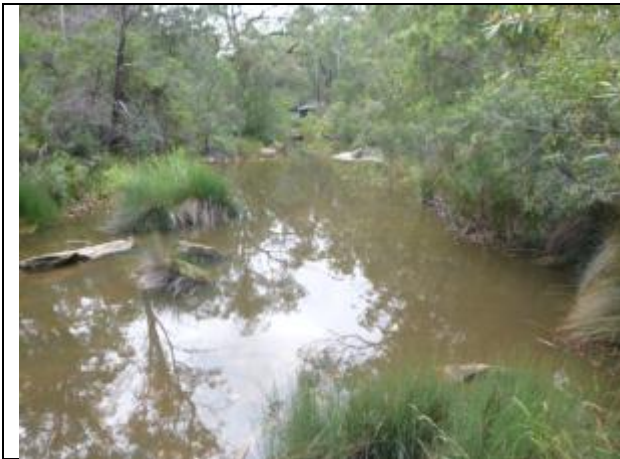
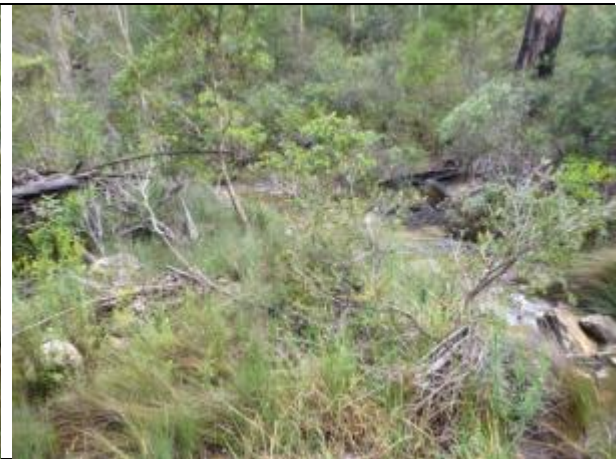
Photo 3: GR\_Pool 54 looking upstream. Taken on 12/01/2015.

Photo 4: GR\_Pool 54 looking downstream. Taken on 12/01/2015.

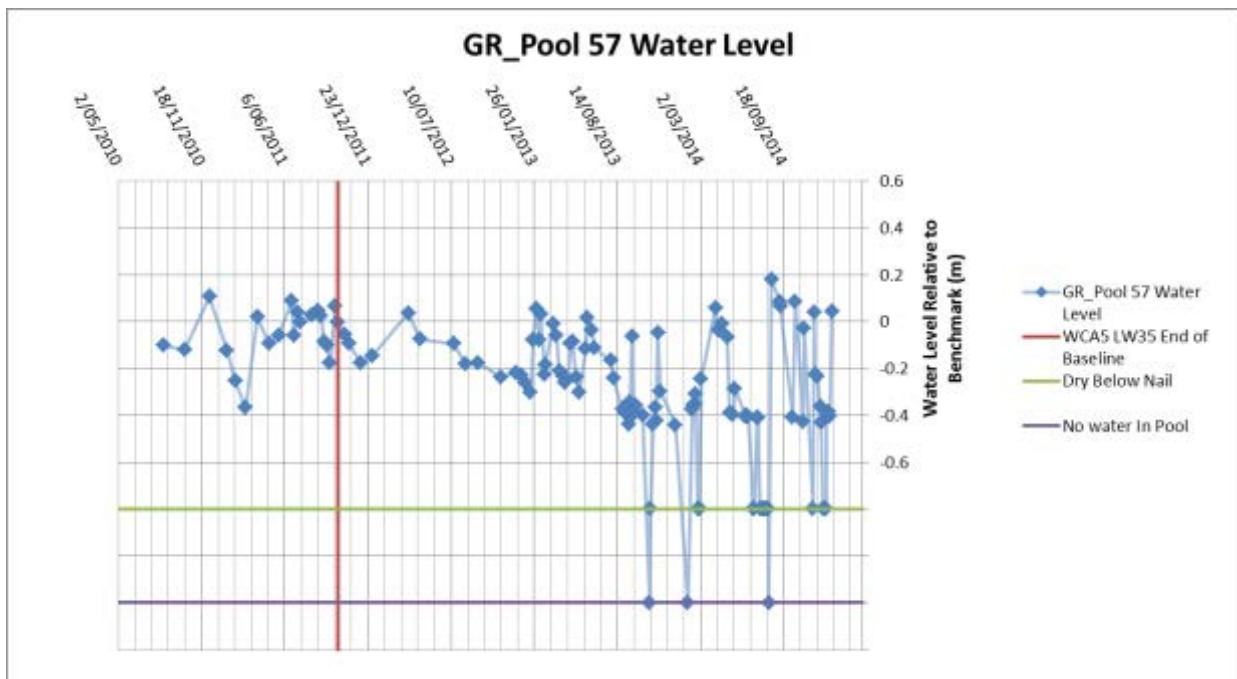
Graph 3: Water levels recorded in GR\_Pool 57

On the latest inspection of GR\_Pool 57 the pool water level was above baseline levels (Graph 3). Photos 5 and 6 show the latest pool conditions.

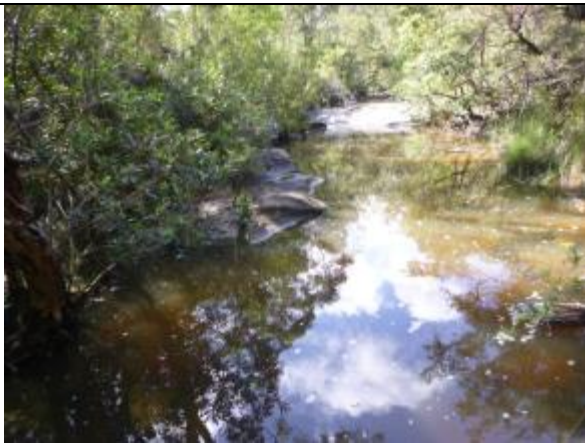
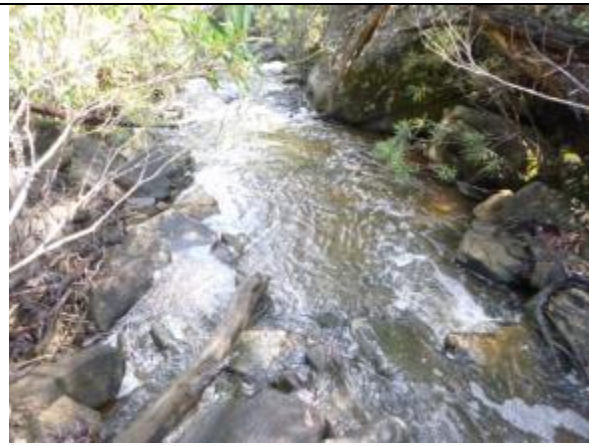
Photo 5: GR\_Pool 57 looking upstream. Taken on 12/01/2015.

Photo 6: GR\_Pool 57 looking downstream. Taken on 12/01/2015.

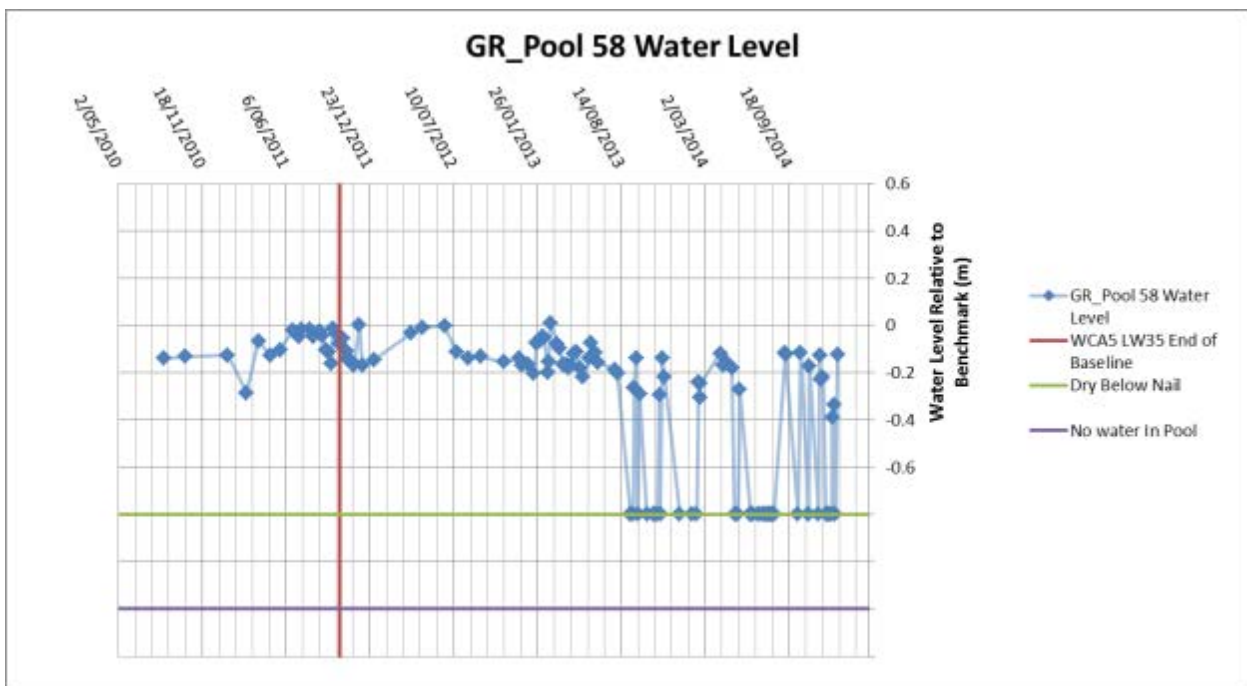
Graph 4: Water levels recorded in GR\_Pool 58

On the latest inspection of GR\_Pool 58 the pool water level was above baseline levels (Graph 4). Photos 7 and 8 show the latest pool conditions.

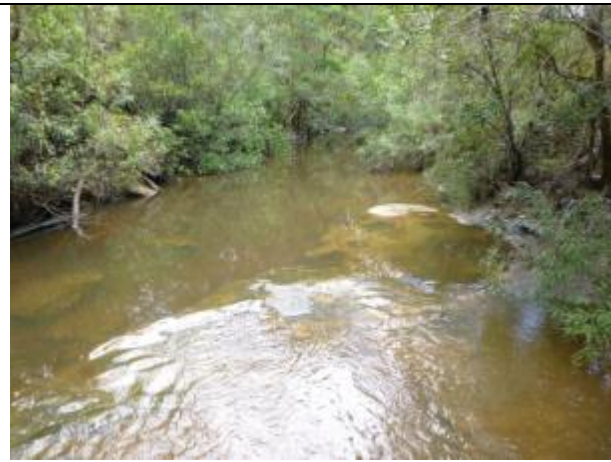
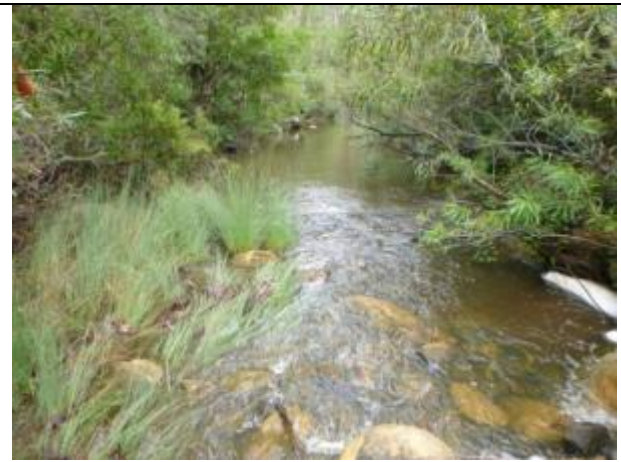
Photo 7: GR\_Pool 58 looking upstream. Taken on 12/01/2015.

Photo 8: GR\_Pool 58 looking downstream. Taken on 12/01/2015.

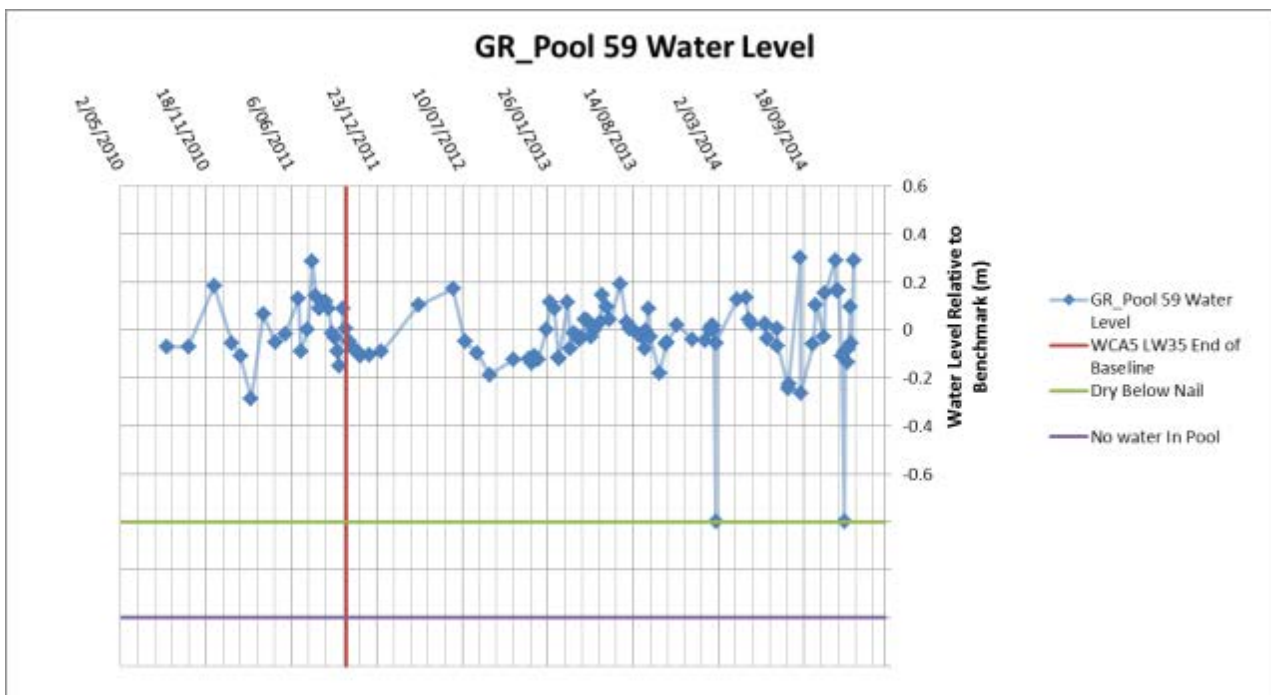
Graph 5: Water levels recorded in GR\_Pool 59

On the latest inspection of GR\_Pool 59 the pool water level was above baseline levels (Graph 5). Photos 9 and 10 show the latest pool conditions.

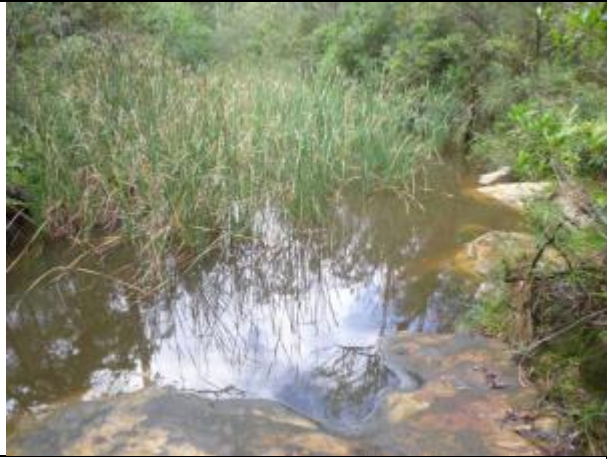
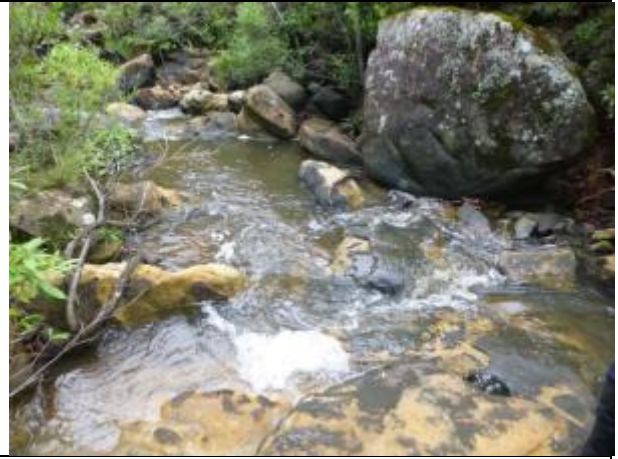
Photo 9: GR\_Pool 59 looking upstream. Taken on 12/01/2015.

Photo 10: GR\_Pool 59 looking downstream. Taken on 12/01/2015.

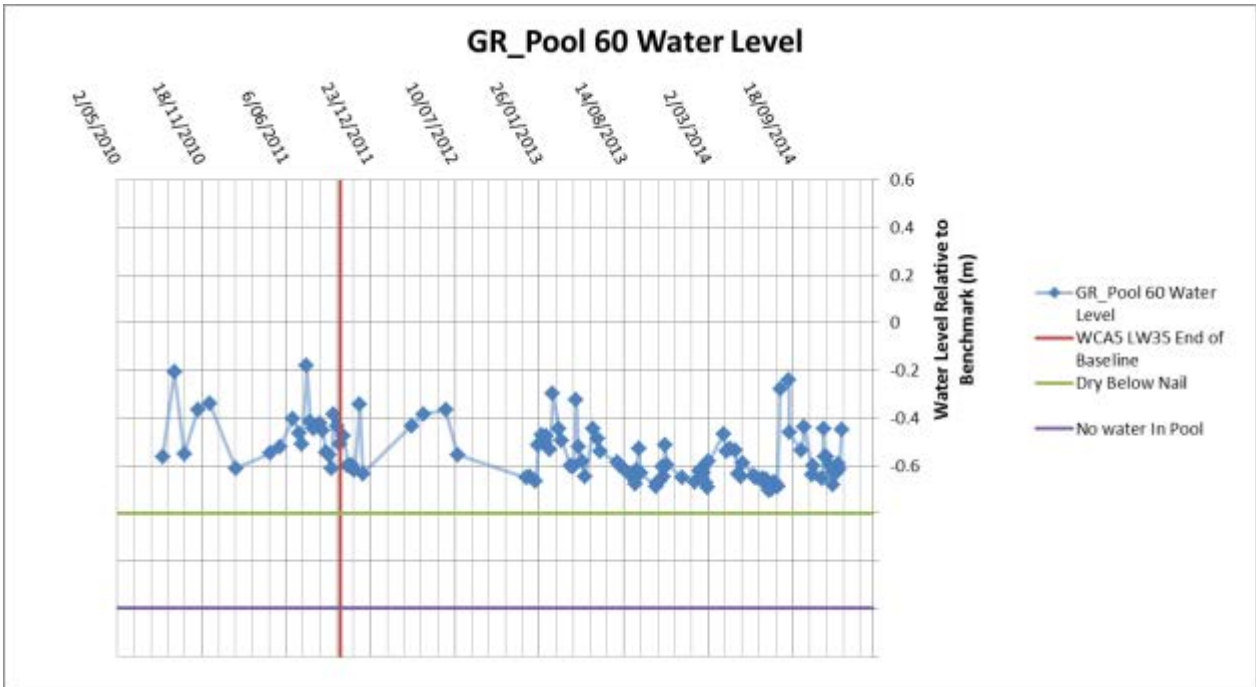
Graph 6: Water levels recorded in GR\_Pool 60

On the latest inspection of GR\_Pool 60 the pool water level was above baseline levels (Graph 6). Photos 11 and 12 show the latest pool conditions.

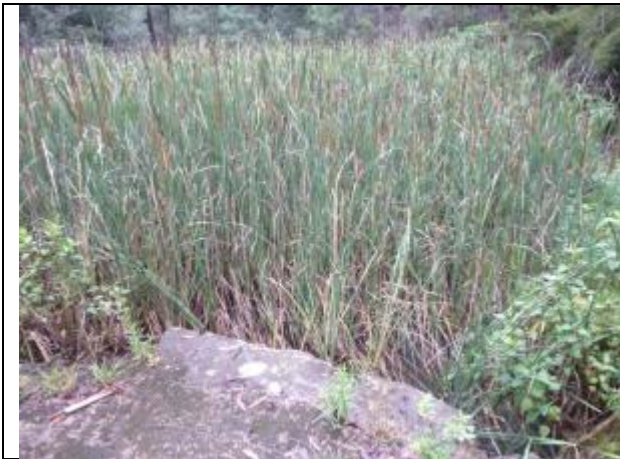
Photo 11: GR\_Pool 60 looking upstream. Taken on 12/01/2015.

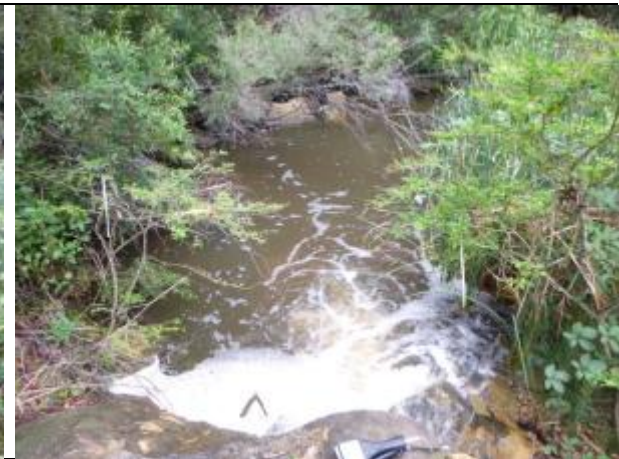
Photo 12: GR\_Pool 60 looking upstream. Taken on 12/01/2015.

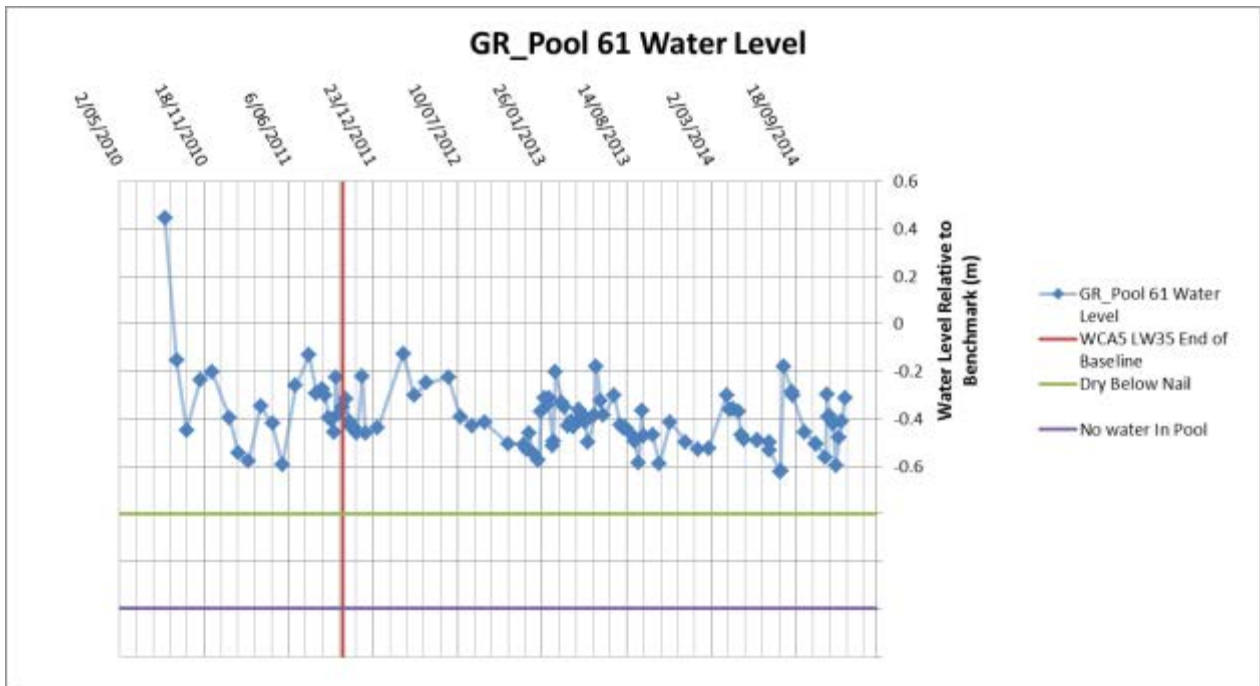
On the latest inspection of GR\_Pool 61 the pool water level was above baseline levels (Graph 7). Photos 15 and 16 show the latest pool conditions.

Graph 7: Water levels recorded in GR\_Pool 61

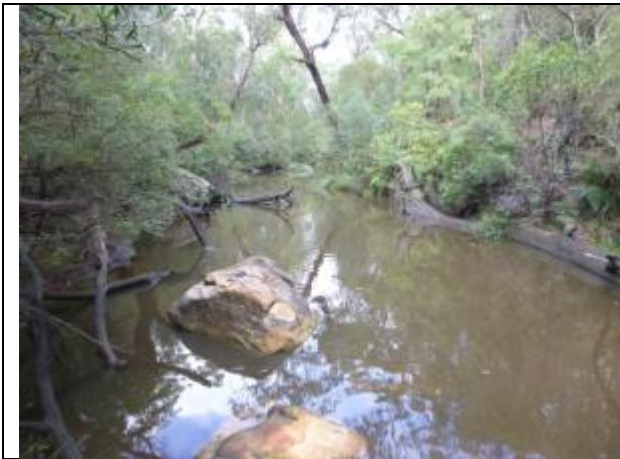
Photo 13: GR\_Pool 61 looking upstream. Taken on 12/01/2015.

An assessment of pool water level reduction and remedial works to restore pool water level is being submitted.

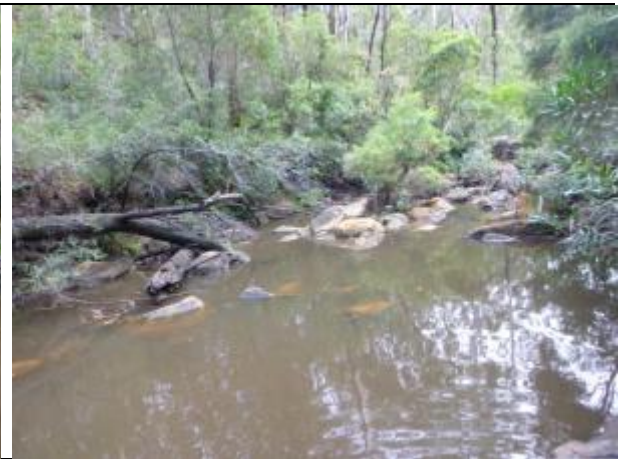
Photo 14: GR\_Pool 61 looking downstream. Taken on 12/01/2015.

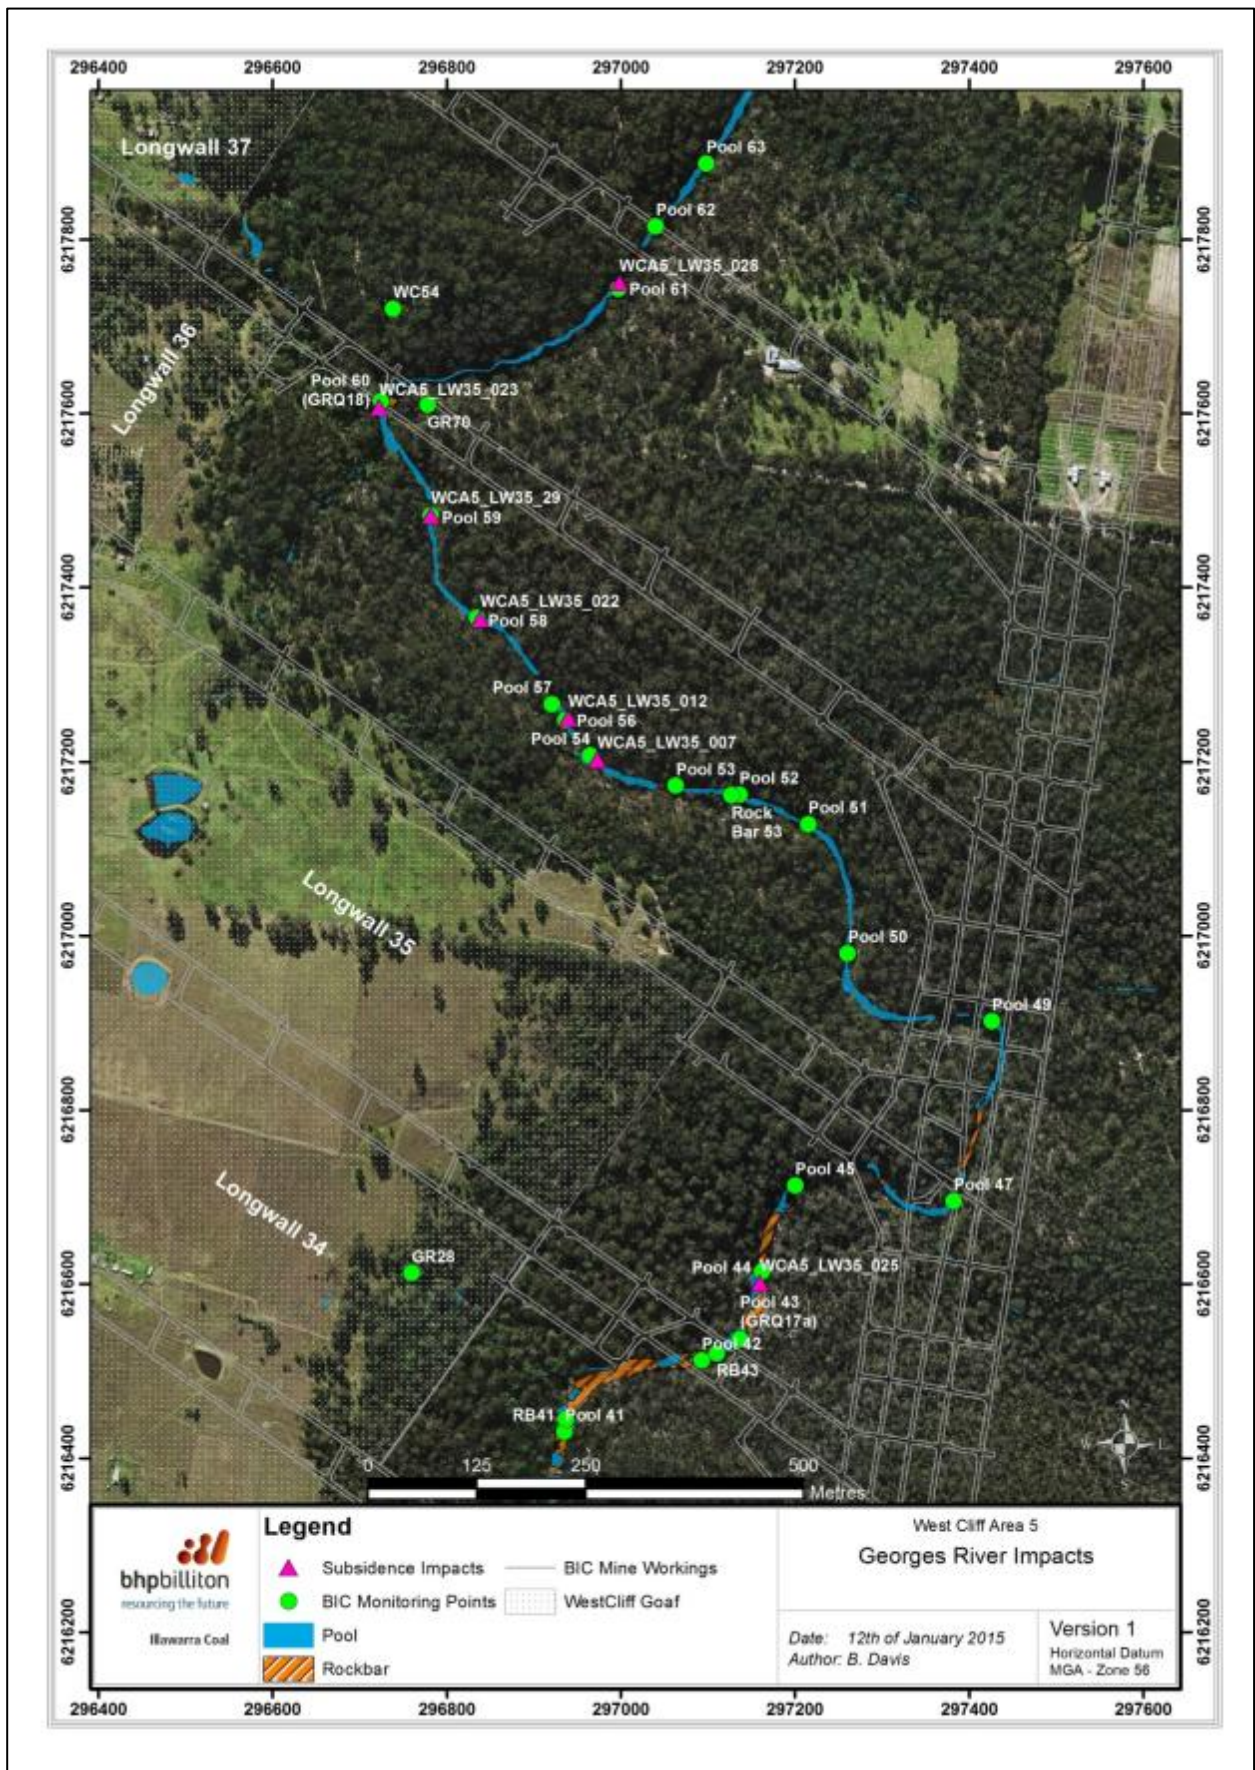
Figure 1: Location impacts discussed in this report and Georges River monitoring sites.
