West Cliff Area 5 Longwall 38, Georges River Update Report

27th of March 2015

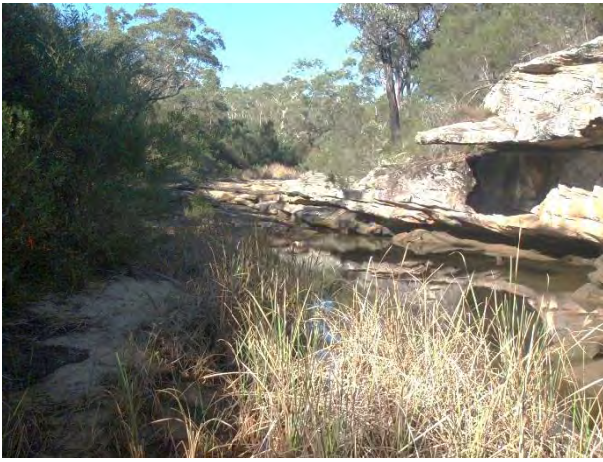
GR_Pool 44 remains 'Dry Below Nail' (Graph 1). This water level has been reported previously, is below baseline levels and is a trigger in the GRMP. Photos 1 and 2 show the latest pool conditions.

Photo 1: GR_Pool 44 looking upstream. Taken on 26/03/2015

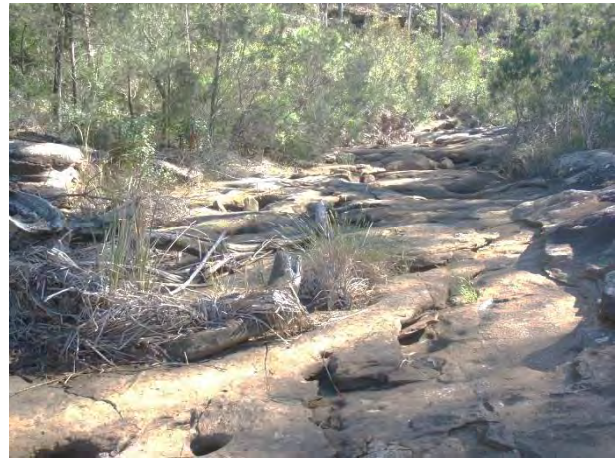
Photo 2: GR_Pool 44 looking downstream. Taken on 26/03/2015

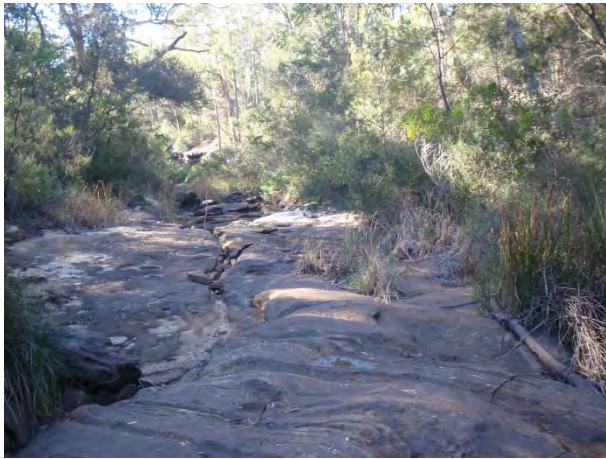
Water level in GR_Pool 54 remains below baseline. On the latest inspection the pool was 'Dry Below Nail' (Graph 2). This has been reported previously, is below the lowest level experienced in the baseline period and is a trigger according to the GRMP. Photos 3 and 4 show the latest pool conditions.

Photo 3: GR_Pool 54 looking upstream. Taken on 26/03/2015

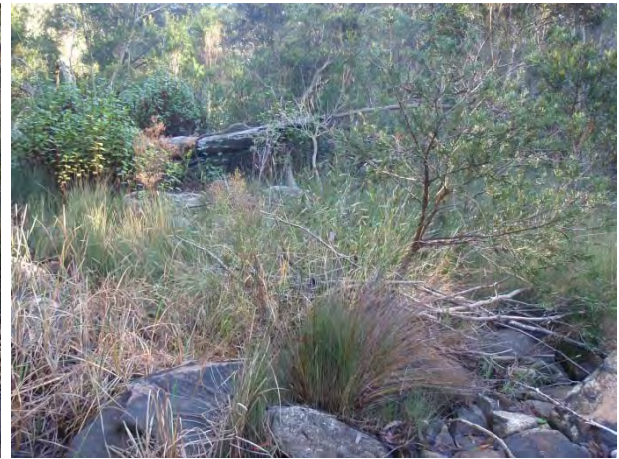
Photo 4: GR_Pool 54 looking downstream. Taken on 26/03/2015

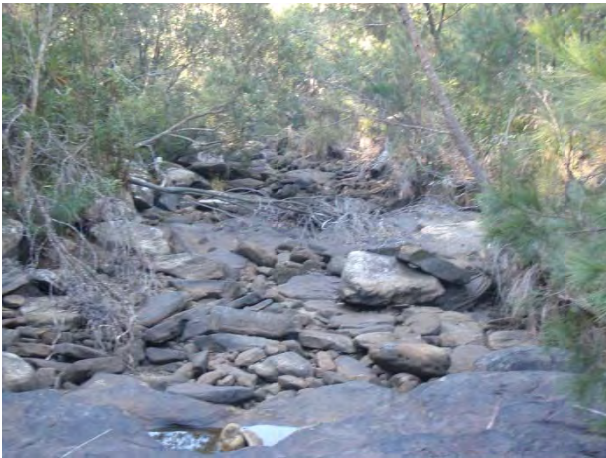
On the latest inspection GR_Pool 56 had surface water present (Graph 3). Photos 5 and 6 show the latest pool conditions.

Photo 5: GR_Pool 56 looking upstream. Taken on 26/03/2015

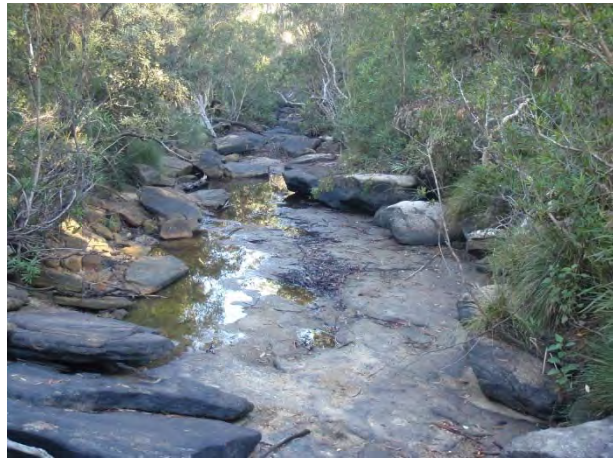
Photo 6: Looking downstream from GR_Pool 56. Taken on 26/03/2015

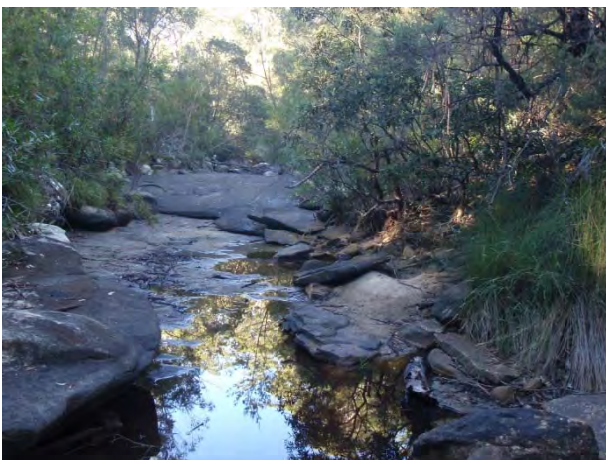
On the latest inspection of GR_Pool 57, water level was recorded as 'Dry Below Nail' (Graph 4). This remains a trigger according to the GRMP. Photos 7 and 8 show the latest pool conditions.

Photo 7: GR_Pool 57 looking upstream. Taken on 26/03/2015

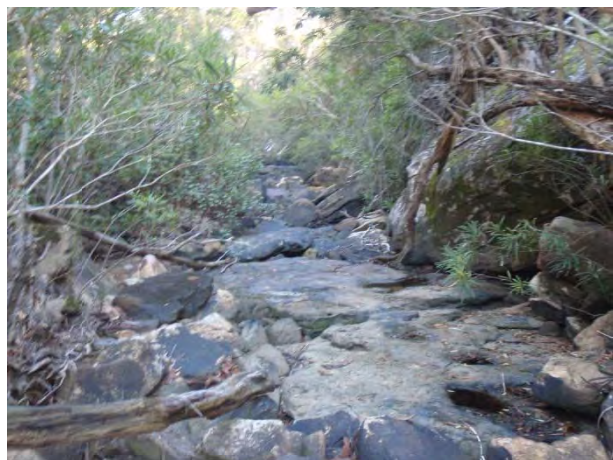
Photo 8: GR_Pool 57 looking downstream. Taken on 26/03/2015

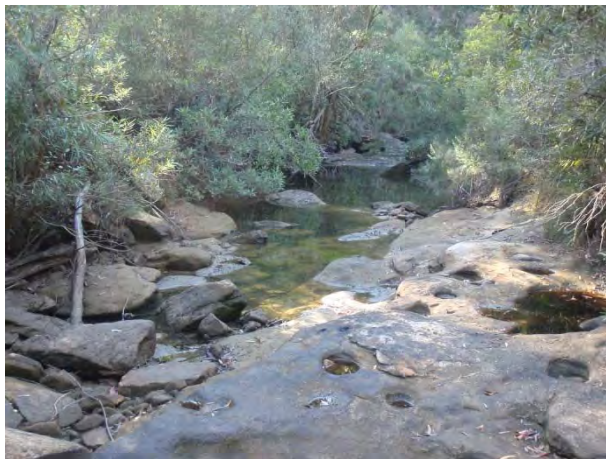
Water level in GR_Pool 58 remains 'Dry Below Nail' (Graph 5). This has been reported previously, is below the lowest level experienced in the baseline period and is a trigger according to the GRMP. Photos 9 and 10 show the latest pool conditions.

Photo 9: GR_Pool 58 looking upstream. Taken on 26/03/2015

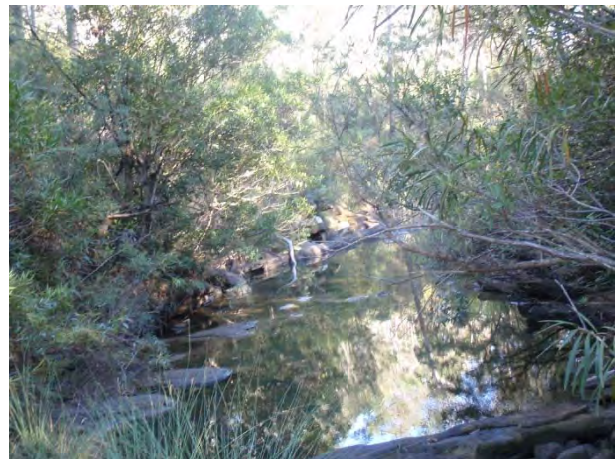
Photo 10: GR_Pool 58 looking downstream. Taken on 26/03/2015

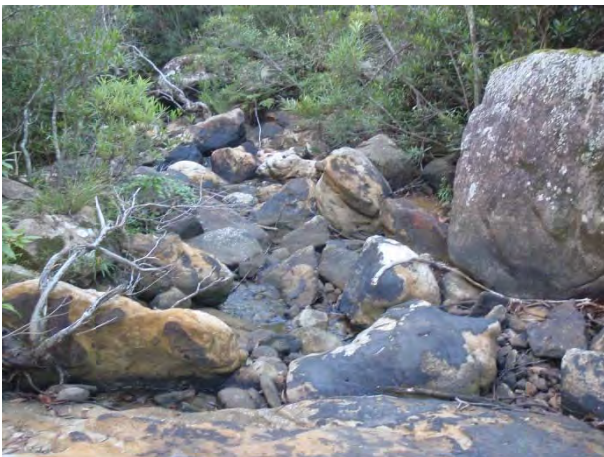
On the inspection carried out on 24th March 2015, water level in GR_Pool 59 was observed to be below baseline levels. This has been reported previously and is a trigger according to the GRMP. The follow up inspection on 26th March 2015 revealed that water level in the pool had returned to above baseline levels (Graph 6). Photos 11 and 12 show the latest pool conditions.

Photo 11: GR_Pool 59 looking upstream .Taken on 26/03/2015

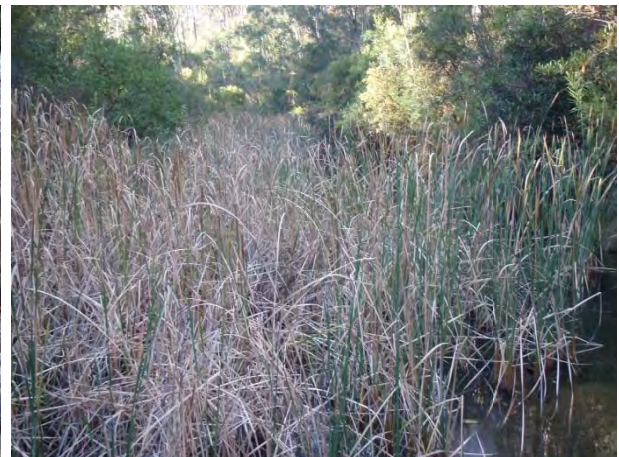
Photo 12: GR_Pool 59 looking downstream. Taken on 26/03/2015

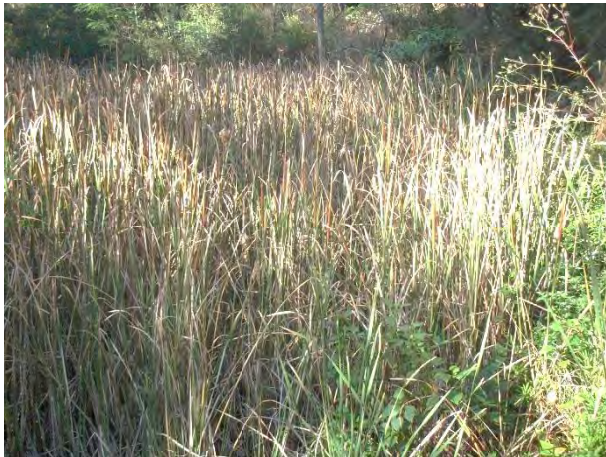
On the inspection carried out on 24th March 2015, water level in GR_Pool 60 was observed to be below baseline levels. This has been reported previously and is a trigger according to the GRMP. The follow up inspection on 26th March 2015 identified that water at returned to the pool above baseline levels (Graph 7). Photos 13 and 14 show the latest pool conditions.

Photo 13: GR_Pool 60 looking upstream .Taken on 26/03/2015

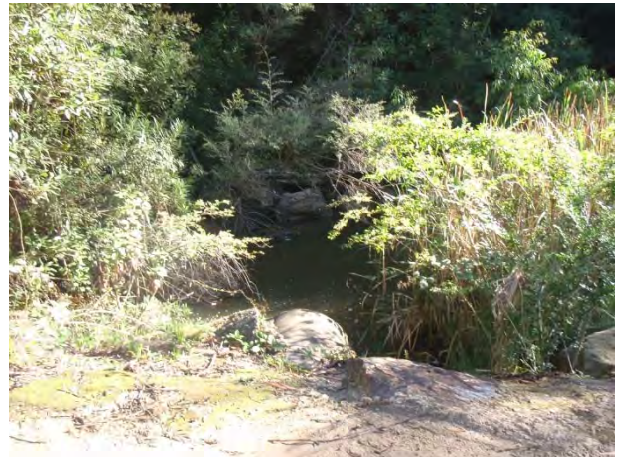
Photo 14: GR_Pool 60 looking downstream. Taken on 26/03/2015

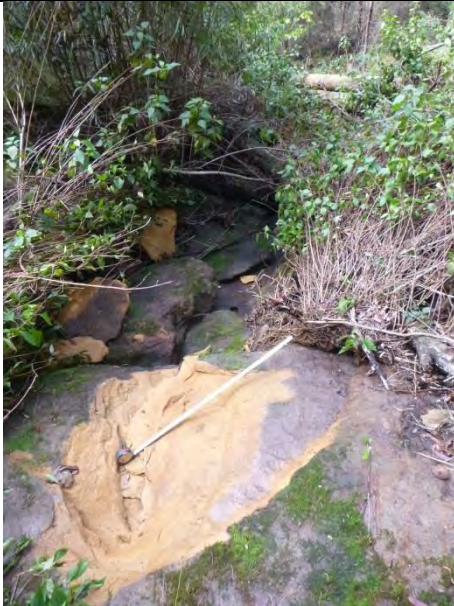
Fracturing to a rockbar of tributary GR104 downstream from Impact WCA5_LW36_001 was identified during the inspection on 24 April 2015. The downstream section of the fracturing is up to 3m long and extends under a small step on the rockbar (Photo 25). Rock fragments up to 0.05m³ have been dislodged and transported downstream (Photos 26 and 27). The upstream section of the fracturing is up to 4m long, extending across the rockbar and under sediment on the southern bank of the tributary (Photos 28 to 30). Rock fragments up to 0.08m³ have been dislodged during the recent flood event.

Photo 27: WCA5_LW38_001- fracturing and dislodged fragments, looking downstream. Taken on 24/04/2015

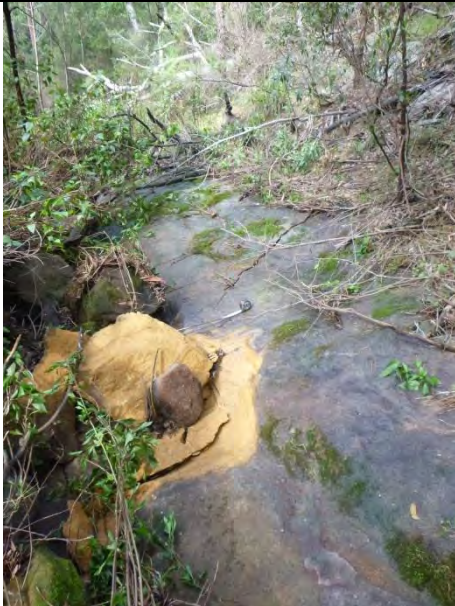
Photo 29: WCA5_LW38_001- upstream section of fracturing and dislodged rock, looking across stream. Taken on 24/04/2015

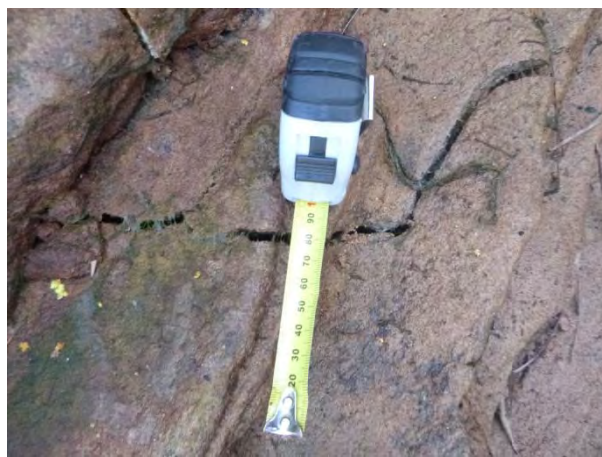
Photo 2: WCA5_LW38_002 – Fracturing perpendicular to bedding plane. Taken on 03/08/2015.

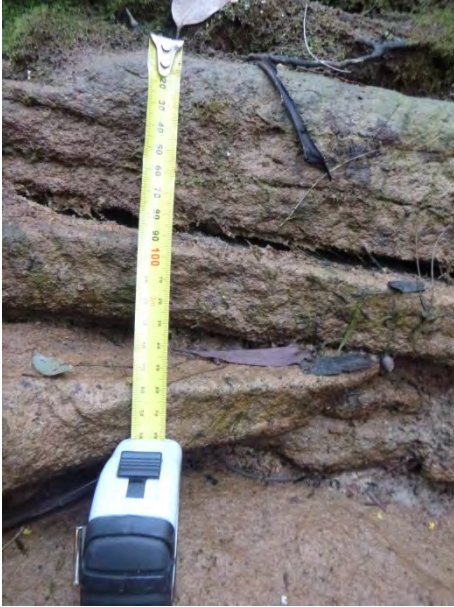
Photo 3: WCA5_LW38_002 – Extension along bedding plane. Taken on 03/08/2015

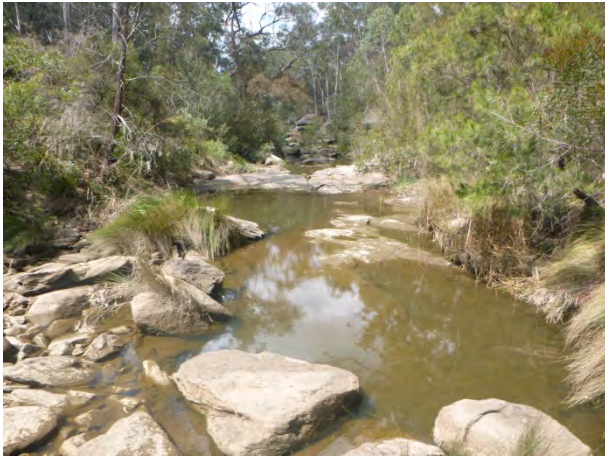
On the latest inspection of GR_Pool 54 water level was lower than the baseline period (Graph 1). This water level has been reported previously and is a trigger according to the Longwall 37 and 38 Extraction Plan. Photos 3 and 4 show the latest pool conditions.

Photo 3: WCA5_LW35_007 – GR_Pool 54 looking upstream. Taken on 2/10/15

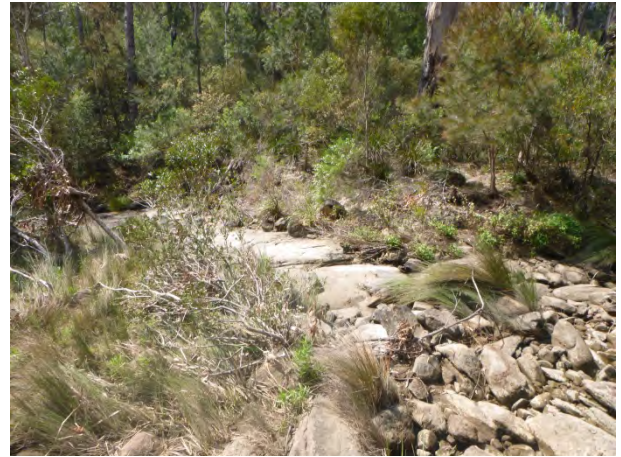
Photo 4: WCA5_LW35_007 – GR_Pool 54 looking downstream. Taken on 2/10/15

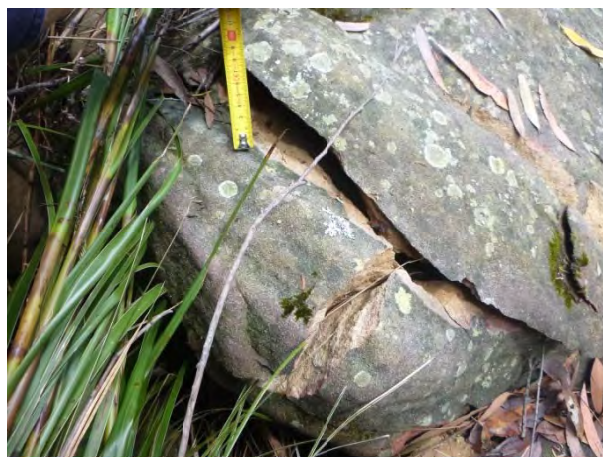
Further rock fracturing and an absence of surface flow were observed at a previously identified impact along tributary GR110 (2nd of October 2015 - Photo 1). During the latest inspection on 16th November 2015, additional fracturing was identified at the site (Photos 2 to 6). Fracturing to the base of the tributary and overlying boulders is also evident along a 15m section of the tributary. Fractures are up to 2.1m long with fracturing to the base of the tributary up to 0.15m wide.

Photo 2: Impact WCA5_LW38_007- additional fracturing to boulder on GR110. Taken on 16/11/2015.

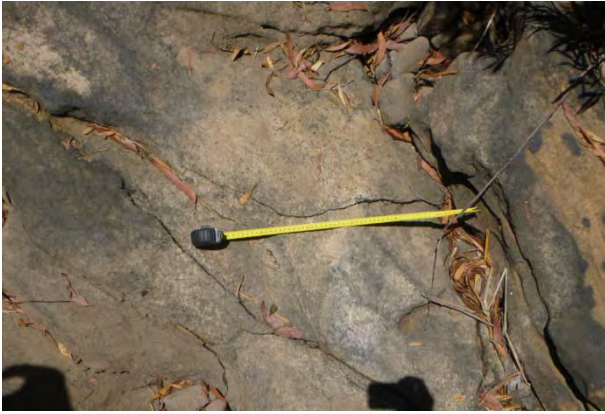
Rock fracturing and displacement was identified on the Georges River at GR_Pool 49 on 10th December 2015. Low water levels during the time of the inspection led to detection of multiple fractures in the rock base of the pool that were previously unidentified. The rock fractures occur along a 60m length of the river and range in length from 1.3m to 10m (photos 1 to 5). The largest fracture is 10m long with a width of 0.04m and since formation has subsequently been infilled with debris (photos 6 & 7). Some rock displacement was observed, the volume of the largest displaced slab is approximately 0.78m³ (photo 8). Flow diversion through surface cracks was observed along the impacted area.

Photo 3: Impact WCA5_LW38_008- Fracturing identified on the Georges River. Taken on 10/12/2015.

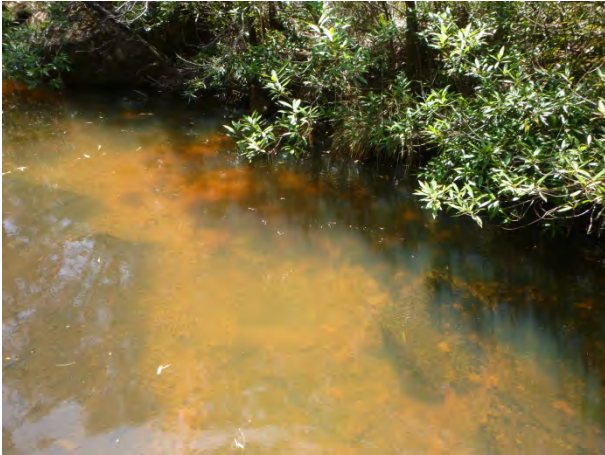
Iron staining was observed originating from a seepage point at the rockbar downstream of GR_Pool 49 (photo 9 and 10). The area of staining covers a 20m section of the river with no visible staining further downstream. No change in surface flow conditions was observed. Monitoring of the impact will be ongoing with results reported in the End of Panel Report and AEMR.

Photo 9: Impact WCA5_LW38_009- Iron staining downstream of GR_Pool 49. Taken on 10/12/2015.

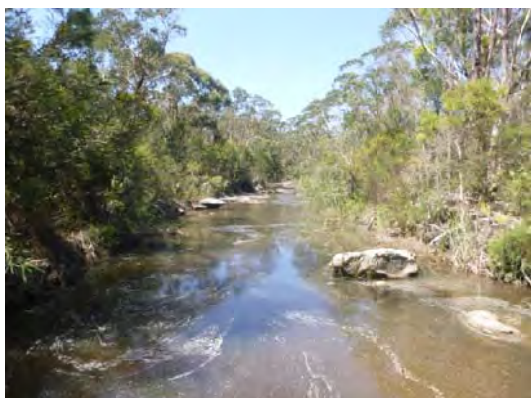
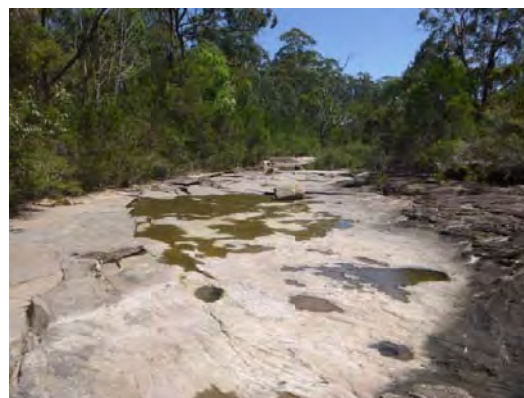
On the 11th of January 2016, water level at GR_Pool 38 was observed to be above baseline conditions, photos 1 and 2 show pool conditions.

Photo 1: GR_Pool 38 looking upstream (11/1/16)

Photo 2: GR_Pool 38 looking downstream (11/1/16)

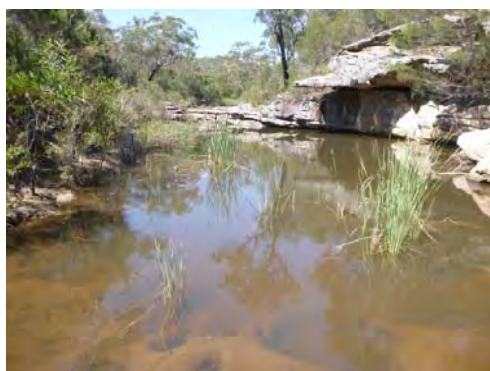
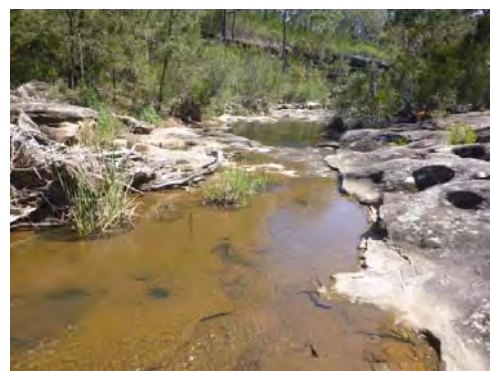
On the 11th of January 2016, water level at GR_Pool 44 was observed to be above baseline conditions, photos 3 and 4 show pool conditions.

Photo 3: WCA5_LW38_025 – GR_Pool 44 looking upstream. Taken on 11/1/16

Photo 4: WCA5_LW38_025 – GR_Pool 44 looking downstream. Taken on 11/1/16.

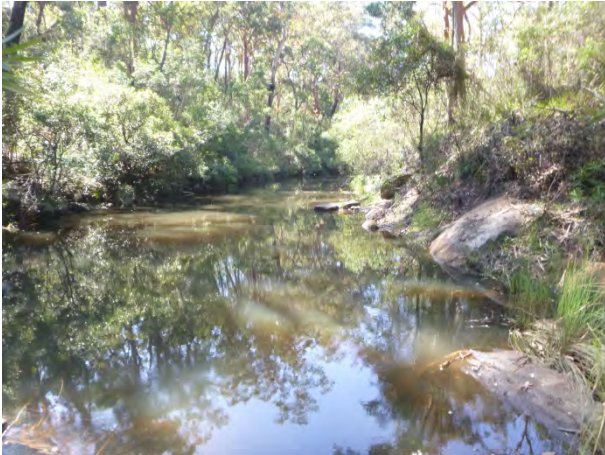
On the 11th of January 2016, water level at GR_Pool 51 was observed to be above baseline conditions, photos 5 and 6 show pool conditions.

Photo 5: WCA5_LW35_024- GR_Pool 51 looking upstream. Taken on 11/1/16

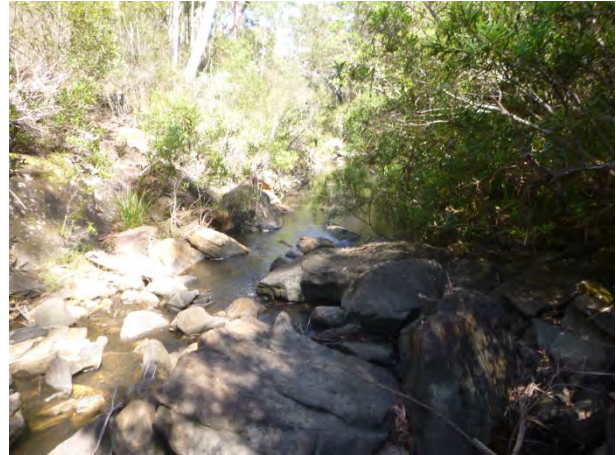
Photo 6: WCA5_LW35_024- GR_Pool 51 looking downstream. Taken on 11/1/16.

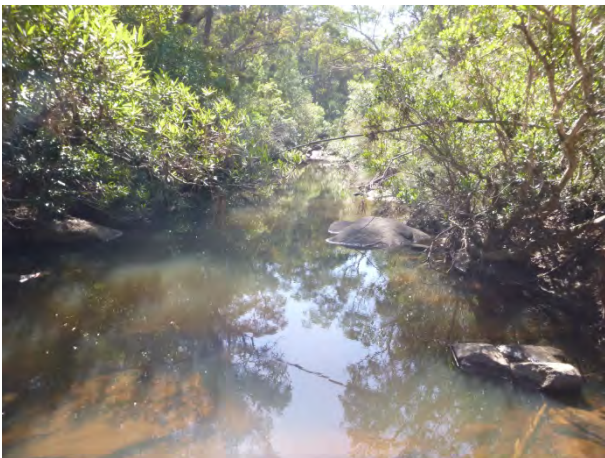
On the 11th of January 2016, water level at GR_Pool 53 was observed to be above baseline conditions, photos 7 and 8 show pool conditions.

Photo 7: WCA5_LW35_027- GR_Pool 53 looking upstream. Taken on 11/1/16

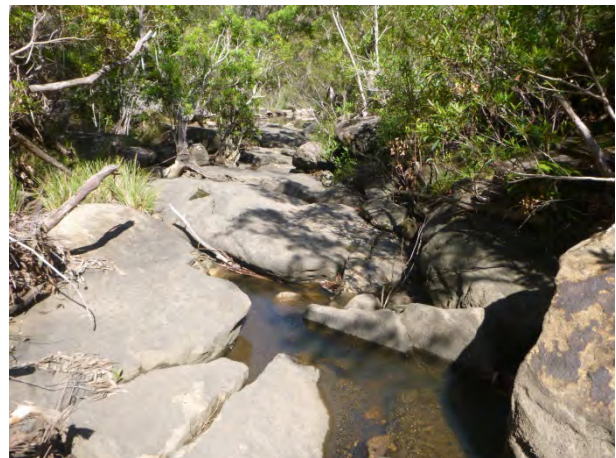
Photo 8: WCA5_LW35_027- GR_Pool 53 looking downstream. Taken on 11/1/16.

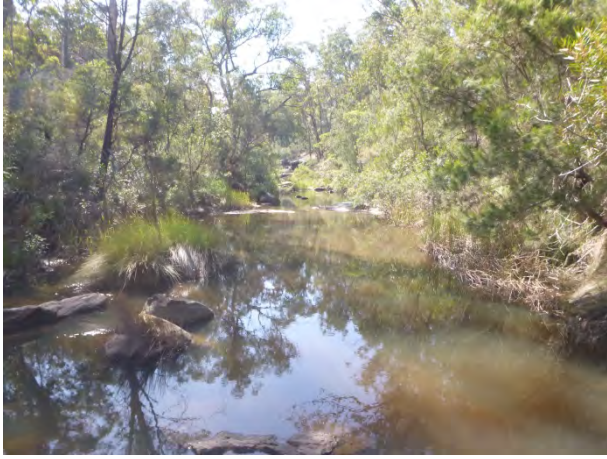
On the 11th of January 2016, water level at GR_Pool 54 was observed to be above baseline conditions, photos 9 and 10 show pool conditions.

Photo 9: WCA5_LW35_007 – GR_Pool 54 looking upstream. Taken on 11/1/16.

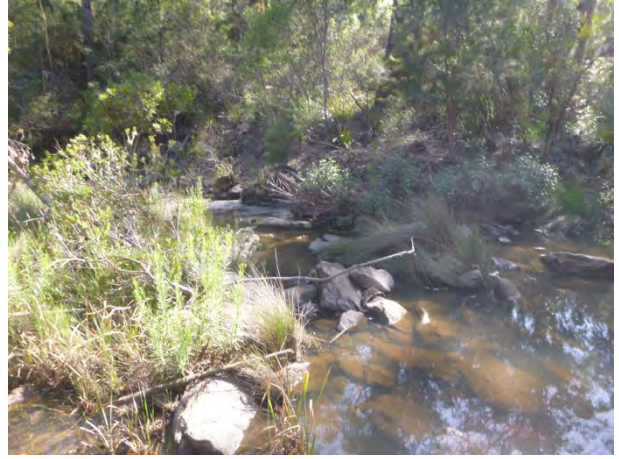
Photo 10: WCA5_LW35_007 – GR_Pool 54 looking downstream. Taken on 11/1/16.

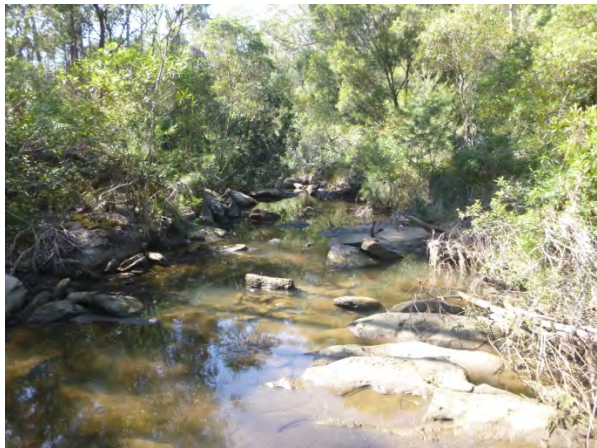
On the 11th of January 2016, water levels at GR_Pool 56 and 57 were observed to be above baseline conditions, photos 11 to 14 show pool conditions.

Photo 11: WCA5_LW35_012 – GR_Pool 56 looking upstream. Taken on 11/1/16.

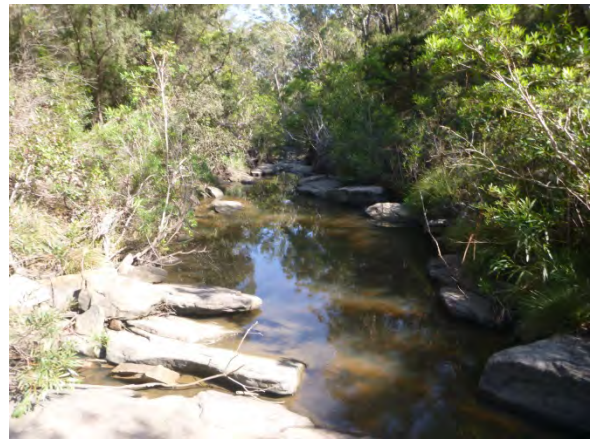
Photo 12: WCA5_LW35_012 – GR_Pool 56 looking downstream. Taken on 11/1/16.

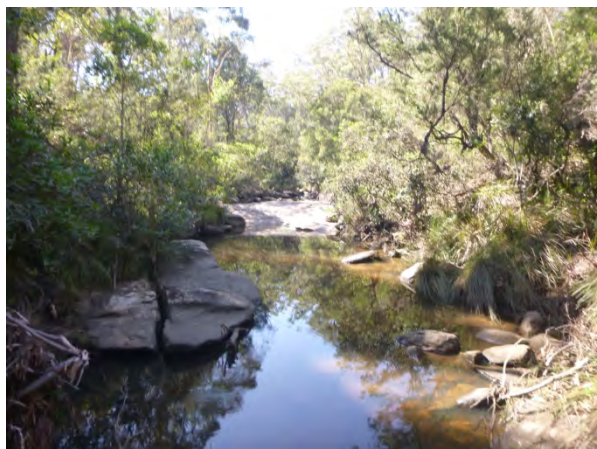
Photo 13: WCA5_LW35_012 – GR_Pool 57 looking upstream. Taken on 11/1/16.

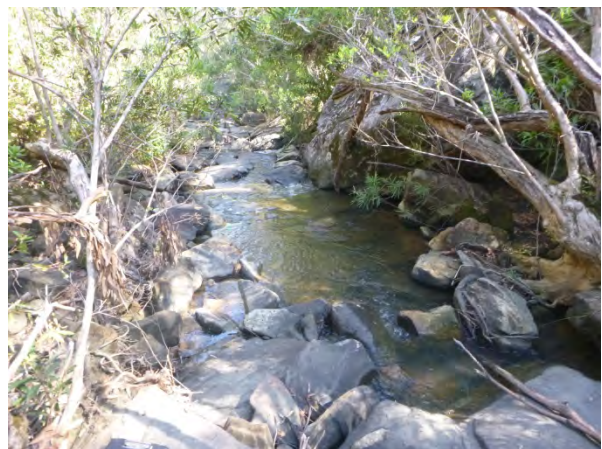
Photo 14: WCA5_LW35_012 – GR_Pool 57 looking downstream. Taken on 11/1/16.

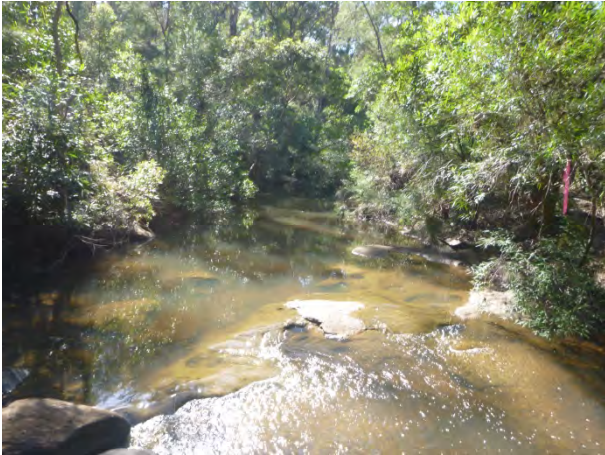
On the 11th of January 2016, water level at GR_Pool 58 was observed to be above baseline conditions, photos 15 and 16 show pool conditions.

Photo 15: WCA5_LW35_022 – GR_Pool 58 looking upstream. Taken on 11/1/16.

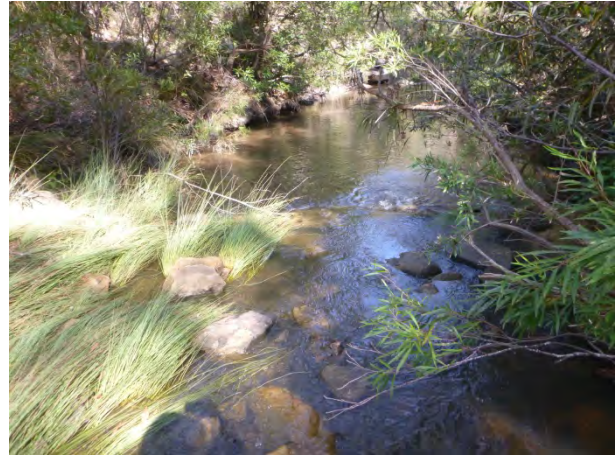
Photo 16: WCA5_LW35_022 – GR_Pool 58 looking downstream. Taken on 11/1/16.

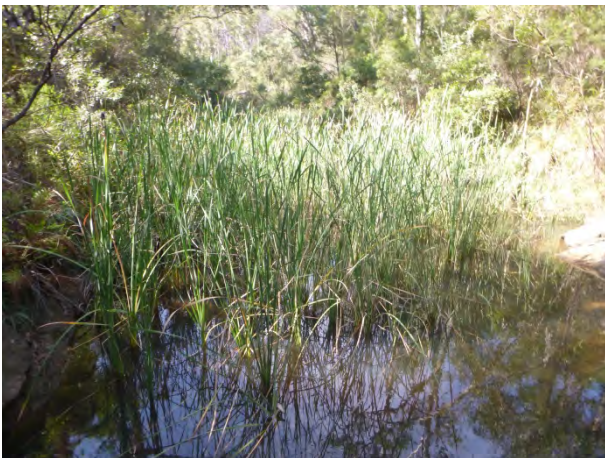
On the 11th of January 2016, water level at GR_Pool 59 was observed to be above baseline conditions, photos 17 and 18 show pool conditions.

Photo 17: WCA5_LW35_029 – GR_Pool 59 looking upstream. Taken on 11/1/16.

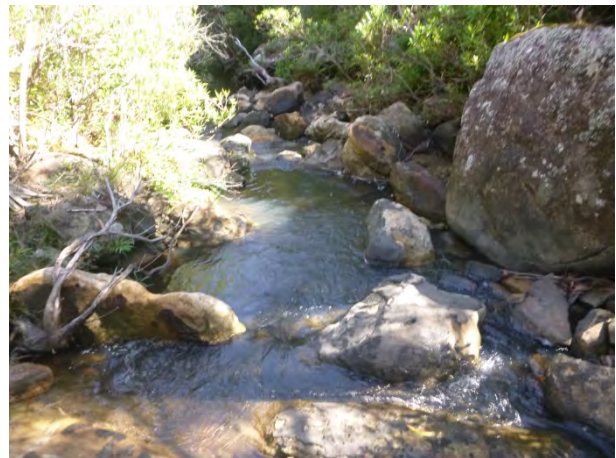
Photo 18: WCA5_LW35_029 – GR_Pool 59 looking downstream. Taken on 11/1/16.

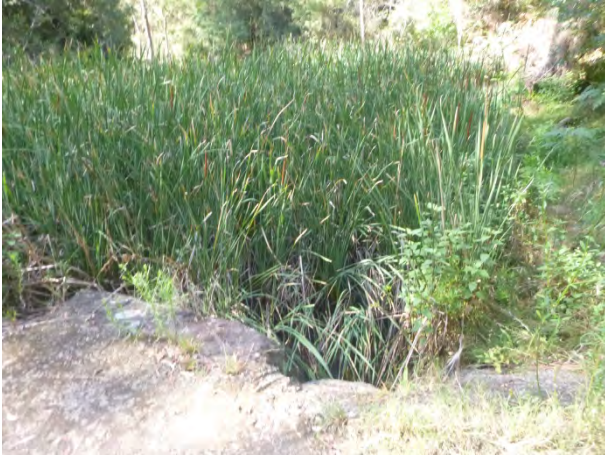
On the 11th of January 2016, water level at GR_Pool 60 was observed to be above baseline conditions, photos 19 and 20 show pool conditions.

Photo 19: WCA5_LW38_023 – GR_Pool 60 looking upstream. Taken on 11/1/16.

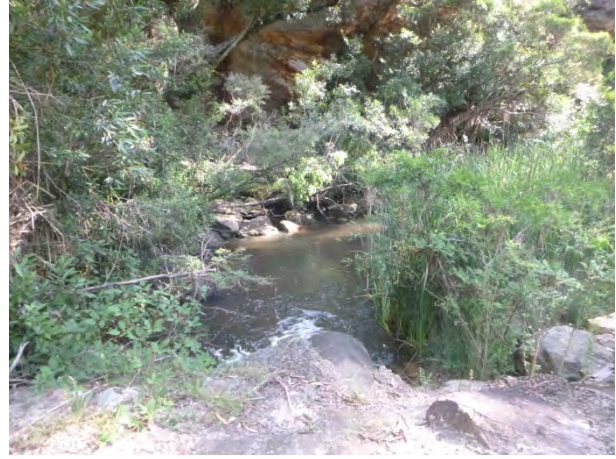
Photo 20: WCA5_LW38_023 – GR_Pool 60 looking downstream. Taken on 11/1/16.

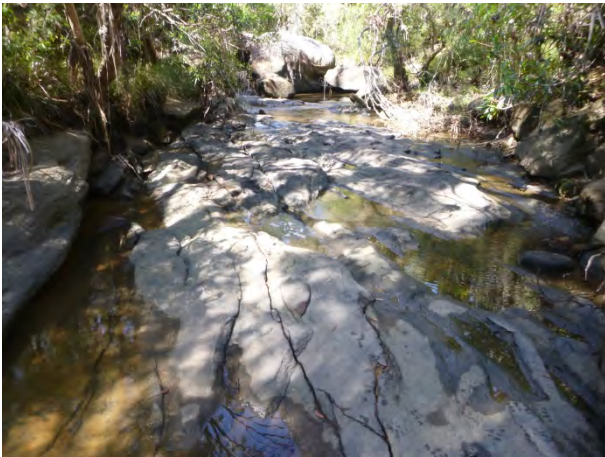
On the 11th of January 2016, surface flow was present along the majority of Rockbar 49. A small section of the rockbar continued to display flow diversion, as shown in photos 21 and 22.

Photo 21: WCA5_LW38_008 – Rockbar 49 with flow diversion present. Taken on 11/1/16.

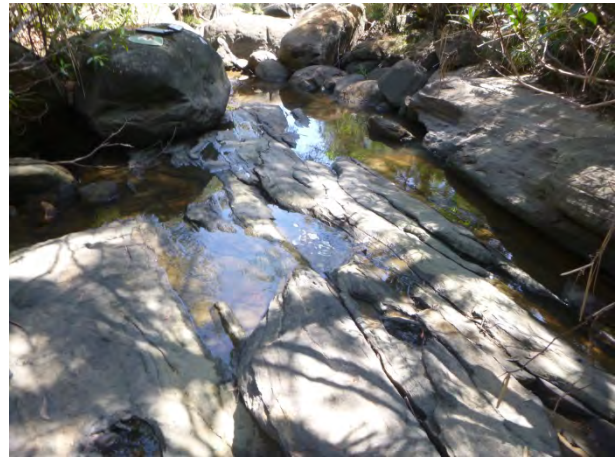
Photo 22: WCA5_LW38_008 – Rockbar 49 with flow diversion present. Taken on 11/1/16.

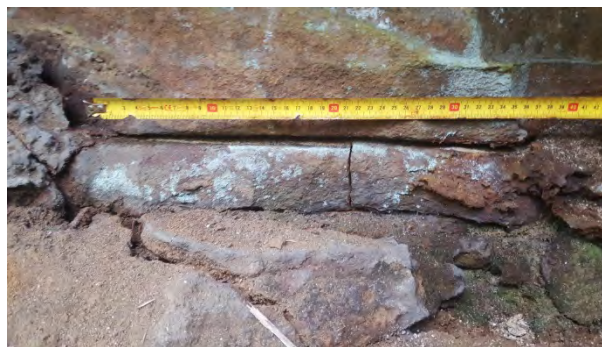
Photo 3: WCA5_LW38_010 – Fracture to base of rock outcropping. Taken on 17/02/16.

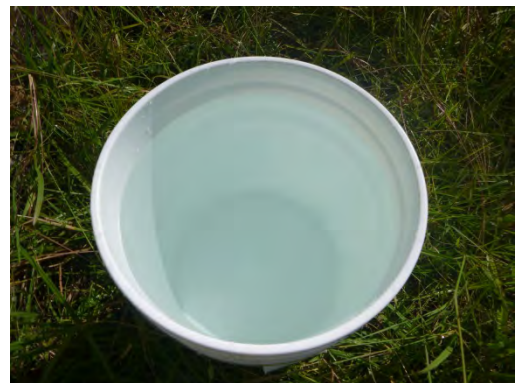
Water Properties: No signs of iron, salinity staining or gas were observed in the water. Pre-mining and post mining water quality is provided in Table 1.

Photo 4: Image of water from pump discharge (03/03/16)
