WEST CLIFF AREA 5
LONGWALL 37 END
OF PANEL REPORT
MAY 2015

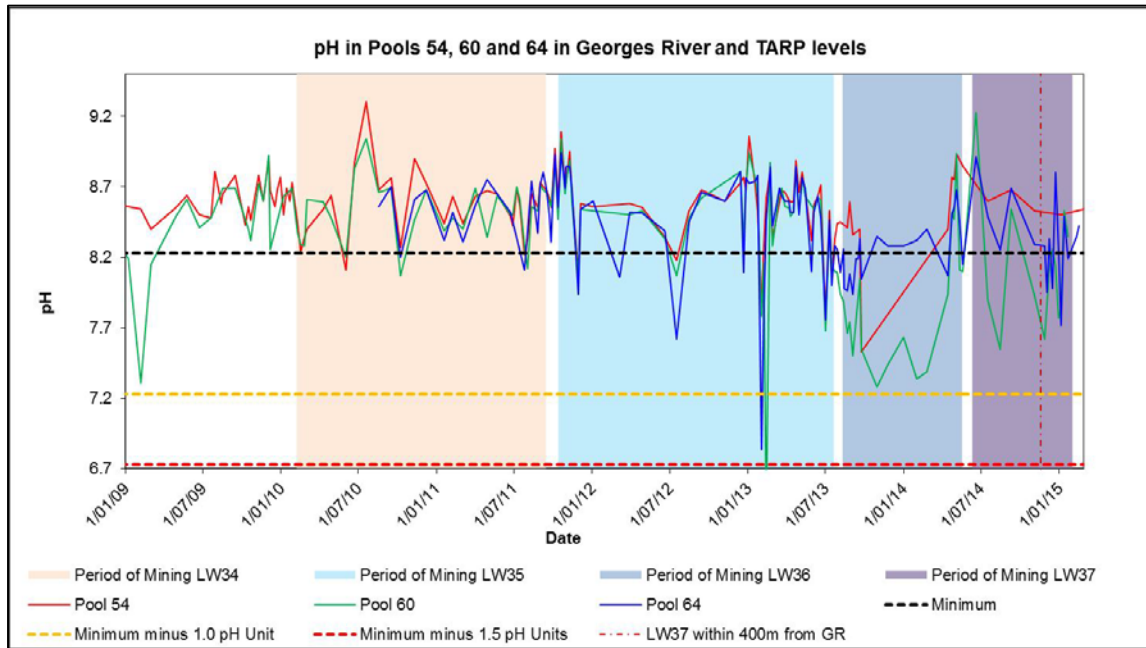
Figure 4-1: Water Quality Data - pH

Longwalls 37 and 38 EP, pH levels were shown to be consistently within -1.0 pH units of the pre-existing minimum baseline value (at Pool 54), and therefore did not trigger a Level 2 TARP (Ecoengineers, 2015).

Other key water quality parameters such as pH, Dissolved Oxygen, Electrical Conductivity (a measure of salinity) and ORP generally remained within expected levels (i.e. <2 standard deviations from the long term pre-mining means) during and immediately after the extraction of Longwall 37, in particular following approach of the longwall to within 400 m from the River (Ecoengineers, 2015). Figure 4-1 to Figure 4-3 display the water quality data for pH, DO and EC from January 2009 to January 2015.

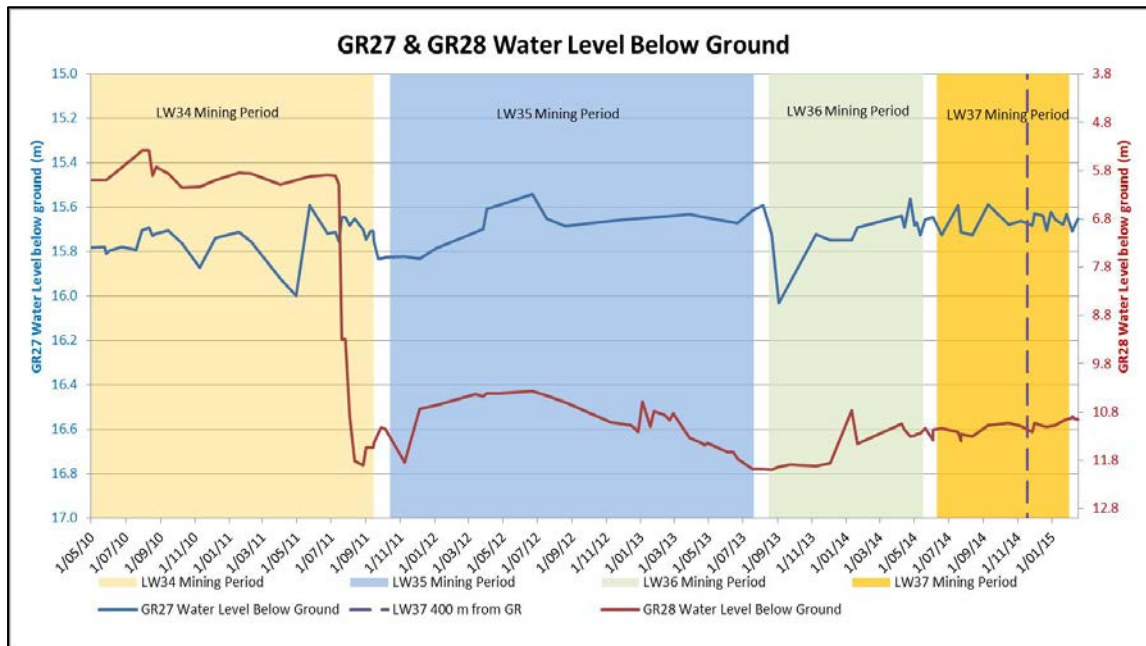
Figure 4-4: GR27 & GR28 water levels

As can be seen in Figure 4-4 below, the mining of Longwall 34 beneath borehole GR28 caused a step fall in the standing water level in the borehole. This period also coincided closely with the time when Longwall 34 was approaching to within 400 m of the River. There was no concurrent effect on the groundwater level in borehole GR27 east of the River (Ecoengineers, 2011).

During the mining of Longwall 37, there is no evidence that any significant comparable impact on water levels had occurred in both boreholes GR27 and GR28.

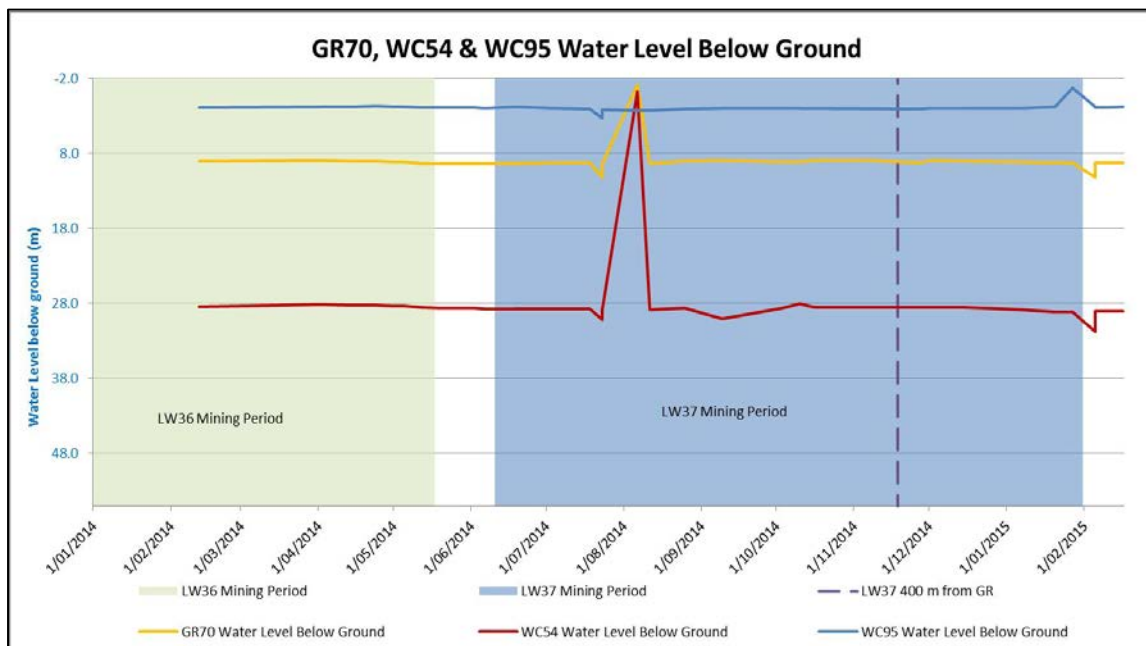
Figure 4-5: GR70, WC54 & WC95 water levels

Figure 4-5 below shows the groundwater levels at shallow boreholes GR70, WC54 and WC95 for the entire period that the sites have been monitored (February 2014 through February 2015).

As can be seen in Figure 4-5 above, there is no evidence showing that the mining of Longwall 37 (directly beneath borehole WC54) caused any significant water level impact in these bores.
