Illawarra Coal

**Annual Environmental Management Report
Dendrobium Mine and Cordeaux Colliery**

AEMR FY15

DENDROBIUM MINE AND CORDEAUX COLLIERY

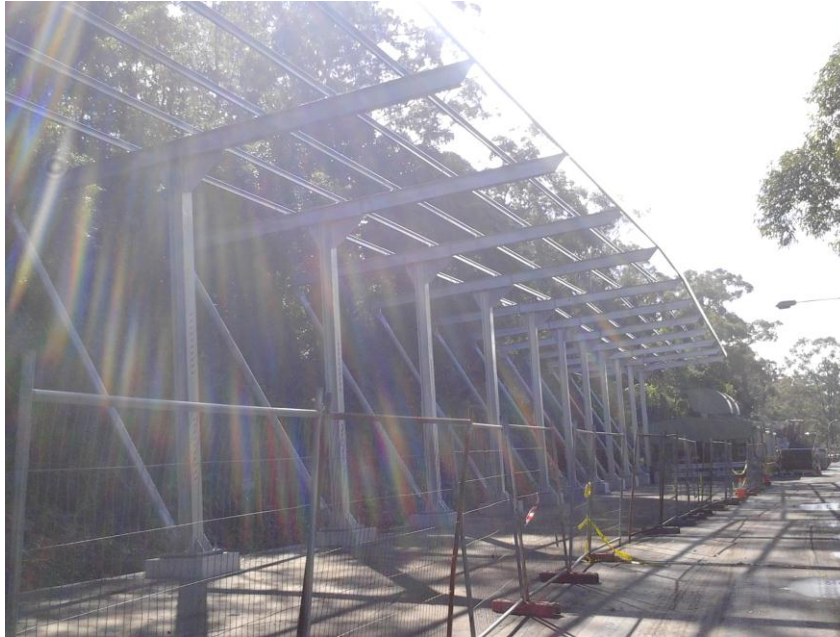
Figure 1: Bulk Storage Cover under Construction in August 2014.

During the reporting period Dendrobium Mine constructed a bulk storage cover on the portal road which was completed in August 2014. The works involved the erection of a counter-levered steel awning to assist in the weatherproofing storage of items prior to being transported underground.

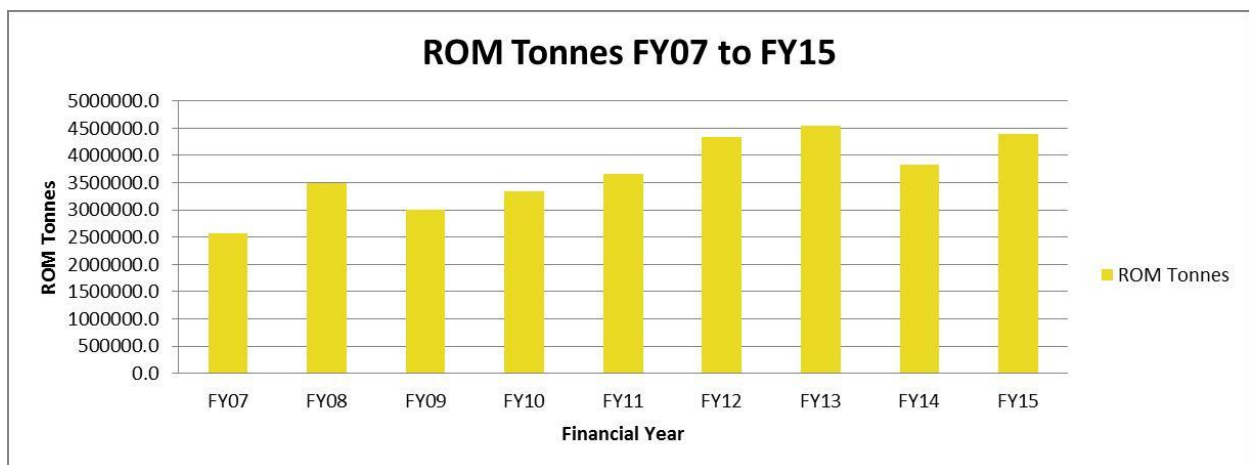
Figure 2: ROM Production: FY07 to FY15

The Run of Mine (ROM) product for the reporting period was 4,391,360 tonnes with a saleable product yield of 78%. A comparison showing the ROM production at Dendrobium Mine for the past eight reporting periods is provided in Figure 2.

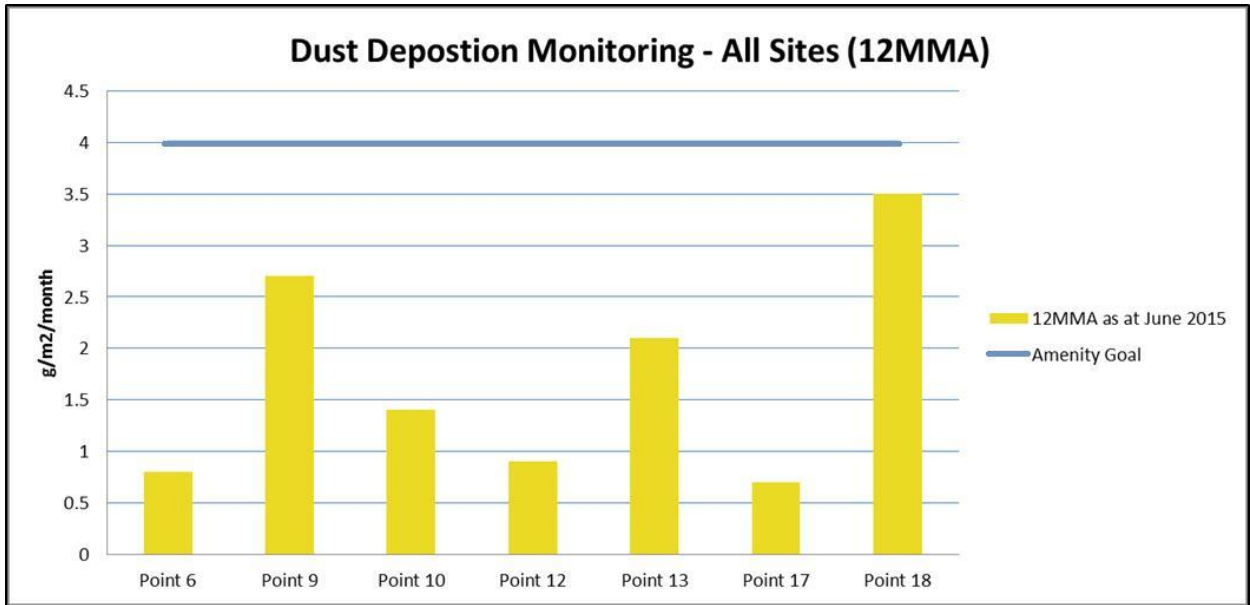
Figure 3: EPL Dust Deposition Gauge, Average Results Summary as at 30 June 2015

Dust levels measured in the dust deposition gauges located within the community were below the amenity goal of 4 g/m²/month (Insoluble Solids). Figure 3 shows the 12 month averages for each of the licensed sites monitored during FY15.

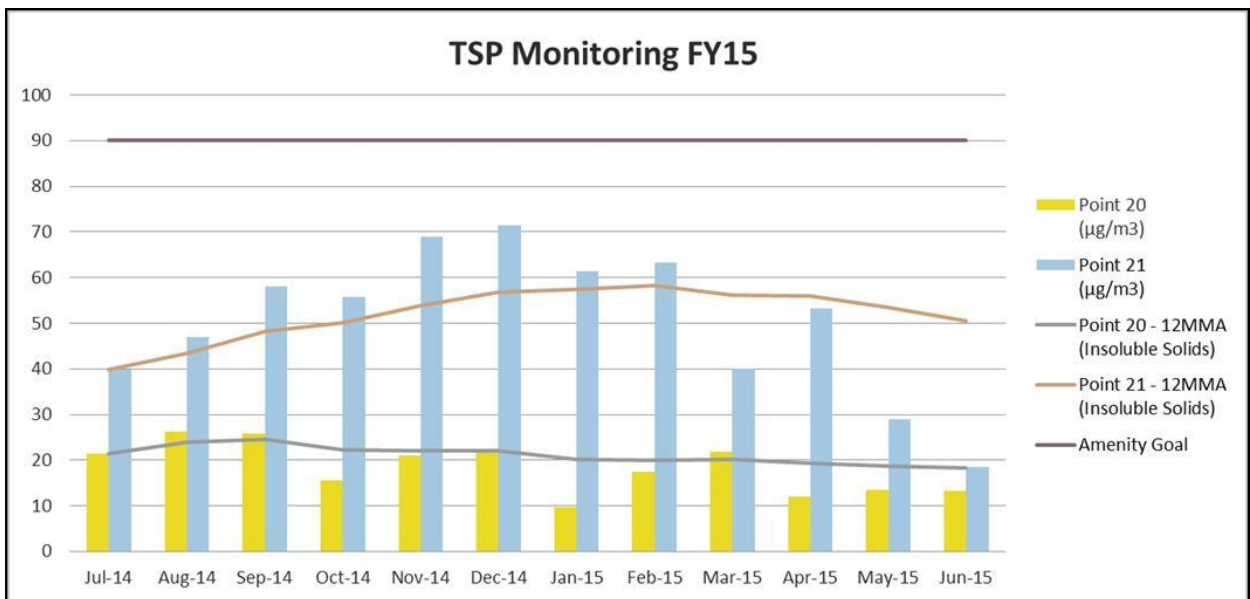
Figure 4: TSP Results

Dust levels from the High Volume Air Sampler (HVAS) for FY15 complied with the relevant standards specified in Table 4.1-1. The monthly TSP results and PM10 results for the Kemira Valley (Point 20) and the Pit Top sites (Point 21) are shown in the following figures 4 and 5.

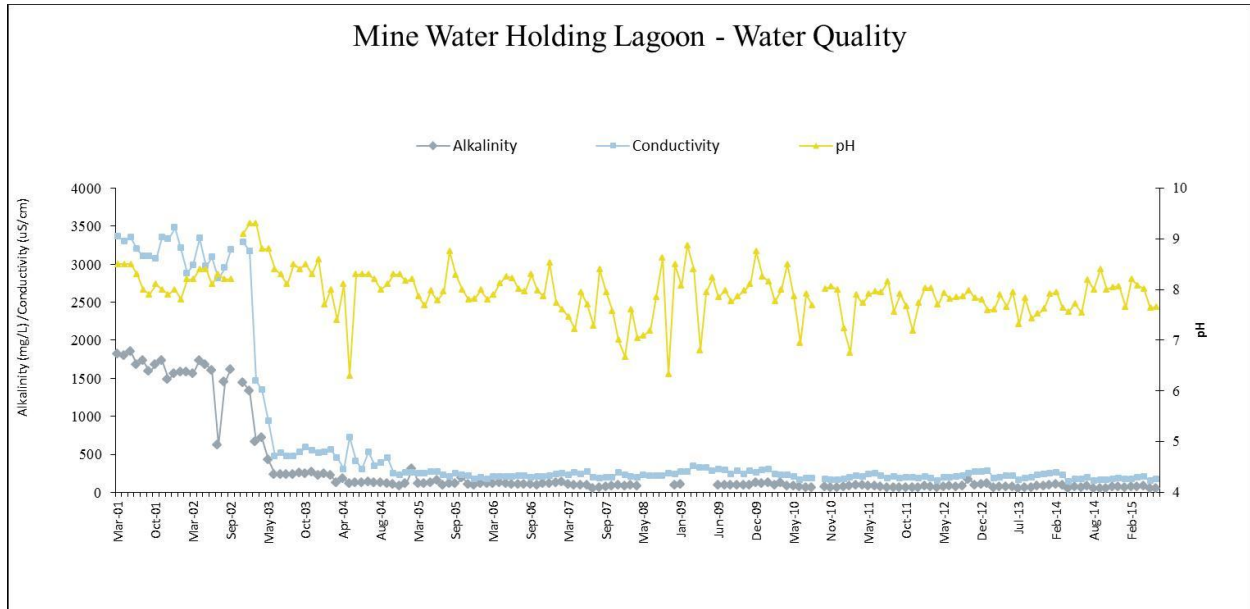
Figure 6: Water Quality Data from the Mine Water Holding Lagoon (2001 to 2015).

Figure 6 shows the trends for water quality results for pH, Conductivity and Total Alkalinity of water within the mine holding lagoons from March 2000 to July 2015. Historical trends show that water quality in the lagoon has significantly improved since the cessation of underground pumping operations in September

2002. During the reporting period, monitoring results within the mine water holding lagoons continue to reflect good water quality (i.e.: nil contamination of rainwater). The pH typically ranged between 7 and 8, Conductivity ranged between 150 and 300 $\mu\text{S}/\text{cm}$. Figure 7 shows water quality data for the mine water holding lagoons.

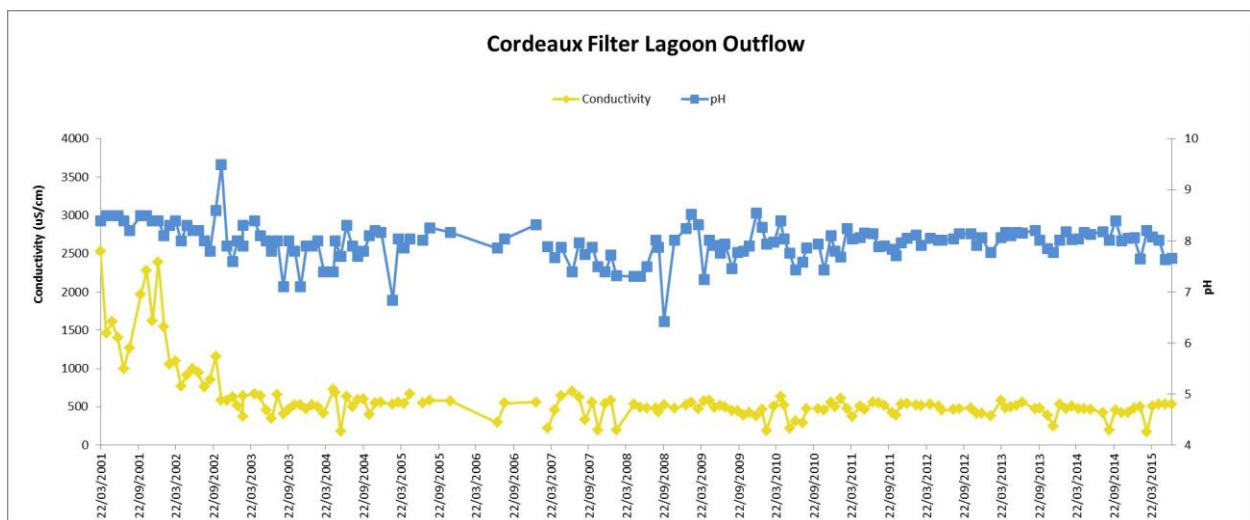
Figure 7: pH and Conductivity at the Cordeaux Filter Lagoon Underflow

The clean area catchment run-off from the Cordeaux pit top site (including the sealed employee car parking area) reports to the sand filter lagoon and leaves site to the local environment via the sand filter underflow. Water quality from this point is analysed on a nominal monthly basis. Water quality analysis for this reporting period (and historical data) shows the discharge water quality consistently of pH 8, with conductivity ranging between 250 and 600 $\mu\text{S}/\text{cm}$, and Oil & Grease (O&G) resulting $<5 \text{ mg}/\text{L}$ (ie: below the Limit of Reporting of 5 mg/L). Due to O&G being below the limit of reporting, O&G results are not displayed in Figure 7.

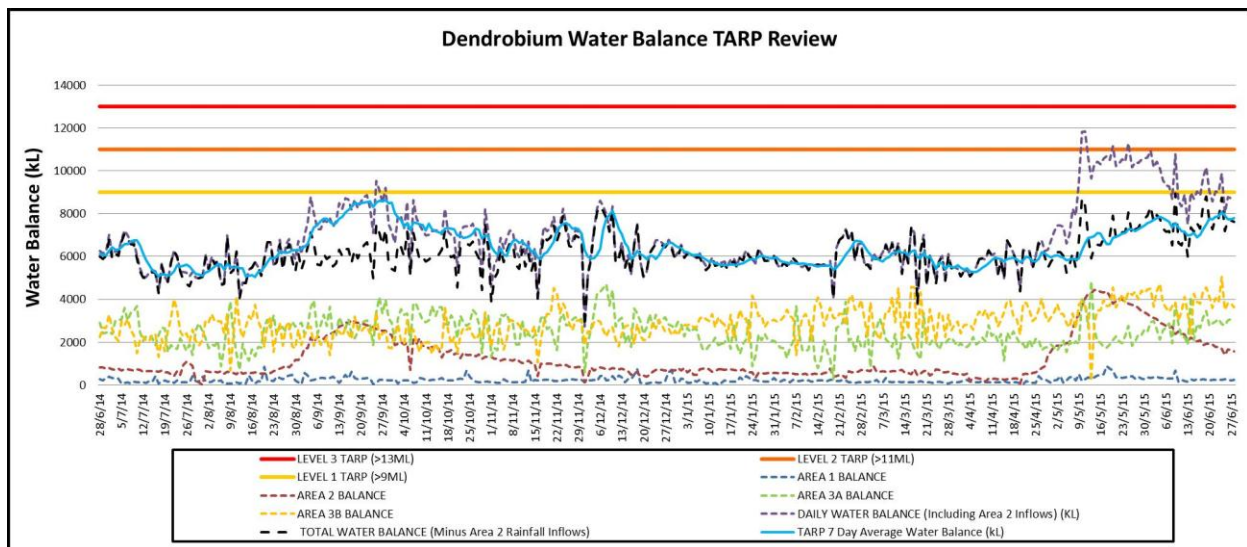
Figure 9: Mine Water Balance July 2014 - June 2015

A summary of the mine water balance for the reporting period is provided in Figure 9.

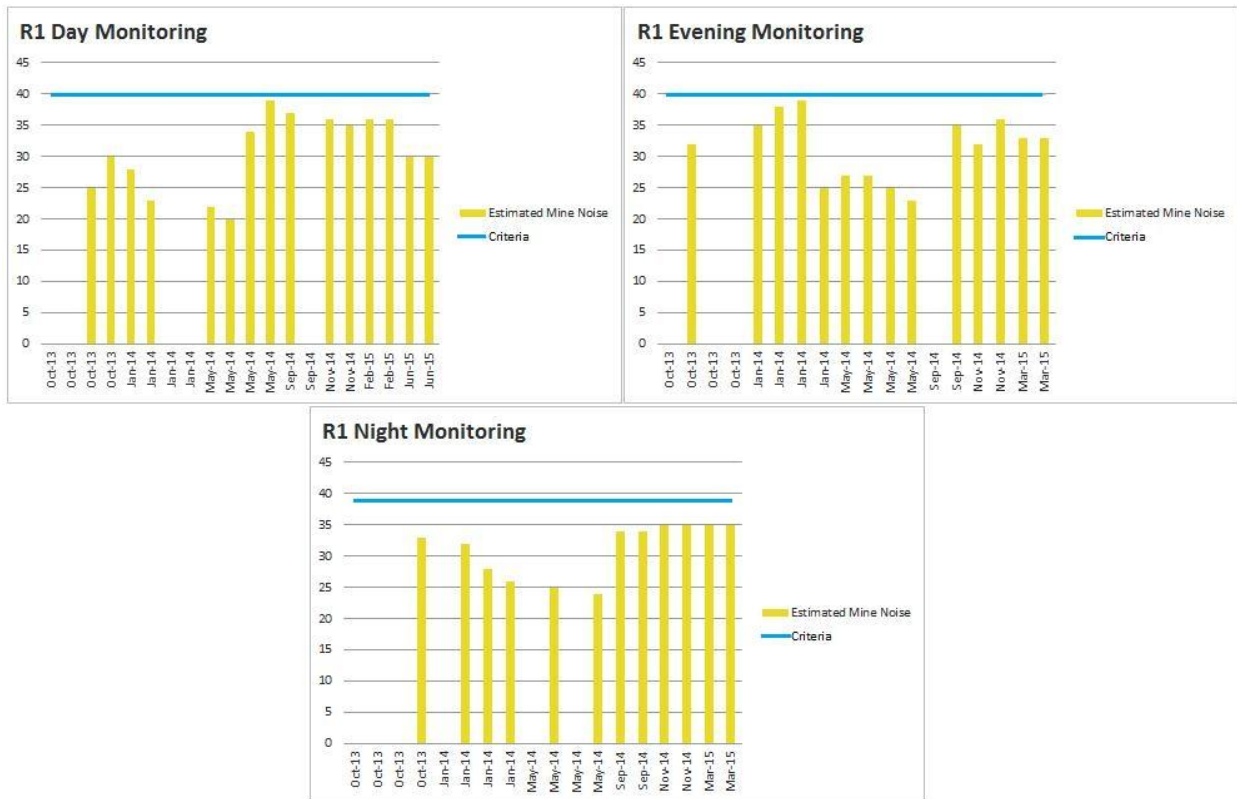
Figure 11: Site R1 Noise Compliance (LAeq, 15 minute) during the Reporting Period

R1 is located to the north of the Pit Top. There were no exceedances of the noise criteria. The LAeq,15 minute results for R1 are provided in Figure 11.

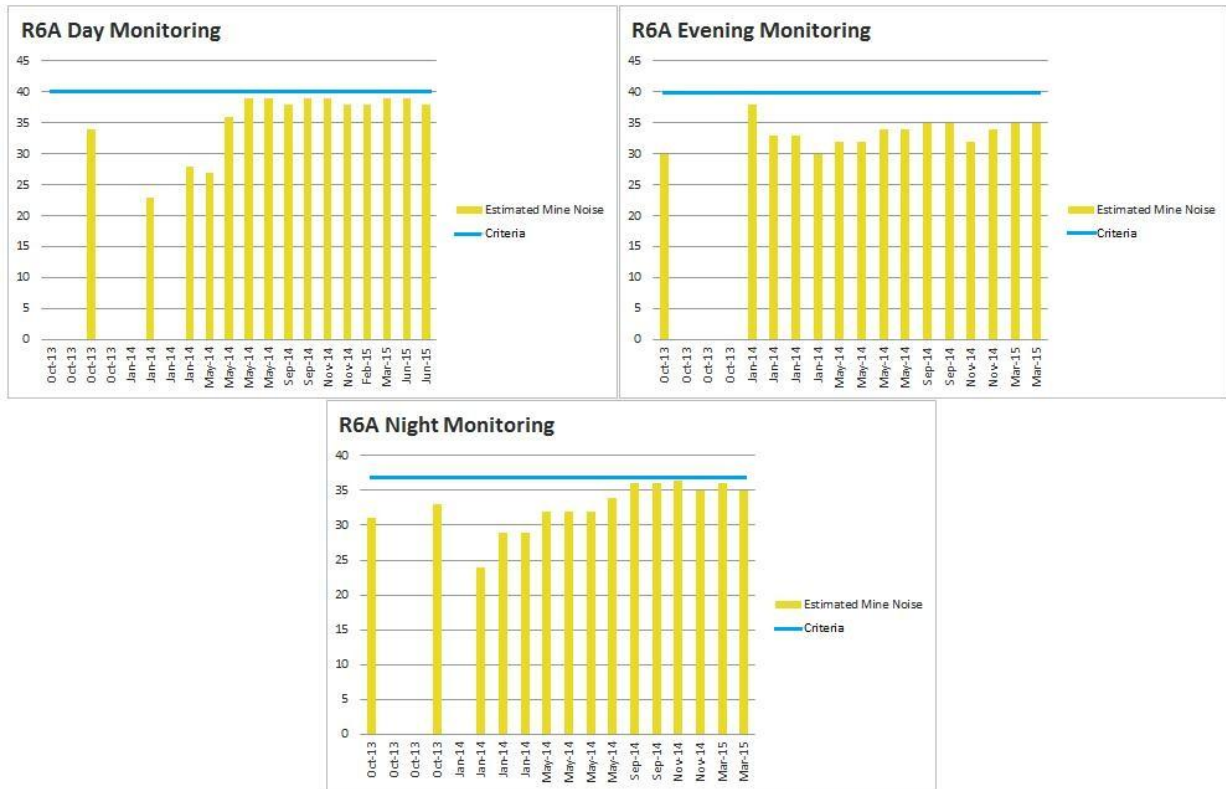
Figure 12: Site R6a Noise Compliance LAeq, 15min during the Reporting Period.

R6a is located to the east of the Dendrobium Pit Top. There were no exceedances of the LAeq, 15 minute noise criteria during the reporting. There were eleven occasions when the mine operations noise was inaudible. There were no exceedances of the LAm_{ax}, 1 minute noise criteria at Site R6a during the reporting period.

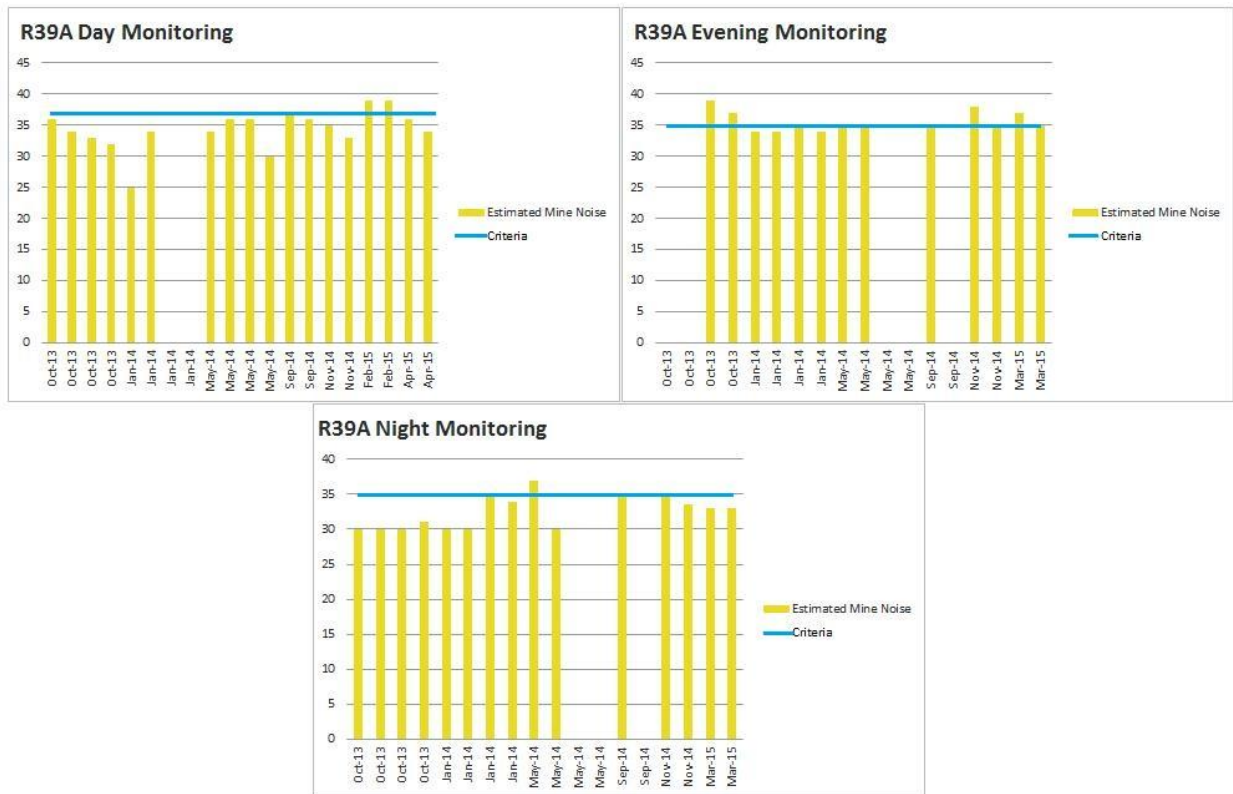
Figure 13: Site R39a Noise Compliance LAeq, 15min during the Reporting Period.

R39a is located to the south-east of KVCLF at Figtree Farm. There were four exceedances of the LAeq, 15 minute noise criteria during the reporting period, two during the day and two during the evening at Site R39a during the reporting period. The source of the exceedances were due to rail movements within KVCLF (train idling) and vehicles working on the stockpile. No exceedance of the LA1.

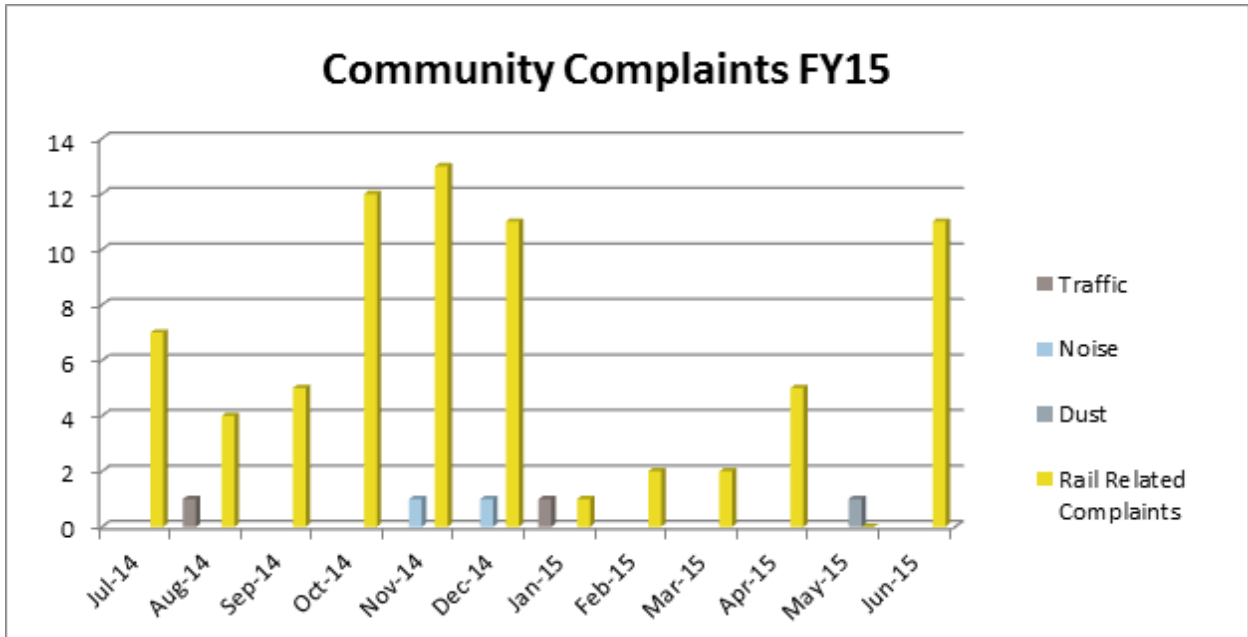
Figure 14: Dendrobium Community Complaints FY15

A total of 78 community complaints were received during the reporting period. Of these, approximately 97% were related to rail noise (Figure 14). Complaints made against the operations and the resolutions of them are reported each month on the South32 website. A summary of the complaints recorded is provided in Appendix D.

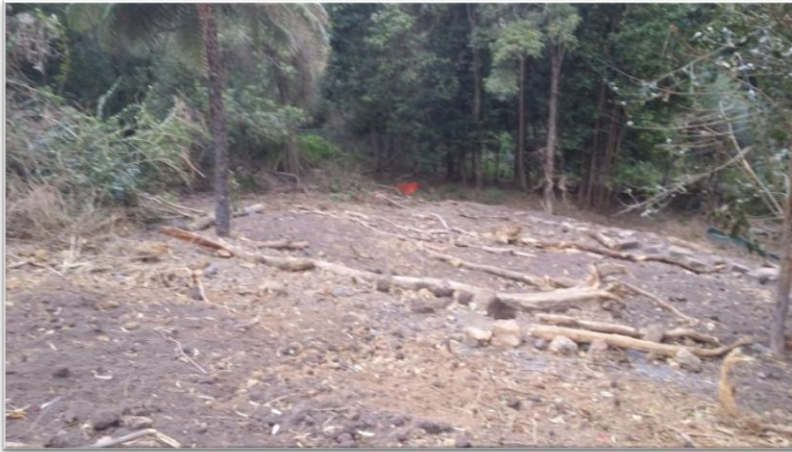
Figure 16: Landform established 12/8/2014

Rehabilitation works commenced in June 2014 and involved the following activities:

- placing fill material in the subsidence feature.
- installation of topsoil over the disturbed area.
- establishment of a stable landform and permanent drainage with appropriate benches, sediment control devices.
- Planting of native tube stock.

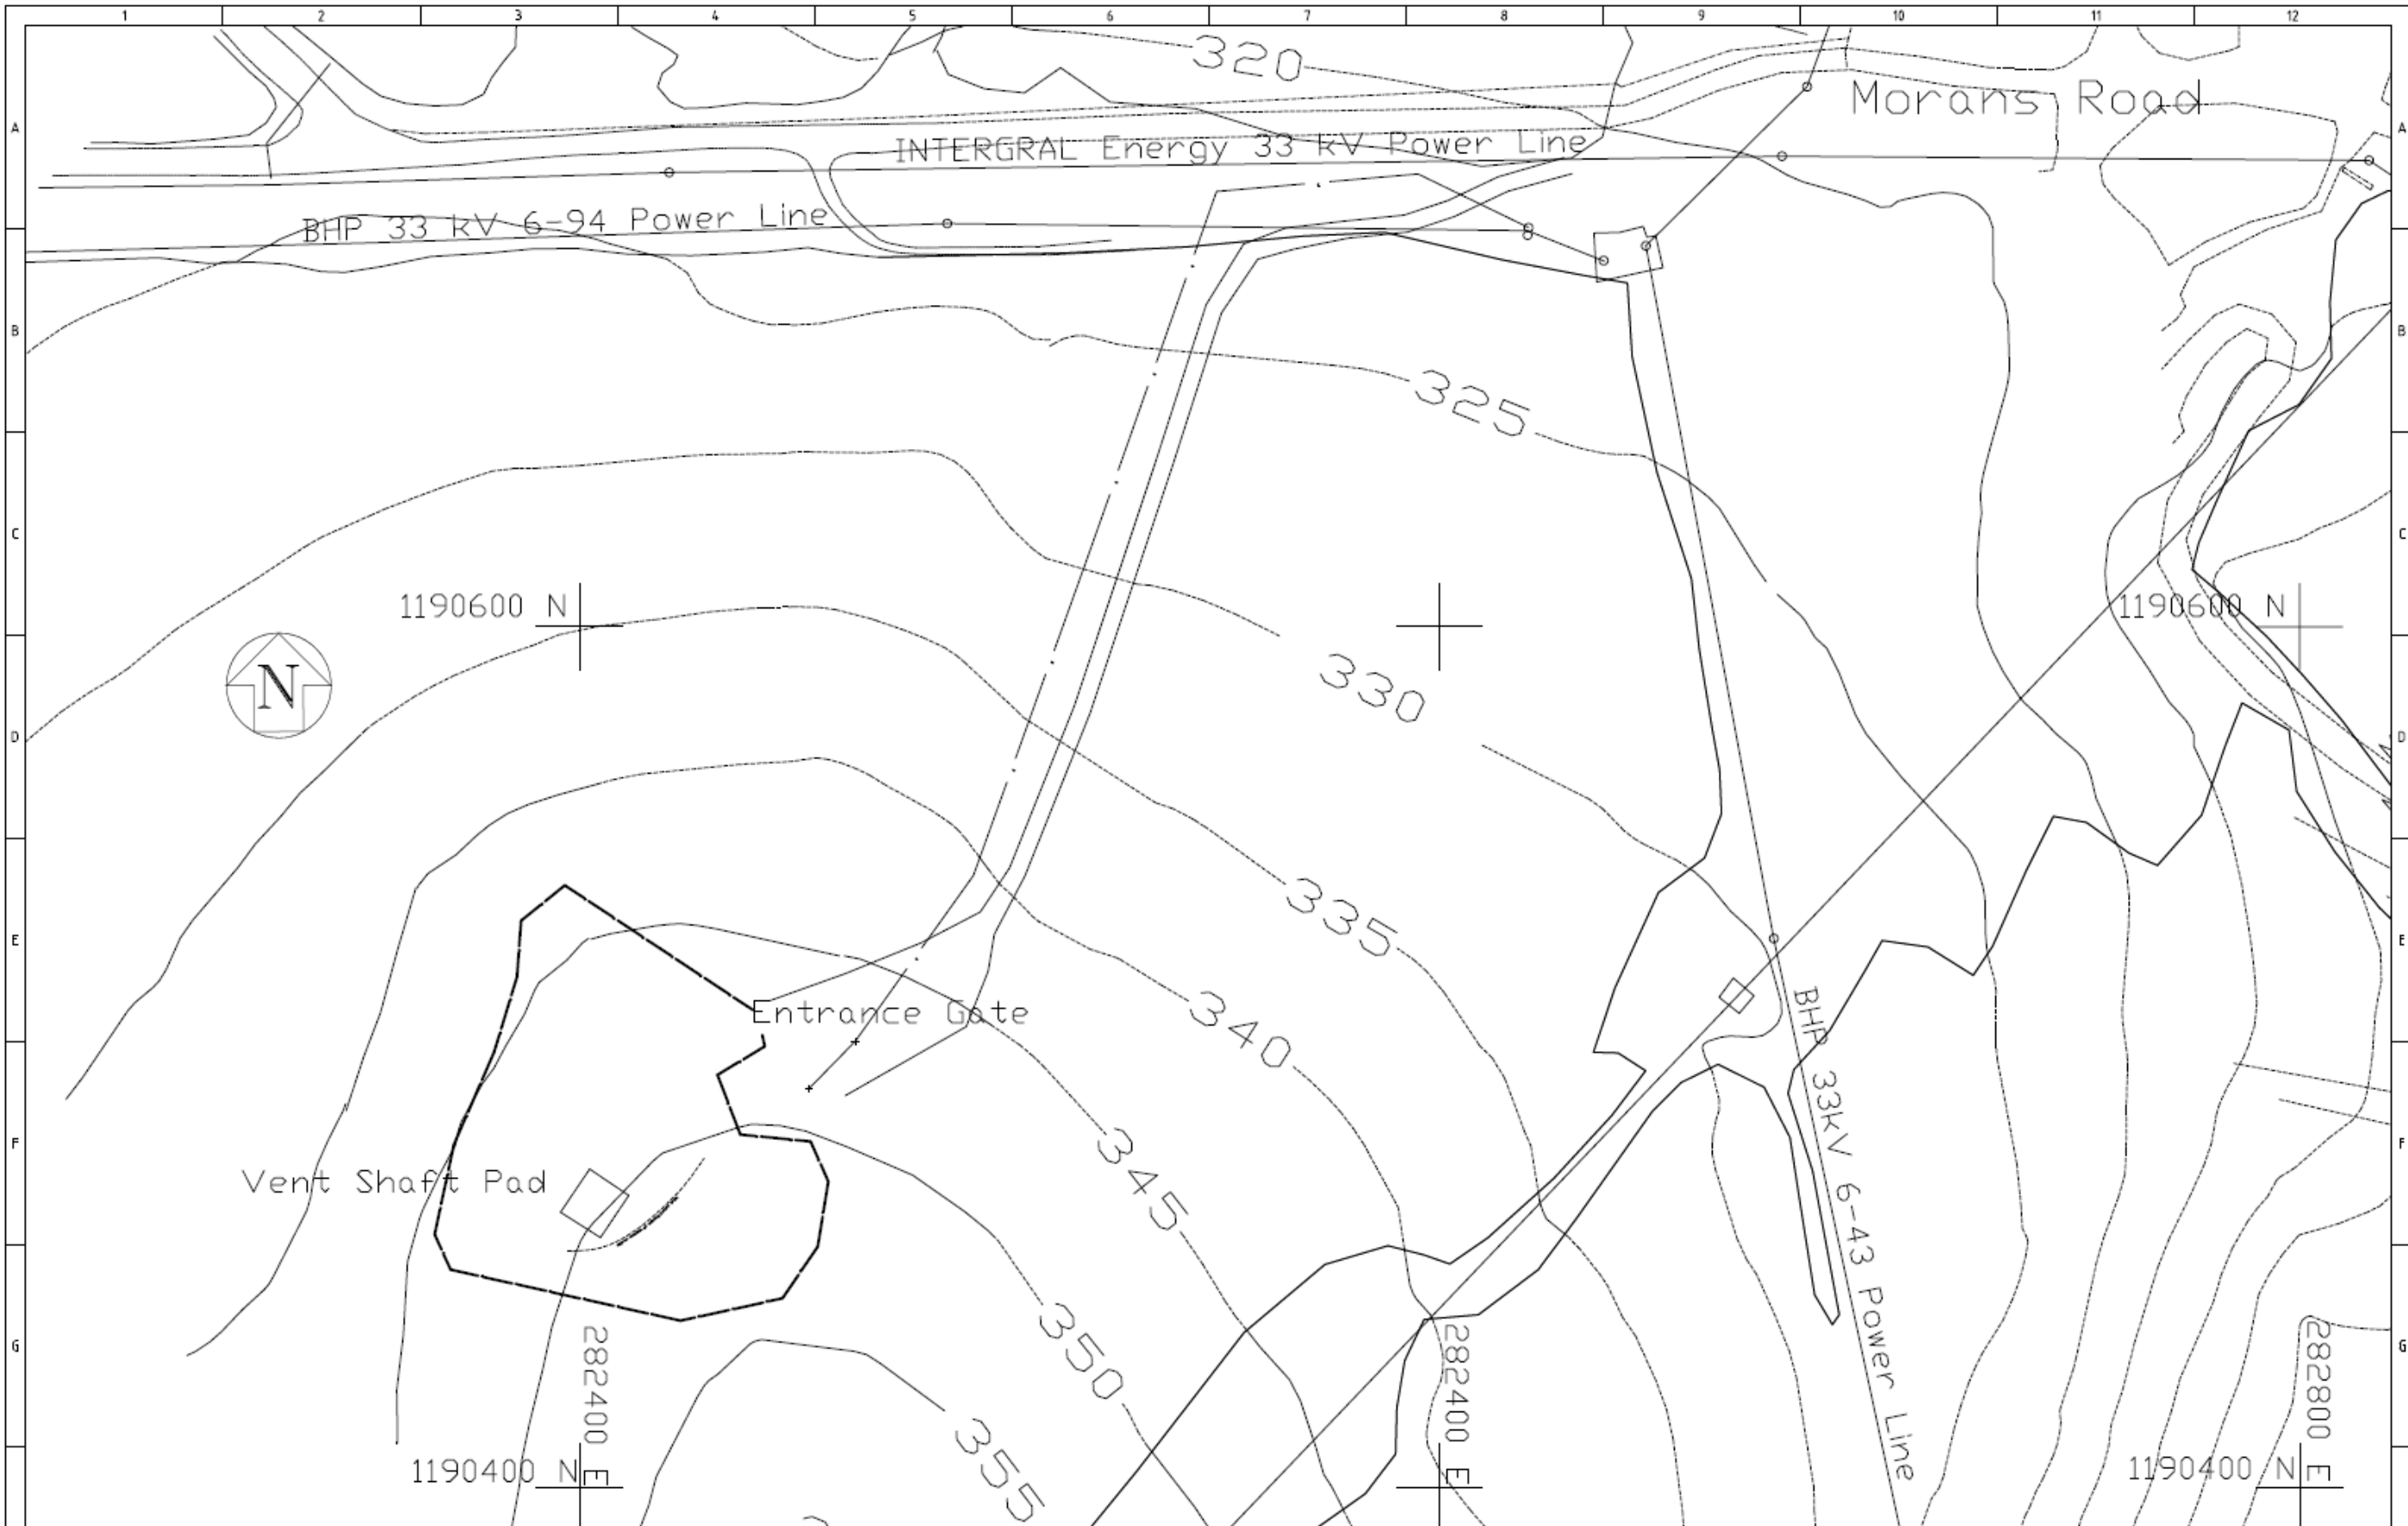
PLAN 4

No. 1 Ventilation Shaft Site Layout

REV	DESCRIPTION	DATE	DRN	CKD	REV	DESCRIPTION	DATE	DRN	CKD
2	INFRASTRUCTURE REMOVED FROM No. 1 FAN SITE	10/9/09	MV
