ILLAWARRA COAL

**DENDROBIUM MINE AND
CORDEAUX COLLIERY**

**ANNUAL REVIEW
FY16**

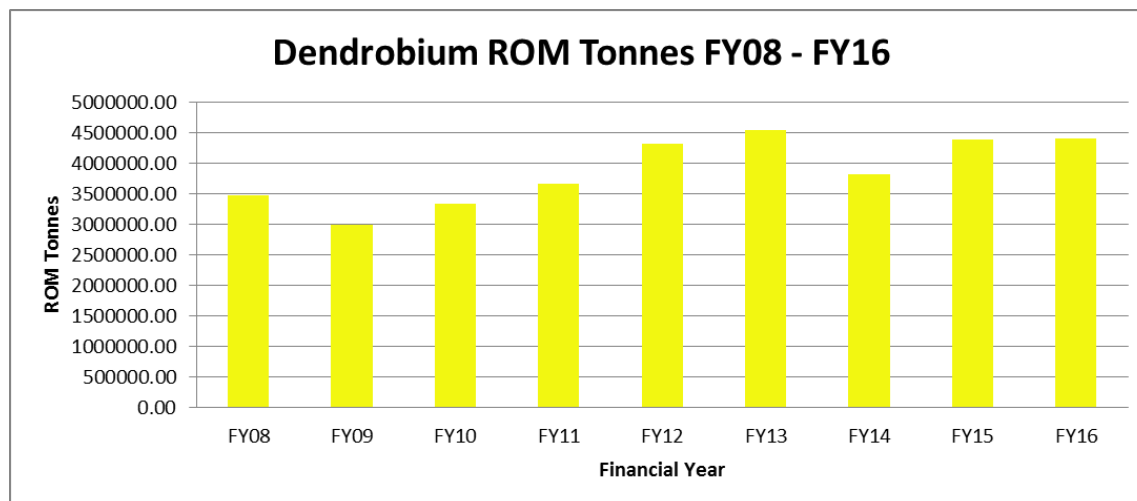
Figure 1: ROM Production FY08 to FY16.

The Run of Mine (ROM) product for the reporting period was 4,421,181 tonnes with a saleable product yield of 77%. A comparison showing the ROM production at Dendrobium Mine for the past eight reporting periods is provided in Figure 1.

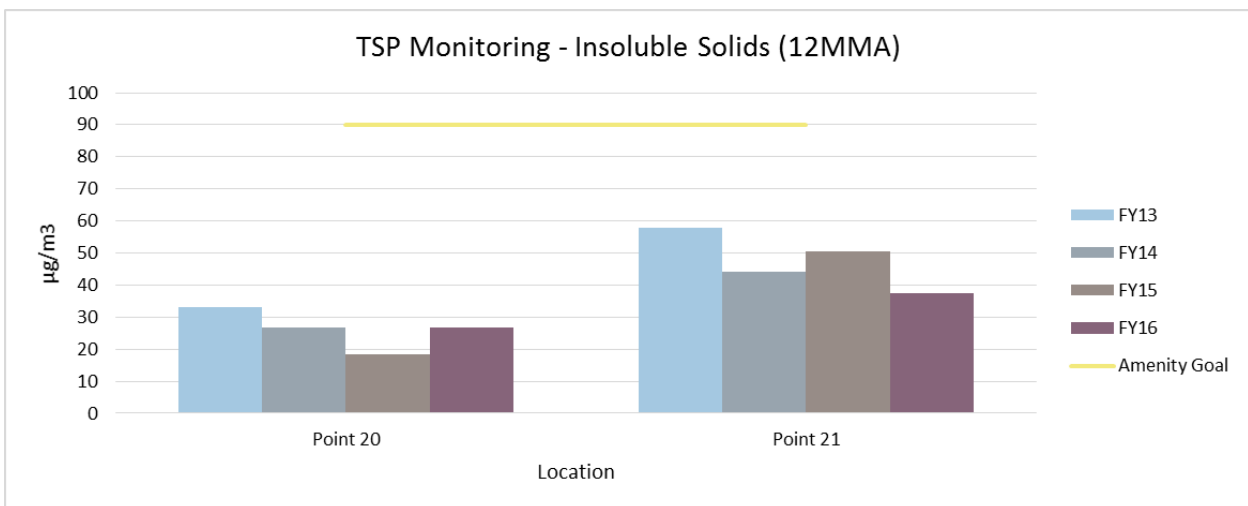
Figure 3: HVAS TSP Results FY16.

Dust levels from the High Volume Air Sampler (HVAS) for FY16 complied with the relevant standards specified in Table 13. The monthly TSP results and PM₁₀ results for the Kemira Valley (Point 20) and the Pit Top sites (Point 21) are shown in

Figure 3 and Figure 4 from FY13 to FY16. One exceedance was reported in April 2016 for PM₁₀ monitoring, this occurred on the same day as a bushfire in the area. Graphs depicting trends in water quality over the past years can be found in Appendix E1.

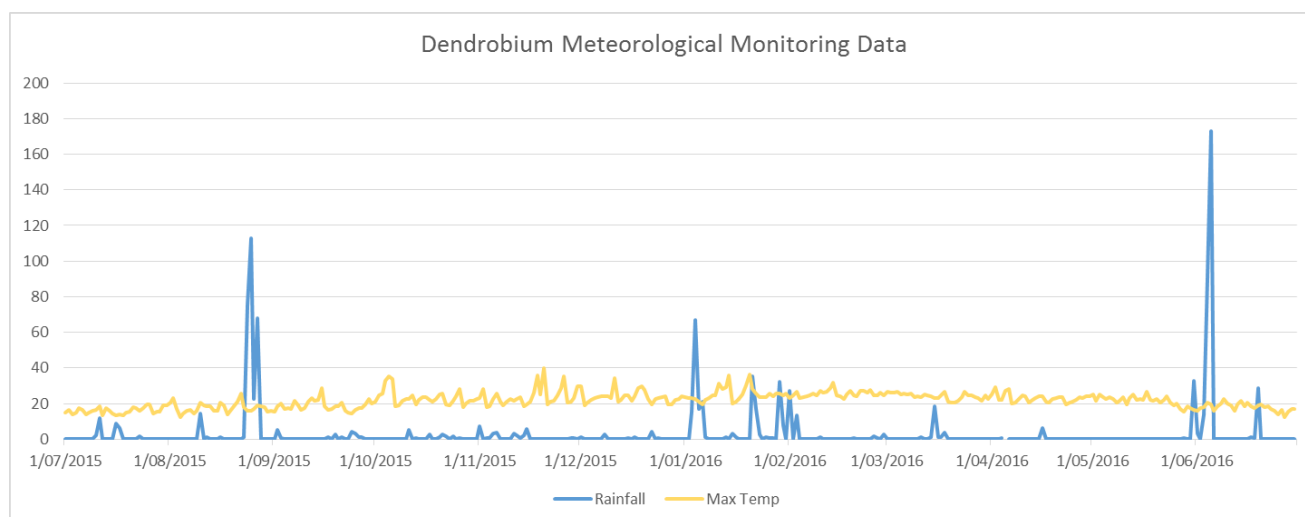
Figure 5: Rainfall and temperature FY16

The majority of the monitoring sites are located in natural watercourses that surround the Dendrobium Pit Top and Kemira Valley sites, Brandy and Water Creek and American Creek. Variations in response to local geology and rainfall were within expectations during the reporting period. The results from the downstream sites are compared to the results from upstream sites at each location. These comparisons are discussed in detail below. Meteorological data for the year can be found below in figure 5.

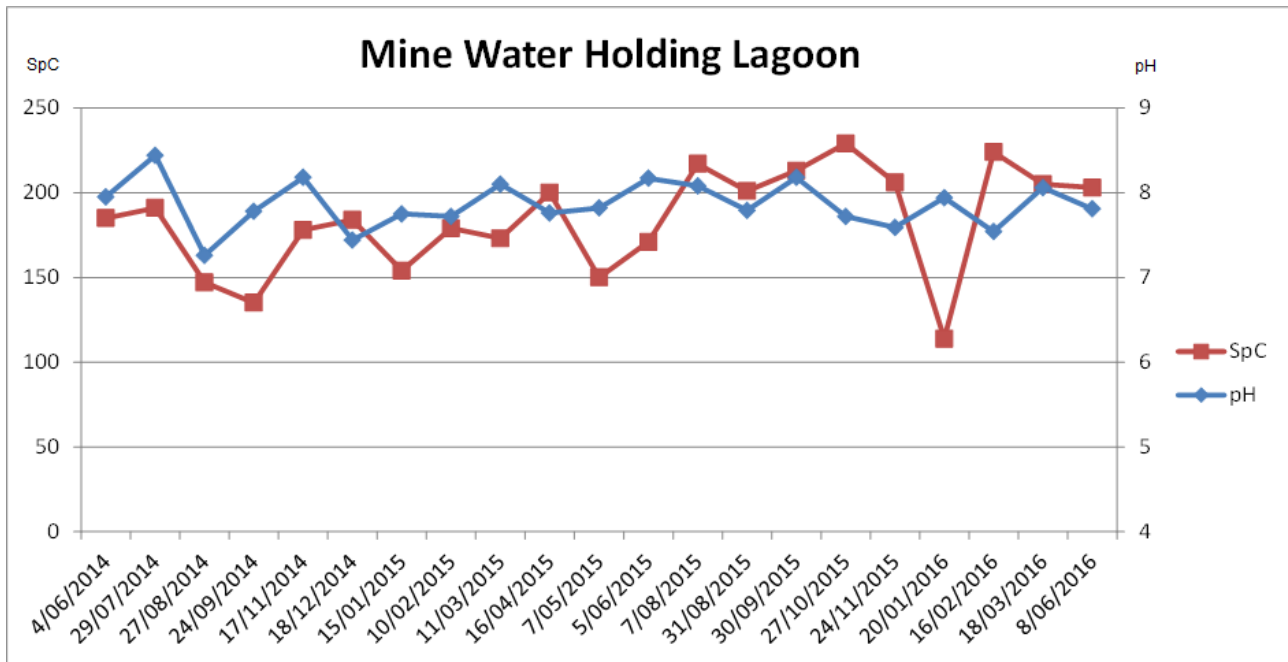
Figure 6: Water Quality Data from the Mine Water Holding Lagoon (2002-2016).

During the reporting period approximately 5 ML of water was discharged from the mine water holding lagoons to the underground workings. Figure 6 shows the trends for water quality results for pH, Conductivity and Total Alkalinity of water within the mine holding lagoons from June 2014 to July 2016. Historical trends show that water quality in the lagoon has significantly improved since the cessation of underground pumping operations in September 2002. During the reporting period, monitoring results within the mine water holding lagoons continue to reflect good water quality (i.e.: nil contamination of rainwater). The pH typically ranged between 7 and 8, Conductivity ranged between 100 and 300 $\mu\text{S}/\text{cm}$.

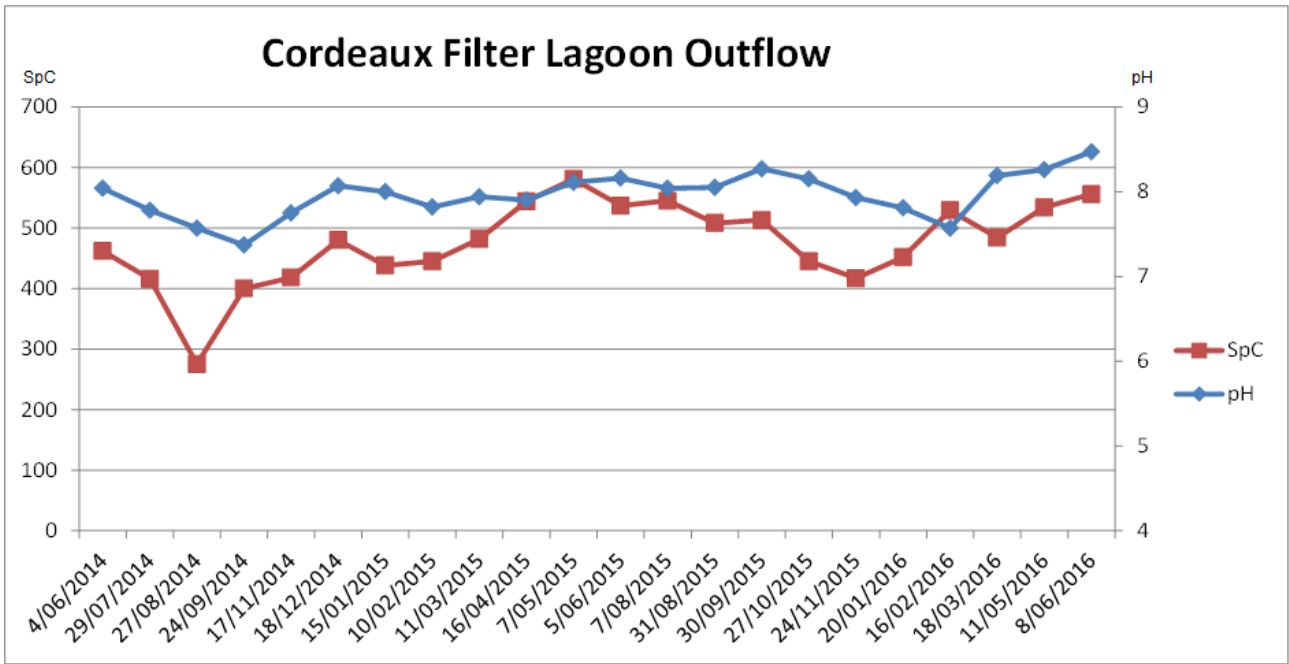
Figure 7: pH and Conductivity at the Cordeaux Filter Lagoon Underflow.

The clean area catchment run-off from the Cordeaux pit top site (including the sealed employee car parking area) reports to the sand filter lagoon and leaves site to the local environment via the sand filter underflow. Water quality from this point is analysed on a nominal monthly basis. Water quality analysis for this reporting period (and historical data) shows the discharge water quality between pH7- 8.5, with conductivity ranging between 250 and 650 $\mu\text{S}/\text{cm}$, and Oil & Grease (O&G) resulting <5 mg/L (ie: below the Limit of Reporting of 5 mg/L). Due to O&G being below the limit of reporting, O&G results are not displayed in Figure 7.

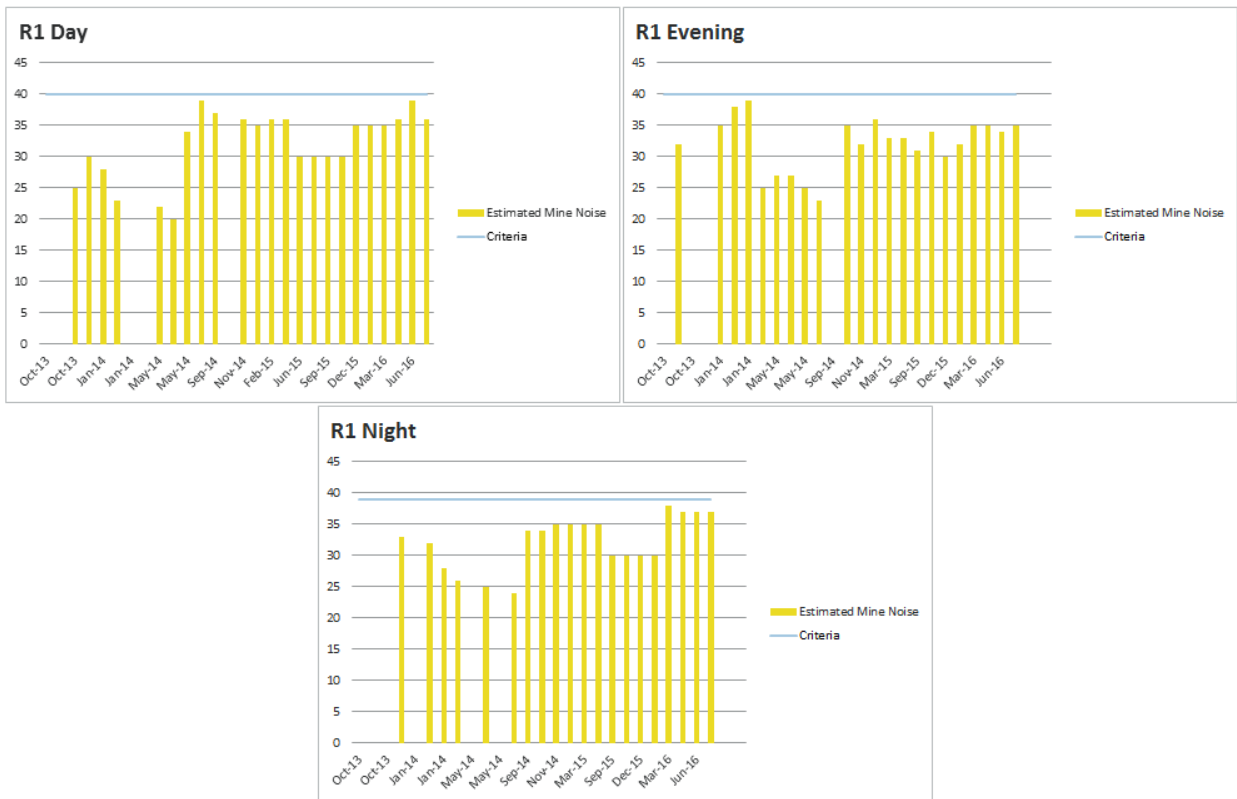
Figure 9: Site R1 Noise Compliance (LAeq, 15 min).

R1 is located to the north of the Pit Top. There were no exceedances of the noise criteria. The LAeq 15 minute results for R1 are provided in Figure 9.

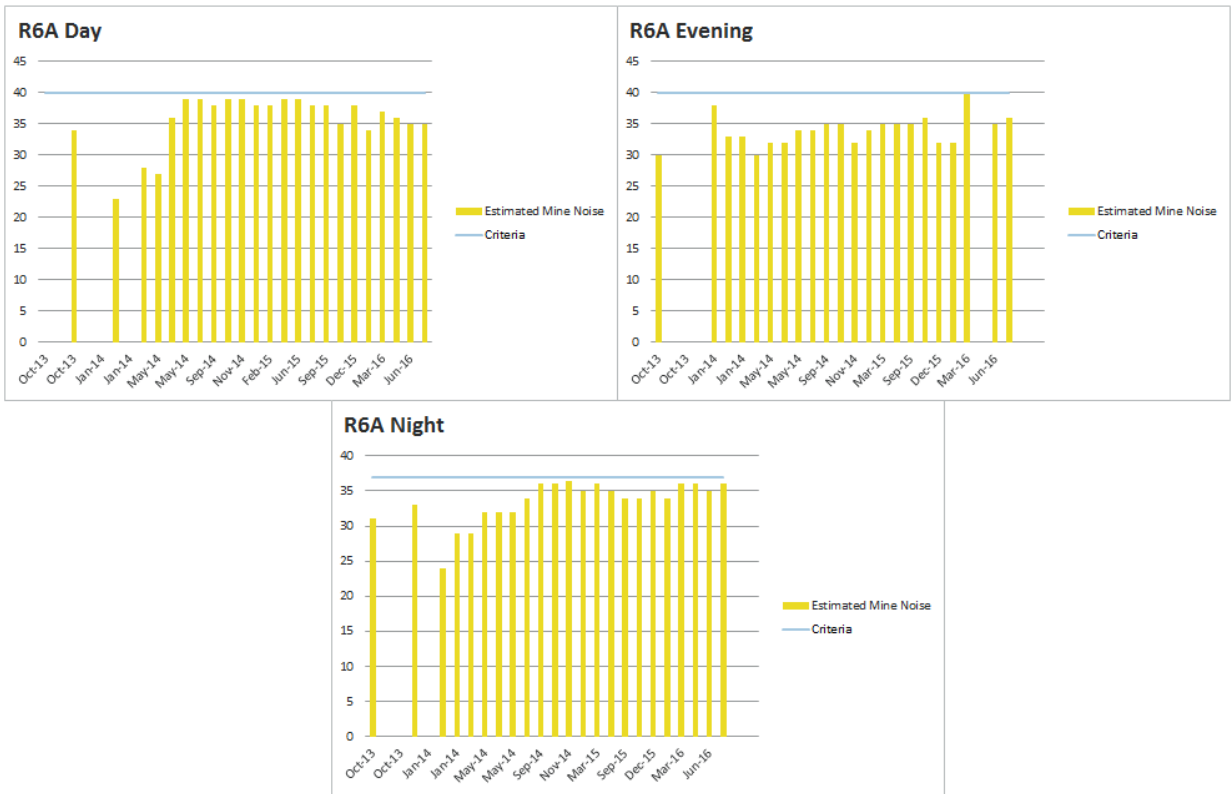
Figure 10: Site R6a Noise Compliance (LA_{eq}, 15 min).

R6a is located to the east of the Dendrobium Pit Top. There were no exceedances of the noise criteria. The LA_{eq} 15 minute results for R1 are provided in Figure 10.

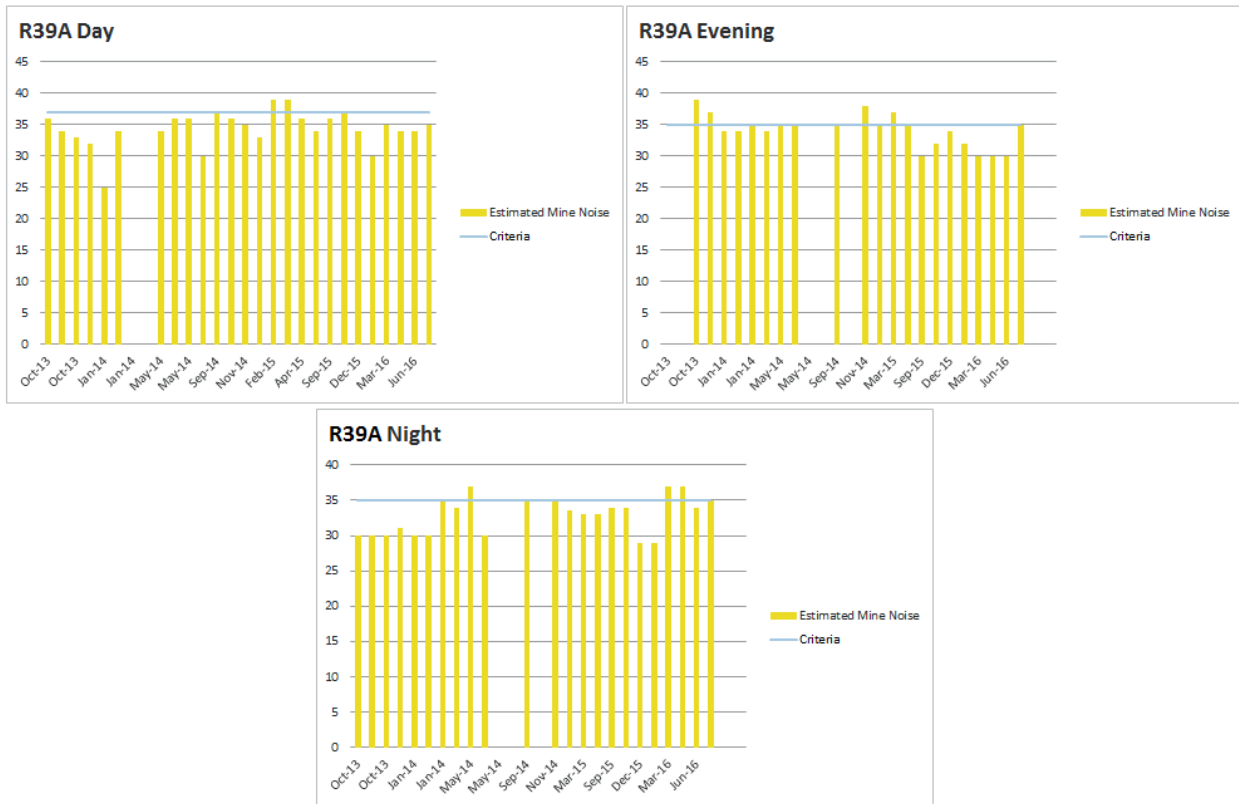
Figure 11: Site R39A Noise Compliance (LAeq, 15 min).

R39a is located to the south-east of KVCLF at Figtree Farm. There were two exceedances of the LAeq, 15 minute noise criteria during the reporting period relating to the conveyor at Kemira Valley, however the noise level remained below the dominant noise (insects, birds and bats).

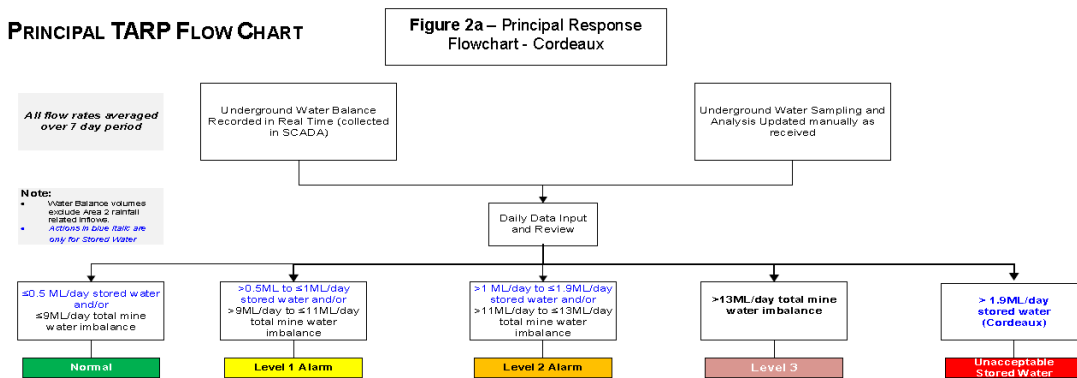
Figure 12: Principal Response Flowchart in “Cordeaux Reservoir DSC Notification Area Contingency Plan”.

Monthly water sampling is performed underground with samples analysed onsite and at NATA accredited laboratories. Mine water usage, water flows and volumes within the mine are analysed and reported on regularly (i.e. on a daily to weekly basis). Surface and underground vibrating wire piezometers are utilised to monitor groundwater response to mining. Monthly reports are prepared and submitted to the DSC, SCA, , NSW Water , Department of Resources and Energy summarising water quality and the water balance at Dendrobium. During the reporting period, Dendrobium operated under a Principal Trigger Action Response Plan (TARP) as outlined in the “Avon and Cordeaux Reservoir DSC Notification Area Contingency Plan”. During this period the mine operated at ‘Normal’ in the Principal Response Flowchart (Figure 12).

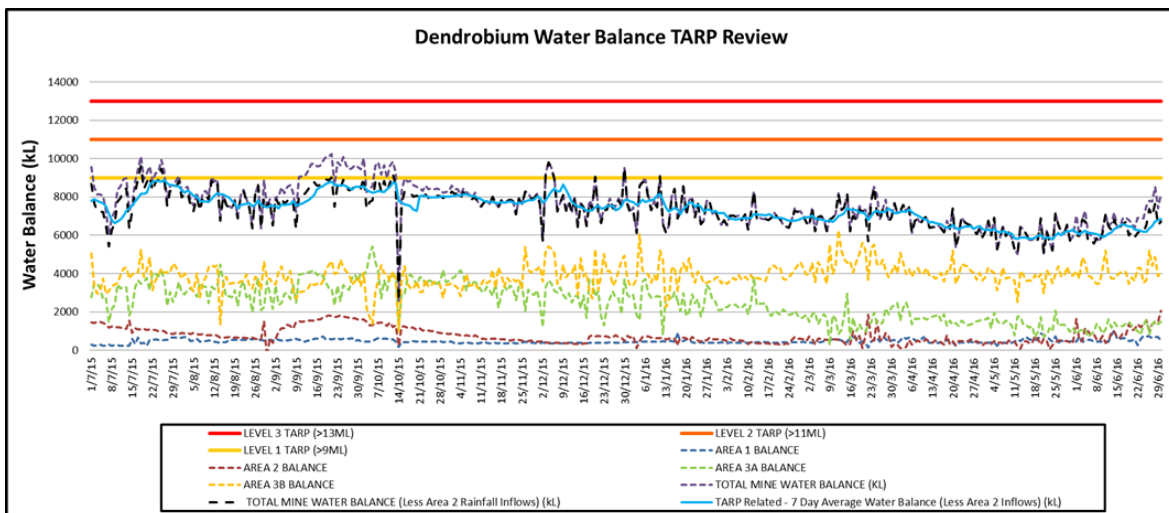
Figure 13: Mine Water Balance July 2015 – June 2016.

A summary of the mine water balance for the reporting period is provided in Figure 13.
