Visual Amenity 14

14 VISUAL AMENITY

EASTERN LEASES PROJECT

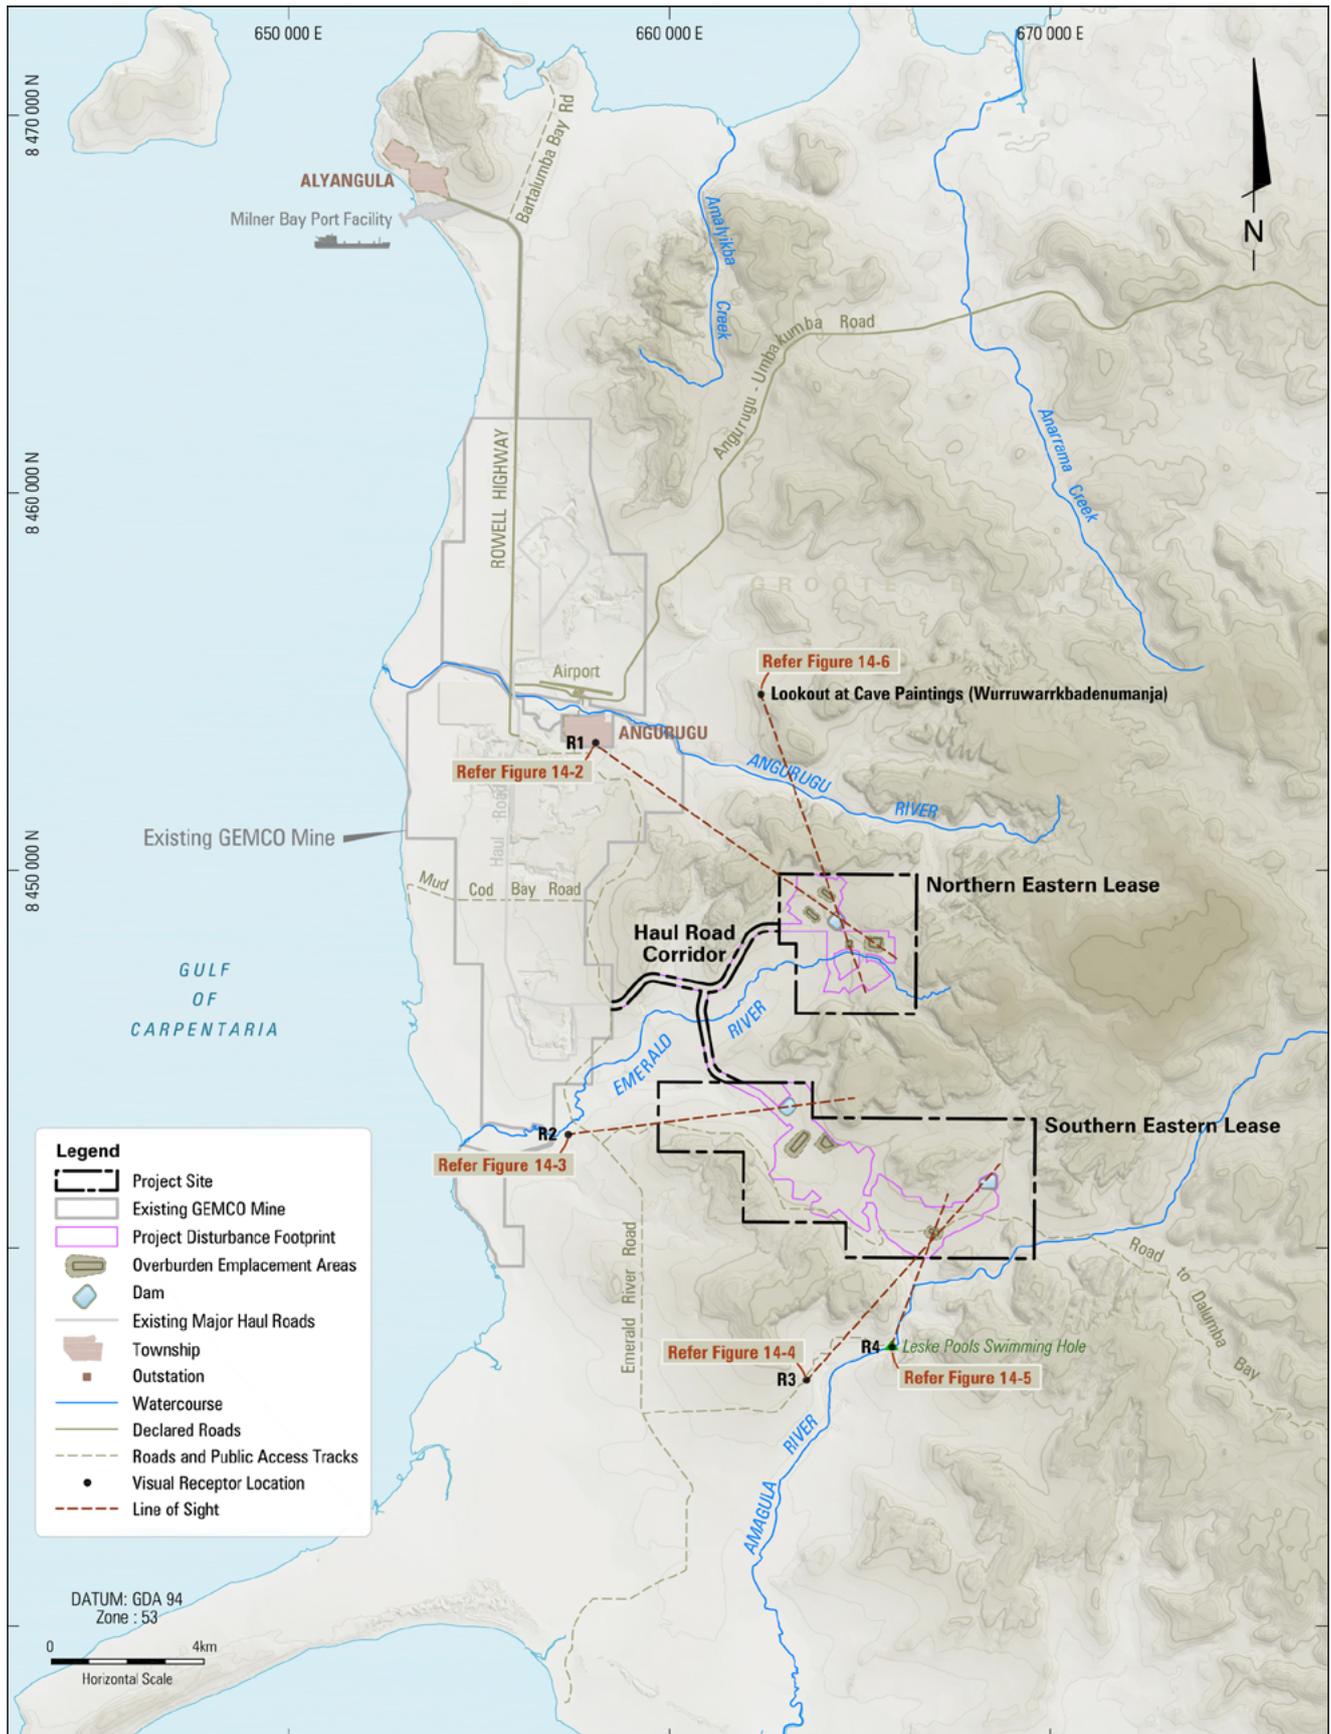
FIGURE 14-1

Local Terrain and Visual Receptors

The project site is characterised by elevated rocky outcrops and gently sloping valleys. Elevations within the project site range from approximately 10 m Australian Height Datum (AHD) to 120 m AHD. The project activities will predominantly take place in the low lying valley areas of the project site. These low lying areas are surrounded by rocky outcrops. The project site is well vegetated and comprises natural bushland that is mainly eucalypt dominated open forest, woodland and shrubland. There is no existing development or infrastructure within or adjacent to the project site. The existing mine is located approximately 2 km to the west of the Southern Eastern Lease (Southern EL) at the closest point (Figure 14-1).

Figure 14-1 shows the viewing locations that were assessed.

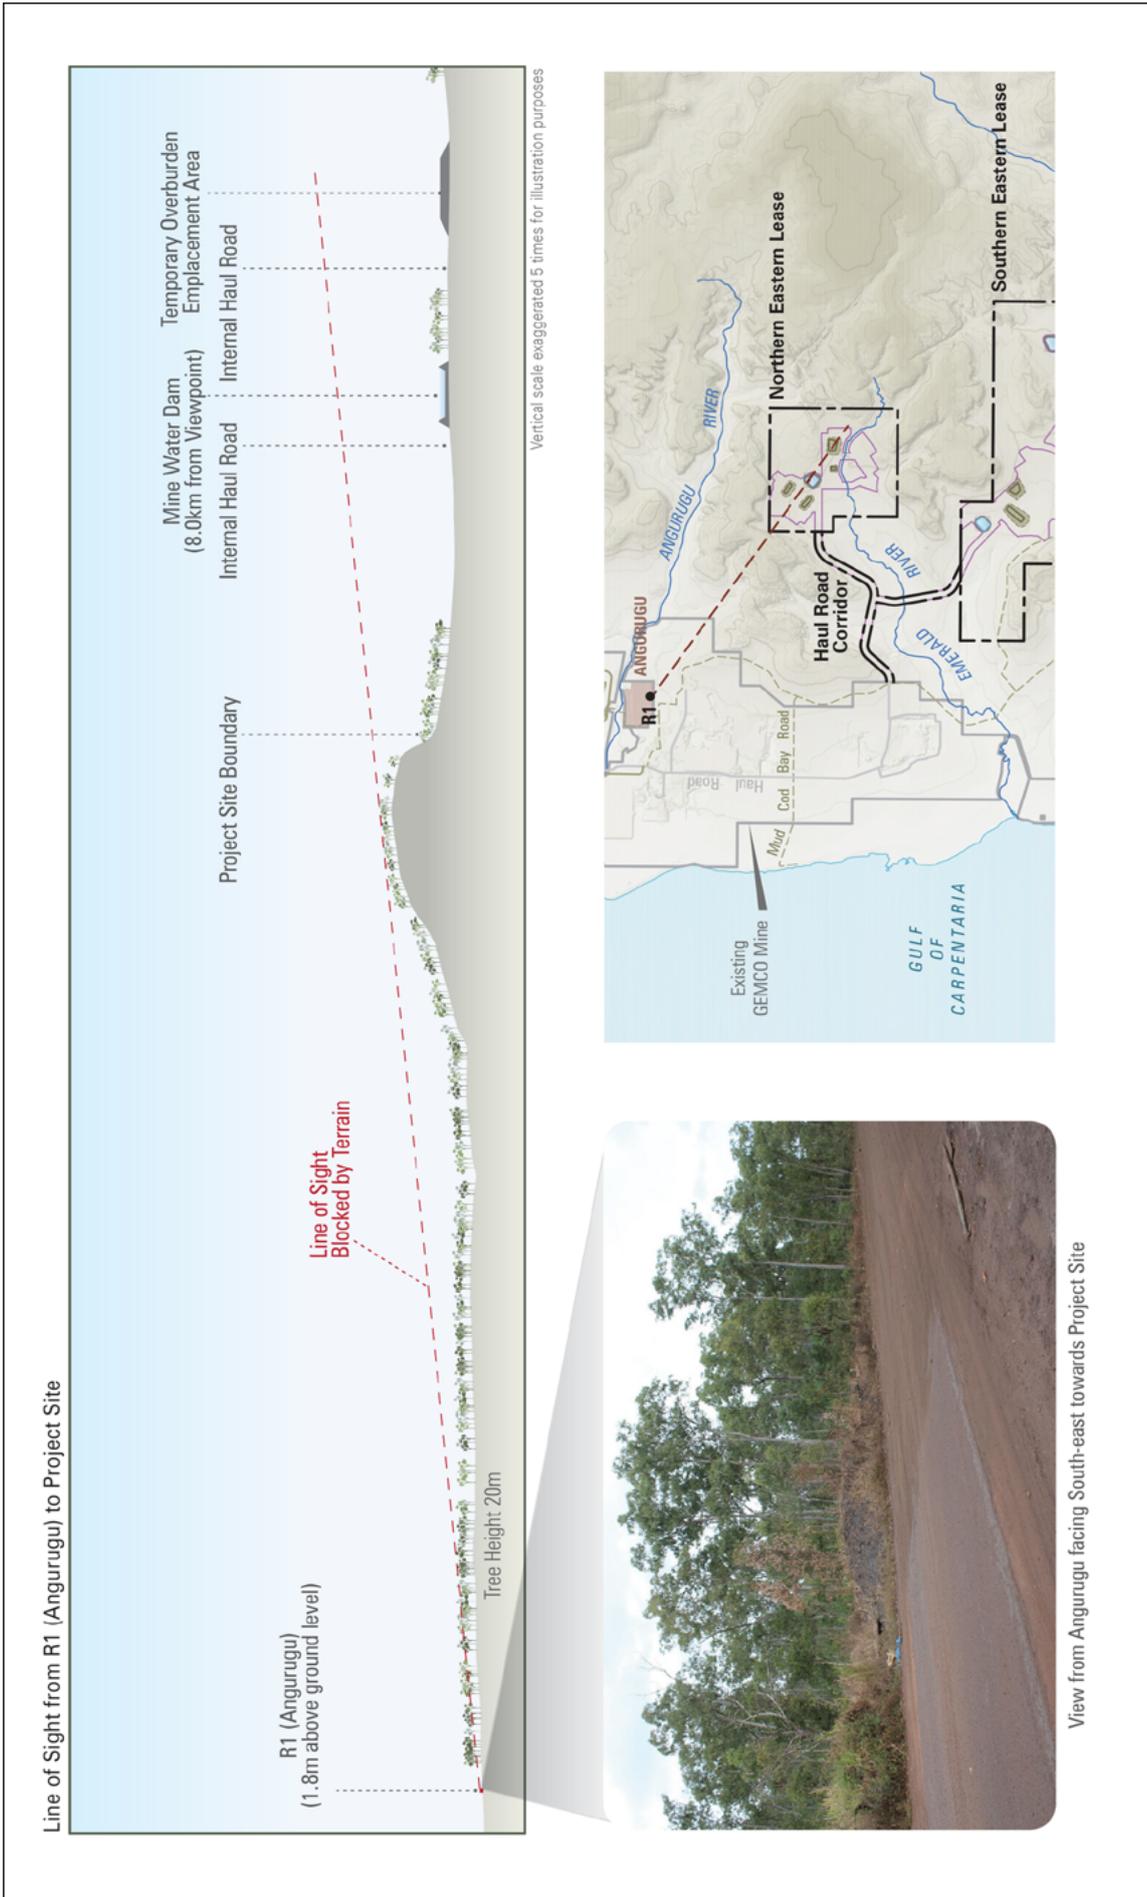
FIGURE 14-2

View from R1 (Angurugu) to the Project Site

- There is intervening topography (i.e. rocky outcrops and ridges), that would prevent any views of project elements from R1 (Angurugu) (Figure 14-2).
- There is intervening topography that would prevent any views of project elements from R2 (Yedikba) (Figure 14-3).
- There is intervening topography (i.e. rocky outcrops and ridges), that would prevent any views of project elements from R3 (Wurrumenbumanja) (Figure 14-4).

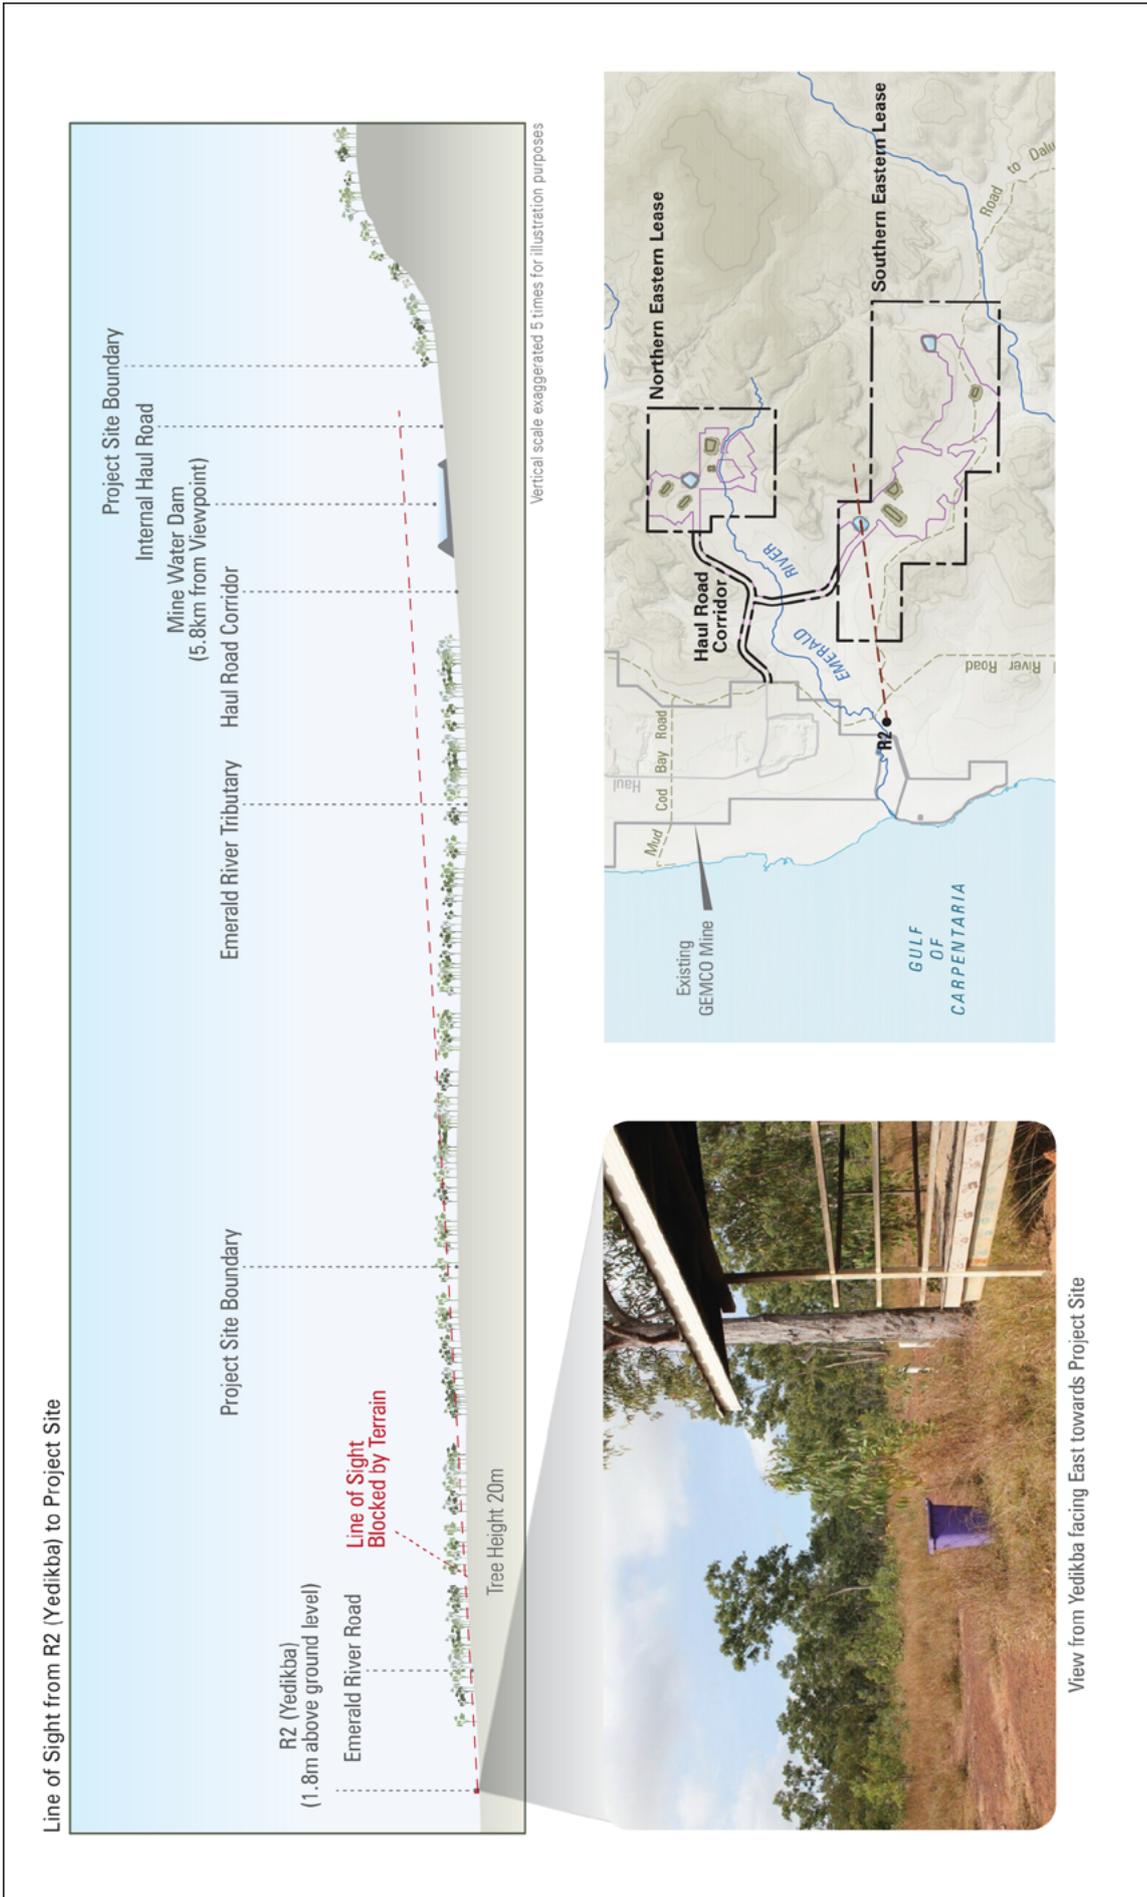
FIGURE 14-3

View from R2 (Yedikba) to the Project Site

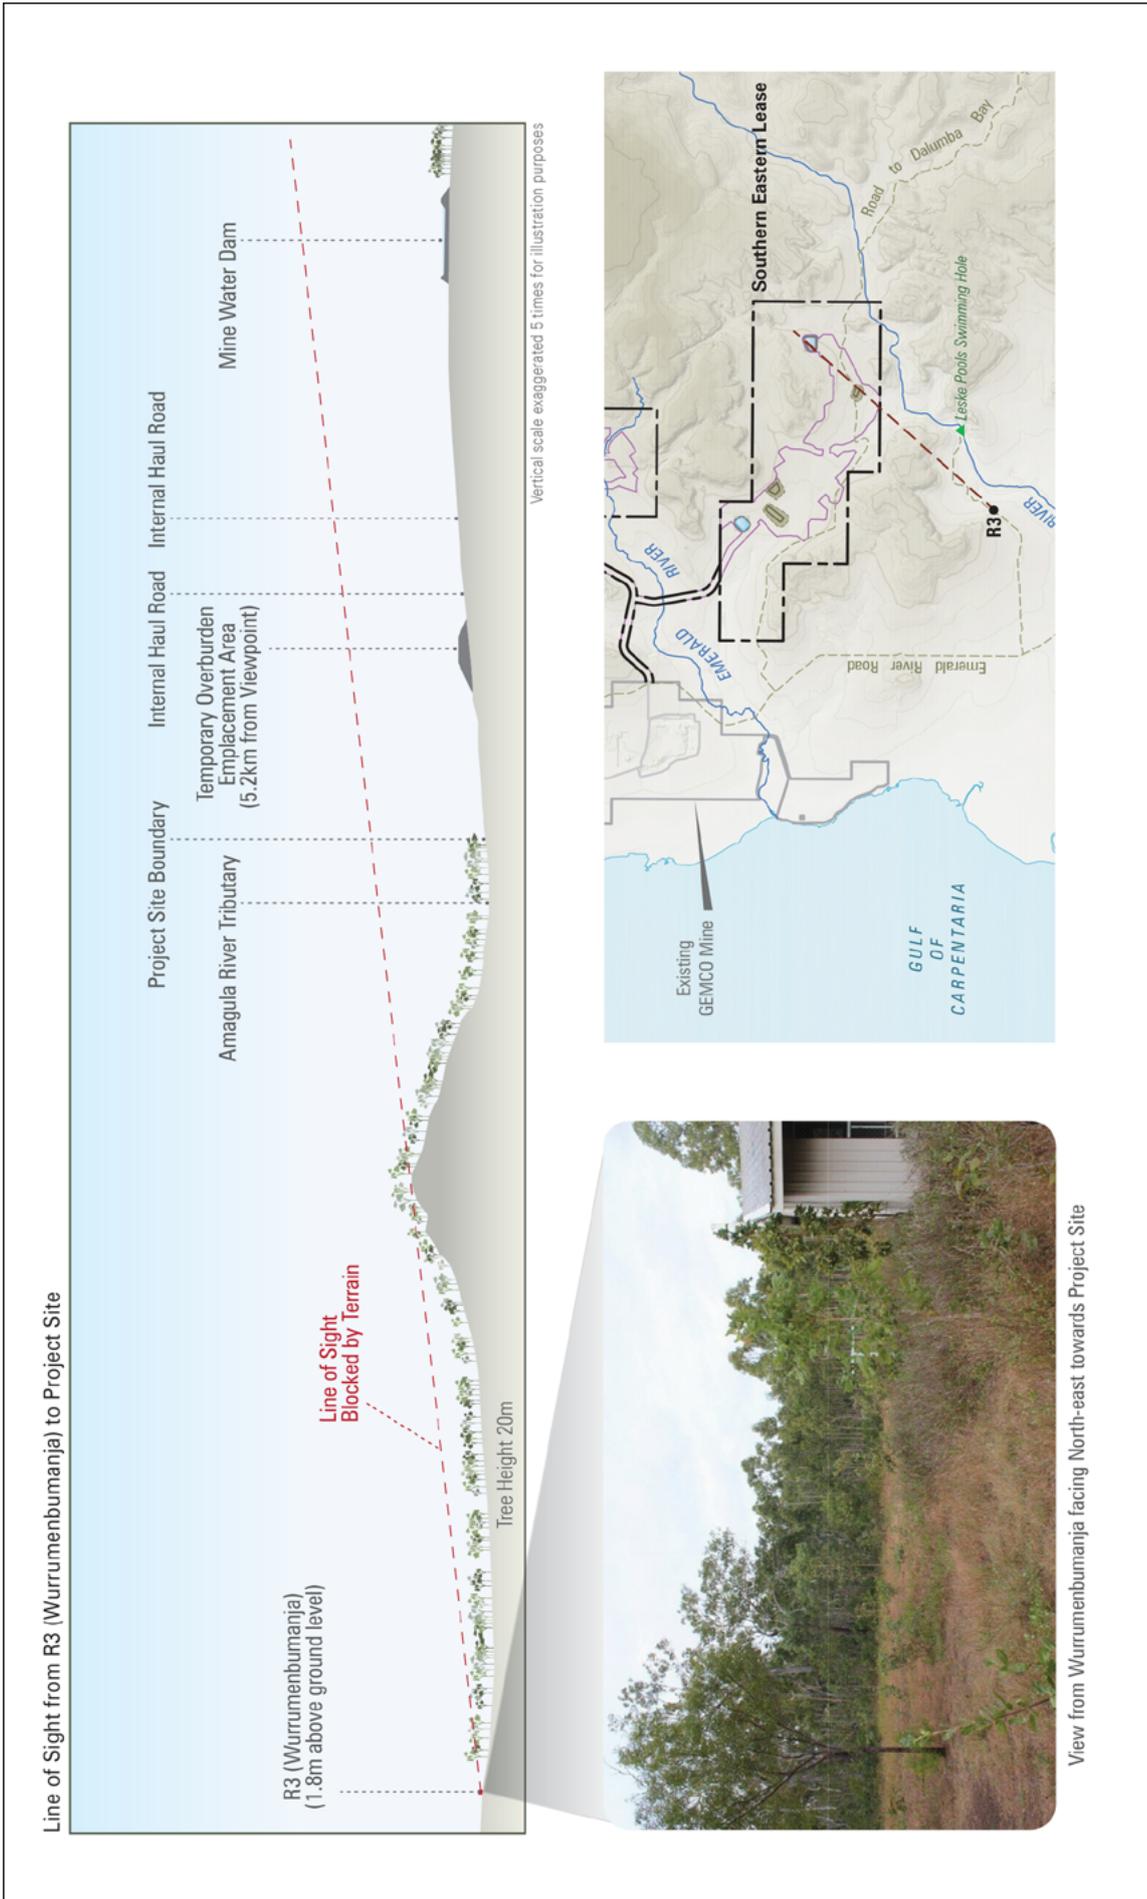
FIGURE 14-4

View from R3 (Wurrumbanjanja) to the Project Site

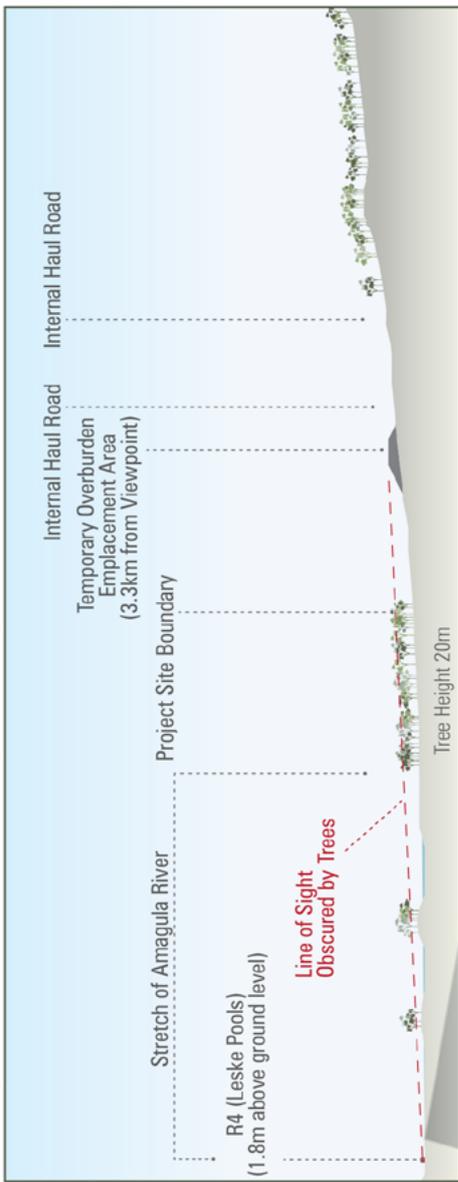
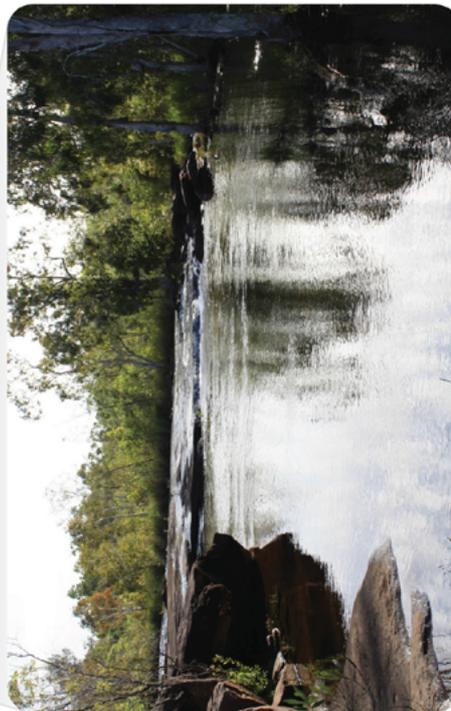
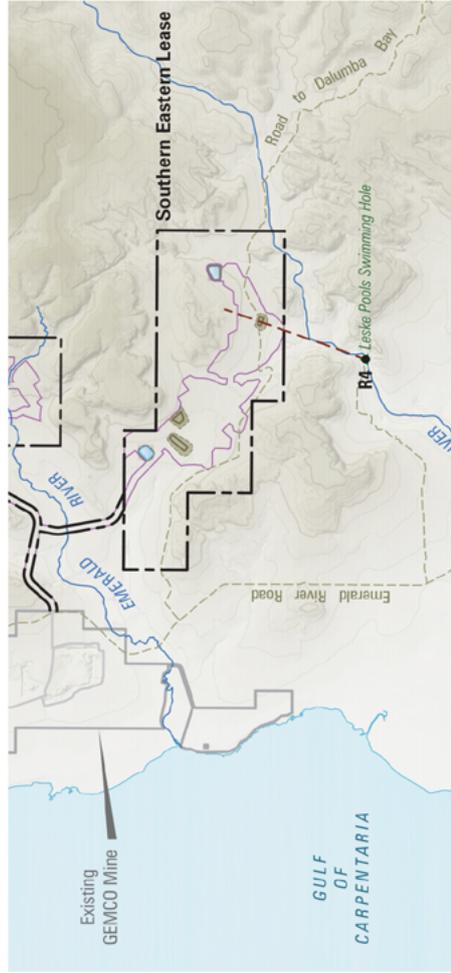
FIGURE 14-5

Line of Sight from R4 (Leske Pools Swimming Hole) to Project Site

Vertical scale exaggerated 5 times for illustration purposes

View from Leske Pools Swimming Hole facing North towards Project Site

View from R4 (Leske Pools Swimming Hole) to the Project Site

- There is dense vegetation surrounding R4 (Leske Pools Swimming Hole), which would block views towards project elements (Figure 14-5).
- There is intervening topography (i.e. rocky outcrops and ridges), that would prevent any views from the lookout at the Wurruwarrkbadenumanja cave paintings (Figure 14-6).

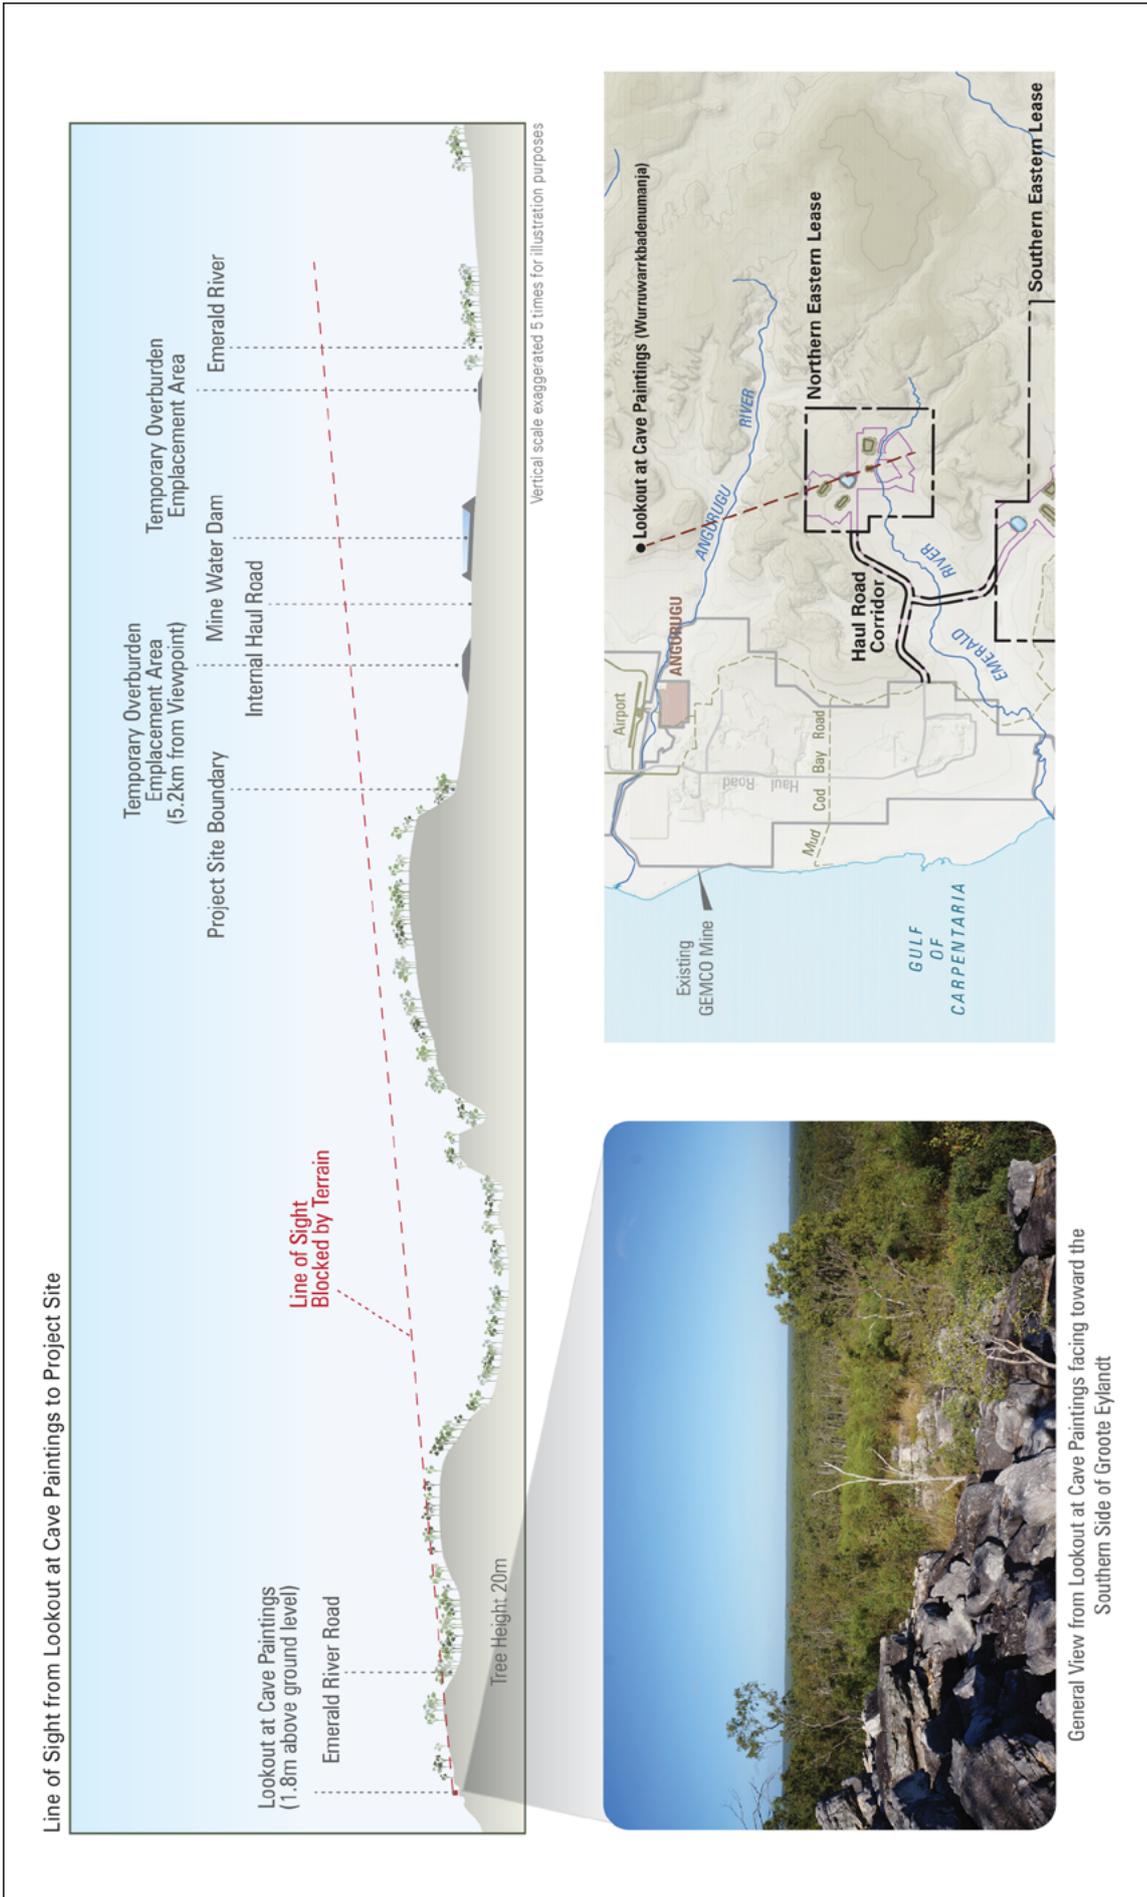
View from Lookout at Cave Paintings (Wurruwarrkbadenumanja) to the Project Site
