Overview of Groundwater and Surface Water Investigations – Town of Patagonia Flood and Flow Committee

May 13, 2021

Hermosa hydrogeological investigations

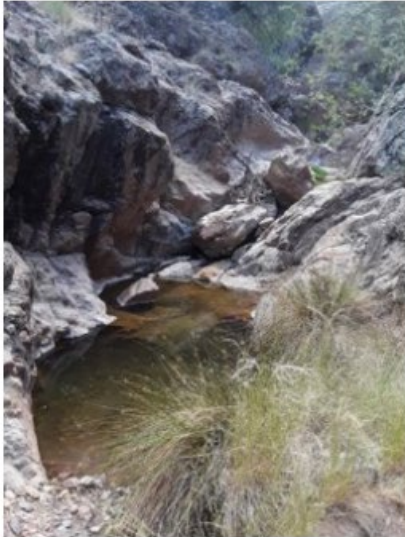
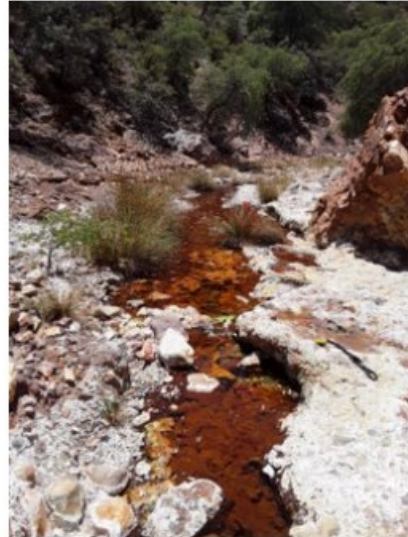
Spring and Seep Catalog

Hermosa Project Area

- Water quality results extended through June sampling in 2020
- Addition of 50 new sites within the Patagonia Mts.
- Site summary pages all include potential impacts to groundwater contributions at the spring/seep from early dewatering
- Site descriptions include date visited, measured flows (when flowing), pH, temperature, and conductance
- Vegetation and wildlife encountered are detailed for each site
- Photographs of wet and dry season conditions are provided for most sites

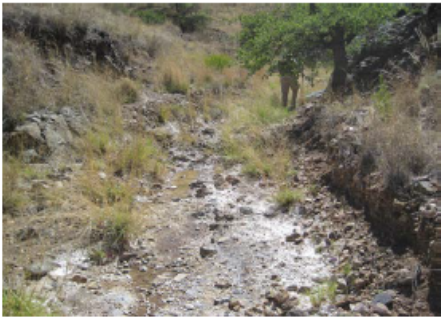
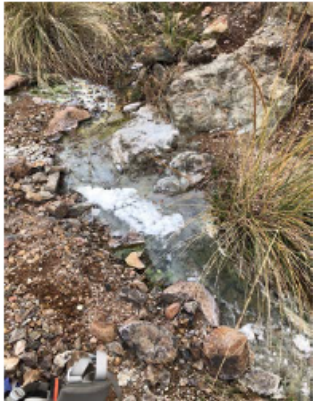
Springs and Seeps: Example Summary Sheet

Hermosa Project Spring and Seep Survey Sample Site Summary, Patagonia, Arizona

Site ID	F6-01		Interpretation of Groundwater Age: Mixed source of modern water and deep groundwater.						
Watershed	Flux Canyon		Potential Impacts/Effects: Flows observed at this site, during site visits, have ranged from immeasurable (<0.25 gpm) to 4.4 gpm. No changes are predicted at this site.						
Monitoring Period	11/2017 - 6/2020								
Number of Visits	6								
Flows and Field Parameters (pH, Temp, SC)									
Dry Season					Wet Season				
Date	Flow (gpm)	pH (s.u.)	Temp (C)	SC (µS/cm)	Date	Flow (gpm)	pH (s.u.)	Temp (C)	SC (µS/cm)
5/30/2018	0.00	6.48	26.6	2848	11/9/2017	0.12	6.33	13.1	2717
5/27/2019	1.10	6.59	20.2	2535	11/29/2018	<0.25	6.70	9.7	1122
6/10/2020	0.12	6.72	31.1	2610	12/7/2019	4.41	5.75	13.4	918
Water Quality Exceedances									
Dry Season					Wet Season				
Date	Parameter				Date	Parameter			
					11/9/2017	Lead, zinc, pH			
5/30/2018	Lead, zinc, pH				11/29/2018	Lead, cadmium, zinc

5/27/2019	Lead, cadmium, zinc				12/7/2019	Lead, Cadmium, copper, zinc, pH			
6/10/2020	Lead, cadmium, zinc								
<p>Aquatic and Vegetation Survey Findings: This site is located in rocky and cobbly section of Flux Canyon with exposed bedrock. Generally, water is present in shallow pools. Bullgrass (<i>Muhlenbergia emersleyi</i>) and riparian obligate rushes (<i>Juncus</i> spp.) are dominate perimeter vegetation along the drainage bottom. Hopbush (<i>Dodonaea viscosa</i>) and Texas bluestem (<i>Schizachyrium cirratum</i>) occur on the adjacent hillsides. Although there is no overstory canopy at the site, overstory trees along the drainage are dominated by Emory oak (<i>Quercus emoryi</i>). Non-native annual rabbitsfoot grass (<i>Polypogon monspeliensis</i>) and invasive plants, Lehmann lovegrass (<i>Eragrostis lehmanniana</i>) and Johnson grass (<i>Sorghum halepense</i>), have been observed. Aquatic invertebrates previously noted within the Flux Canyon drainage including beetles, boatmen, backswimmers, dragonflies, and damselflies. No aquatic vertebrates have been observed.</p>

Dry Season Photo (5/30/2018)					Wet Season Photo (11/29/2018)

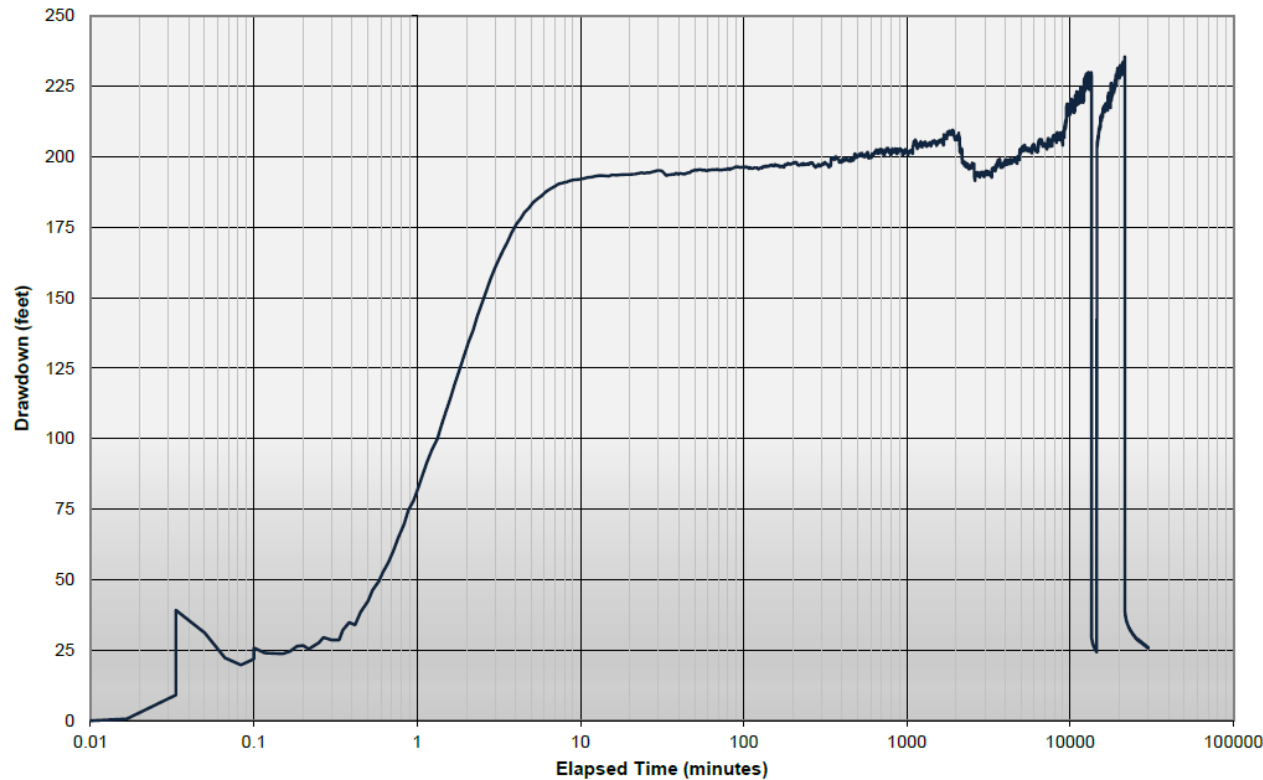
Pumping Well WW-1

Aquifer testing at Hermosa (examples)

- A total of 11 different aquifer tests have been conducted on various wells at Hermosa conducted from 2017 through 2019
- Aquifer testing has been used to understand the range in permeability of the differing geologic materials (volcanic and sedimentary aquifer units)
- Some tests lasted only a few hours with less than 1 gpm
- The largest of the aquifer tests was at well WW-1, extending for approximately 15 days at 1,950 gpm

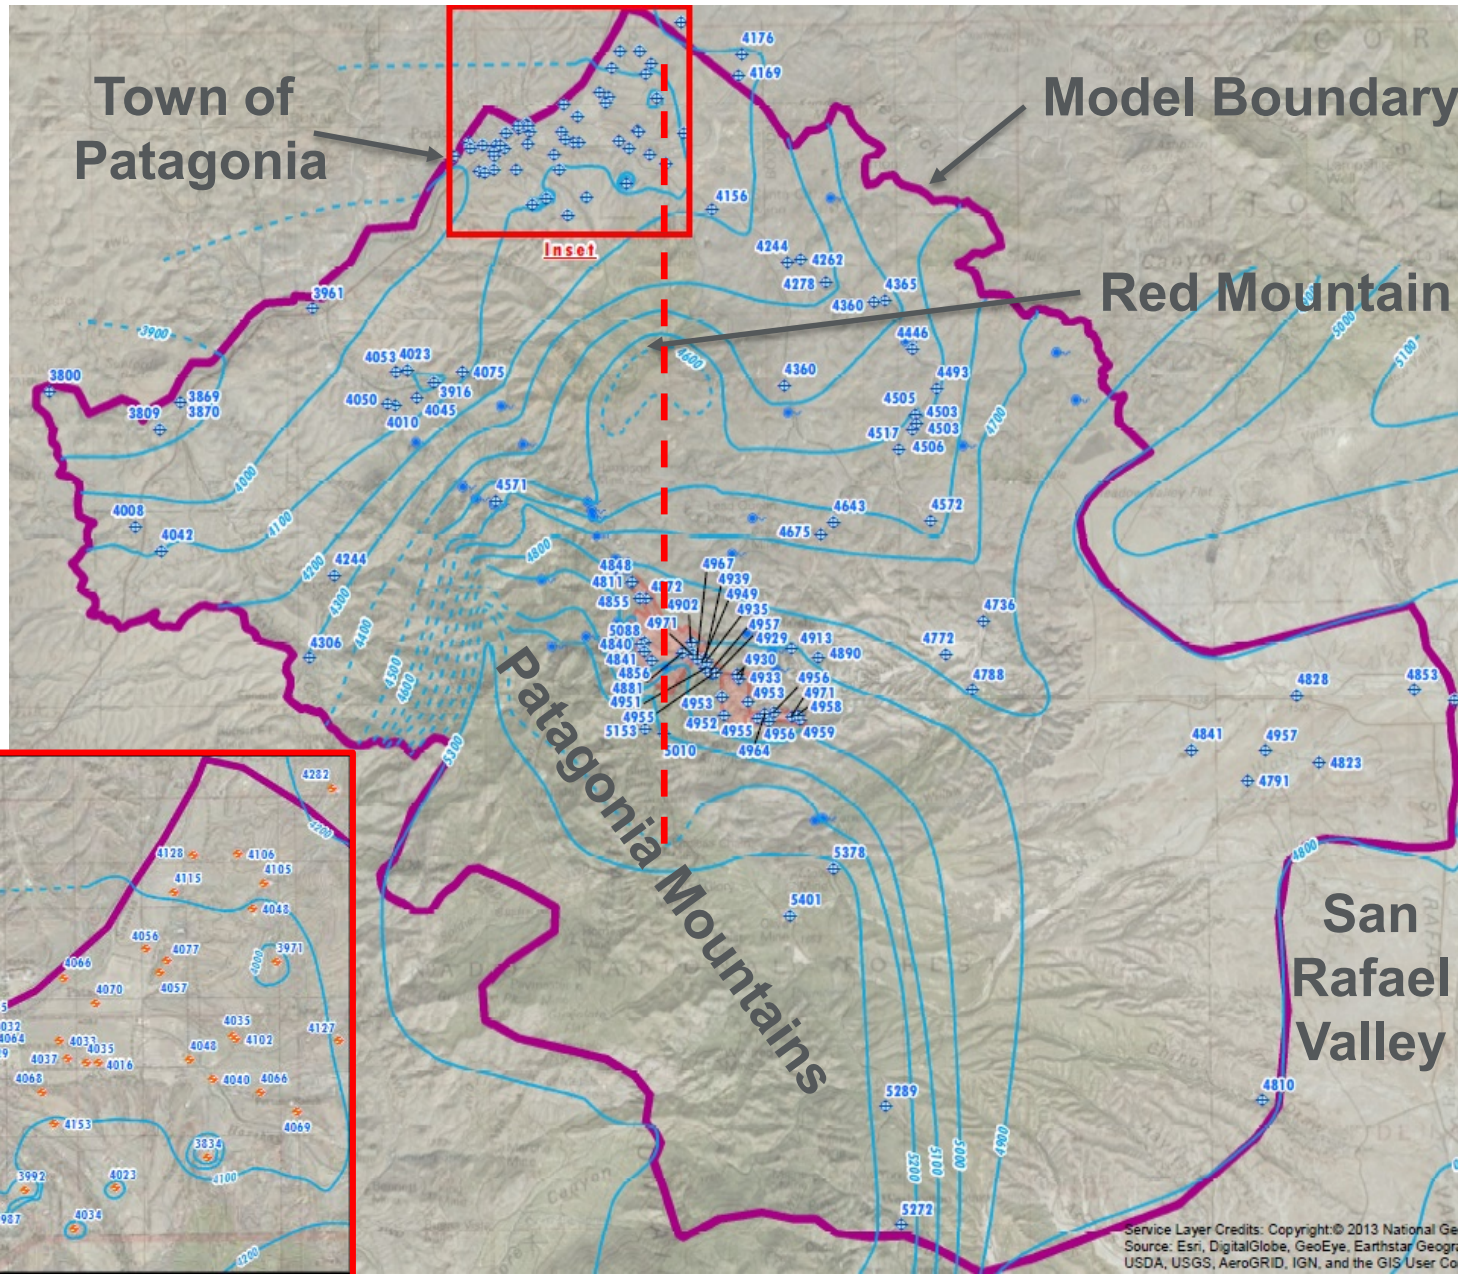
Groundwater measurements and model boundaries

- Measured water levels indicate flow from Patagonia Mts. toward Sonoita Creek
- Groundwater is recharged at high elevations and moves towards the surrounding valleys.
- In some locations, springs have provided some guidance for groundwater elevations
- Opportunities to expand our understanding of hydrogeology south of Hermosa property

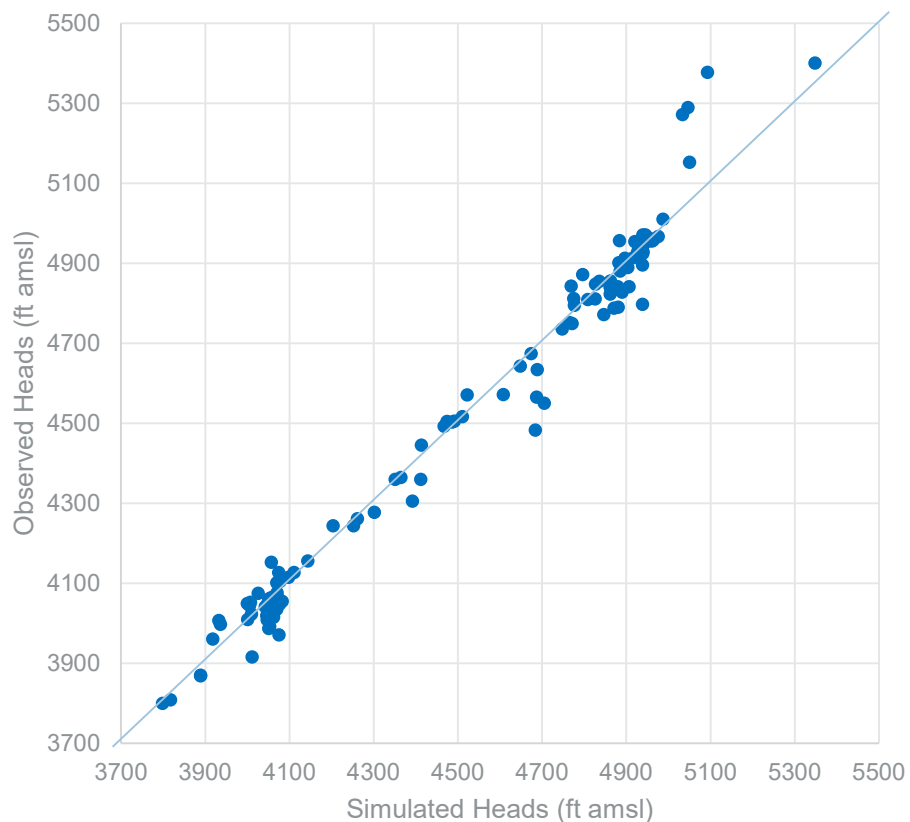
Steady State Calibration

Numerical groundwater model calibration

Residual Mean	0.235
Absolute Residual Mean	19.30
Residual Std. Deviation	29.68
Sum of Squares	130400
RMS Error	29.68
Number of Observations	148
Range in Observations	1601
Scaled Residual Std. Deviation	0.019
Scaled Absolute Residual Mean	0.012
Scaled RMS Error	0.019
Scaled Residual Mean	0.00015
