Appin Area 9

Appin Area 9 Longwalls 901 to 904 Extraction Plan
Annex E – Land Management Plan, 31 October 2013

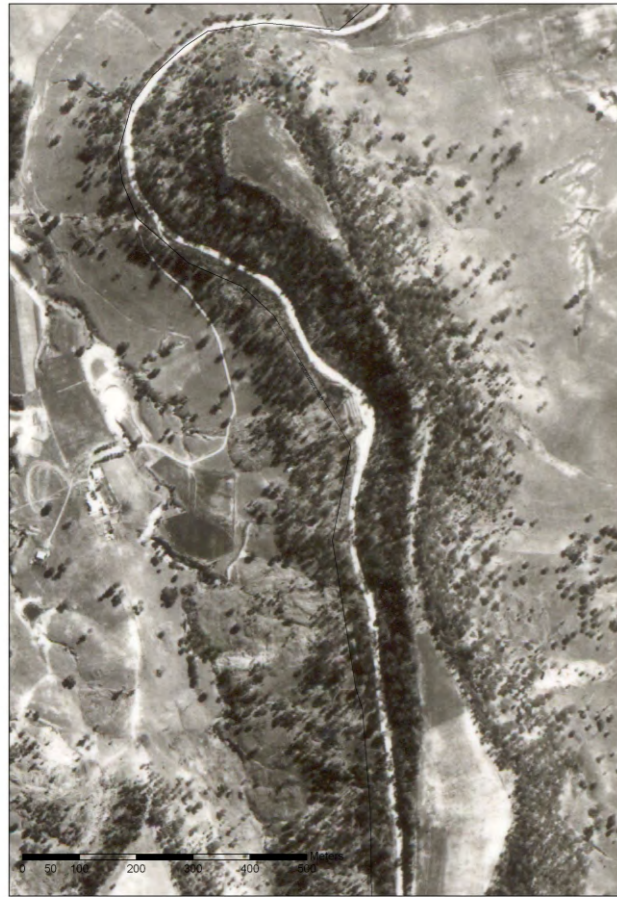
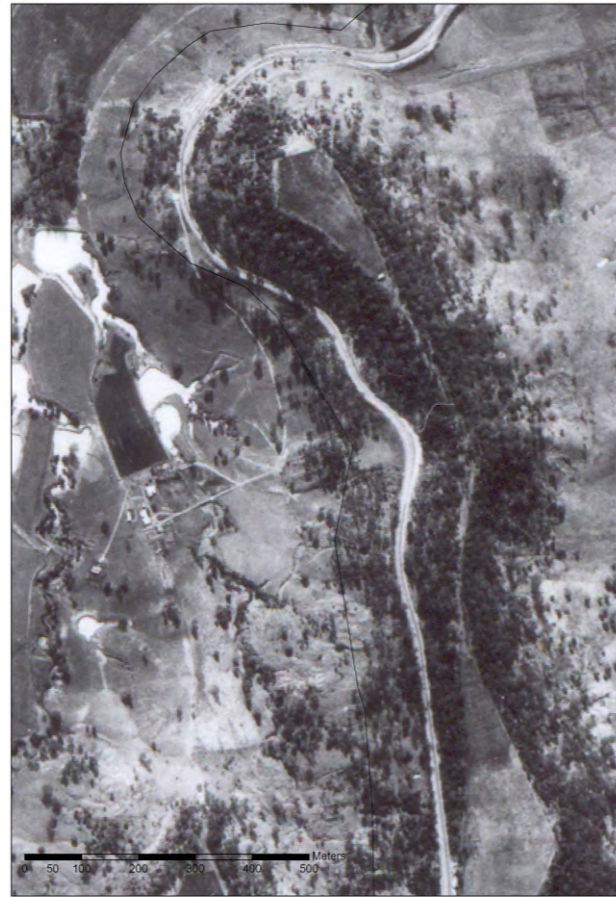
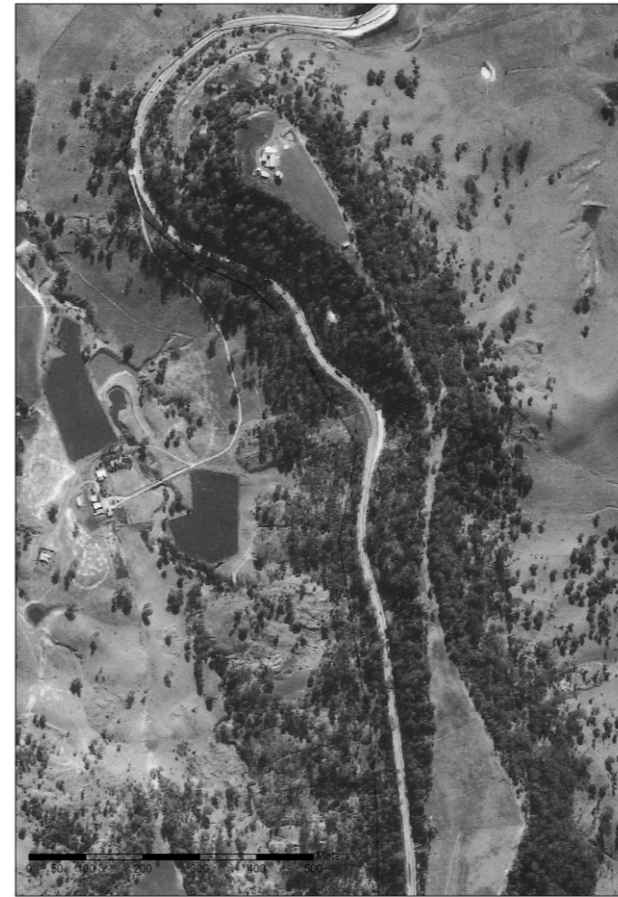
Example of change in landslide morphology, 1966 - 2008
Remembrance Drive, Razorback

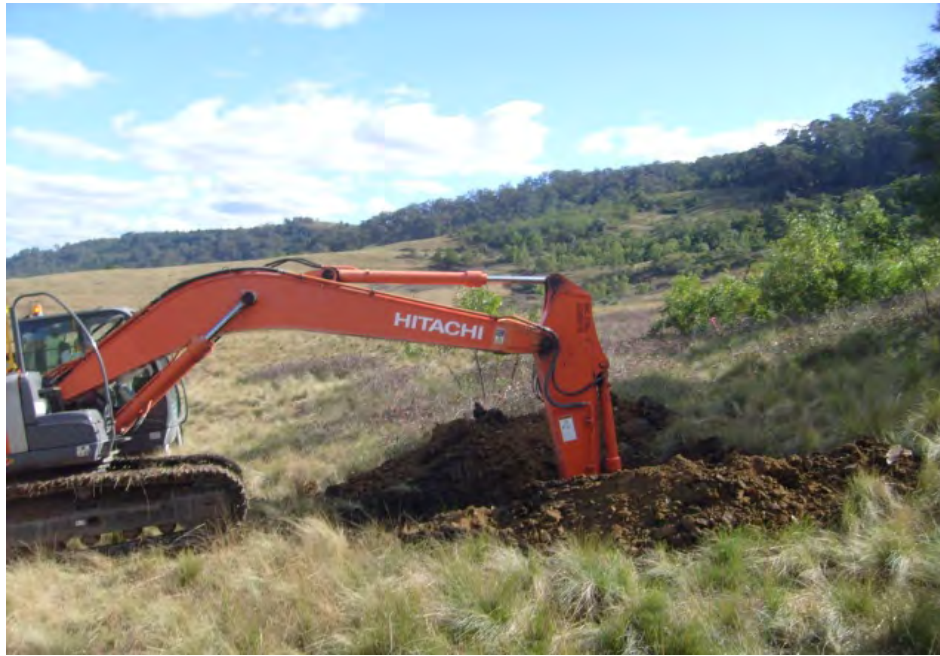
Deep Test Pit In Colluvium Soils Near Toe Of Landslide

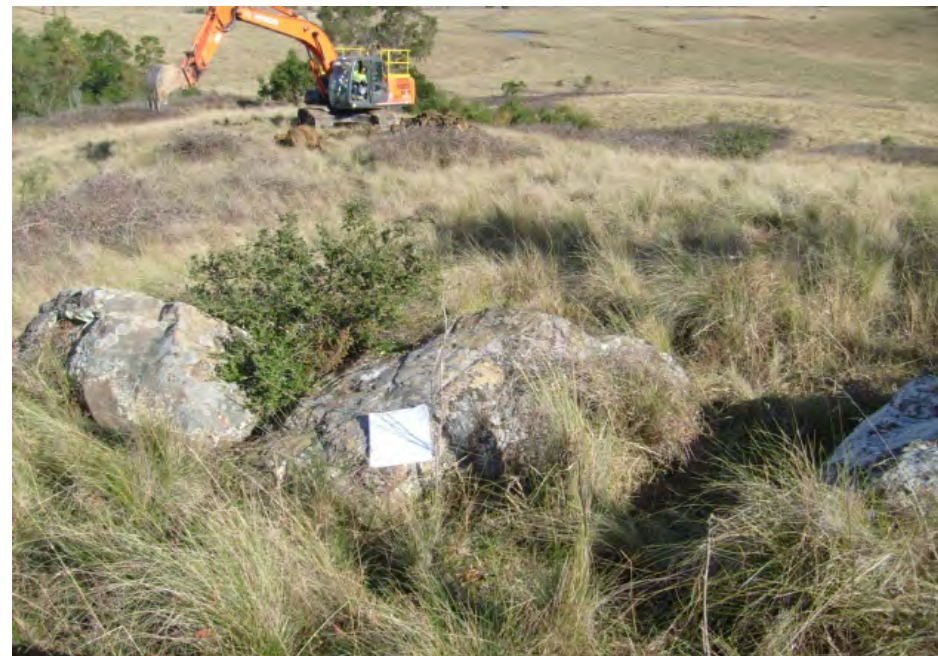
Large Boulders on Surface Part of Colluvium on Lower Part of Landslide

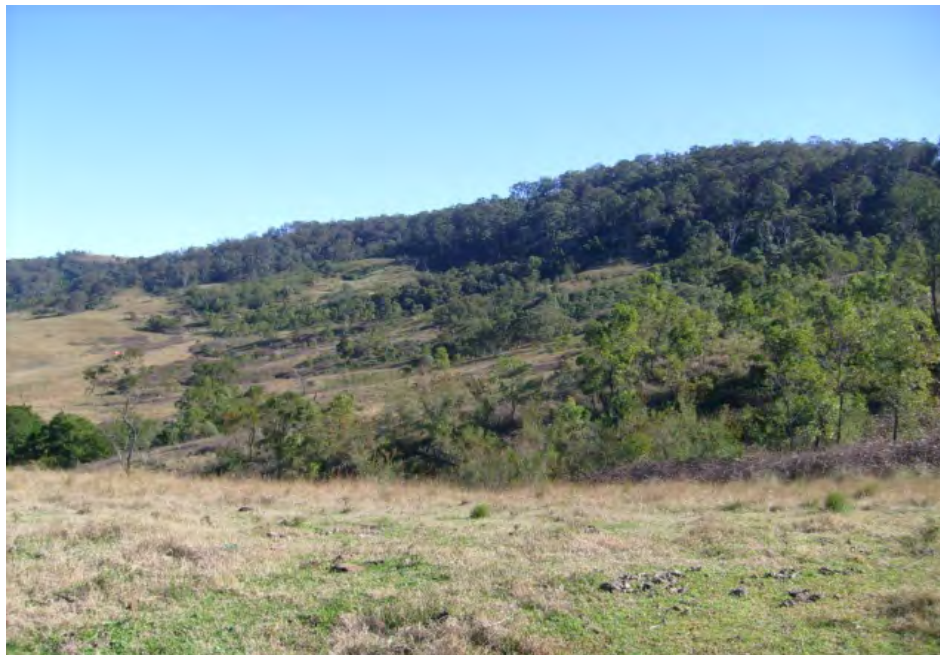
View to Southwest Looking Across Numerous Landslides on Slopes Below Tree Covered Escarpment

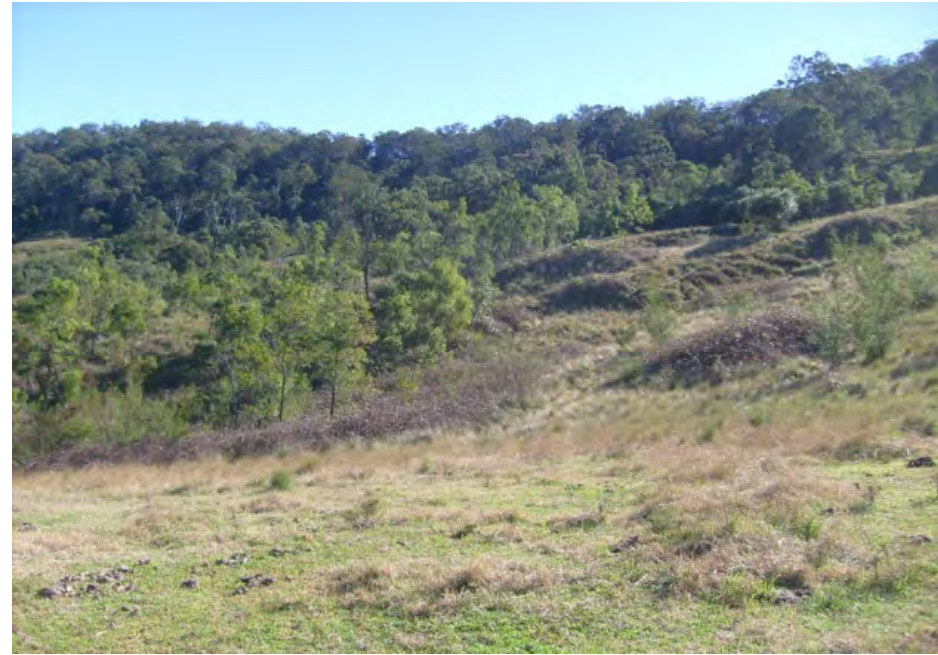
Note Landslide Lobes on Hillside

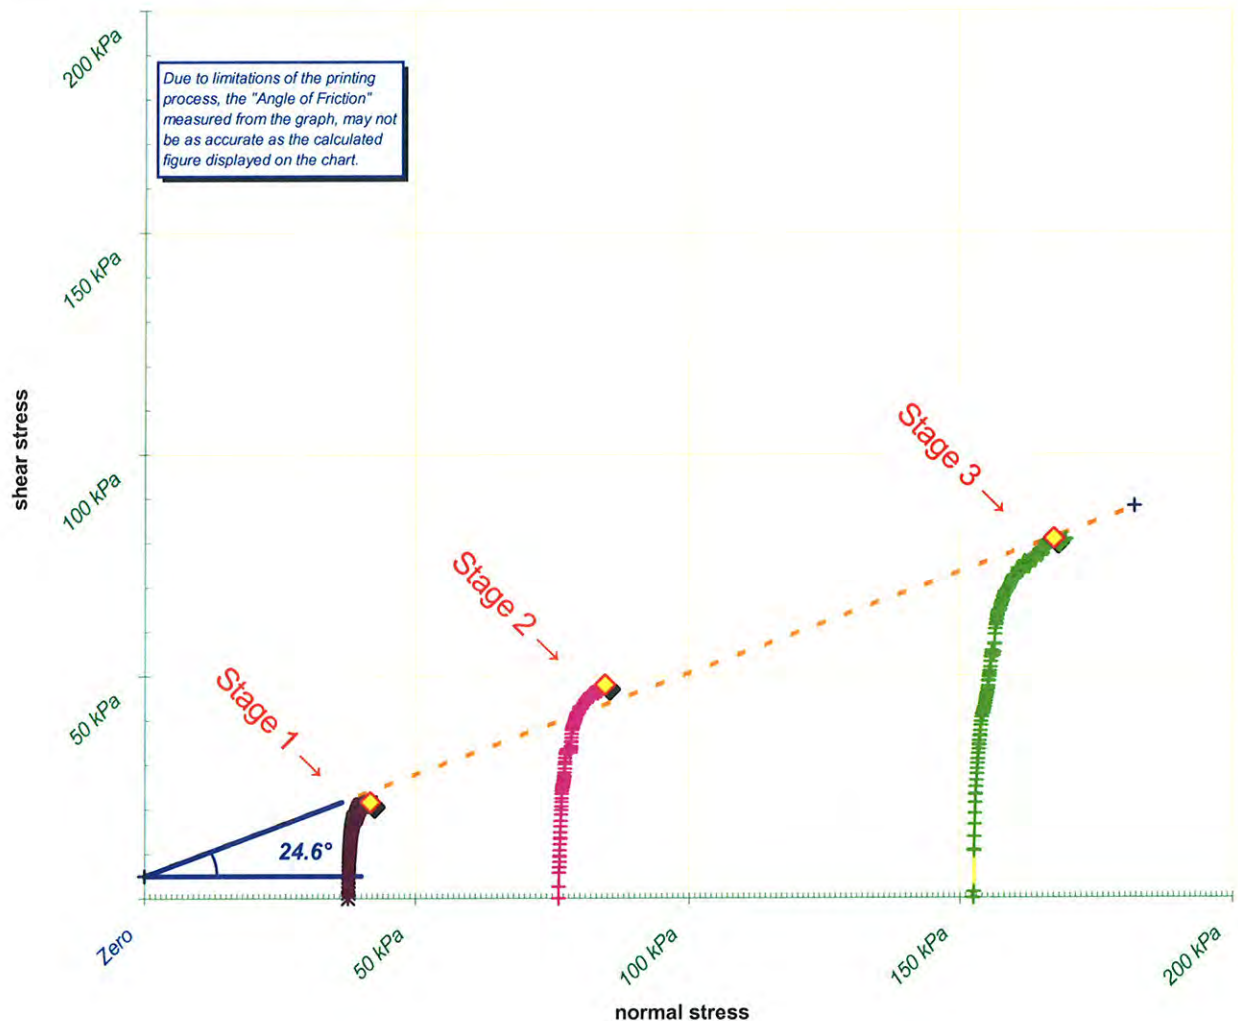
test procedure: **AS 1289.6.2.2** test date: **17th to 19th August, 2010**
test type: **Peak shear Stress**

laboratory sample no: GLEN10S - 05852	borehole no: CTP05
client Sample Number CTP05 3.5 to 3.7m	Depth: 3.50 to 3.70m
material classification: -6.7mm Material Tested

shear rate: 0.005 mm/min	cohesion: 5.0 kPa
Average Dry Density: 1.72t/m³	angle of friction: 24.6°
Average Moisture Content: 15.2%	
type of test: Saturated Consolidated Drained	
note: 1. 3 X Single Individual Recompacted Specimens. 2. Box Dimensions (mm):- 70.75 x 70.90 x 44.5

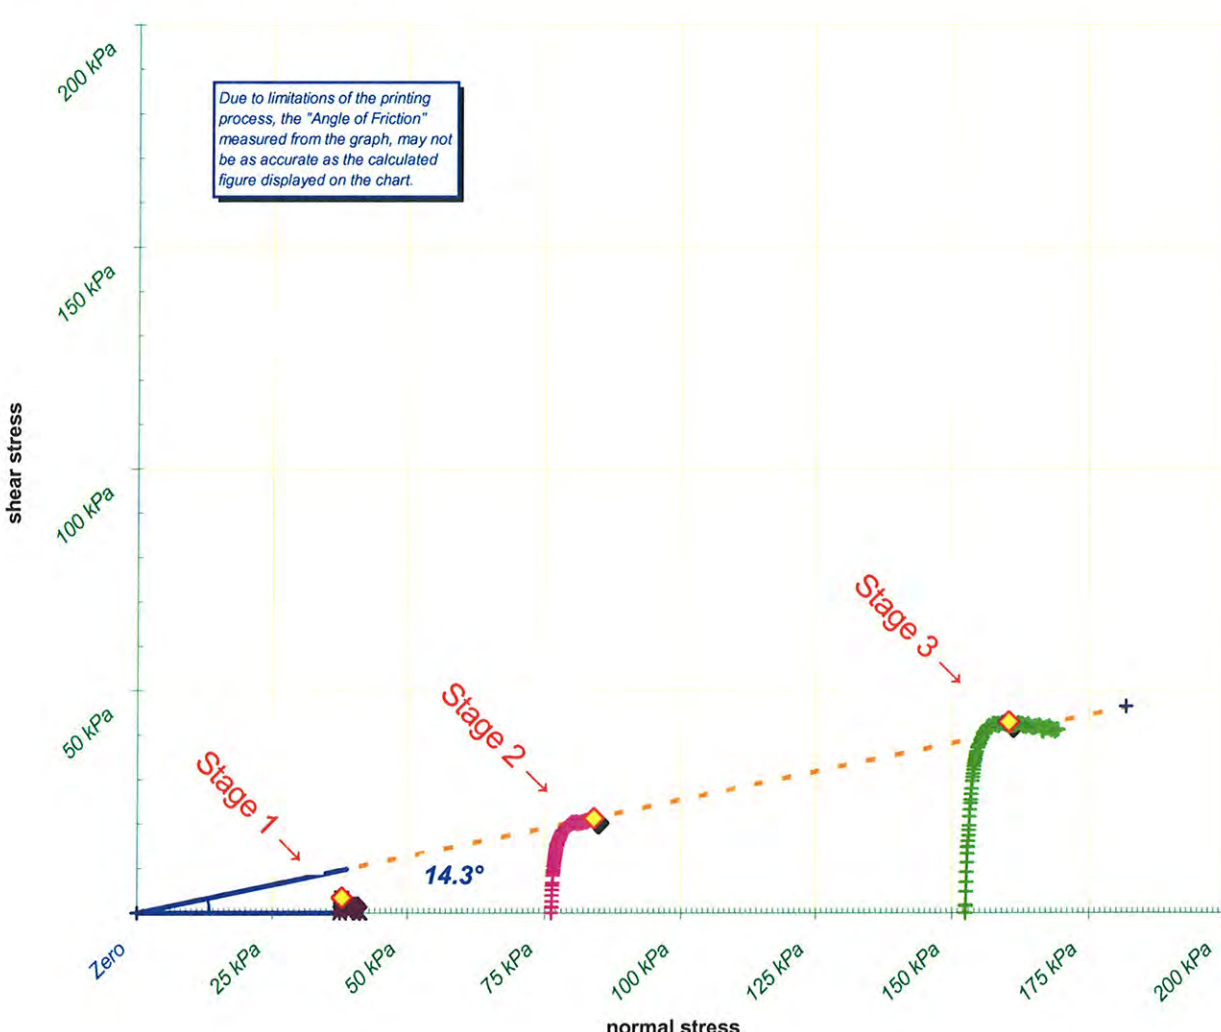
direct shear test

client: COFFEY GEOTECHNICS PTY LTD (GEOTWOLL02834AA) principal: CARDNO FORBES RIGBY project: LANDSLIDE RISK ASSESSMENT location: LOT 1 DP553170 - RAZORBACK RIDGE	job no : INFOGLEN576AA laboratory : Lane Cove West report date : 25 Aug 2010 test report : IOLT4099
test procedure: AS 1289.6.2.2 test type: Peak shear Stress	
laboratory sample no: GLEN10S - 05854 borehole no : CTP11A cleint Sample Number CTP11A 1.30 to 1.60m Depth: 1.30 to 1.60m material classification: -6.7mm Material Tested

shear rate: 0.005 mm/min	cohesion: 0.0 kPa
Average Dry Density: 1.74t/m³	angle of friction: 14.3°
Average Moisture Content: 14.8%	
type of test: Saturated Consolidated Drained	
note: 1. 3 X Single Individual Recompact Specimens. 2. Box Dimensions (mm):- 70.75 x 70.90 x 44.5

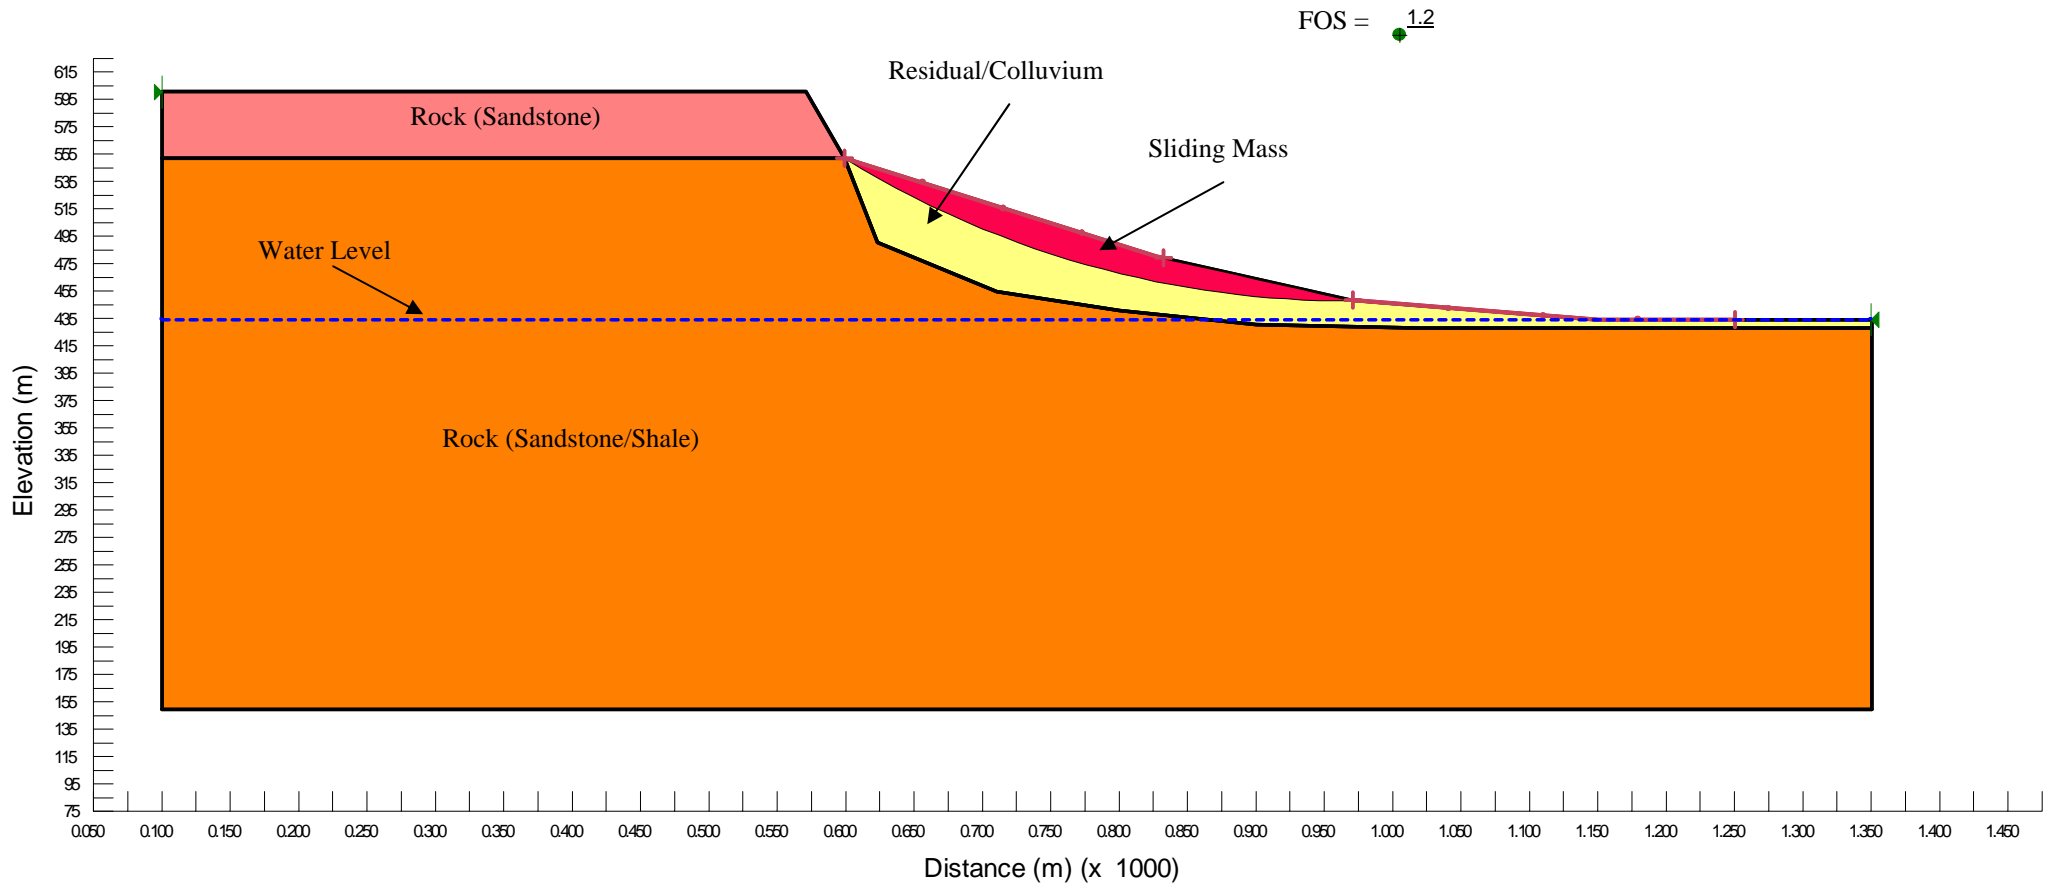
client:	CARD0 (NSW) PTY LTD	
project:	LANDSLIDE RISK ASSESSMENT FROM MINE SUBSIDENCE EFFECTS Appin Area 9 Proposed Longwalls, Douglas Park NSW	
title:	Case 1: Natural Slope with water Table at Toe of Slope	
project no:	GEOTWOLL02834AA-AG	figure no: FIGURE 1
