ANNEX E LAND MANAGEMENT PLAN

WEST CLIFF AREA 5 LONGWALLS 37 AND 38 EXTRACTION PLAN

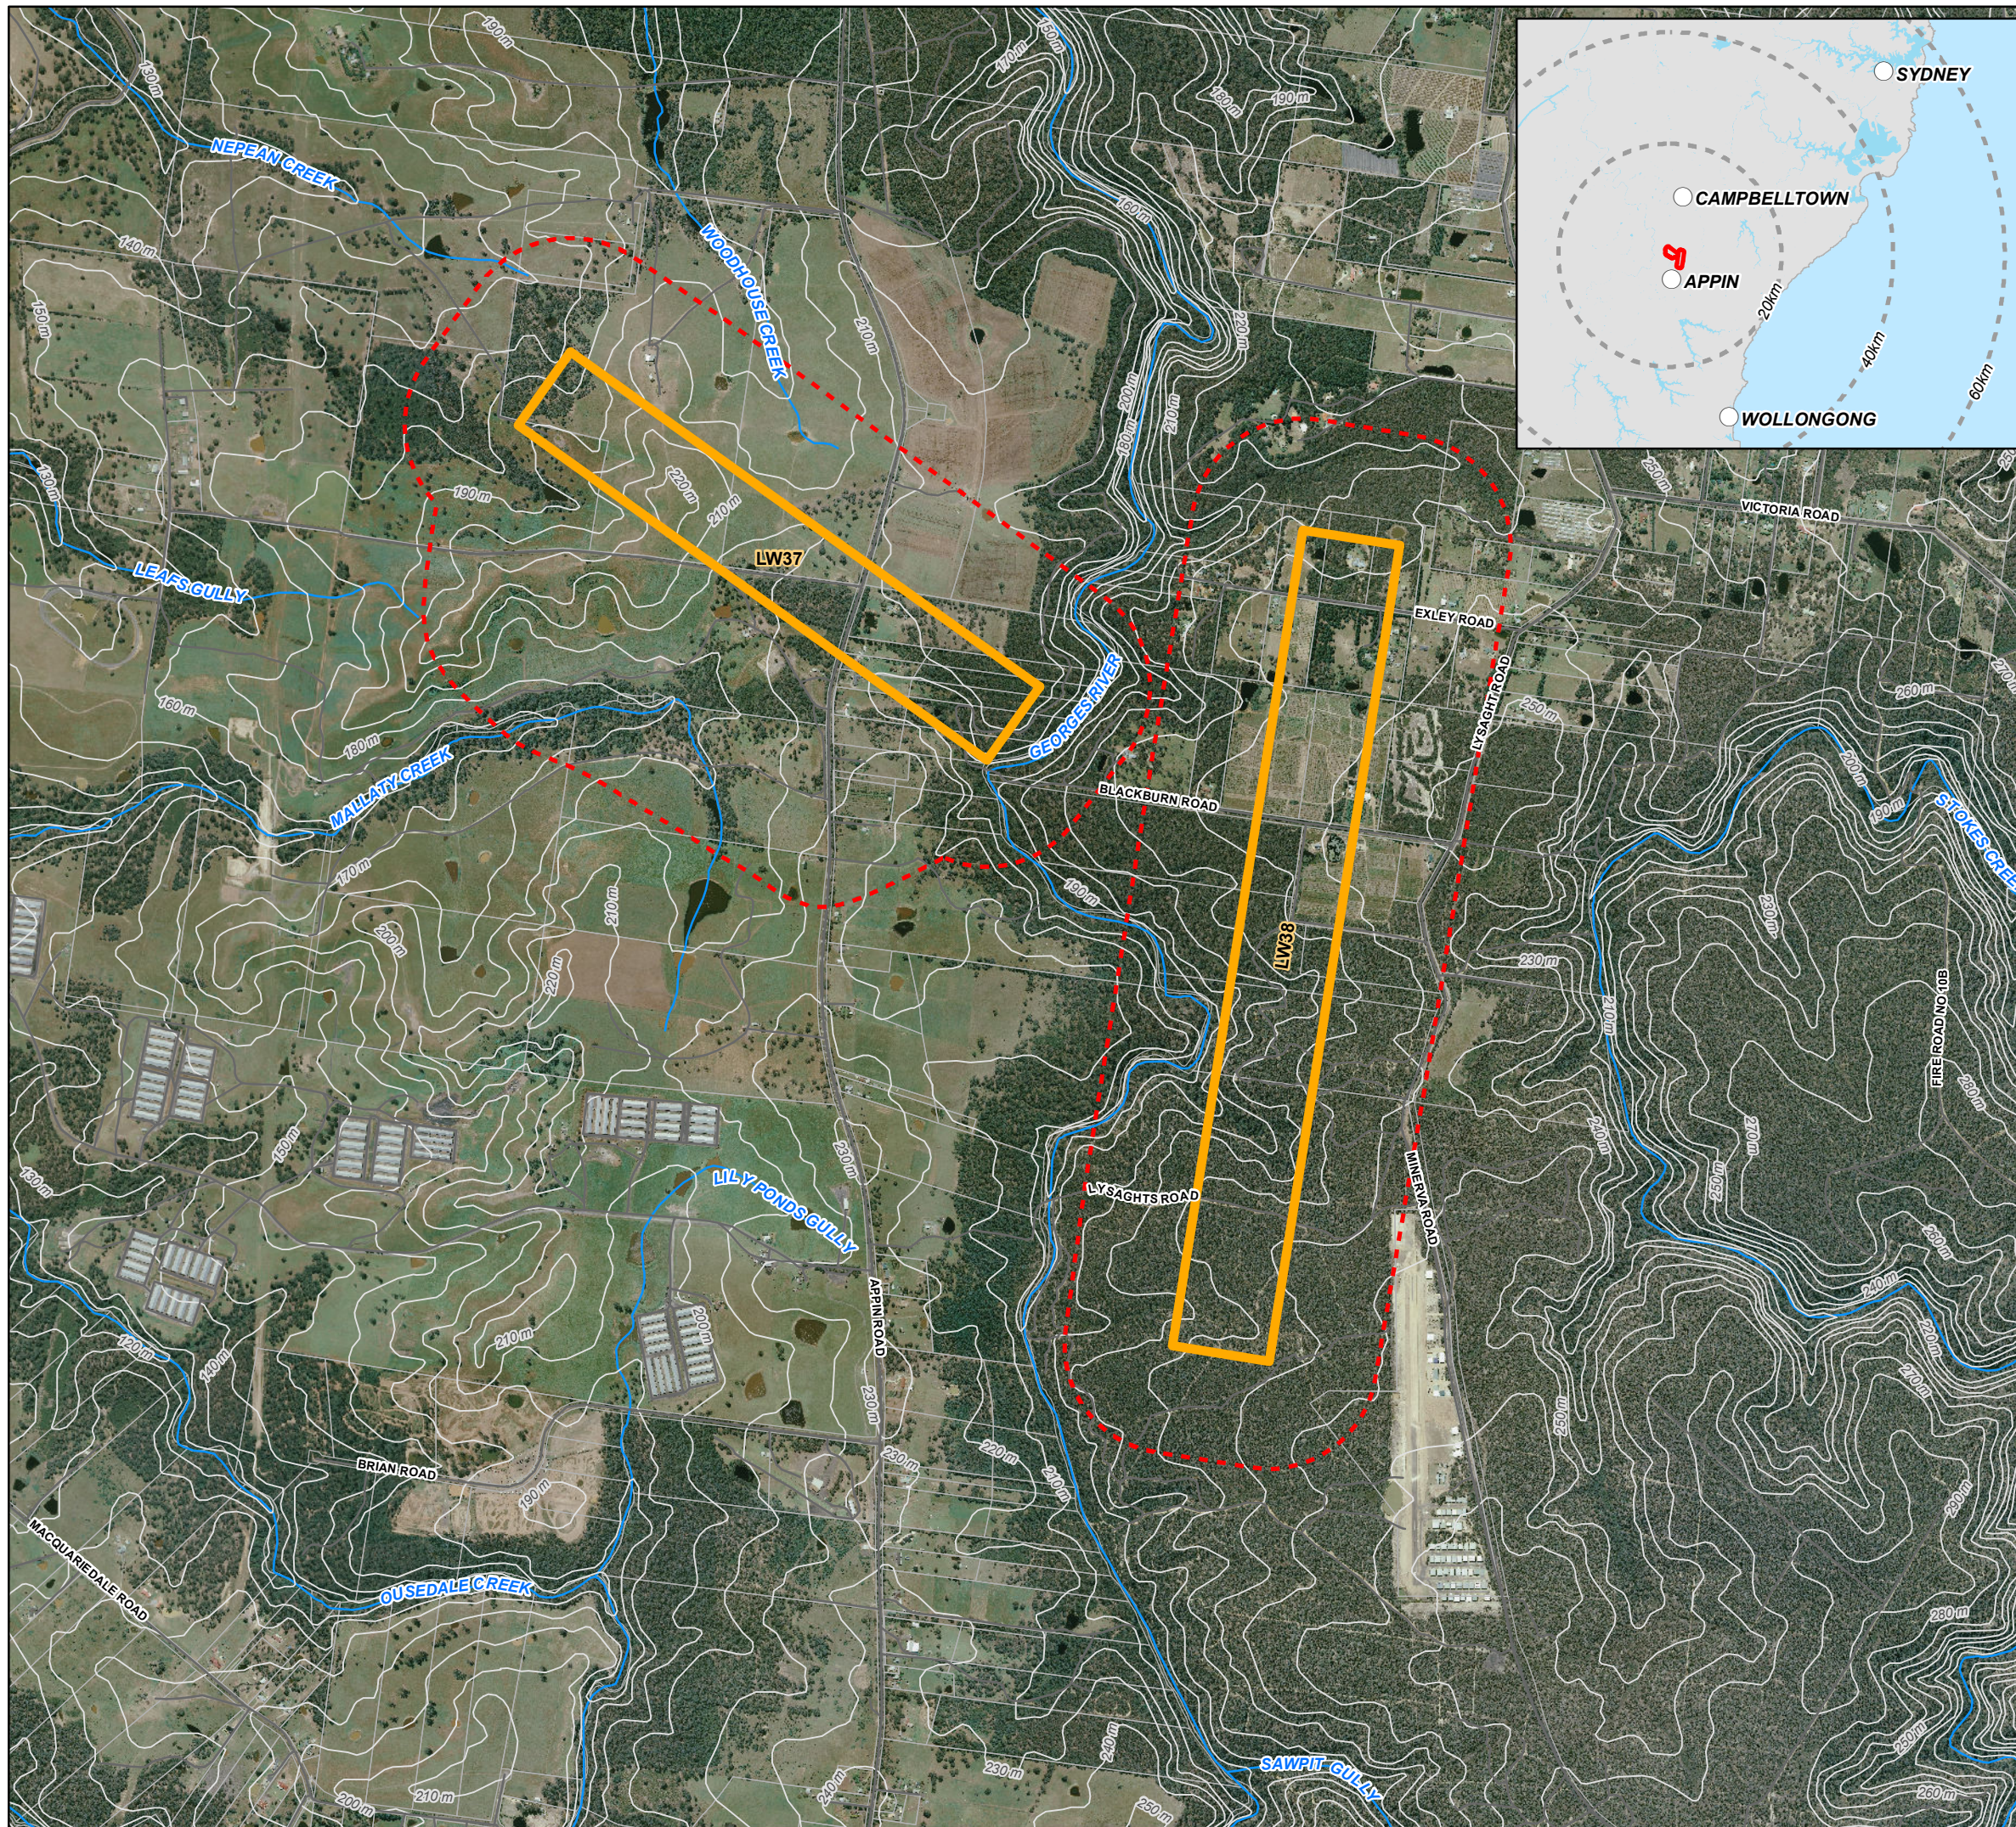
West Cliff Area 5 Study Areas (LW37 and 38)

Two separate Study Areas have been defined, one for each of the longwalls. The Longwall 37 Study Area is located primarily to the west of the Georges River, with the Longwall 38 Study Area primarily to the east of the Georges River. The Study Area locations are illustrated by **Figure 1** (MSEC, 2013). It is noted that while the Study Areas do traverse the Georges River, neither of the proposed longwalls would result in mining under the River.

Figure 1 – West Cliff Longwalls 37 to 38 Study Area.....	3
Figure 2 – Cliff, Steep Slopes and Rock outcrop locations	8

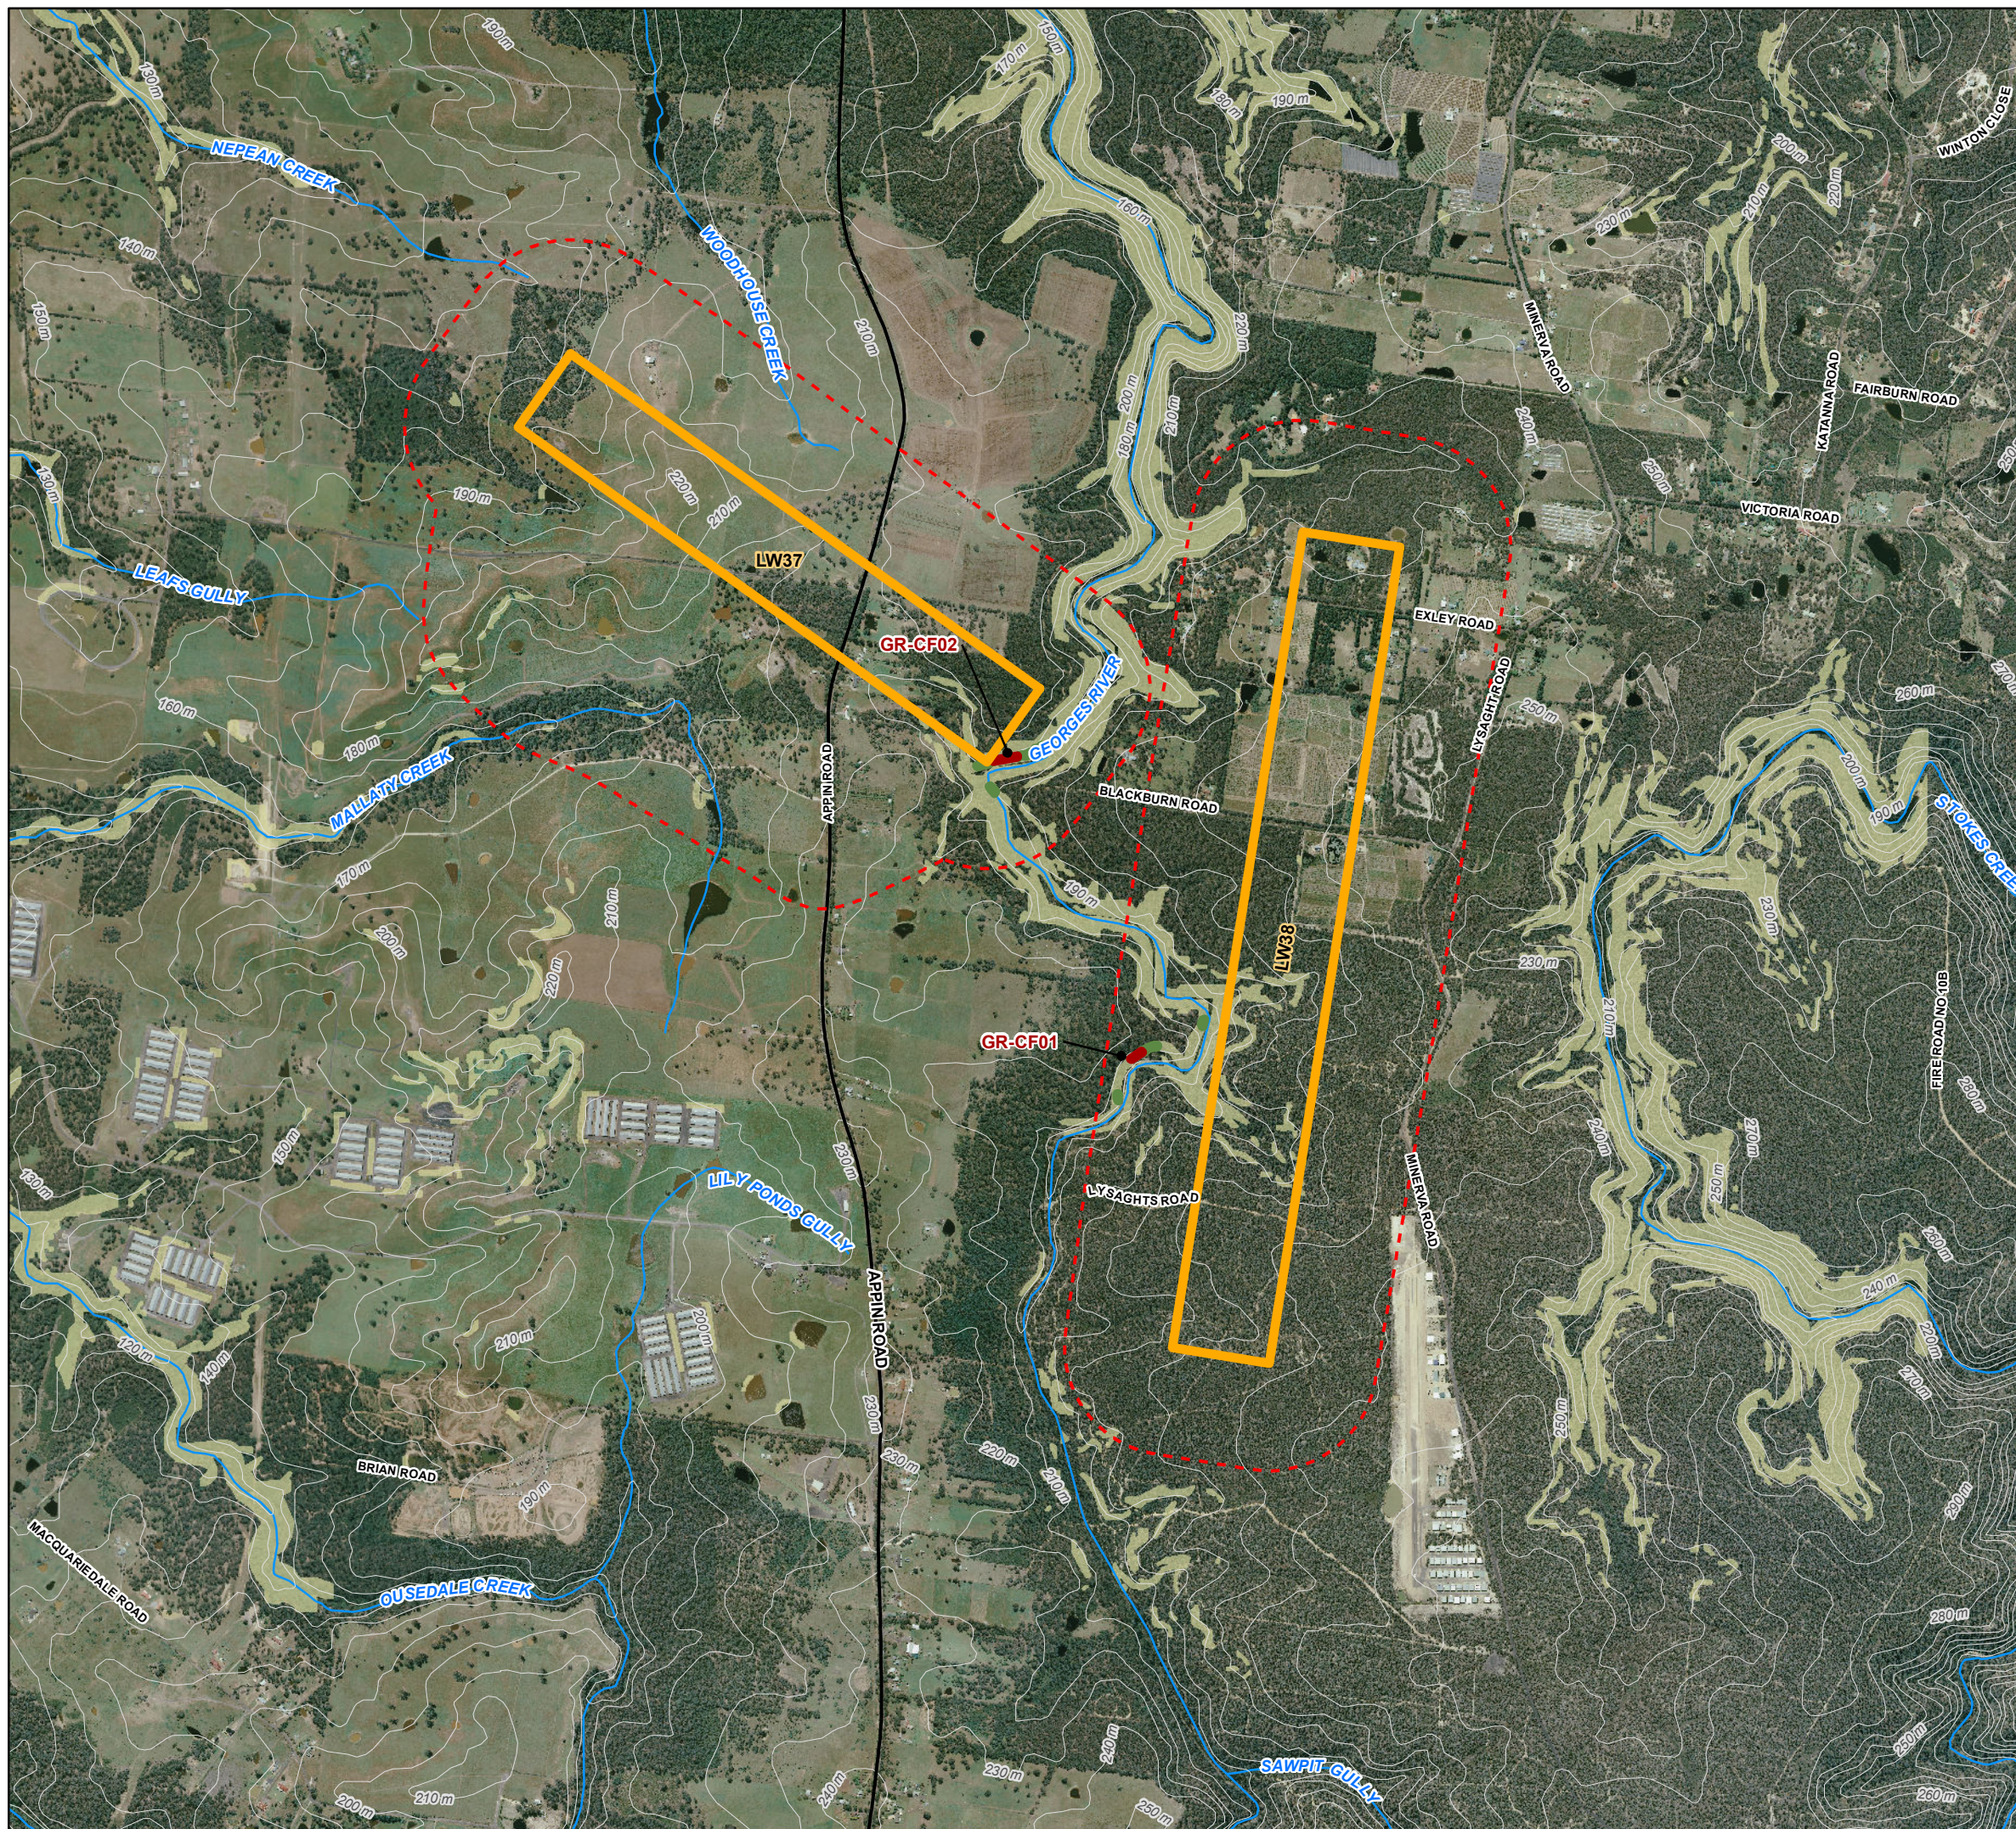
Map Produced by Cardno NSWACT Pty Ltd (WOL)
 Date: 14/03/2013
 Coordinate System: GDA 1994 MGA Zone 56
 Project: 112054-01
 Map: G1006_CliffsSteepSlopes.mxd 01
 Aerial imagery supplied by BHPBIC (2007 and 2009)

Specific focus will be on cliffs and steep slopes including cliffs of 'special significance' (i.e. longer than 200 m and/or higher than 40 m and cliff like rock faces higher than 5 m that constitute waterfalls, as defined by BSO approval *Condition 1, Schedule 3*), and other cliffs flanking the Georges River and associated tributaries, as shown in **Figure 2** and the drawing in MSEC (2013), Drawing No. MSEC533-10.
