Illawarra Coal

End of Panel Report

Appin Area 7

Longwall 707 End of Panel Report

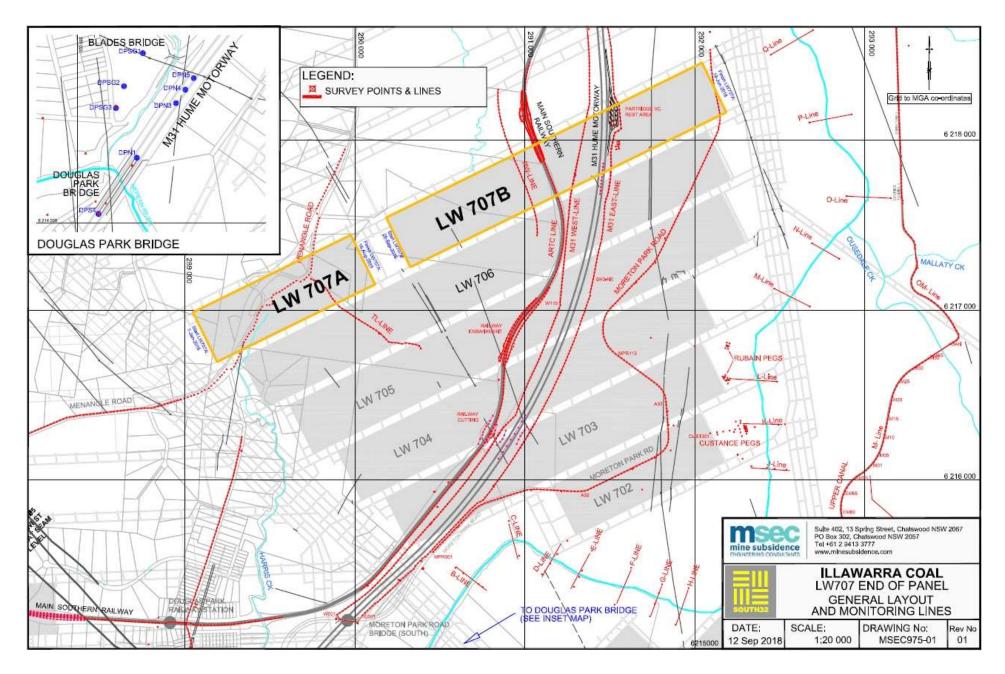
Figure 1: Longwall 707 Subsidence Monitoring Lines (MSEC975).

The locations of these monitoring lines and points are shown in Figure 1.

The built features located near Longwall 707A and Longwall 707B are shown in Figure 1. The features considered in this End of Panel report include those located within either the 35° angle of draw line from Longwall 707A and Longwall 707B and/or the predicted 20 mm incremental subsidence contour due to the extraction of these longwalls. The built features expected to experience far-field or valley related movements that could be sensitive to these movements have also been considered. The built features include:

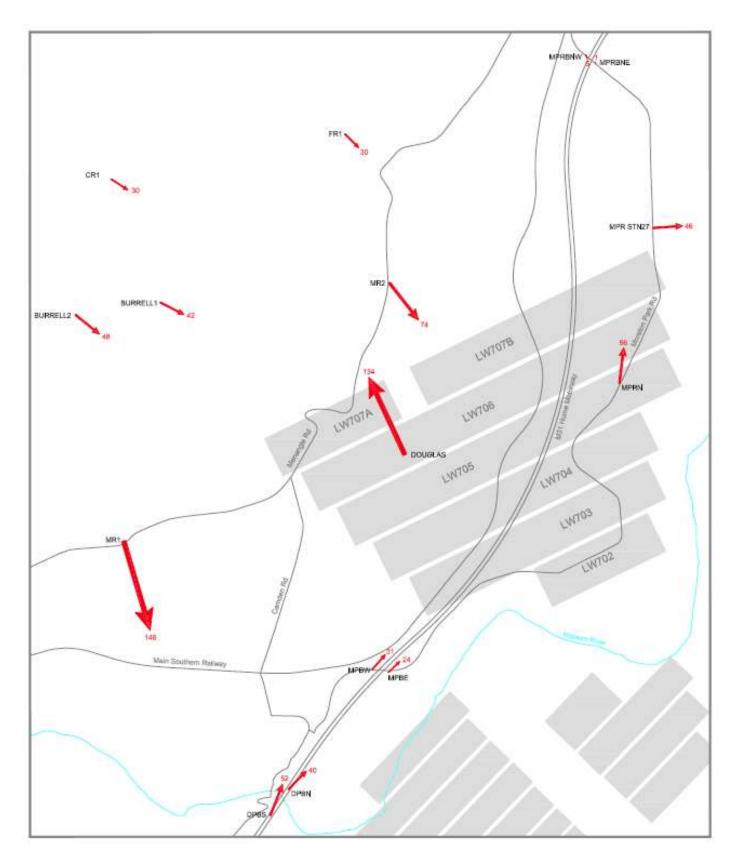
The far-field mine subsidence movements were measured by IC using a number of 3D marks in the vicinity of LW707A and LW707B.

Figure 2: Measured (mm) absolute incremental horizontal movements at the far-field 3D marks due to the extraction of LW707A and LW707B.

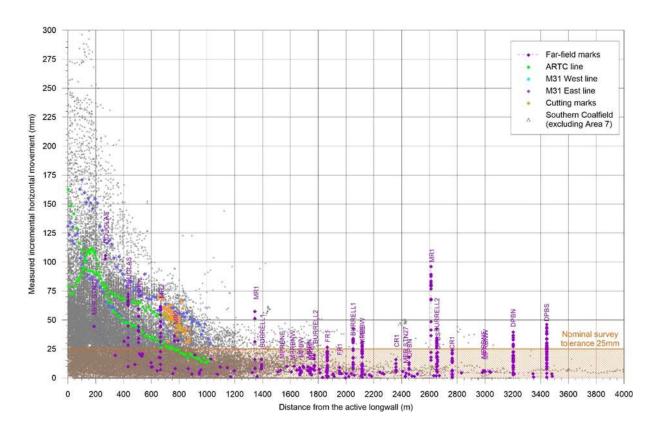
Figure 3: Measured incremental horizontal movements versus distance from the active longwall.

The measured incremental horizontal movements at the far-field 3D marks, due to the extraction of LW707A and LW707B, were typically within the range of those measured elsewhere in the Southern Coalfield at distances up to approximately 2000 m.

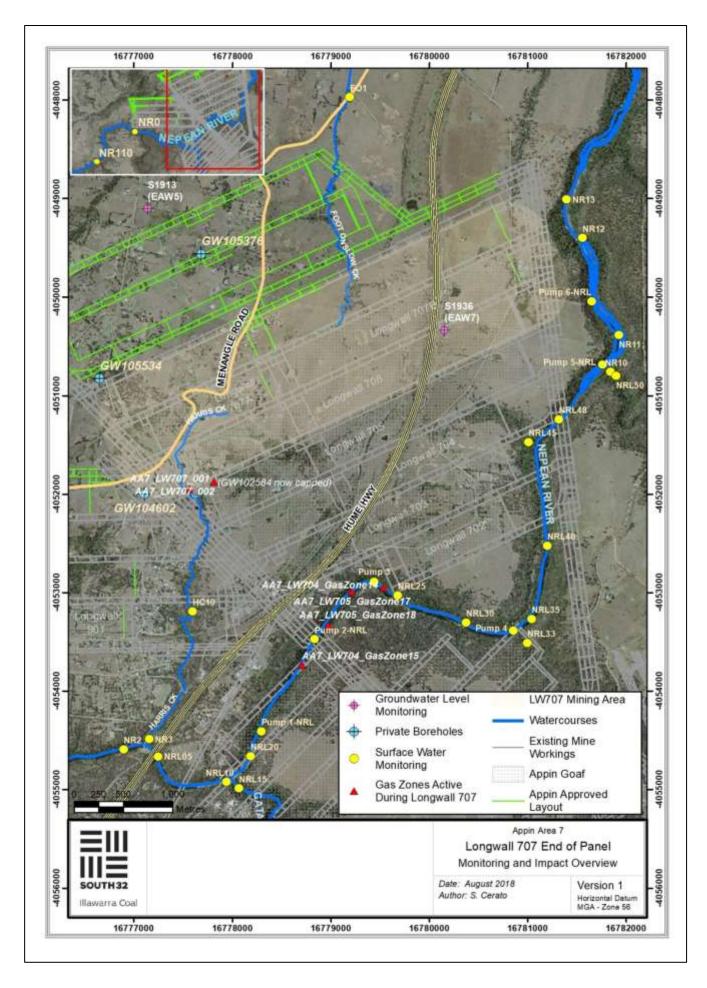
Figure 4: Natural features and monitoring sites within the AA7 study area.

Based on the monitoring conducted by the ICEFT and, supported by **Figure 4**, there have been no periods in the Nepean River where dry and / or flooded areas of riverbed were observed during the extraction of Longwall 707.

Fully cemented, sealed vibrating wire piezometer arrays were installed by IC in bores EAW5 (S1913) and EAW7 (S1936) (Figure 4).

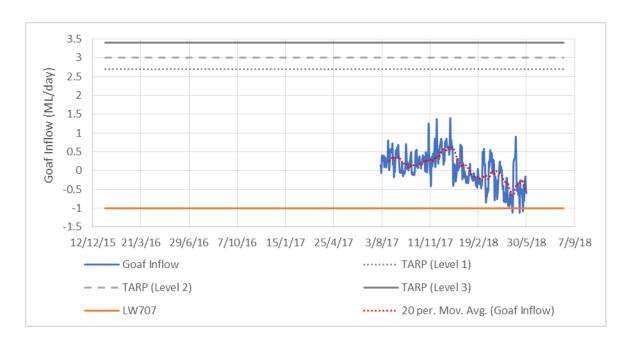
Figure 5: Daily goaf inflow for AA7, which is determined by subtracting the estimated water supply volume (to AA7) from the total volume of water pumped to storage.

Daily mine groundwater inflow data for the Area 7 workings was available between 31 July 2017 and 30 May 2018. During the extraction of Longwall 707, with the available data, the estimated mine water balance did not reach or exceed any TARP trigger levels (Figure 5).
