Illawarra Coal

Bulli Seam Operations

# **ANNUAL ENVIRONMENTAL MANAGEMENT REPORT FY15**

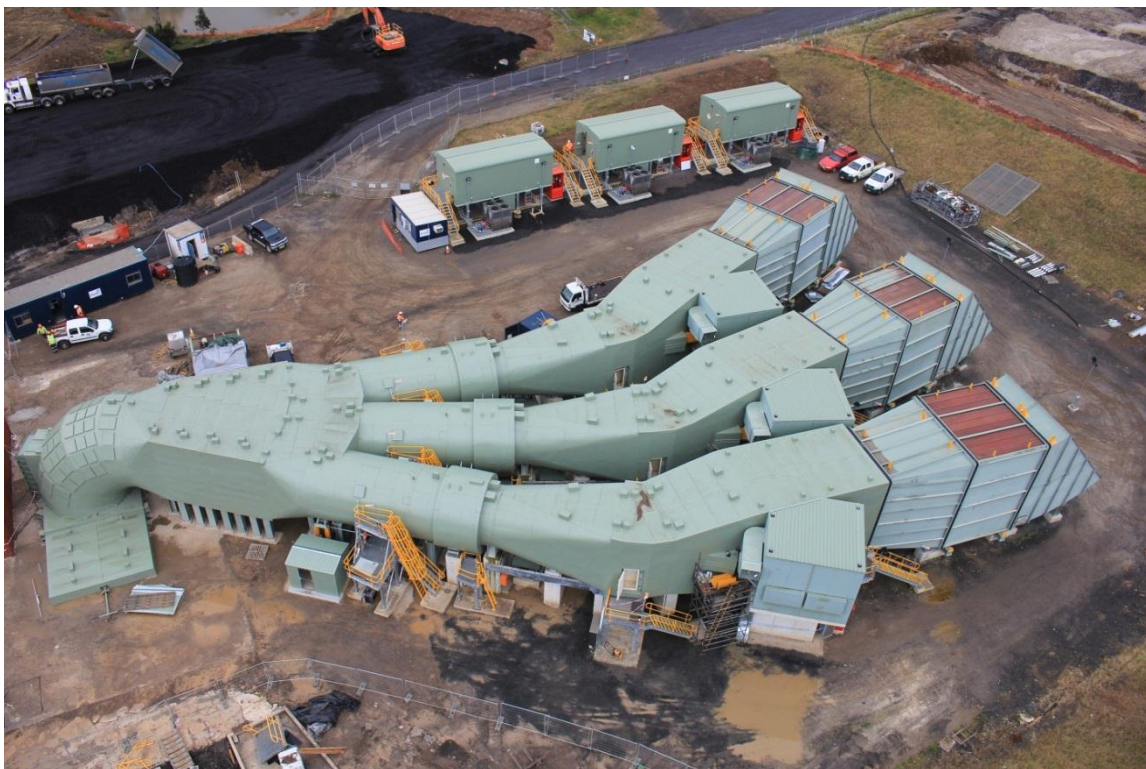
Figure 1: An elevated view of the VS#6 precinct during commissioning. Three fan housings (centre) and ducting connecting to the vent shaft (left).

As of June 2015 the majority of the surface infrastructure construction for vent shaft No.6 has been completed, all surface buildings are in place in preparation for the commissioning of the vent shaft. The primary construction item yet to be completed is the earthen noise barrier. This landform is being constructed using coal washery rejects and is expected to be completed in the first half of FY16. Commissioning of the fans occurred in August 2015 and will be reported in the FY16 AEMR.

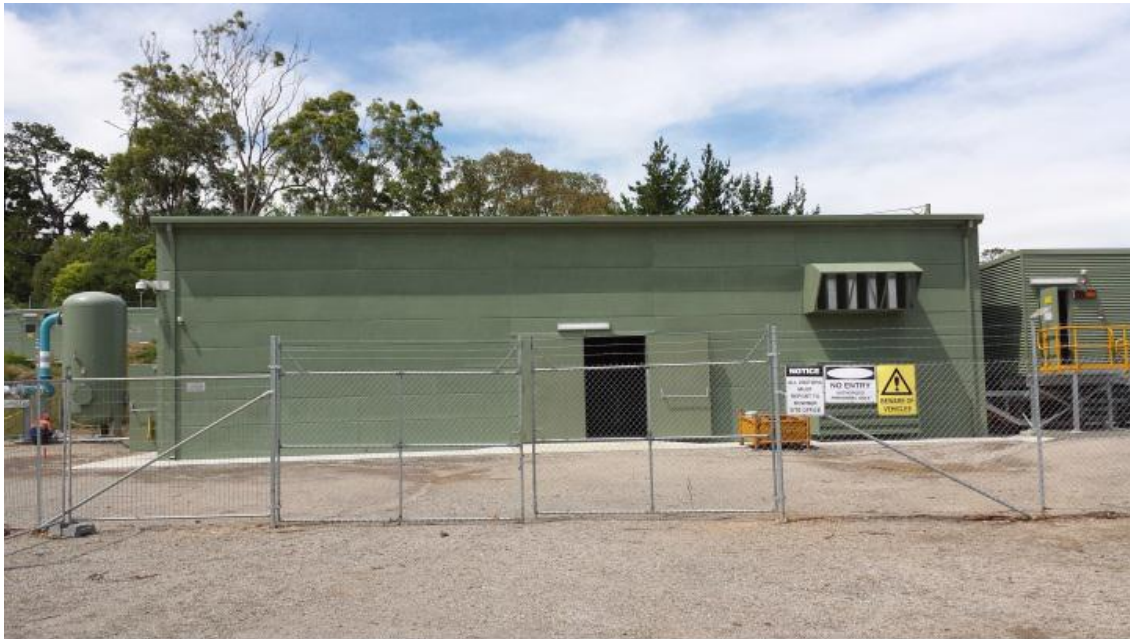
Figure 2: VS#6 Air Compressor Shed.

Service boreholes in the VS#6 precinct were installed to supply compressed air, electricity and communications to underground. Relevant surface infrastructure has been installed such as the compressor shed below.

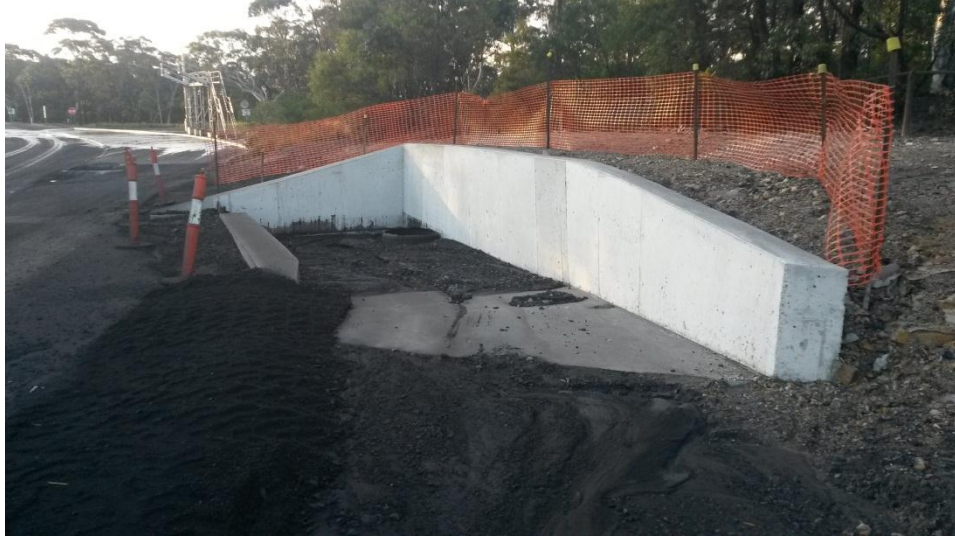
Figure 3: New sediment sump near completion. Under-road drainage pipe (as per table above) exits sump on left of frame.

- Concrete kerb and guttering was installed along 500 metres of roadside which flowed into a new sediment trap (

- 
- Figure 3) before flowing under the road in the drainage pipe line.
- As part of the road upgrades high MPA concrete was used to resurface the area from the truck turnout to the end of the trapping area (Figure 4).

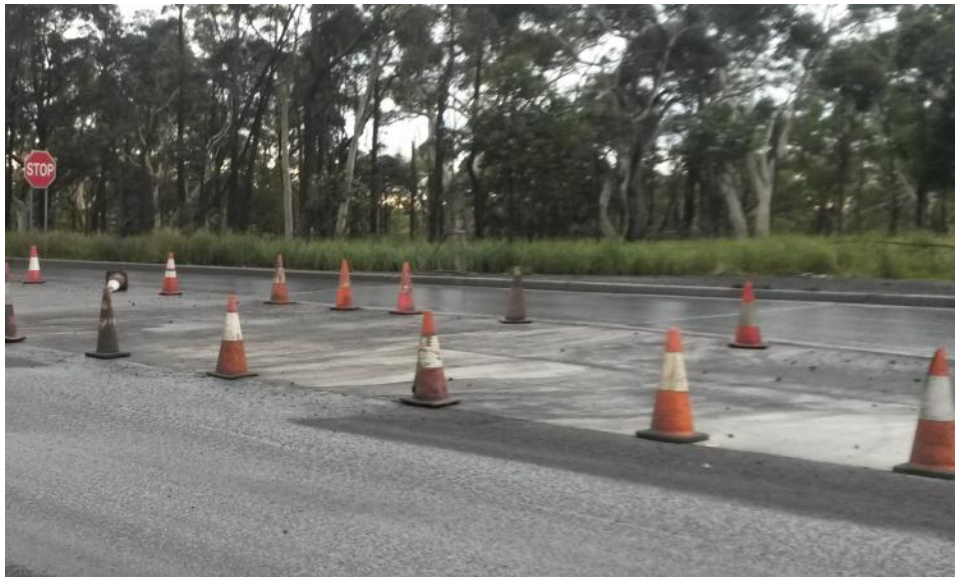
Figure 4: New concrete section of road at truck turn-out area.

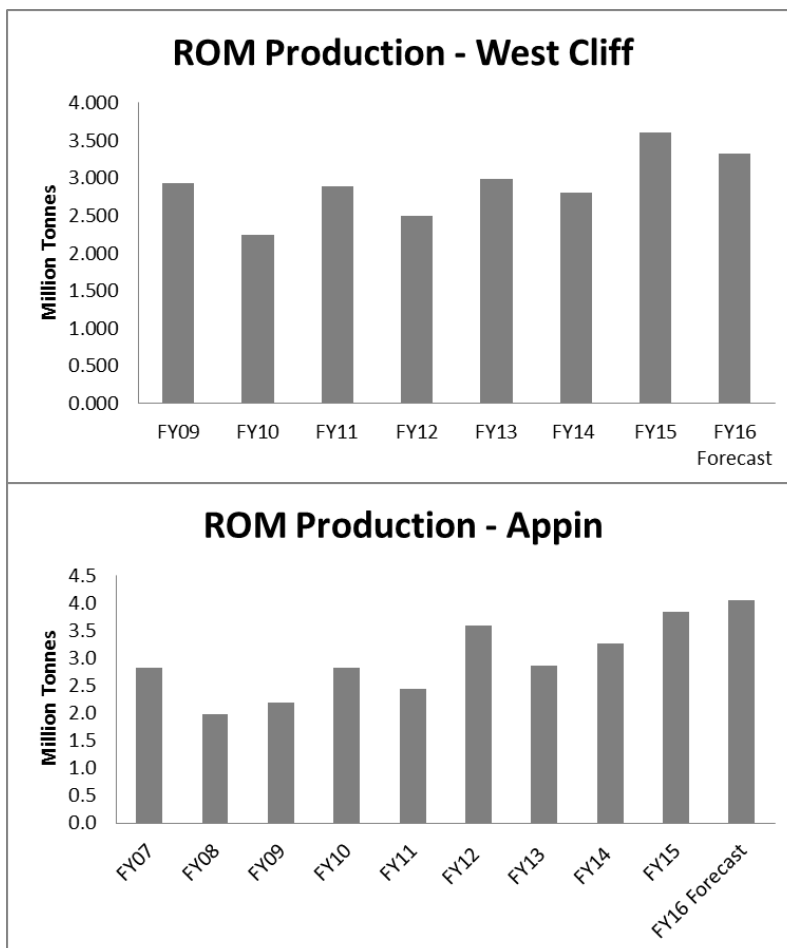
Figure 5: ROM production - BSO

West Cliff Colliery extracted 3.6 million tonnes of 'Run of Mine' (ROM) coal via roadway development and longwall extraction methods for the reporting period, a decrease of approximately 17% when compared to the 2013/14 reporting period. The ROM production levels from FY09 through to the current reporting period are provided in

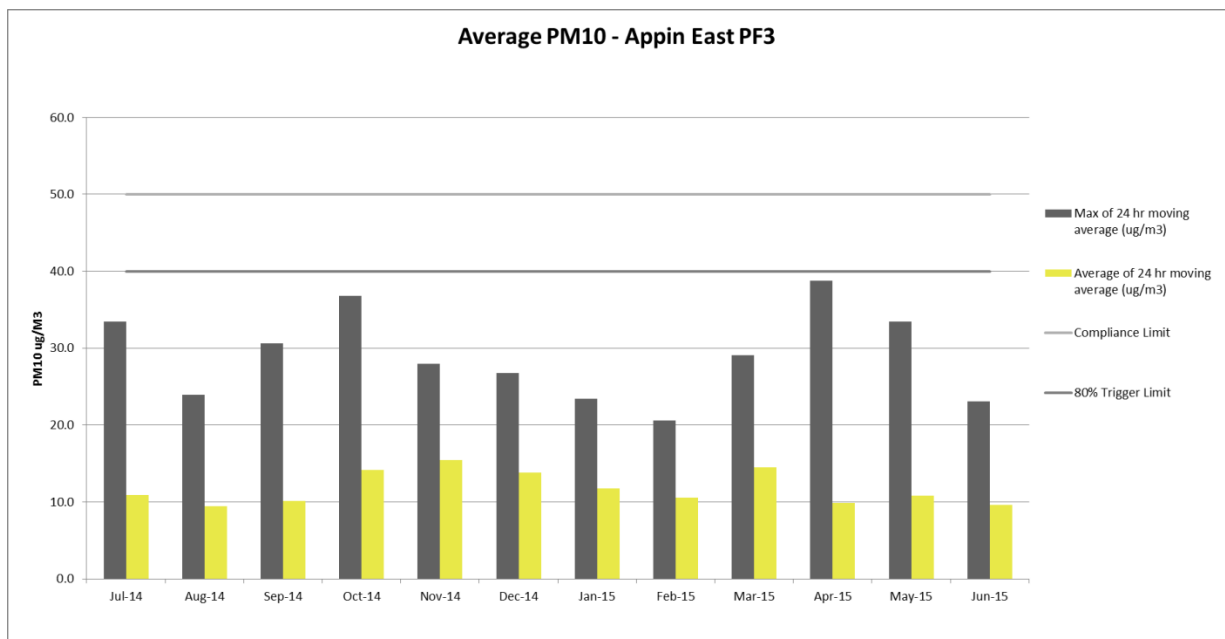
Figure 7: PM<sub>10</sub> average 24 hour levels and maximum 24 hour levels at Appin East.

As described in the BSO AQMP, if the optical photometer at Appin East (AE-PF3) indicates dust levels greater than 80% of the Air Quality Criteria (refer to Schedule 4, condition 9 of the BSO project approval) additional monitoring will be undertaken using the HVAS (AE-HV1) in order to assess compliance. The PM<sub>10</sub> levels at this site remained well below the 80% trigger (24 hour average) for the reporting period; therefore the HVAS was not required (Figure 7). Currently, the optical photometers are unable to determine the difference between dust, rain and fog. High results are, almost without exception, the result of dense fog in Appin area. A minor improvement planned for the next reporting period is the installation of a heated inlet on optical photometer AE-PF3 in an attempt to improve this weakness in the sensor design.

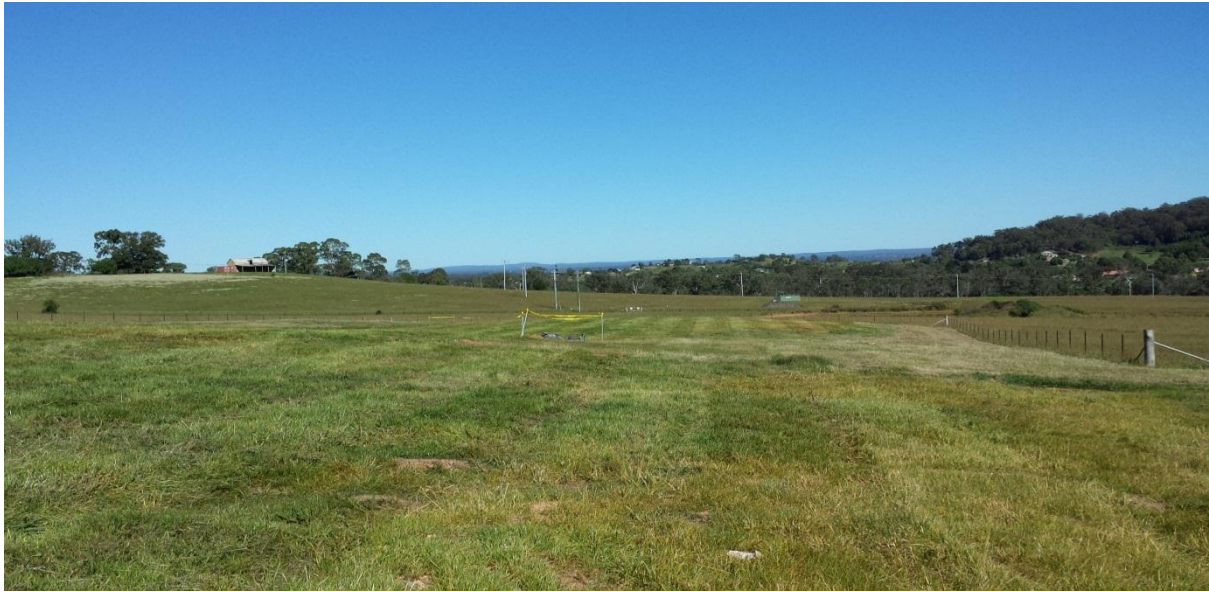
Figure 12: LW 704 pads during rehabilitation works

- Shielding wells from residences as practicable. This included utilising natural topography and vegetation to screen operations and optimising the position of pad infrastructure;
- Where possible infrastructure was green coloured, or housed in a green coloured compound;
- Green coloured noise barriers were installed at the perimeter of sites within sight of residences. During 2014/2015 noise barriers remained in place around Area 9 operational sites; and
- Revegetation of exposed areas as soon as practicable. Pads associated with Longwall 705 were re-vegetated in 2014/15.

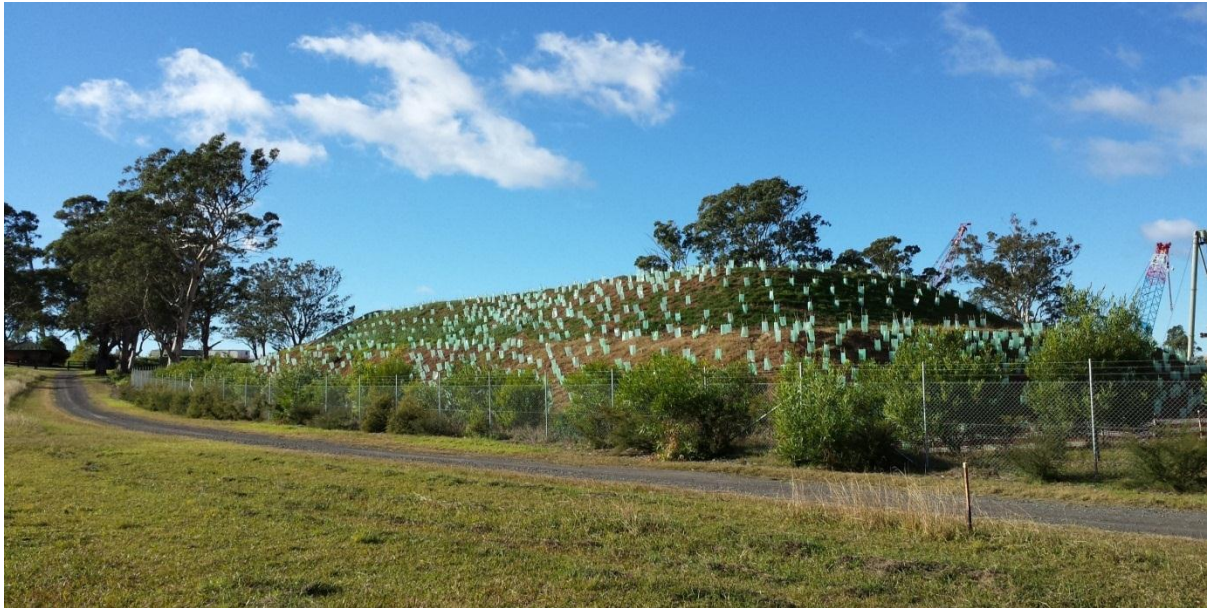
Figure 13: VS#6 Spoil revegetation.

Construction activities for the VS#6 precinct continued throughout 2014/15. To minimise the visual disturbance from these activities, exposed areas were revegetated progressively as final landform is achieved. The most significant feature still to be revegetated is the earthen noise barrier that is currently under construction using coal wash.

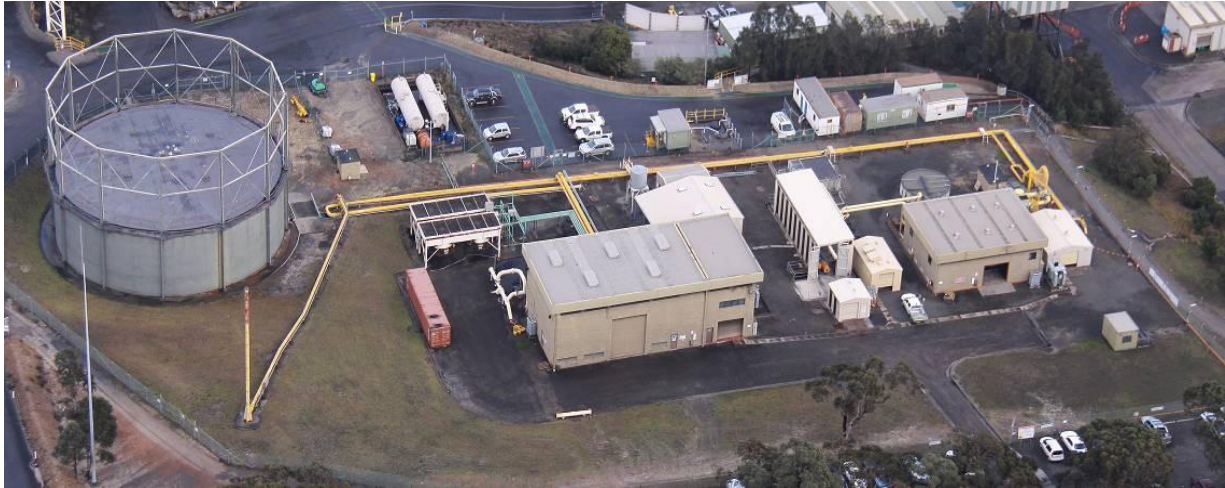
Figure 14: Methane extraction plant – West Cliff

Cliff Methane Drainage Extraction Plant and the gas blower station that are part of the infrastructure to transport the drainage gas via the overland pipeline is shown in the figure below.

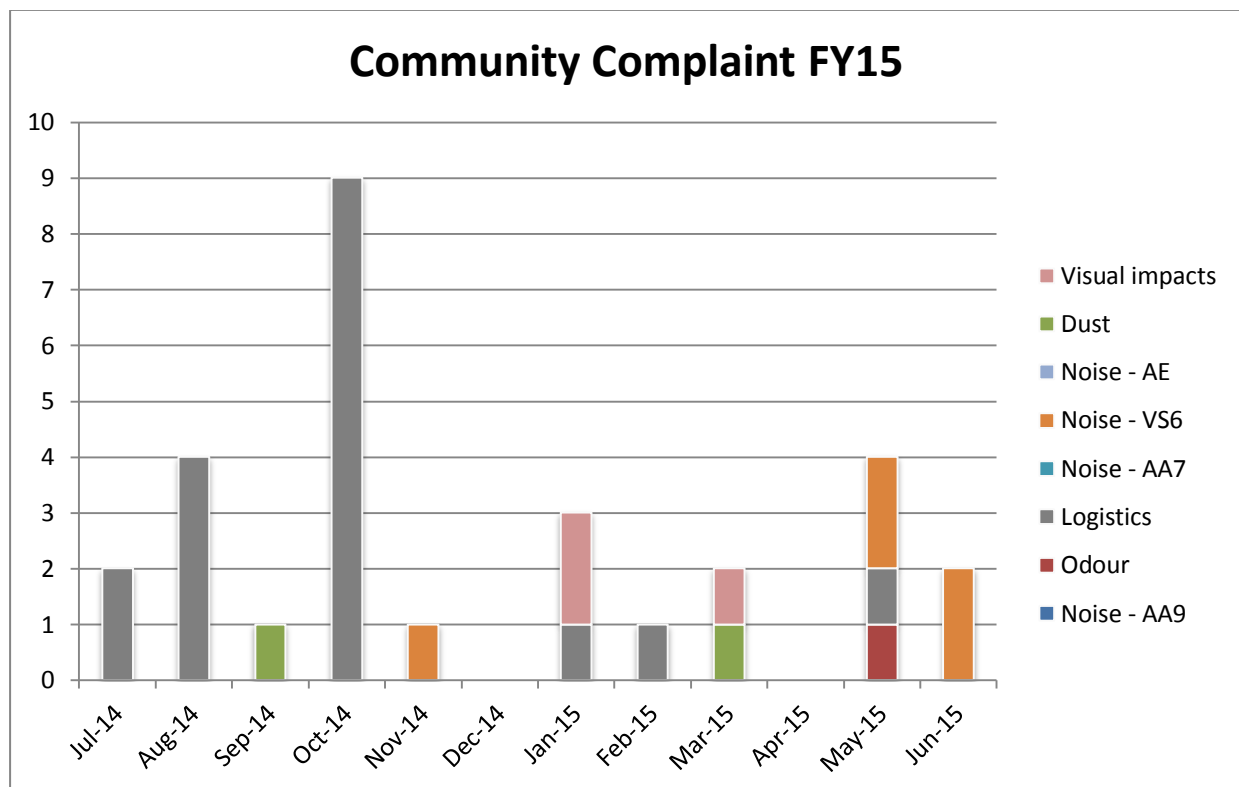
Figure 15: Summary of complaints for FY15.

During this reporting period 29 complaints were received in relation to BSO operations (including Pit Tops, Mine Safety Gas Drainage projects, exploration work and coal transportation). Details of the complaints received and the actions taken are provided in Appendix C – FY15 Complaints. A summary of all complaints received across the BSO is included in refer to Figure 14.
