# **Avon and Cordeaux Reservoirs DSC Notification Area Management Plan**

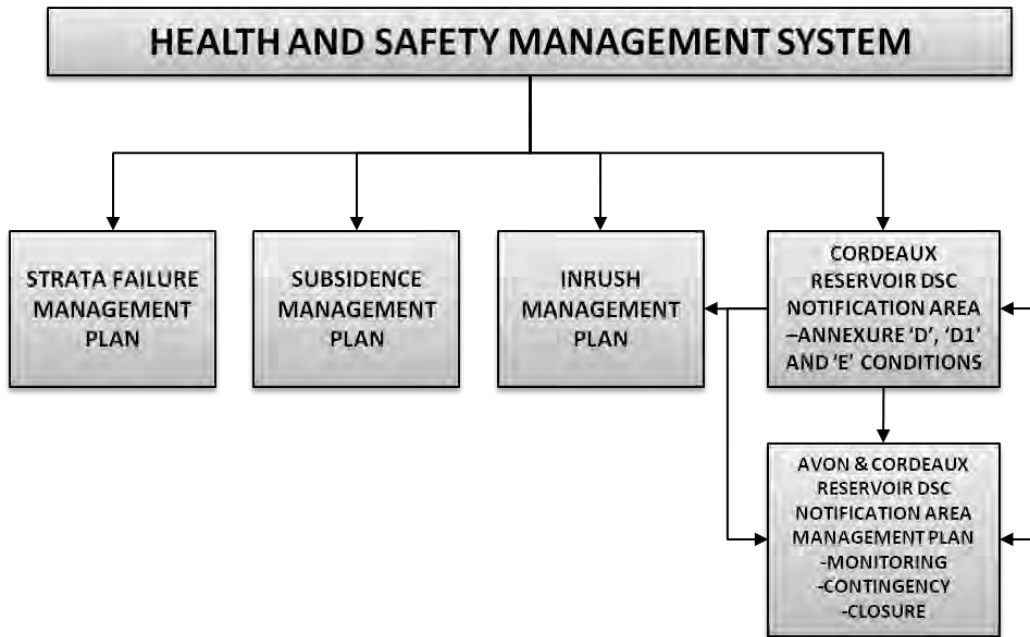
Figure 1 – Dendrobium Coal Health and Safety Management Structure

Figure 1 describes the interrelationship between the Management Plans.
