**Illawarra Coal  
Dendrobium Mine & Cordeaux Colliery**

# Annual Environmental Management Report

1 July 2013 to 30 June 2014

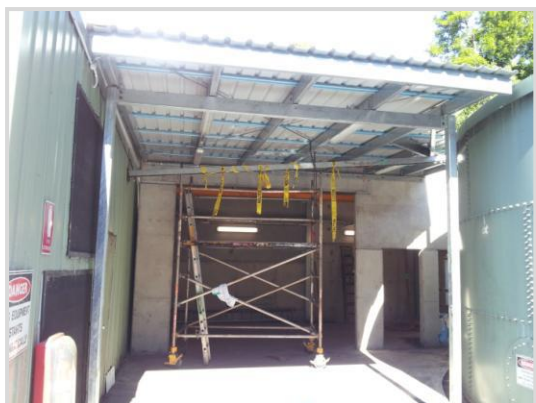
**Figure 1: Construction of compressor building**

Minor construction that was started during the FY13 reporting period on a compressor building at the Kemira Valley Coal Loading Facility (Figure 1) was commissioned and completed in early FY14.

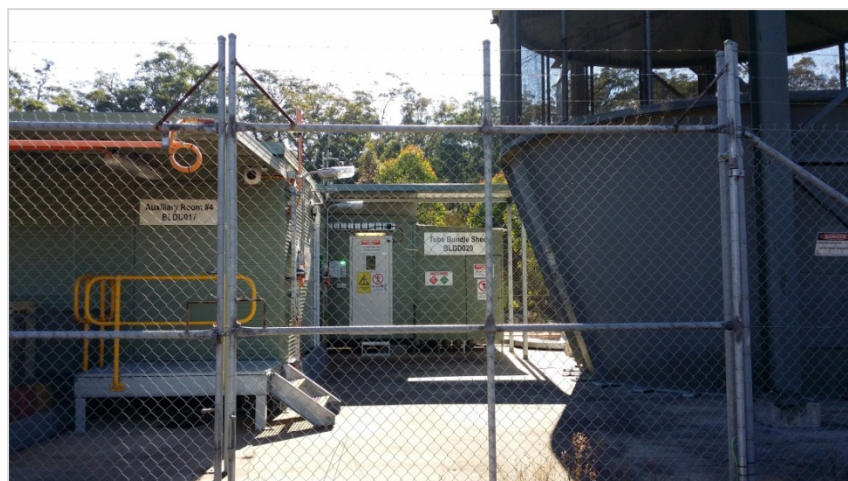
**Figure 2: Tube bundle shed**

An upgrade to the ventilation monitoring at the Ventilation Shaft 2/3 site was undertaken which included the installation of the tube bundle shed.

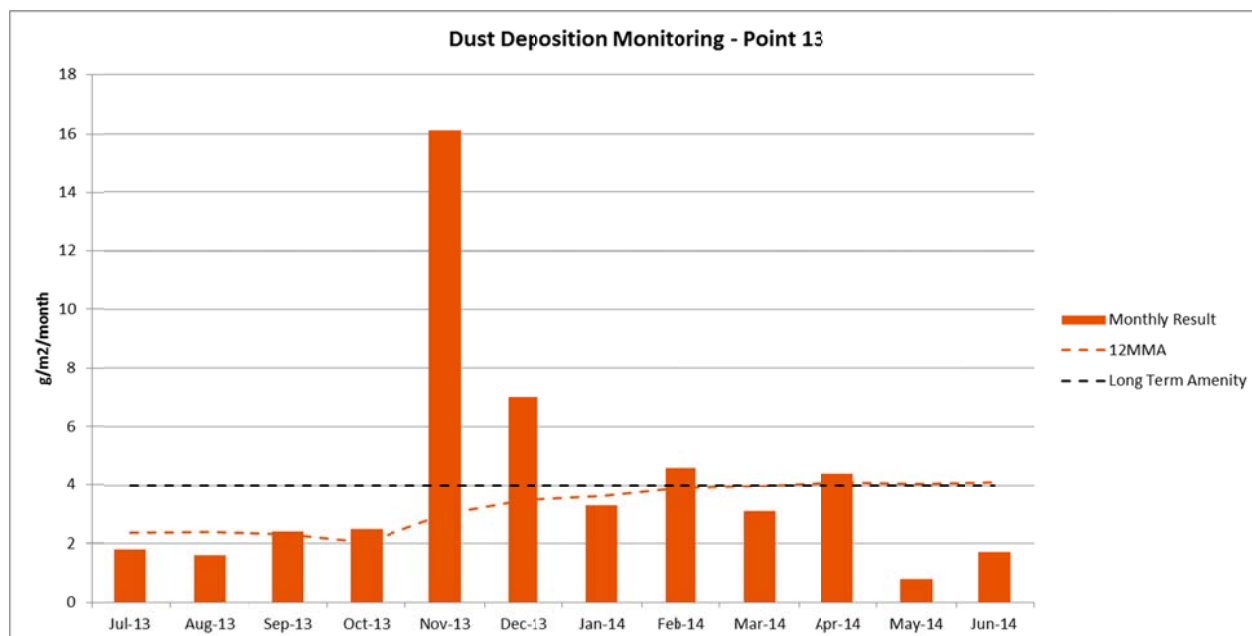
Figure 5: Point 13 Dust Deposition Gauge results for FY2014

Point 13 is an operational control gauge located on the Dendrobium Pit Top. Eight of the twelve readings for the year were below the amenity goal (Figure 5) with the four above the goal. The contributing factors for these exceeded readings were due to dirt, insects and vegetation (Figure 6).

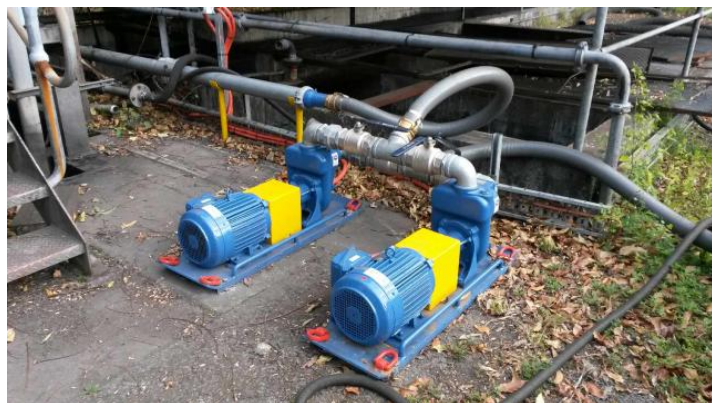
Figure 9: Newly installed GWTP pumps

The GWTP pumping system was upgraded during the reporting period. The upgrade included the installation of new pumps and updates to the Programmed Logic Controller (PLC). Refer to Figure 9.

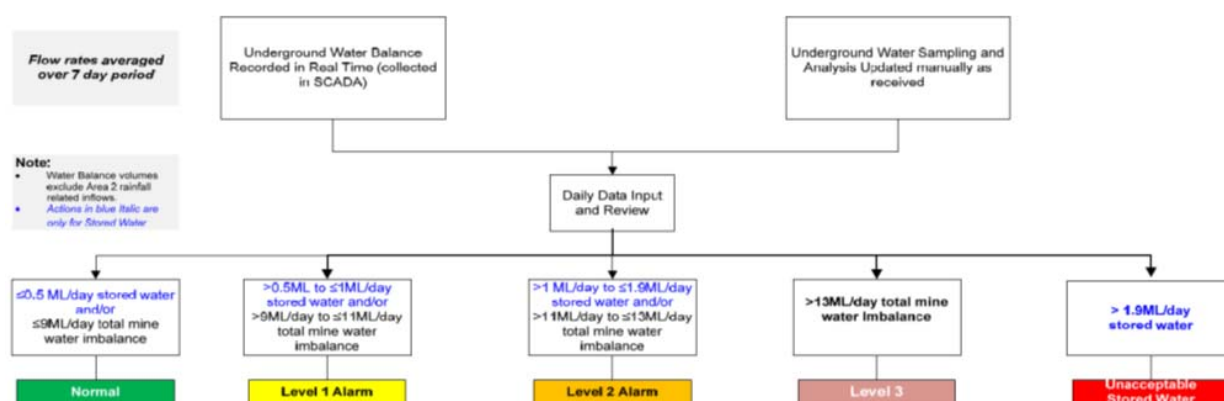
Figure 15: Extract from Principal Response Flowchart in “Cordeaux Reservoir DSC Notification Area Contingency Plan”.

During the reporting period, Dendrobium operated under a Principal Trigger Action Response Plan (TARP) as outlined in the “Cordeaux Reservoir DSC Notification Area Contingency Plan”. During this period the mine operated at ‘Normal’ in the Principal Response Flowchart (Figure 15).

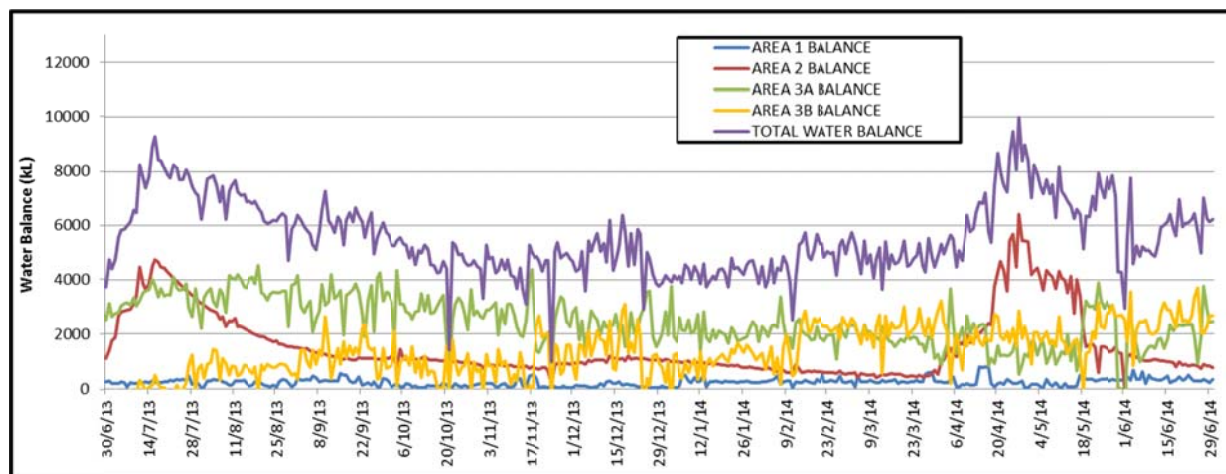
Figure 16: Mine Water Balance July 2013 - June 2014

A summary of the mine water balance for the reporting period is provided in Figure 16.

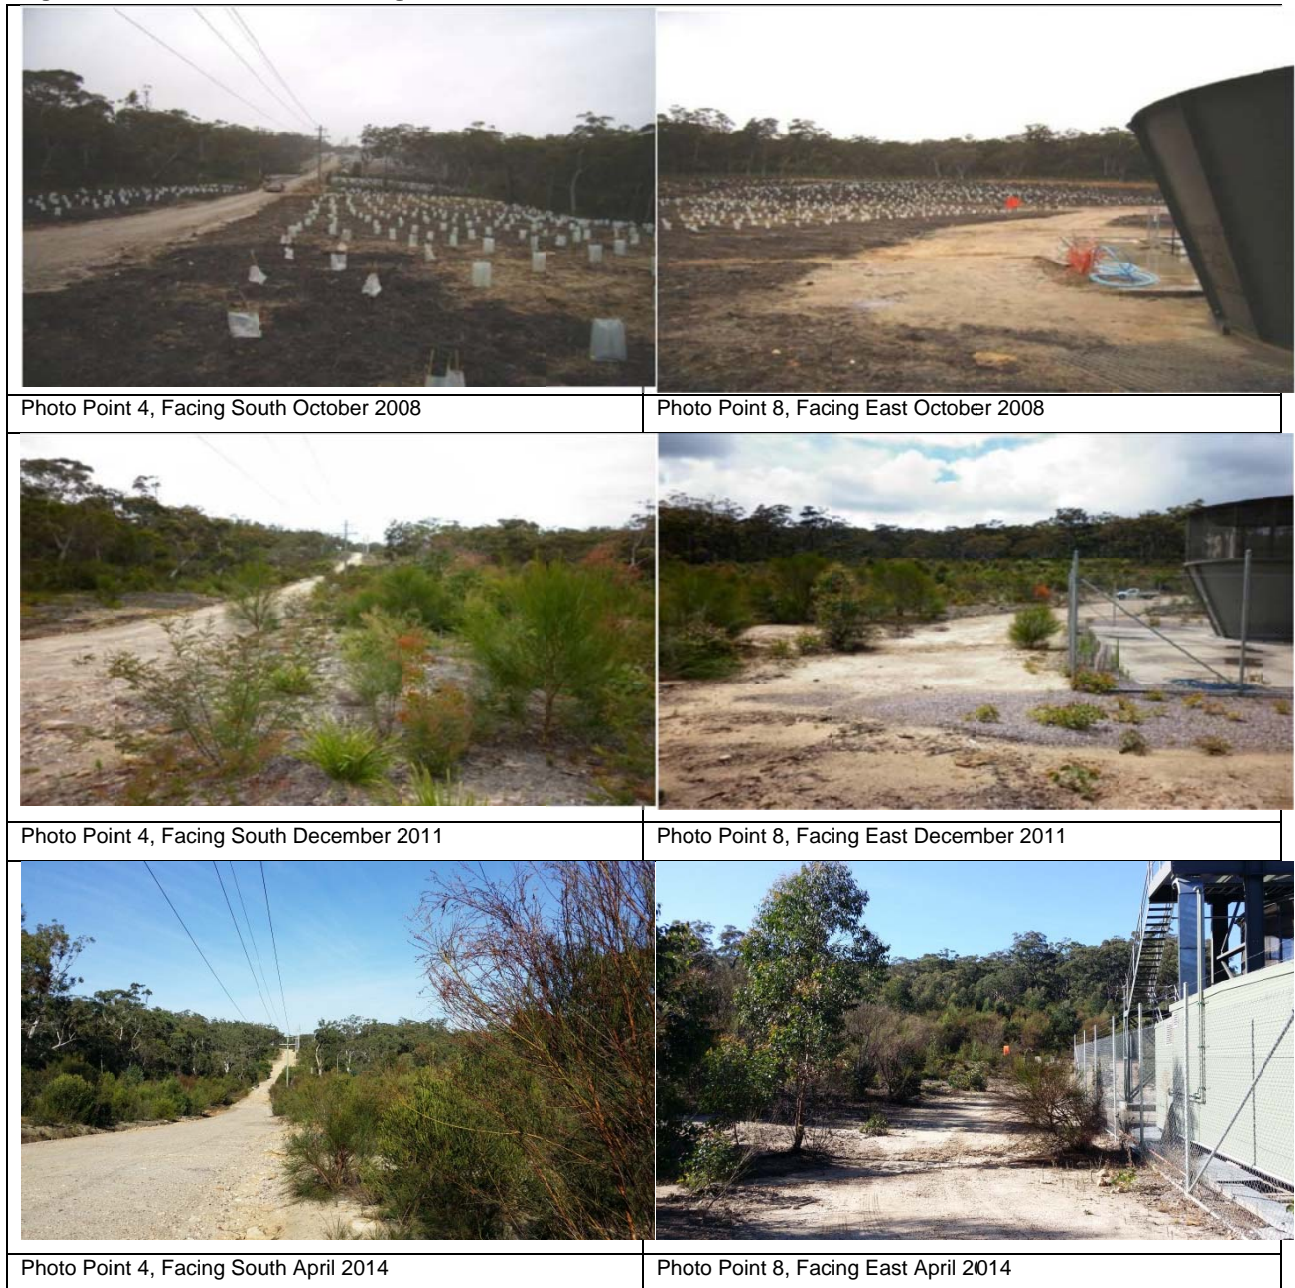
Figure 26: Photo locations monitoring rehabilitation

Monitoring of the 2/3 Ventilation Shaft site was inspected on six monthly basis during the reporting period by Environmental representatives. Refer to the photo catalogue provided in Figure 26.

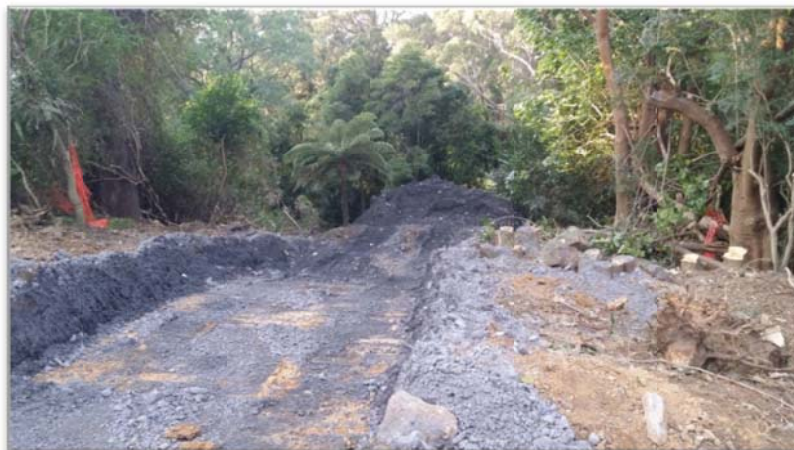
Figure 27: Fill material being delivered to site 23/6/2014

- placing fill material in the subsidence feature
- installation of topsoil over the disturbed area.
- establishment of a stable landform and permanent drainage with appropriate benches, sediment control devices.

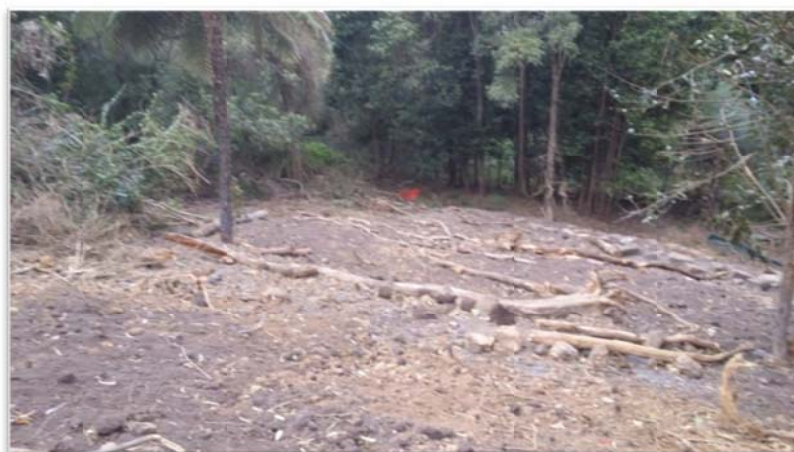
Figure 28: Landform established 12/8/2014

Rehabilitation of the site will continue to be progressed and monitored during FY15 and results/outcomes will be reported in the next AEMR.

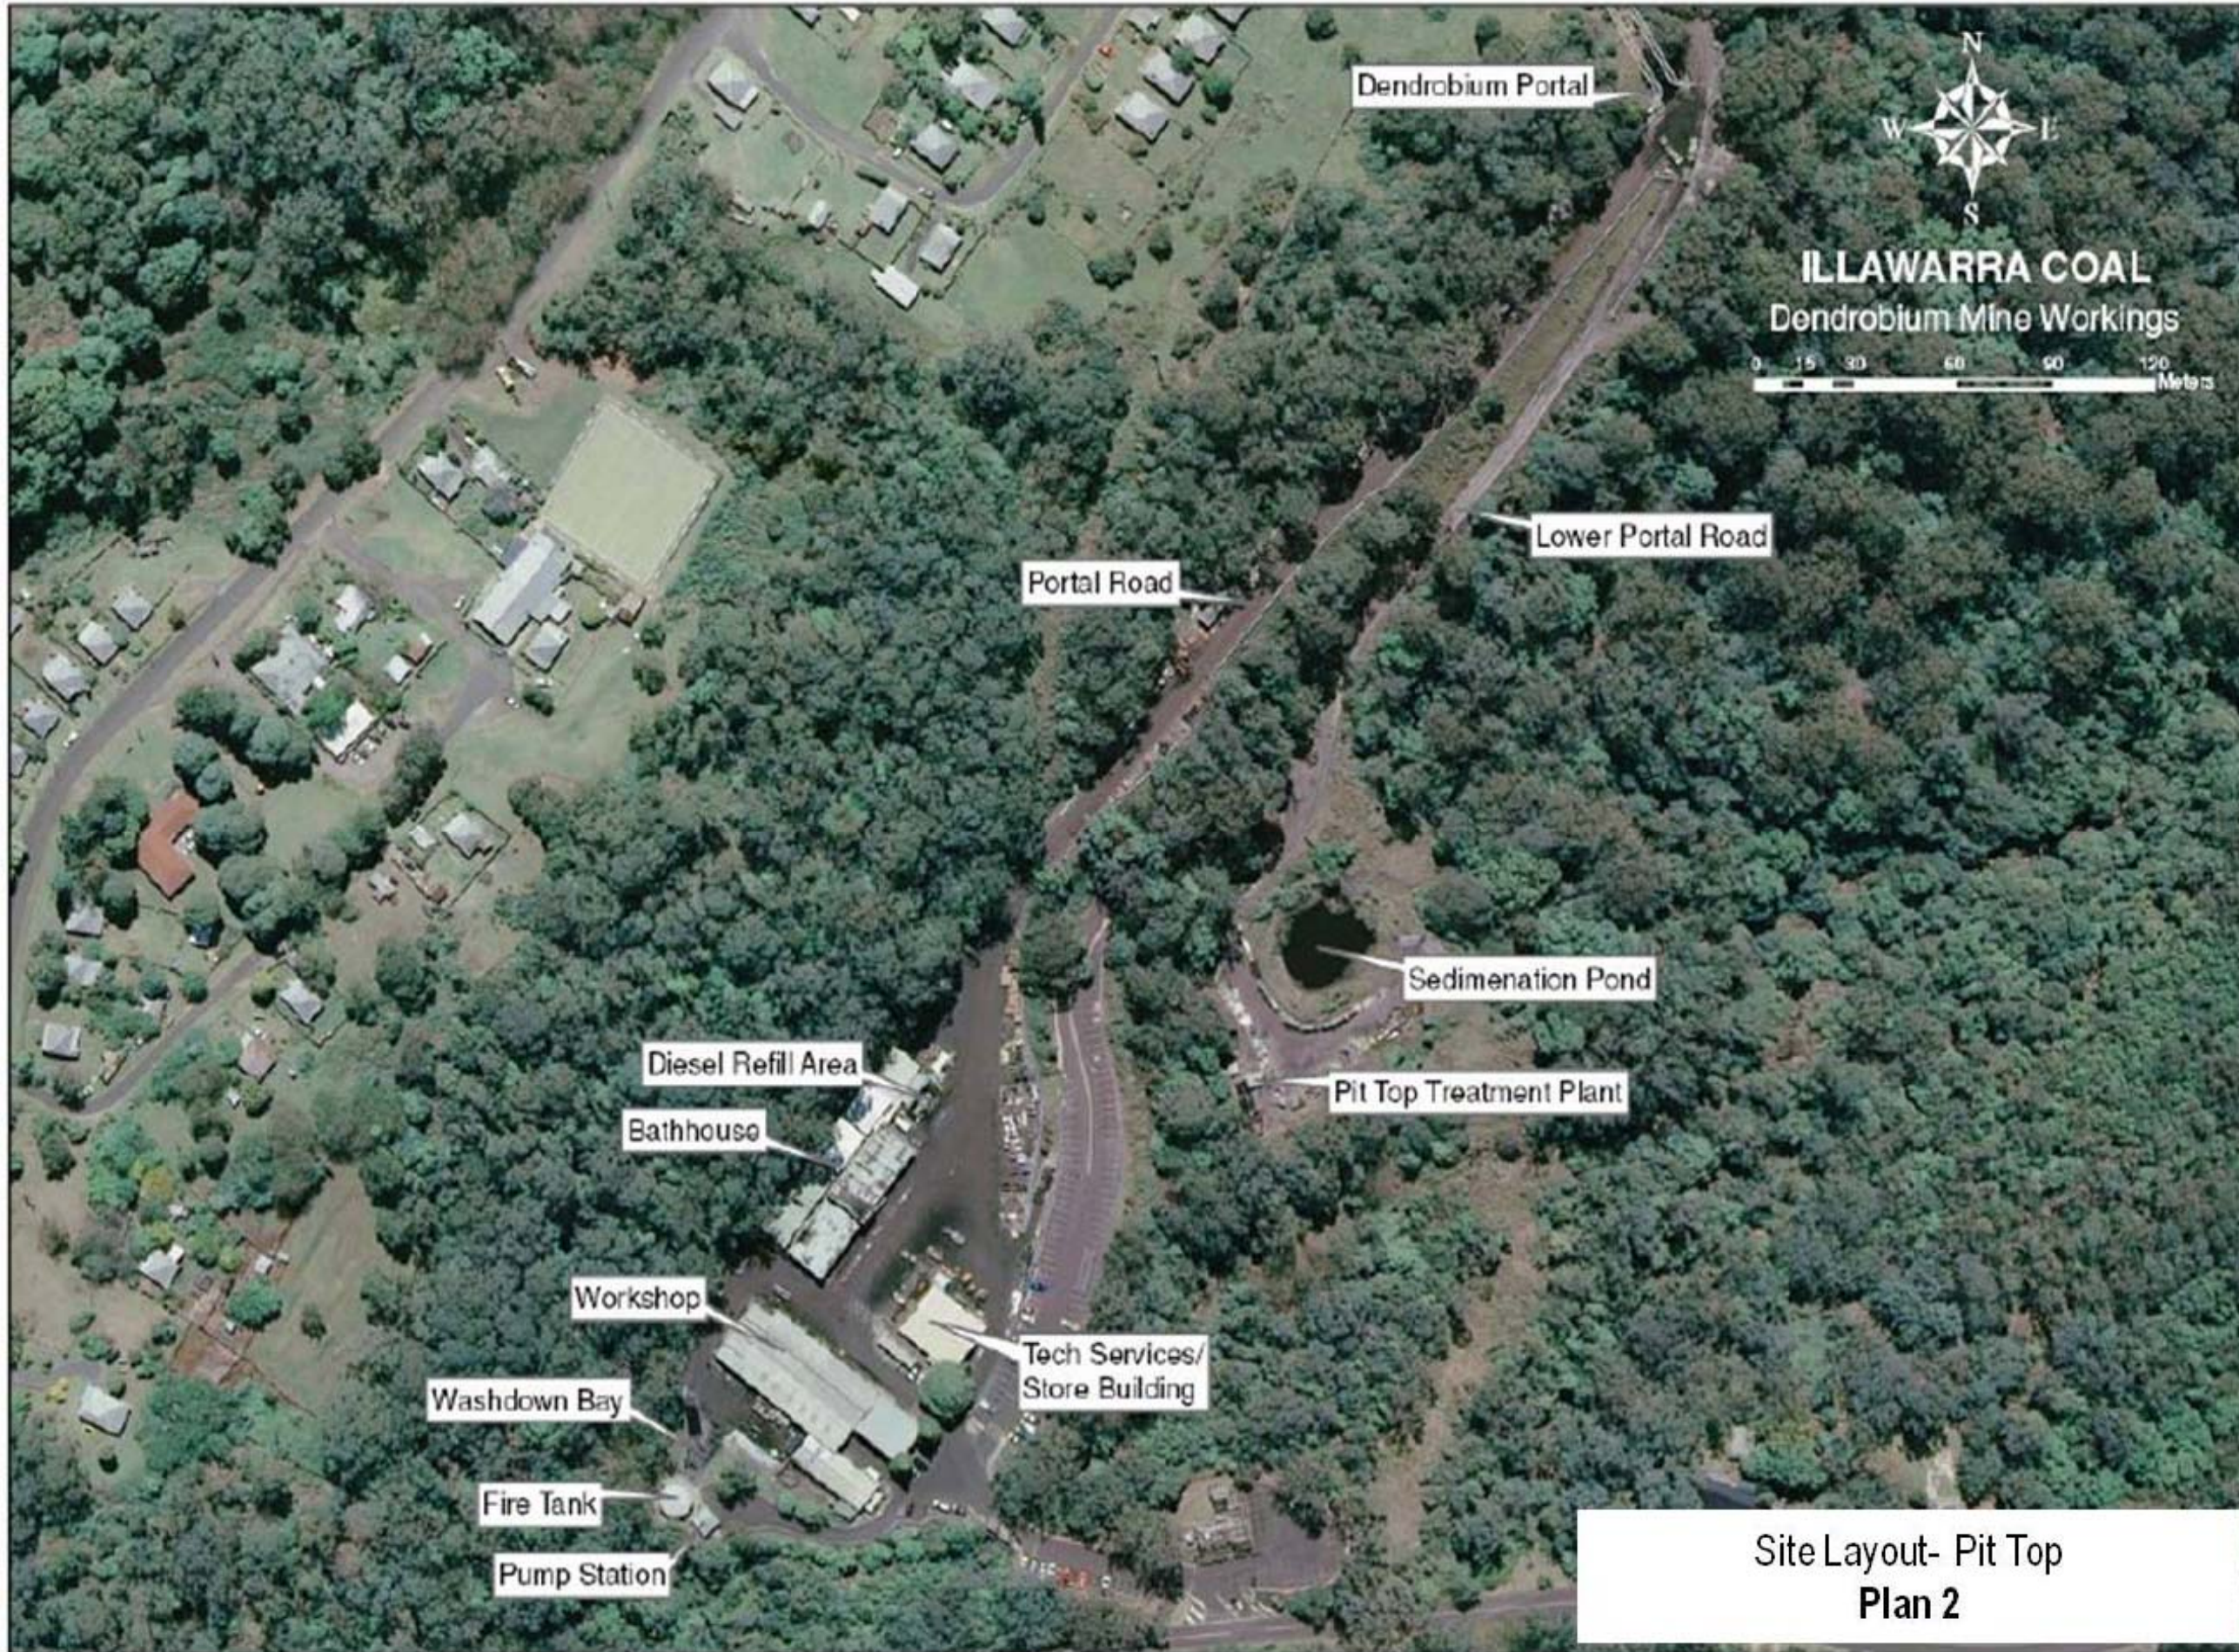
Site Layout- Pit Top  
Plan 2

A-Site Layout – Pit Top

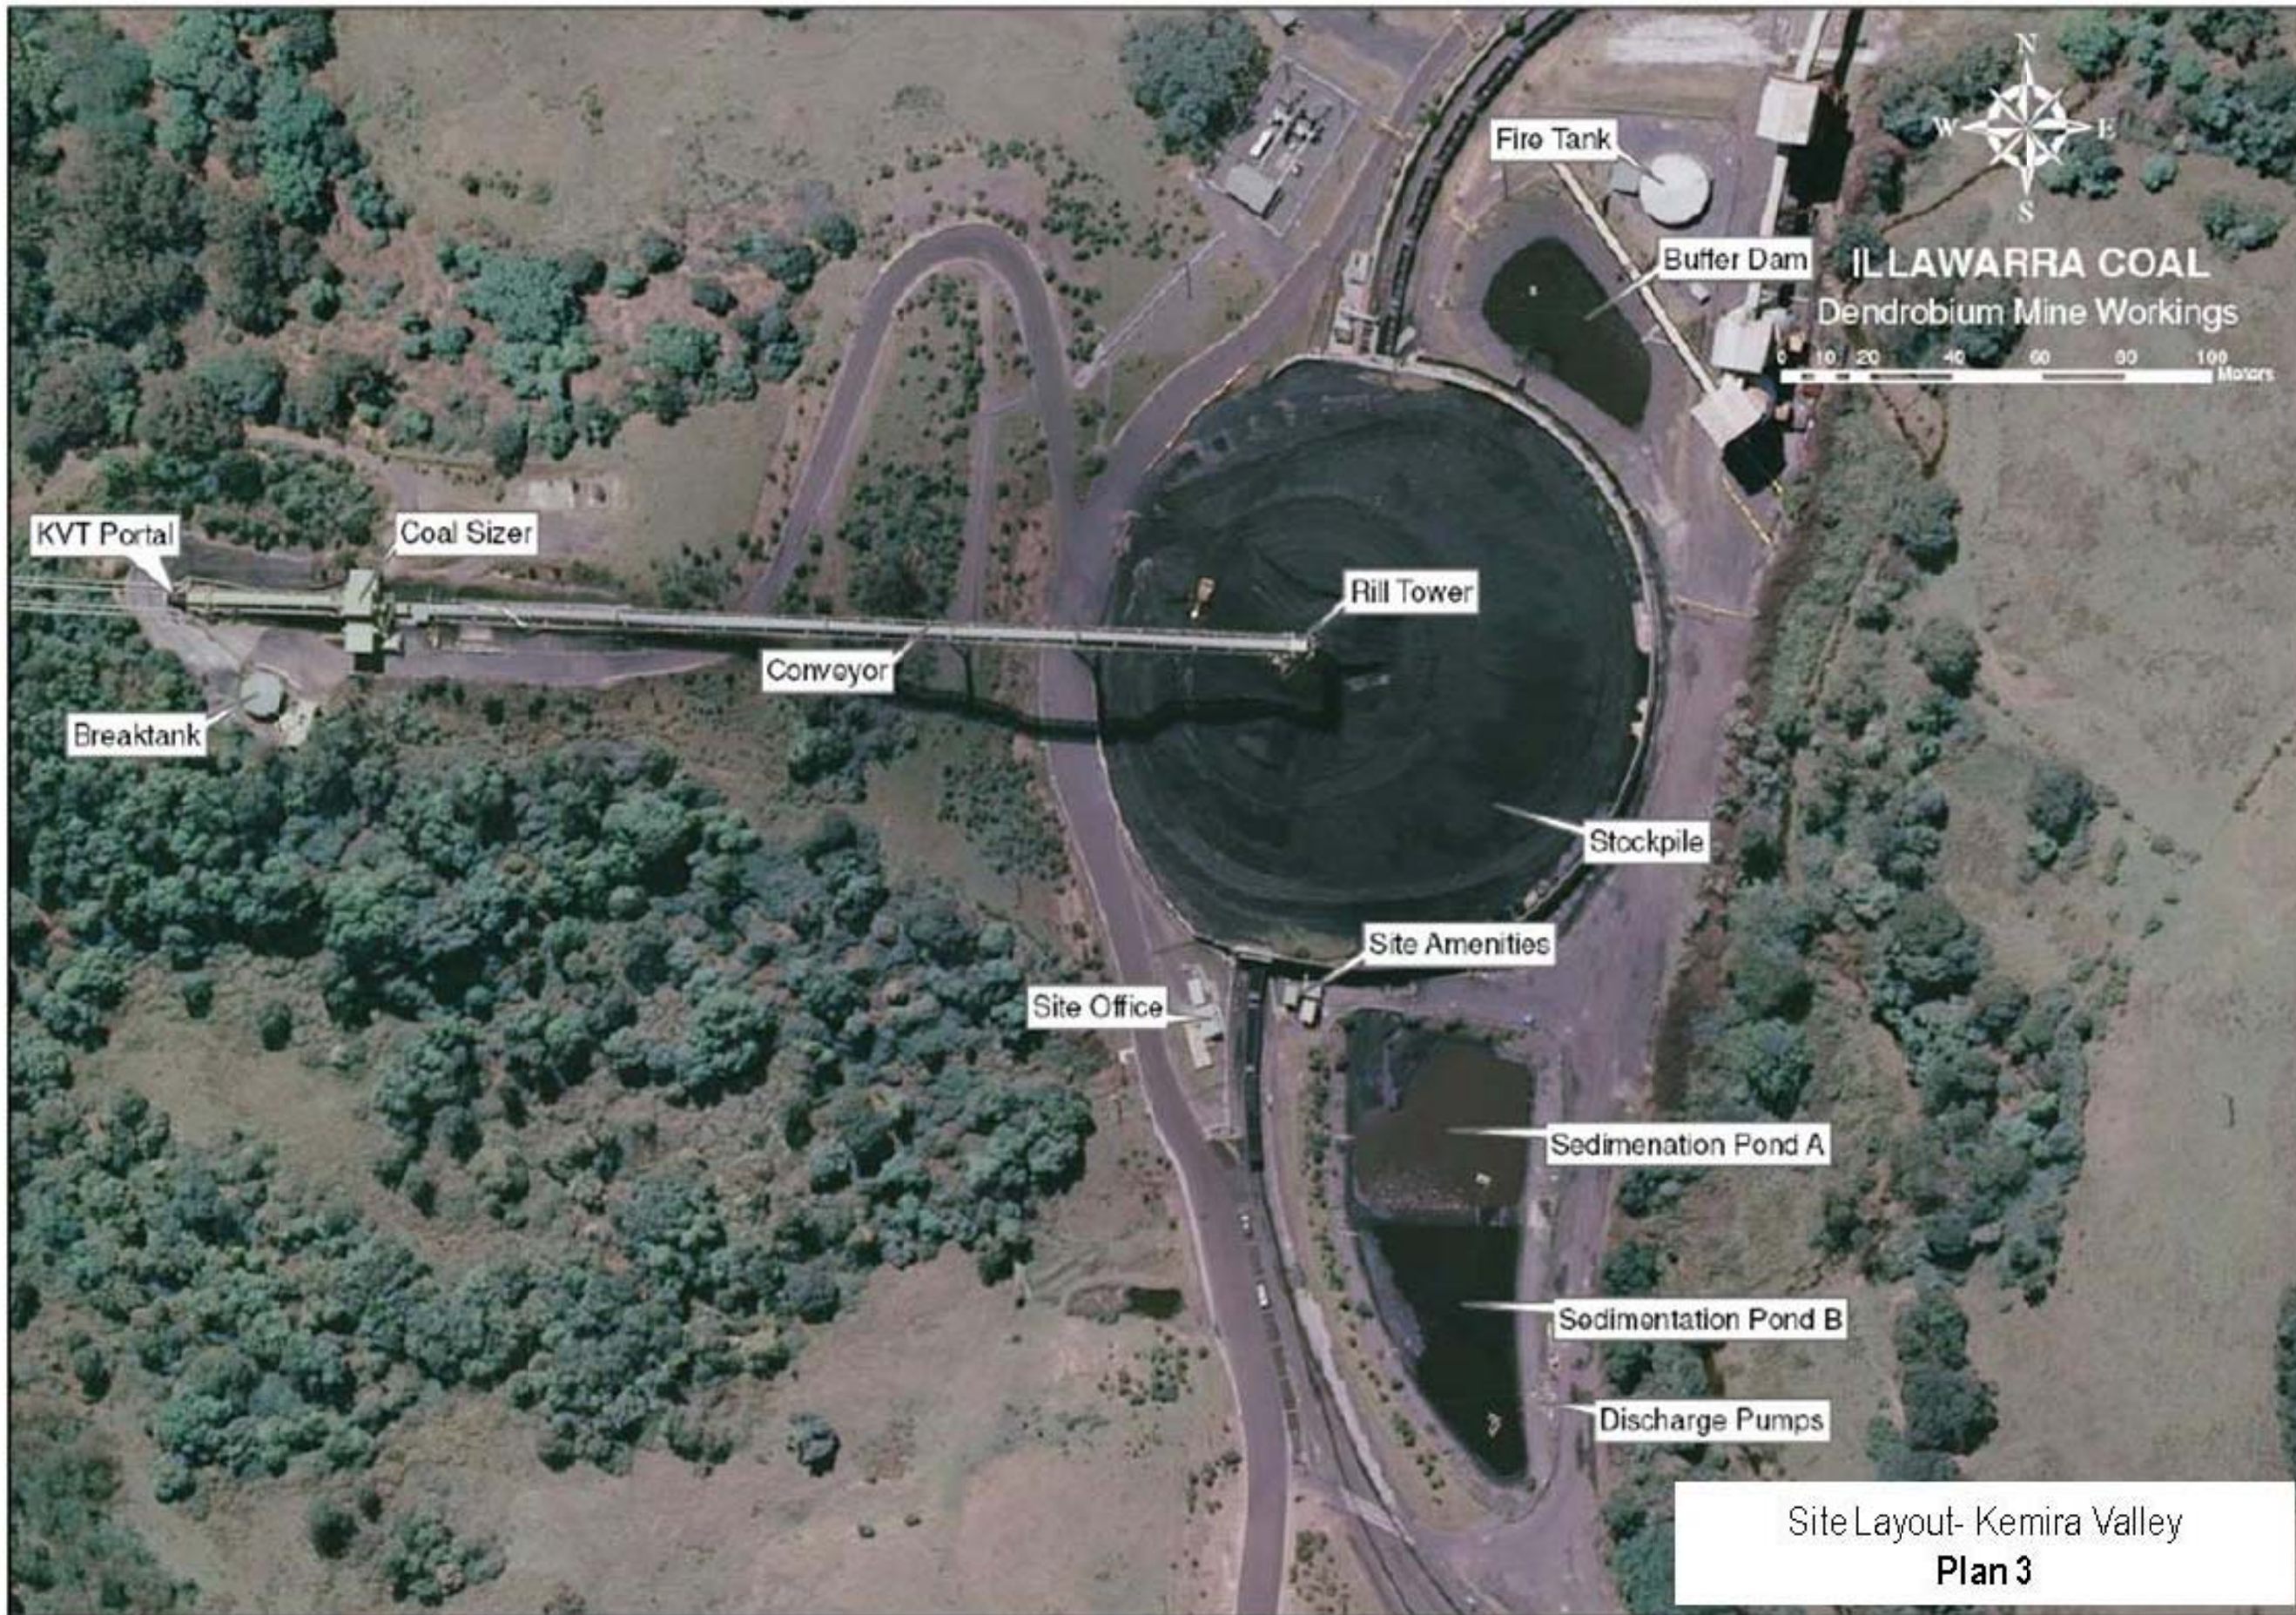
# PLAN 3

Site Layout – Kemira Valley

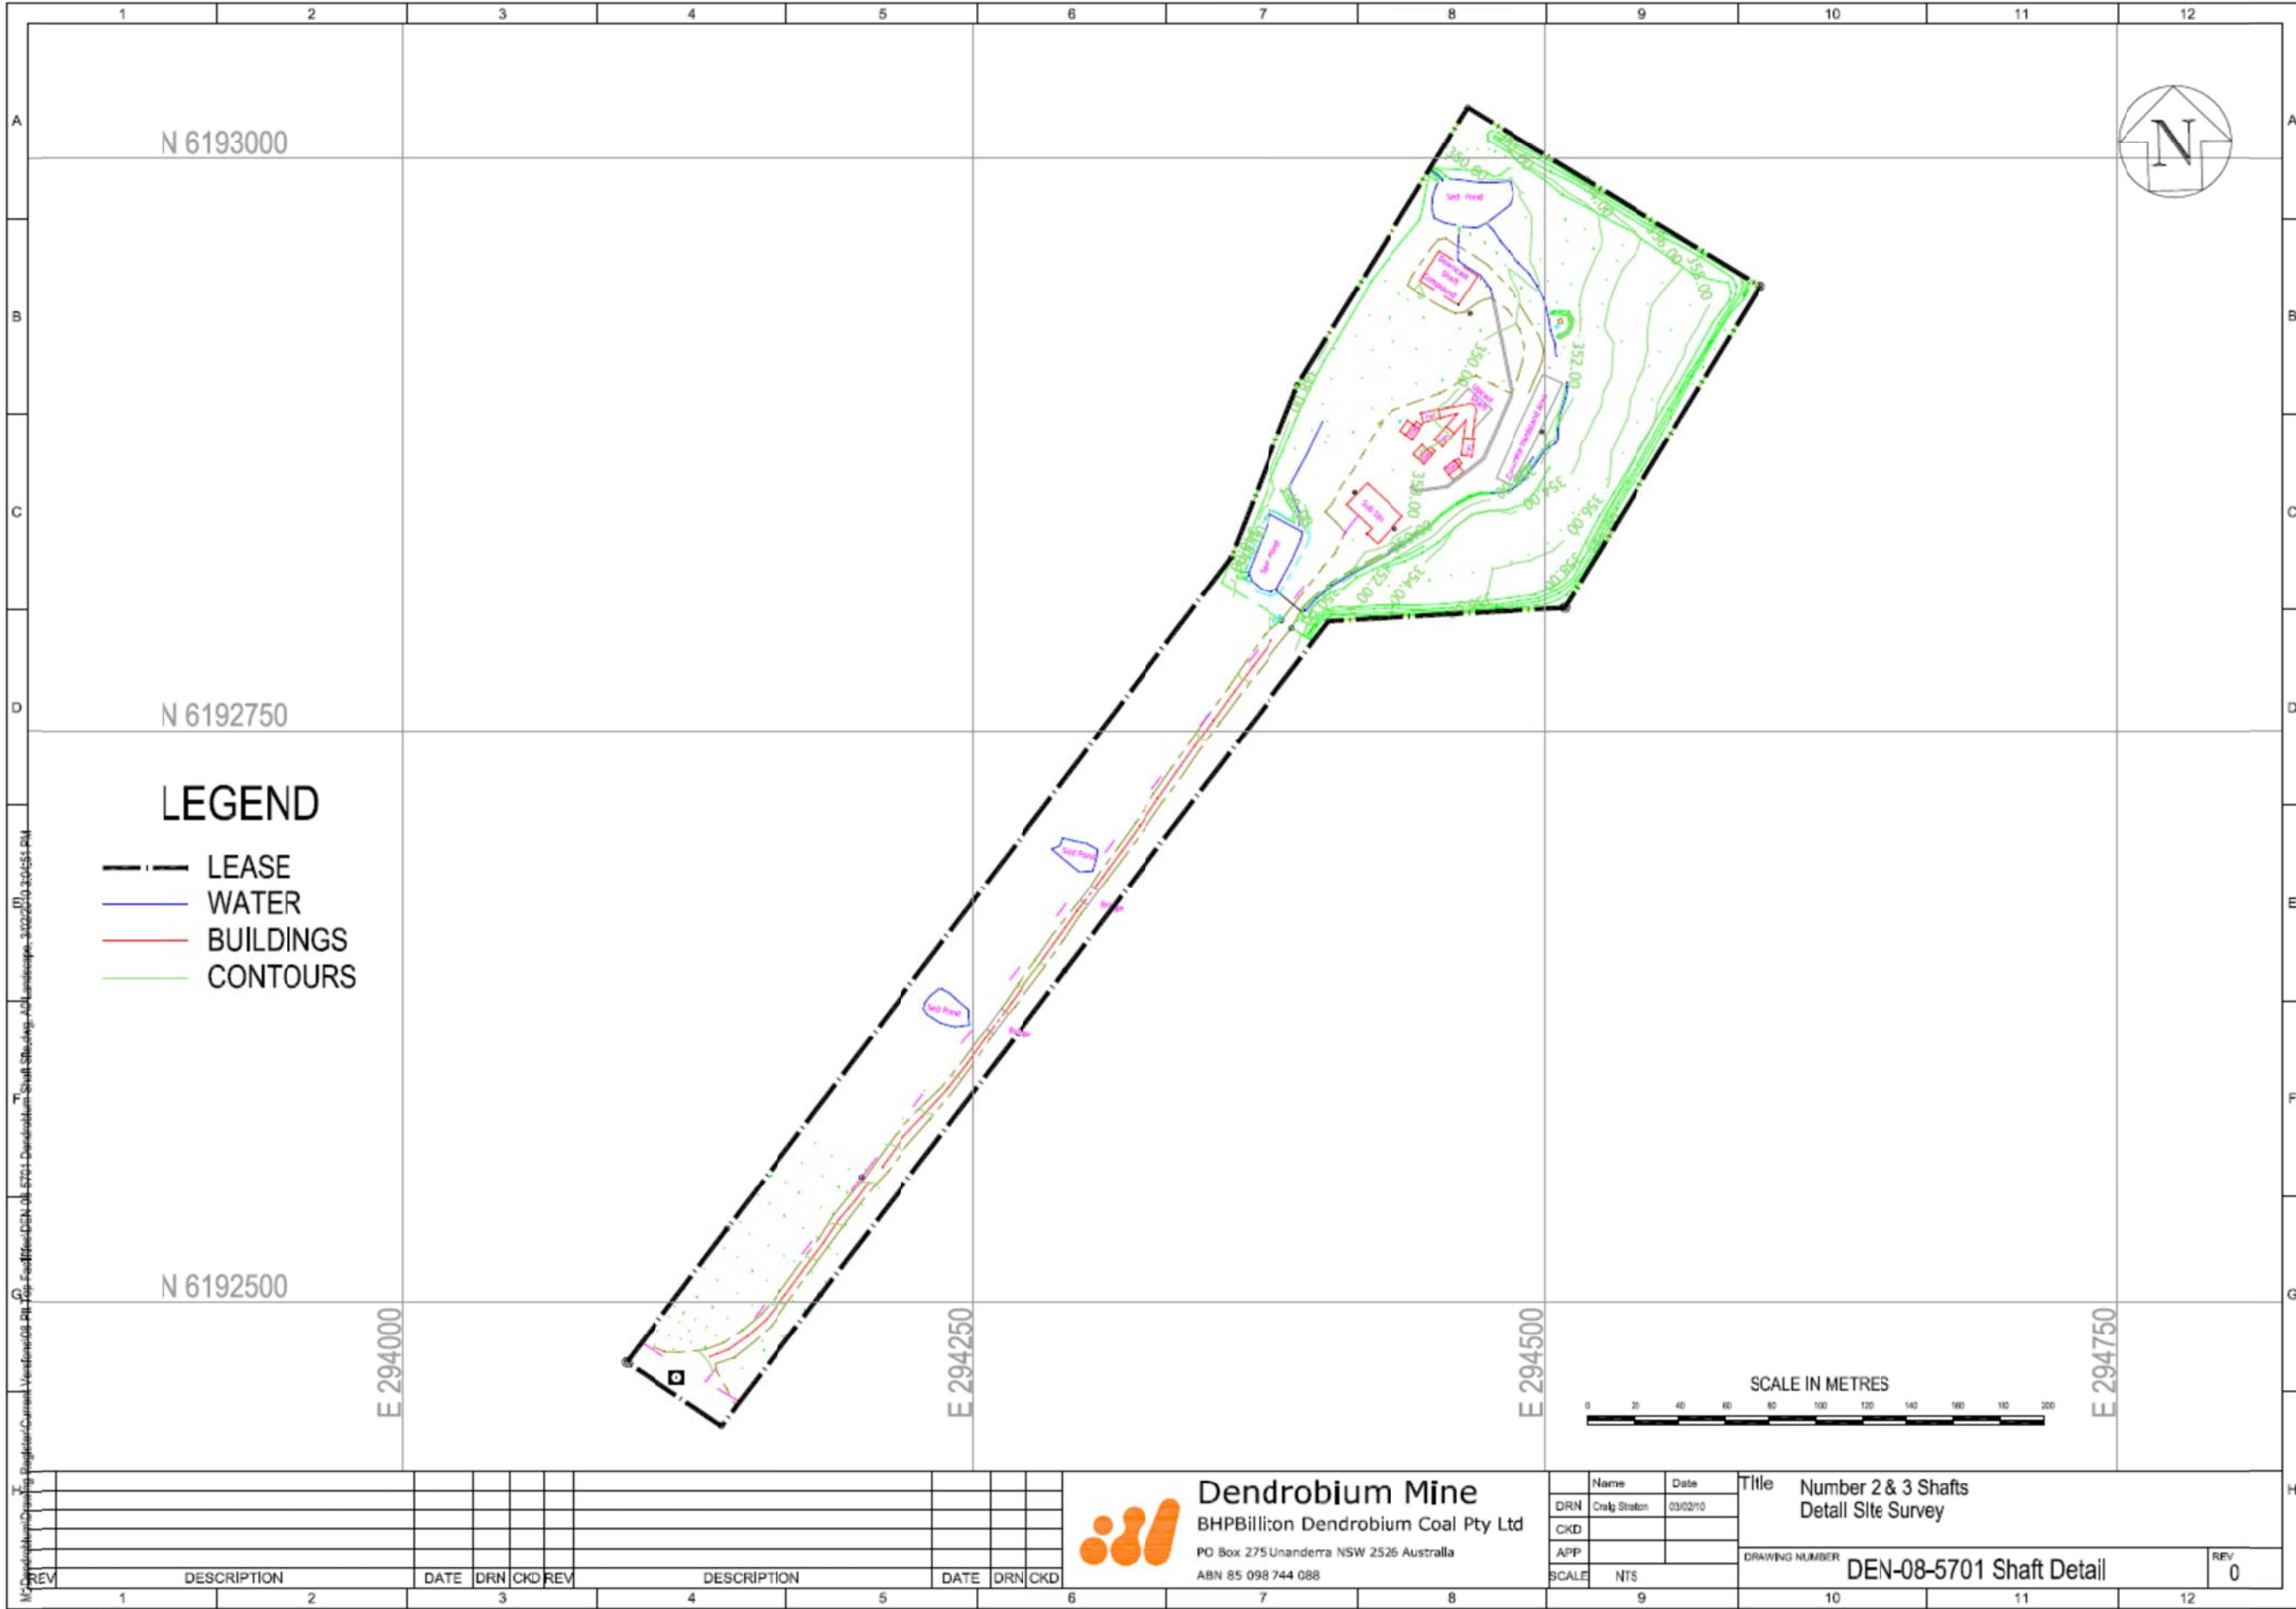
# PLAN 5

No. 2 and 3 Ventilation Shaft Site Layout

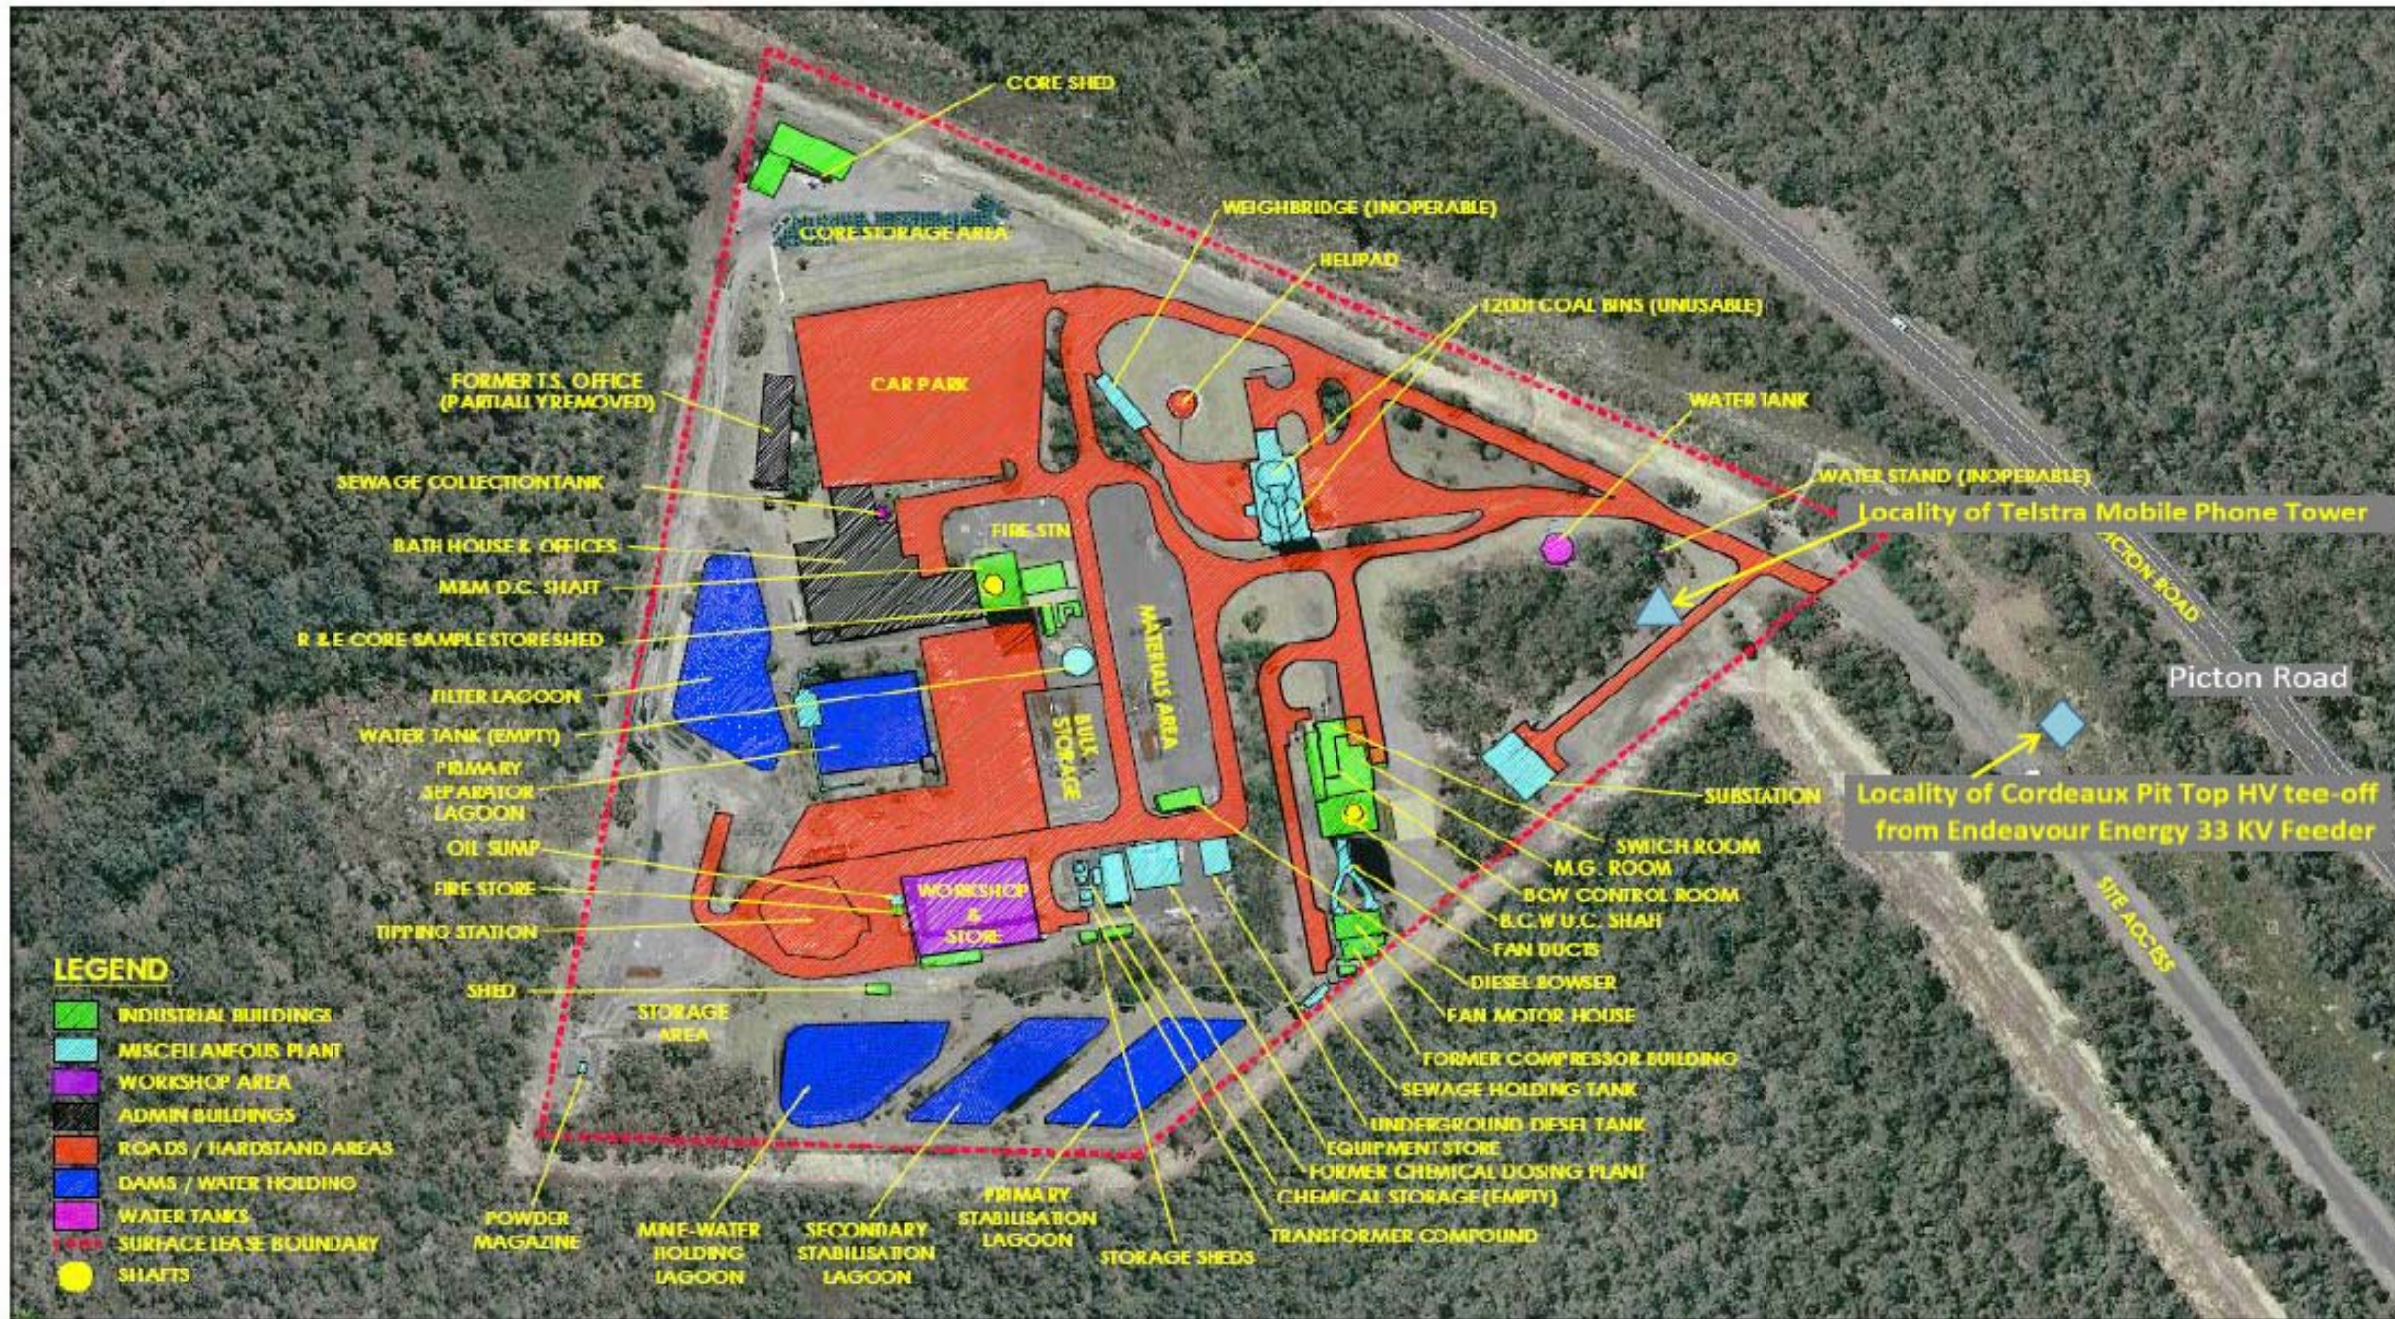
# PLAN 12

Cordeaux Colliery Pit Top Infrastructure
