≡III III≡**SOUTH32** Illawarra Metallurgical Coal

DENDROBIUM MINE AND CORDEAUX COLLIERY ANNUAL REVIEW FY21

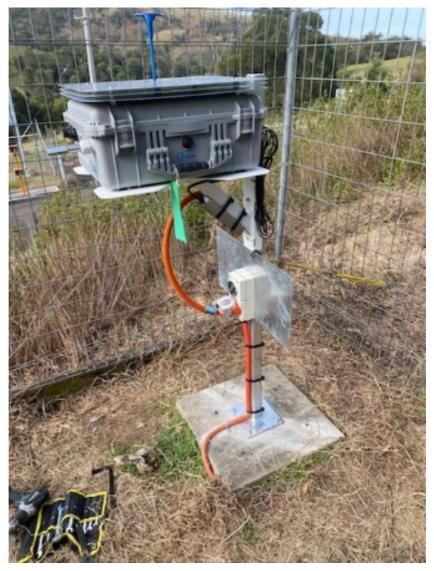
In July 2021, Dendrobium's EPL was amended to include the use of real-time air quality optical photometers and remove the requirement to monitor air quality using DDGs and HVAS. In the next reporting period, DDG and HVAS monitoring will be decommissioned in place for real-time monitoring. Photometers were installed and commenced monitoring on 15 July 2021. The photometer installed at the KVCLF is shown in Plate 2.

Plate 2: Photometer dust monitor located at the KVCLF

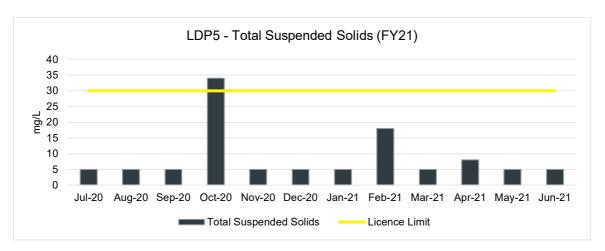
Figure 14: LDP 5 - TSS (FY21)

non-compliance was reported for TSS limits in October 2020, however the general trends for LDP 5 remained relatively consistent for FY21 as shown in Figure 13 and Figure 14. Long-term average trends have shown stable results within limits. Graphs depicting trends in water quality over previous years is provided in Appendix 6: Dendrobium Long-Term Environmental Monitoring Data.

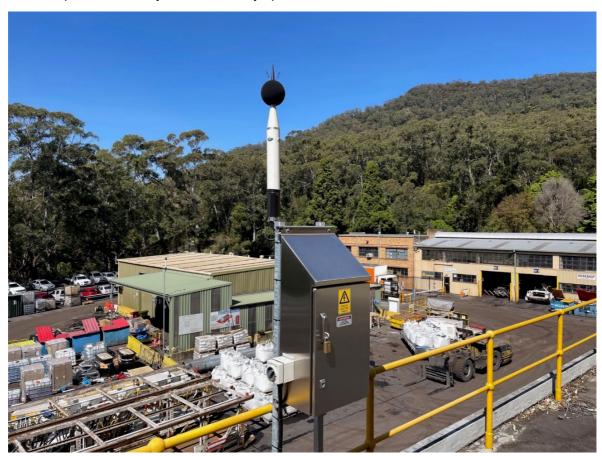
Noise trigger levels have been identified, and when the trigger levels are reached, a notification will be provided to the control room personnel. This will allow the control room personnel to identify noisy equipment or activities that are contributing to higher noise levels and take action to reduce noise levels on site where practical and feasible.

Plate 3: Real-time noise monitor on roof of Operations Building (Pit Top)

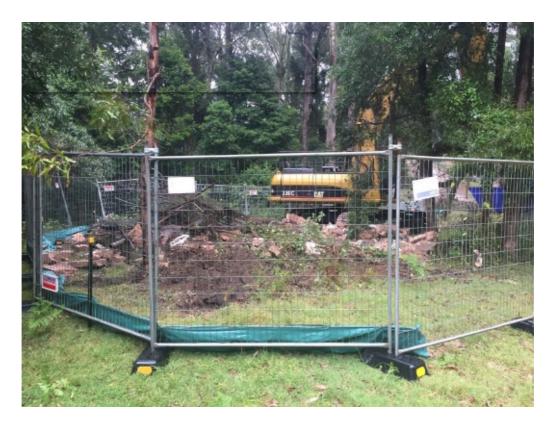
- Completion of reporting on projects undertaken during the FY20 reporting period.
- Removal of the O'Brien's Gap pumphouse (May 2021). This involved the demolition of the pumphouse building (see Plate 4). Contaminated soil identified post demolition is yet to be removed.
- Demolition and rehabilitation of a section of the 6-67 powerline circuit (Wongawilli to Wongawilli Air Shaft) that was within rural residential areas (August 2020). This involved the removal of poles and wires.
- Removal of the final power pole associated with the 6-10/15 circuit from BlueScope Steel to Figtree, located in the Australian Rail Track Corporation (ARTC) corridor (June 2021).

Plate 4: Demolition of O'Briens Gap Pump House
