Watercourse	Site	Area	Easting (z56)	Northing (z56)	Z_Elevation [mAHD]	Catchment area [km <sup>2</sup> ]	Installation	Structure type		Logger
Wongawilli Ck	WWU	u/s A3B	290808	6189716	352.94	3.211	Stainless Steel housing	Natural control		Orpheus
Wongawilli Ck	WWL	d/s A3A,B	290975	6197526	261.86	20.079	Stainless Steel housing	Natural control		Diver
Wongawilli Ck	WWL_A	d/s A3A,B	290962	6197370	263.22	19.602	PVC housing	Half pipe	225 mm	Orpheus
WC21	WC21S1	A3B	290529	6194255	283.07	2.434	Stainless Steel housing	Natural control		Diver
WC15	WC15S1	A3B	290754	6192239	324.71	1.192	PVC housing	Natural control		Diver
WC12	WC12S1	A3B	290964	6191459	322.34	0.380	Polypipe housing	Weir and half pipe flume	150 mm	Orpheus
LA2	LA2S1	A3B	288364	6191364	324.65	0.824	Polypipe housing	Weir and half pipe flume	150 mm	Orpheus
LA3	LA3S1	A3B	288385	6191548	323.82	0.375	Polypipe housing	Weir and half pipe flume	150 mm	Orpheus

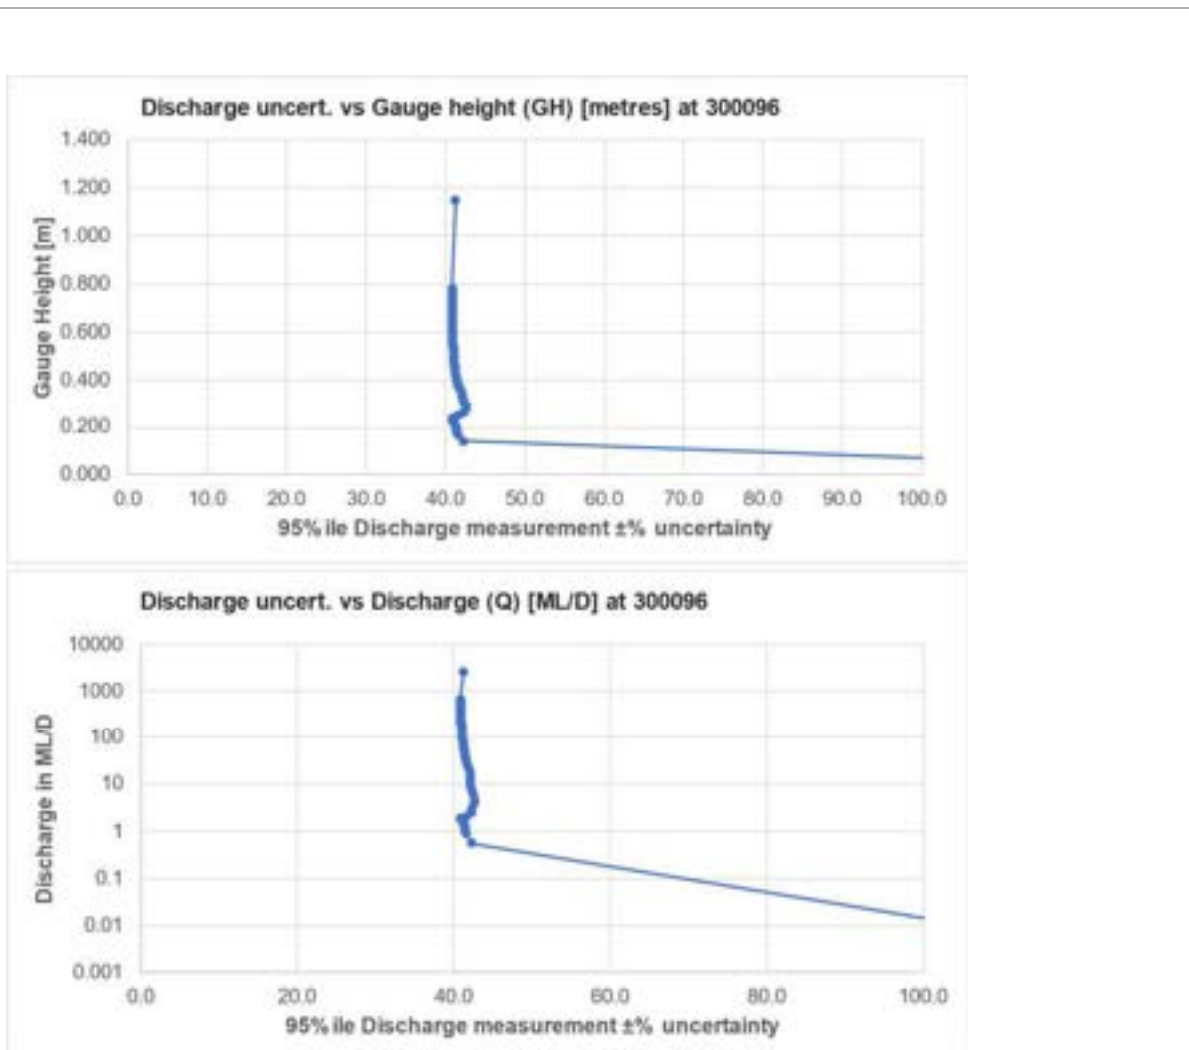
## Gauge 300096 – CR36

The use of an artificial control (halfpipe) leads to generally lower uncertainty than for the natural control sites (e.g. DCS2, WC21).

- 8) There are 68 rating table change points- which seems excessive for such a site;
- 9) Most of the gaugings are at very small flowrates and depths, making the uncertainty of individual gaugings (and hence the rating curve plotted through them) to also be higher;
- 10) Note the existence of the one high gauging at 0.91m, quite a rarity- this stops the extra uncertainty of rating curve extension for most of the range of interest.
- 11) The % deviation varies of similar magnitude whether gauging is volumetric or pygmy meter in half pipe

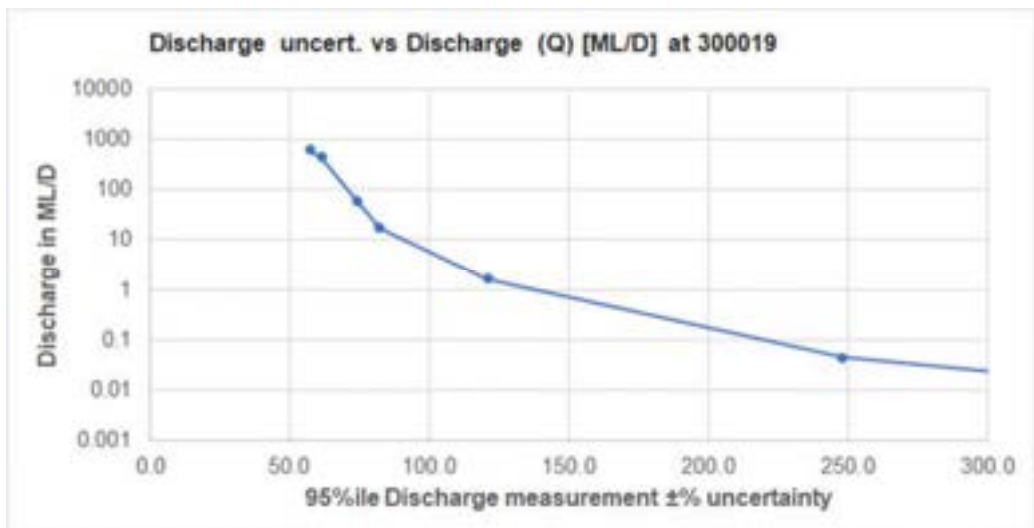
Gauge 300019 – SC10CS1

The reliance on natural control at this site leads to higher uncertainty than for the artificial/flume sites.

Comments from Enviromon:

- 1) 22 of the 24 gaugings have deviations greater than 10%, and 19 greater than 20%- ALS to address why there are so many with significant differences;
- 2) 18 of the 24 gaugings are in the depth range from CTF to 0.05 m, but the rating only has 3 points covering this range- ALS to address why only 3 points used. Is it related to the fact that many of the gaugings show large deviations (see point 1, above)?
- 3) Level measurement uncertainty is high at this site, mainly due to two particular field check differences (26mm on 10/2/21, and 23mm on 23/11/22). The hypotheses are that the sensor could be becoming faulty, or are these large differences due to inaccuracy in field measurements. ALS to consider.

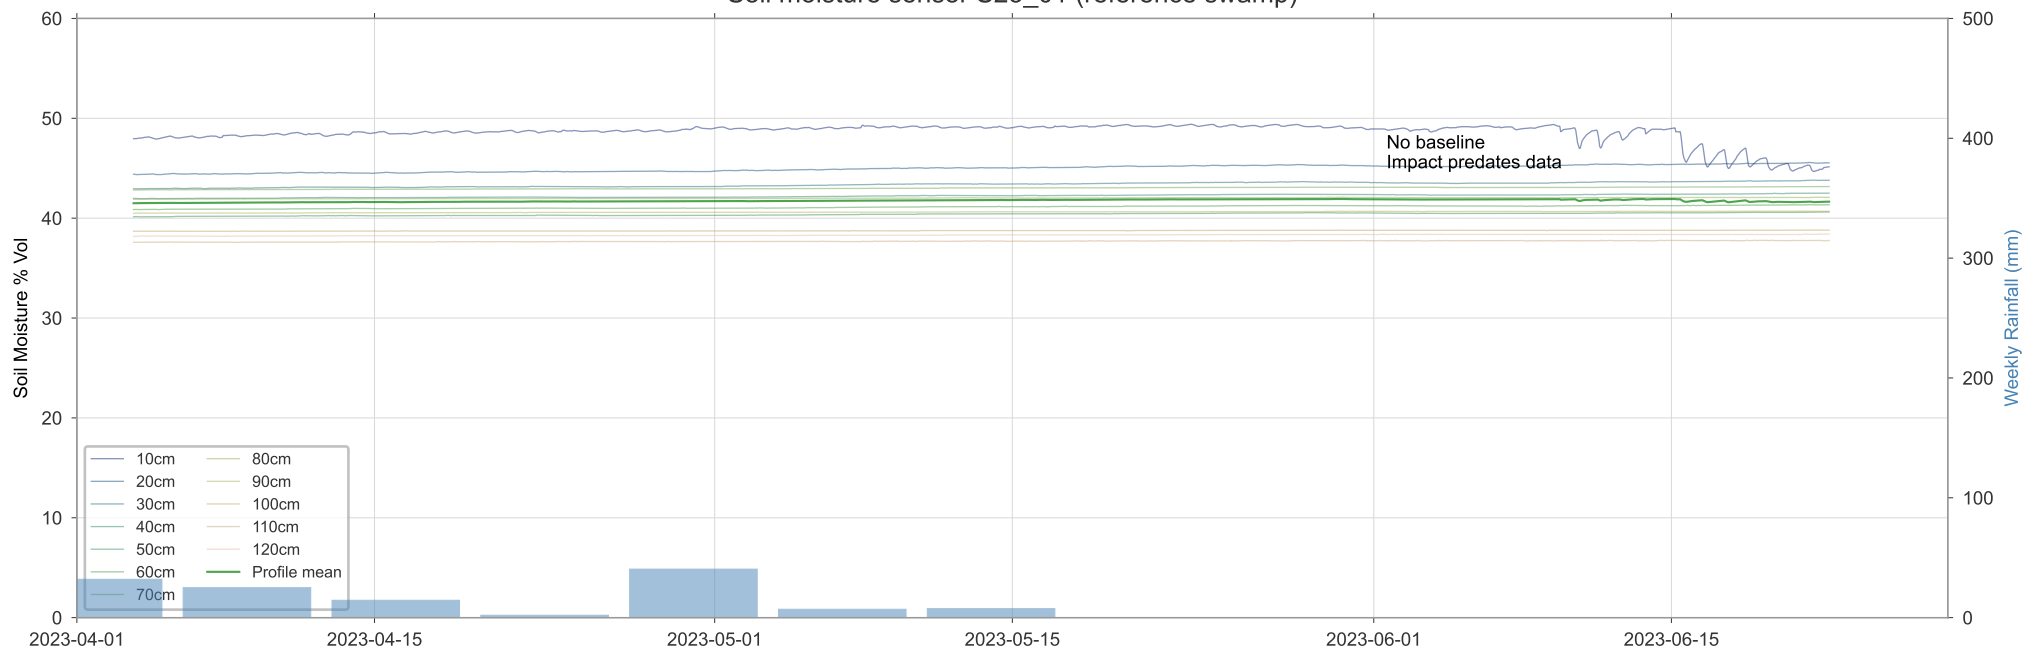
Soil moisture sensor S25\_01 (reference swamp)
