Illawarra Coal

Appin Area 7 Longwall 705 Landscape End of Panel Report

May 2014

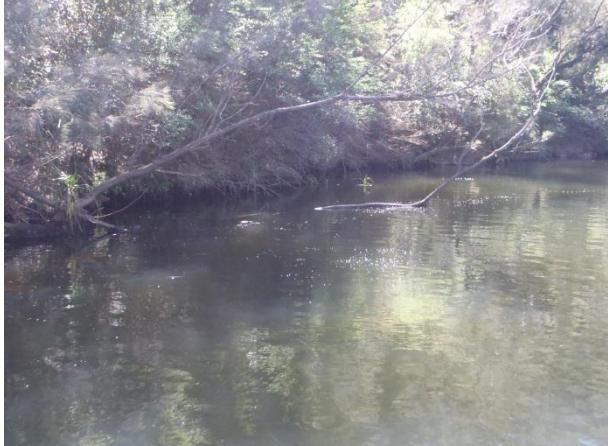
Photo 1: AA7LW705 Gas Zone 16 looking downstream. Taken on 04/10/2012.

Three gas zones (Gas Zones 16, 17 and 18) have been observed on the Nepean River. Gas Zone 16 was first observed on the 4th October 2012 and consisted of multiple releases in an approximate 60m x 5m area. This release has not been active since the 17th January 2014 (**Photos 1 - 3**). Gas Zone 17 was first observed on the 12th February 2013 and has not been active since the 19th February 2014. It consisted of up to seven releases (**Photos 4 & 5**). Gas Zone 18 was first observed on the 18th March 2013 and consisted of up to 20 releases; it remains active at the time of this report (**Photos 6 & 7**).

The flow rate from Gas Zone 16 was estimated to be approximately 200L/min. Gas Zones 17 and 18 were too small and diffused to estimate flow rates. The releases are Level 1 Impacts according to the TARPs, specifically: Identification of strata gas plume of flow rate <3000L/min.

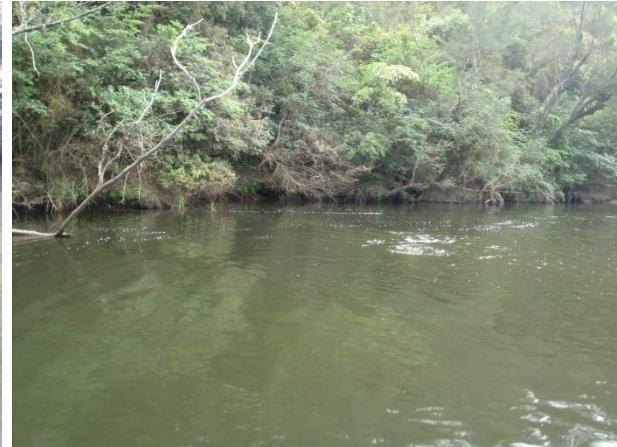
Photo 2: AA7LW705 Gas Zone 16 looking downstream. Taken on 23/10/2012.

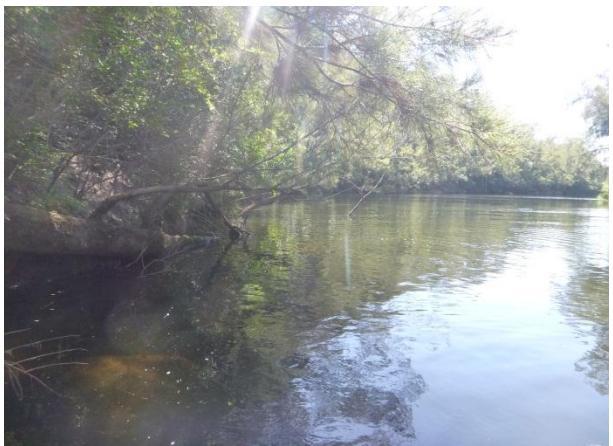
Photo 3: AA7LW705 Gas Zone 16 looking down stream. Gas zone not active. Taken on 17/01/2014.

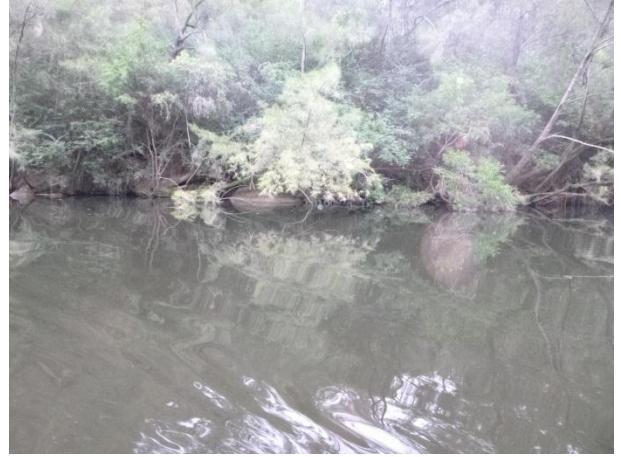
Photo 5: AA7LW705 Gas Zone 17 looking across stream. Gas zone not active. Taken on 19/02/2014.

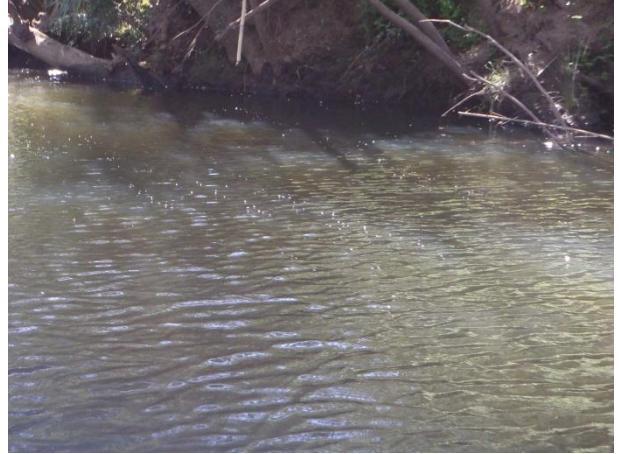
Photo 7: AA7LW705 Gas Zone 18 looking downstream across stream. Taken on 18/03/13.

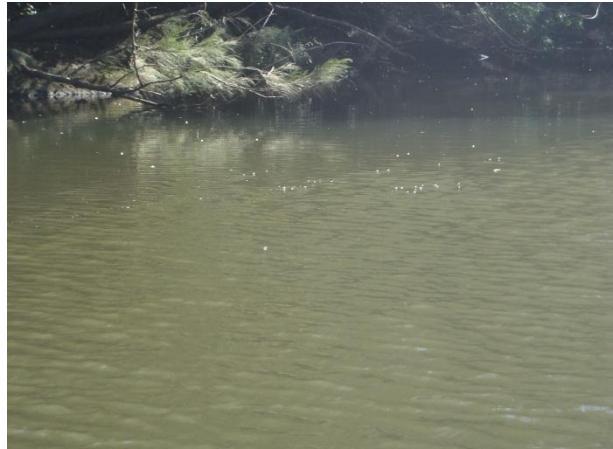
Photo 4: AA7LW705 Gas Zone 17 looking across stream. Taken on 18/03/2013.

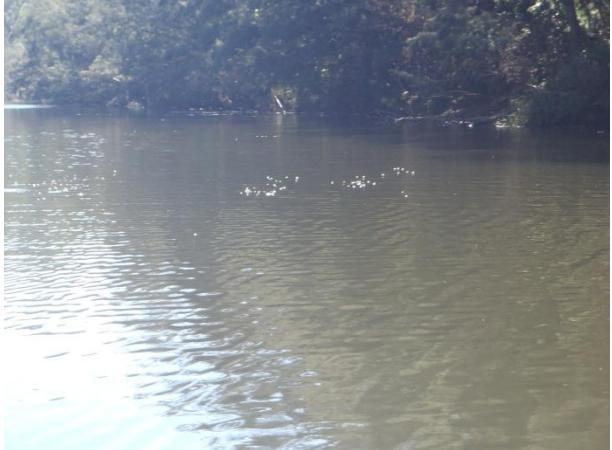
Photo 6: AA7LW705 Gas Zone 18 looking downstream. Taken on 18/03/13.

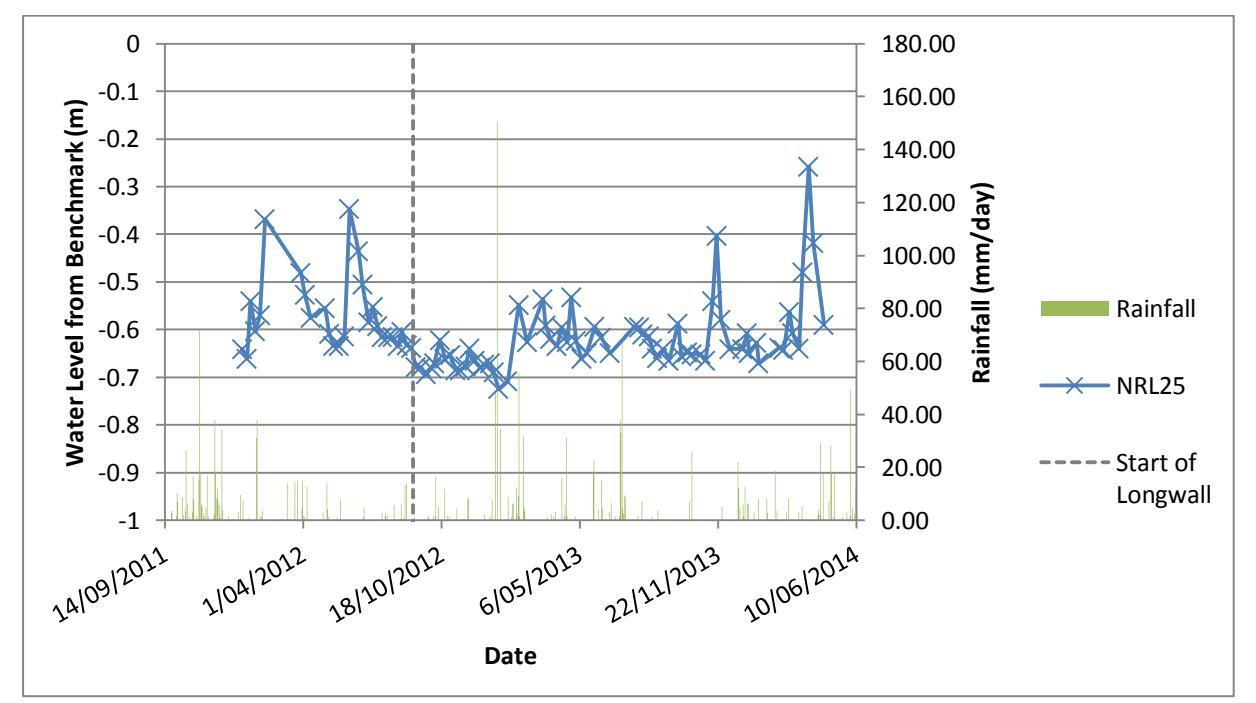
Figure 2: Comparison of Water Level at Nepean River site NRL25 with Daily Rainfall before and after the beginning of Longwall 705. Rainfall data collected from *Bureau of Meteorology (BoM) Douglas Park (St Marys Towers) NSW.*

impacts to the water levels of the Nepean River or its tributaries were observed during the extraction of Longwall 705 (**Figures 2 – 5**).

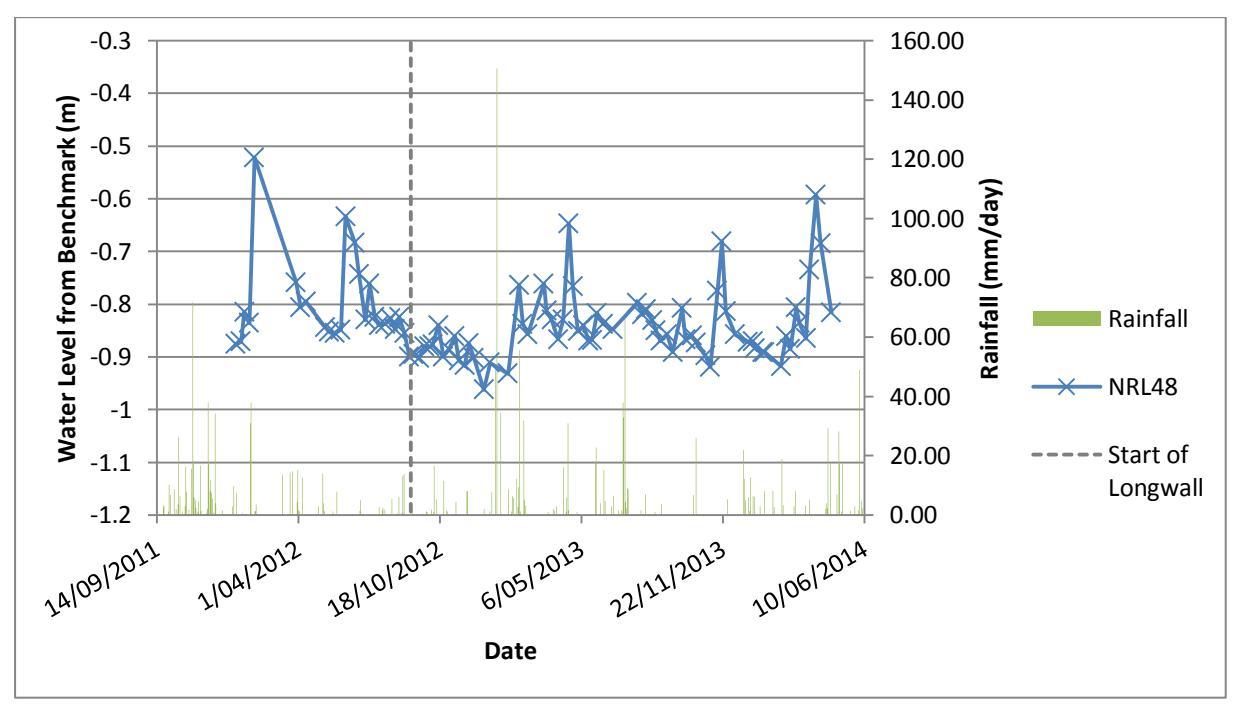
Figure 3: Comparison of Water Level at Nepean River site NRL48 with Daily Rainfall before and after the beginning of Longwall 705. Rainfall data collected from *Bureau of Meteorology (BoM) Douglas Park (St Marys Towers) NSW.*

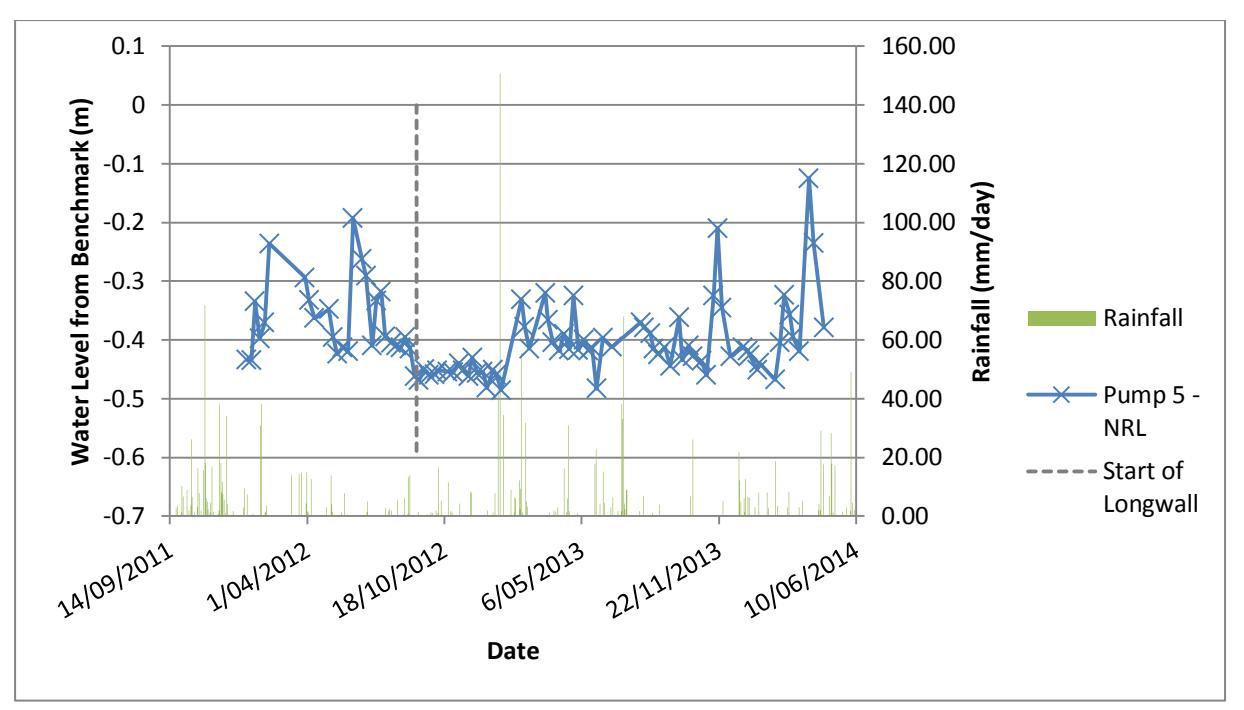
Figure 4: Comparison of Water Level at Nepean River site Pump 5 – NRL with Daily Rainfall before and after the beginning of Longwall 705. Rainfall data collected from *Bureau of Meteorology (BoM) Douglas Park (St Marys Towers) NSW.*

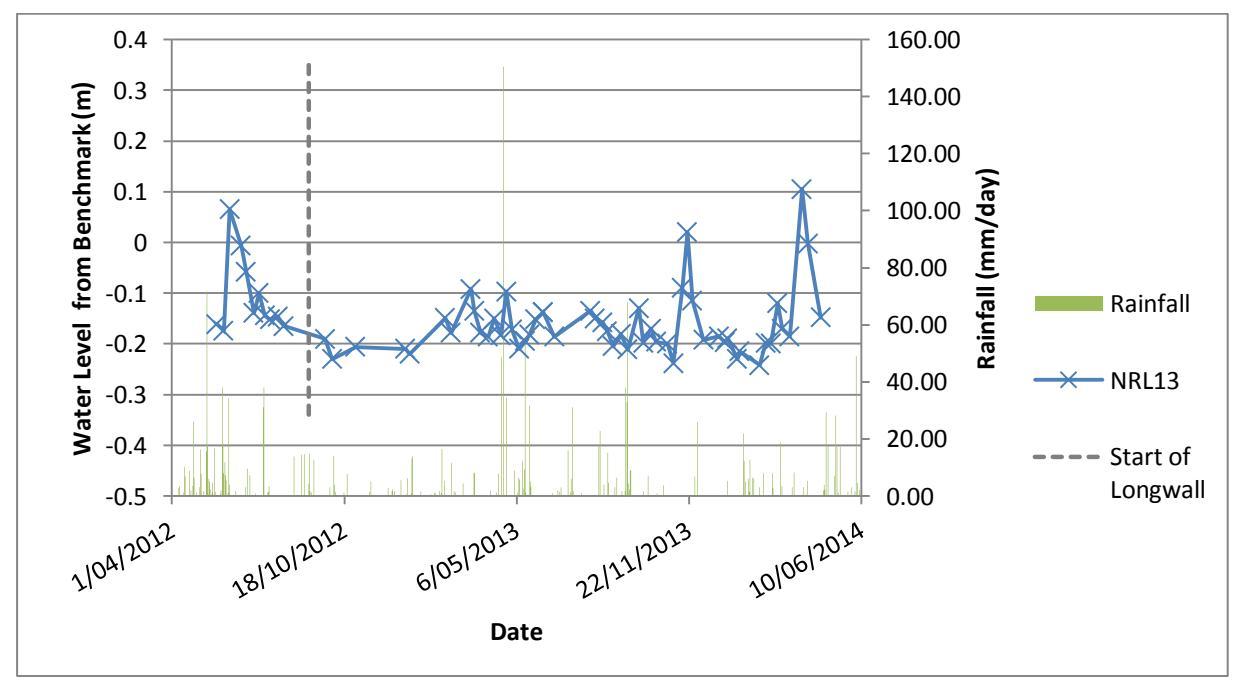
Figure 5: Comparison of Water Level at Nepean River site NRL13 with Daily Rainfall before and after the beginning of Longwall 705. Rainfall data collected from *Bureau of Meteorology (BoM) Douglas Park (St Marys Towers) NSW.*

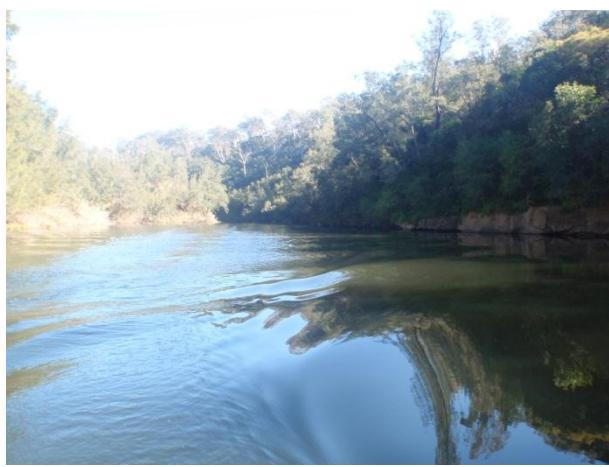
Photo 8: NRL25, located downstream of Longwall 705, looking downstream. Taken on 05/09/12 (prior to start of Longwall 705).

The appearance of the Nepean River and its tributaries is monitored by the ICEFT on a weekly basis (when access is available). Photographs are taken of monitoring sites, gas zones and any other potential impact site. No impacts to the appearance of the Nepean River or its tributaries were observed during the extraction of Longwall 705 (**Photos 8 – 13**).

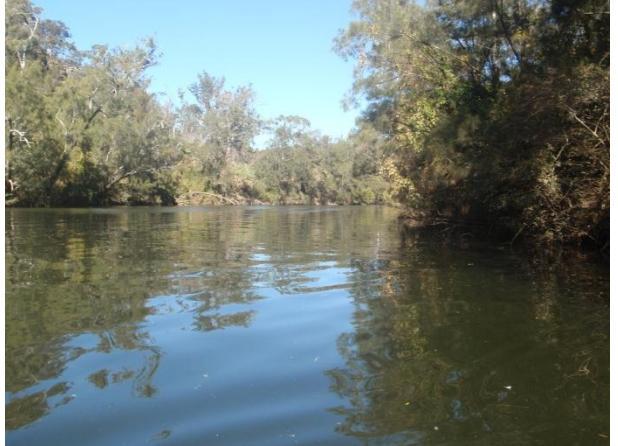
Photo 10: NRL48, located upstream of Longwall 705, looking upstream. Taken on 05/09/12 (prior to start of Longwall 705).

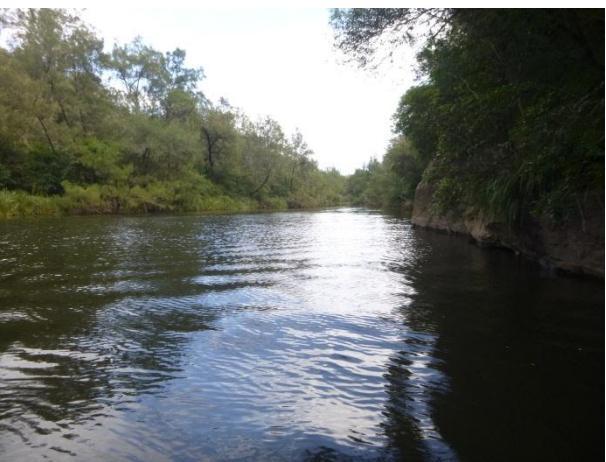
Photo 9: NRL25, located downstream of Longwall 705, looking downstream. Taken on 16/04/14 (Following extraction of Longwall 705).

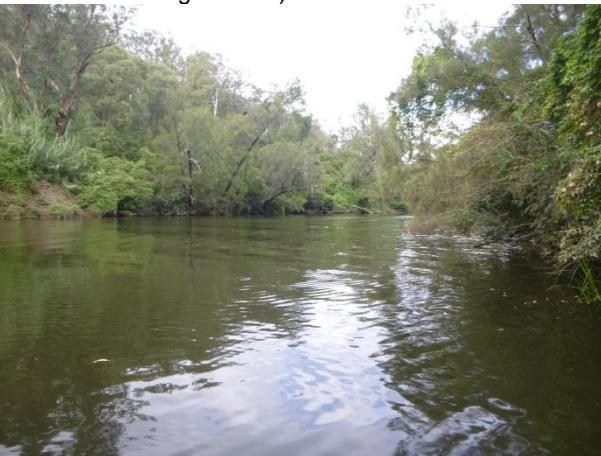
Photo 11: NRL48, located upstream of Longwall 705, looking upstream. Taken on 16/04/14 (Following extraction of Longwall 705).

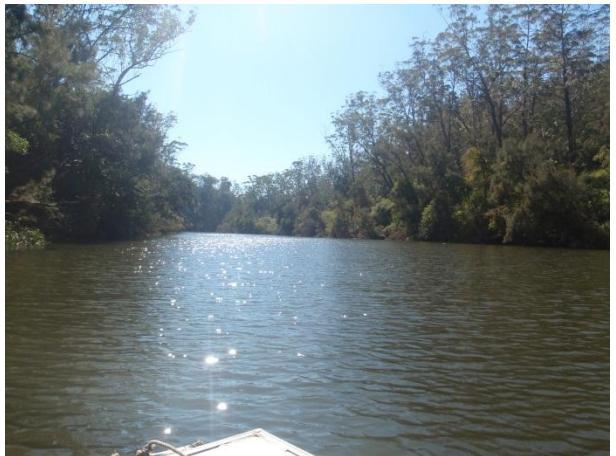
Photo 12: NR13, located downstream of Longwall 705, looking downstream. Taken on 05/09/12 (prior to start of Longwall 705).

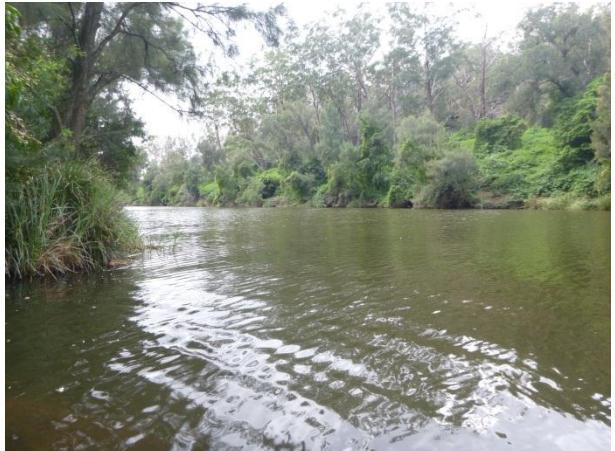
Photo 13: NR13, located downstream of Longwall 705, looking downstream. Taken on 16/04/14 (Following extraction of Longwall 705).

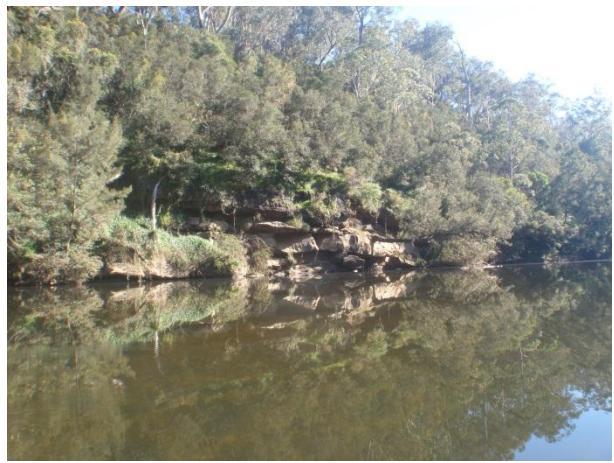
Photo 14: Cliffline downstream of site Pump 2 – NRL before mining. Taken on 05/09/12 (before start of Longwall 705).

Observations and photographs of landscape features such as cliffs and steep slopes along the Nepean Gorge and associated tributaries were conducted by the ICEFT. No impacts to landscape features were found during the extraction of Longwall 705 (**Photos 14 - 17**).

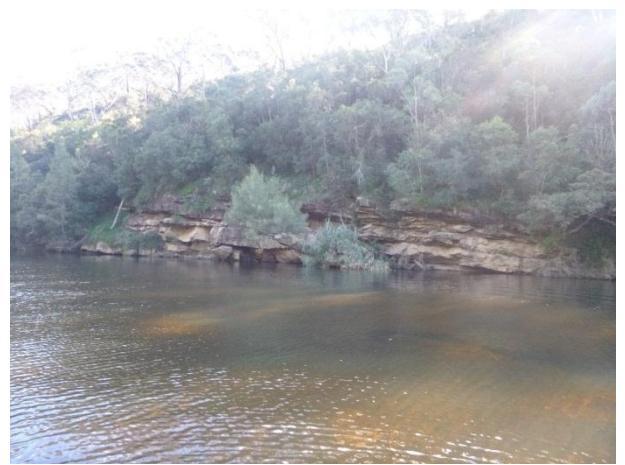
Photo 15: Cliffline downstream of site Pump 2 – NRL before mining. Taken on 30/04/14 (after start of Longwall 705).

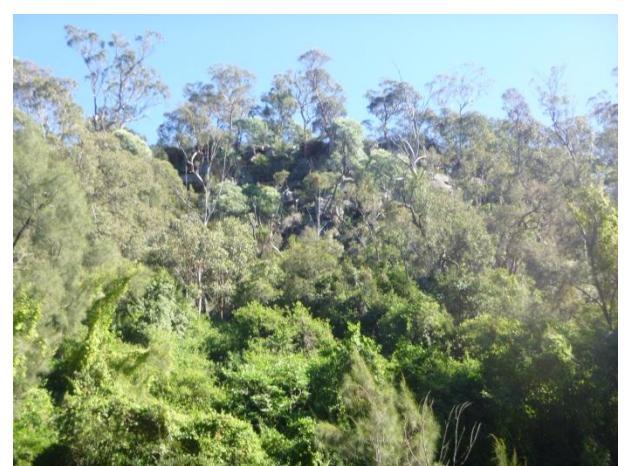
Photo 16: Cliffline near NR11, no impact. Taken on 30/04/14.

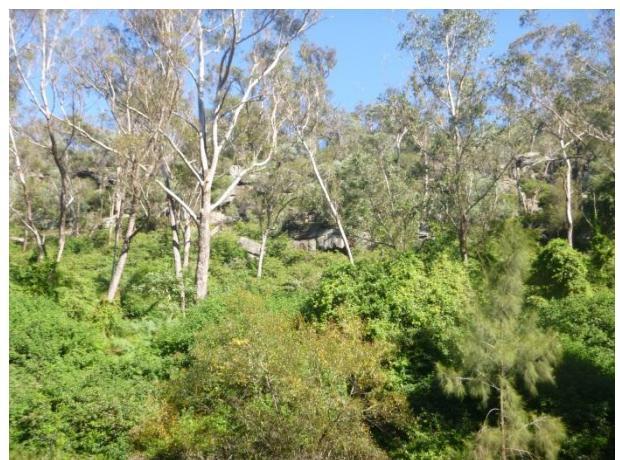
Photo 17: Cliffline and steep slope area near NR11, no impact. Taken on 30/04/14.
