≡III III≡ SOUTH32 Illawarra Metallurgical Coal

POLLUTION INCIDENT RESPONSE MANAGEMENT PLAN (EPL 2504) APPIN MINE

This document UNCONTROLLED once printed				
Document ID	APNMP0124	Version	2.1	Page 1 of 60
Last Date Updated	23/11/2023	Next Review Date	6/03/2026

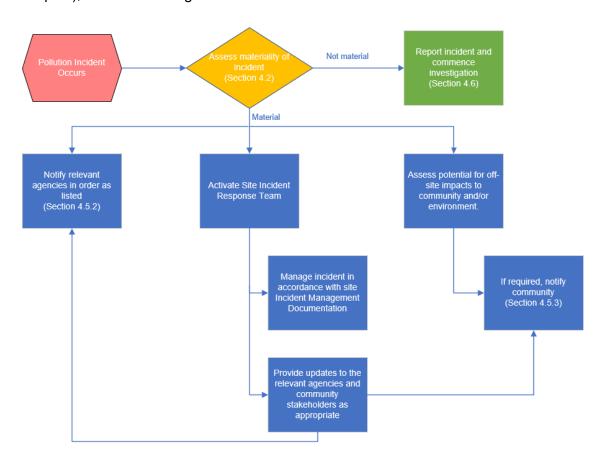
Figure 1: Incident Response Process Flow

The incident response protocols, including the communication protocol and on-site emergency response actions for responding to an incident that has resulted in a material impact to human health or the environment (as per the definition provided in Section 4.3 of this plan), are shown in Figure 1.
