# Appin Mine

Area 9 Longwall 905 End of Panel surface water and groundwater monitoring review

Project number: J21562

Report: D23216

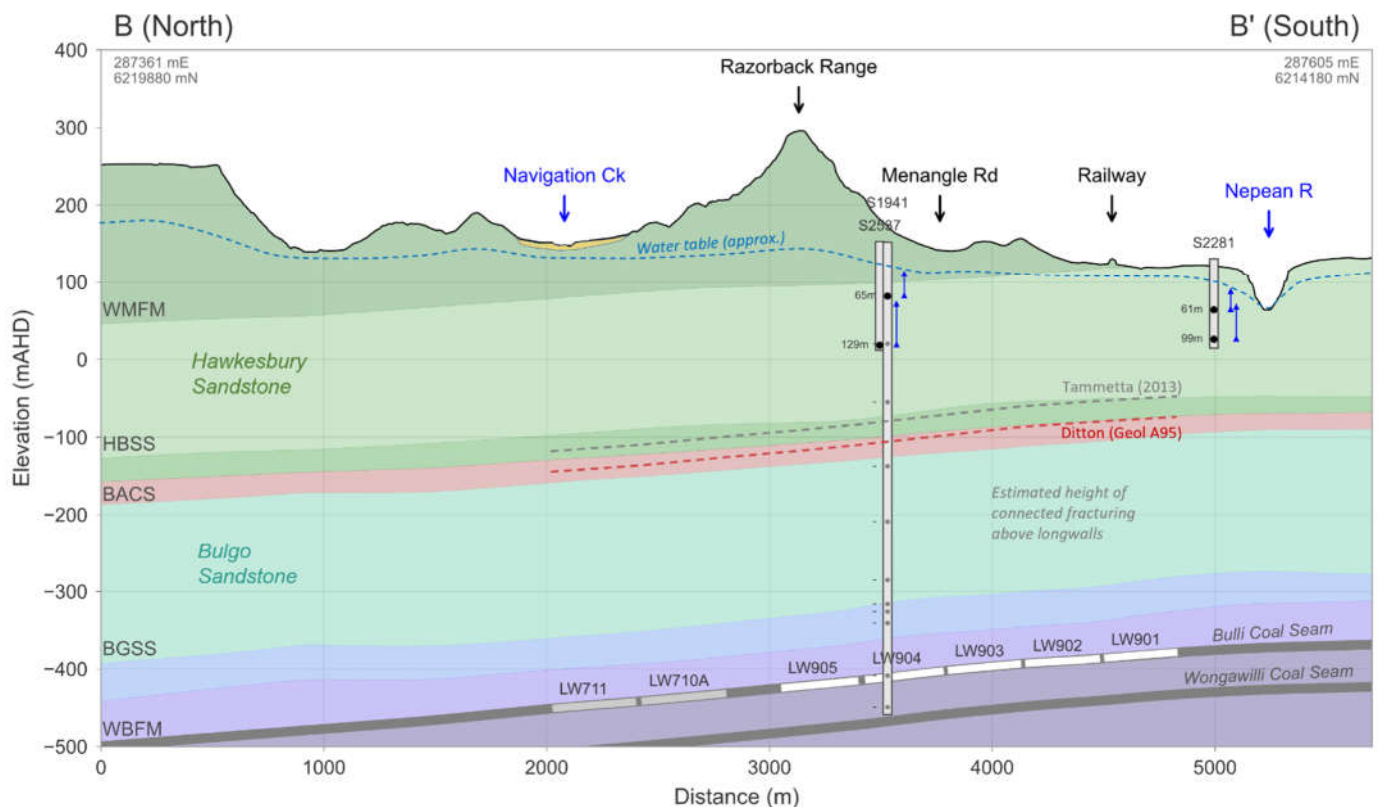
Figure 5. Hydrogeological cross section (N-S) through AA7 / 9

Appin Colliery is located within the Southern Coalfield within the Sydney Geological Basin. The Bulli and Wongawilli Coal Seams are the primary target seams in the top part of the Illawarra Coal Measures. The Coal Measures are overlain by Triassic sandstones, siltstones and claystones of the Narrabeen Group, the Hawkesbury Sandstone and the Wianamatta Group. The Hawkesbury Sandstone is the dominant outcropping formation adjacent to, and underlying, the Nepean River Gorge. Wianamatta Group shales and claystone-dominated units underlie elevated areas including the Razorback Range. The geology and hydrogeology of the area is illustrated in a north-south cross section in Figure 5.

Group is a confined aquifer in the Study Area. Multi-level piezometers indicate locally artesian groundwater pressures (e.g. Bore S1913; Figure 5)
