SANDY CREEK WATERFALL MANAGEMENT PLAN

1 INTRODUCTION

The Sandy Creek Waterfall Management Plan has been revised to monitor and manage the proposed extraction of Longwall 19 at Dendrobium Mine.

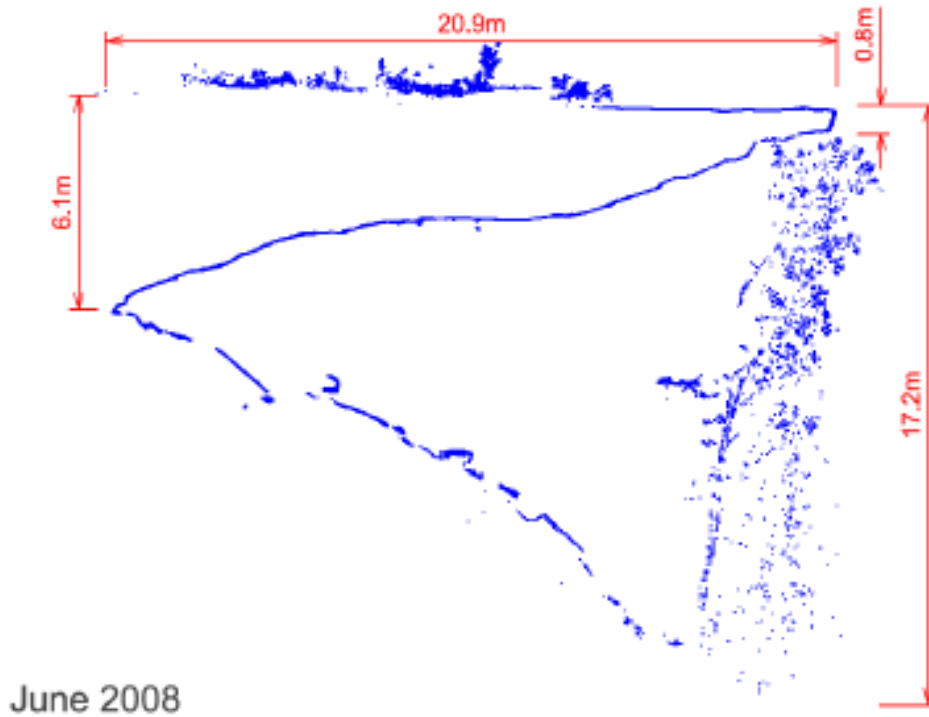
Sandy Creek Waterfall - Nominal Cross Section

Figure 5 Sandy Creek Waterfall Nominal Cross Section based on Terrestrial Laser Scan

In addition to the regional topography IMC has undertaken Terrestrial Laser Scans (TLS) within the overhang and the top of the overhang to define the extent of the overhang as an input to geomechanical modelling. Figure 5 shows a section along the centreline of the creek, through Sandy Creek Waterfall.

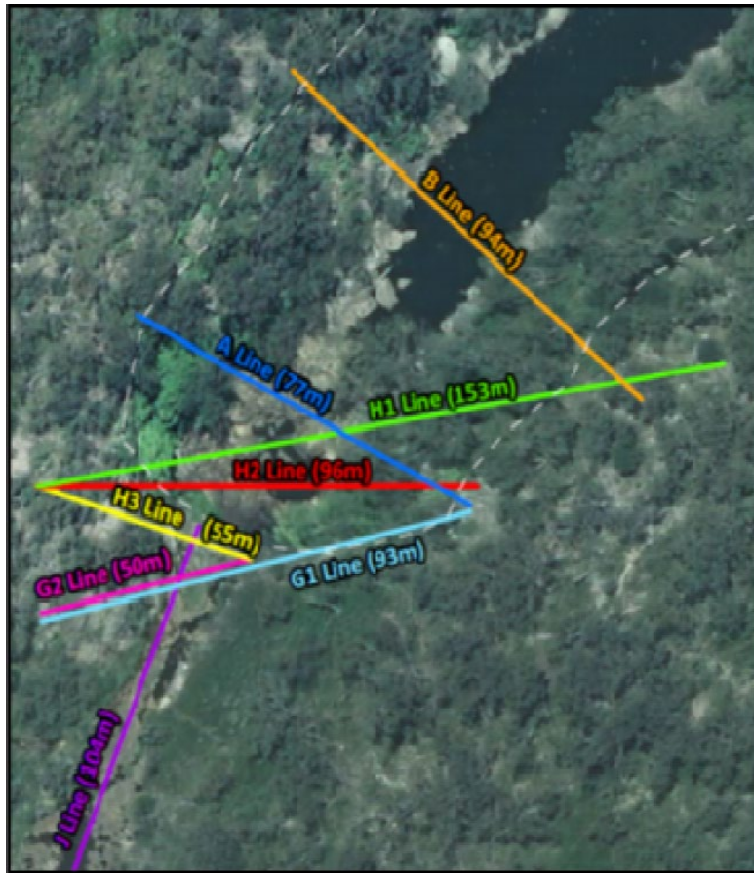
Figure 7 Sandy Creek Waterfall High Resolution Survey H1, H2, H3, G1, G2 and AA Lines

The valley closure effects across Sandy Creek Waterfall due to the mining of Longwalls 6 to 8 were measured using the Sandy Creek Waterfall High Resolution Survey (HRS) H1, H2, H3, G1, G2 and AA Lines. The locations of these monitoring lines are shown in Figure 7.

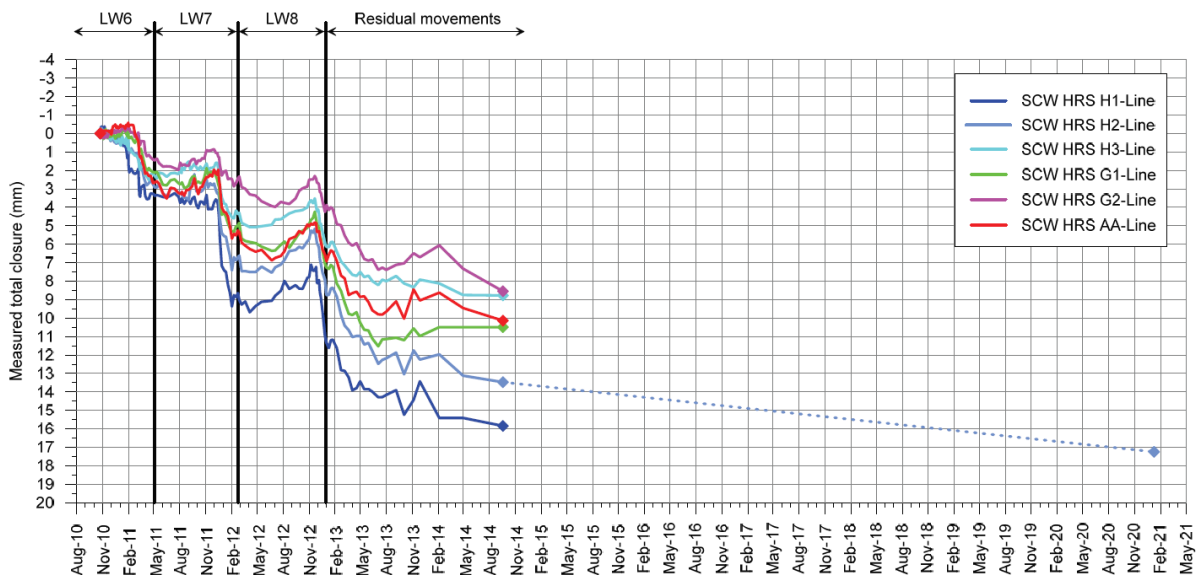
Figure 8 Measured total closure for the Sandy Creek Waterfall high resolution survey monitoring lines for Longwalls 6 to 8

The measured total closures for Sandy Creek Waterfall HRS lines are illustrated in Figure 8. The survey accuracy for these high-resolution monitoring lines is in the order of ± 0.5 mm to ± 1 mm. The measured movements also include a component due to environmental effects (i.e. changes in temperature and rainfall) in the order of ± 1 mm to ± 2 mm.

The maximum total closure measured at the Sandy Creek Waterfall HRS lines is 17 mm at the H2-Line. The actual closure at the H1-Line could be slightly greater than this value, as additional movements could have occurred after the last survey in September 2014, as was observed for the H2-Line.
