SANDY CREEK WATERFALL MANGEMENT PLAN

The Sandy Creek Waterfall Management Plan has been revised to monitor and manage the proposed extraction of Longwalls 19 and 19A at Dendrobium Mine.

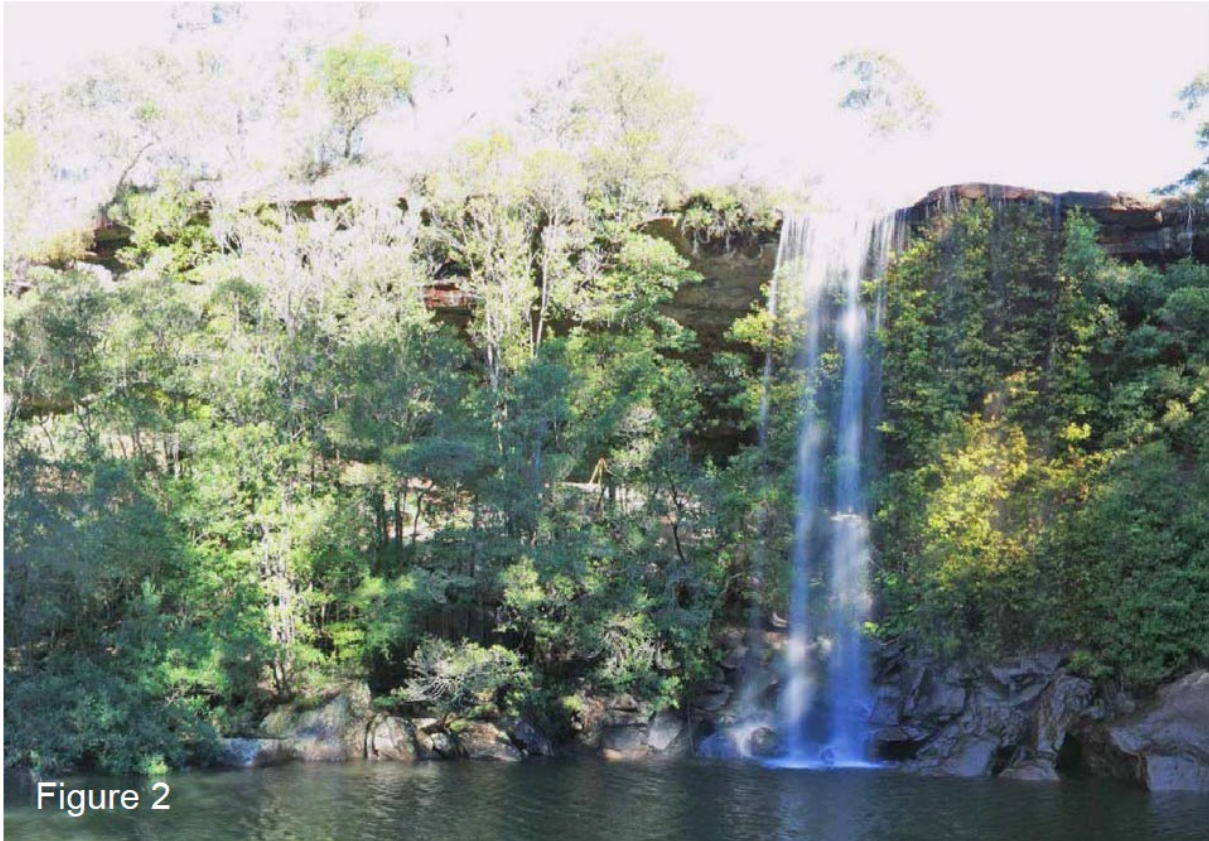
Figure 2 Photograph of Sandy Creek Waterfall

Sandy Creek Waterfall is located within the Metropolitan Special Catchment Area, at the point where Sandy Creek flows into Cordeaux Reservoir. The waterfall is a 25 m high concave cliff face with a maximum overhang of 20 m. Figure 1 shows the location of the waterfall in relation to the reservoir. Figure 2 and Figure 3 are images which capture the nature of the waterfall and the overhang.

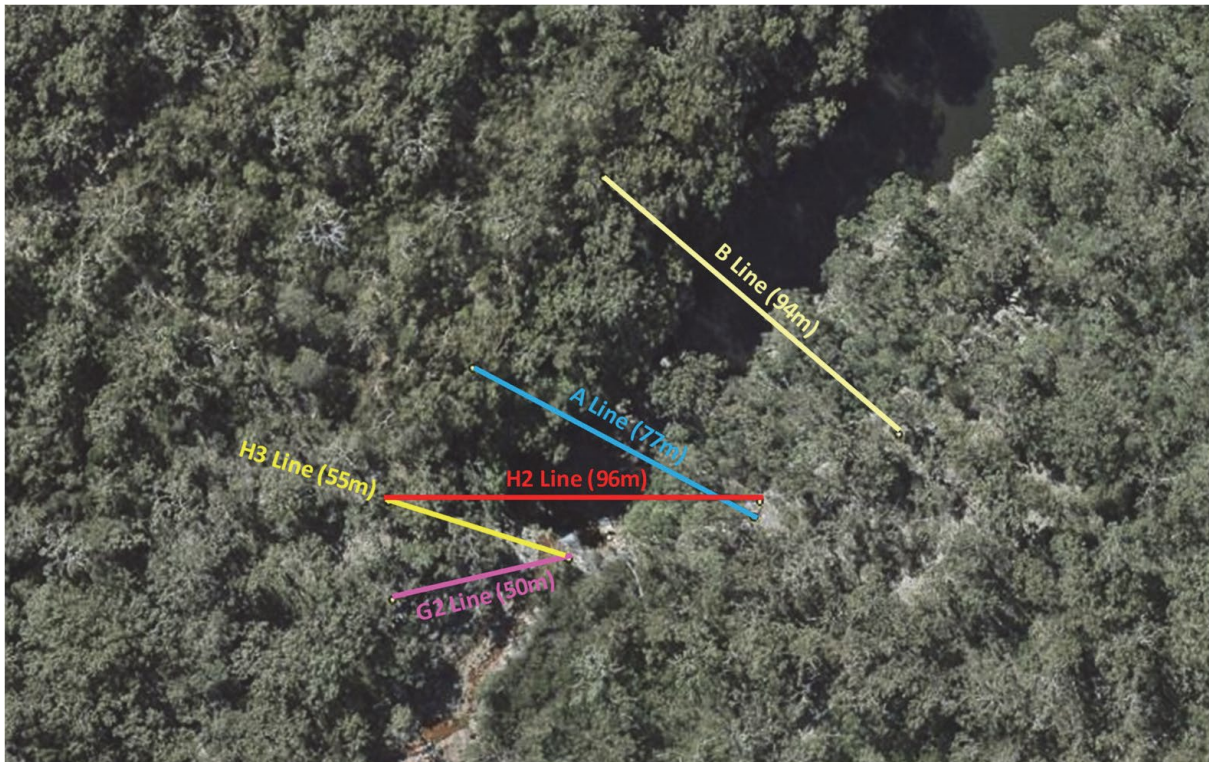
Figure 7 SCW High Resolution Survey A, B, H2, H3 and G2 Lines

The valley closure effects across Sandy Creek Waterfall due to the mining of Longwall 19 were measured using the SCW High Resolution Survey (HRS) A, B, H2, H3 and G2 Lines. The locations of these monitoring lines are shown in Figure 7. Three survey lines which were monitored during extraction of Longwall 6 to 8 were not able to be re-established due to significant vegetation growth blocking the line of sight.

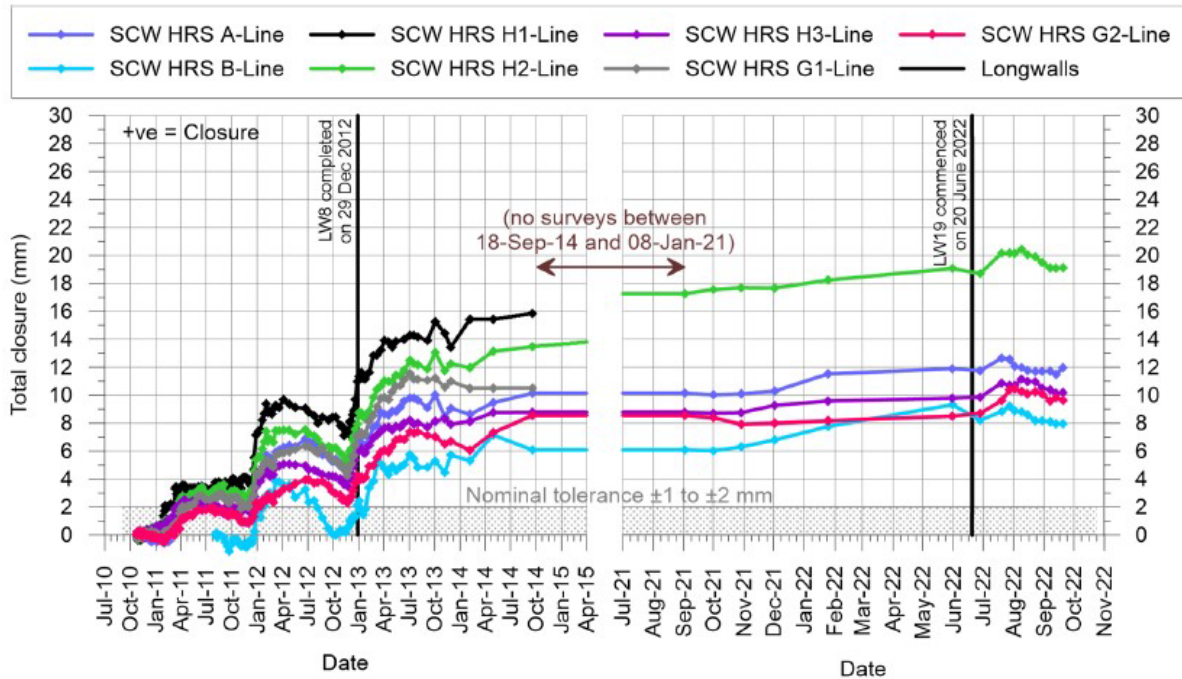
Figure 8 Measured total closure for the Sandy Creek Waterfall high resolution survey monitoring lines for Longwalls 6 to 8 and Longwall 19

The measured total closures for SCW HRS lines are illustrated in Figure 8. The survey accuracy for these high-resolution monitoring lines is in the order of ± 0.5 mm to ± 1 mm. The measured movements also include a component due to environmental effects (i.e. changes in temperature and rainfall) in the order of ± 1 mm to ± 2 mm.

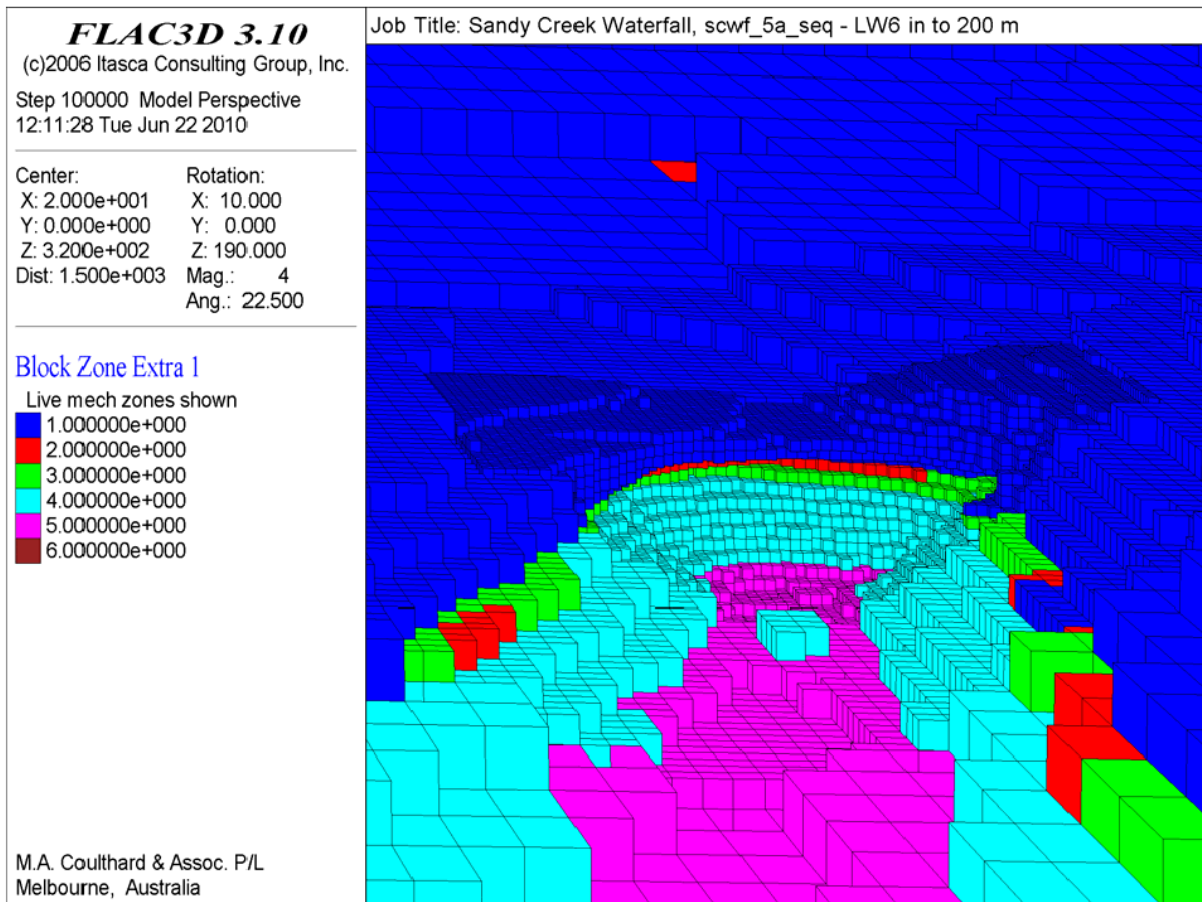
Figure 9 Detail of Sandy Creek Waterfall in Numerical Model

Prior to Longwall 6 approaching the Waterfall, Dr Michael Coulthard of M.A. Coulthard and Associates prepared a three dimensional numerical model using FLAC3D software under the direction of Dr K Mills in consultation with the Technical Committee. The model is based on input from the topography defined by the ALS and TLS, geological model, geomechanical testing of rock properties and in situ stress. The model is 1,500 m x 1,500 m area to the base of the Bulgo Sandstone, centred on the waterfall. The model has graduated cell sizes 2 m adjacent to the waterfall, increasing to 10 m at the margins of the model. Figure 9 shows the central part of the model grid showing the valley geometry and stratigraphy.
