DENDROBIUM MINE AND CORDEAUX COLLIERY ANNUAL REVIEW FY22

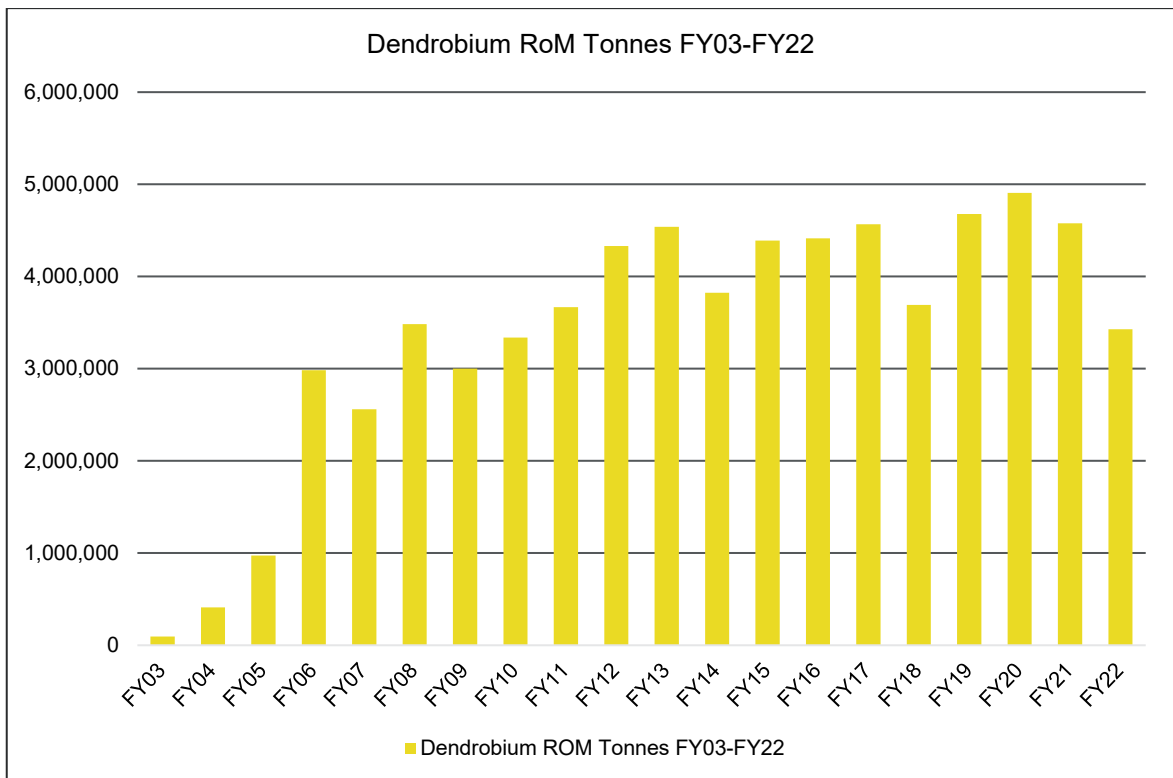
Figure 1: RoM Production for Dendrobium Mine.

The RoM product for the reporting period was 3.43 million tonnes with a saleable product yield of 76%. A comparison showing the RoM production at Dendrobium Mine for past reporting periods is provided in Figure 1. During this reporting period, Dendrobium continued longwall mining in Area 3B and relocated to Area 3A in June 2022. Development will continue in Area 3A and 3C in the next reporting period.

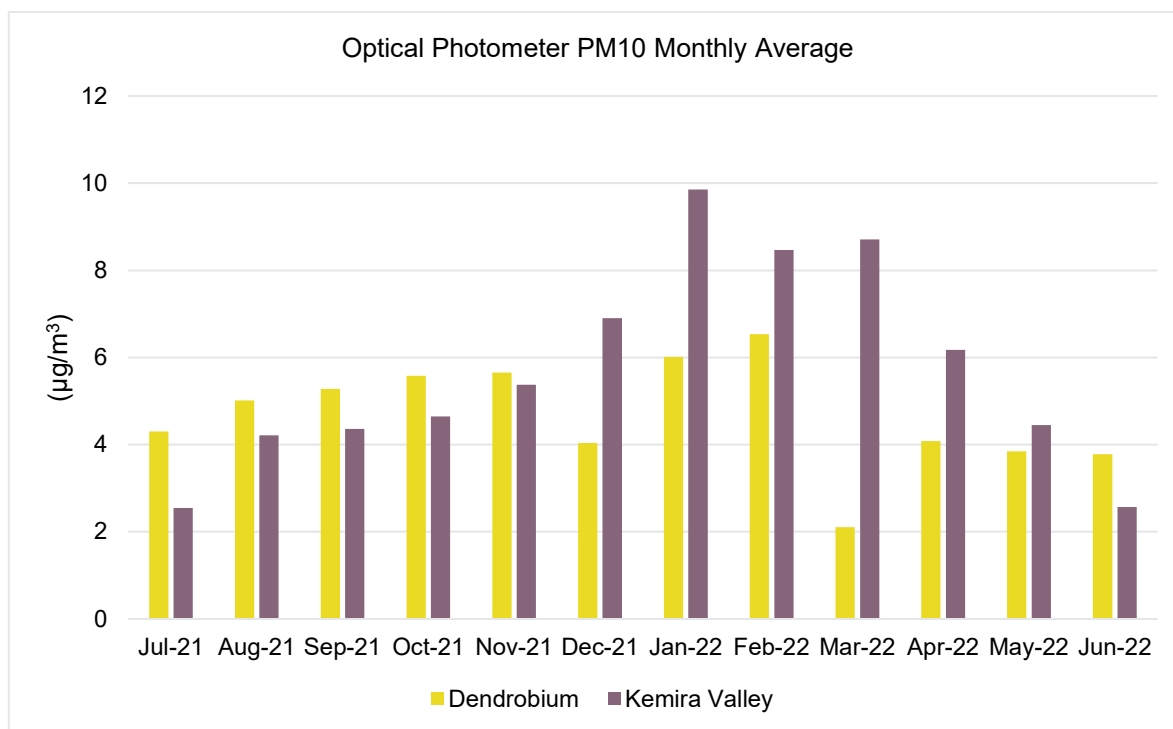
Figure 2: Optical Photometer Results - FY22

Dust levels measured by the optical photometers at both Kemira Valley and Dendrobium displayed levels well below the required limits, as shown in Figure 2. In addition to mitigation measures implemented on site, significant rainfall over the majority of the reporting period has also assisted in the reduction of dust emissions. As this is the first reporting period for the optical photometers, a direct comparison to long term trends is not possible, however the results are below the air quality impact assessment criteria. A direct comparison to previous reporting periods will be included in future Annual Reviews.

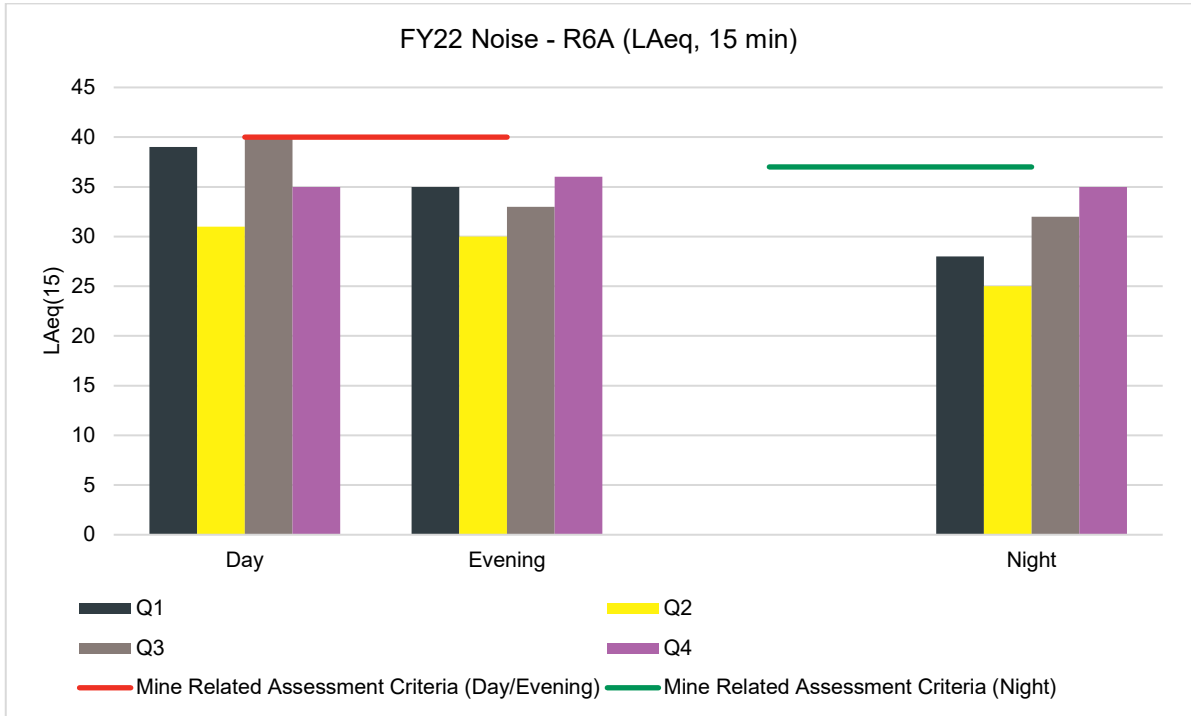
Figure 15: Site R6a Noise Compliance (LAeq,15 min) – FY22

R6a is located to the east of the Dendrobium Pit Top. The representative noise results did not exceed the noise criteria during the reporting period. LAeq 15-min representative noise results for R6a for FY22 are provided in Figure 15 and annual averages are provided in Figure 16.

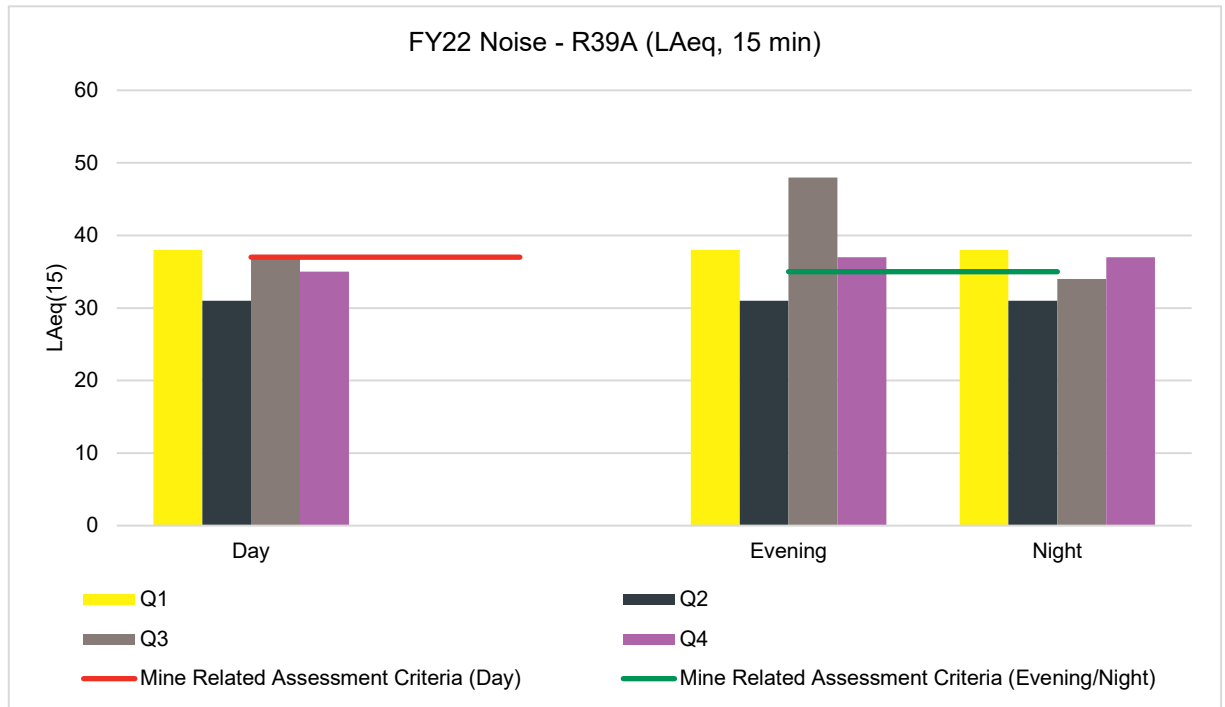
Figure 17: Site R39a Noise Compliance ($LA_{eq,15\text{ min}}$) – FY22

R39a is located to the south-east of the KVCLF. There were three exceedances of the $LA_{eq,15\text{ min}}$ noise assessment criteria in Condition 1 of Schedule 4 of the Consent in July 2021, one exceedance on 9 February 2022 and two exceedances on 2 June 2022. These exceedances are discussed in Section 11. The $LA_{eq,15\text{-min}}$ representative noise results for R39a are provided in Figure 17 and annual averages are provided in Figure 18.

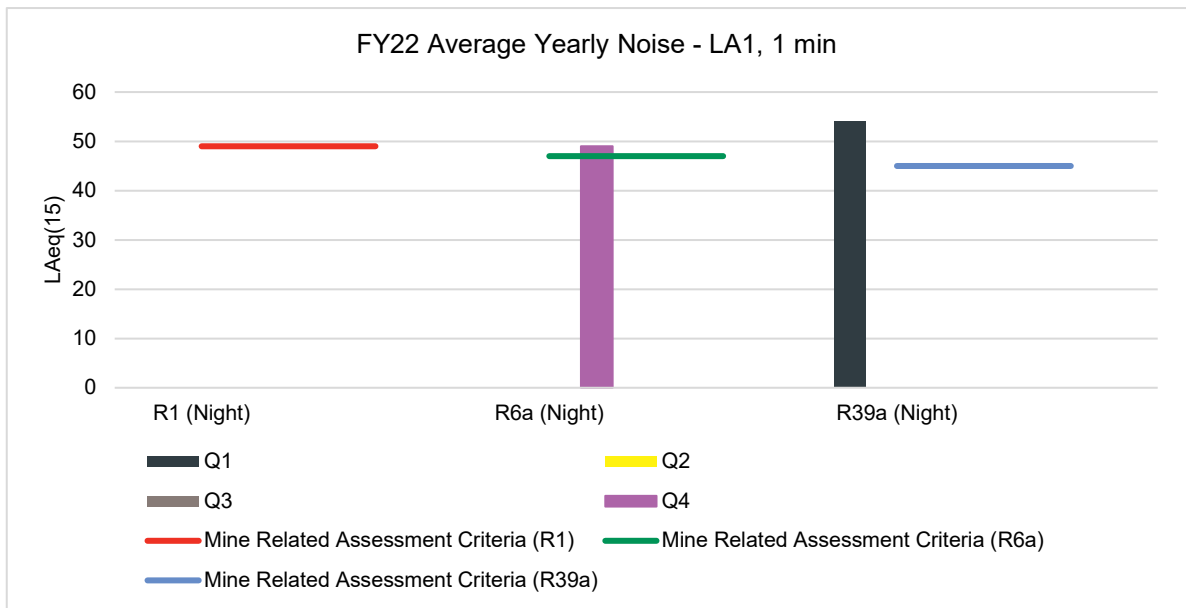
Figure 19: Site Noise Compliance (LA_{1,1 min}) for R1, R6a and R39a FY22¹²

There was one exceedance recorded for the LA_{1,1 min} noise impact assessment criteria in Condition 1 of Schedule 4 of the Consent at R39a in July 2021 and one exceedance at R6a recorded on 2 June 2022. These exceedances are discussed in Section 11. No exceedances or non-compliances were observed at R1 against LA_{1,1 min} criteria in Condition 1 of Schedule 4 of the Consent during the reporting period. LA_{1,1 min} representative noise results for sites R1, R6a and R39a are shown in Figure 19.

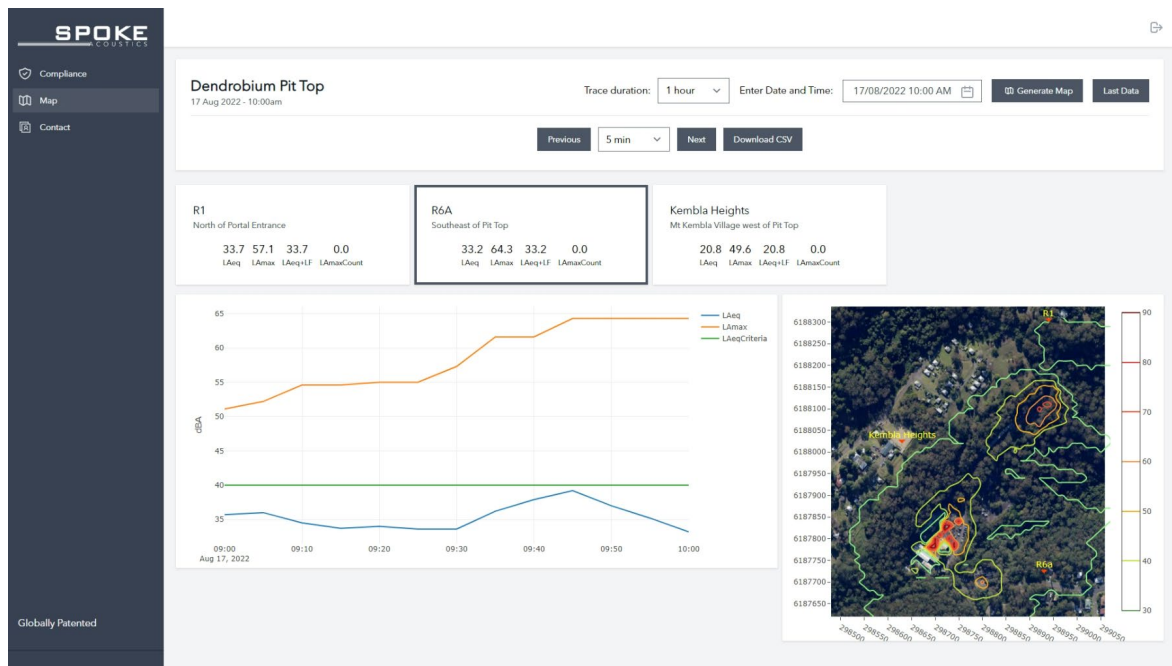
Plate 1: Real-time noise monitor system LA_{eq-15min} graph output

Noise trigger levels have been identified, and when the trigger levels are reached, it is planned for a notification to be provided to the appropriate site personnel using a traffic light warning system located in several locations around the Pit Top. This will allow site personnel to identify noisy equipment or activities that are contributing to higher noise levels and take action to reduce noise levels on site where practical and feasible.

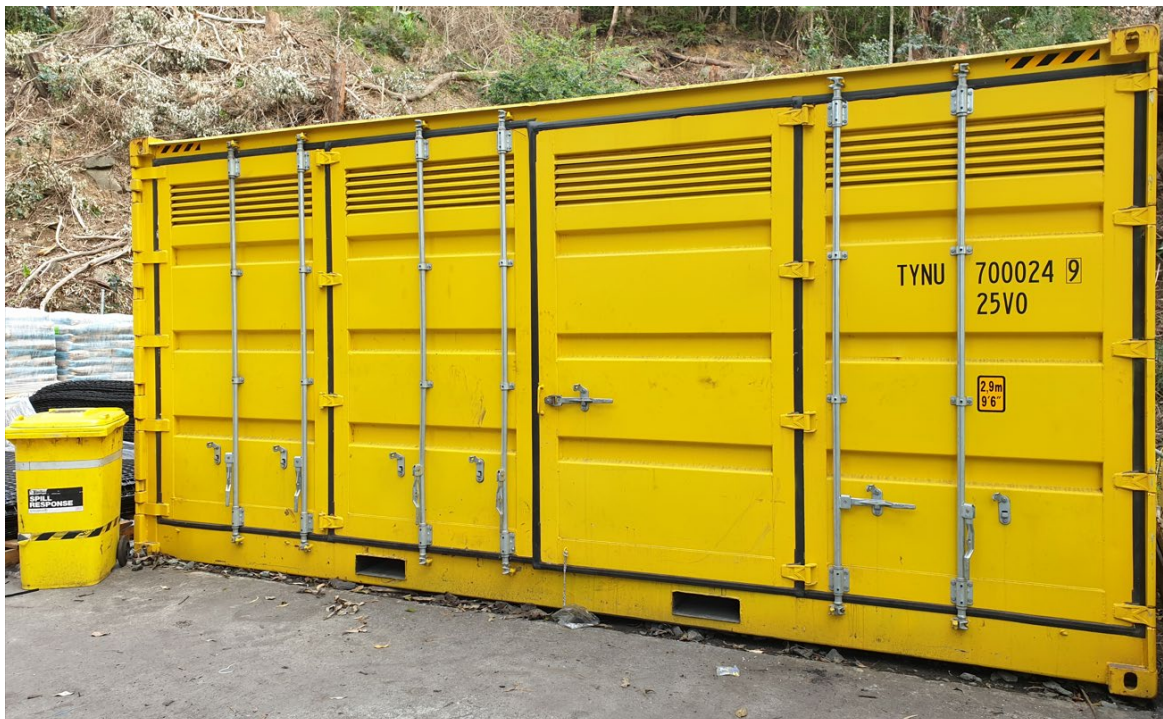
Plate 2: Hydrocarbon Storage Container

In this reporting period, a self-bunded hydrocarbon storage container (as shown in Plate 2) was installed along the Portal Road, to partially replace the permanent bunded storage area removed in FY21.

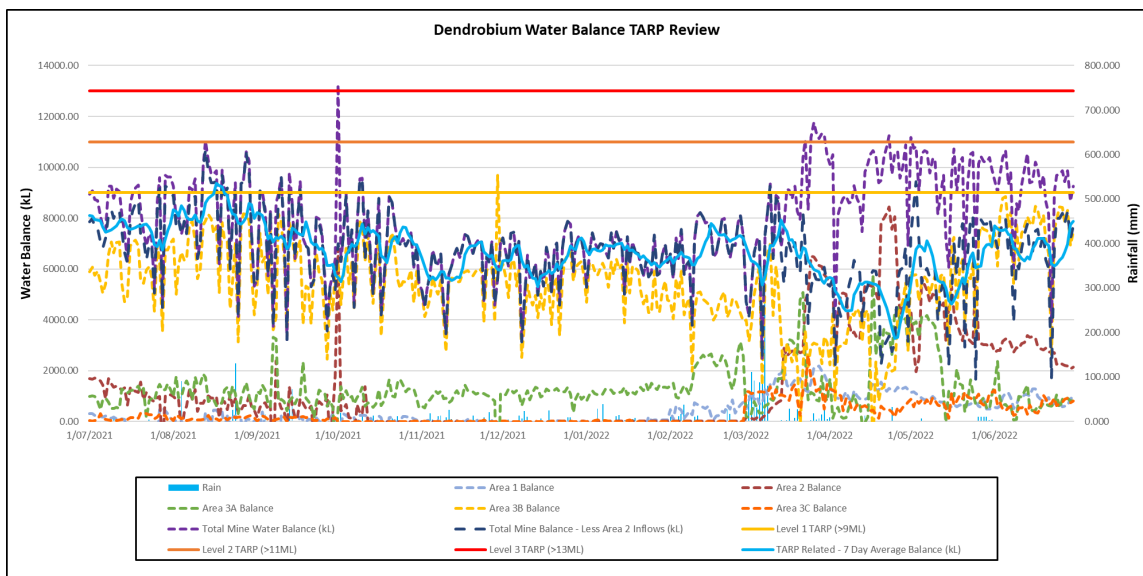
Figure 24: Dendrobium Mine Water Balance

A summary of the mine water balance for the reporting period is provided in Figure 24.

The groundwater reporting to the mine workings during normal conditions is largely characteristic of coal measure and associated strata water. This water is higher in salinity and age based on water chemistry and isotope analysis. Water samples from inflow events have been typical of near seam coal and shale water. Geochemistry, and isotope analysis is conducted monthly to determine probabilistic proportions of any modern rain or dam water entering the workings. Fluctuations in the water balance were largely a result of significant rainfall events. The water balance for the reporting period is shown in Table 32.

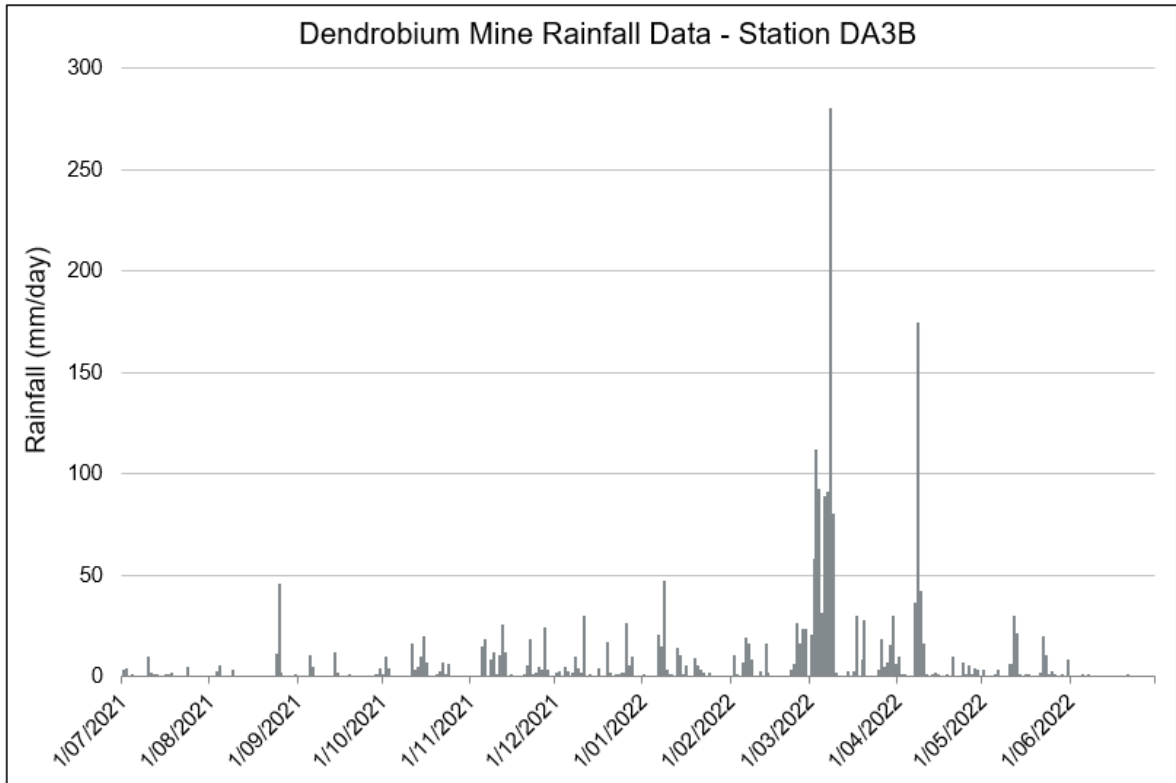
Figure 25: Dendrobium daily rainfall data for FY22

Dendrobium rainfall recorded during the reporting period was 2274.5 mm, an increase when compared to the previous reporting period in which 1544 mm rainfall was recorded. Annual rainfall for weather station DA3B located within the Dendrobium Mining Area is displayed in Figure 25. Rainfall data for FY11 to FY22 is displayed in Figure 26.

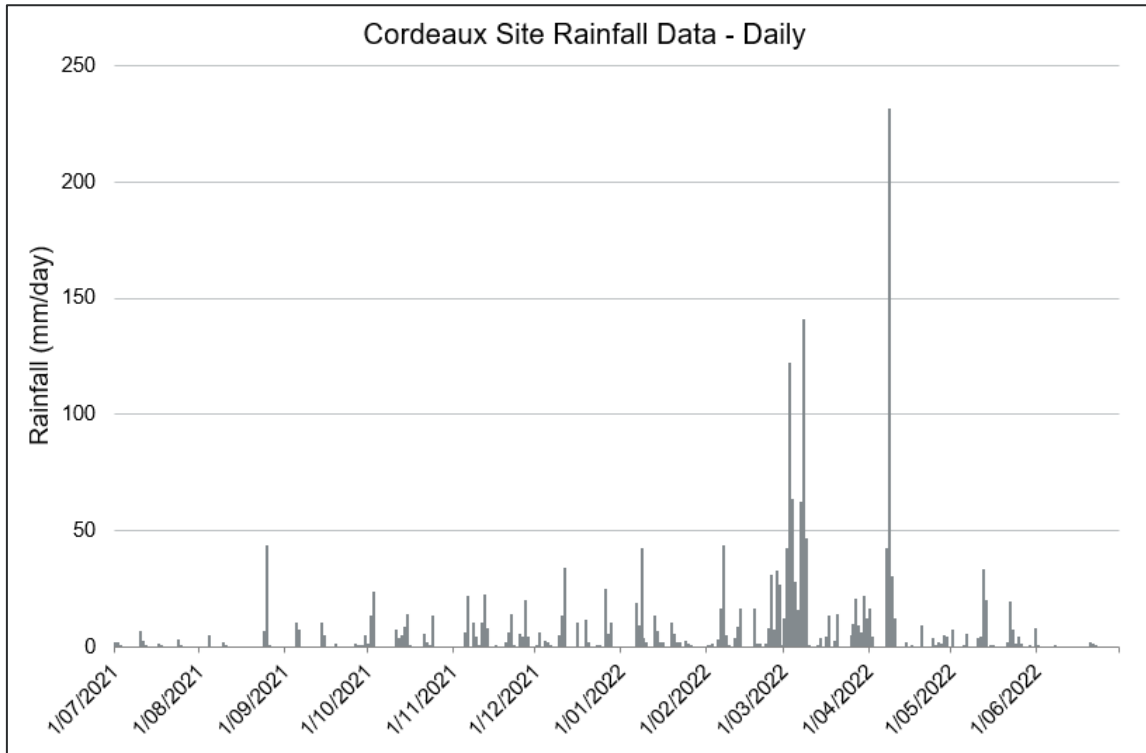
Figure 27: Cordeaux FY22 daily rainfall - site rain gauge

Rainfall for the Cordeaux surface facilities is recorded on a daily basis from a rainfall gauge located at Cordeaux Colliery Pit Top. The Cordeaux site received a total of 1962 mm of rainfall during the reporting period, which was an increase from the previous reporting period (1561.5 mm). Annual rainfall for the rain gauge located at Cordeaux Colliery is displayed in Figure 27. Figure 28 shows the total recorded rainfall for past reporting periods.

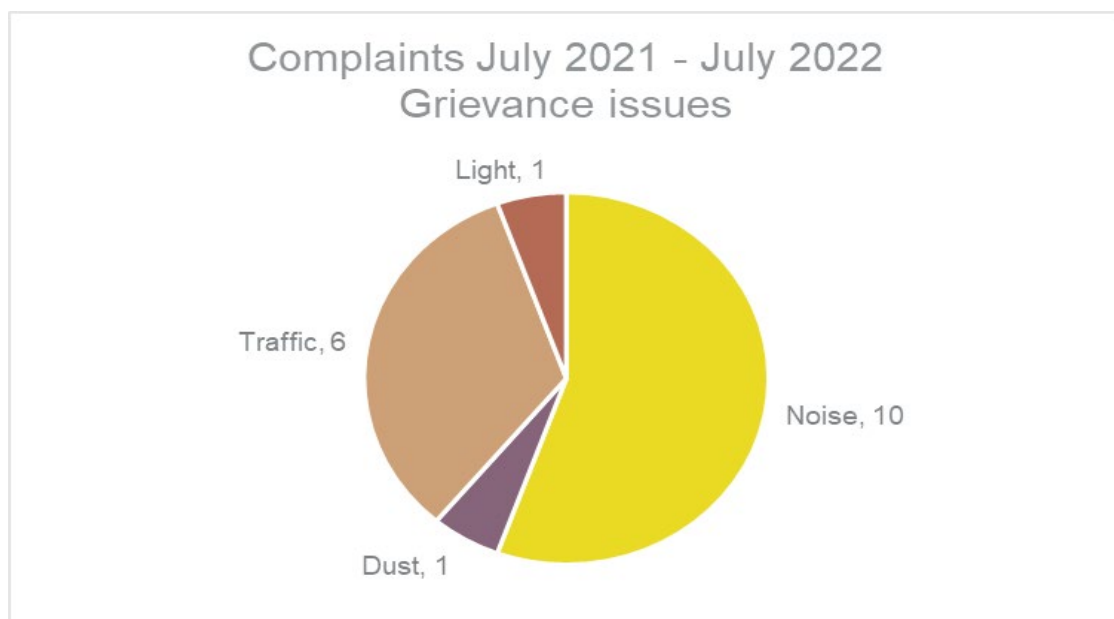
Figure 29: Issues recorded under Grievance 0045671 -FY22

Figure 29 displays complaints received by issue under Grievance 0045671 for FY22. Noise and parking on Cordeaux Road are the primary cause for concern, with 18 complaints received in total.
