**DENDROBIUM AREA 3B
LONGWALL 16 END OF PANEL
LANDSCAPE REPORT
DECEMBER 2020**

This report summarises the observed and measured subsidence effects on landscape features resulting from the extraction of Dendrobium Area 3B (DA3B) Longwall 16.

Longwall 16 is the eighth panel extracted from DA3B. Extraction began on 26 February 2020 and was completed on 4 November 2020.

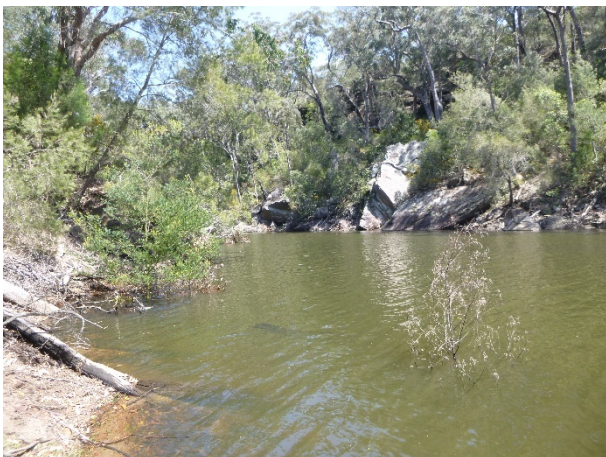
Sandy Creek-SC10 confluence and the Sandy Creek-Cordeaux Dam confluence (Photo 21 and Photo 22). On 15 October 2020, no iron staining was observed within Cordeaux Dam (Photo 23).

Photo 23: Sandy Creek Arm, looking upstream towards Sandy Creek. Taken on 15/10/2020.

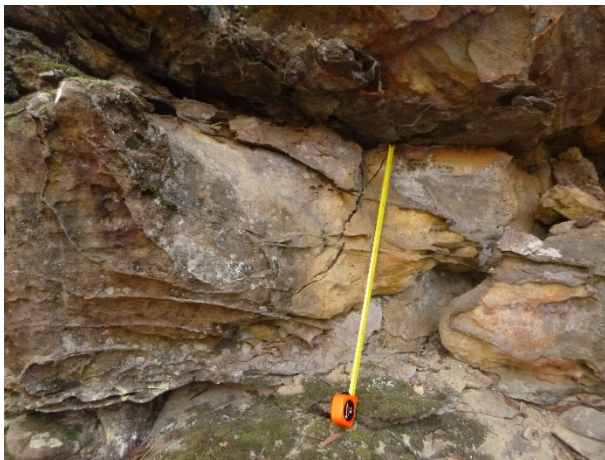
DA3B_LW16_015 is located at the base of a steep slope/step between *Lake Avon* and *Fire Road 6A* (Figure 2). The site was undermined by Longwall 16 on 9 March 2020. The impact is comprised of rock fracturing (Photo 31 and Photo 32). The rock fracturing has a length of 1.2m, a width of 0.014m and a maximum measurable horizontal depth of 0.19m. On 19 November 2020, the maximum width of rock fracturing was observed to have increased to 0.04m (Photo 33).

Level 1: Crack or fracture up to 100mm width, and/or, crack or fracture up to 10m length.

Photo 31: DA3B_LW16_015, overview of the rock fracturing. Taken on 15/05/2020.

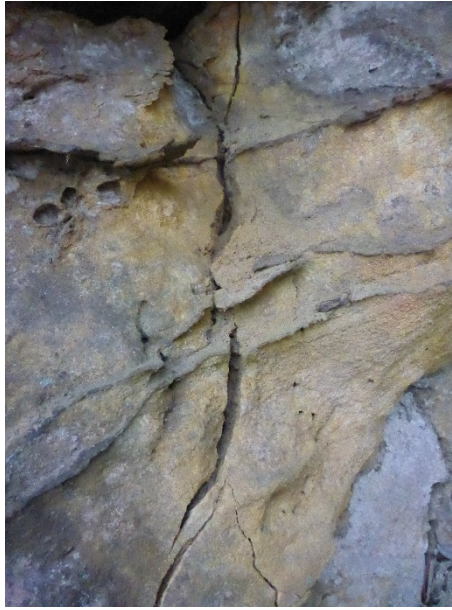
Photo 33: *DA3B_LW16_015*, looking at the rock fracturing. Taken on 19/11/2020.

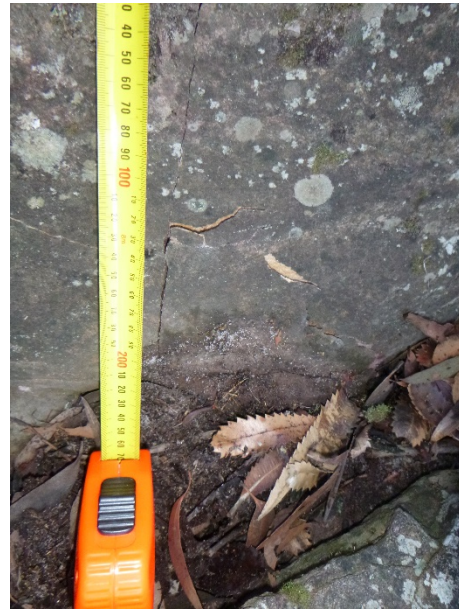
DA3B_LW16_018 is situated at SLMMP Site A3b-SS16, located between Swamp 23 and tributary LA2 (Figure 2). The site was mined beneath by Longwall 16 on 6 May 2020. The impact is comprised of two rock fractures and minor rock fragmentation (Photo 39 and Photo 40). The rock fracturing has a maximum continuous length of 4.5m, a maximum width of 0.004m and a maximum measurable depth of 0.21m. The rock fragmentation has a maximum length of 0.1m and a maximum width of 0.05m. DA3B_LW16_018 was inspected on 19 November 2020 and remains unchanged from original identification.

Level 1: Crack or fracture up to 100mm width, and/or, crack or fracture up to 10m length.

Photo 39: DA3B_LW16_018, looking at a section of rock fracturing. Taken on 16/06/2020.

Photo 40: DA3B_LW16_018, looking at a section of rock fragmentation. Taken on 16/06/2020.

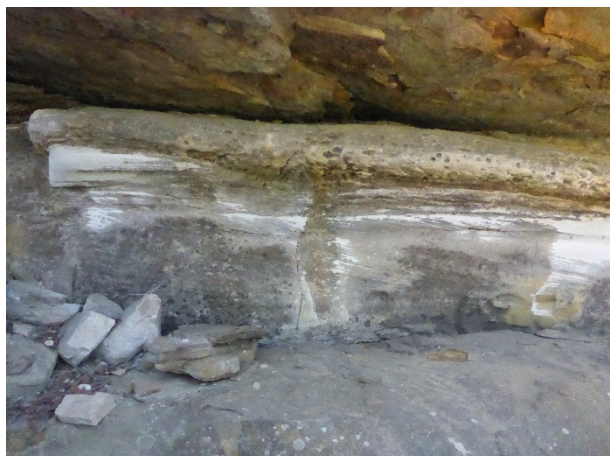
DA3B_LW16_031 is located on a step to the north-west of tributary WC15 (Figure 3). The impact is comprised of two vertical rock fractures and a rockfall (Photo 64 and Photo 65). The largest rock fracture has an approximate length of 1.5m and approximate maximum width of 0.005m. The rockfall consists of 10 pieces with an average volume of approximately 0.1m x 0.2m x 0.1m. The impact appears to be from a previous longwall, likely Longwall 15. DA3B_LW16_031 was inspected on 1 December 2020 and remains unchanged from original identification.

Level 1: Crack or fracture up to 100mm width, and/or, crack or fracture up to 10m length, and/or, rockfall from a cliff (step) which is left mostly intact (<10% length) resulting in insignificant ground disturbance.

Photo 64: DA3B_LW16_031, looking at the rock fracturing. Taken on 28/09/2020.
