Monitoring of watercourses, swamps and landscape features is undertaken to identify subsidence impacts. These features are monitored by the Illawarra Metallurgical Coal Environmental Field Team (IMCEFT) on a monthly basis prior to mining and weekly during mining. Monitoring is conducted in accordance with the approved Subsidence Management Plan (SMP) for Dendrobium Area 3A (DA3A). Extraction of Longwall 19 commenced 20 June 2022 and as of 2 August 2022 had progressed approximately 284m. During a recent inspection, two new subsidence impacts were identified.

**DA3A\_LW19\_001 (E 292826, N6192225)**

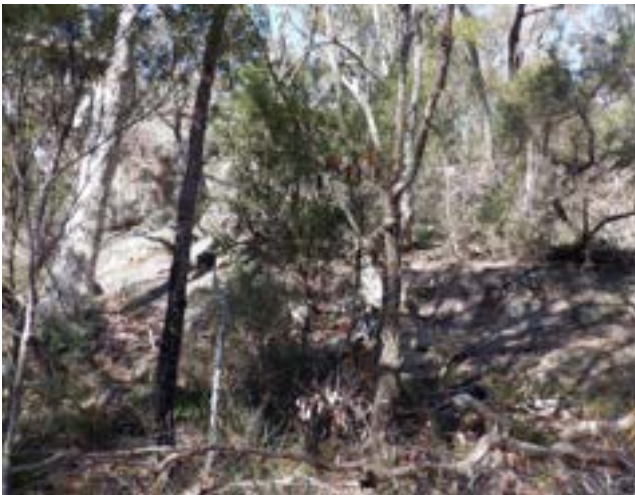
DA3A\_LW19\_002 is located on a steep slope/ step east of Fire Road 6F (Figure 1). The impact was identified on 3 August 2022, consisting of two rock fractures approximately 10m apart. The rock fracturing has an approximate maximum length of 4m and a maximum width of less than 0.1m (Photo 2 to Photo 4). Measurements have been estimated due to safety concerns.

DA3A\_LW19\_002 is a Level 1 trigger as per the Dendrobium Area 3A Landscape TARP (Table 1), specifically;

Photo 2: DA3A\_LW19\_002, showing overview of site. Taken 3/08/2022.

- Continue monitoring program as required in the DA3B SMP.
- Report impacts to key stakeholders (Biodiversity and Conservation Division; WaterNSW; NSW Resources Regulator; Regional NSW – Mining, Exploration and Geoscience)
- Summarise impacts and report in the End of Panel Report and Annual Review.

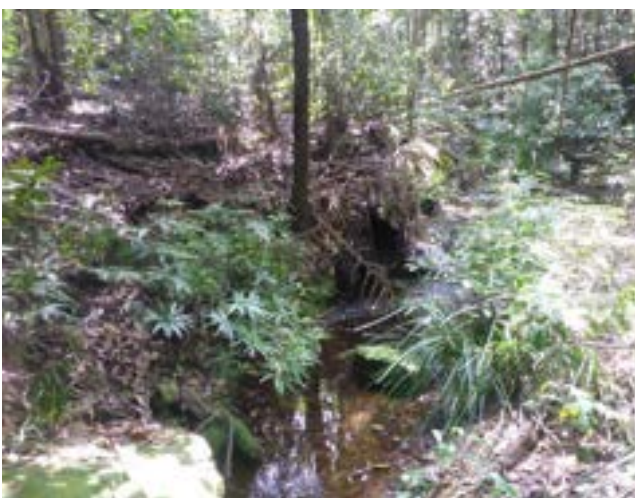
Photo 1: WC14\_Pool 3 looking upstream. Taken on 22/12/2021.

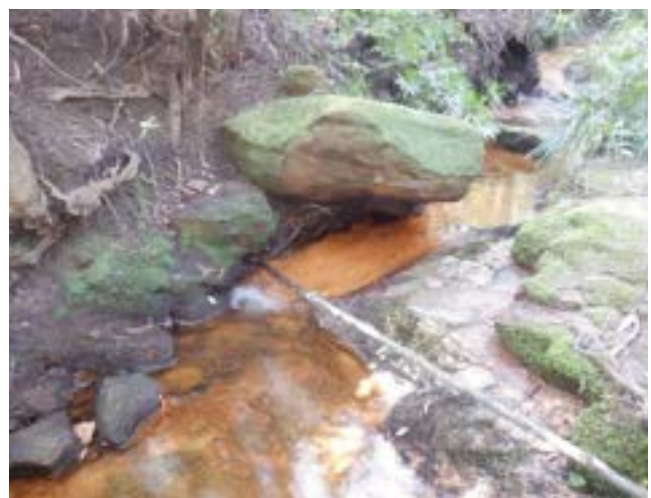
WC14 is a tributary of Wongawilli Creek, that flows westward from DA3A mining operations (Figure 1). Rock fracturing and iron staining on WC14 was previously identified and reported in January 2020, however likely occurred during the extraction of Longwall 8. During recent inspections of WC14, an increase in the extent of the iron staining was observed between WC14\_Pool 10 and the confluence of WC14 and Wongawilli Creek (Photo 1 to Photo 12). Iron staining was not evident in Wongawilli Creek (Photo 4). Isolated sections of iron staining were evident upstream between WC14\_Pool 10 and WC14\_Step 3. Similar observations were recorded during baseline mapping in 2020 (Photo 13 and Photo 14). No iron was observed upstream of WC14\_Step 3 (Photo 15 and Photo 16).

This observation is a Level 2 trigger as per the DA3A Watercourse Impact, Monitoring Management and Contingency Plan (Table 1), specifically:

Photo 2: WC14\_Pool 3 looking upstream. Taken on 16/08/2022.

- Continue monitoring program as required in the DA3A SMP;
- Report impacts to key stakeholders;
- Summarise impacts and report in the End of Panel Report;
- Review monitoring frequency;
- Submit letter report to DPE, Resources Regulator and Water NSW and seek advice on any CMA required;
- Implement agreed CMAs as approved (subject to agency feedback).

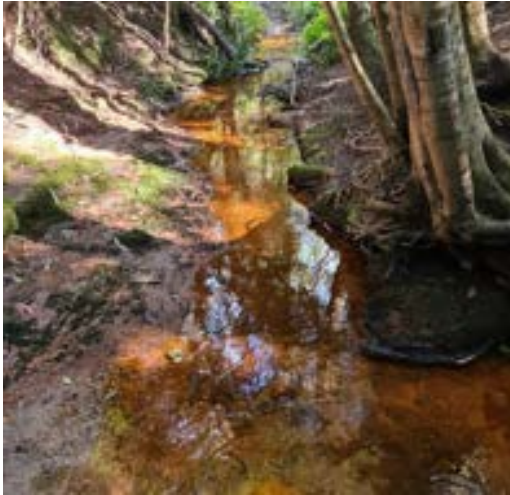
Photo 3: WC14\_Pool 3 looking downstream towards Wongawilli Creek. Taken on 16/08/2022.

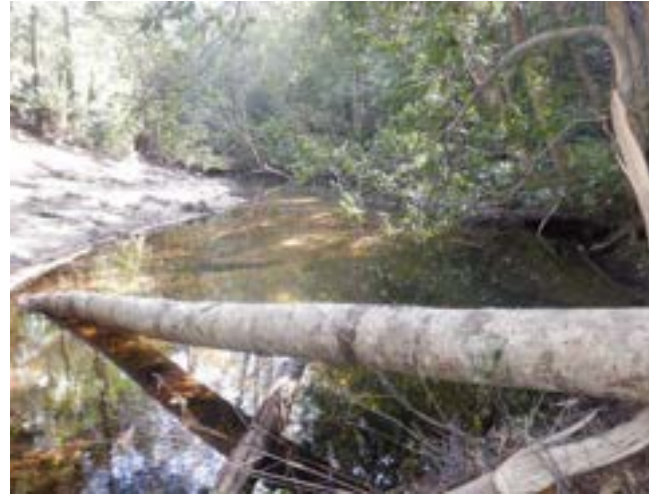
Photo 4: WC14 and Wongawilli Creek confluence, looking downstream. Taken on 16/08/2022.

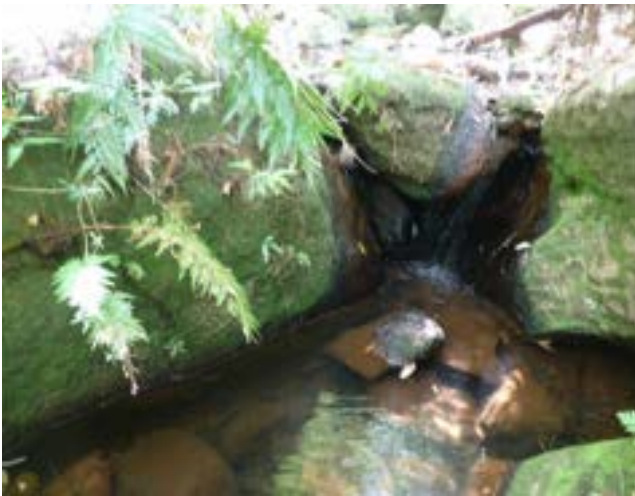
Photo 5: WC14\_Pool 9 looking upstream taken on 11/12/2020

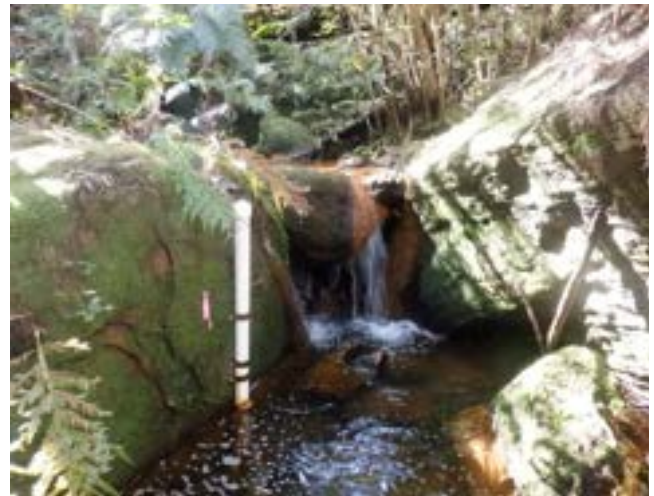
Photo 6: WC14\_Pool 9 looking upstream taken on 16/8/2022.

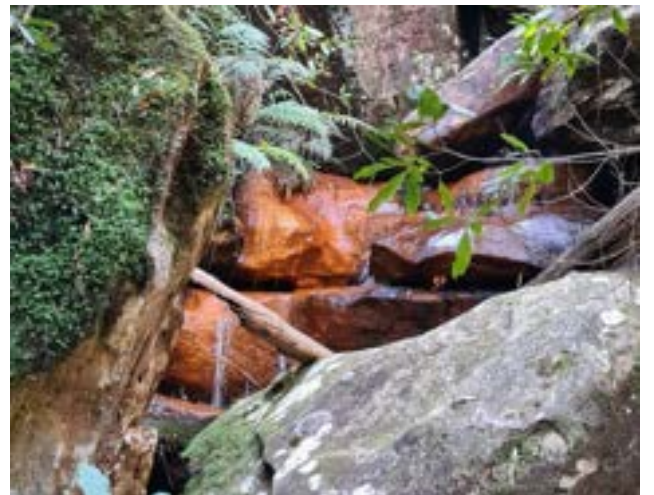
Photo 8: WC14\_Boulderfield 1, looking at the same section of iron staining. Taken on 16/08/2022.

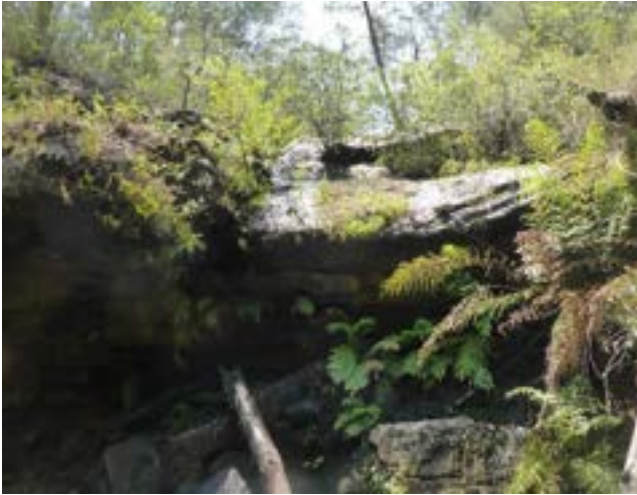
Photo 9: WC14\_Step 1, looking upstream. Taken on 17/12/2019.

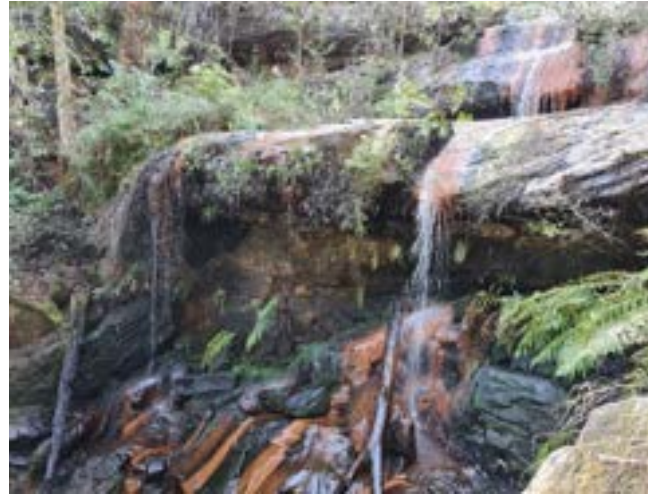
Photo 10: WC14\_Step 1, looking upstream. Taken on 16/08/2022.

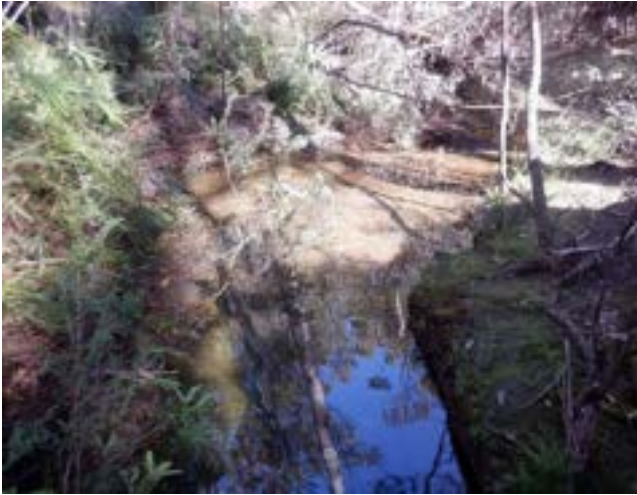
Photo 15: WC14\_Pool 16, looking downstream. Taken on 16/08/2022.

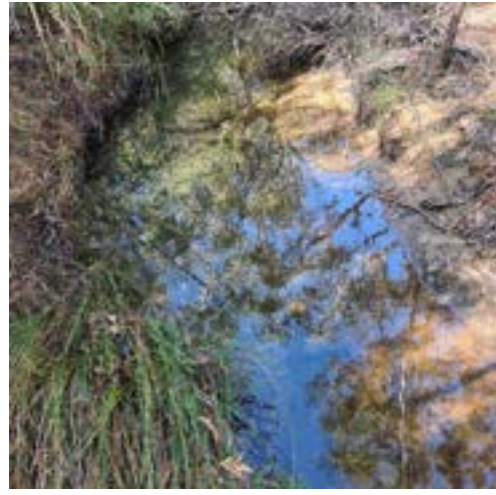
Photo 16: WC14\_Pool 18, looking upstream. Taken on 16/08/2022.

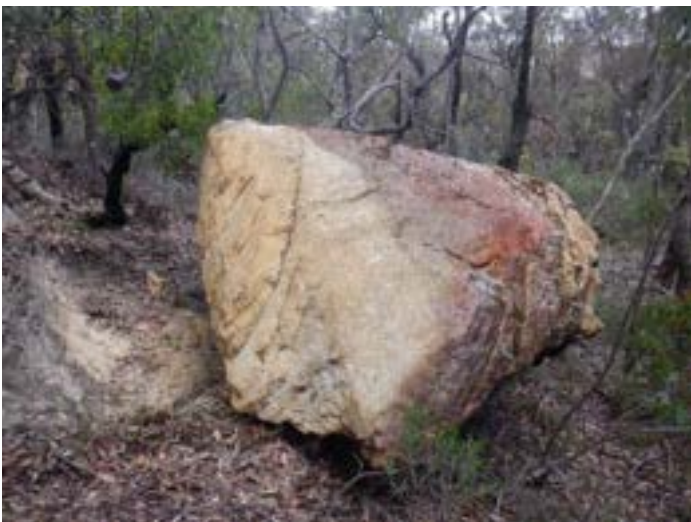
*DA3A\_LW19\_014* is a Level 1 trigger as per the Dendrobium Area 3A Landscape TARP (Table 1), specifically:

Photo 13: *DA3A\_LW19\_014*, looking at the displacement of the boulder. Taken on 7/11/2022.

- Continue monitoring program as required in the Longwall 19 SMP
- Report impacts to key stakeholders (Biodiversity and Conservation Division; WaterNSW; NSW Resources Regulator)
- Summarise impacts and report in the End of Panel Report and Annual Review
- Review monitoring frequency
- Notify relevant technical specialists and seek advice on any CMA required
- Provide safety signage and barricades as appropriate
- Implement agreed CMAs as approved

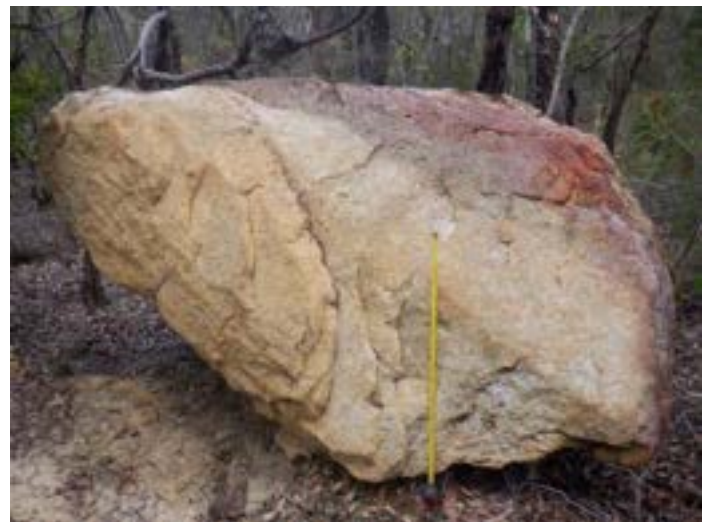
Photo 14: *DA3A\_LW19\_014*, looking at the displacement of the boulder. Taken on 7/11/2022.

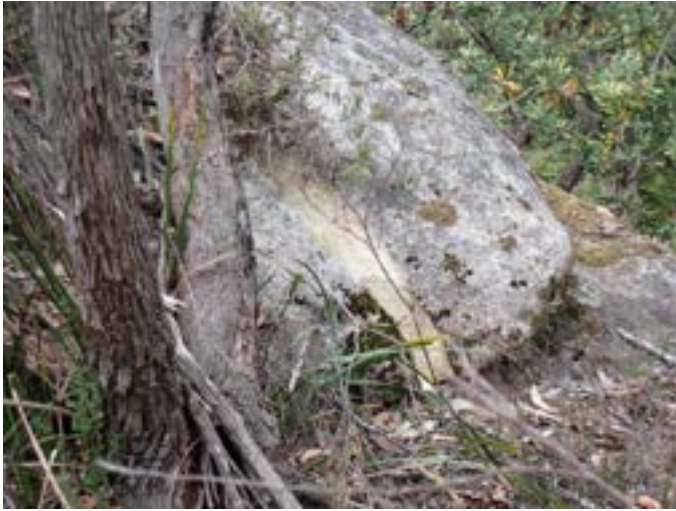
*DA3A\_LW19\_024* is a Level 2 trigger as per the Dendrobium Area 3A Landscape TARP (Table 1), specifically:

Photo 1: DA3A\_LW19\_024, section of rock fracturing. Taken on 20/12/2022.

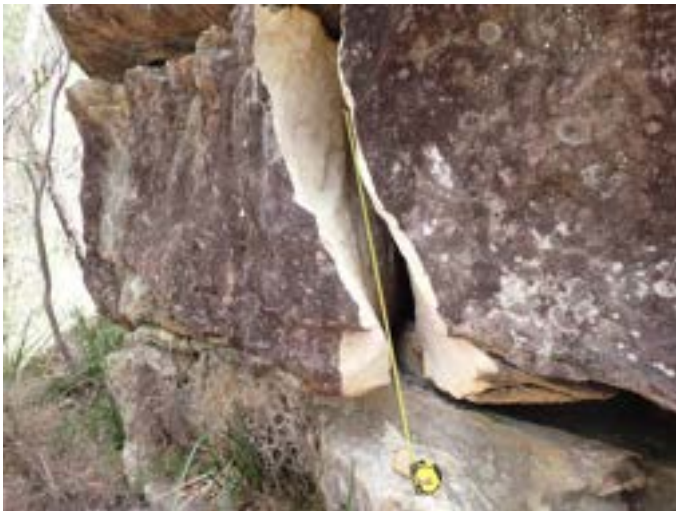
DA3A\_LW19\_015 is located approximately 390m east of Fire Road 6F and consists of a rock fracture to a steep slope/step (Figure 1). The rock fracturing has a maximum length of 1.2m, a maximum width of 0.20m and maximum measurable depth of 3m (Photo 9 and Photo 10). Measurements were previously estimated due to safety concerns. Other smaller rock fractures are also present (Photo 11 and Photo 12). Flagging tape is in place at the site as a safety precaution. Site coordinates have been corrected due to an error in previous reporting.

DA3A\_LW19\_015 is a Level 2 trigger as per the Dendrobium Area 3A Landscape TARP (Table 1), specifically:

Photo 9: DA3A\_LW19\_015, section of rock fracturing. Taken on 20/12/2022.

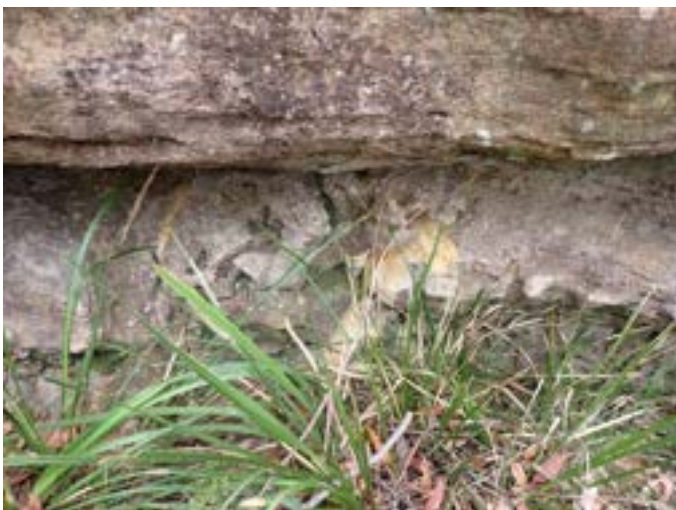
Photo 11: DA3A\_LW19\_015, section of rock fracturing. Taken on 20/12/2022.

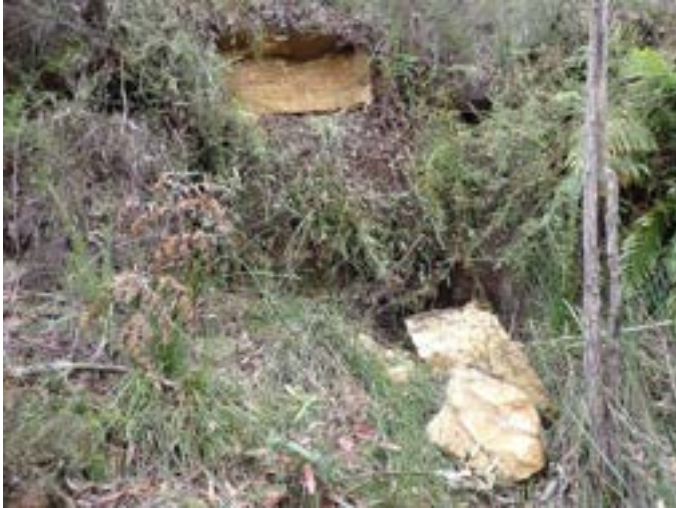
DA3A\_LW19\_016 is located 380m east of Fire Road 6F and consists of rock fracturing, fragmentation and fall (Figure 1). The rockfall has an approximate volume of 1m<sup>3</sup> (Photo 13). The largest fracture has an approximate length of 2m and a maximum approximate width of 0.1m (Photo 14 and Photo 15). Measurements have been

*DA3A\_LW19\_016* is a Level 2 trigger as per the Dendrobium Area 3A Landscape TARP (Table 1), specifically:

Photo 13: *DA3A\_LW19\_016*, section of rock fall. Taken on 20/12/2022.

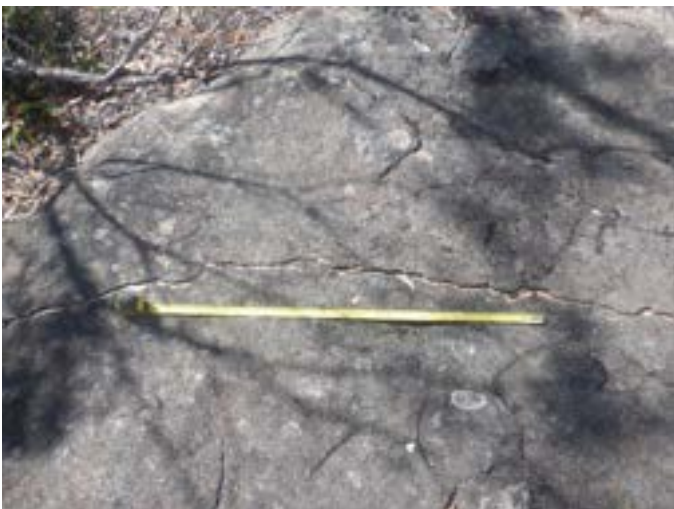
DA3A\_LW19\_028 consists of rock fracturing to a rock outcrop east of Fire Road 6F (Figure 1). The impact consists of three rock fractures within an area of 25m x 1m. The rock fracturing has a maximum continuous length of 5.86m, a maximum width of 0.016m and a maximum measurable depth of 0.4m.

DA3A\_LW19\_028 is a Level 1 trigger as per the Dendrobium Area 3A Landscape TARP (Table 1), specifically:

Photo 1: DA3A\_LW19\_028, section of rock fracturing.  
Taken on 6/02/2023.

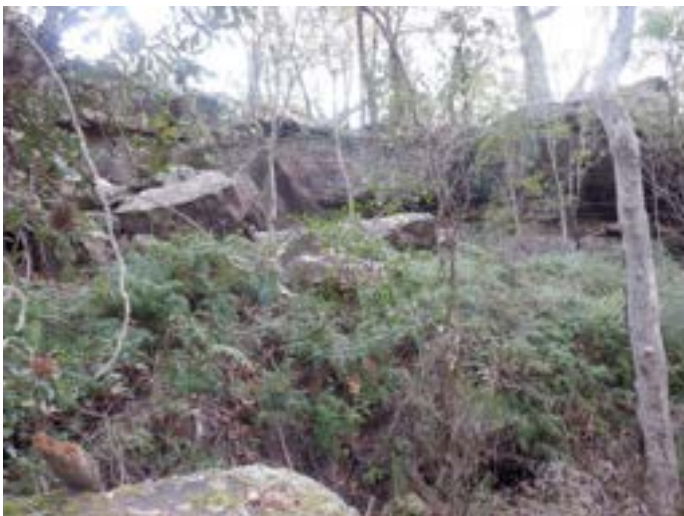
Photo 6: Landscape monitoring site *LW19\_SS11*. Taken 16/06/2022.

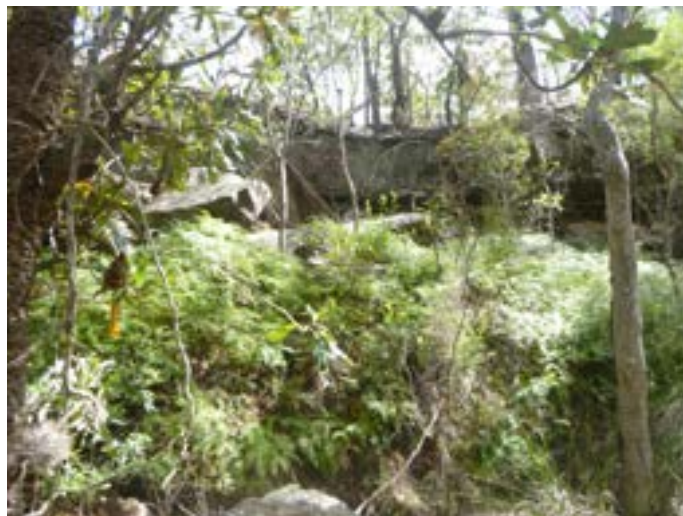
Photo 7: Landscape monitoring site *LW19\_SS11*. Taken 16/02/2023.

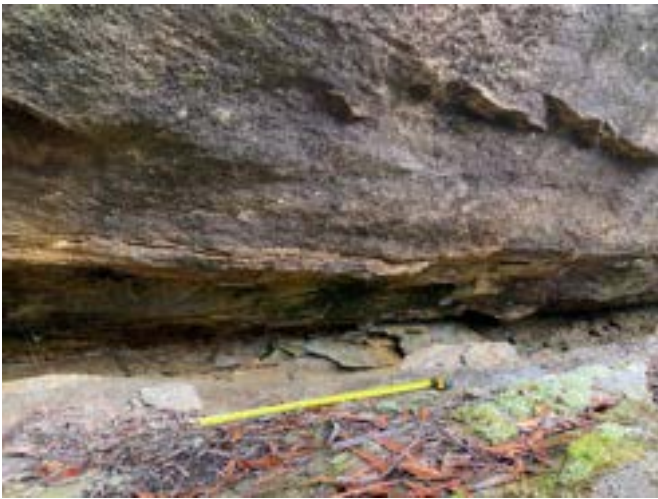
DA3A\_LW19\_037 is a Level 2 trigger as per the Aboriginal Cultural Heritage Management Plan Longwall 19, Dendrobium Area 3A TARP (Table 2), specifically:

Photo 1: DA3A\_LW19\_037, rock fracturing. Taken on 28/03/2023.

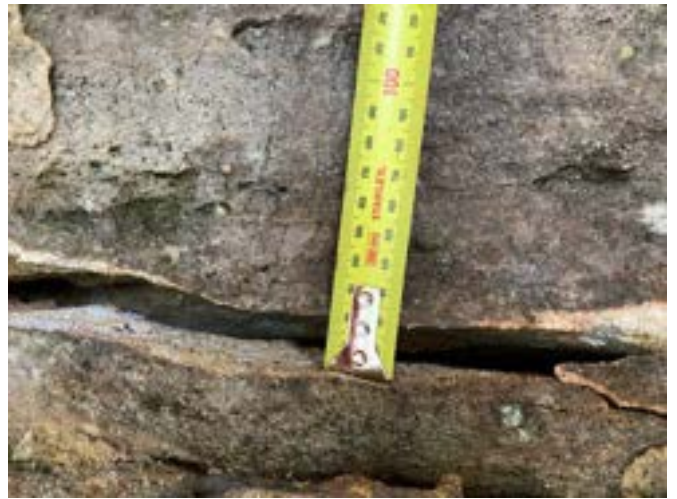
Photo 2: DA3A\_LW19\_037, rock fracturing. Taken on 28/03/2023.

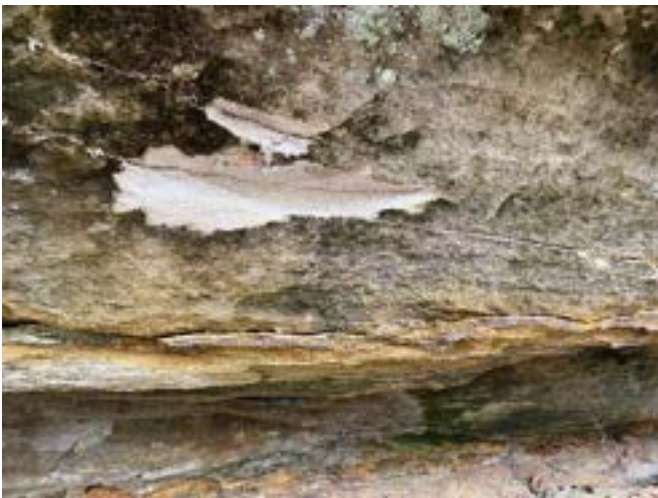
Photo 3: DA3A\_LW19\_037, rock fall. Taken on 28/03/2023.

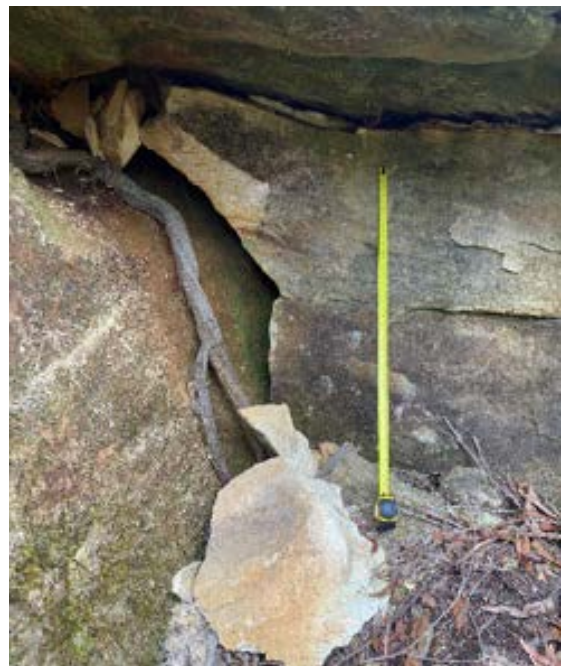
Photo 4: DA3A\_LW19\_037, rock fall. Taken on 28/03/2023.

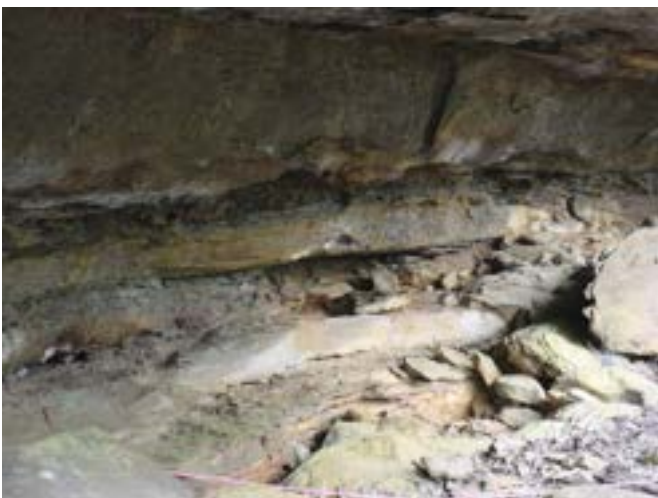
Photo 5: Baseline photo of Sandy Creek 21. Taken circa October 2020.

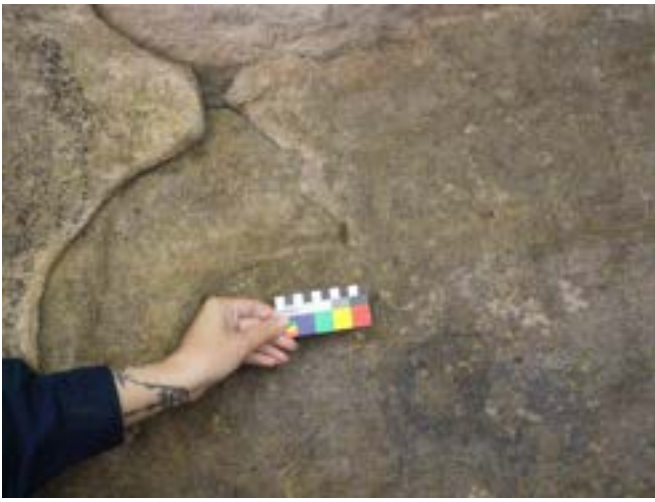
Photo 7: Baseline photo of art at Sandy Creek 21.  
Taken circa October 2020.

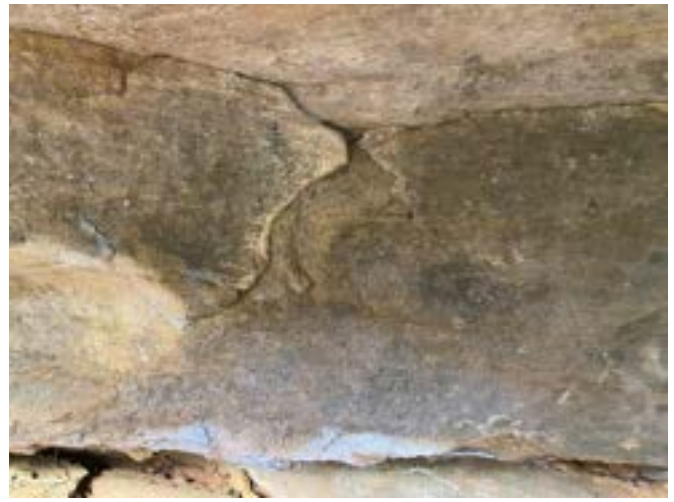
Photo 8: Sandy Creek 21 showing no impacts to art.  
Taken on 28/03/2023.

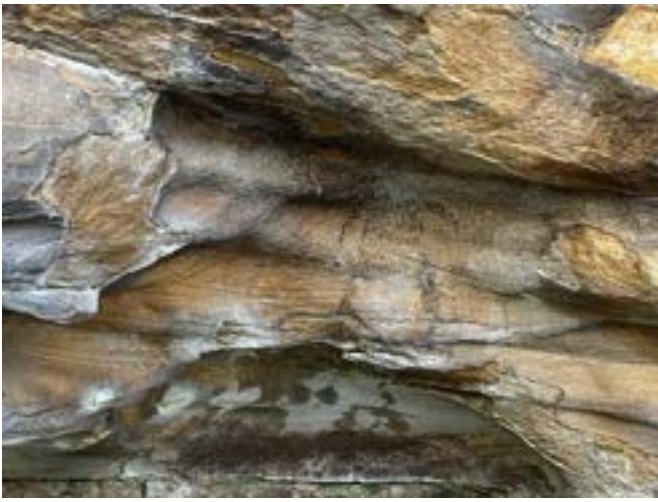
*DA3A\_LW19\_038* is a Level 2 trigger as per the Aboriginal Cultural Heritage Management Plan Longwall 19, Dendrobium Area 3A TARP (Table 2), specifically:

Photo 9: DA3A\_LW19\_038, rock fracturing at artwork. Taken on 28/03/2023.

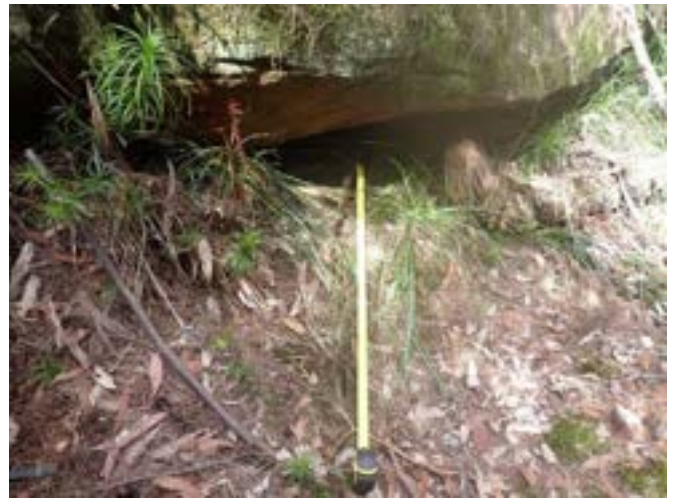
Photo 2: DA3A\_LW8\_003, looking at the extent of rock fracturing. Taken 12/04/2023.

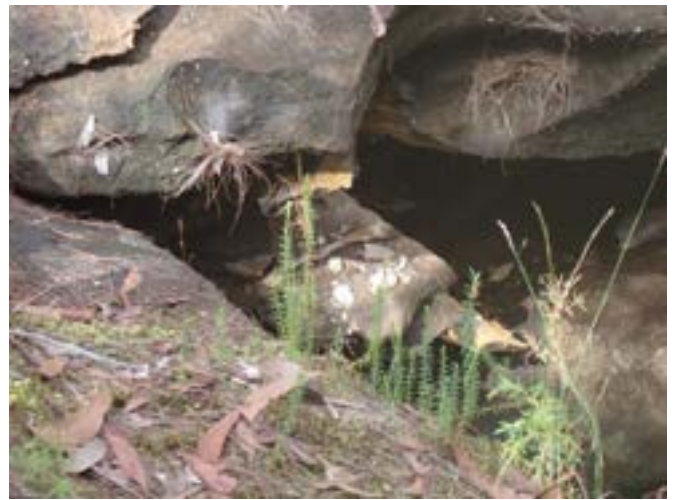
Photo 4: DA3A\_LW8\_003, looking at the rockfall and associated fragments. Taken on 12/04/2023.

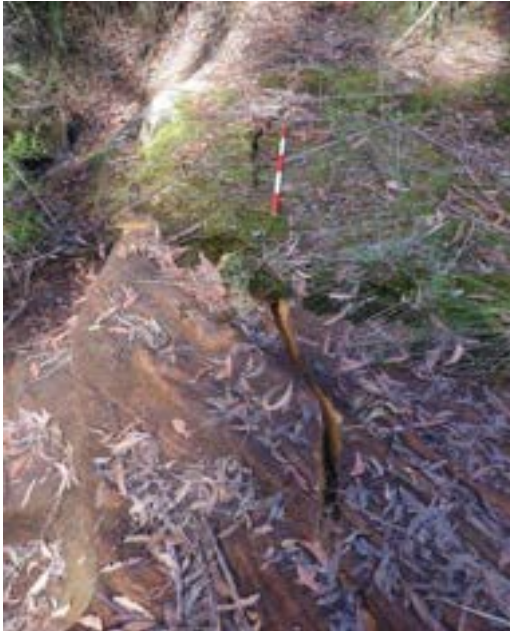
DA3A\_LW19\_043 consists of multiple rock fractures and some associated uplift on *WC14*, a tributary to *Wongawilli Creek* (Figure 1). The largest fracture has a maximum continuous length of 7.7m, a maximum width of 0.08m and a maximum measurable depth of 0.81m (Photo 1 to Photo 4). Some rock fracturing has uplifted on the rockbar with a measured uplift of 0.130m occurring at the downstream end of the impacted rockbar. No Flow was present during the inspection however some flow diversion could be expected during surface flow as the fracture runs across the main flow path of the tributary.

DA3A\_LW19\_043 is a Level 2 trigger as per the DA3A Watercourse Impact, Monitoring Management and Contingency Plan (Table 1), specifically:

- Crack or fracture that (could) result in observable loss of surface water or erosion.

Photo 1: DA3A\_LW19\_043, looking at rock fracturing on rockbar. Taken 17/04/2023.

- Continue monitoring program as required in the Longwall 19 SMP
- Report impacts to key stakeholders (Biodiversity and Conservation Division; WaterNSW; NSW Resources Regulator)
- Summarise impacts and report in the End of Panel Report and Annual Review
- Review monitoring frequency
- Submit letter report to DPE, DRG and WaterNSW and seek advice on any CMA required
- Implement agreed CMAs as approved (subject to agency feedback)

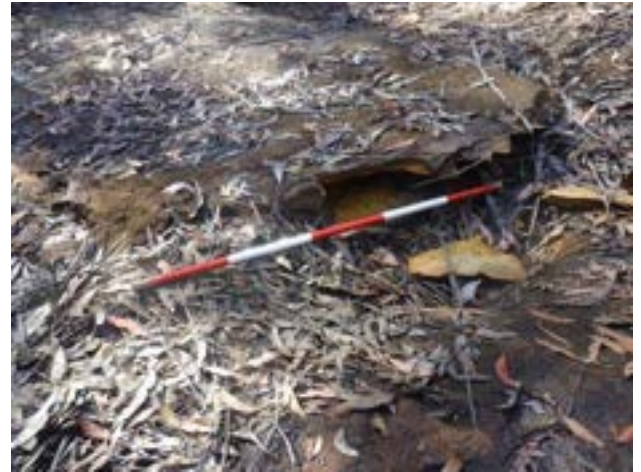
Photo 4: DA3A\_LW19\_043, looking at section of uplift. Taken 17/04/2023.

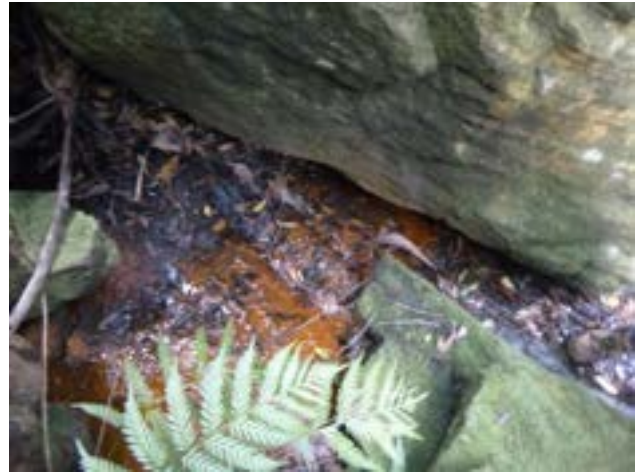
Photo 2: DA3A\_LW19\_045, showing iron staining disappearing beneath a boulder. Taken on 26/04/2023.

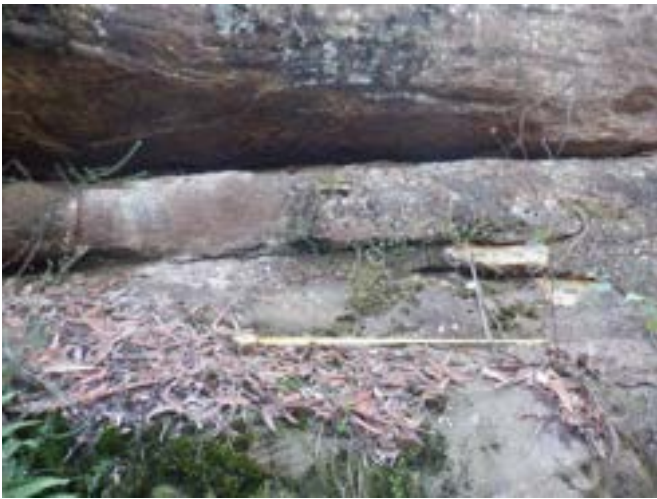
*DA3A\_LW19\_054* is located 365m to the west of *Fire Road 6F* (Figure 1). The impact consists of rock fracturing and associated fragmentation. The rock fracturing has a maximum continuous length of 3.4m and a maximum width of 0.01m (Photo 7 and Photo 8). The largest rock fragment has a volume of less than 0.01m<sup>3</sup> (Photo 8).

*DA3A\_LW19\_054* is a Level 1 trigger as per the Dendrobium Area 3A Landscape TARP (Table 2), specifically:

- Crack or fracture up to 100mm width;
- Crack or fracture up to 10m length;

Photo 7: *DA3A\_LW19\_054*, showing rock fracturing and fragmentation. Taken on 4/5/2023.

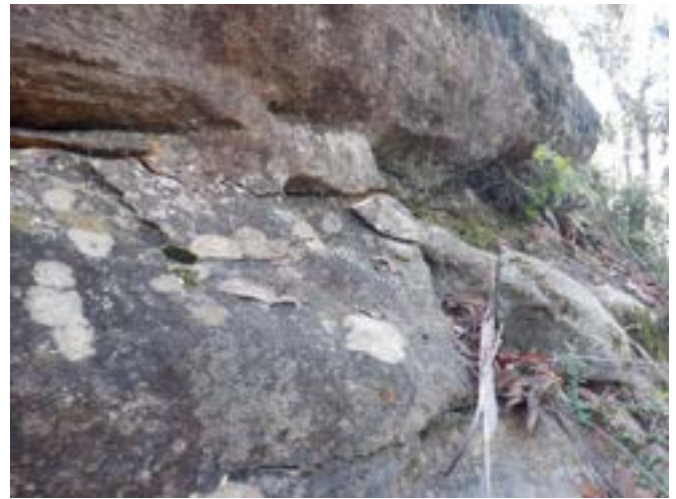
Photo 8: *DA3A\_LW19\_054*, showing rock fracturing and fragmentation. Taken on 4/5/2023.

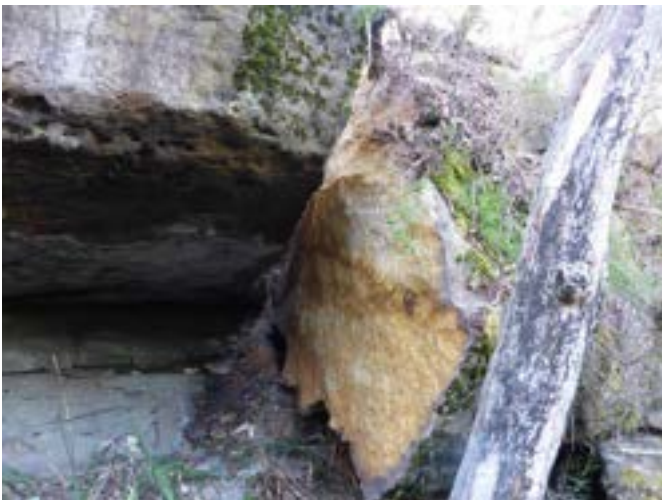
DA3A\_LW19\_056 is located 160m to the north of tributary WC14 (Figure 1). The impact consists of rock fracturing and rockfall/block movement on a step/overhang. The rock fracture has a maximum continuous length of 17.5m. The large section of rock that has detached from the adjacent ground has an estimated volume of 110m<sup>3</sup> (Photo 11). There are multiple fractures under the overhang estimated to be up to 1.5m in length with widths up to 0.05m. There are also three rock fractures on the outcrop above the overhang, up to 0.15m in length and a width up to 0.04m (Photo 12). The impact site has minimal downslope vegetation disturbance. The immediate area around the impact was flagged with marking tape as a safety precaution.

DA3A\_LW19\_056 is a Level 2 trigger as per the DA3A Watercourse Impact, Monitoring, Management and Contingency Plan (Table 1), specifically:

- Rock fall or overhang collapse at a cliff (step) site, where characteristics of the cliff (step) have changed.
- Crack or fracture between 10 and 50m length.

Photo 11: DA3A\_LW19\_056, showing step/overhang that detached. Taken on 5/05/2023.

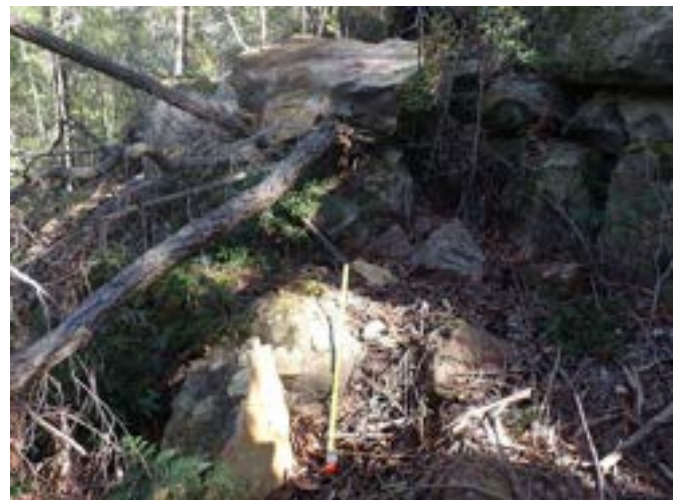
Photo 2: DA3A\_LW19\_063, showing associated rock fragmentation.  
Taken on 10/05/2023.
